AHERA 2016 REINSPECTION

WIGGINS SCHOOL DISTRICT
320 CHAPMAN STREET
WIGGINS, CO 80654

RLH Engineering Project #16072

SUBJECT: Wiggins School District
2016 AHERA 3-Year Reinspection
RLH Engineering Project Number 16072

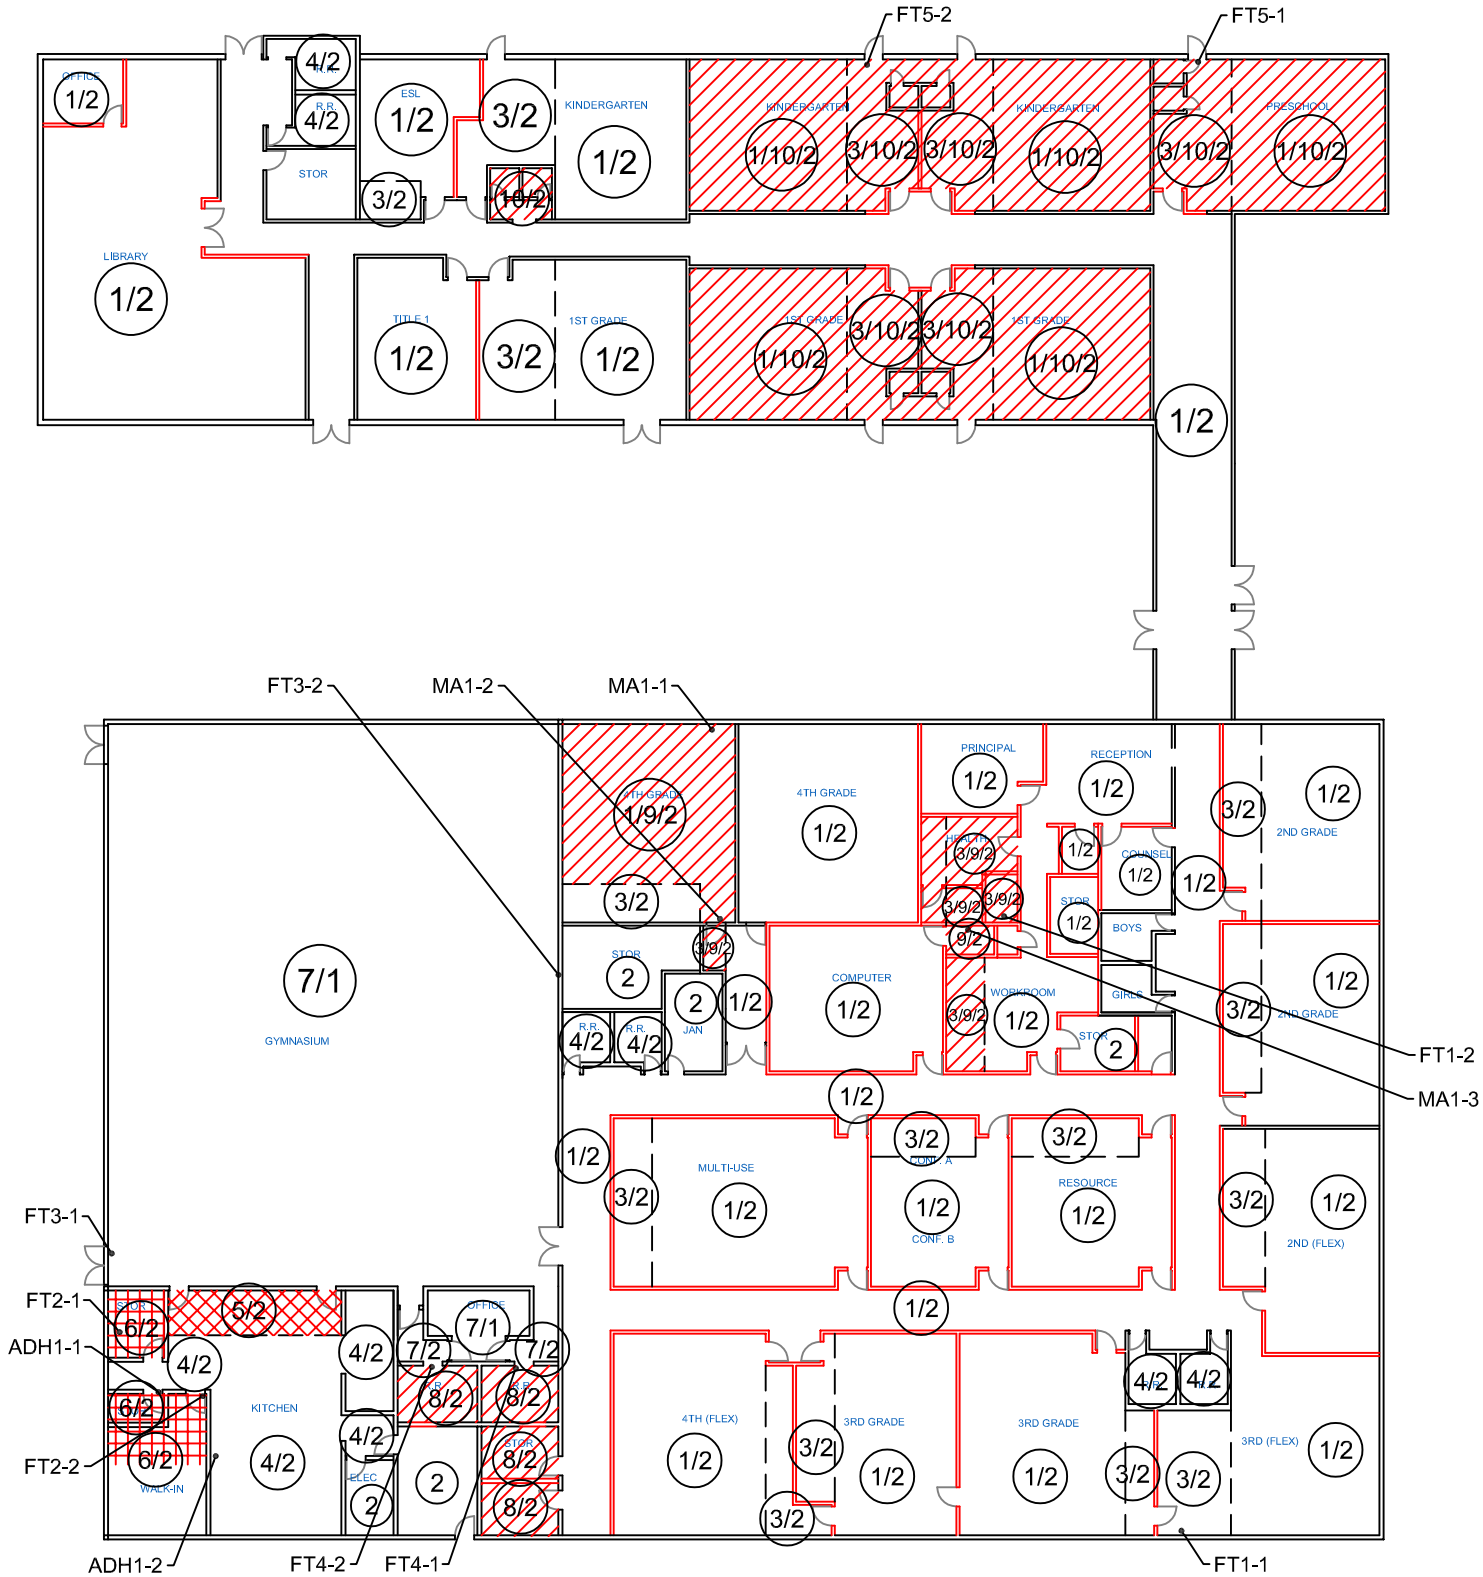
MAIN FLOOR PLAN
SCALE: 1"=30'-0"

- 12"x12" Floor Tile – Kitchen Storage/Office: This material is in good condition
- Adhesive under 2"x2" ceramic floor tile – Kitchen: This material is assumed ACM, as it is inaccessible for sampling without damaging the ceramic tile. The tile itself is in good condition.
- Adhesive under 4"x4" ceramic wall tile – Kitchen: This material was confirmed ACM through sampling, but was not previously identified as ACM in the management plan. The material is in good conduit and protected by ceramic tile.

- **Black Mastic – Misc. Areas:** This material exists in many of the locations where asbestos floor tile formerly existed. The material is in good condition and covered by non-ACM flooring, with the exception of the main data closet. It is recommended this material be covered with non-ACM flooring, in order to preserve the ACM in good condition.
- **Transite Panels – Exterior, at windows/doors:** This material is assumed ACM, but was not previously identified in the AHERA management plan. The panels are in good condition but should be painted to preserve the panels in good condition.

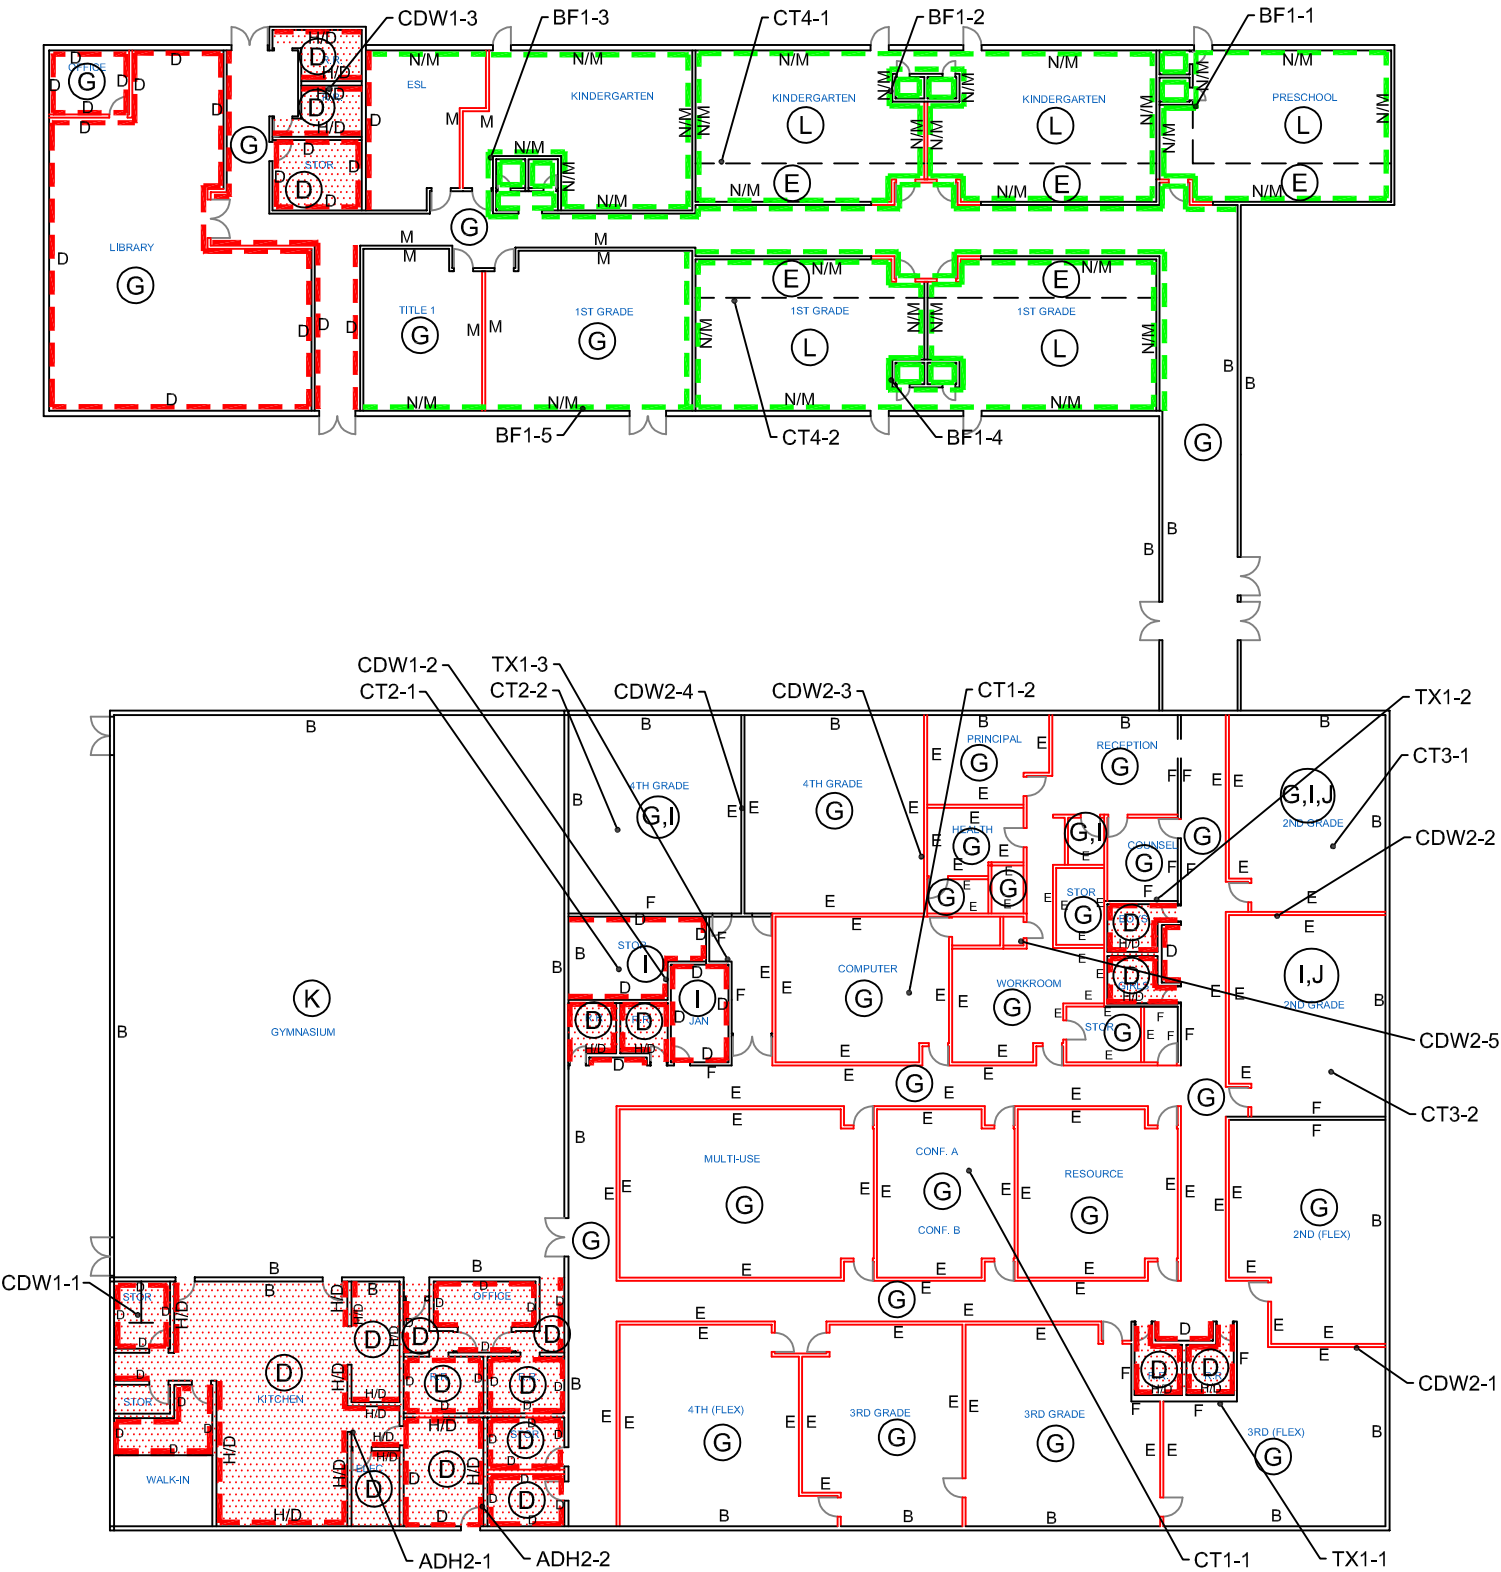
MAIN FLOOR PLAN
SCALE: 1"=30'-0"

N	cmu block - painted	BF1-1, BF1-2, BF1-3, BF1-4, BF1-5	3,960 SF	BLOCK FILLER: YES
***The white ceramic tile and associated adhesive is labeled as ACM because the samples taken contained "white compound" in the lab report that was asbestos containing. This is joint compound from the drywall that the white ceramic tile is adhered to.

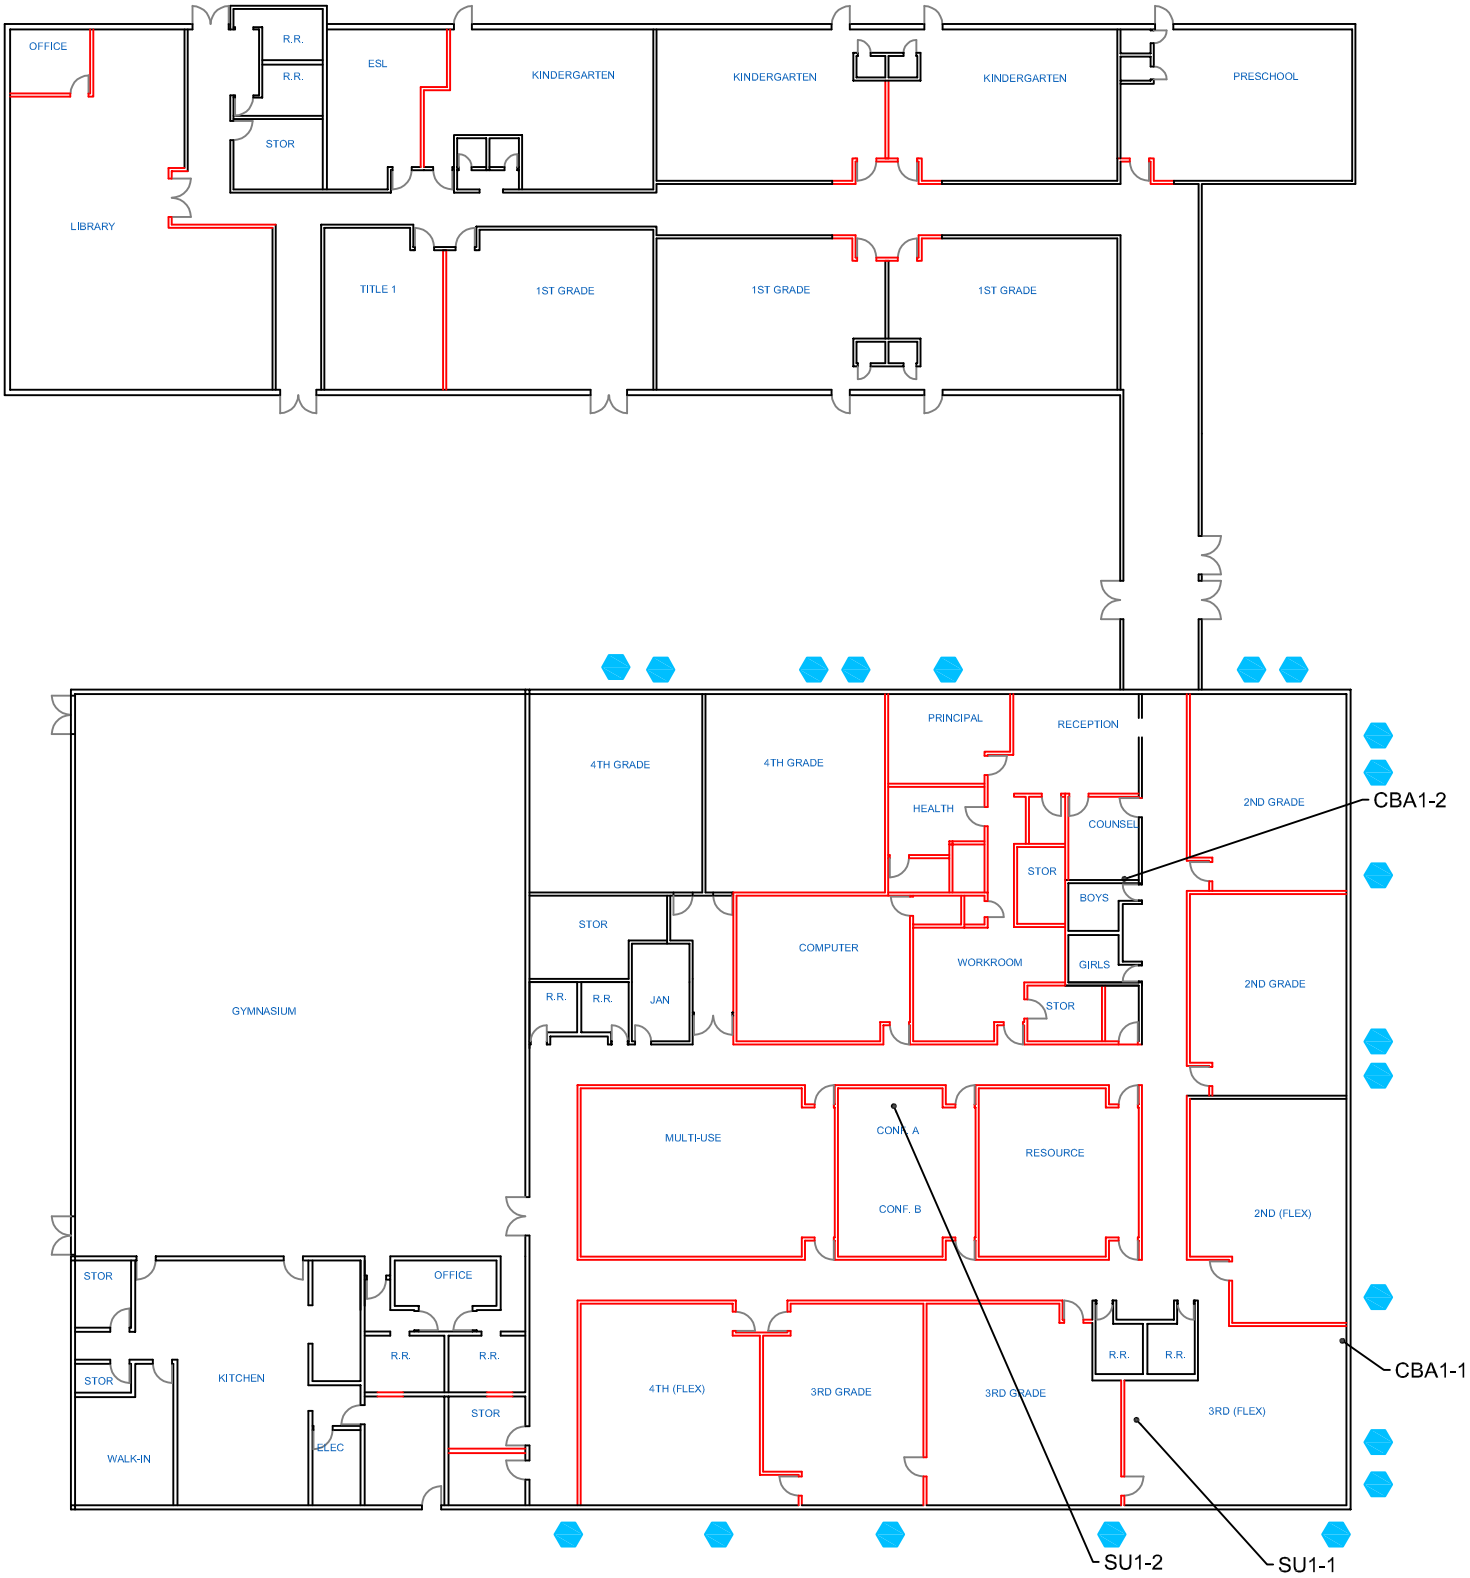
MAIN FLOOR PLAN
SCALE: 1"=30'-0"

Transite Panels (assumed ACM)	Panels below classroom windows	NF	LOW	GOOD	5	Non-friable material in good condition	Paint is peeling from some panels, but panels are intact.
Block Filler	Kindergarten Rooms, 1 st Grade Rooms, Board Room	NF	LOW	GOOD	5	Non-friable material in good condition	Material is covered by paint and in good condition

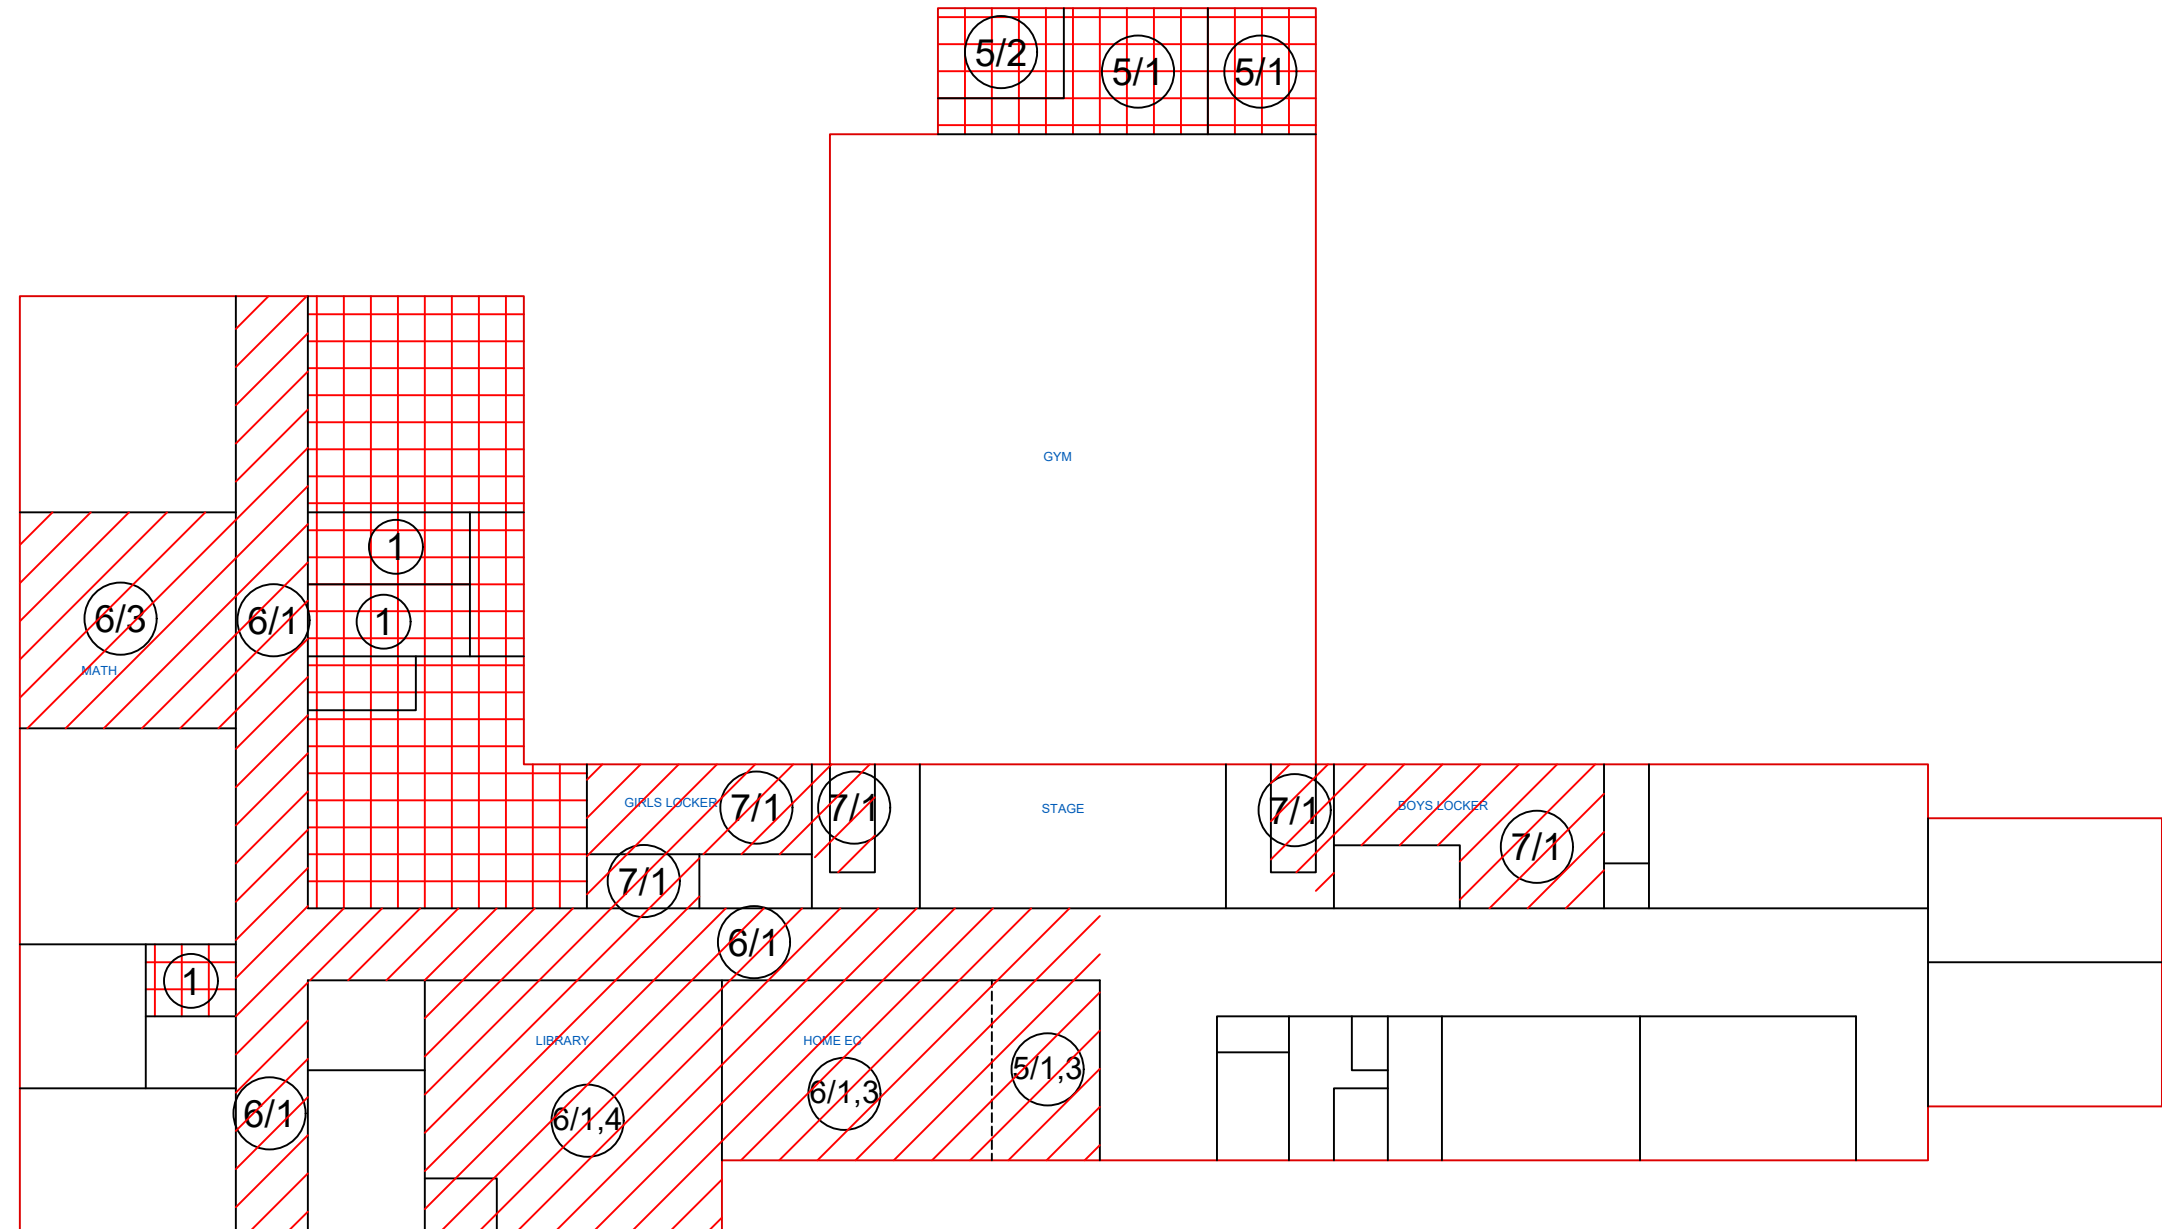
MAIN FLOOR PLAN
SCALE: NONE

- **12"x12" Floor Tile, Cream/Tan/Brown, Non-ACM Mastic – Restrooms, Locker Rooms, Concessions Area, Sick Room:** This material is in good condition. However, some areas noted are not consistent with the material description from the previous management plan documents. Sampling of these materials is recommended to confirm presence of ACM.
- **9"x9" Floor Tile, Green with White and Black, ACM mastic – Concessions:** This material is in good condition. However, some areas noted are not consistent with the material description from the previous management plan documents. Sampling of these materials is recommended to confirm presence of ACM.

- 9"x9" Floor Tile, Green with White Blotch, ACM mastic – Science Rooms, Prep Room, Dark Room, Library: This material is in good condition. However, some areas noted are not consistent with the material description from the previous management plan documents. In particular, in the Science Rooms, visible floor tile is a 12"x12" white/gray tile. However, green 9"x9" tile is visible under older casework. Although the exposed areas of 9"x9" tiles may have been removed/replaced, the presence of ACM mastic under the newer tile is suspected to remain and these materials should remain managed under the asbestos management plan program. Sampling of these materials is recommended to confirm presence of ACM.

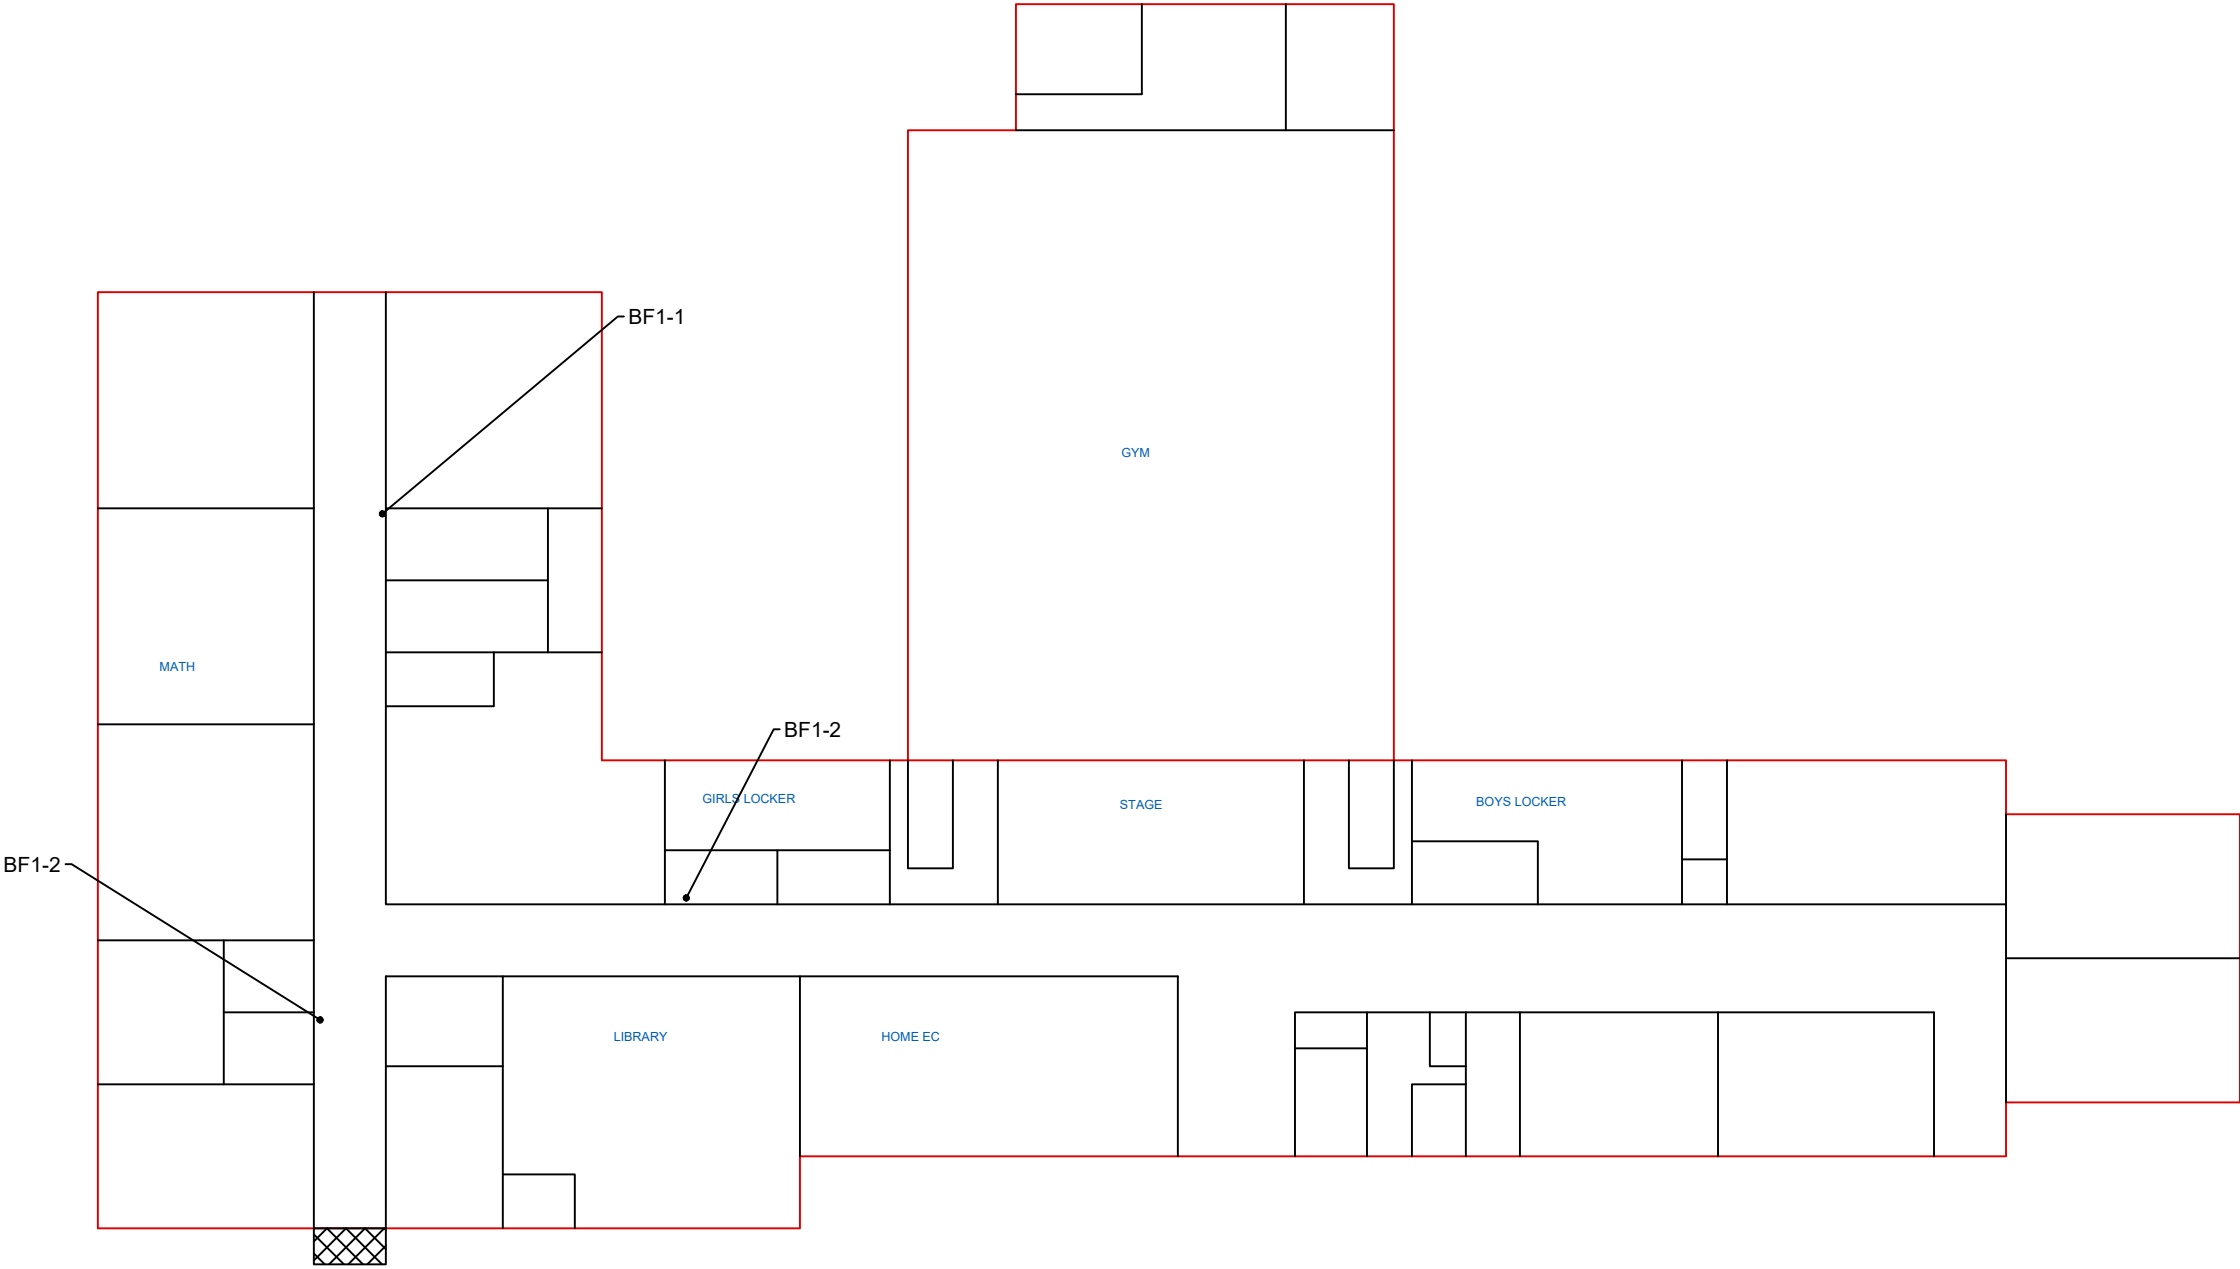
MAIN FLOOR PLAN
SCALE: NONE

- Transite Panels – Above Main Entrance at Admin Office: This material is assumed ACM, but was not previously identified in the AHERA management plan. The panels are in good condition but should be painted to preserve the panels in good condition.

BLOCK FILLER SAMPLES (BF1-1, BF1-2, BF1-3)
NON-DETECT FOR ASBESTOS

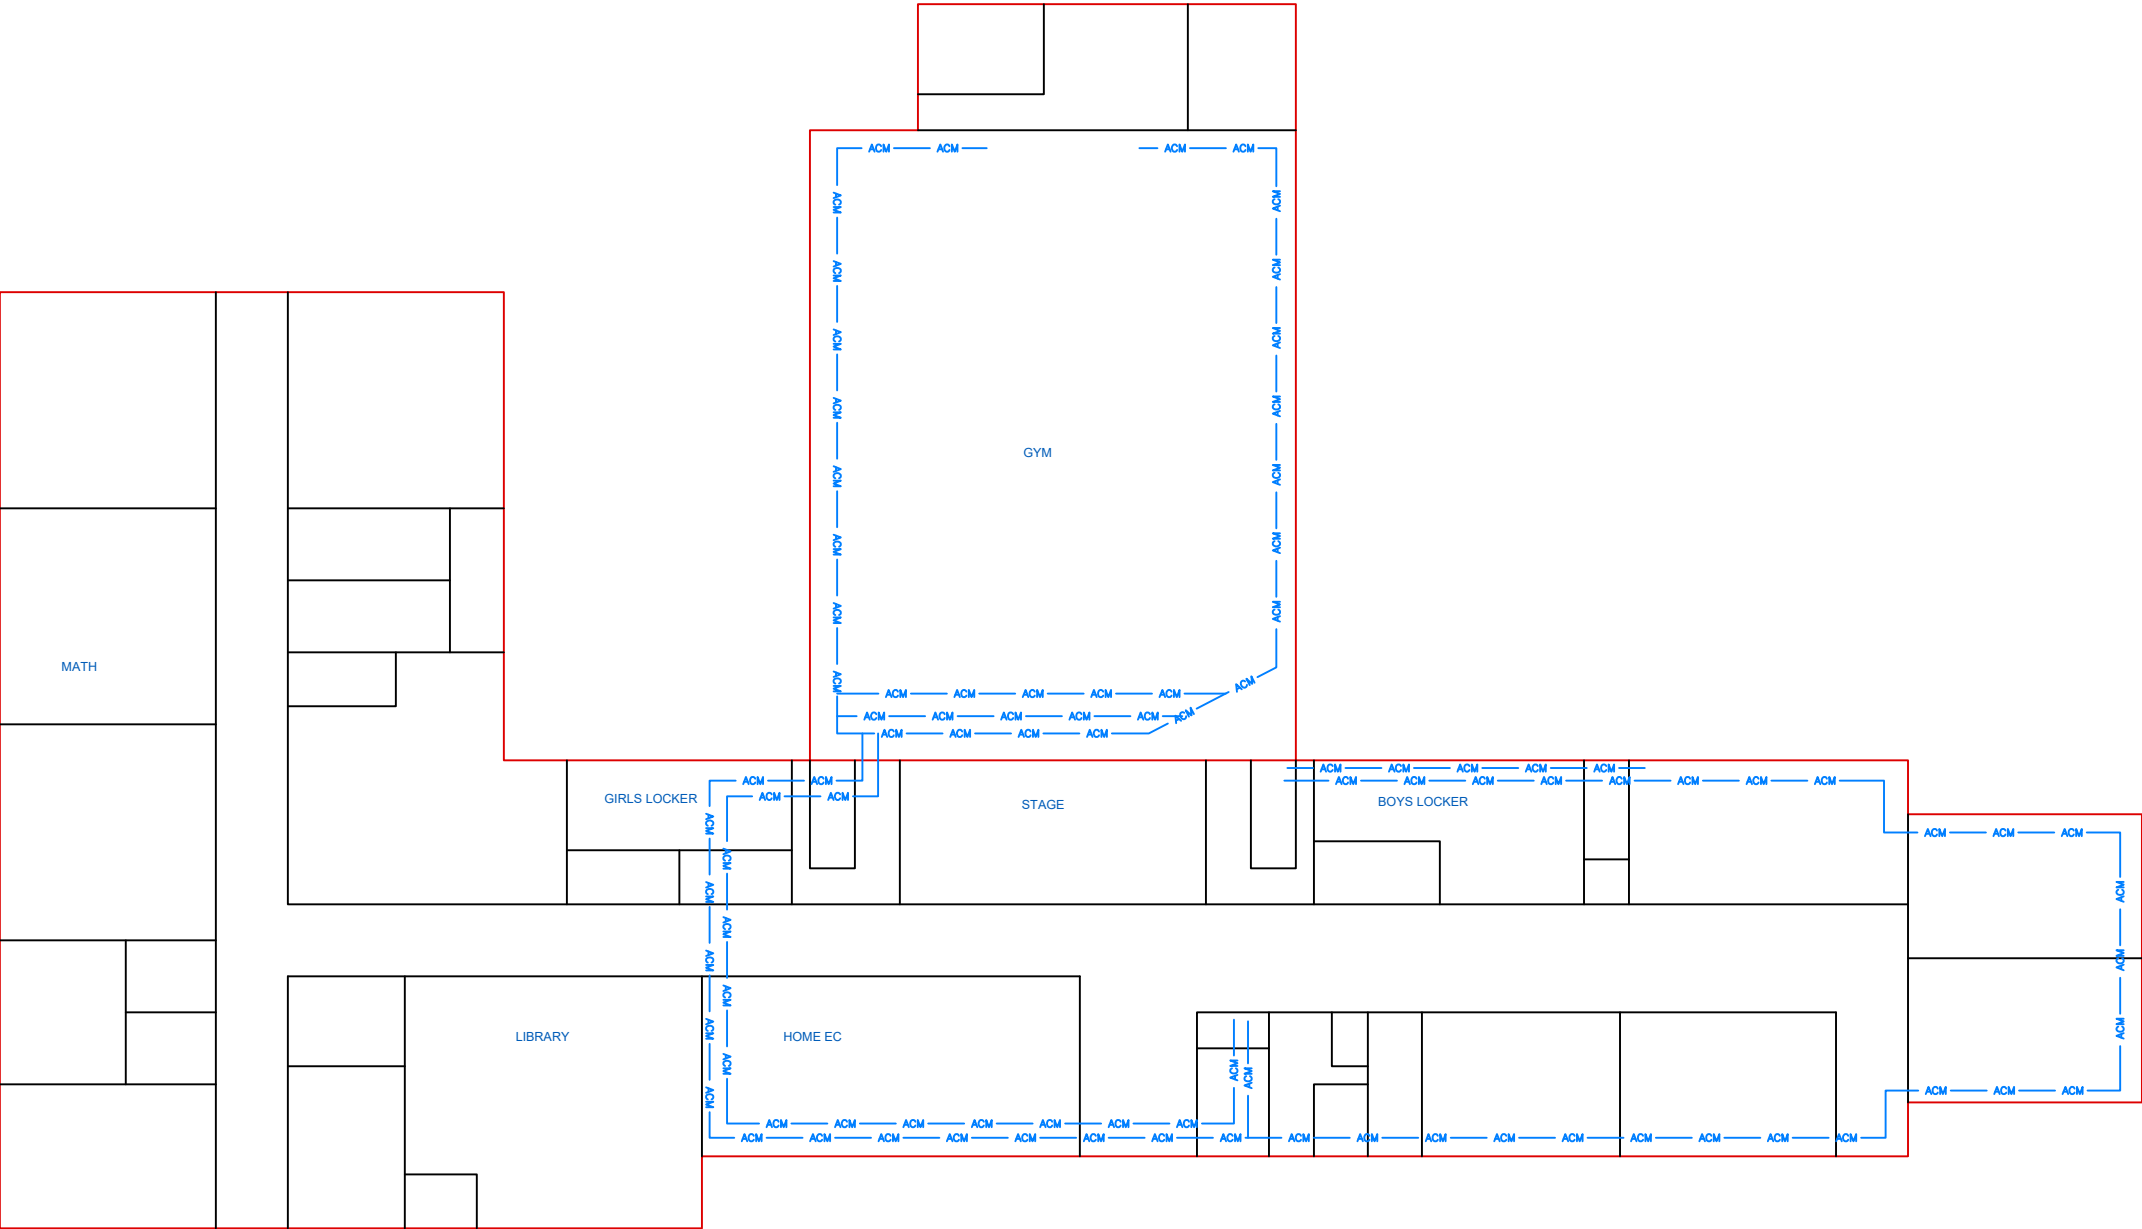
MAIN FLOOR PLAN
SCALE: NONE

- Pipe Insulation – Crawlspace/Tunnels: This material exhibits localized damage at various locations, but is inaccessible to most building occupants, accessible only to district administration and maintenance staff. However, doors and hatches further segregating this material from personnel were noted as in poor condition, and lacked proper warning placards. For damaged materials in storage or utility areas accessible to staff, repair or abatement of damaged materials is recommended. Where materials can be closed off to staff via locked doors, it is recommended these barriers be reestablished and proper warning placards affixed.

9"x9" Floor Tile – Tan with Cream and Brown streak (Mastic is non- ACM)	PM: See original AHERA plan for Preventative Measures prescribed	1989		Continuous	PM: Continue waxing tile to maintain material in good condition
	RA: See original AHERA plan for Recommended Actions prescribed				RA: None, unless disturbance by renovation/demolition anticipated. Sampling of material should be conducted to verify presence of ACM. Perform abatement if necessary.
9"x9" Floor Tile – Green with White Blotch (Mastic is also ACM)	PM: See original AHERA plan for Preventative Measures prescribed	1989		Continuous	PM: Continue waxing tile to maintain material in good condition
	RA: See original AHERA plan for Recommended Actions prescribed				RA: None, unless disturbance by renovation/demolition anticipated. Sampling of material should be conducted to verify presence of ACM. Perform abatement if necessary.
Pipe Insulation	PM: See original AHERA plan for Preventative Measures prescribed	1989		Continuous	PM: Secure access ways to tunnels and crawlspace; affix appropriate warning labels.
