# **WATER DAMAGE/MOLD INVESTIGATION**

**Massachusetts Life Science Center  
1000 Winter Street  
Waltham, Massachusetts**

Prepared by:  
Massachusetts Department of Public Health  
Bureau of Environmental Health  
Indoor Air Quality Program  
July 2014

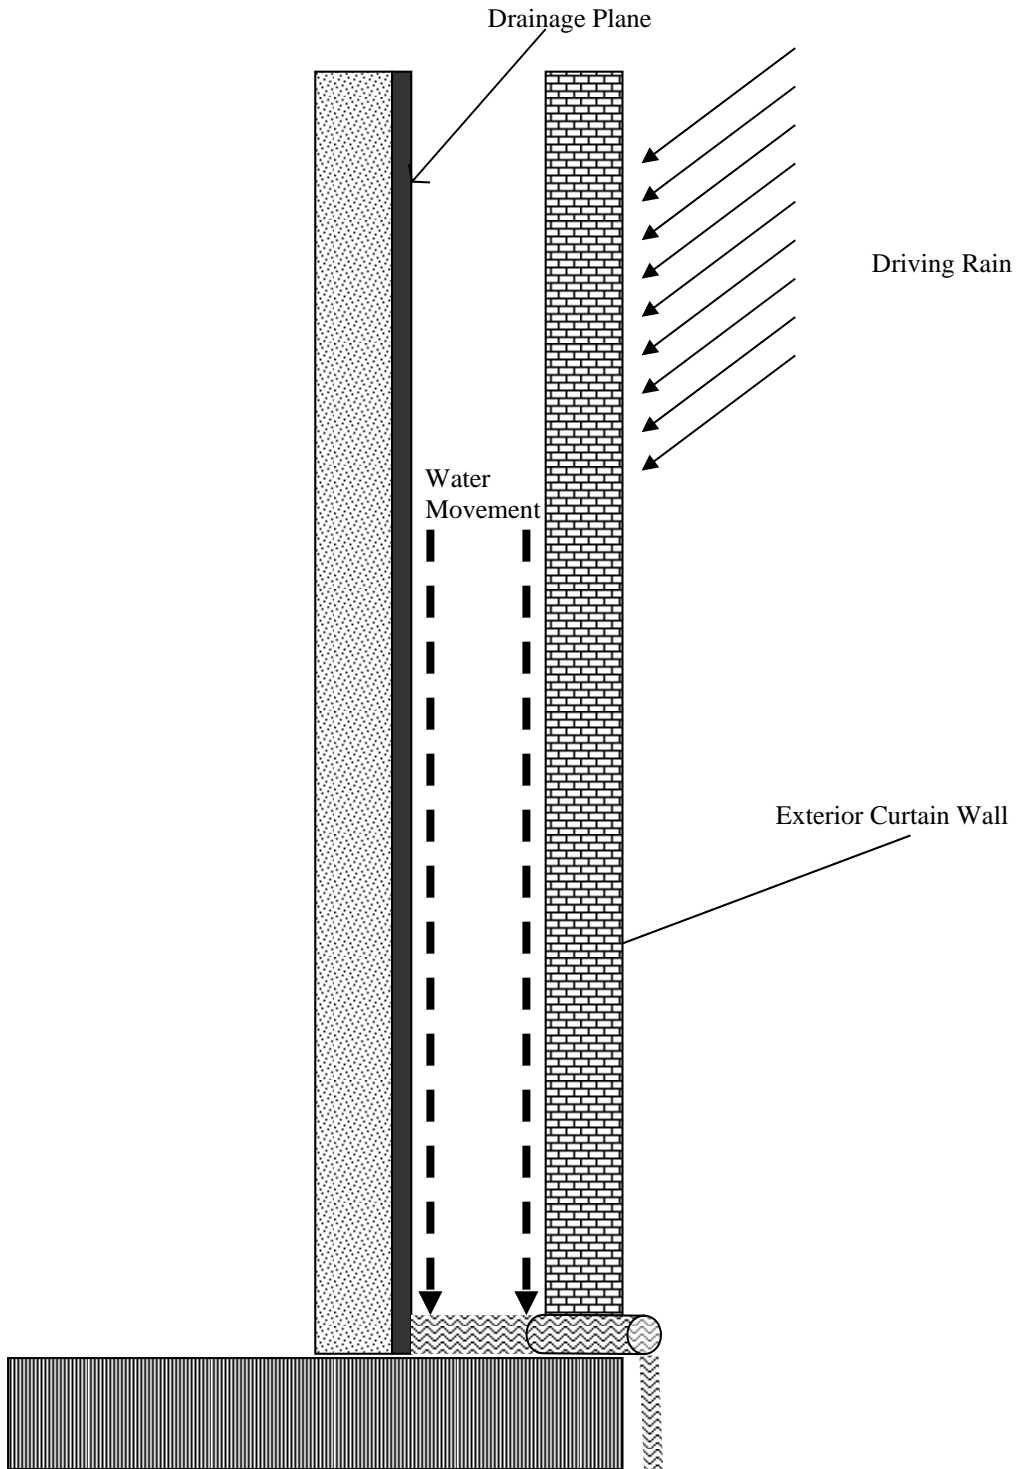
**Figure 1**

A drainage plane is one component of an exterior wall system that is typically designed to prevent moisture penetration into the building interior. The drainage plane within the wall system is typically installed in a manner that redirects water out, allowing building components to remain dry. An exterior wall system should also have the following components to drain water (Figure 1):

**Drainage Plane Function: Weep Holes Drain Water from the Wall System to Prevent Moisture Penetration into the Interior**

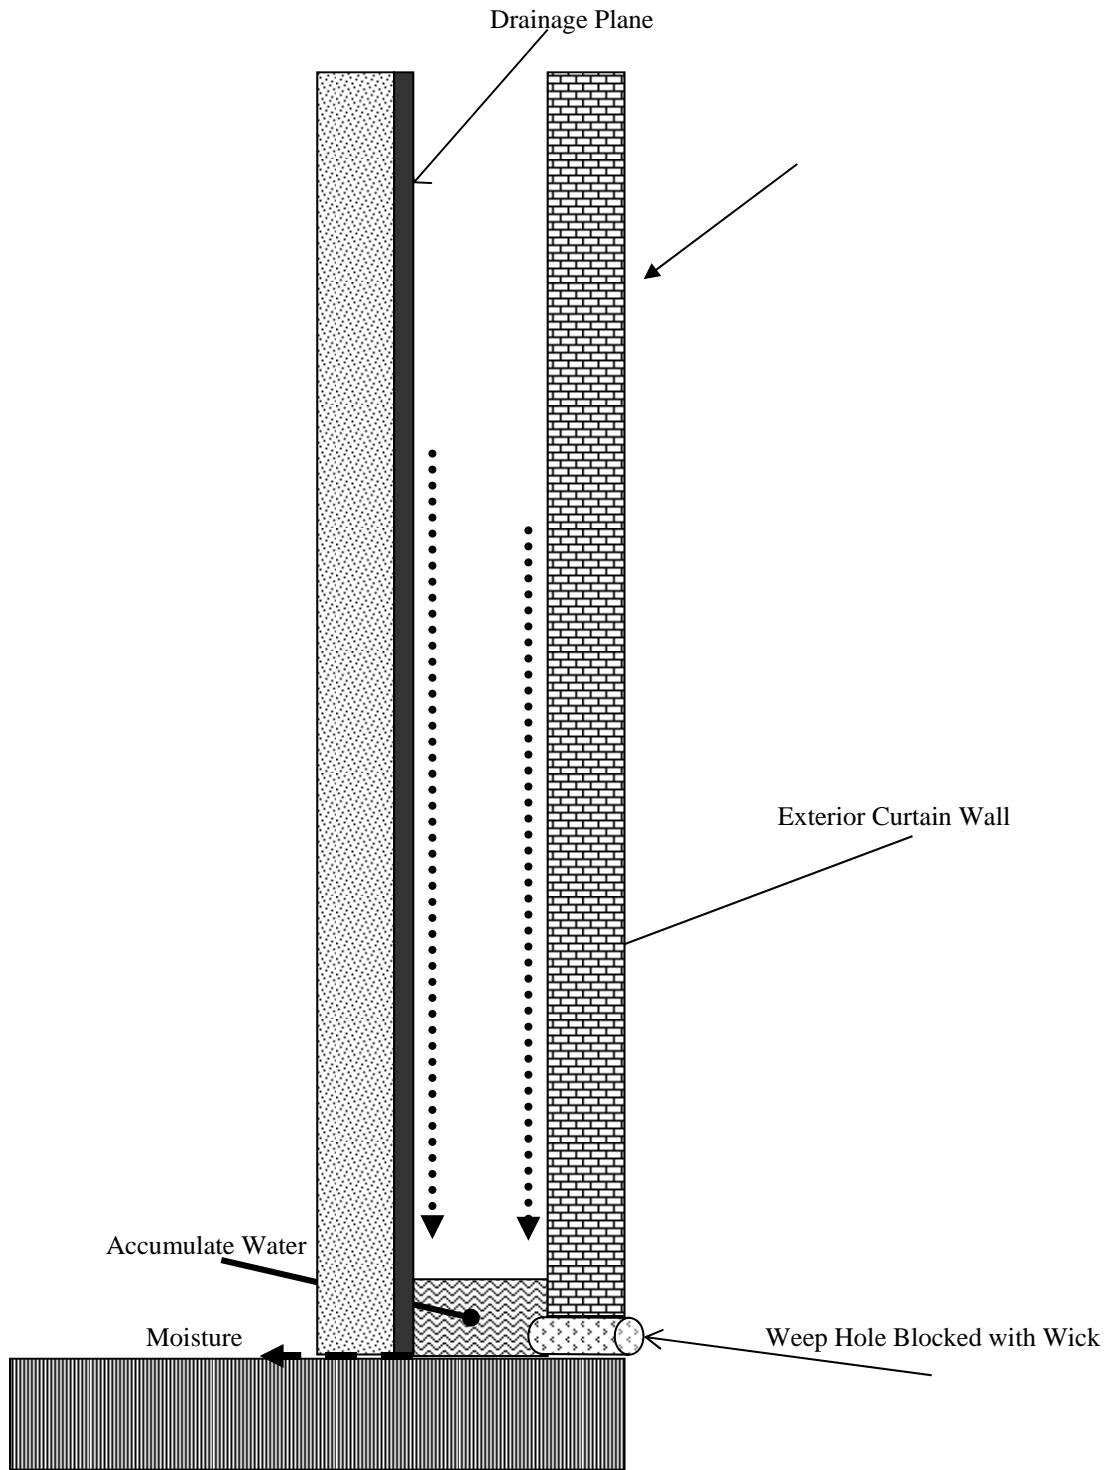
Figure 2

- Flashing to direct water to weep holes is typically installed around breaks/penetrations in the drainage plane (e.g., window systems, door systems, and fresh air intakes). If the drainage plane is discontinuous, missing flashing, or lacking an air space, rainwater can accumulate inside the wall cavity and penetrate the building.
- Weep holes at the base of the curtain wall that allow for water drainage. Weep holes are customarily installed at or near the foundation slab/exterior wall system junction (Figure 1). Weep holes allow for accumulated water to drain from a wall system (Dalzell, 1955). Lack of weep holes in brickwork, burial of weep holes below grade, or sealing of weep holes with cement will allow water to accumulate in the base of walls, resulting in seepage and possible moistening of building components (Figure 2).

Blocked Weep Hole: Water Accumulates in the Drainage Plane

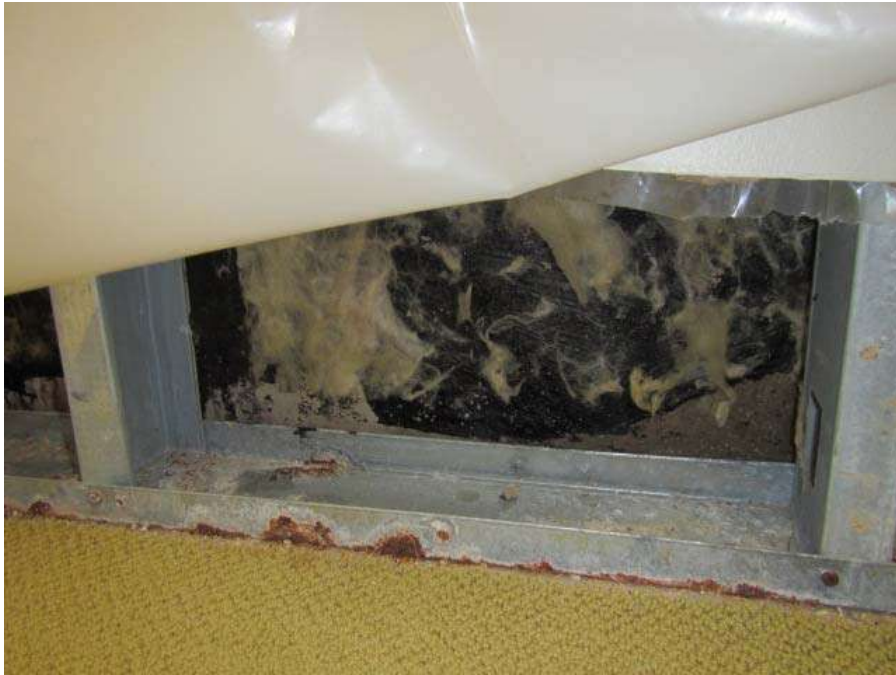
**Picture 1**

As mentioned, affected materials in JR office had largely been removed prior to the BEH/IAQ assessment (Picture 1). Water-damaged materials had been removed along a south-facing exterior wall. All remaining materials were dry at the time of assessment; however, when BEH/IAQ removed vinyl base coving, dark staining consistent with mold growth was observed on intact GW (Pictures 2 and 3). Other signs of water damage, as evidenced by the presence of rust on metal wall studs, were observed in the impacted office (Picture 1). Rust is caused by prolonged moisture exposure. While rust is a characteristic sign of water penetration, it is not mold growth.

**GW removed from JR office, note rust on metal frame and studs**

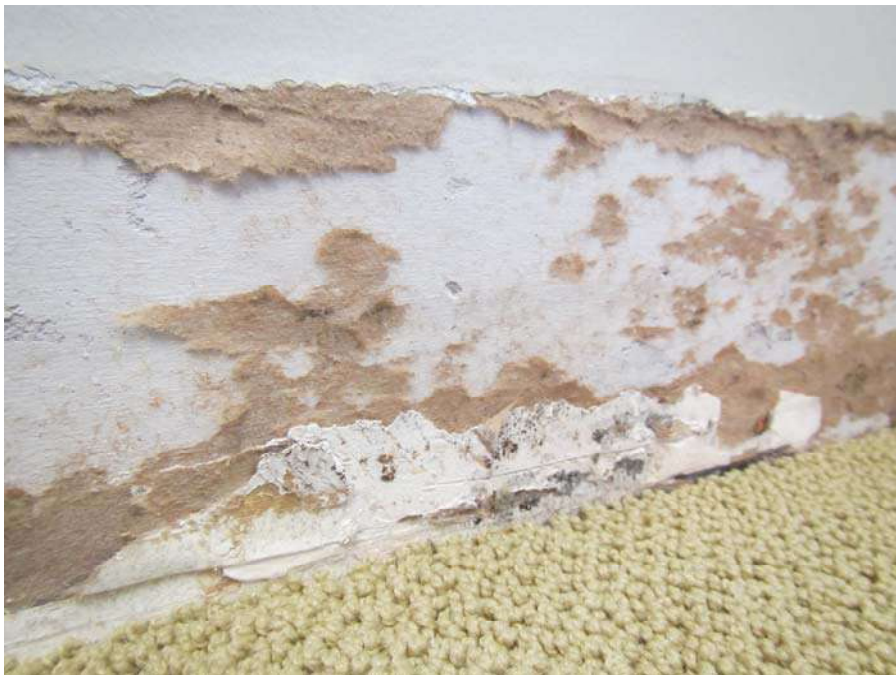
**Picture 2**

**GW behind coving in JR office, note black staining, indicative of mold growth**

1. Remove remaining water-damaged materials (e.g. GW) in a manner consistent with recommendations found in “Mold Remediation in Schools and Commercial Buildings” published by the US Environmental Protection Agency (US EPA, 2001).
2. Cover employee workstations in areas of remediation to protect items and facilitate cleanup.
3. Place water-damaged/mold-colonized materials in plastic bags for transport.
4. Insulate wall cavity with a material that can withstand New England temperature extremes, and created particularly on this wall by constant exposure to heat and moisture.

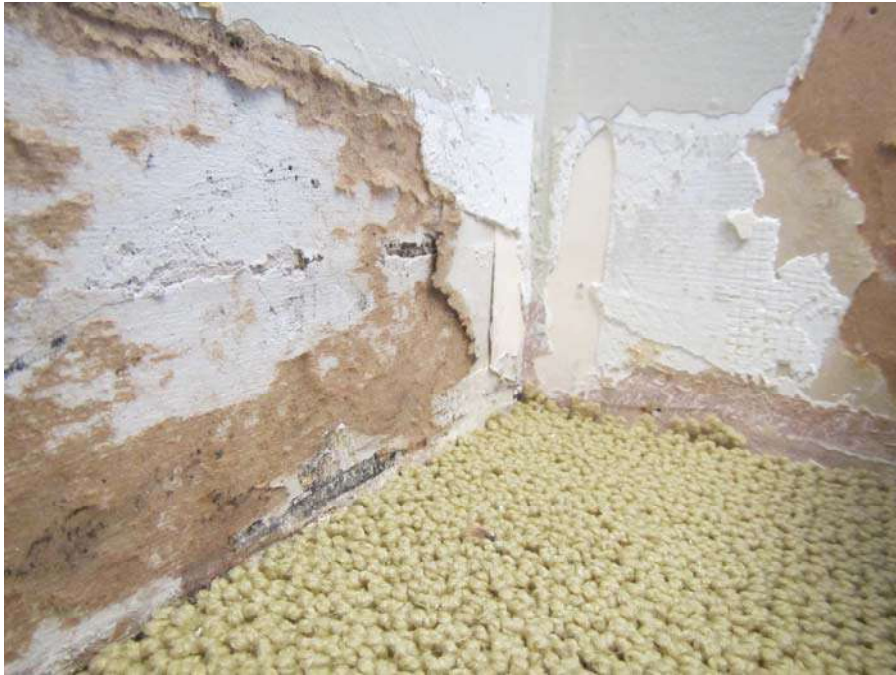
**Picture 3**

**GW behind coving in JR office, note black staining indicative of mold growth**

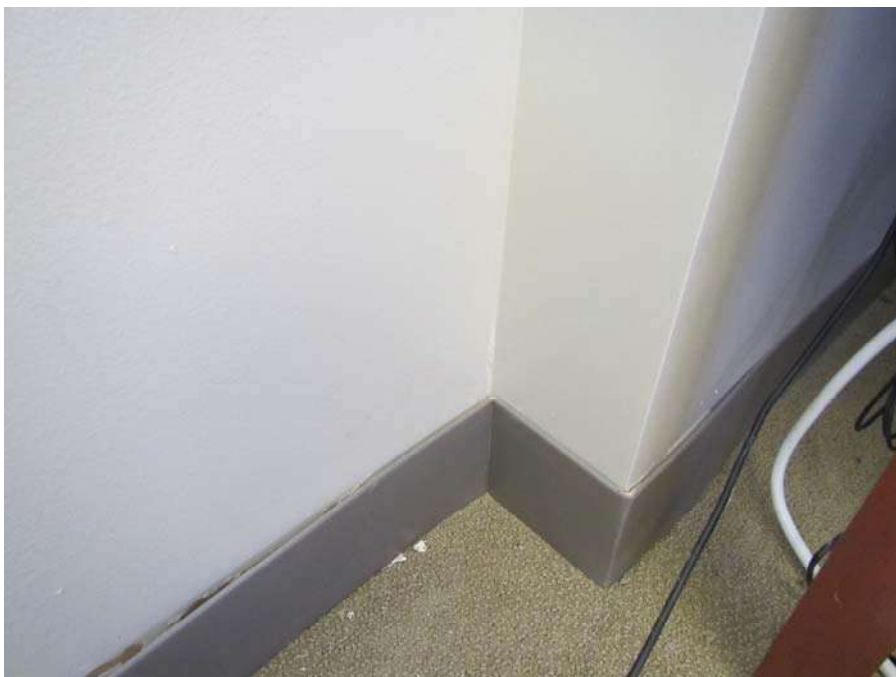
**Picture 4**

BEH/IAQ staff found water-damaged GW in another office (SWB office) located adjacent to JR office. When vinyl coving was removed in the SWB office, BEH/IAQ staff observed evidence of mold growth on GW. BEH/IAQ staff also conducted moisture testing and found damp GW on the same south-facing wall that had been impacted in the JR office (Table 1; Pictures 4 and 5). At the time of assessment, BEH/IAQ recommended that the affected materials be removed.

**Water-damaged corner wall in SWB office**

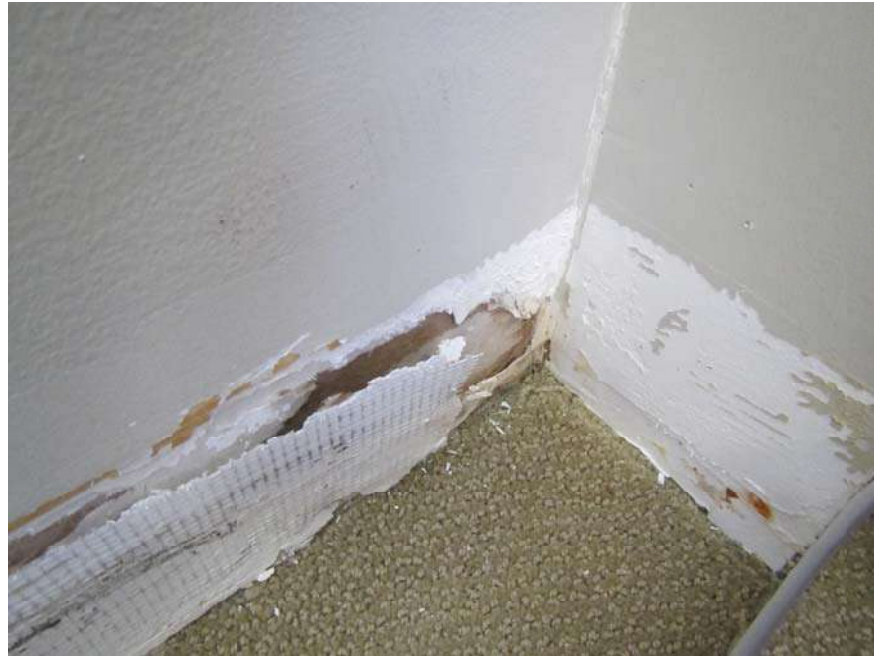
**Picture 5**

**Water-damaged/mold growth on GW in SWB office, note rusted stud**

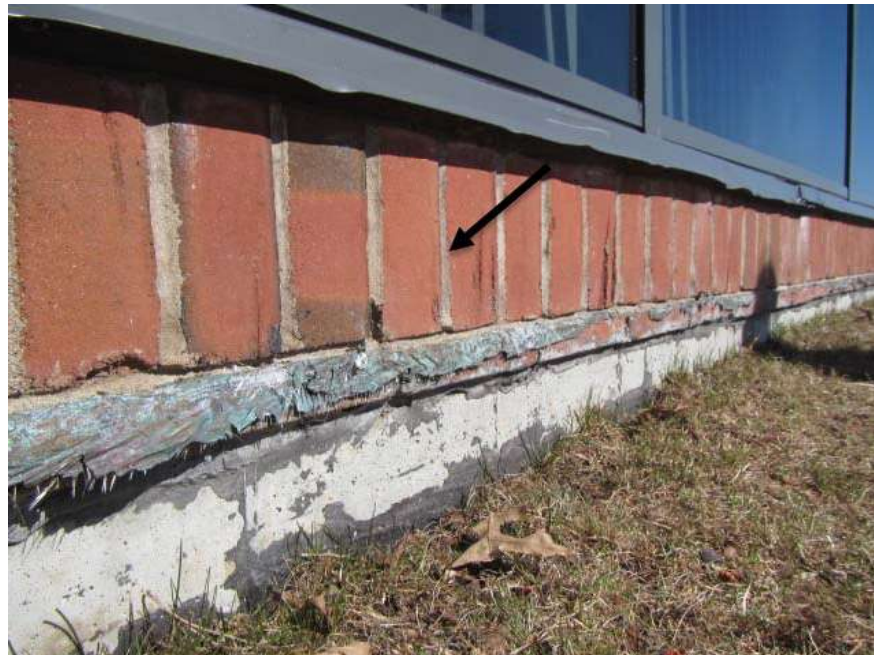
**Picture 6**

BEH/IAQ staff examined the exterior wall system to identify the location and condition of weep holes. Weep holes on the south-facing wall were observed approximately at the brick wall/foundation junction (Picture 6); these weep holes were blocked with cement or accumulated sediment from bricks/mortar (Picture 7). In some areas, the building foundation was not visible. Weep holes in the wall beneath the overhang appear to be buried beneath layers of mulch.

- Poor drainage from the exterior wall drainage plane, resulting in water directed towards the building
- Damaged/eroded waterproof coating on the exterior foundation (Picture 6), which may allow for water entry into the building via capillary action through foundation concrete and masonry (Lstiburek and Brennan, 2001).
- An opening in the exterior wall, which would allow water to accumulate against the foundation (Picture 9).
- Poor insulation of building materials. The purpose of insulating the interior wall cavity is to provide resistance to temperature changes of the outdoors (e.g., air, ground/soil). When insulation is inadequate, condensation can accumulate in the wall cavity as a result of the foundation wall being buried beneath the ground/soil. In this configuration, the cement temperature becomes that of the ground/soil.

**Weep holes approximately at the brick wall/foundation junction; also note damage to waterproof coating at foundation**

12. Consult with building engineer/drainage specialist to improve drainage adjacent to impacted offices to prevent further water infiltration.
13. Examine waterproofing material on the building exterior and maintain its integrity.

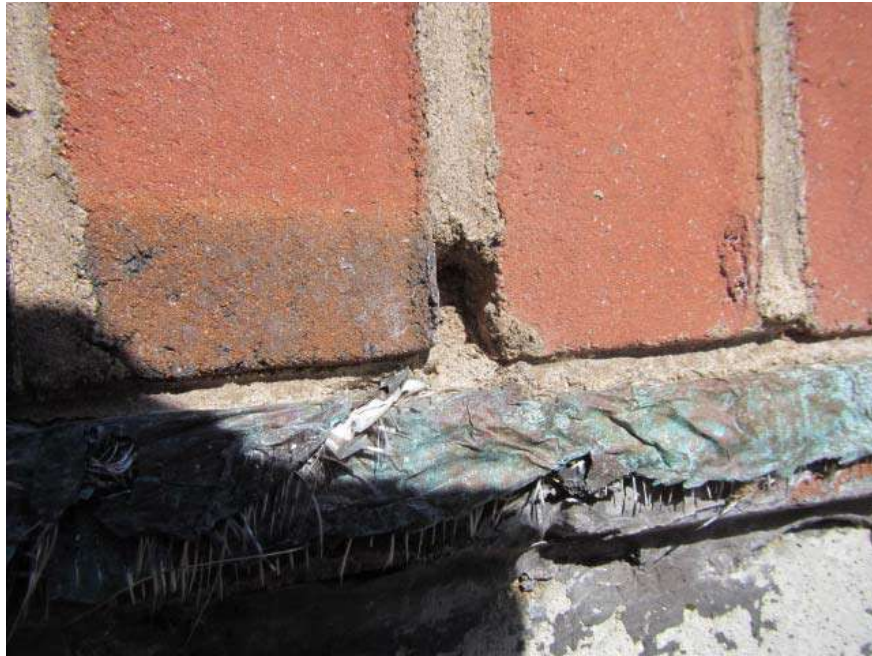
**Picture 7**

Without appropriate drainage, moisture can build up inside the wall's drainage plane, resulting in increased water/moisture problems.

**Weep holes blocked with cement or accumulated sediment from bricks/mortar**

9. Ensure all exterior wall weep holes are open and above the soil line.
10. Seal hole in exterior wall shown in Picture 3.
11. Ensure interior section of pipe in Picture 7 is properly insulated.

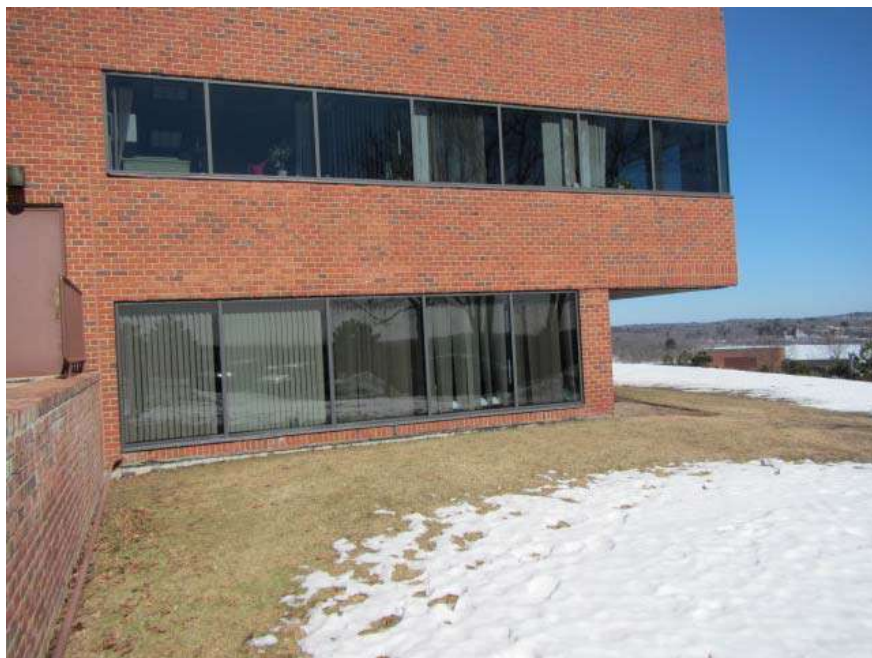
**Picture 8**

As mentioned, the two adjacent offices with moistened GW are located on a south-facing wall. Unlike other offices/spaces along the exterior of the building, these offices do not have an overhang that protects the exterior wall from driving precipitation (Picture 8). Direct impingement of water on the foundation can result in water penetration. Movement of water to the building interior is further aided by other conditions:

**Offices experiencing water damage are located on a south-facing wall not protected by an overhang**

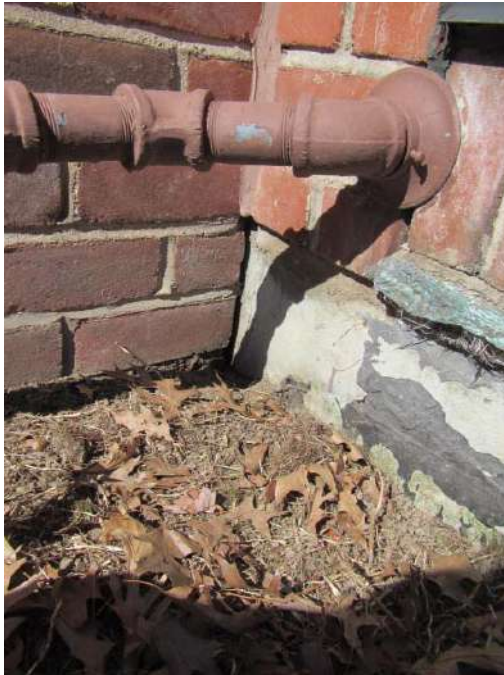
**Picture 9**

**Opening in brick of exterior wall**
