WIGGINS SCHOOL DISTRICT RE-50J 2016 DISTRICT MASTERPLAN

JULY 2016

hord | coplan | macht

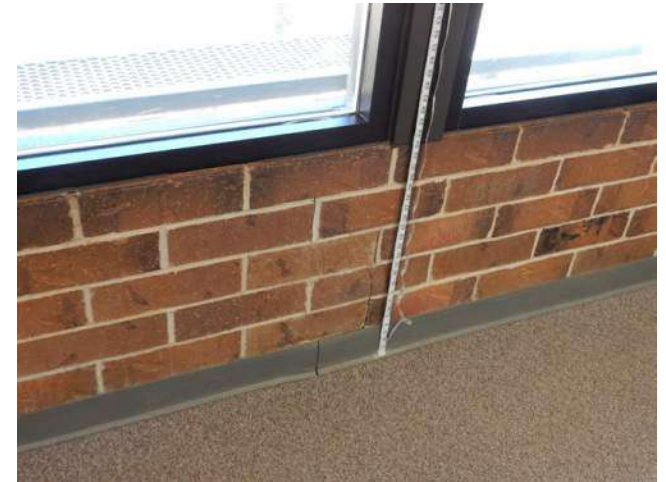
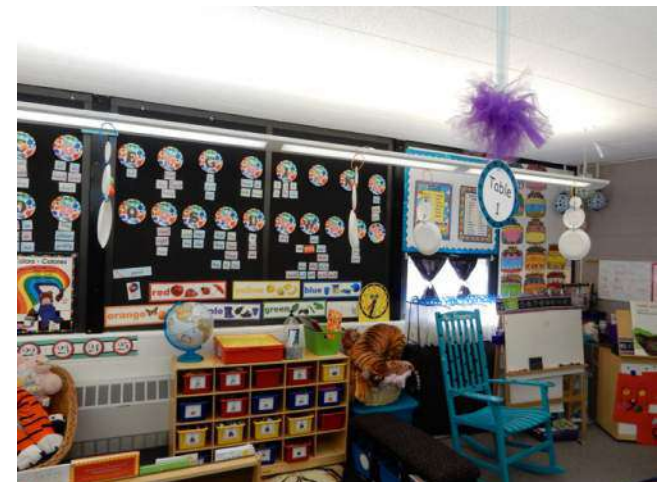
The exterior wall system is in good condition. There are minimal signs of cracking in the structural brick along window sill in the east corridor. This is likely from lack of control joints at these openings in the masonry, not from movement at the foundation. It is recommended to cut in masonry control joints and infill with flexible elastomeric sealant to account for movement in the brick around the entire building.

There is a combination of original and replacement windows around the building. All of the classroom windows in the north wing have been replaced with insulated translucent fiberglass panels. These panels are worn, brittle and have yellowed over time with UV exposure. The assemblies are weather-tight, with no noticeable water infiltration. However, the interiors of these panels in the classrooms have been covered with tackable wall surface, eliminating all natural daylight except at the operable units. This doesn't allow for visual connection to the outside and forces the use of electric lighting to illuminate the interior. The classroom windows in the south building are a combination of bronze anodized aluminum with insulated glazing and painted hollow metal frames with non-insulated single pane glazing. It is recommended to replace all the translucent fiberglass panels and single pane glazing around the entire building with new insulated glass units. The frames can be either hollow metal or aluminum depending on the desired aesthetic.

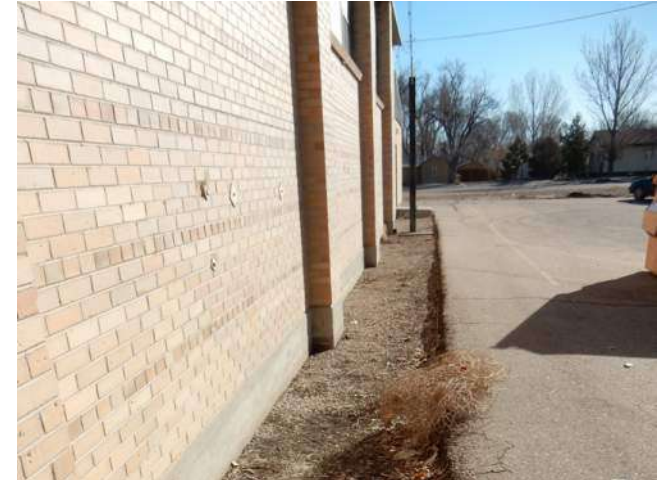
The original windows of the 1948 building and the 1953 gym have been removed and replaced with insulated translucent fiberglass panels. These panels are worn, brittle and have yellowed over time with UV exposure. The assemblies are weather-tight, with no noticeable water infiltration. However, the aging of these panels has made them darker, reducing the amount of daylighting within the building, and forcing the use of electric lighting to illuminate the interior. These panel systems are also translucent, which prevents visual connection to the exterior of the building. The 1964 addition has the original single pane, aluminum frame side sliding windows.

While both of these window assemblies are functioning, it is recommended to replace all of the windows in the building. The translucent panels do not provide visual connection to the exterior which is important in learning environments, nor does the interior of building benefit from natural daylight which improves indoor environmental quality and can help reduce electric lighting usage. The aluminum frame windows are single pane and do not provide adequate insulation or proper control of visible light transmittance and solar heat gain.

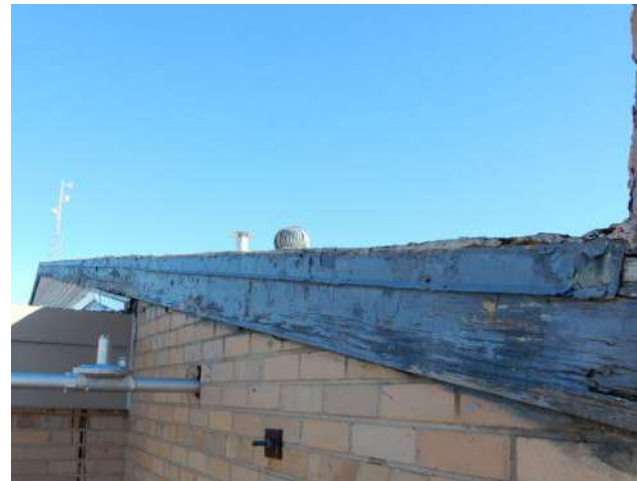
There are three roof assemblies on the building, each corresponding with the additions. The original school has a built-up asphalt roof with rock ballast with internal roof drains. The edge condition is a sheet metal gravel stop. The gymnasium addition has a liquid rubber roofing poured directly over urethane foam insulation, also with internal roof drains. The 1964 classroom addition has a low-slope standing seam metal roof with perimeter roof drainage gutter and downspout systems. The built-up roof and standing seam metal roof over the main classroom building are in good condition. The ballast is intact and properly sized around the roof drains. The standing seam metal roof is new, with no visible damage to the assembly. New sheet metal flashing and downspouts have been installed at these two roof assemblies, which are properly installed and functioning well. The poured rubber roof over the gym is failing around the perimeter where the rubber terminates into the adjacent wood fascia. This will lead to water infiltration, compromised insulation and damaged interior finishes. The perimeter wood fascia is also deteriorated due to weather exposure, also contributing to water infiltration around the roof. It is recommended to replace this roofing with a sheet rubber membrane, and remove and replace the wood fascia with sheet metal flashing around the perimeter of the gym.

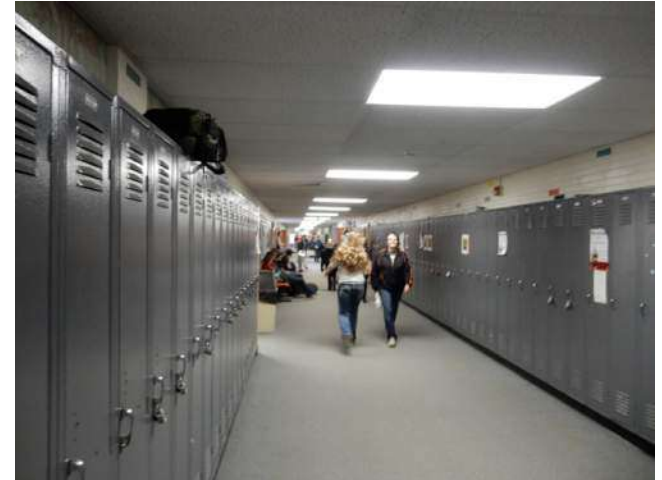
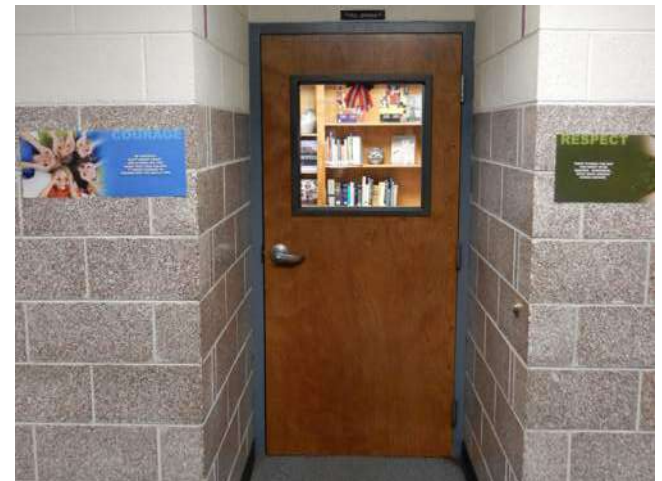
office. Building engineer and staff indicate numerous problems with temperature control in classrooms and offices. Most of the original controls, pneumatic tubing, wiring and thermostats have been abandoned in place. There appears to be adequate ventilation in occupied spaces and no ventilation in the original high school hallways. The gym area is heated with gas fired radiant heaters mounted on the ceiling. There is little to no ventilation in this area. There is no conditioned air for the IT equipment room.

The rooftop units are nearing the end of their serviceable life of 15 years. The serviceable life of the equipment is a measure of equipment life to a point where component parts are no longer available or the service of the equipment will be of little benefit to the operation of the equipment. Envision Mechanical Engineers Inc. (EME) recommends upgrading Rooftop Units and Integrating Direct Digital Controls (DDC) with new high efficiency equipment with CO2 control that will enhance occupant comfort and increase energy savings.

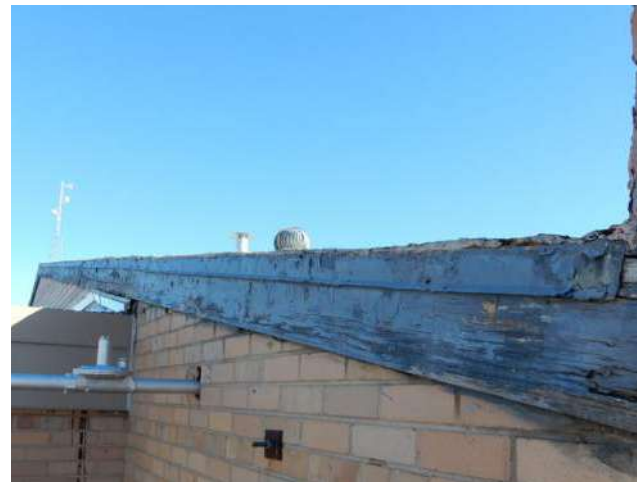
- Extensive use of surface mounted raceway and plug strips for power and low voltage systems throughout.
- Exposed rooftop conduit runs impede future work on roof/repairs.
- A majority of equipment and wiring in the facility is beyond useful life (1940's vintage) and no longer manufactured requiring complete replacement
- Older panels are generally full, outdated, undocumented and have no spare capacity.
- There is no surge protection installed at any of the service entrance facilities.
- Building is not equipped with a generator, while not required, it may be worth consideration for emergency and optional standby loads such as emergency lighting and certain voice/data and security systems.

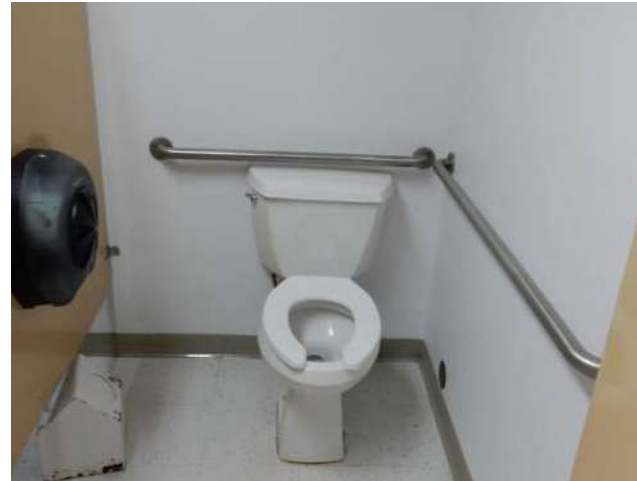
The entrance to this building is at grade, however the cross slope of the sidewalk in front of the school exceeds 2% which is the maximum allowed. There are dedicated accessible parking spaces serving the Event Center across the street, however there is not an accessible route from those spaces to the entry of middle school. ADA parking spaces should be striped on the east side of the Event Center parking lot and curb ramps installed to provide an accessible route to the middle school. Some of the door hardware has been upgraded to accessible lever sets, but not all. It is recommended to upgrade any old hardware sets with new accessible lever sets. There are handicap stalls provided in each of the student toilet rooms. These stalls are not the compliant width, as they are narrower than the minimum 5' required. There are grab bars installed within this toilet compartment, a vertical grab bar is required. The lavatories have insulated waste piping, but the faucet hardware is not compliant for those with dexterity issues. The restrooms would require some modest renovations to become fully accessible.

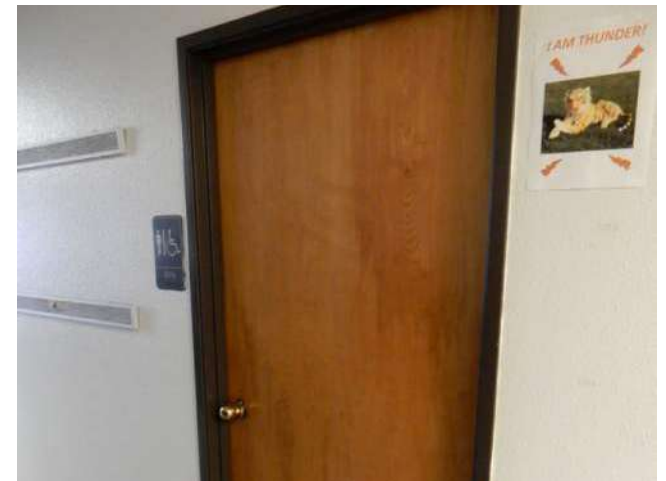
There is not a secure entrance into the high school. The entrance door remains locked at all times for building security, which requires students to knock each time the need entry into the building. Each classroom has an exterior door, which can impact the overall building security if these are not latched properly. There is no Card Access Stations nor is the building equipped with an Intrusion detection system.

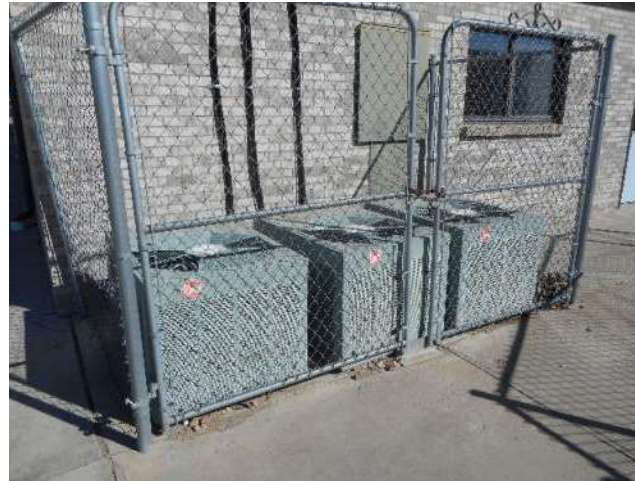
The Middle School is served by 5 RHEEM residential style split system heat pumps installed in 1998. The units are controlled through the Invensys DDC system. Units and controls are beyond their 15 year serviceable life. There is a radon mitigation system installed and appears to be functional but is beyond its serviceable life. Envision Mechanical Engineers Inc. (EME) recommends upgrading heating/cooling units and controls with new high efficiency equipment with CO2 control that will enhance occupant comfort and increase energy savings. EME also recommends updating the radon mitigation system.

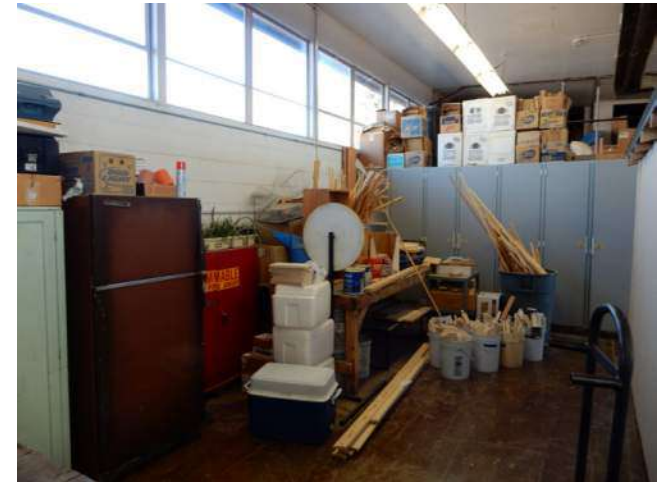
The original single pane steel windows are still in place and in good condition. This building has excellent natural daylighting due to these windows. They are operable hoppers, but due to their location high on the wall, they are never opened. As a single pane window, there is no insulation within the glazing. It is recommended to either replace the windows with insulated glazing or install storm windows on the inside face of the existing to improve thermal comfort.

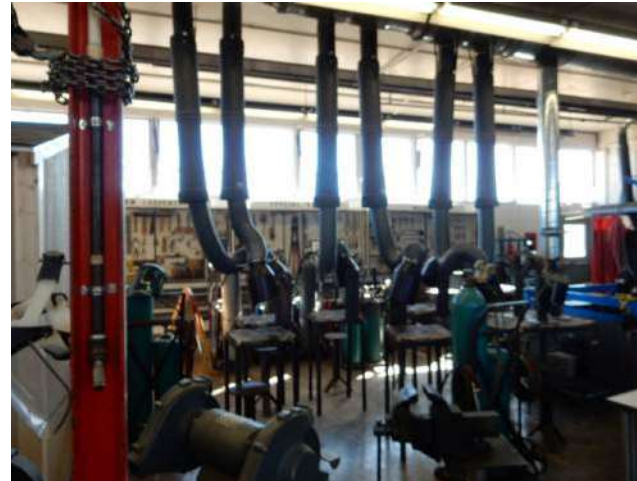
Direct Digital control system that was installed for the elementary building in 2003. Staff and building engineer indicated numerous problems with temperature control and scheduling. The shop area is heated by gas fired radiant heaters mounted on ceiling. There is no cooling for this area. There is currently no dust collection system in place. The exhaust system for the welding arms was upgraded in 2003 and appears to be in good working order. The paint room is heated via a gas fired radiant heater and ventilated via a propeller exhaust fan, this system is not code compliant. The green house is heated by two gas fired unit heaters and cooled by an evaporative cooler that are beyond their 15 year serviceable life. (ag shop DSCN1670)

EME recommends upgrading Rooftop Units and controls with new high efficiency equipment with CO2 control that will enhance occupant comfort and increase energy savings. It is also recommended to add a dust collection system, install a paint booth and replace the heating and cooling units in the green house.

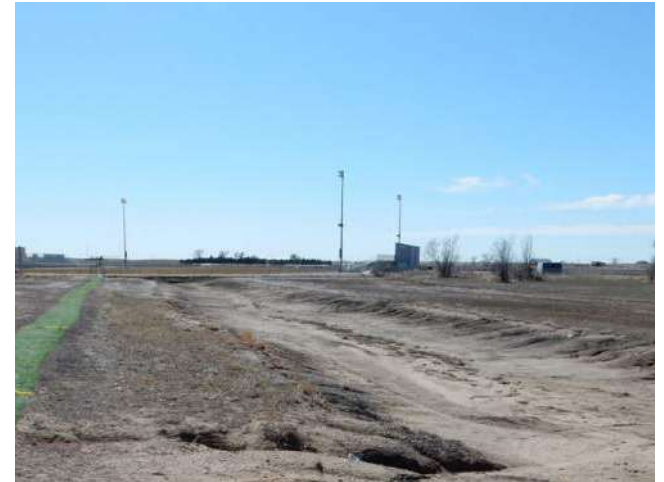
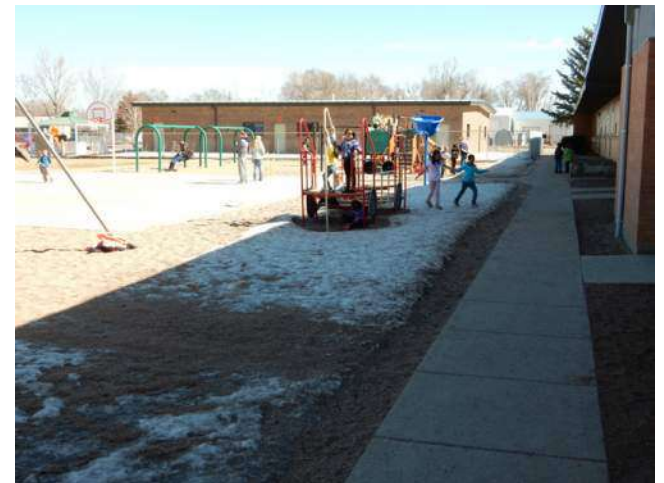
There are multiple playgrounds around the site. The preschool and elementary school playground to the north of the elementary school is large and well-used. Due to seasonal shadows during winter months, a large sheet of ice accumulates on the north side of the playground that can create a dangerous condition for the students. The playground on the south side of the elementary school is also large and has new playground structures. The rubber mats surrounding the equipment is deteriorated from weathering and should be replaced. (elem school DSCN1904, 1875)
