CLAYTON

Elementary School

Certificate of Necessity

Project No.: 18047
August 09, 2019

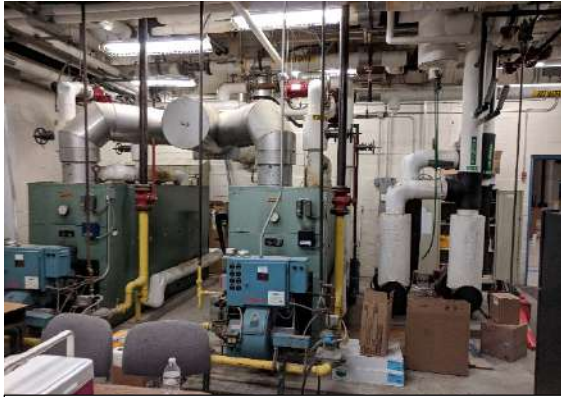
Photograph #1 – Boilers in Mechanical Room

- The central heating plant is past its useful service life and overdue for replacement. (Photograph #1)
- The exhaust/make-up air ventilation unit serving the kitchen is past its useful service life and should be replaced with a new system. (Photograph #2)
- All (8) rooftop exhaust fans are past their useful life and should be replaced. (Photograph #3)
- Classrooms 1 – 15 in the original building have comfort and humidity issues that need to be addressed in a study. It is likely that the UVs (15 total) are not properly controlling the outside air damper and will need to be upgraded. (Photograph #4)
- The air cooled chiller has aged past its recommended service life and is due for replacement.

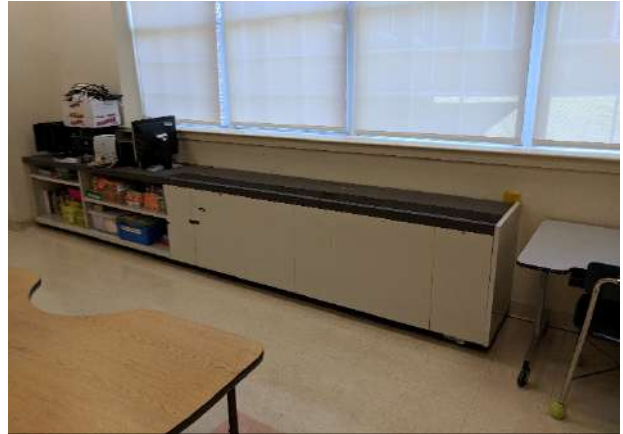
Photograph #4 – Typical Classroom Unit Ventilator

Some, if not all of these issues have been documented at CES.

However, since there is already a central chiller in place with useful remaining service life, it is unrealistic to recommend a complete system replacement. The best compromise is to modify existing UV controls to only provide space cooling (no ventilation) with economizer function. New Energy Recovery Units (ERU) would be installed on the roof or in mechanical mezzanines. This system modification maximizes

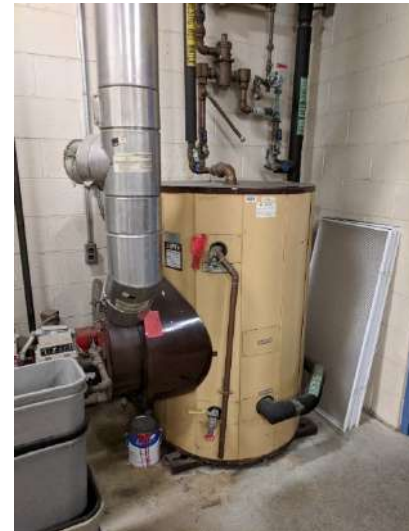
Photograph #5 – Water Heater

- Replace the domestic hot water heater and recirculation pump (Photograph #5)

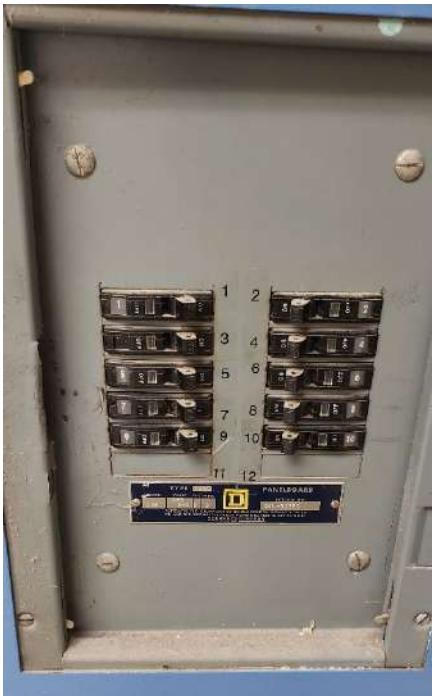
While the existing system has been well maintained and the panelboards are currently working, there are a few panelboards that have exceeded their useful service life. Panelboards labeled as LP-A, LP-B, and MDA-2 have all exceeded their useful service and we would recommend that the same be replaced. The switchboard SE and panelboards LP and CP were installed in 2006 and panelboards CP-1 and CP-2 were installed in 2009. Distribution Panelboard MDP and most of the other branch panelboards throughout the school are manufactured by GE and were installed in 1993.

Photo #4 Panelboard LPB

- Replace panelboards MDA-2, LP-A, LP-B.
