# SMYRNA *Elementary School*

## *Certificate of Necessity*

**Gipe Associates, Inc.**  
CONSULTING ENGINEERS

*Project No.: 18047*  
*August 09, 2019*

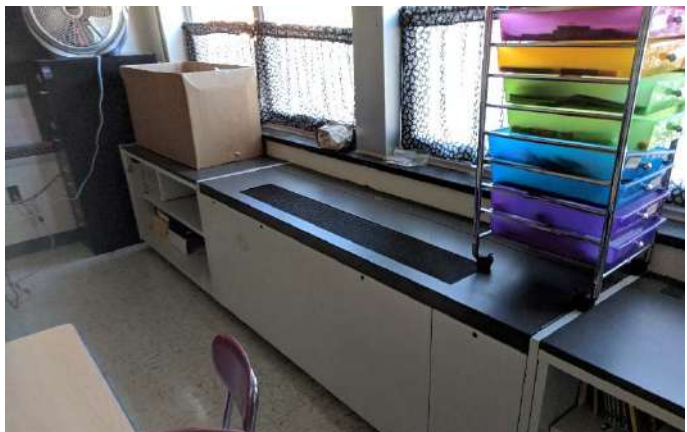
Photo #10 Typical Unit Ventilator

Unit Ventilators (UV) were standard HVAC equipment for school classrooms built in the 1990's and earlier, however they have several disadvantages that are well documented compared to modern HVAC system solutions which include:

- Source of noise within the classroom
- Valuable floor space is occupied within the classroom
- Outdoor air control limitations
- Humidity control limitations

Some, if not all of these issues have been documented at SES.

**We strongly recommend refraining from UVs for all new construction and major renovations going forward. As described in the section above, a decoupled design approach is ideal.**

However, since there is already a central chiller and boiler in place with useful remaining service life, it is unrealistic to recommend a complete system replacement. The best compromise is to modify existing UV controls to only provide space cooling (no ventilation) with economizer function. New Energy Recovery Units (ERU) would be installed on the roof or in mechanical mezzanines. This system modification maximizes the use of existing equipment while decoupling ventilation and should be considered a mid-term solution until the next major renovation.

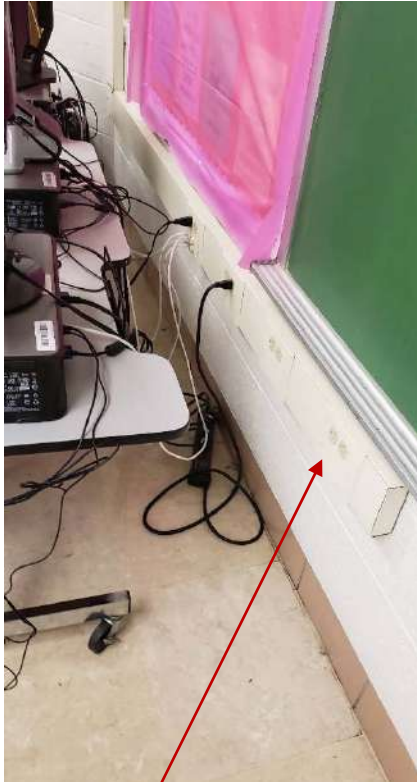
Photo #5 Receptacle in Surface Mounted Raceway

While the building appears to be in good condition, the recessed receptacles installed in the building are beginning to show signs of aging. Over the years, additional receptacles have been installed using surface metal raceway. We would assume that the building wiring to the recessed receptacles are the same age as the receptacle, so both would probably need replacement within the next 5 years. In addition, the current National Electrical Code (NEC) requires that all child care facilities have tamper resistant receptacles. The code defines a child care facility as a building or portion thereof, for educational, supervisory, or personal care services for more than four children 7 years old or less. So, this elementary school would fit this definition so we would recommend that all non-locking-type 125V, 15 and 20 ampere(A) existing receptacles be replaced with tamper-resistant receptacles. Many of the exterior disconnects are showing signs of rusting, so we would recommend that new NEMA 4X, stainless steel disconnects be provided for all exterior HVAC equipment that is replaced. The technology department has some planned improvements for buildings special systems as outlined below in the planned improvements section of this report.

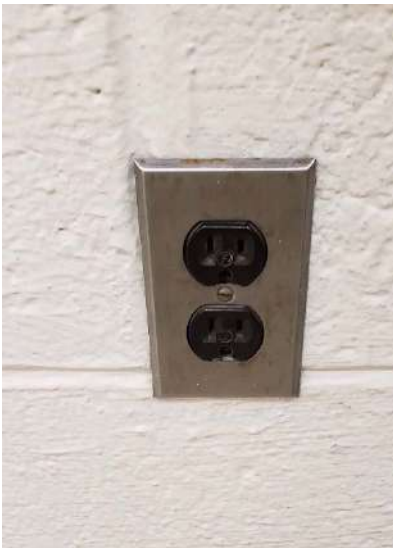
Photo #18 Typical Receptacle

1. Replace all existing building non-locking-type 125V, 15 and 20 ampere receptacles with tamper-resistant receptacles to comply with the current National Electrical Code.
2. Upgrade Fire Alarm system to voice evacuation system to comply with current NFPA 101 Life Safety Code.

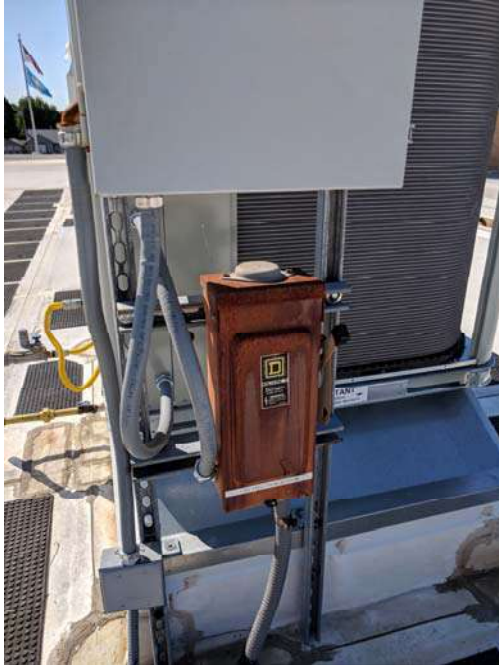
Photo  
#21

AHU-2 Rusty  
Disconnect Switch (B)

| Equipment Type | | |
|---|---|---|
| P-01 | Exterior disconnects | Replace exterior disconnects for all HVAC units that are replaced. Otherwise exterior disconnect switches to remain. |

- Replace exterior disconnect switches for all exterior HVAC units that are replaced.

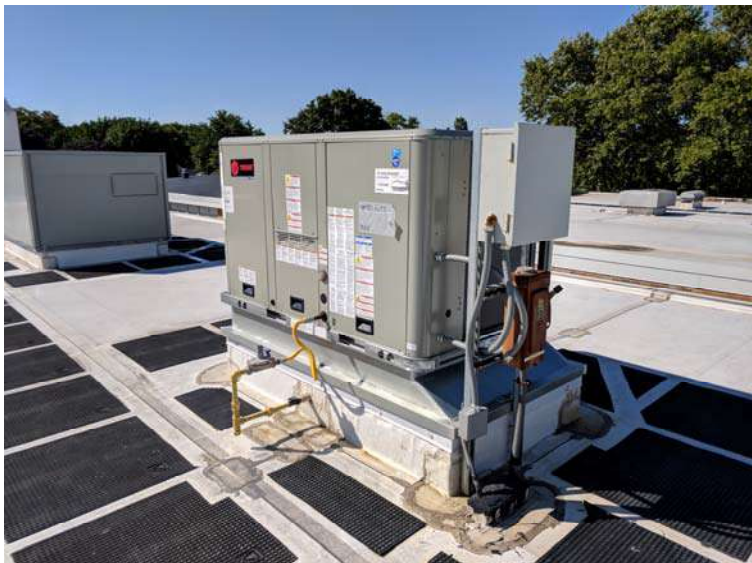
Photo #22

AHU-2 Rusty Disconnect Switch
