CN / REFERENDUM SUPPORT ASSESSMENT

August 2019

Fearn Clendaniel Architects Inc

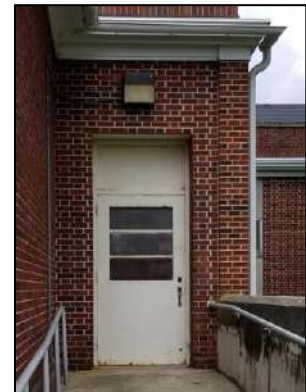
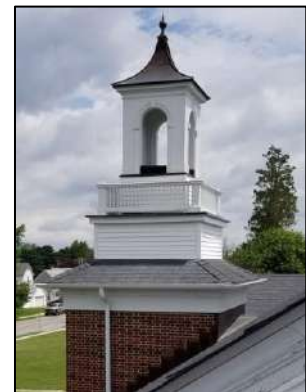
CES.68

The existing wood cupola structure is subject to continual weathering. While it is structurally sound and fundamentally in good condition, it is maintenance-intensive and requires regular painting and other upkeep. This will keep the cupola, railings, and other items in service for the moderate future. As part of a long term plan, the

District should consider future replacement with weatherproof construction, such as fiberglass or aluminum.

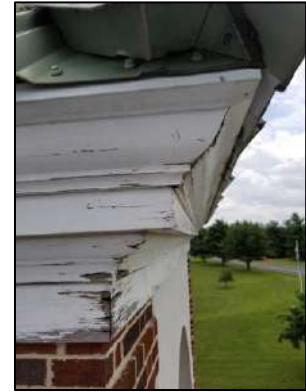
The existing wood cornices and other trims on older parts of the building are subject to continual weathering and maintenance-intensive. Numerous areas are showing signs of rot and water infiltration. In the near term, this requires painting to prevent further deterioration. If funding is available, we recommend this trim should be clad with or replaced by prefinished aluminum trims. Cost will vary by size and complexity of the trim profile.

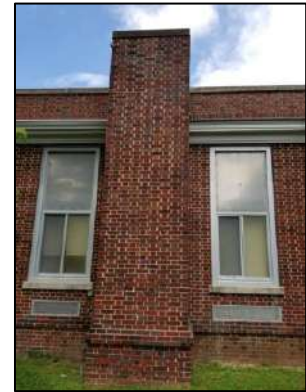
The existing brick walls are in good to fair condition throughout the building, despite the age of older portions. Cracking and settlement are minimal and localized. Some weathering of mortar joints has occurred, particularly around stone windowsills. A program of masonry cleaning and repointing in the mid-term future will help preserve strength and appearance. One item requires priority attention: an existing chimney on the east of B wing shows significant cracking. At a minimum, the cracks require repair and repointing. This chimney is believed to be abandoned and could be demolished to eliminate future problems.

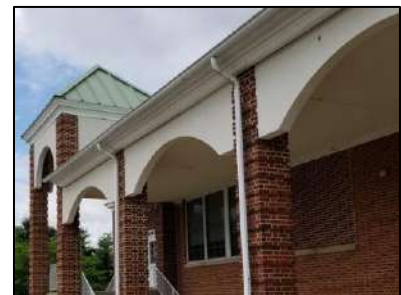
Finishes at the existing soffit ceilings at the main entrance canopy and other door / entry locations are weathered. Repaint / refinish these areas for proper appearance and to prevent deterioration.

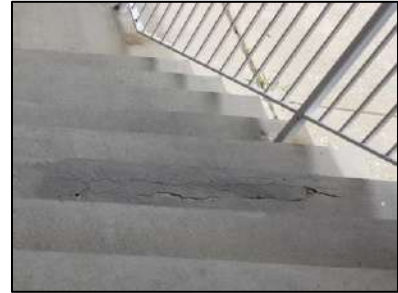
Existing concrete walk areas are in generally good to fair condition. Regular maintenance with replacement of individual sections as necessary will keep them in service. On the exterior of A Wing, cracks in the accessibility ramp and main entrance stairs should be corrected before further damage occurs.

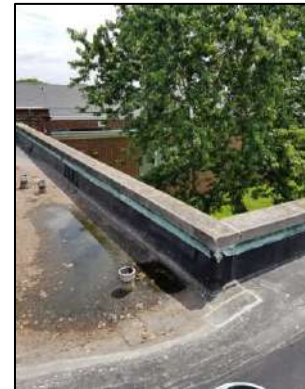
Original built-up roofs were replaced by EPDM membrane roof systems in the early 1990s. These in turn have reached the end of their expected service life and should be replaced within the next 3-4 years. Areas of delamination and deteriorated flashings were observed throughout low-slope areas. Ponding is a problem in some places. Timely roof replacement is critical to avoid the expense of additional interior water damage. As part of this program, remaining cast stone copings should be covered with new prefinished aluminum copings to improve water integrity of the roof / exterior wall connection.

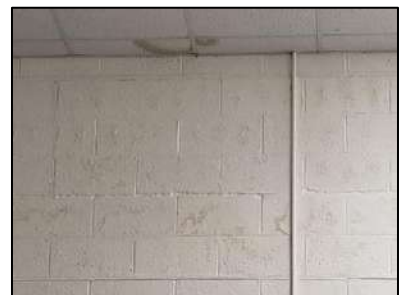
Walls in offices, work areas, and corridors are predominantly painted or glazed masonry. Some cracking was observed in varying areas, and should be repaired. There is also evidence

of water penetration in the Large Training Room 116. Once that situation is resolved, the affected walls will require cleaning, preparation, and repainting.

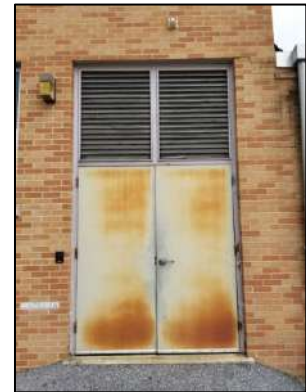
Exterior hollow metal doors / frames and hardware are aged. All require paint in the near future to prevent further weathering. Some exterior doors are rusting or damaged and should be replaced in the near future. Storefront at main building entrance is in very good condition and needs only routine maintenance.

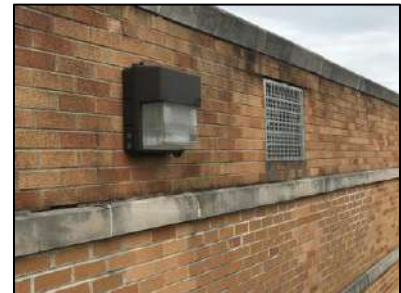
The existing brick / CMU walls are in fair to poor condition throughout the building. Cracking and settlement has occurred in several areas and requires repair. Extensive weathering of mortar joints has occurred, particularly around stone copings and windowsills. Walls show evidence of chronic wetness around downspout and overflow locations. A program of masonry cleaning and repointing in the mid-term future will help preserve strength and appearance.

Of particular concern is the upper stone trim around the Large Training Room 116 (*image above*). Mortar and sealant joints at this trim have eroded almost completely, exposing structural steel to the weather and creating numerous water infiltration points. Evidence of water infiltration is visible inside this room. This area requires immediate attention.

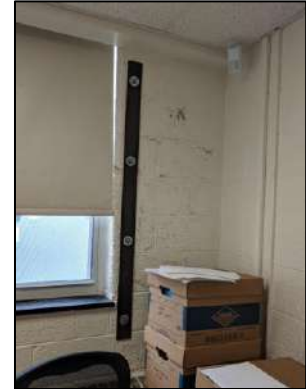
Another area showing problems is the exterior corner of Office 109, with substantial cracking. This has been stabilized with through-bolted steel sandwich plates, but requires permanent structural correction.

At the exterior end wall of the 100 wing, masonry piers are eroding due to water overflow from the roof immediately above. Top sections of these piers should be rebuilt and capped with metal trim to promote water deflection.

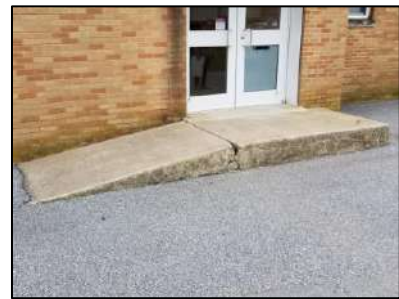
Walks are minimal on site, but landings and ramps at each exterior door are in generally poor condition. Although the main entrance is ADA compliant, most other doors are not. Considering their poor condition, these landings and adjoining ramps should be replaced with accessible, ADA-compliant features.

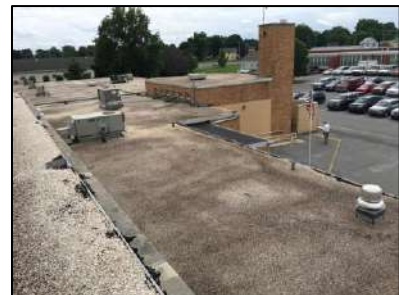
Gravel-ballasted built-up roofs across the building may be original, and have exceeded their expected service life. Drains and scuppers show evidence of chronic water overflow onto walls below. Ballast / topping erosion and deteriorated flashings were observed throughout low-slope areas. Ponding is a problem in some places. To avoid the expense of additional water damage, both interior and exterior, all roofs should be replaced within the next 3-4 years, or earlier if feasible. Timely roof replacement is critical. As part of this program, all metal roof edge trims, scuppers, and downspouts should be replaced. Remaining cast stone copings should be covered with new prefinished aluminum trim to improve water integrity of the roof / exterior wall connection.

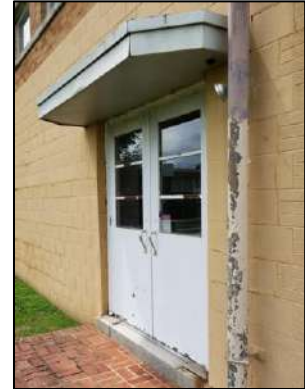
Exterior canopy roofs and related structures at Large Training Room 116 are deteriorated. These canopies should be demolished and replaced with similar construction.

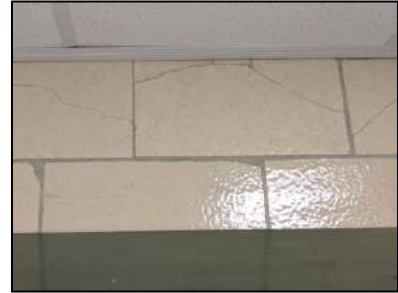
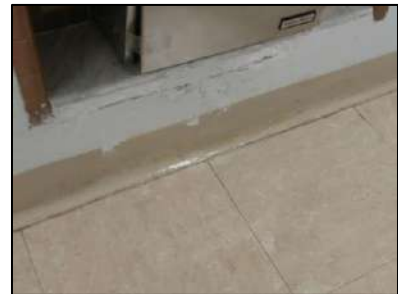
Walls in offices, work areas, and classrooms are predominantly painted plaster of gypsum wallboard. Cracking and damage was observed in varying areas, and should be repaired. Masonry and glazed masonry walls in high traffic areas show cracking and damage. Where repair is possible it should be performed. Where repair is not feasible, regular inspection is necessary to monitor future deterioration.

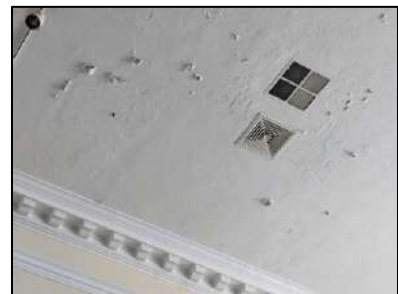
Plaster ceilings throughout the 2nd floor area show moisture and other damage. These require repair to avoid further deterioration, and repainting throughout. Localized areas throughout the building show evidence of minor water infiltration or leaks in acoustical panel or other ceilings. These must be investigated by District personnel, the water sources corrected as required, and damaged materials replaced.

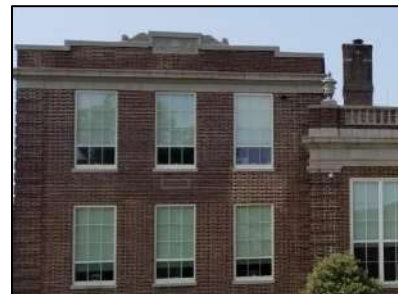
The existing brick / masonry walls are in generally sound condition. However, at more than 100 years old, brick in certain areas is showing surface erosion. Limestone trim is weathering as well. These items will require routine

inspection and care. A program of masonry preservation in the long-term future will help preserve strength and appearance.

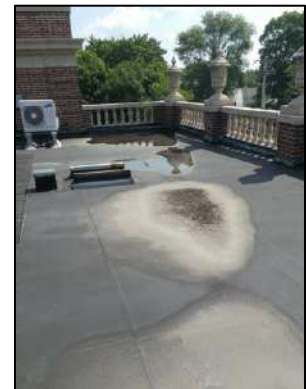
At this point in the building's history, all original roofs have been replaced with EPDM membrane systems throughout low-slope areas. Although still within expected service life, some of these replacements show signs of age or imperfect workmanship. Older areas show numerous wrinkles, delaminations, or raised fasteners. Ponding is a problem in some places. Flashings, both metal and membrane, require attention. In particular, vertical membrane flashings were installed to cover and protect weathered brick parapets. Many of these are beginning to un-adhere and delaminate from the substrate. These should be repaired or reinstalled with additional fastenings and termination bars.

Membrane roofs will require a replacement program in the long-term future as older replacements reach the end of their own service cycles. This is expected to begin approximately 8-10 years from date of this writing.

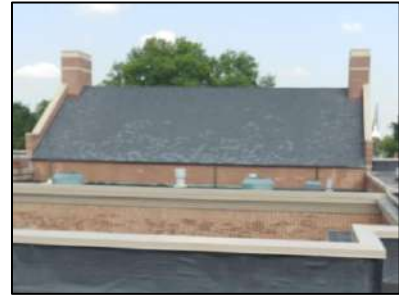
The sloped shingle roof of the Auditorium is in good condition. In the past it was replaced with a long-life synthetic slate shingle, with a service life of 40-50 years. This shows evidence of weathering and repair, but has remaining service life exceeding the timeline of this assessment. This roof requires routine inspection and maintenance, but should serve for the next decade at least.

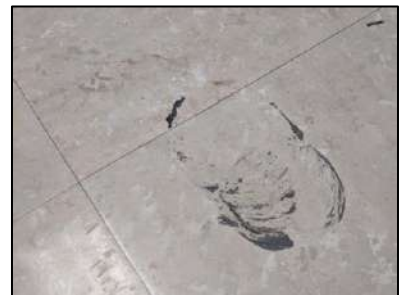
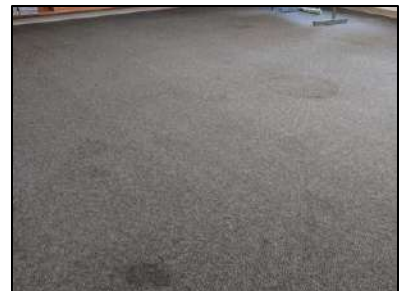
The majority of resilient floor finishes throughout the building are in acceptable condition. Occasional areas of damage or cracking should be corrected. Base trims, however, are worn, damaged, and dated in color (see Walls below for more information). Areas of carpet in Wings A and C-D are worn, stained, and damaged. They are past their expected service life, and should be replaced with new carpet and resilient base trim.

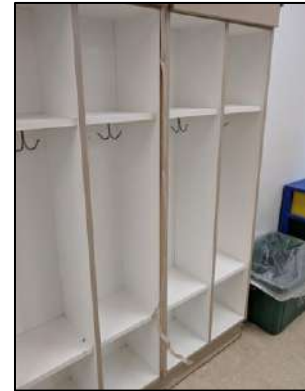
Casework (cabinets, countertops, and shelving) is worn and damaged. Most rooms are still serviceable. Selected areas of damaged casework in Wing A and throughout Wing B should be repaired or replaced in kind. See also Accessibility segment above for non-compliant casework modifications.

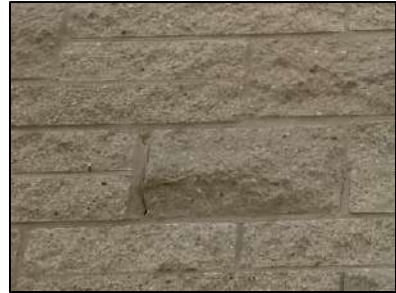
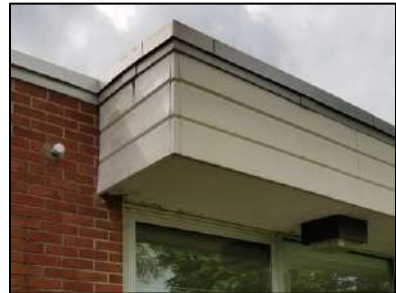
Exterior metal siding and soffit panels on Wings A, C, and D are aged, deteriorating, and have been previously painted. Paint is peeling and mildewed. These should be replaced with new prefinished metal wall panels and soffits to match 2005 addition and provide a coherent exterior appearance.

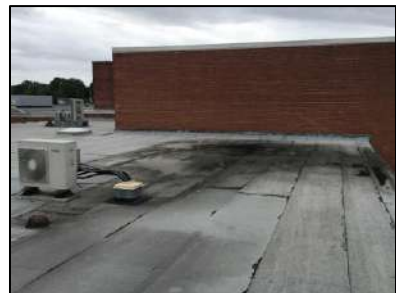
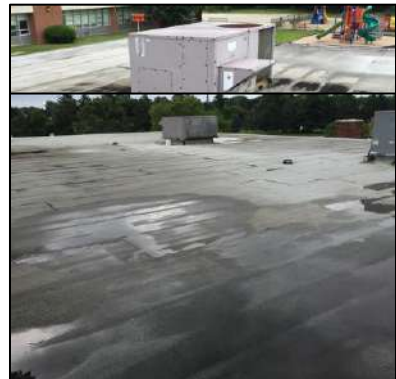
Original built-up roofs were replaced by a modified bitumen roof (MBR) system in approximately 2002. These in turn have reached the end of their expected service life and should be replaced within the next year if possible. Deteriorated insulation and flashings were observed throughout. Ponding is a major problem in most places, and evidence of water infiltration is visible in various interior locations. Timely roof replacement is critical to avoid the expense of additional interior water damage. As part of this program, existing cast stone copings should be covered with new prefinished aluminum copings to improve water integrity of the roof / exterior wall connection. During roof

replacement, the District should strongly consider installing additional insulation depth where feasible rather than simply replacing in kind.

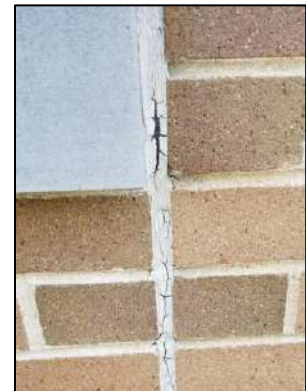
Sealant joints at most stone window sills and masonry control joints are failing and should be replaced as part of a routine exterior maintenance program.
