# SUNNYSIDE

*Elementary School*

## *Certificate of Necessity*

*Project No.: 18047*  
*August 09, 2019*

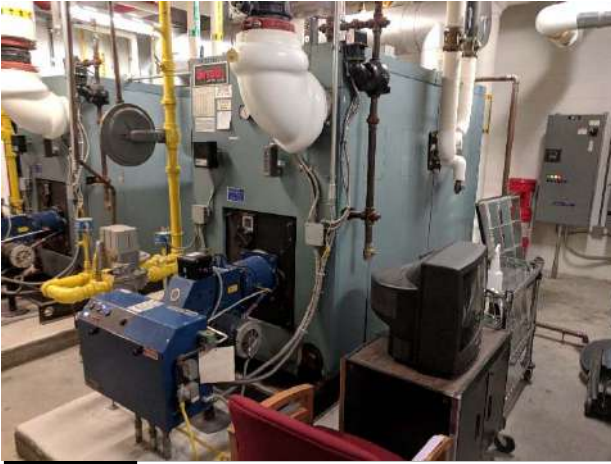
<b>CENTRAL HEATING SYSTEM</b>		
System or Unit Type		Service Life Estimate (years)
<b>Boiler(s), Hot Water</b>		<b>25</b>
<b>P-04</b>	Quantity	2
	Capacity	3,172 MBH input each
	Performance Efficiency	80.0%
	Fuel	Dual Fuel: Natural Gas, #2 Oil
	Plant Heating Capacity	4,034 MBH
	Location	Mechanical Room
	Service	Entire Building
	Nameplate Date	2007

Photo #1 Boilers in Mechanical Room

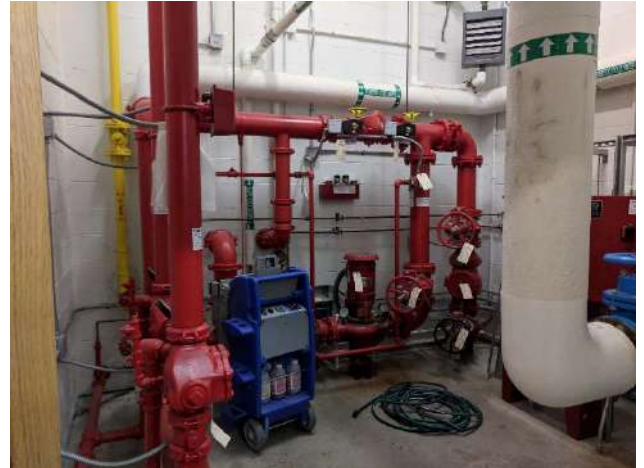
- Copper domestic piping is prone to corrosion due to water chemistry in Smyrna. Other schools in the district have experienced this and replaced piping with Uponor PEX (cross-linked polyethylene). It is recommended that the Middle School do the same. Domestic water piping needs replacement in all areas except the Kitchen and 'A' Wing.

Photo #2 Domestic and Fire Protection Water Entrances

Uponor PEX is currently being installed in place of copper for domestic water supply piping in the 'A' wing of the building.

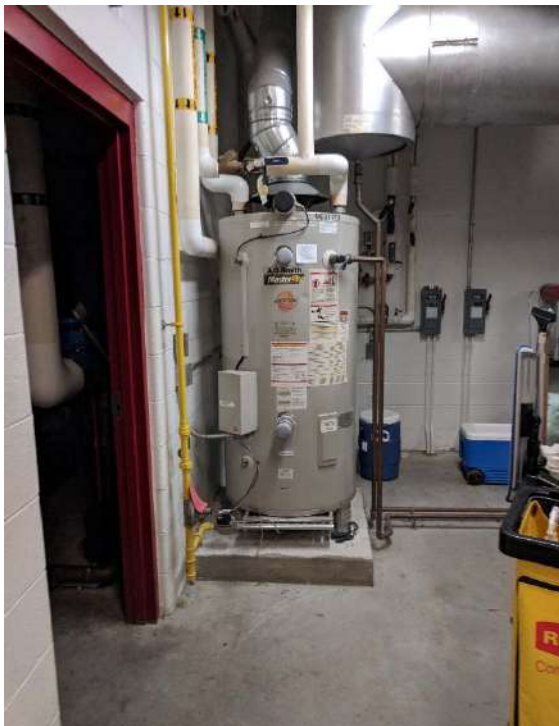
PLUMBING EQUIPMENT		
System or Unit Type	Service Life Estimate (years)	
<b>Domestic Hot Water Heater, natural gas</b>		<b>15</b>
P-03	Quantity	1
	Input Capacity	390 MBH
	Storage Capacity	100 Gallon
	Expansion Tank?	Yes
	Location	Mechanical Room
	Service	Entire Building
	Nameplate Date	2007
<b>Pump(s), Inline</b>		<b>18</b>
P-04	Quantity	2
	Capacity	1/20; 1/6 HP
	Location	Mechanical Room
	Service	Dishwasher, Domestic Hot Water Recirculation
	Nameplate Date	2007

Photo #3 Domestic Water Heater

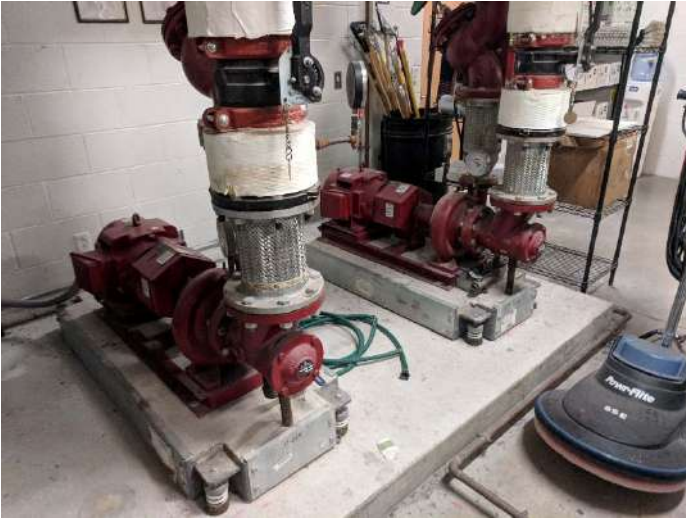
<b>HYDRONIC DISTRIBUTION</b>		
Equipment Type		Service Life Estimate (years)
<b>Pump(s), Base-mounted</b>		<b>20</b>
<b>P-04</b>	Quantity	2
	Capacity	15 HP each
	Control	VFDs on pumps, 3-way control valves on equipment
	Location	Mechanical Room
	Service	Entire Building for space heating
	Nameplate Date	2006
<b>Pump(s), Inline</b>		<b>18</b>
<b>P-04</b>	Quantity	2
	Capacity	1 HP each
	Control	Constant Speed
	Location	Mechanical Room
	Service	Boiler Primary Pumps
	Nameplate Date	2006

Photo #5 Heating Water Pumps in Mechanical Room

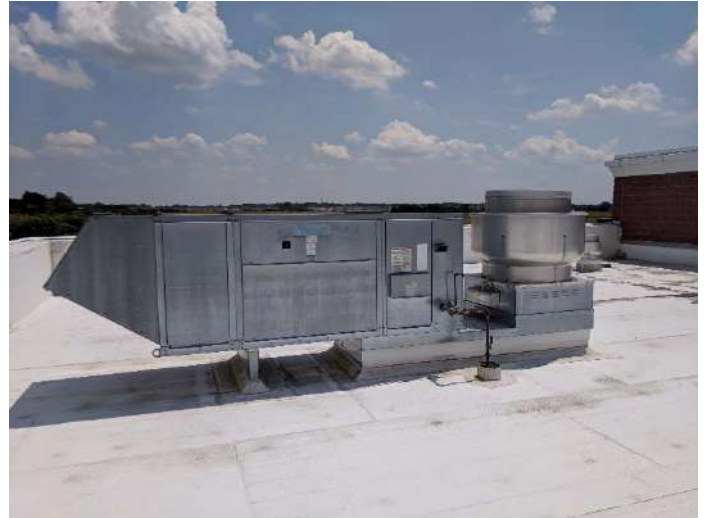
<b>VENTILATION SYSTEMS</b>		
System or Unit Type		Service Life Estimate (years)
<b>Make-Up Air Unit, Gas Heat</b>		<b>15</b>
<b>P-03</b>	Quantity	1
	Capacity	3,166 CFM
	Location	Roof
	Service	Kitchen
	Nameplate Date	2007
<b>Fan, Centrifugal</b>		<b>20</b>
<b>P-04</b>	Quantity	14
	Capacity	75 - 6,332 CFM
	Location	Roof
	Service	Bathrooms, Kitchen, Janitor Closets, General Exhaust
	Nameplate Date	2006

Photo #6 Kitchen Make Up Air Unit

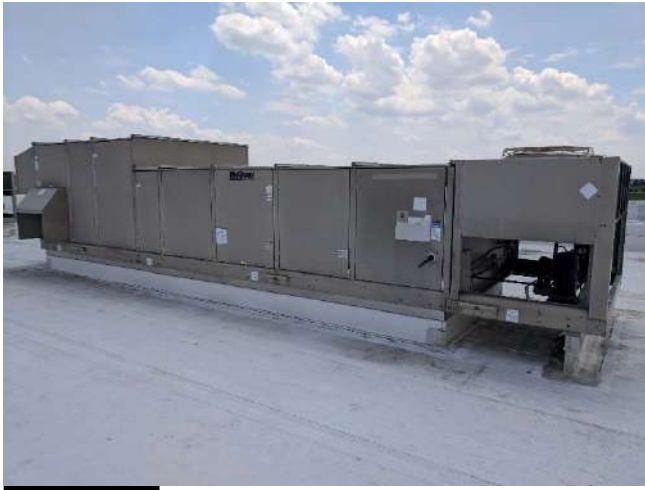
<b>AIR DISTRIBUTION SYSTEMS</b>		
Equipment Type	Service Life Estimate (years)	
<b>Packaged DX Unit, energy recovery wheel</b>	<b>17</b>	
<b>P-02</b>	Quantity	8
	Capacity	60 - 264 MBH
	Refrigerant	R-22
	Location	Roof
	Service	Entire Building - Variable Volume
	Nameplate Date	2007
<b>Packaged DX Unit, air-cooled, gas heat</b>	<b>17</b>	
<b>P-02</b>	Quantity	2
	Capacity	18 - 72 MBH
	Refrigerant	R-22
	Location	Roof
	Service	Entire Building - Variable Volume
	Nameplate Date	2007

All RTUs utilize R-22, which will be phased out by the EPA in 2020. It is recommended that the units be replaced or modified in order to utilize refrigerants more widely available.

Photo #9 Typical Packaged RTU with Energy Recovery

The packaged controllers for the RTUs do not effectively interface with the supervisory ATC system. We recommend replacing the control boards and reprogramming the units to increase compatibility with the control system.

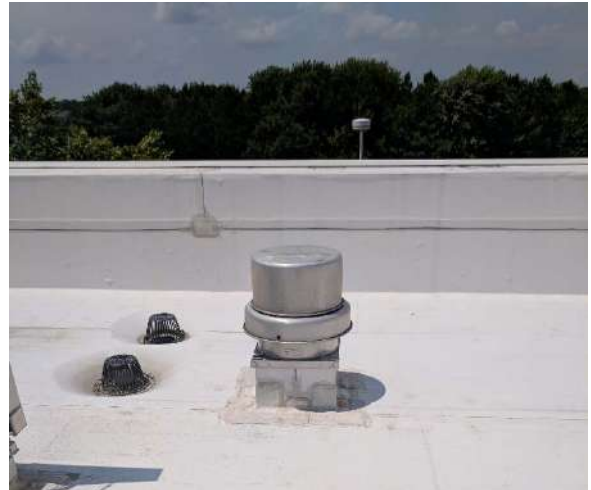
Photo #10 Typical Rooftop Exhaust Fan

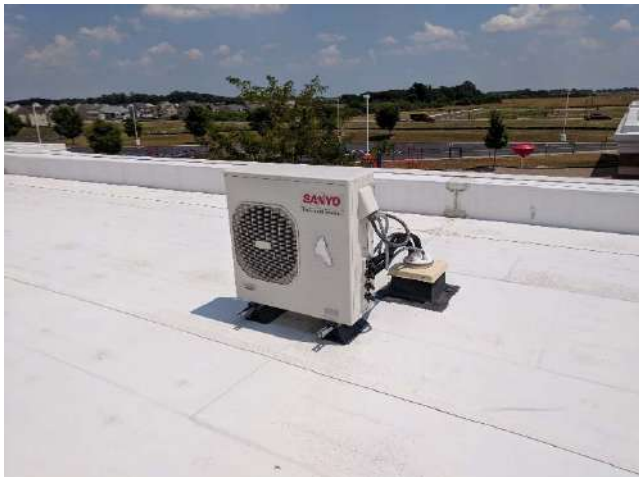
<b>SUPPLEMENTAL UNITS</b>		
Equipment Type		Service Life Estimate (years)
<b>Split DX Unit, air-cooled</b>		<b>17</b>
<b>P-02</b>	Quantity	2
	Capacity	9 - 18 MBH
	Refrigerant	R-22
	Condensing Unit Location	Roof
	Service	Kitchen, MDF Room
	Nameplate Date	2007
<b>P-04</b>	Quantity	1
	Capacity	18 MBH
	Refrigerant	R-410A
	Condensing Unit Location	Roof
	Service	Administrative Space
	Nameplate Date	2011

Photo #11 Typical Split DX Condensing Unit

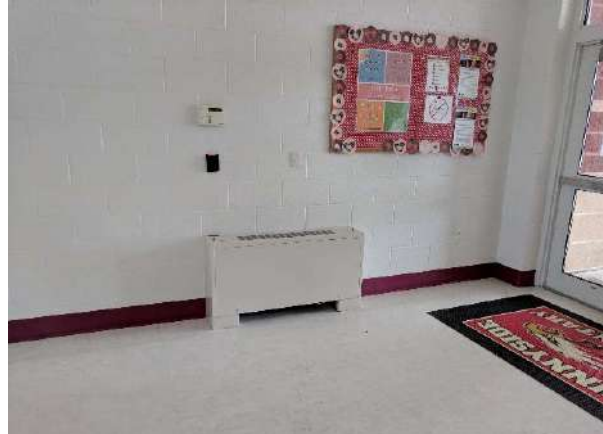
Photo #14 Typical Vestibule Cabinet Heater

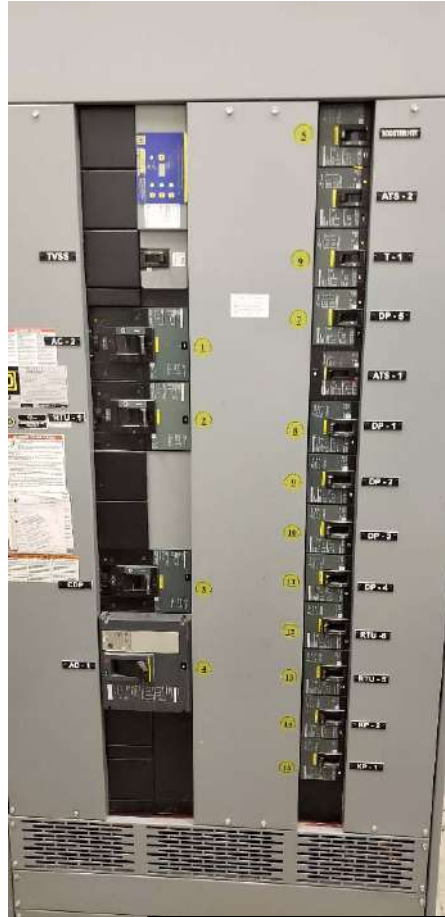
There are no immediate or significant repairs that need to be made to the electrical service or branch panelboards located in the main electrical room or throughout the school. The switchboard and panelboards are manufactured by Square D and were installed in 2007 and appear to be in good condition.

Photo #6  
Distribution Section of Main Switchboard

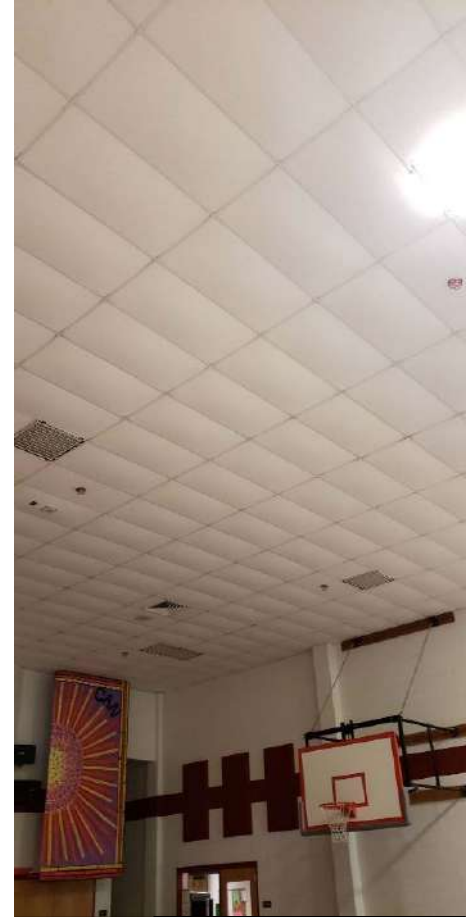
Photo #7  
Lights and Ceiling in Gym/Auditorium/Cafe

While the lighting systems are not in immediate need of replacement, as part of general improvements to the building, changing from fluorescent and metal halide light sources to LED light sources would result in energy savings. Installing lighting controls such as occupancy sensors in the classrooms throughout the building could also increase energy savings as the current building does not have an automatic means to turn off the lights in that space when that space is unoccupied. The current lighting controls do not comply with the current edition of ASHRAE 90.1. Routine and periodic maintenance of the lighting system is recommended.

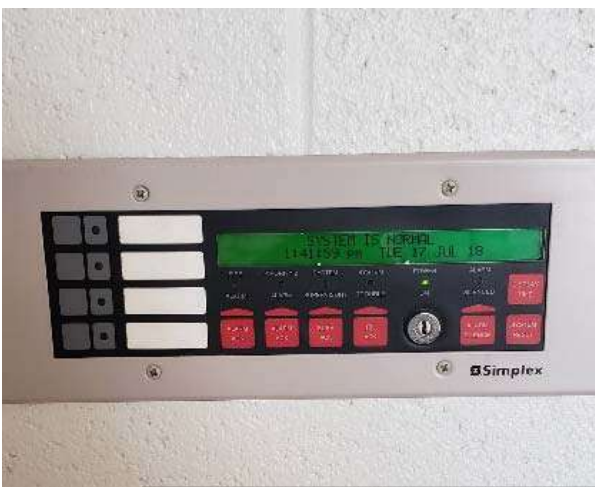
There are no immediate or significant repairs that need to be made to the building fire alarm system. Routine and periodic testing and maintenance of the fire alarm system is recommended. While the existing fire alarm is in good condition, it utilizes audible horns and visual strobe notification devices and does not have a voice evacuation system. The 2015 NFPA 101 Life Safety Code requires that any new schools with 100 or more occupants have a fire alarm system utilize an emergency voice/alarm communications system to notify occupants. Even though a change is not required now, if a major renovation was to occur to the existing school, then the existing fire alarm system would need to be upgraded to a voice evacuation system.

Photo #8  
Fire Alarm Annunciator Panel

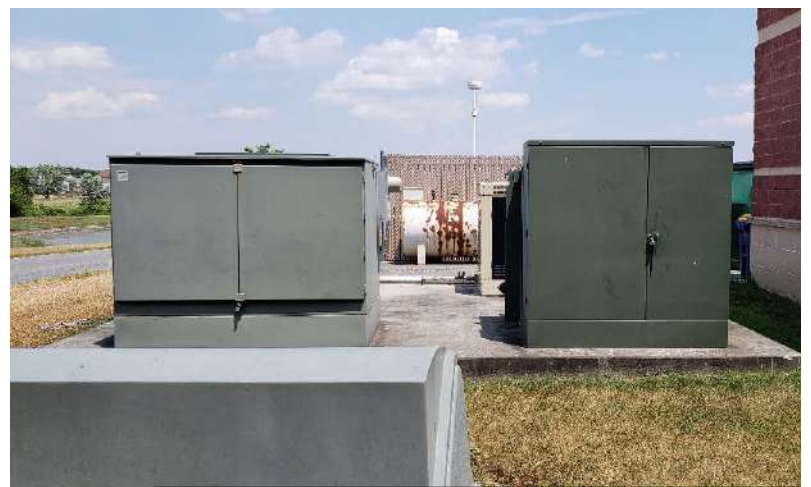
The generator is located outside on a concrete pad with the primary metering station, PMH-5 switch and transformer. The generator and associated automatic transfer switches were installed during the original construction in 2007 and appear to be in good condition. The generator is installed in a weather-proof enclosure and piped for natural gas. There do not appear to be any immediate or significant repairs that need to be made to the generator.

Photo #9  
Metering Station, Transformer PMH-5 Switch and Generator

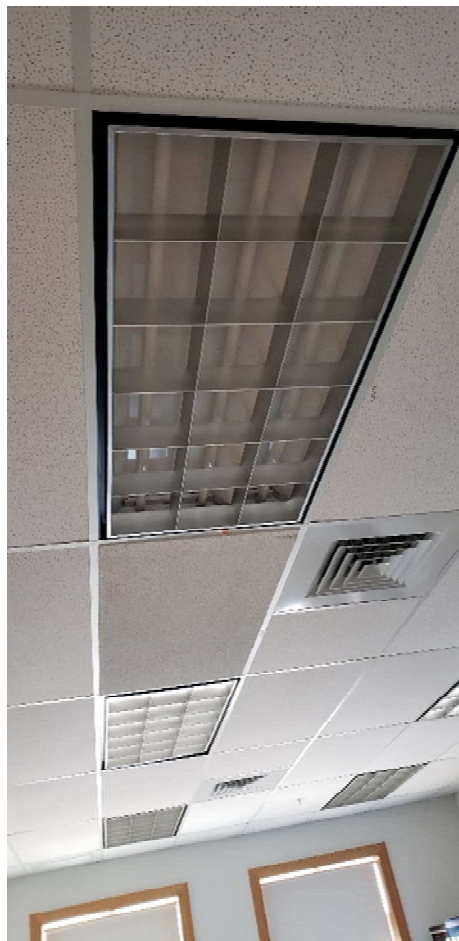
Photo #11 Typical Classroom Lighting Fixture

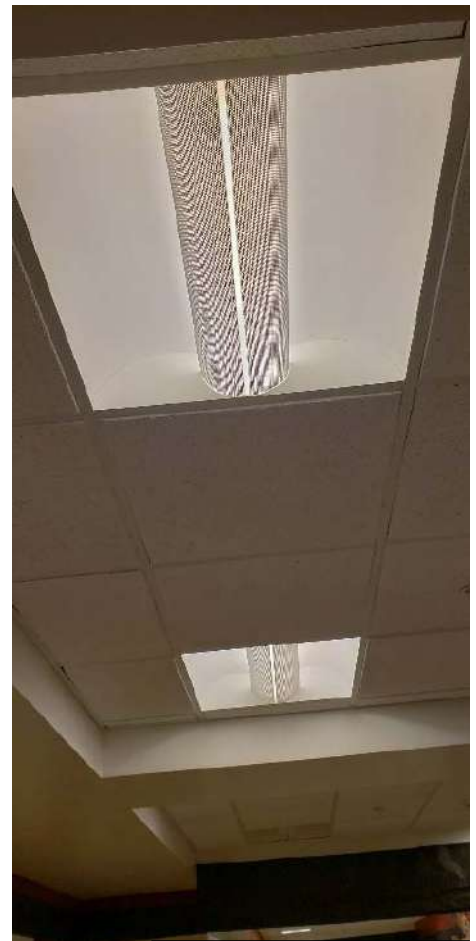
Photo #12 Typical Corridor Lighting Fixture
