# BUILDING CONDITION REPORT

**JEFFERSON HIGH  
SCHOOL DISTRICT #1**  
July 21, 2020

# BUILDING CONDITION REPORT SUMMARY

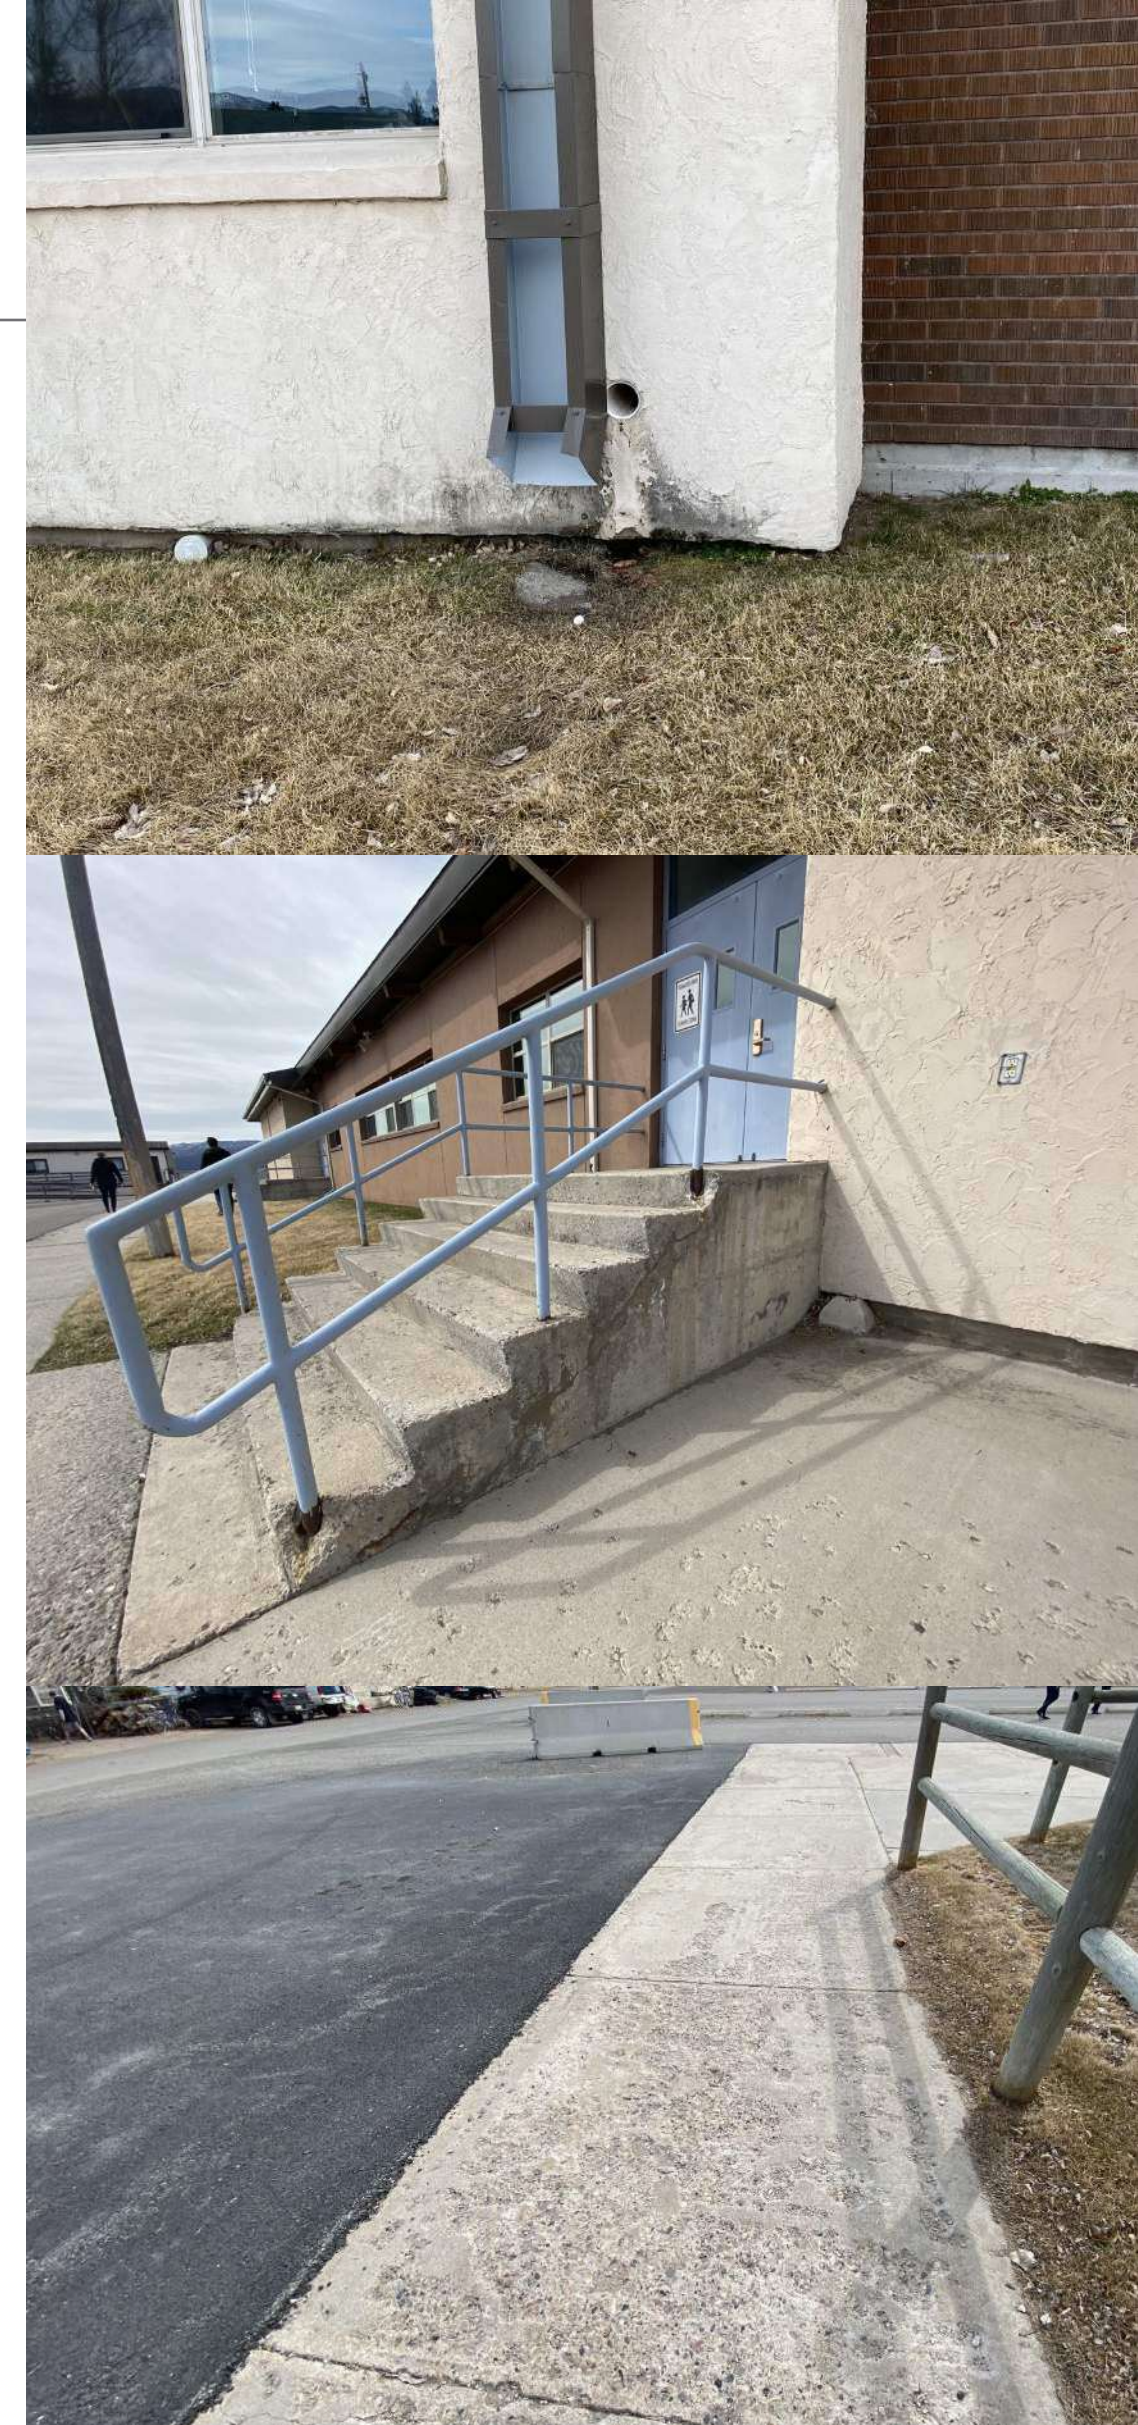
- Foundation in good condition
- Some Roof drains do not direct water away from foundation. Add splash blocks or other to direct water away from building.
- Exterior concrete stairs and exterior concrete flatwork is spalling and cracking.
- Entrance accessibility is good.
- Some damage or discoloration of exterior finishes, but otherwise in good condition.
- Exterior doors and windows in good condition.
- Security:
  - Not able to see visitors as they approach building

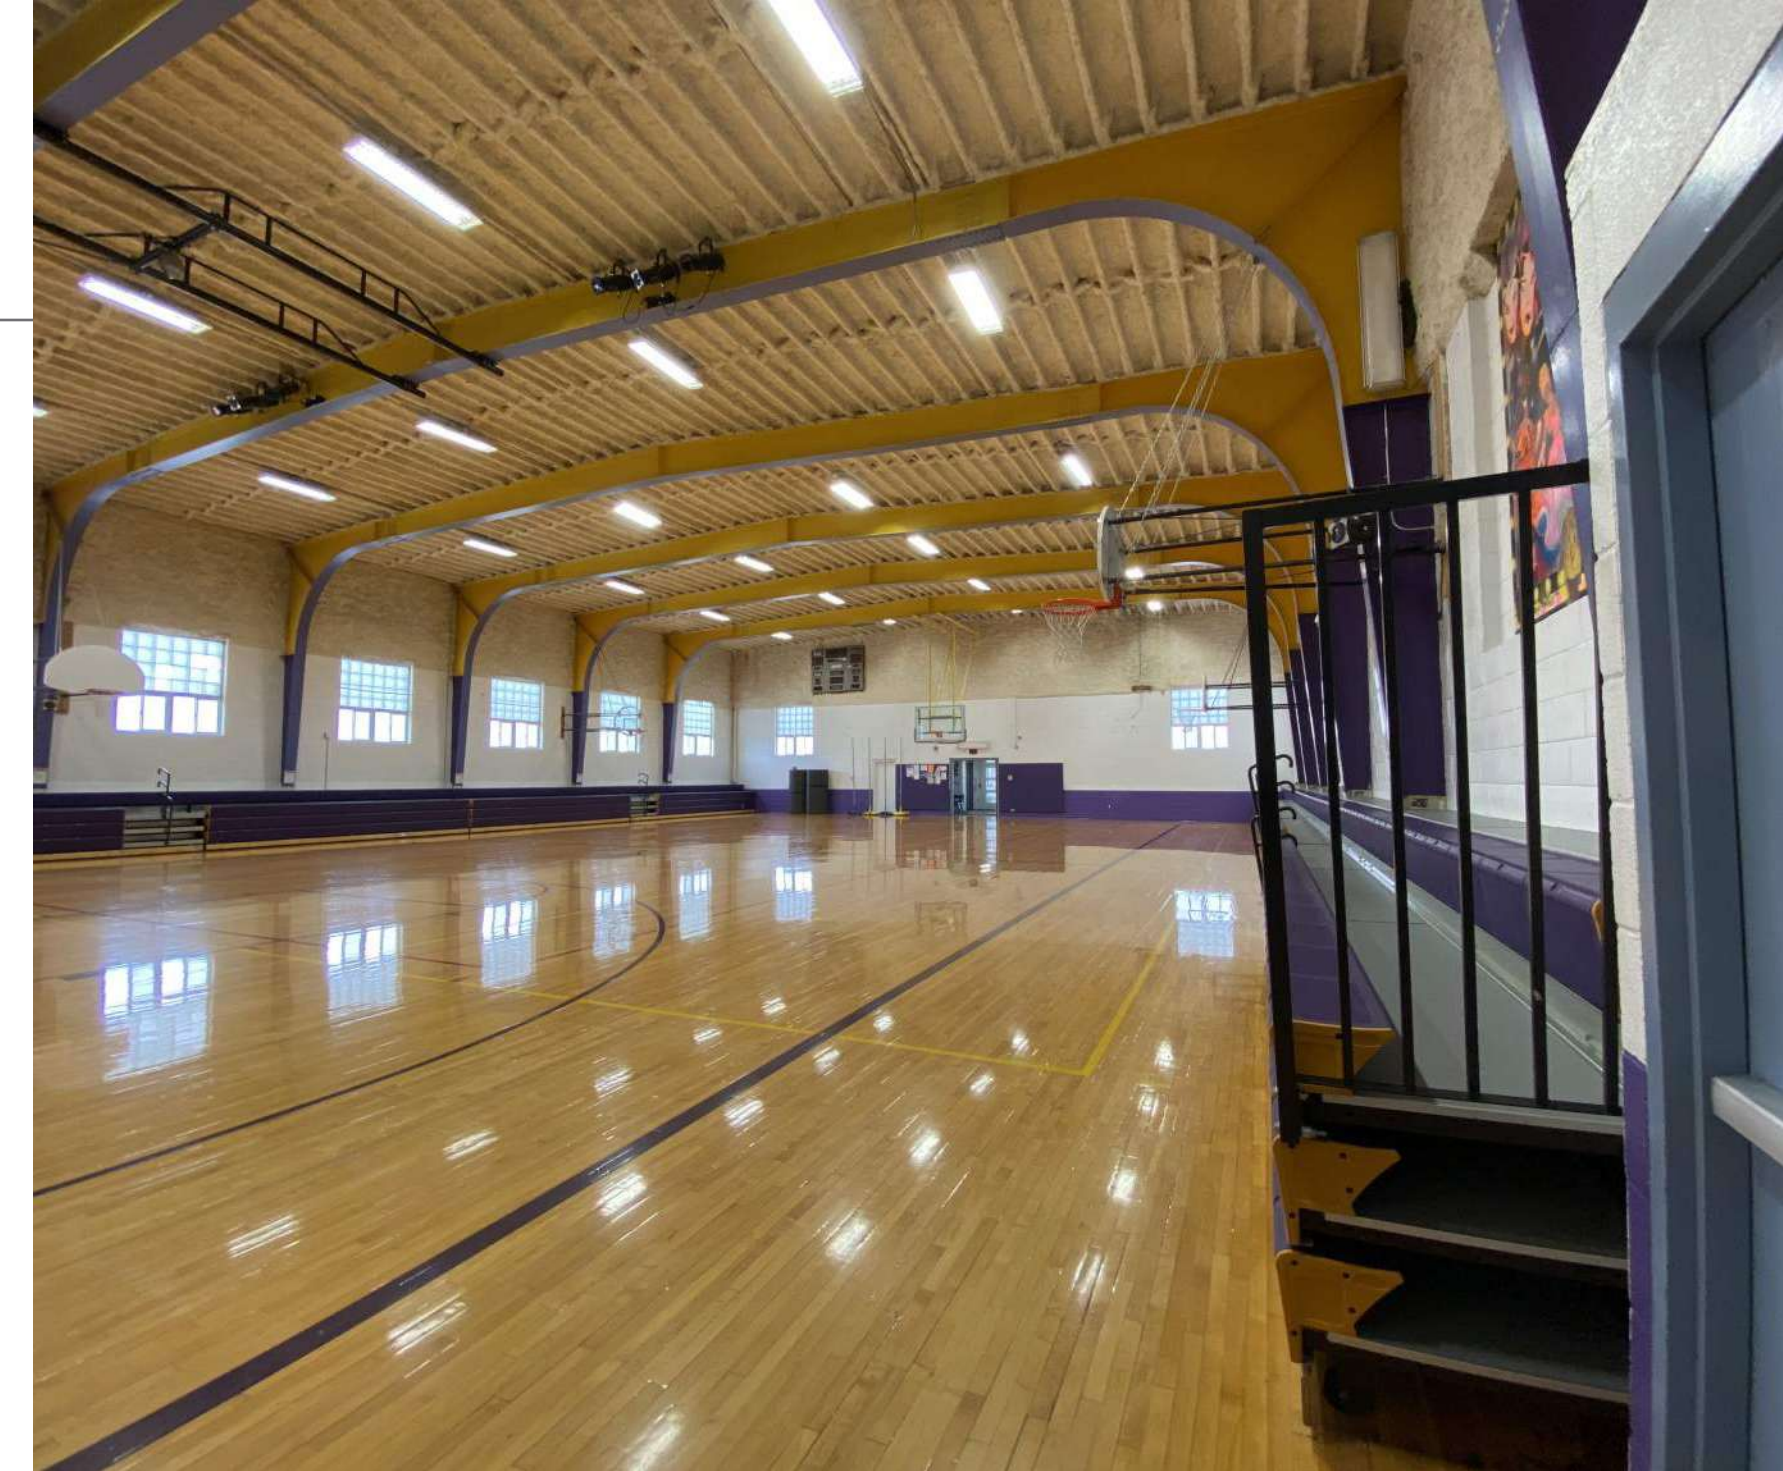
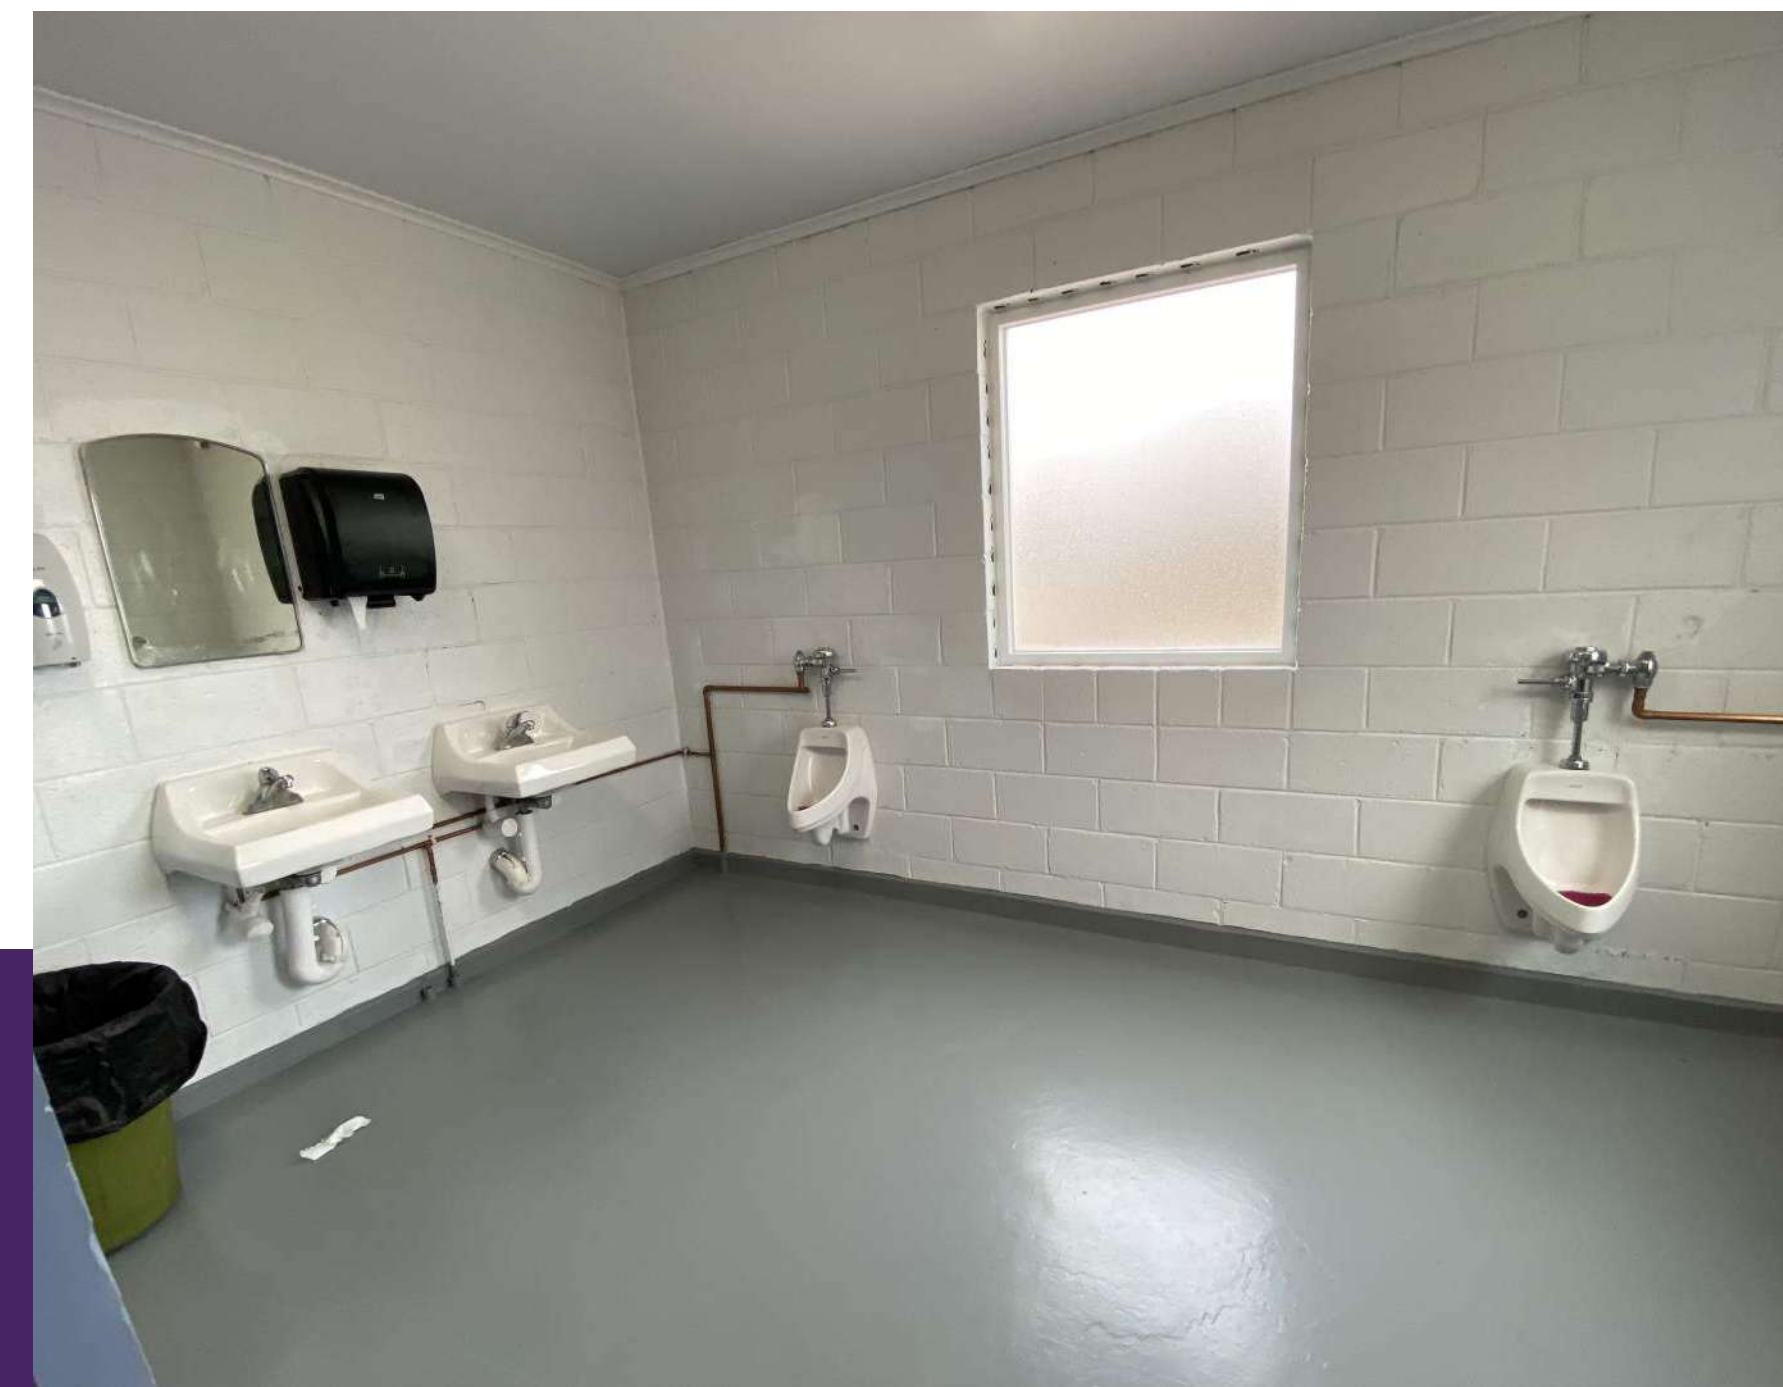
- Gym floor in good condition and was recently refinished
- Lighting is high-bay fluorescent and does not meet sufficient lumen output
- Acoustics for athletics, drama and theater have added spray insulation but still inadequate. Material may be flammable.
- Restrooms in vestibule lack privacy and are not ADA
- Additional gym is an asset but cannot be used to full potential with scheduling conflicts with drama/theater

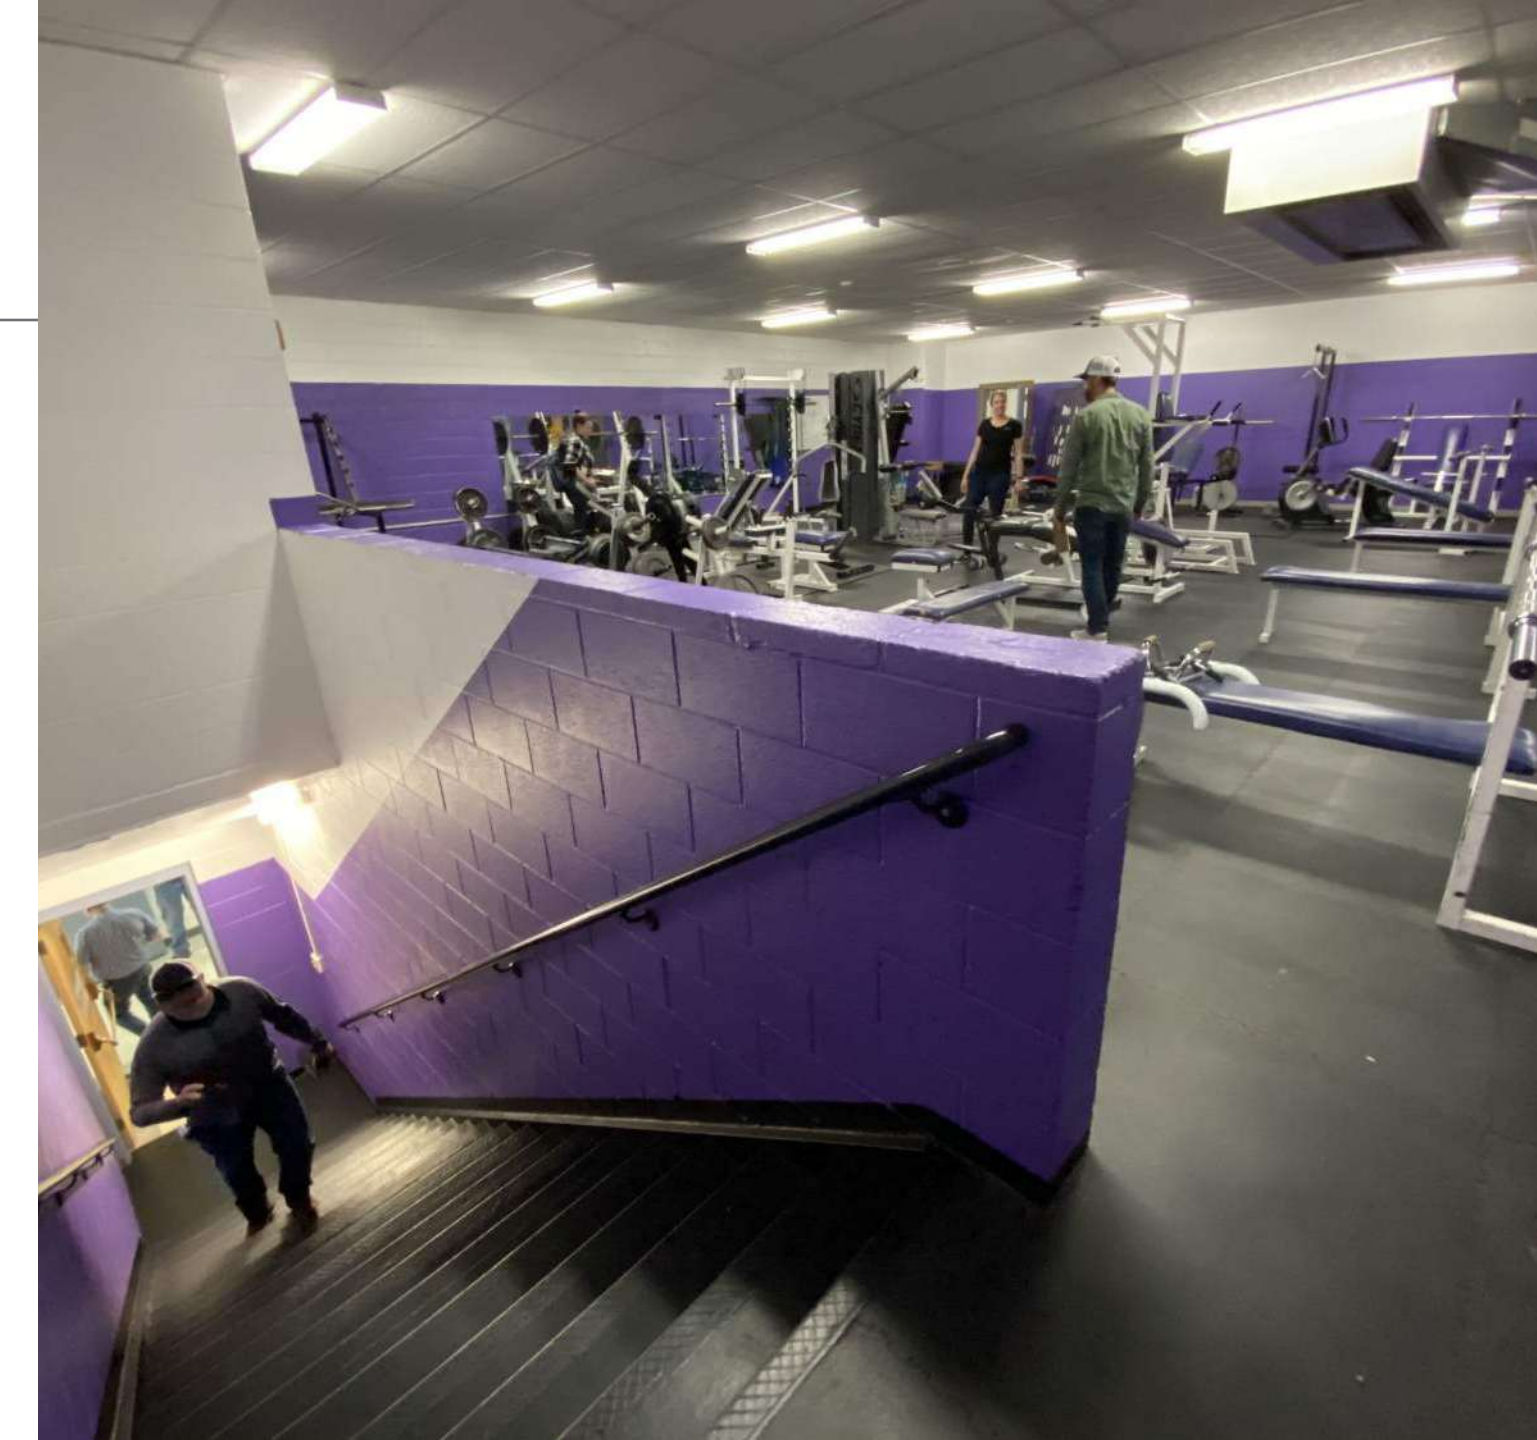
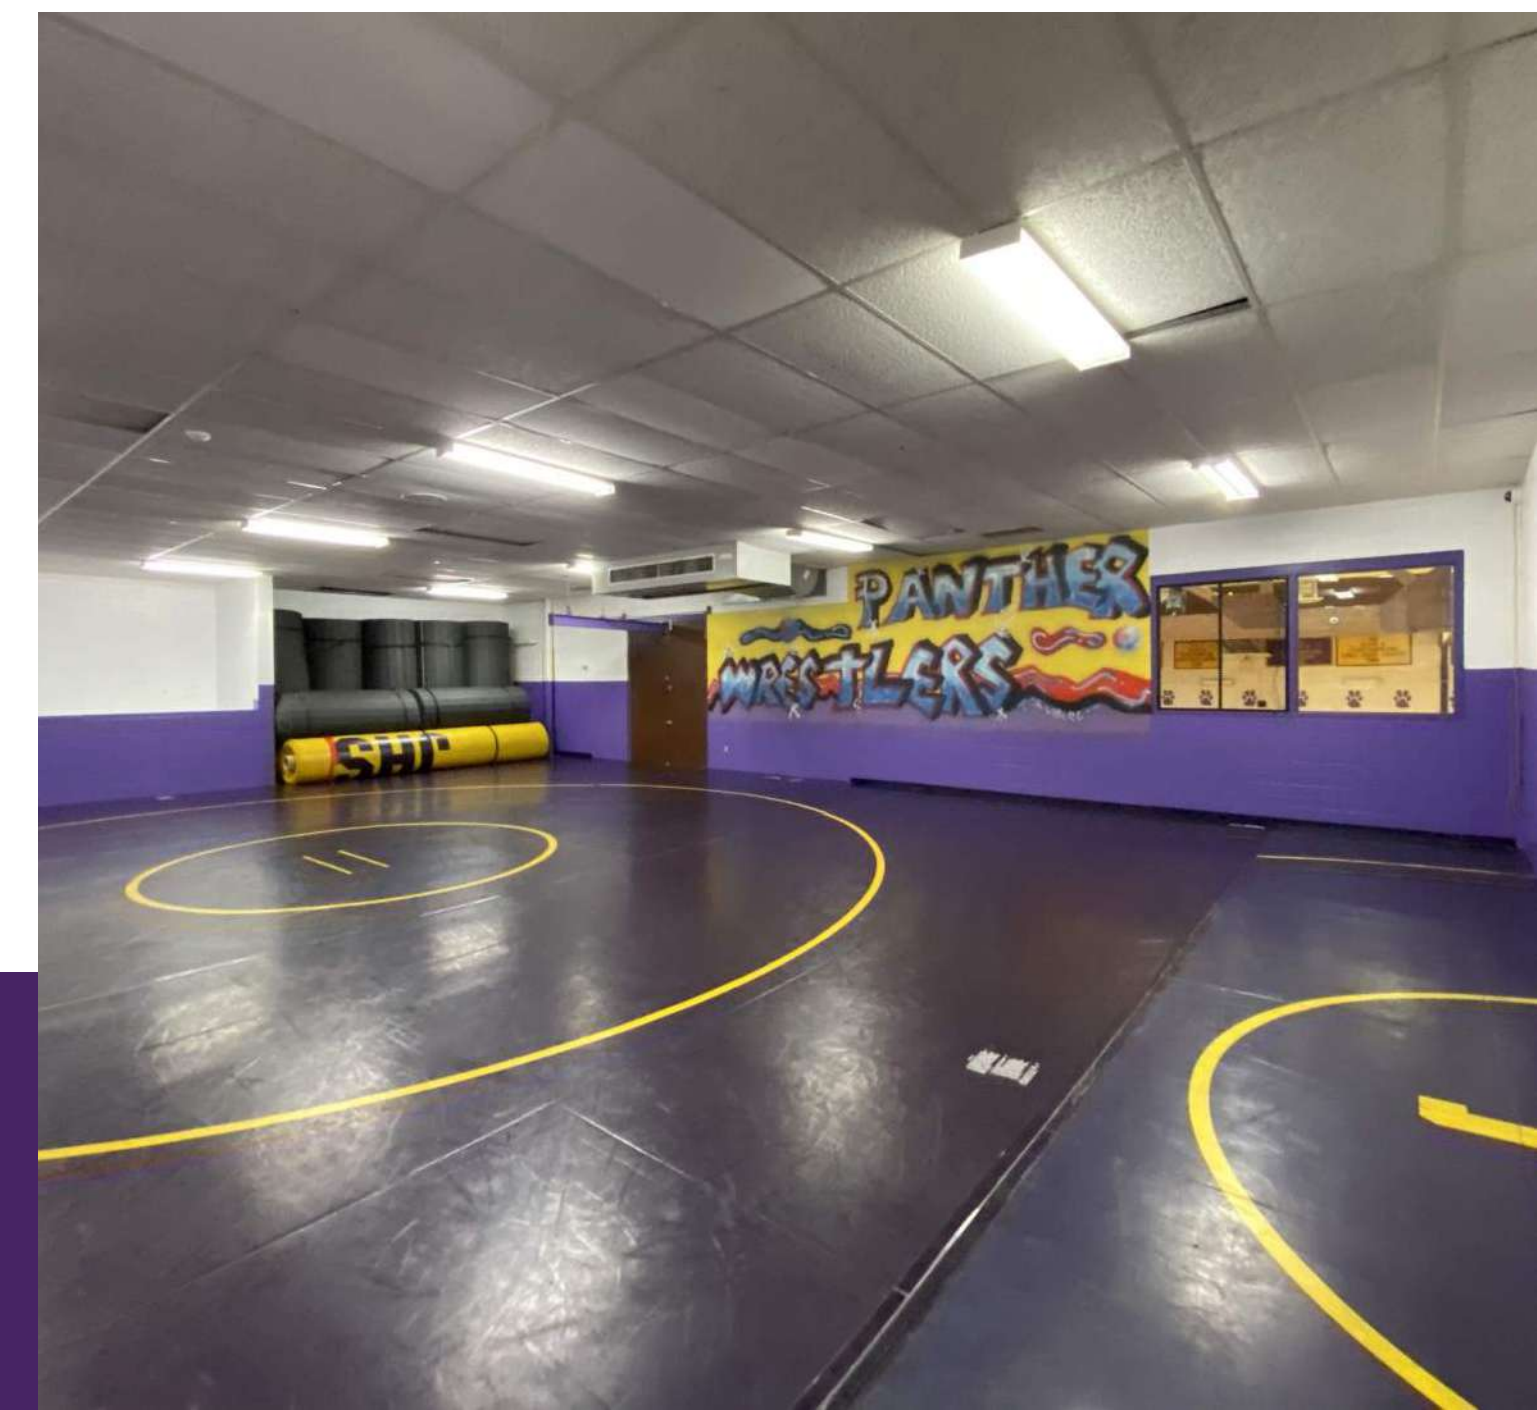
- Accessed via stairs to the mezzanine
- Finishes well maintained, but ceiling tiles showing damage, warping and stains
- Not ADA accessible
- Stair riser height taller than allowed code (measured at 7.5", code is 7")
- Mezzanine not designed as weight or wrestling room—drawings say designed as “Multi-Purpose Room”
- Weight of equipment and heavy plates striking composite slab is likely causing damage faster than intended
- Overall weight room undersized for students and equipment, more equipment and space needed to accommodate current class sizes
- Wrestling space cannot accommodate women’s and men’s wrestling
- Communication between weight and wrestling is only through telephone to the gym (difficult for setting up mats, etc.)

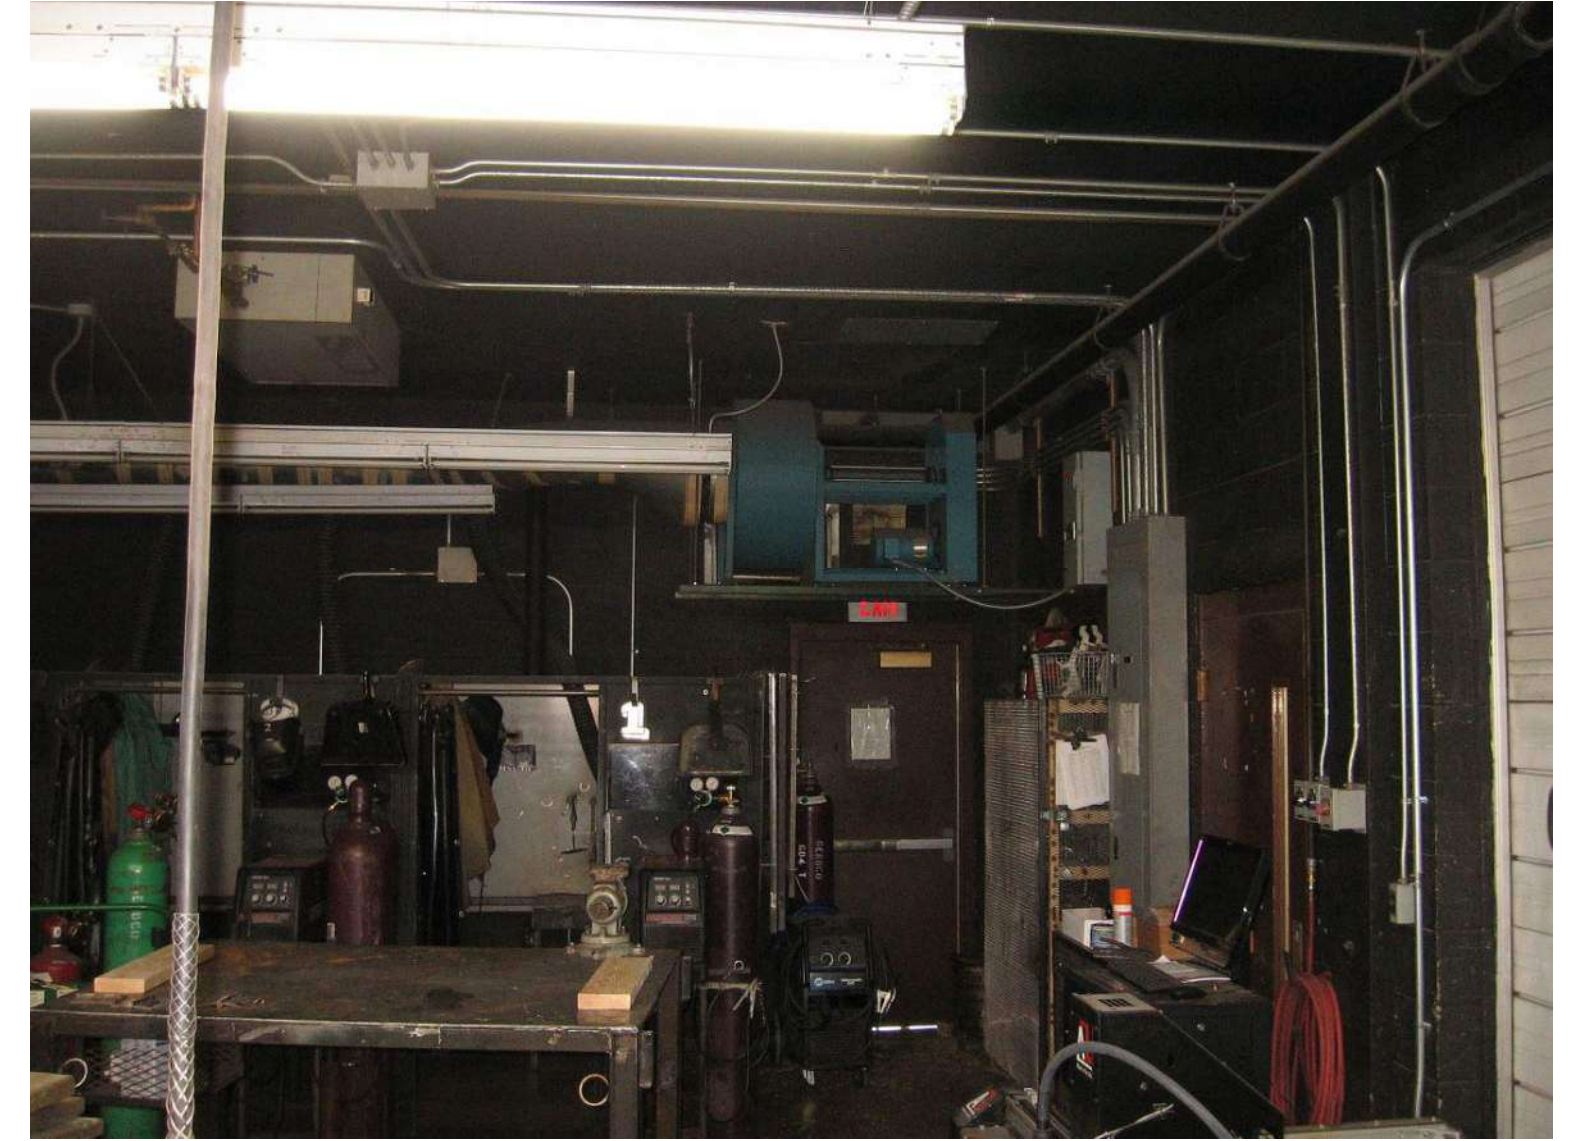
M21: Welding Shop Exhaust Fan

- Kitchen
  - Indirect drain lines revised to provide air gap
  - Prep sink piped as an indirect drain with air gap
  - Grease interceptor replaced
- Install mixing valves in bathroom lavatories
- Domestic water entrance lines leak
- Welding exhaust fan repaired/replaced

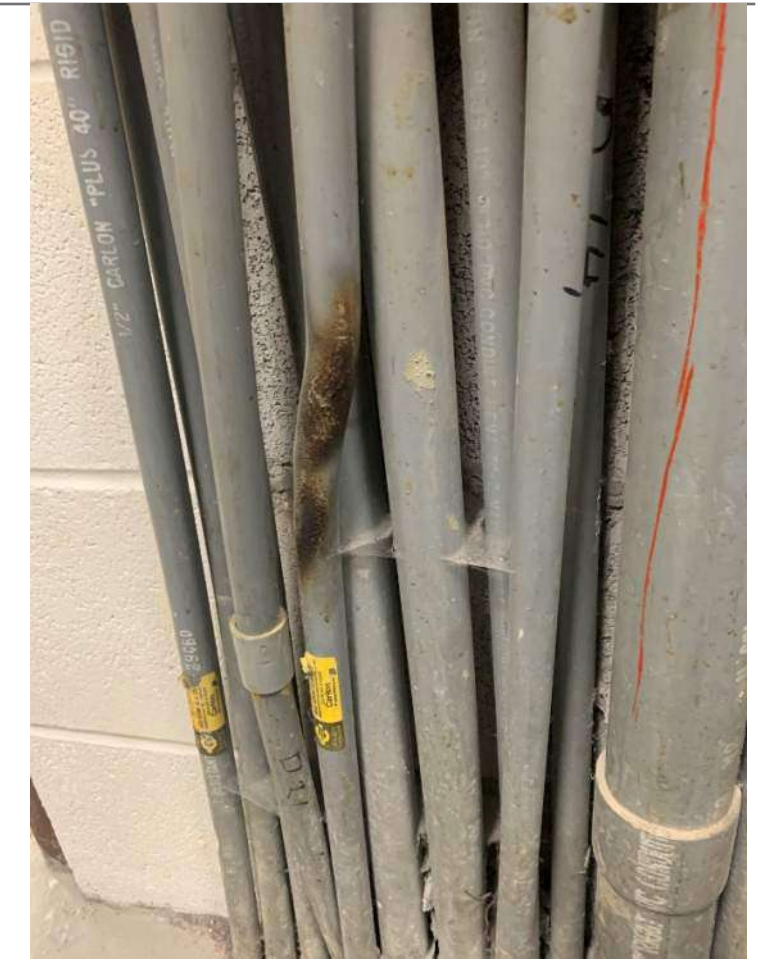
- Emergency & Egress Lighting Upgrades
- Motor Control center cover plates missing
- Conduit showing signs of electrical fire at panel D1

E5: Conduit shows signs of electrical fire and should be replaced.

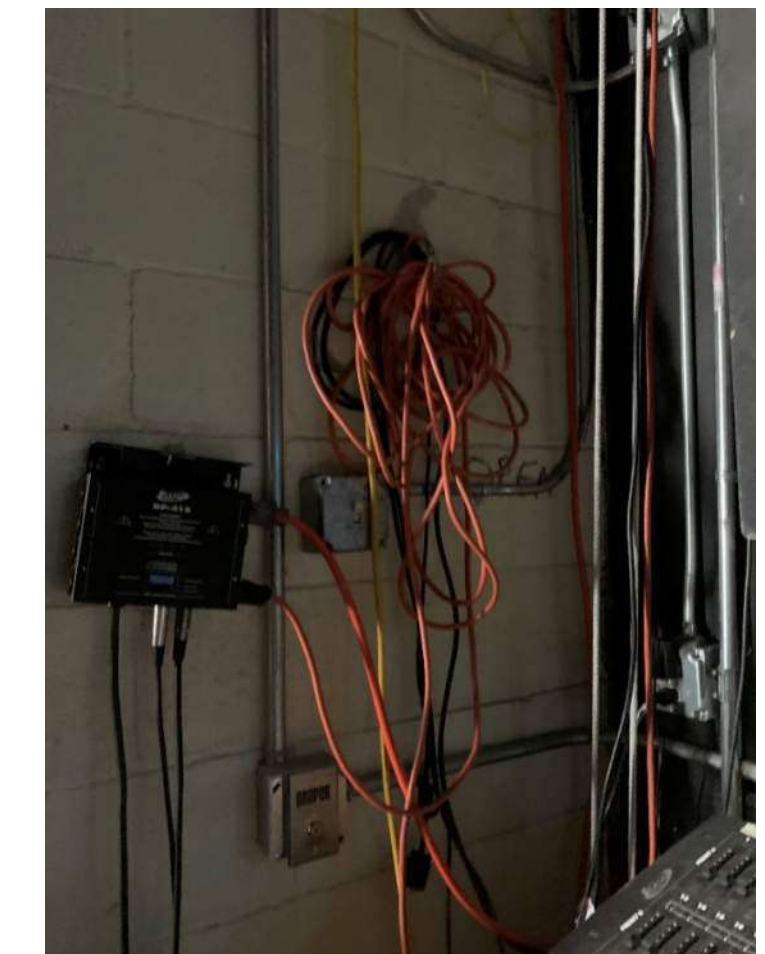
- Extension cords in South Gym Stage
- Extension cords & power strips in Library
- Communication cables routed along floor

E7: Extension cords at stage area.

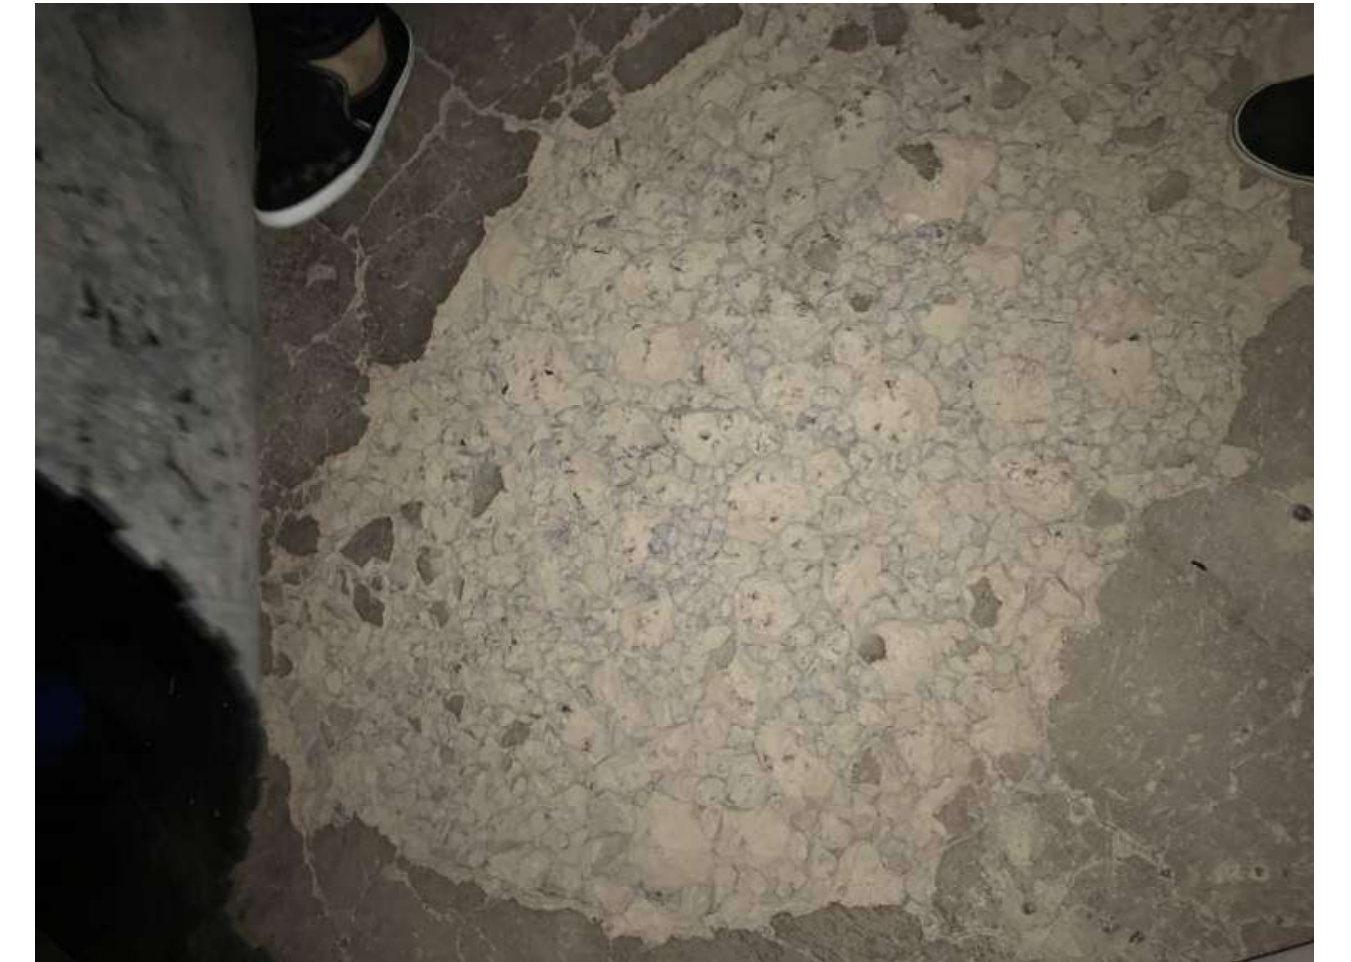
Figure 5. Deteriorated Concrete Floor Slab in Weight Room (1985 Addition)

- Overall in good condition, considering its age
- Very few signs of deterioration, damage or over stressing
- Recommend replacement of weight room floor in damaged areas of concrete slab.
- General roof to wall connections
- Treat exposed wood roof framing ends on exterior

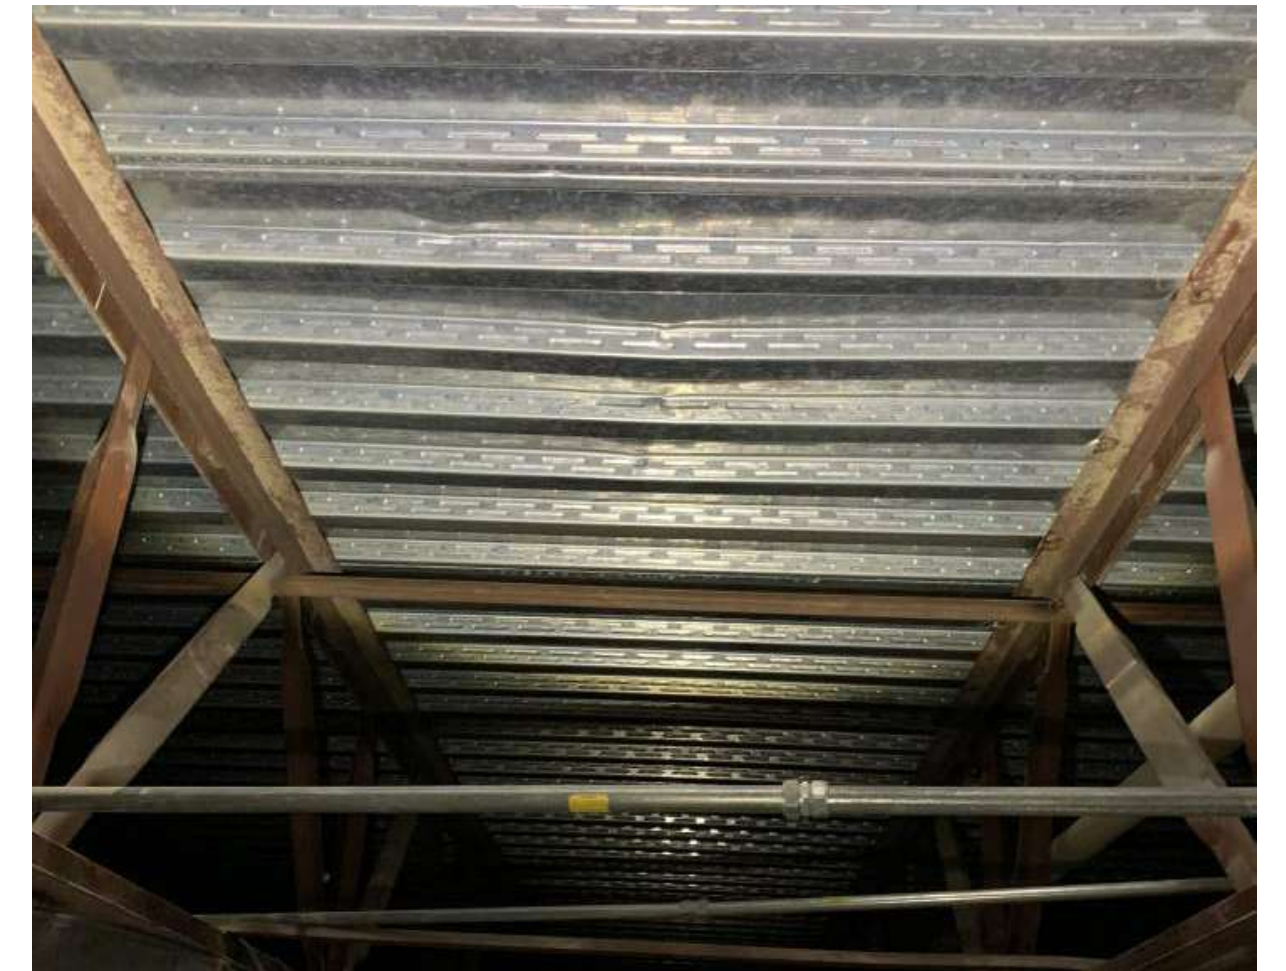
Figure 6. Deformed Metal Deck Below Weight Room (1985 Addition)
