January 8, 2018

Re: Gym Parapet Wall Collapse  
Linderman School  
Polson, MT.

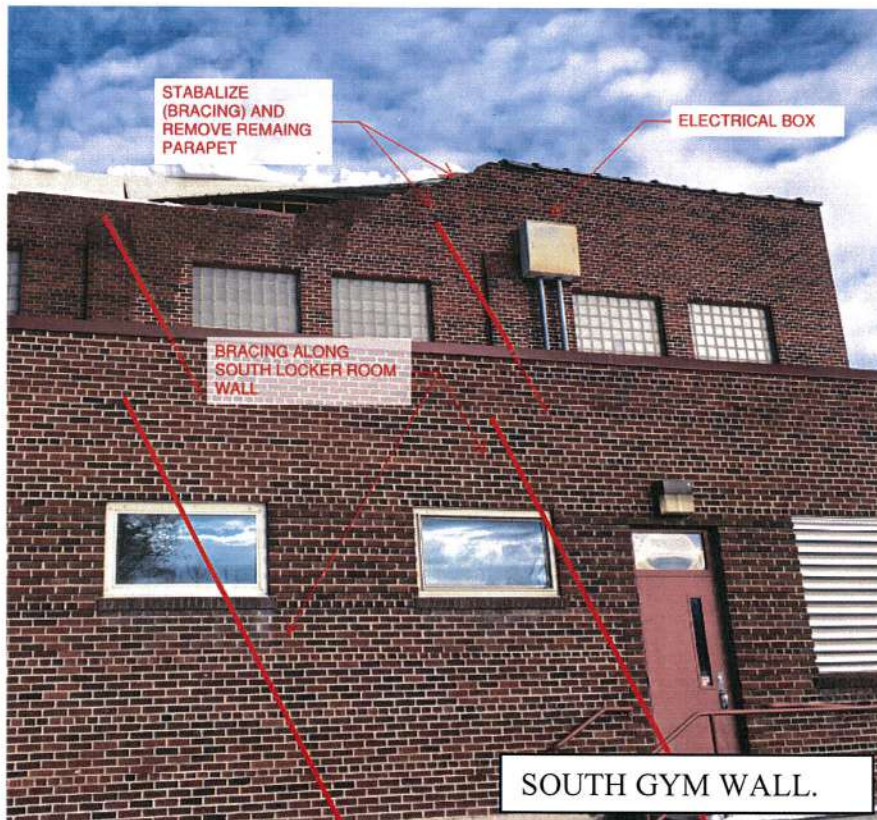
At your request, we have conducted a follow-up investigation for the collapse of the south parapet gym wall and locker room roof that occurred since our previous site visit on Tuesday, January 2<sup>nd</sup>. Chris Schlegel (PE) and Mark Bradford (PE) met on-site with the Superintendent (Rex Weltz), the Maintenance Director (Dan Giles), and Paul Bishop (Paradigm Architects) to inspect the damage and determine steps required to stabilize the structure. The majority of the south gym parapet (~3'-0" tall) had peeled off of the gym wall and landed on the south locker room lower roof below causing the lower roof to collapse (in conjunction with additional sliding snow). A section of parapet is still remaining along the east and west end bays for the gym. The locker room roof framing consists of wood trusses at 16" o/c with 2x6 top chords, 2x diagonal members, and 2x10 bottom chords. The framing spans N/S and is supported by the interior gym brick wall and exterior locker room brick wall.

The gym roof consists of 2x12 rafters at 16" o/c spanning east/west and supported atop timber trusses approximately 21'-7" (6 bays). The trusses are supported on concrete columns which are partially inset into the brick walls on the north and side of the gym walls. A 6'-0" level was placed (along top section of column) on each of the concrete columns located on the south side of the gym. These columns were consistently +/- ½" out of plumb (outward, south). A 4'-0" level was placed at the top of the south gym wall between the columns which indicated the brick wall was out of plumb +/- ½" along the 2 middle bays only. The columns and wall on the north side were all plumb when measured at the same upper location. The exterior brick wall on the southside of the locker room was +/- 1" out-of-plumb (outward, south) along the entire wall based on a 4'-0" level measured approximately 2/3 up the wall.

DCI recommends the following to stabilize the south gym walls upon which further investigation and recommendations may be provided:

1. Isolate gym parking lot on all exposed sides with chain link fence to keep pedestrians safely away from the building. The gym was currently taped off along the parking lot and the fence was being delivered while we were on-site.
2. Hand remove snow on north parapet.
3. Install diagonal braces along the south locker room brick wall for stabilization.
4. Brace/stabilize the east parapet above the electrical box (currently peeling off) so that the parapet may be safely removed and the electrical box preserved from potential damage.
5. Install diagonal braces along the gym wall to the south locker room wall to stabilize the south gym wall.
6. Demo locker room roof and determine extent of damage on south gym and locker room walls once debris is removed.
