CLARINDA COMMUNITY SCHOOL DISTRICT

FACILITY CONDITION ASSESSMENT
February 19th, 2018

EXECUTIVE SUMMARY

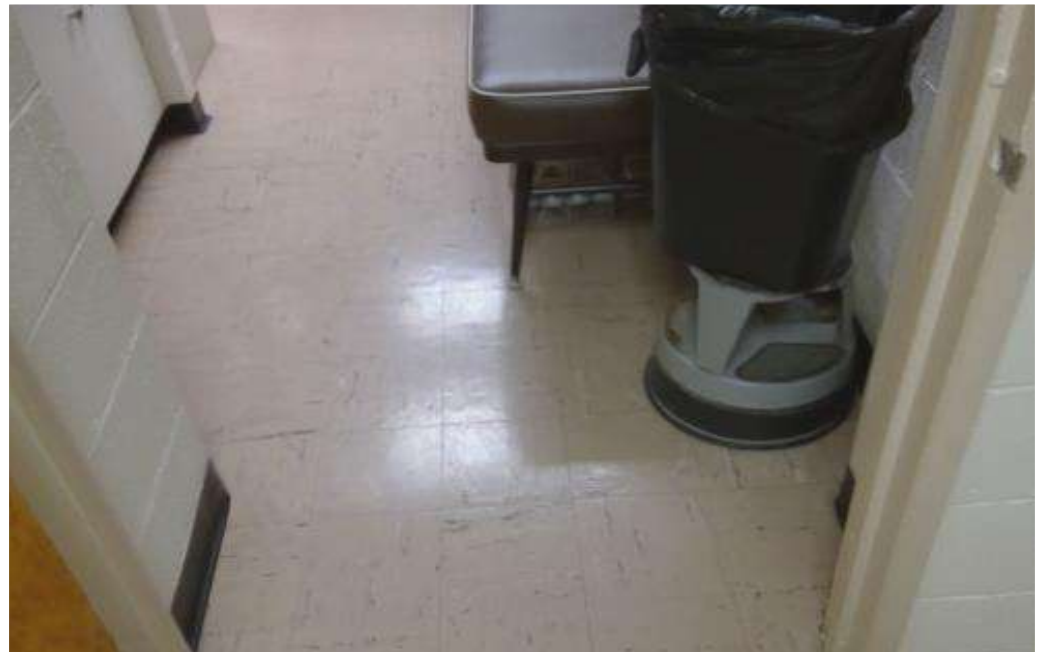
Existing asbestos containing floor tile

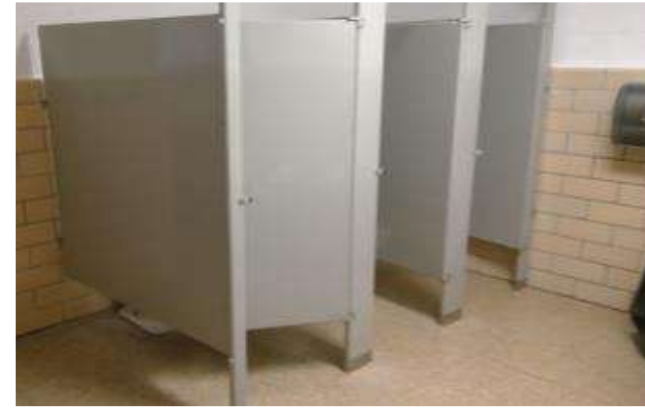
Existing conditions

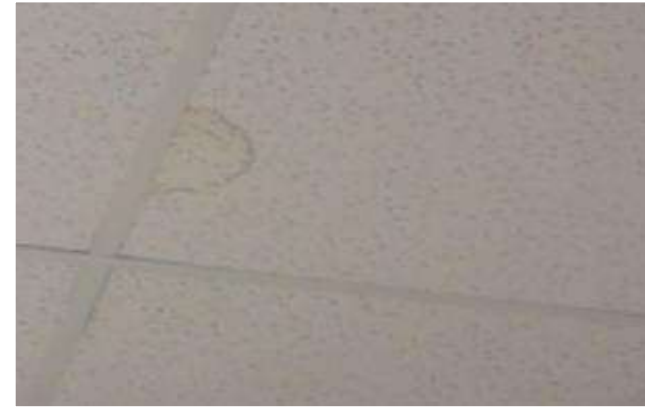
Existing water damaged ceiling tile

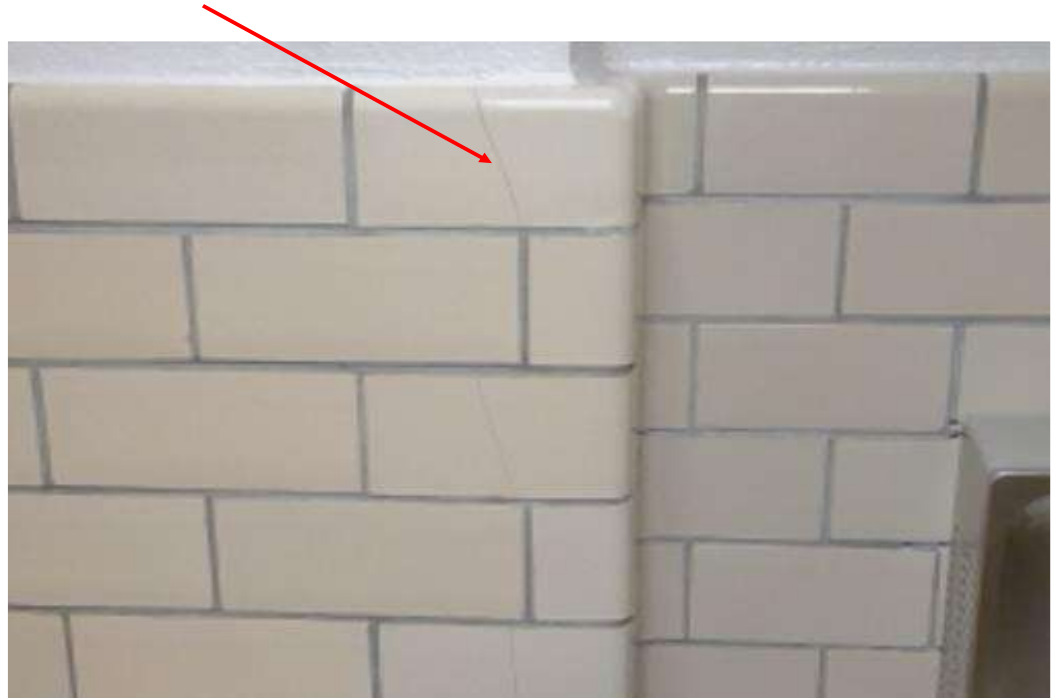
Existing crack in wainscoting

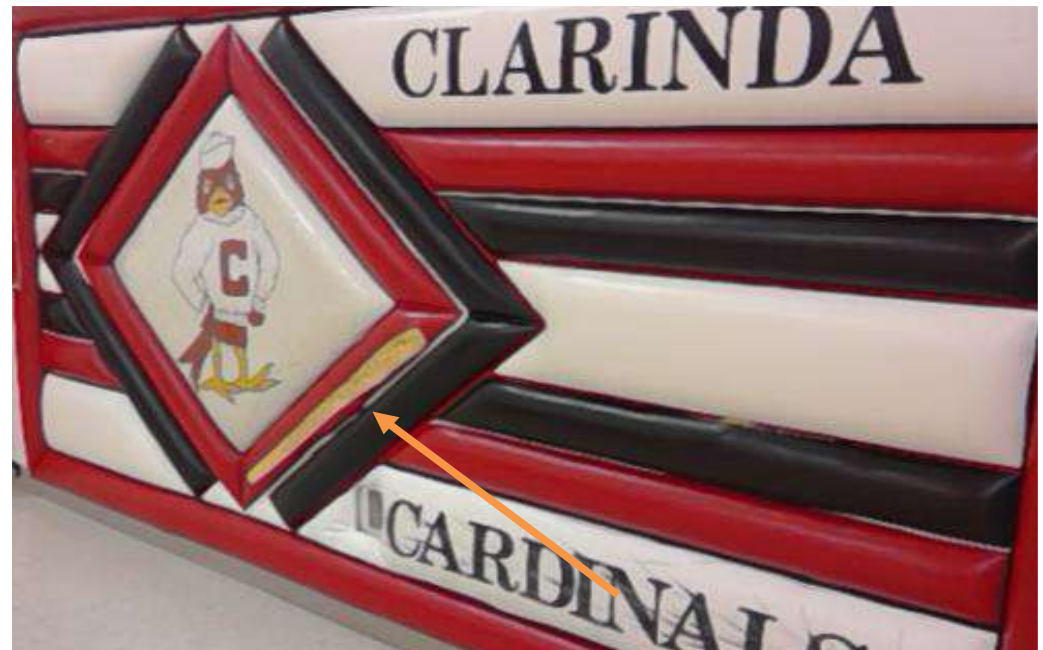
Existing damaged gymnasium wall pads

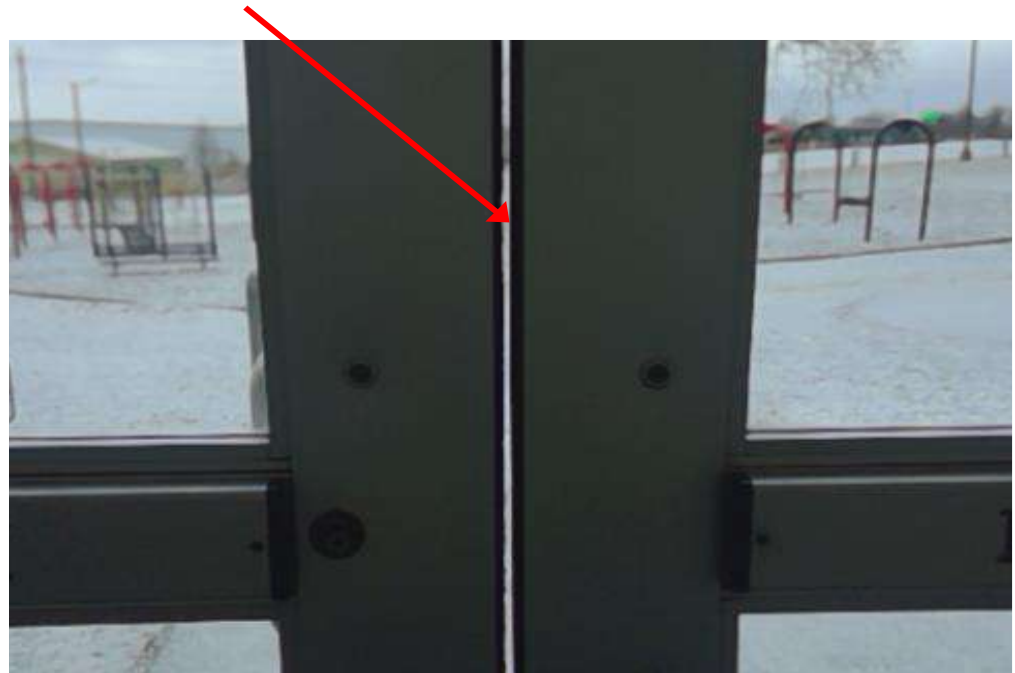
Existing air gap at exterior doors

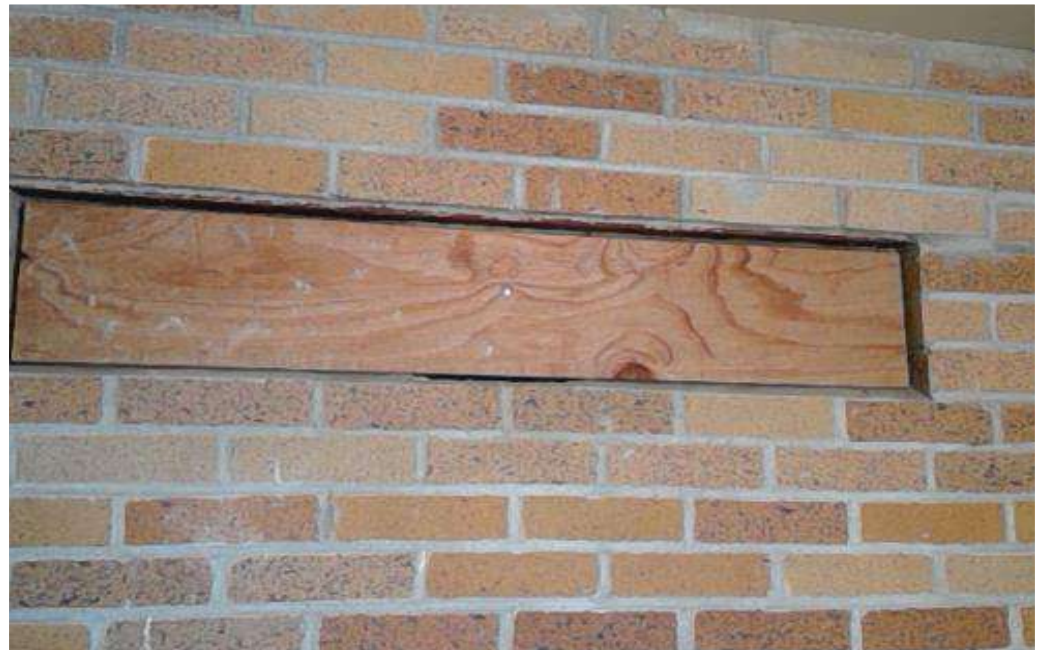
Existing masonry opening

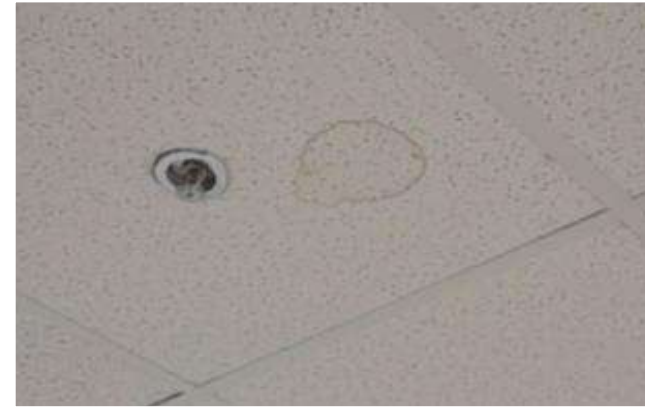
Existing water damaged ceiling tile

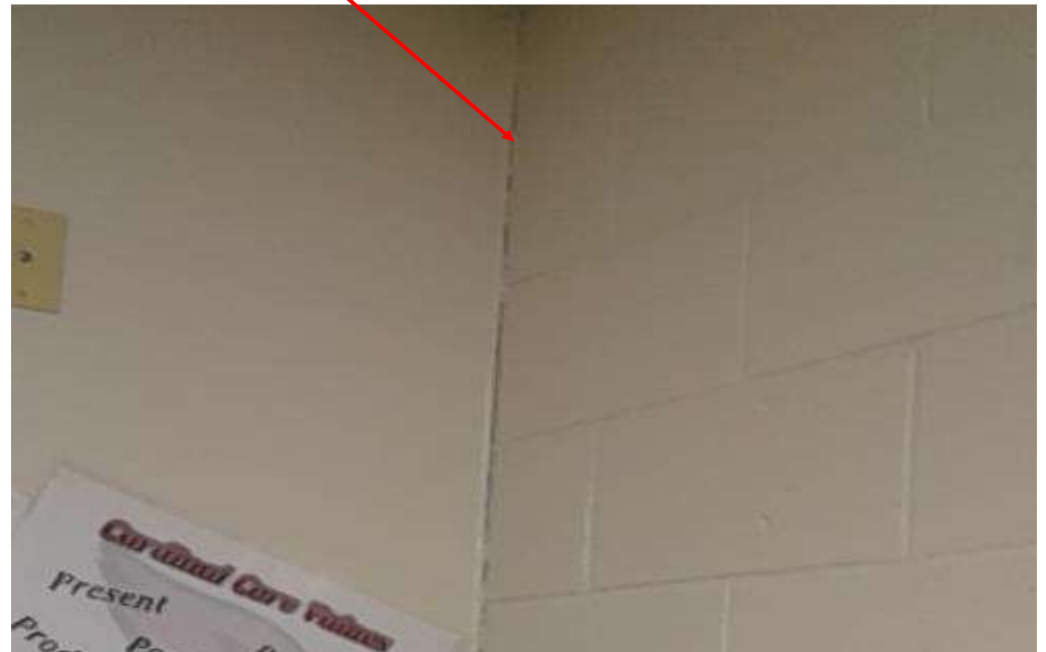
Existing masonry caulk joint

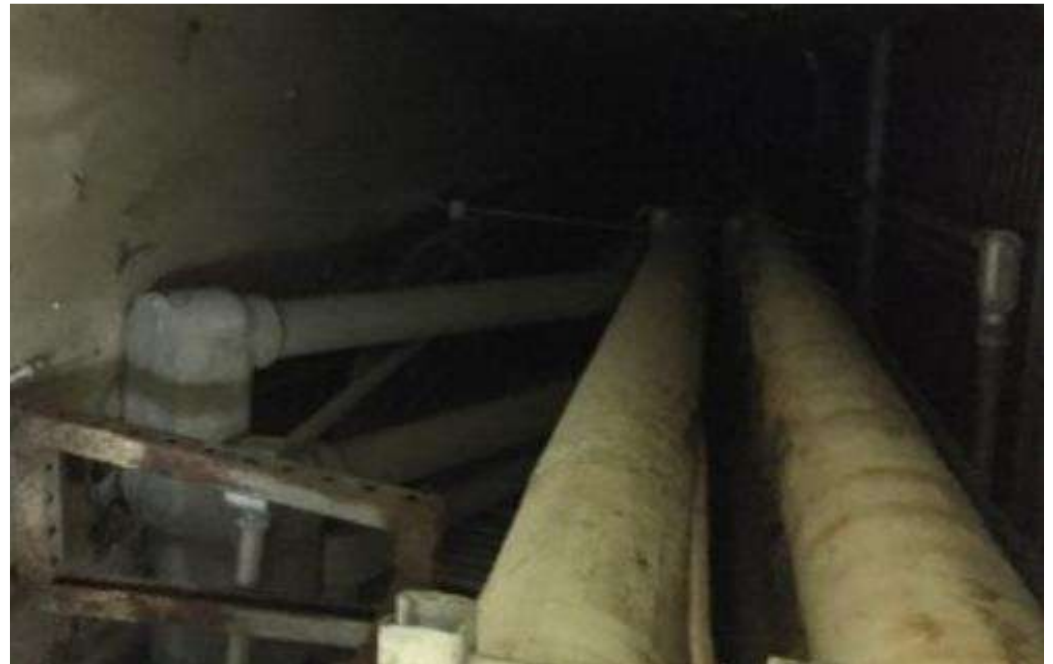
Existing asbestos insulation

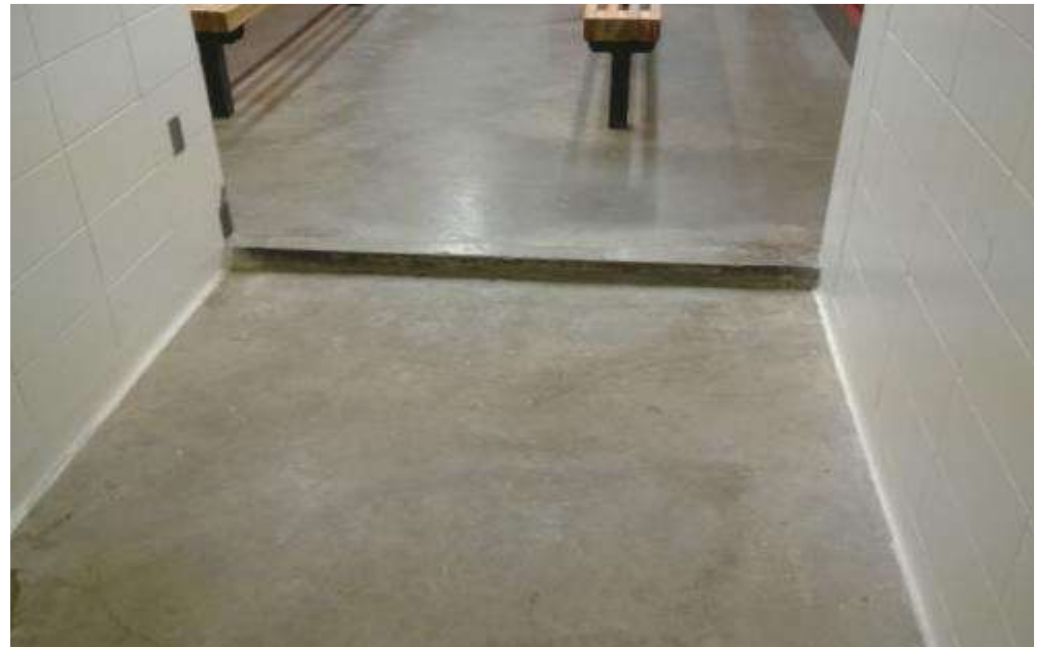
Existing step down in floor

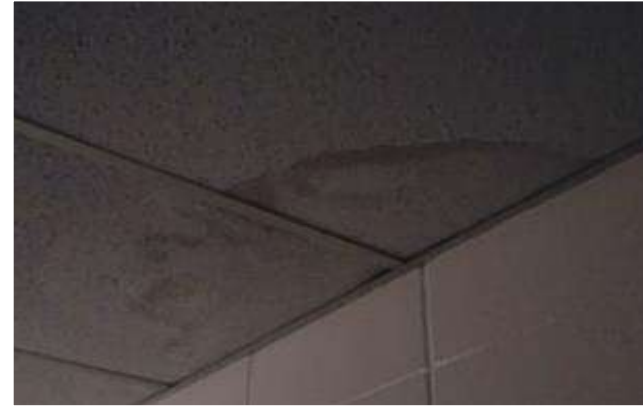
Existing water damaged ceiling tile

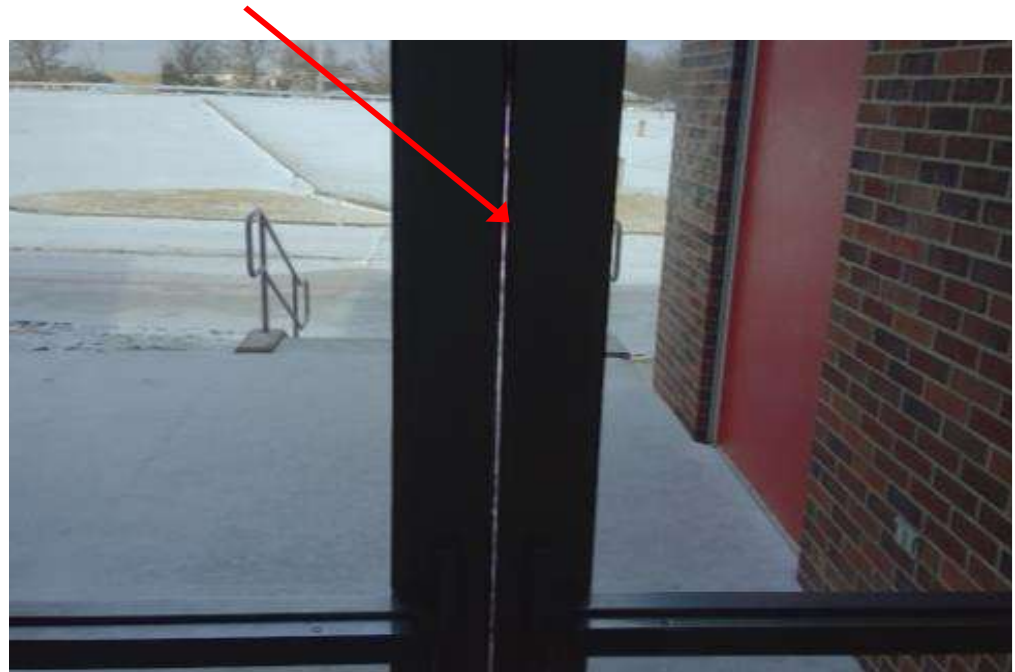
Existing air gap at exterior doors

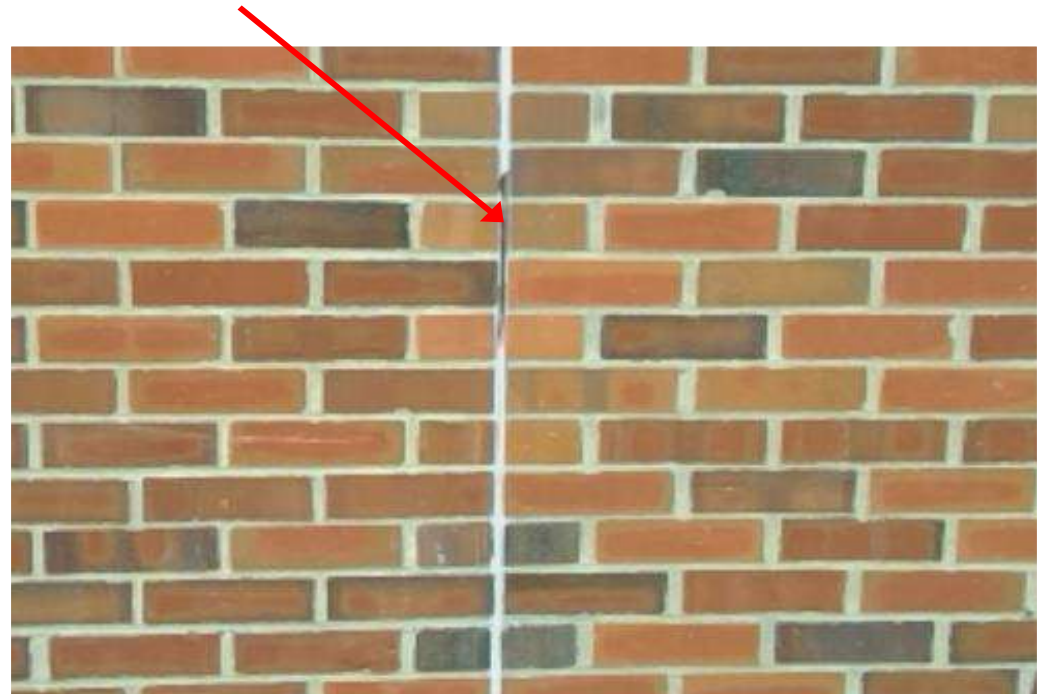
Existing masonry requiring new joint sealant

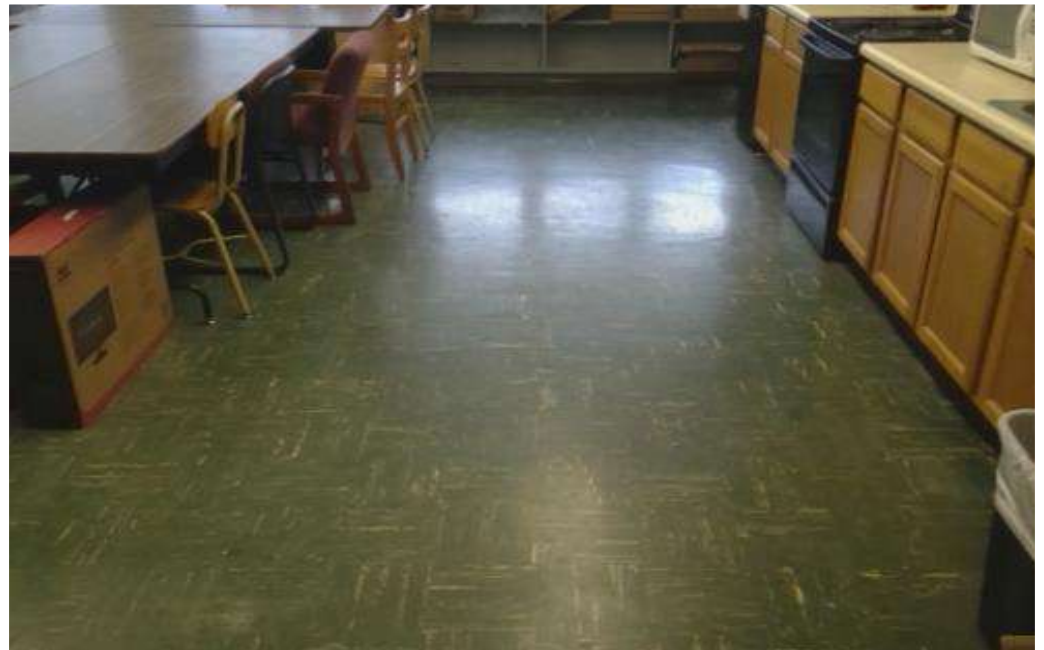
Existing asbestos containing floor tile

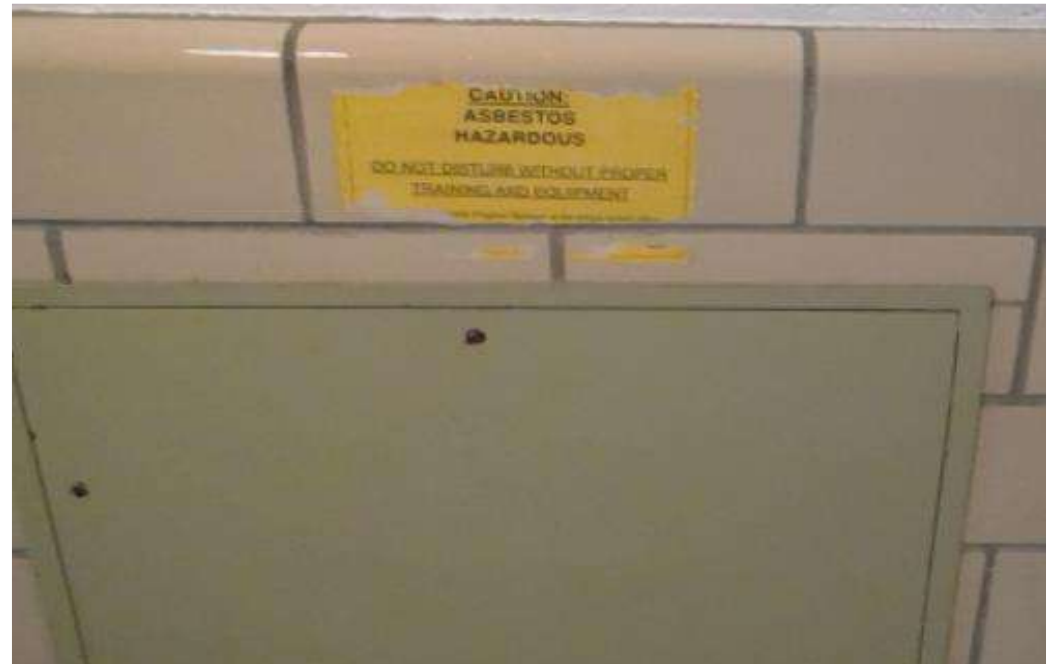
Asbestos insulation warning label

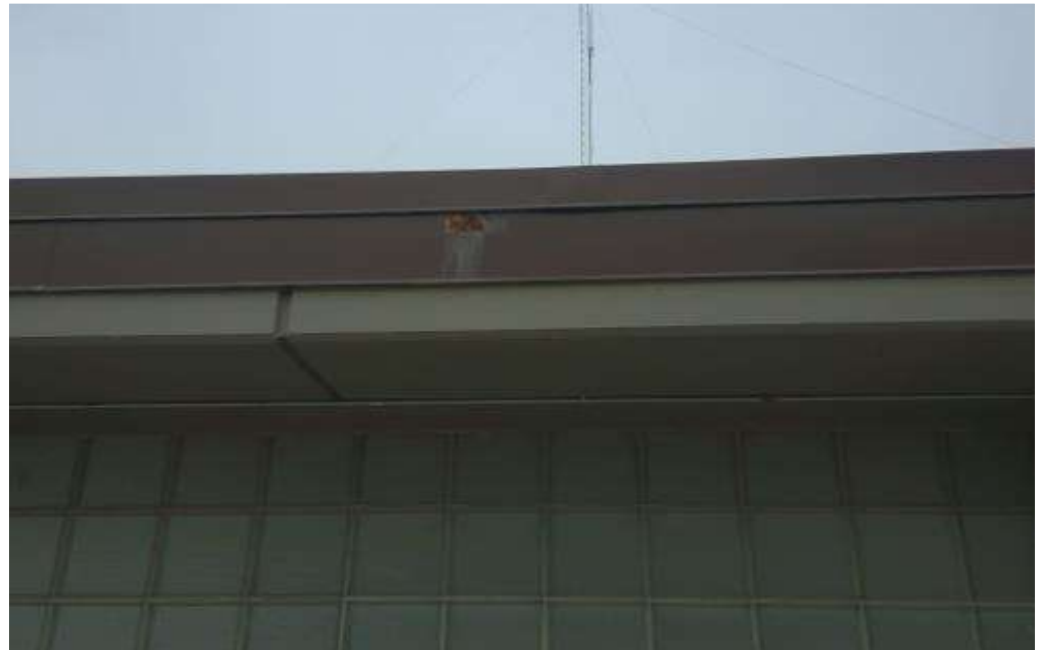
Existing damaged fascia

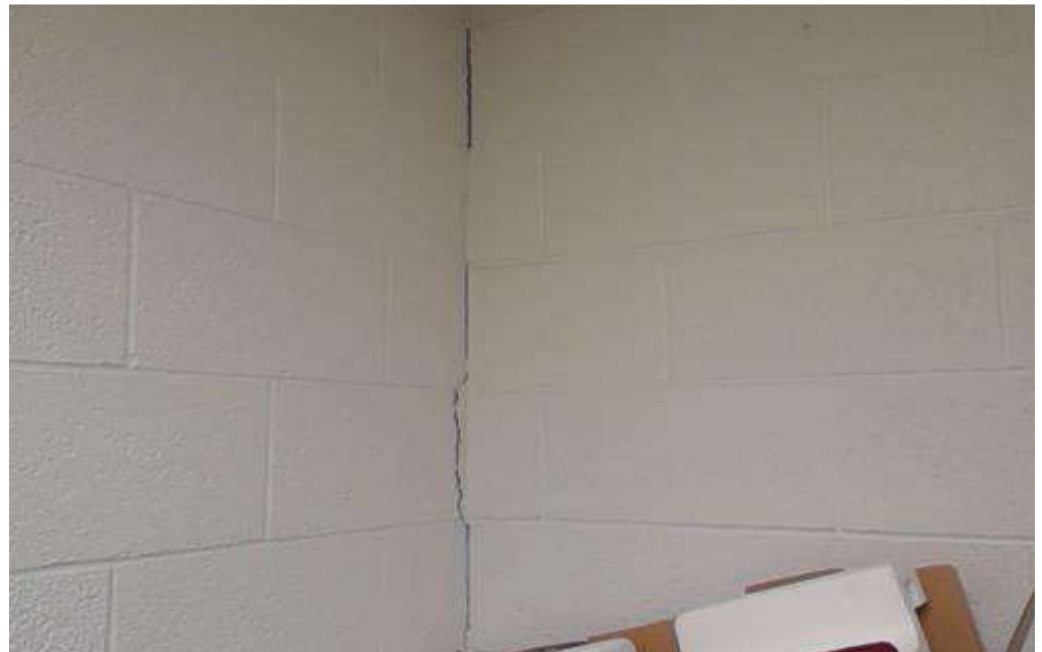
Existing masonry caulk joint

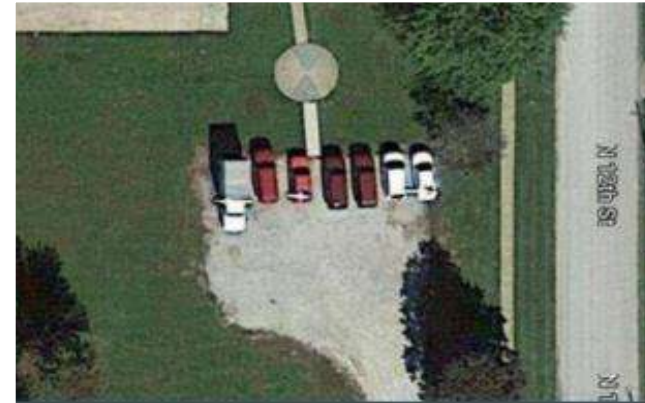
Existing parking conditions

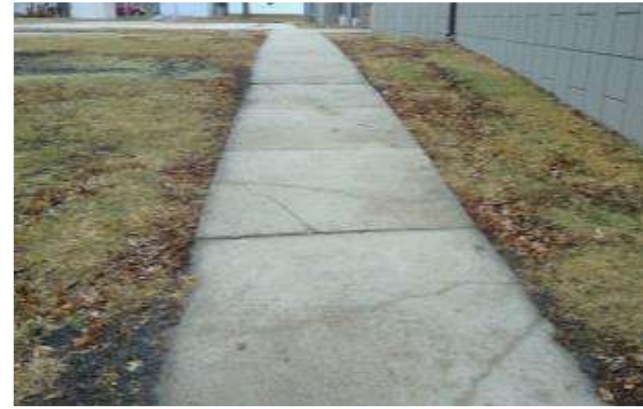
Existing sidewalks needing repair

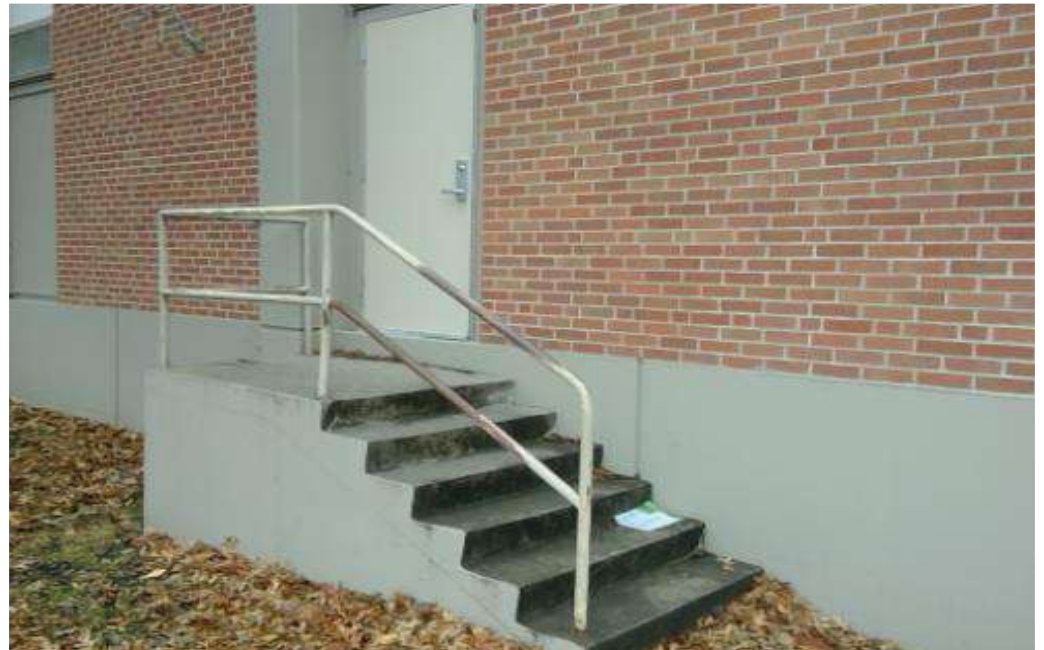
Existing exterior stairs

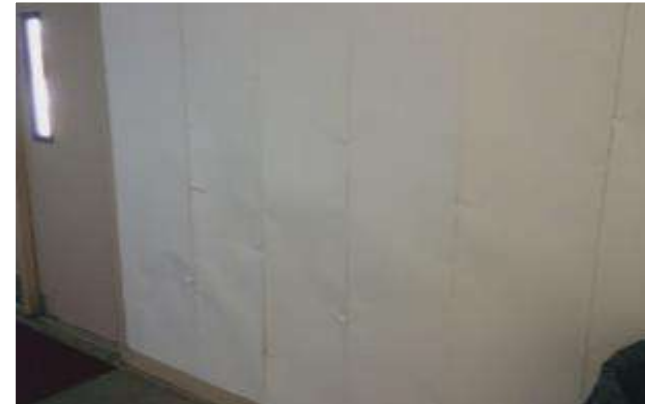
Existing wall conditions
