ASBESTOS MANAGEMENT PLAN

**West Linn High School-Bolton Campus
5933 Holmes Street
West Linn, OR 97068**

WEST LINN-WILSONVILLE SCHOOL DISTRICT

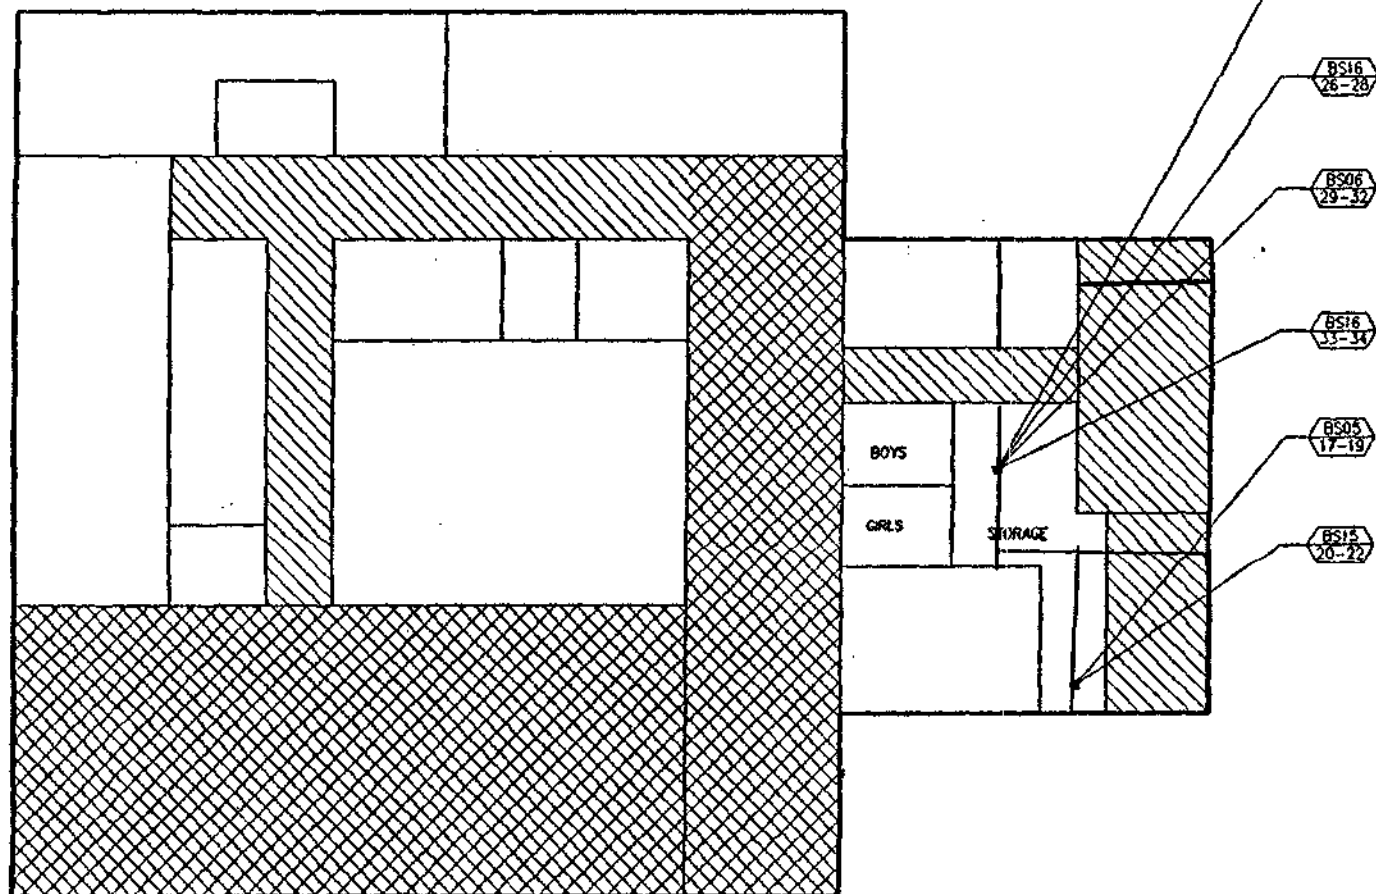
ALL FLOOR TILE CONTAINS ASBESTOS

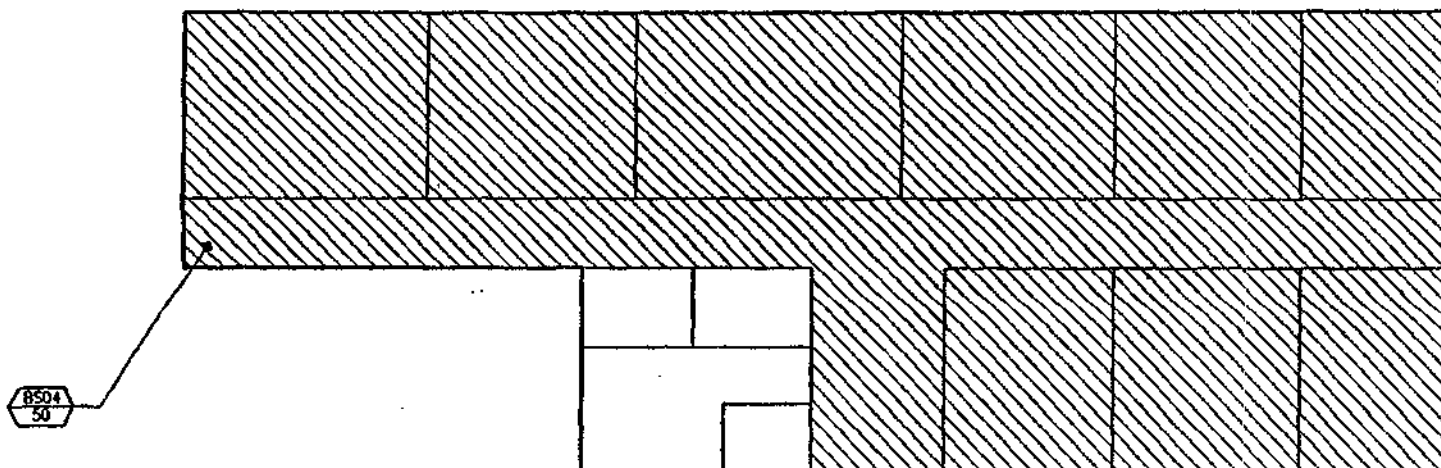
37-0050-002-001
WEST LINN SCHOOL DISTRICT
BOLTON MIDDLE SCHOOL
UPPER BUILDING LOWER LEVEL

ALL FLOOR TILE CONTAINS ASBESTOS
