EDGEWOOD-COLESBURG

COMMUNITY SCHOOL DISTRICT

MASTER PLAN

Executive Summary

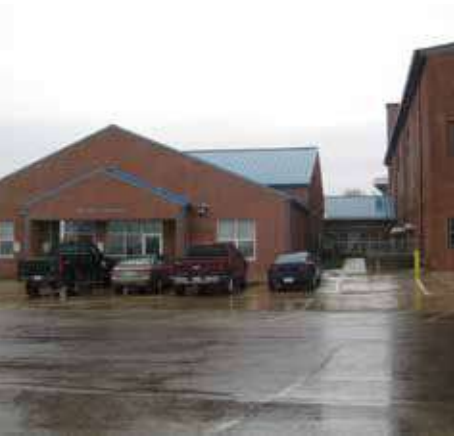
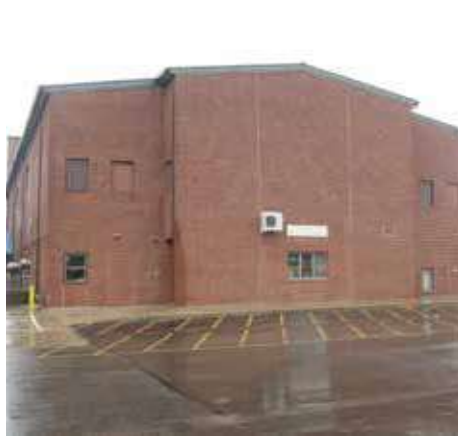
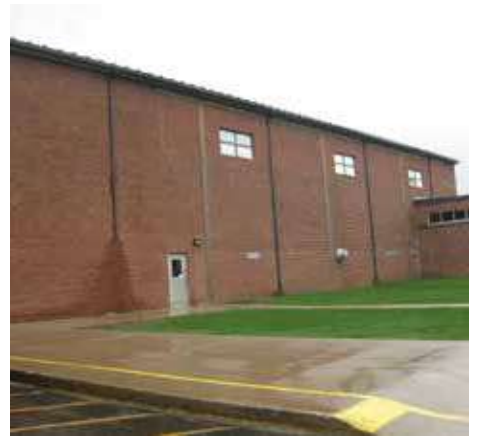
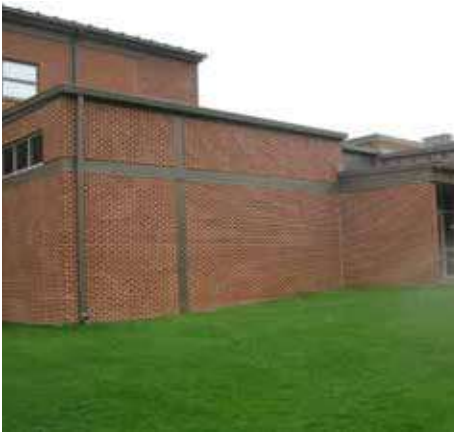
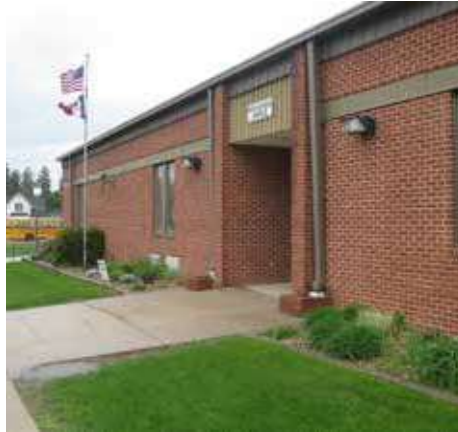
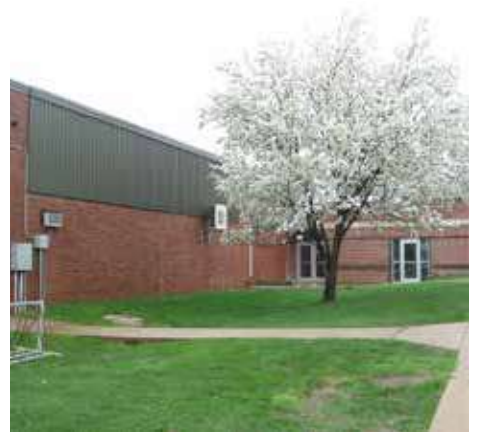
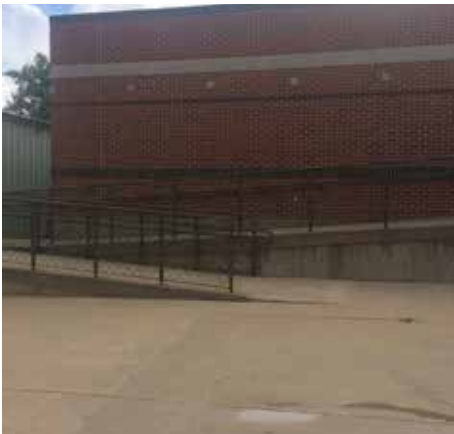
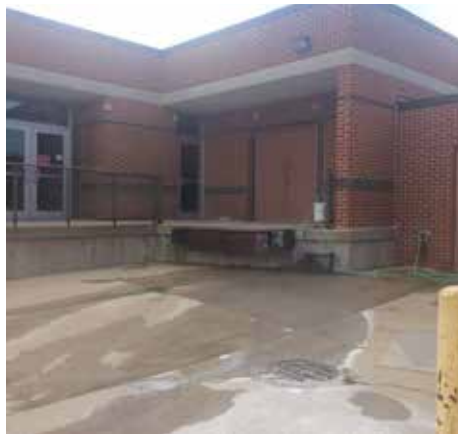
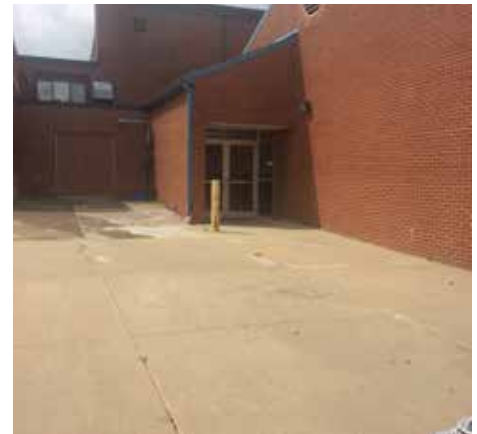
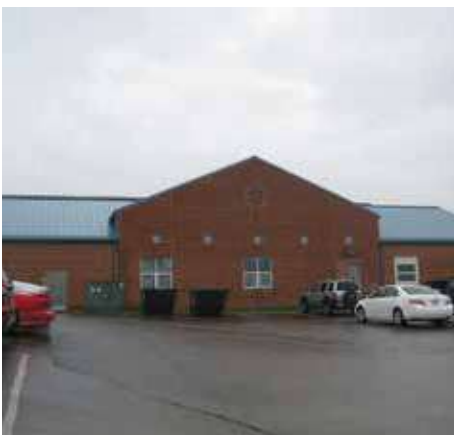
The original section of the building is a two-story structure constructed of masonry bearing walls with brick cladding. This portion of the building was found to be in average condition for its age with minor masonry repairs needed at various locations due to damage and deterioration. The addition to the north and east is single story. It is constructed out of masonry cavity walls with brick exterior, steel or wood roof framing and concrete slab on grade floors. The brick is in overall good condition on the newer single story additions.

The roof on the west and south portions of the building is a steep slope standing seam metal roof, while the remainder of the building has a low slope membrane roof. The insulation amounts could not be verified, however, it is assumed due to the age of the building and recent Energy Code requirement increases that it is below current Energy Code minimums. A newer building with code minimum insulation amounts in both the walls and roof would have a positive impact on the energy required to condition the building.

The exterior windows and doors are aluminum frame windows with dual pane insulated glass. Some windows are also wood clad windows with insulated glass. The windows are not energy efficient and are past their useful life. It is recommended to consider replacing the windows with dual pane, insulated LowE glass filled with Argon to enhance energy efficiency of the windows. The exterior doors are a combination of aluminum full glass entrance doors and also hollow metal doors and frames. All doors, frames and glass appear to be in good working condition. All doors appear to have the proper egress panic devices where required.

There is a parking lot on the north side of the site that allows for parking for staff and students. There is angled on street parking along North Chestnut Street to the east. This provides parking for visitors. Access to the building from the parking lot and streets is directly on grade or by exterior ramps, therefore accessibility requirements are met. The parking lot is not adequately sized for everyday use or for large athletic events, so students and spectators commonly park on side streets or across the street at the golf course. There is available land to the north and west of the back parking lot where additional parking could be added. The student pick-up and drop-off arrangement is a safety concern for both parents and school administration. With the highway running right in front of the school and no designated parent pick-up area, parents tend to park along the highway and students walk or run through the parking lot and across the busy highway to get to their parent's cars. A redesigned bus and parent pick-up / drop-off area should be considered on site to alleviate the safety concerns.

- A redesigned parking area should be considered with designated pick-up / drop-off area to improve safety and add additional parking as needed.
- Windows are not energy efficient and should be replaced.

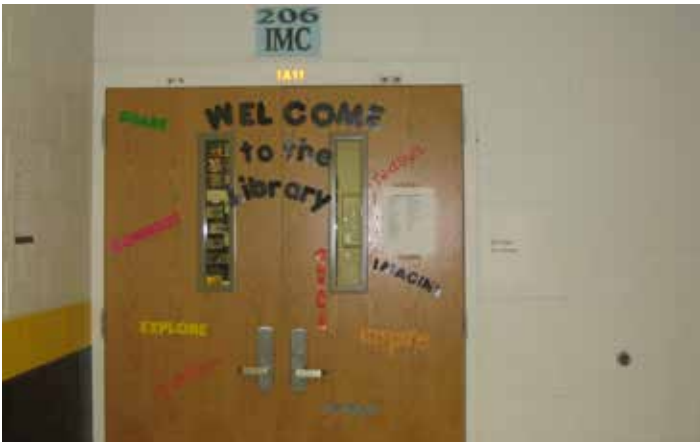
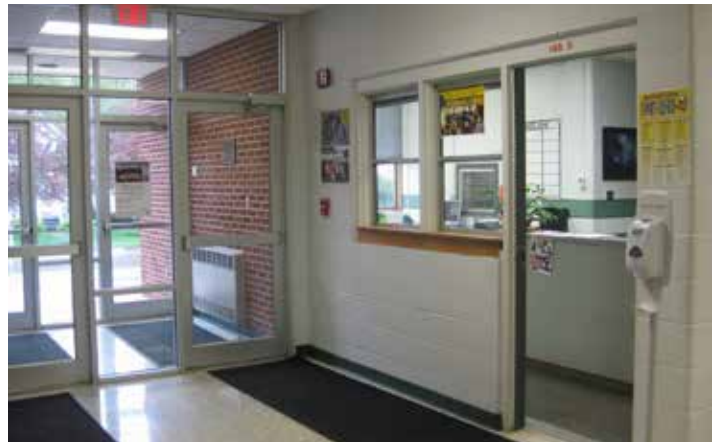
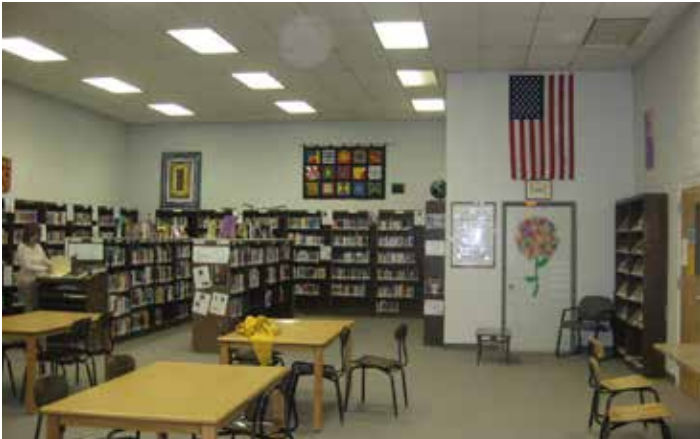
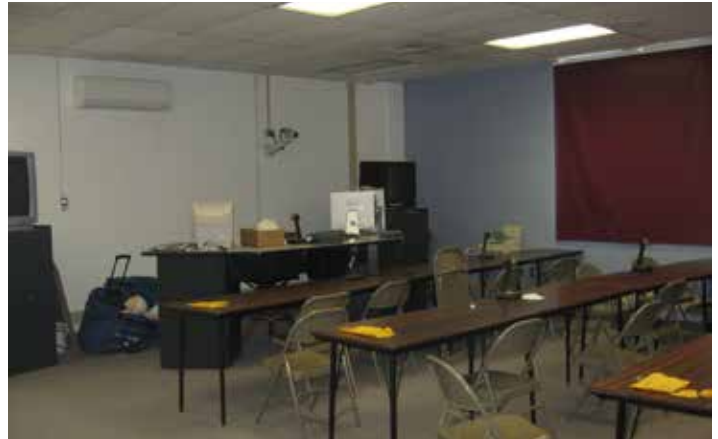
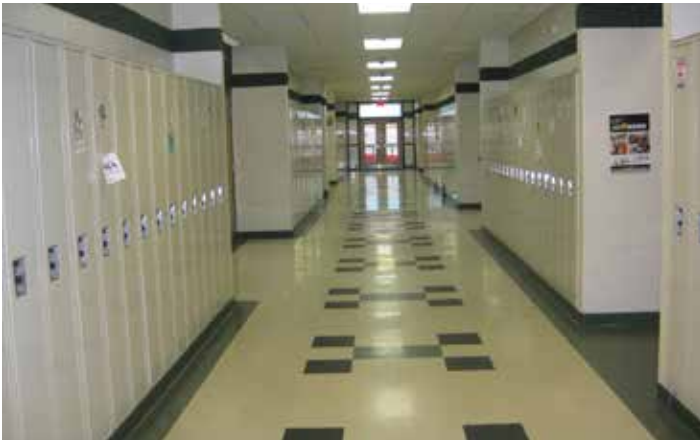
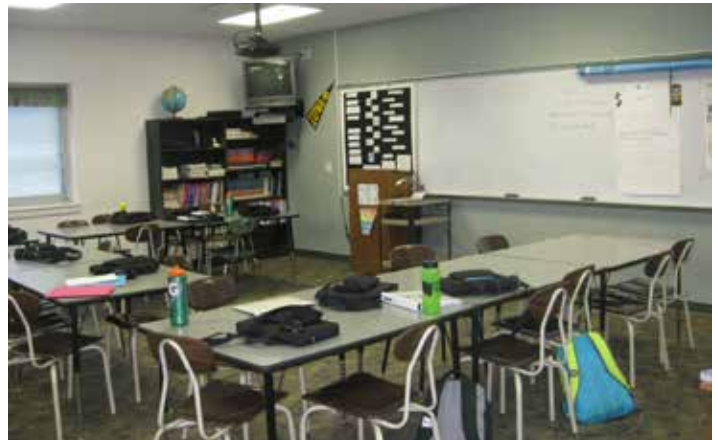
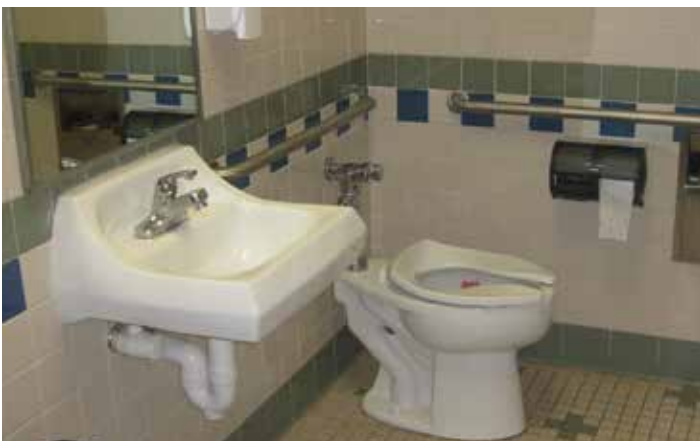
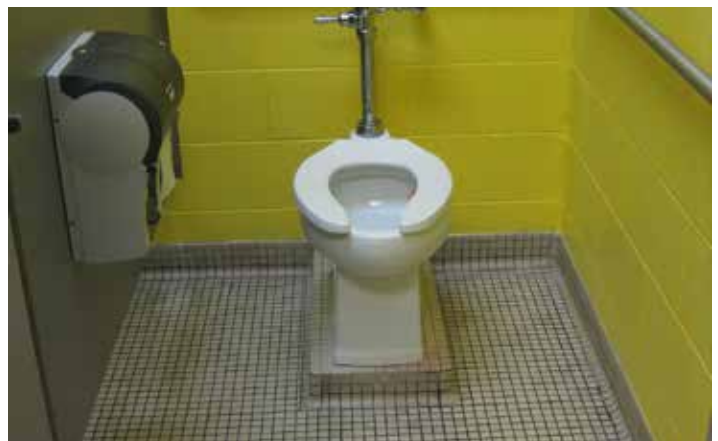
The interior environment varies depending on the part of the building examined. In the newer educational wing, the main corridors have a vinyl tile floor finish, while the classrooms are either carpet or vinyl tile. All flooring in this part of the building appears in good condition based on the age of the building. In the older classrooms, media center and music area the flooring is carpet and appears worn and torn in some areas and could be replaced in the next 5 – 10 years. The lower level of the original building has vinyl tile flooring, which is in average condition and could also be replaced in the next 5- 10 years.

The wall finishes throughout the majority of the building are painted concrete block, with some areas in the original building being glazed block. Ceilings are acoustic ceiling tiles in 2x2 or 2x4 sizes. The 2x2 tile ceilings are in good condition. The older 2x4 ceilings appear to sag a little due to the use of 2x4 tile and could be replaced with 2x2 tile in the future as needed. The casework that is installed is in good condition for the age of the building.

The interior doors are solid oak with hollow metal frames. The newer classroom addition has appropriate ADA door hardware, while most of the doors in the older parts of the building have knob style door hardware that does not meet accessibility requirements. Replacement of this hardware with lever-type hardware should be considered in the future to meet ADA code requirements for accessibility.

The main restrooms have painted concrete block walls, mosaic ceramic tile floors and phenolic toilet partitions. Although there is a ADA stall present, it does not meet accessibility requirements for a proper sized ADA stall. Secondary restrooms on the lower level do not meet accessibility requirements and the doors are too narrow for ADA requirements. The restrooms would need to be renovated and doors enlarged to meet requirements. The finishes within the restrooms are dated and worn and should be updated. The number of plumbing fixtures present is less than that required by current codes for the occupant load of the building. However, based on the actual number of students and staff the number seems adequate. If the student population increases or building additions added, more restrooms would need to be included.

While signage in the newer classroom addition appears to meet code, the signage in the older parts of the building does not include braille and is not in compliance with current ADA codes. Non-compliant signs should be updated in the near future.

- Knob style hardware should be replaced with accessible door hardware where necessary.
- Restrooms in some parts of the building should be renovated to meet accessibility requirements and finishes updated.

- Interior signage should be replaced with ADA compliant signs where required.
- An elevator or relocation of lower level spaces should be considered to meet accessibility requirements.

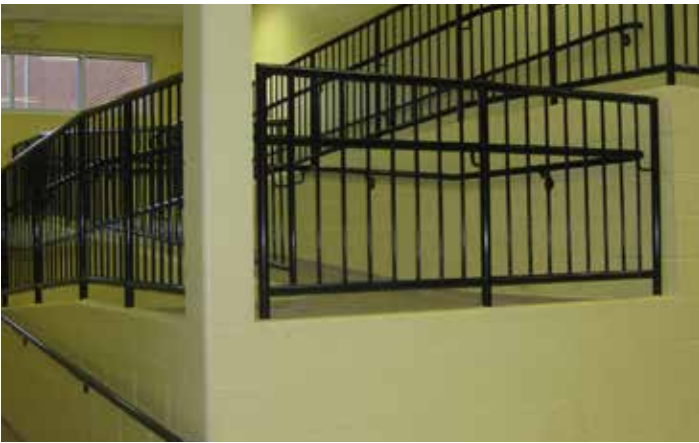
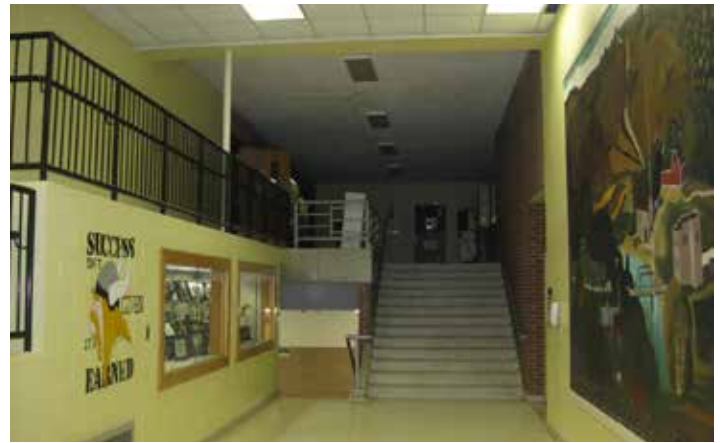
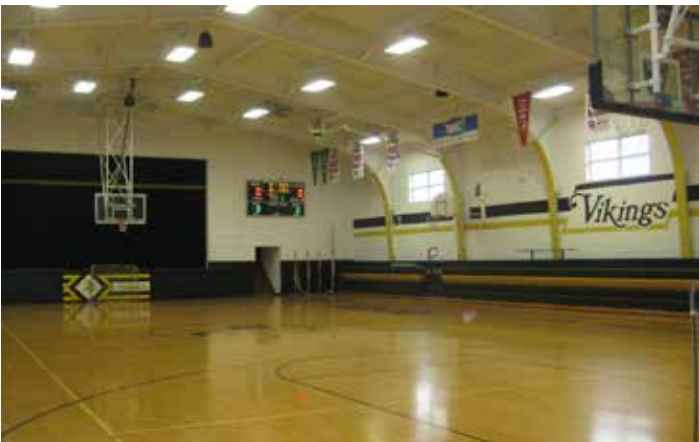
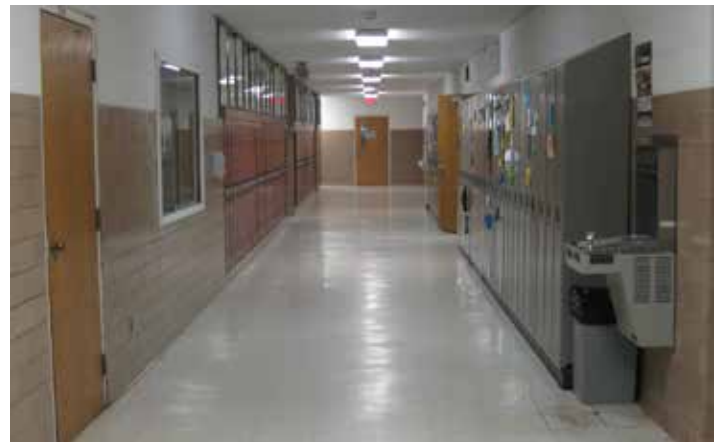
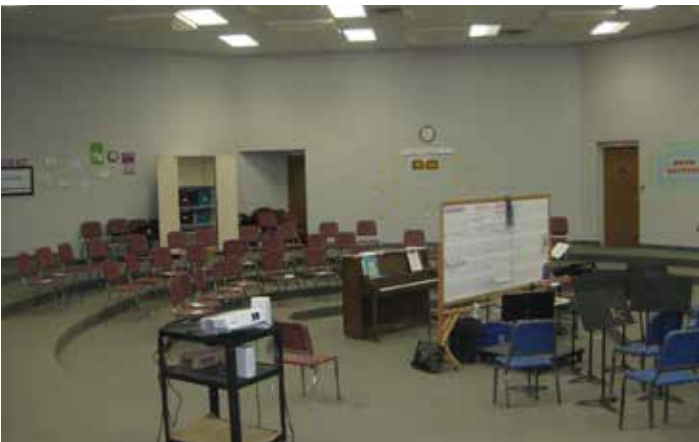
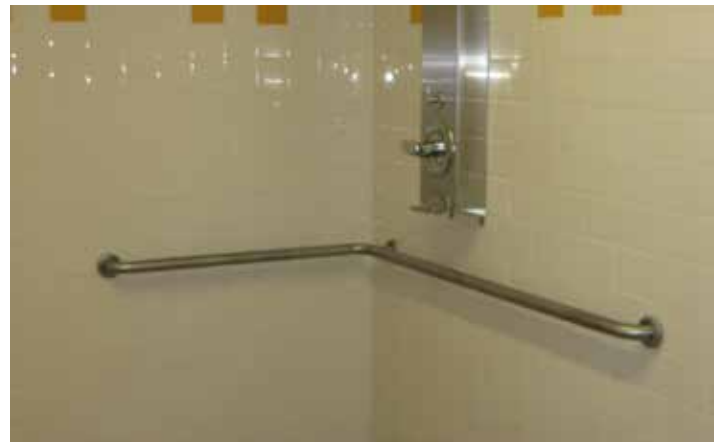
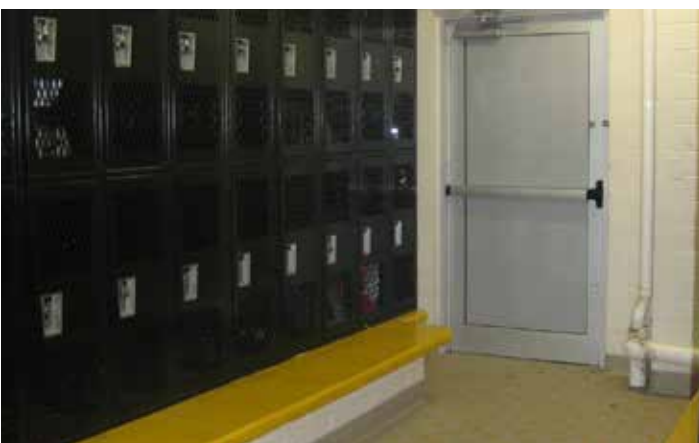
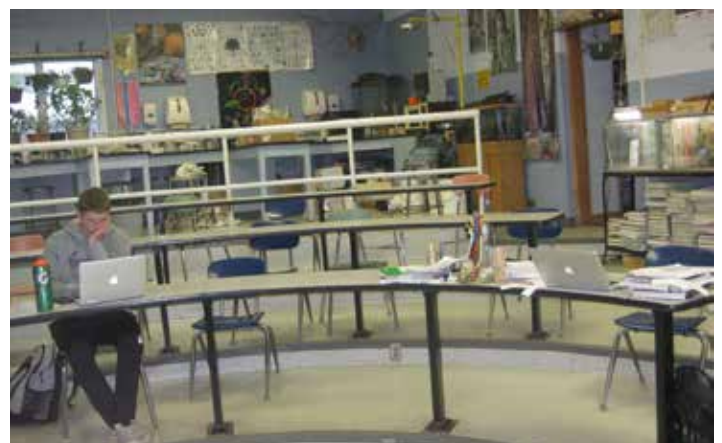
The building includes an original gym on an upper level. The gym is accessed by way of an interior stairway. Accessibility is accomplished by way of a lengthy interior switch-back ramp. While this solution is acceptable, it is quite cumbersome. The original portion of the upper corridor that is open to below has a railing that doesn't appear to meet current code requirements for size of openings and is a safety concern. This railing should be replaced in the near future.

The lower level science room is an old original music room with built-in risers. The vinyl tile floor is in average condition, however, there are areas where the stair nosing is missing and tile is falling off the risers. Due to the built-in risers, the room does not meet accessibility requirements and would be impossible for a wheelchair bound student or teacher to use it. Thought should be given to relocating this classroom to the main level and/or a room without risers.

The locker rooms have mosaic ceramic tile floors, painted concrete block walls and concrete locker benches. The showers appear to have been updated recently with nice ceramic tile on the walls and updated shower assemblies, including an ADA unit. The restrooms also appear to have been updated recently with new toilet partitions. Lockers appear to have been replaced recently as well.

- The upper landing guardrail does not meet current building code requirements and should be replaced.
- Technology updates, such as interactive white boards and/or LED monitors, would enhance learning spaces.

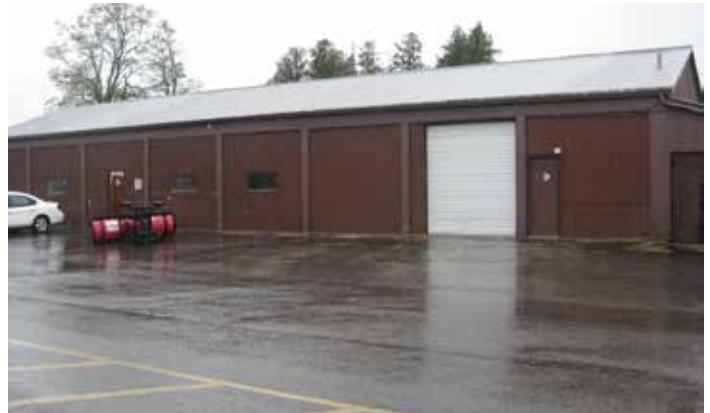
IMG_3621.JPG

The current bus maintenance facility sits just west of the high school. It is a concrete masonry building with some siding infills. The roof is wood framed with metal panels. Walls do not appear to be insulated. The windows are not energy efficient and are past their useful life. It is recommended to consider replacing the windows with dual pane, insulated LowE glass filled with Argon to enhance energy efficiency of the windows and/or consider replacement of the entire building.

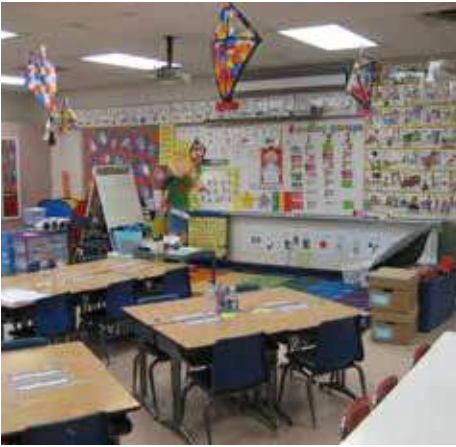
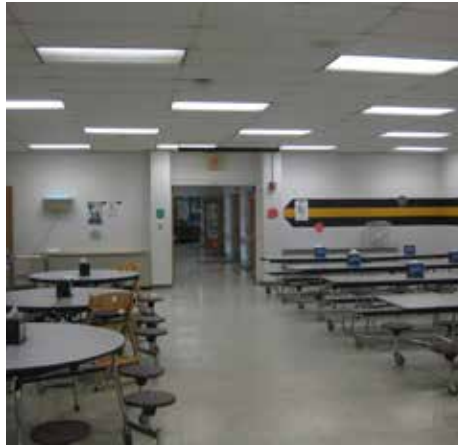
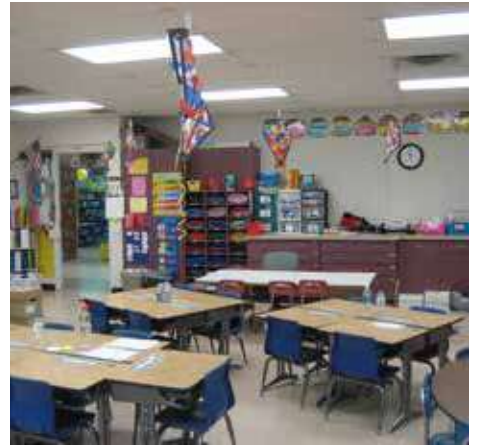
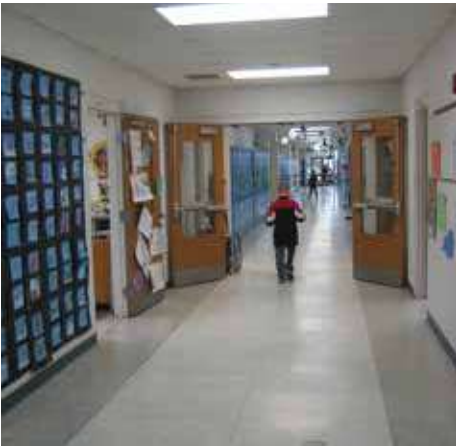
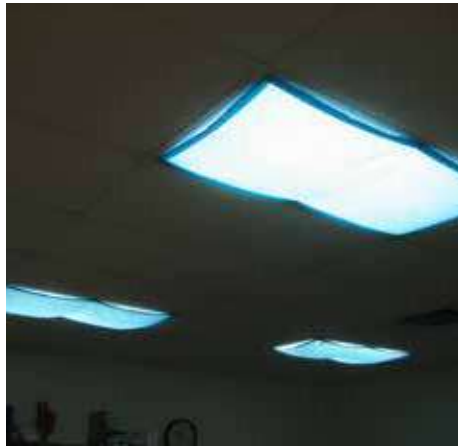
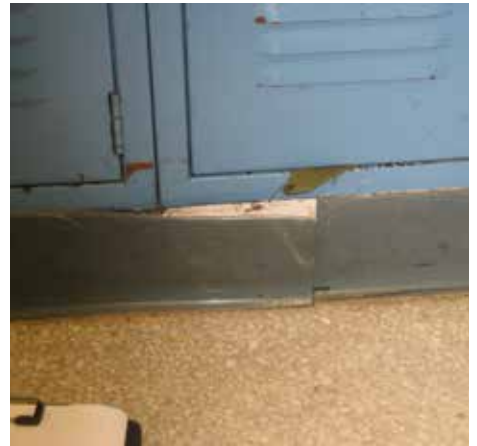
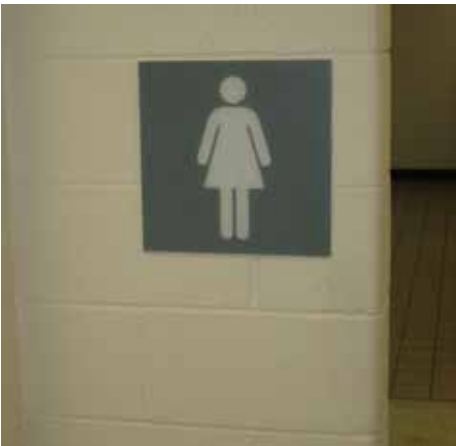
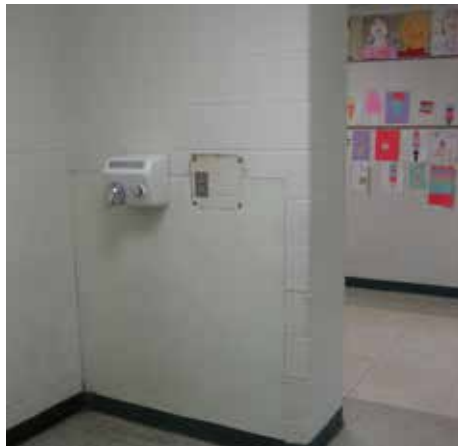
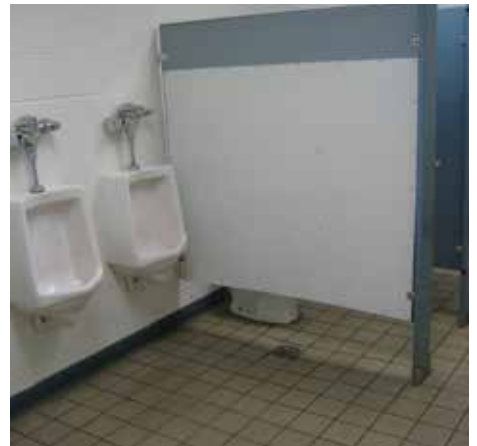
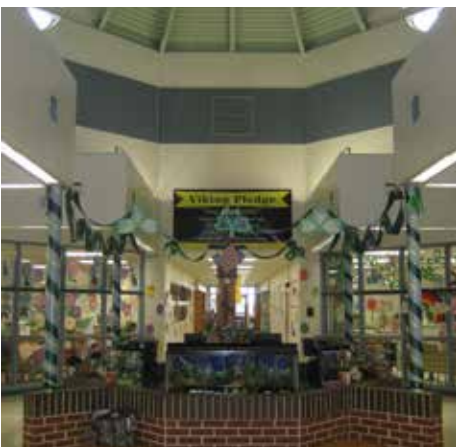
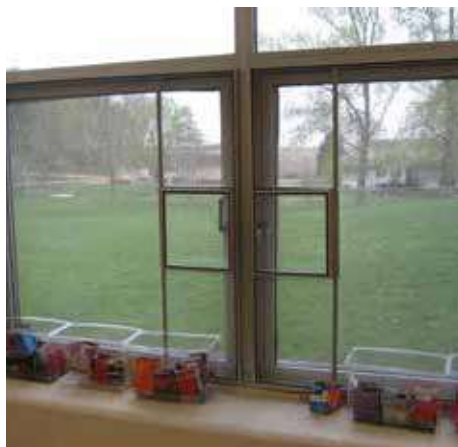
The interior environment varies depending on the part of the building examined. In the newer educational wings, the main corridors have a terrazzo floor finish, while the majority of the rooms have vinyl tile with some having carpet. All flooring appears in average condition based on the age of the building. All corridor and classroom areas have vinyl base, which shows signs of age particularly in the corridors and could be replaced in the next 5–10 years.

Corridor lockers are metal and show signs of rust. These should be replaced in the next 5–10 years for aesthetic reasons.

The wall finishes throughout the majority of the building are painted concrete block. Ceilings are acoustic ceiling tiles in 2x4 sizes. Ceilings appear to sag a little due to the use of 2x4 tile and could be replaced with 2x2 tile in the future. The casework that is installed is in generally good condition for the age of the building.

The interior doors are solid oak with hollow metal frames. A majority of the doors in the building have knob style door hardware that does not meet accessibility requirements. Replacement of this hardware with lever-type hardware should be considered in the future to meet ADA code requirements for accessibility.

The main restrooms have painted concrete block walls, quarry tile floors and metal toilet partitions. They appear to meet accessibility requirements with proper sized wheelchair stall and access to the sinks. Secondary restrooms near the cafeteria do not have an accessible stall in the restrooms and the doors are too narrow for ADA requirements. The restrooms would need to be renovated and doors enlarged to meet requirements. The kindergarten restrooms have vinyl tile on the floors, which shows signs of age and should be replaced with a more durable flooring material appropriate for restrooms. The finishes within all restrooms are dated and worn and should be updated.

Signage in the building does not include braille and is not in compliance with current ADA codes. Signs should be updated in the near future.

- Corridor lockers appear to be rusting and will need updating in the next 5 – 10 years.
- Knob style hardware should be replaced with accessible door hardware.

- Interior signage should be replaced with ADA compliant signs.
- The ramp railings do not meet current building codes and should be replaced.
- Color changing LED lighting should be considered for special education spaces.

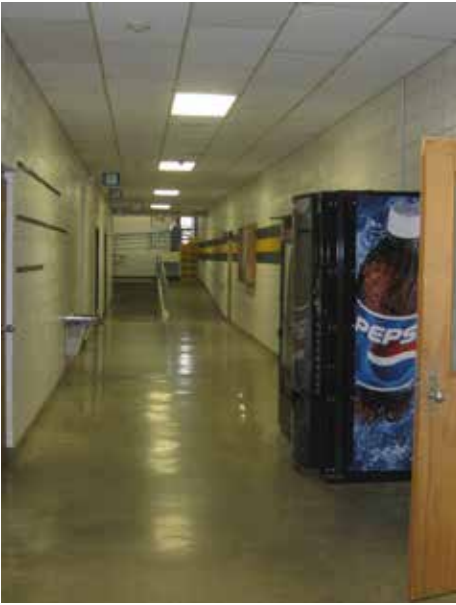
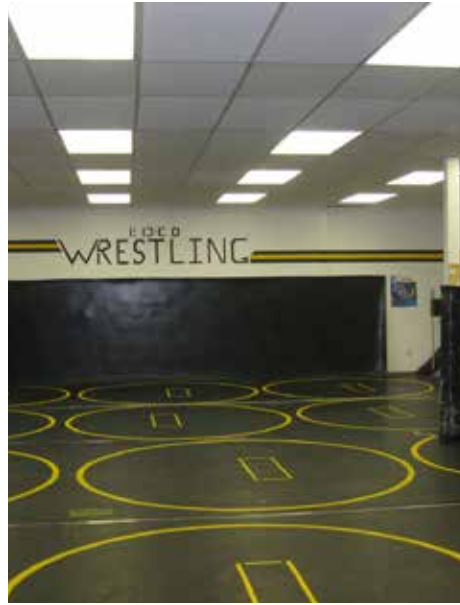
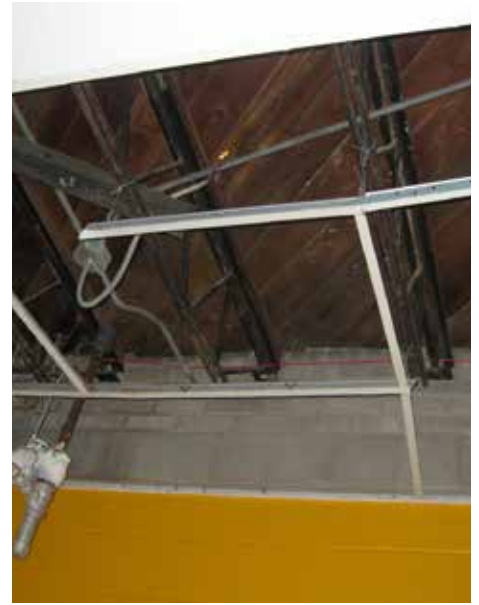
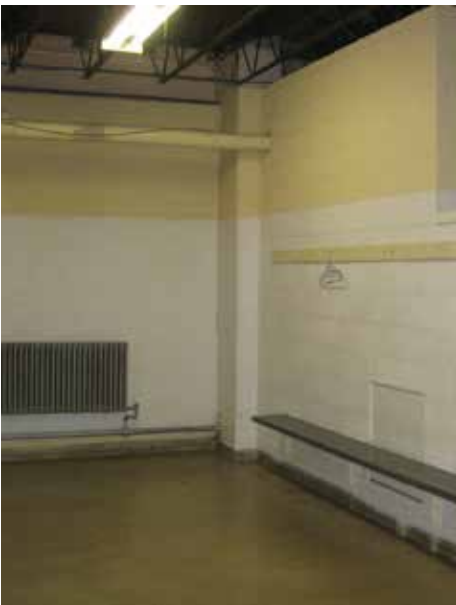
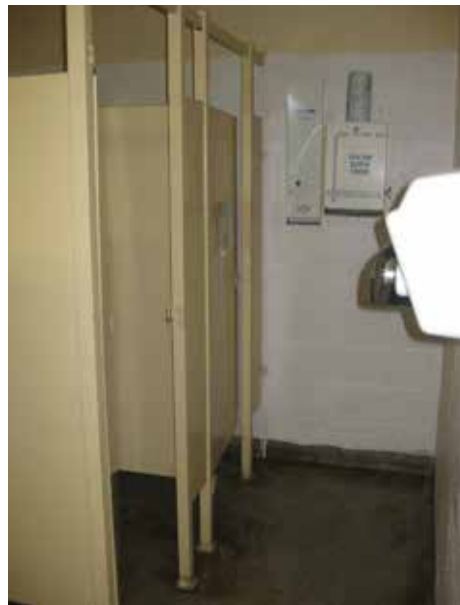
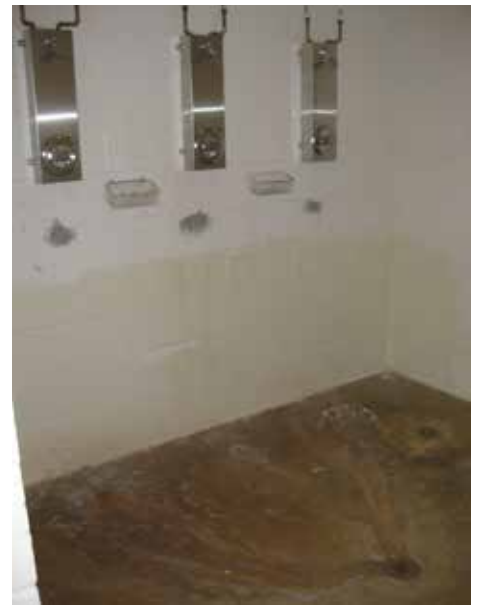
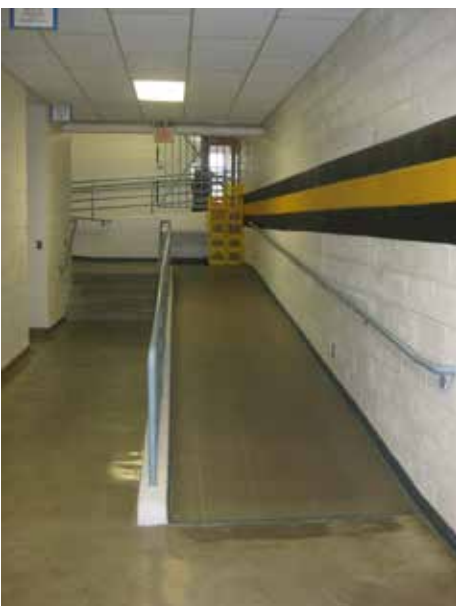
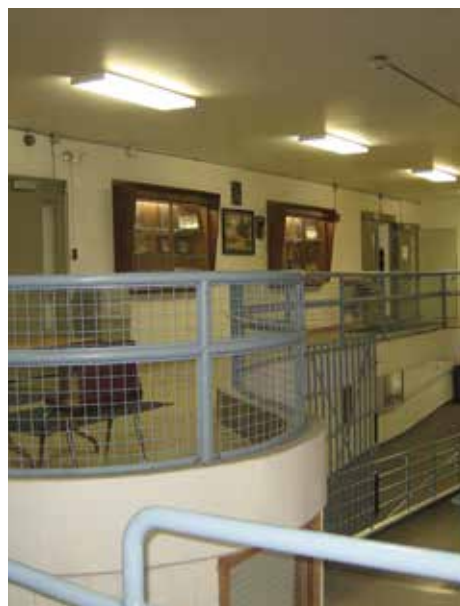
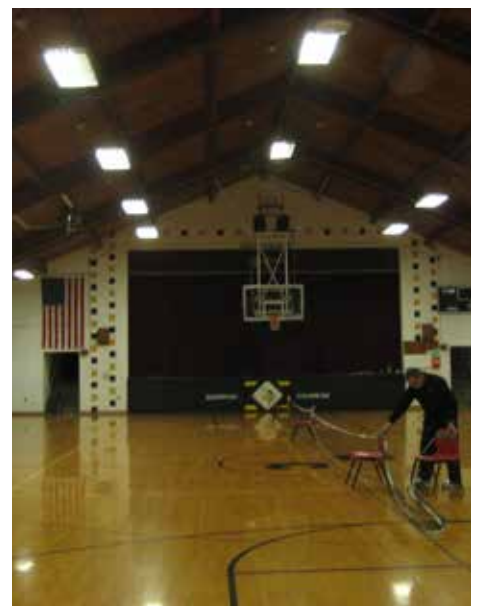
The original 2-story building includes a gym on the upper level and four locker rooms, weight room, and three original classrooms on the lower level. The classrooms are currently being used for storage. The gym is currently used for junior high competitions. The gym is on the upper level and is accessed by means of interior ramps, which appear to be ADA compliant. However, the ramp guardrails don't appear to meet code requirements for size of openings and pose a safety hazard. Guardrails should be replaced where needed to meet current code requirements. The gym has exposed glue-lam roof beams which give it a unique and attractive appearance. However, windows are small and the room could benefit from some additional natural lighting. The gym floor is wood and is in average condition. Wood gym floor should be refinished as needed. The wrestling room is undersized and has interior columns which pose a safety hazard in a room of this use. The finishes are also in need of repair. The locker rooms are outdated and in need of some cosmetic updates as well as ADA updates to the restrooms to include accessible toilet stalls. If the gym and locker rooms will continue to be used, the locker rooms should be updated with new finishes and fixtures.
