JESUP COMMUNITY SCHOOLS

Facility Assessment Report

July 2020

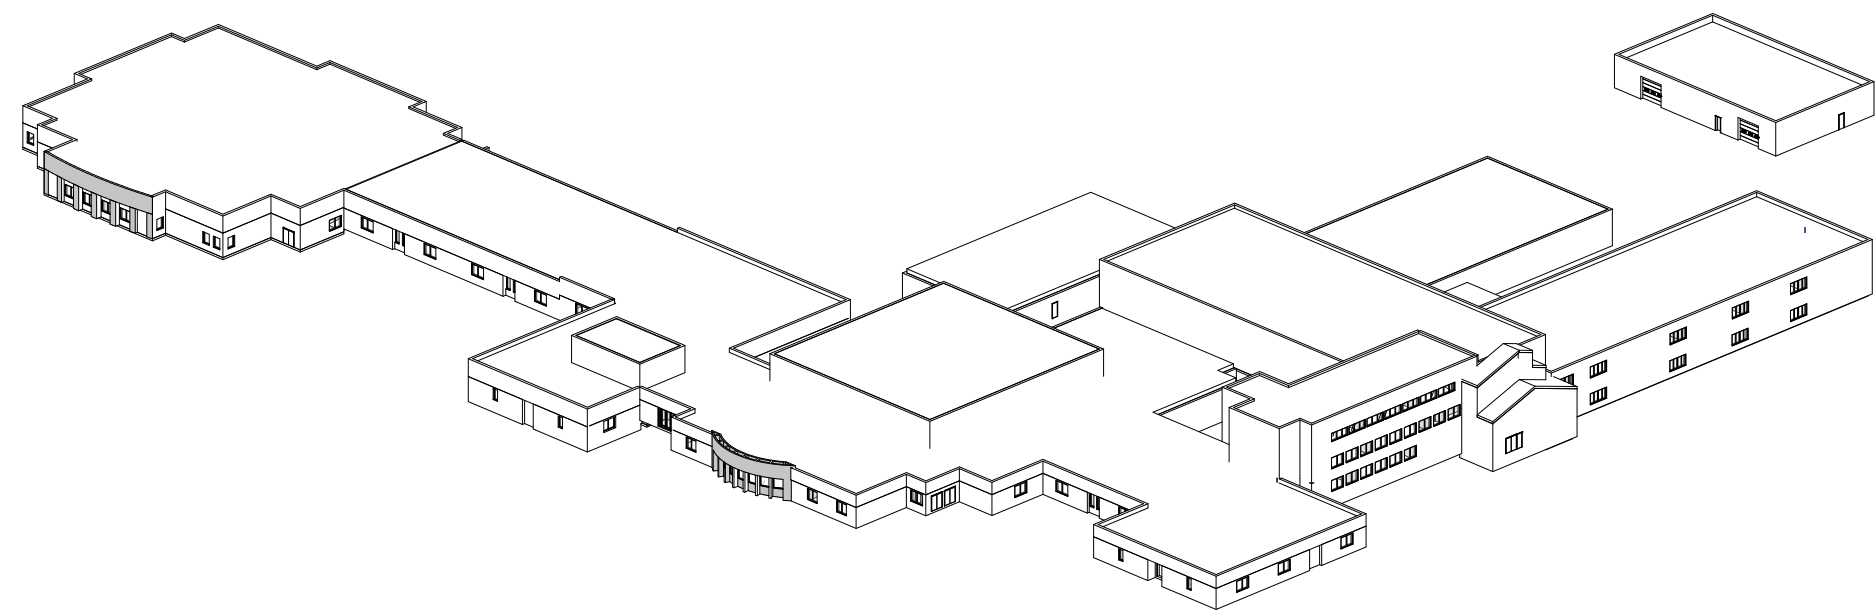
KEY ISSUES

- 1. Water damage on brick and mortar
- 2. Grade above exterior flashing
- 3. Drainage issues along wall
- 4. Ramp not ADA compliant
- 5. Metal panels in poor condition
- 6. Damaged overhead door
- 7. Brick and joints cracked at corner
- 8. Damaged lintel

- 9. Rotting fascia board
- 10. Paint wearing off concrete stairs and ramp
- 11. Mortar joints at columns cracked. Mortar missing
- 12. Efflorescence at hose bib indicating water issue
- 13. Missing and damaged seals at overhead jamb
- 14. Foundation blocks loose and damaged
- 15. Standing water and poor drainage
- 16. Downspouts draining over concrete surface
- 17. EIFS joints in need of repair

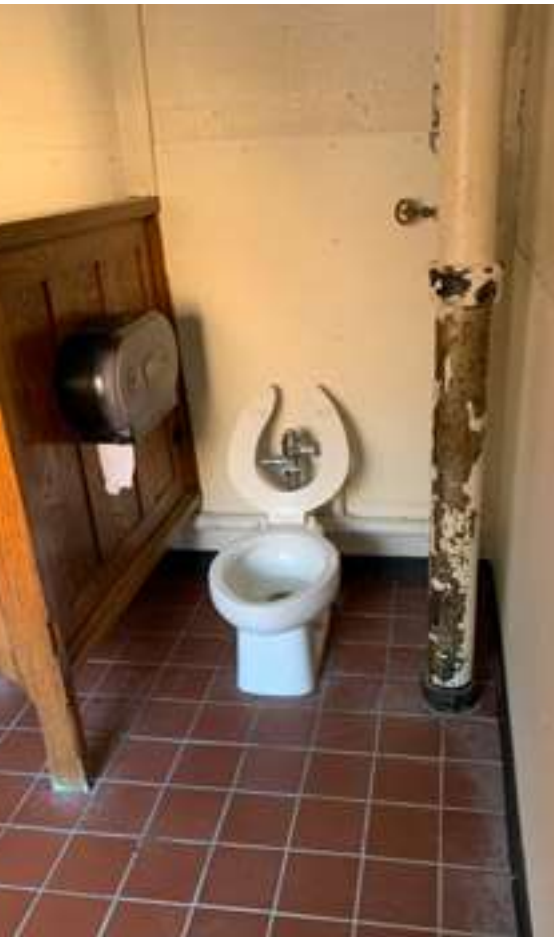
FIGURE 01 - Wood stalls in original bathroom of high school too short and missing doors

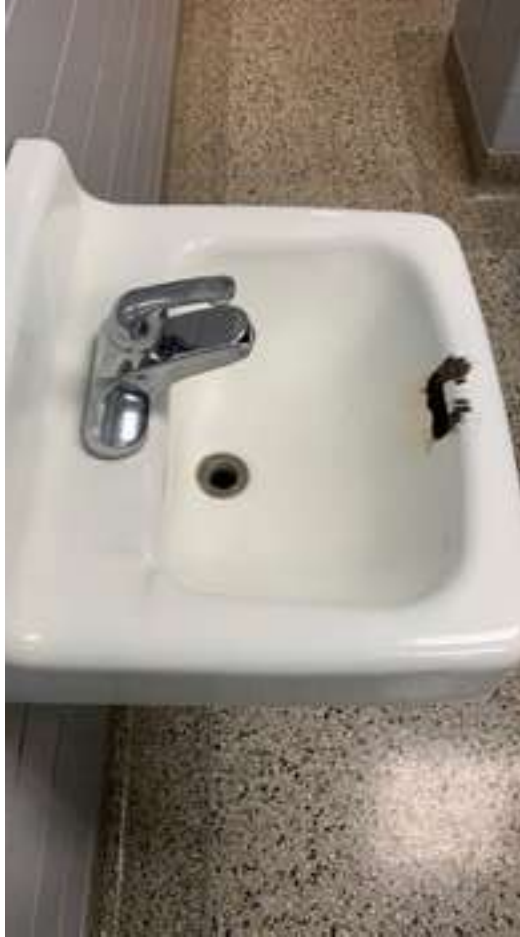
FIGURE 02 - Wall mount sinks showing wear at overflow drain

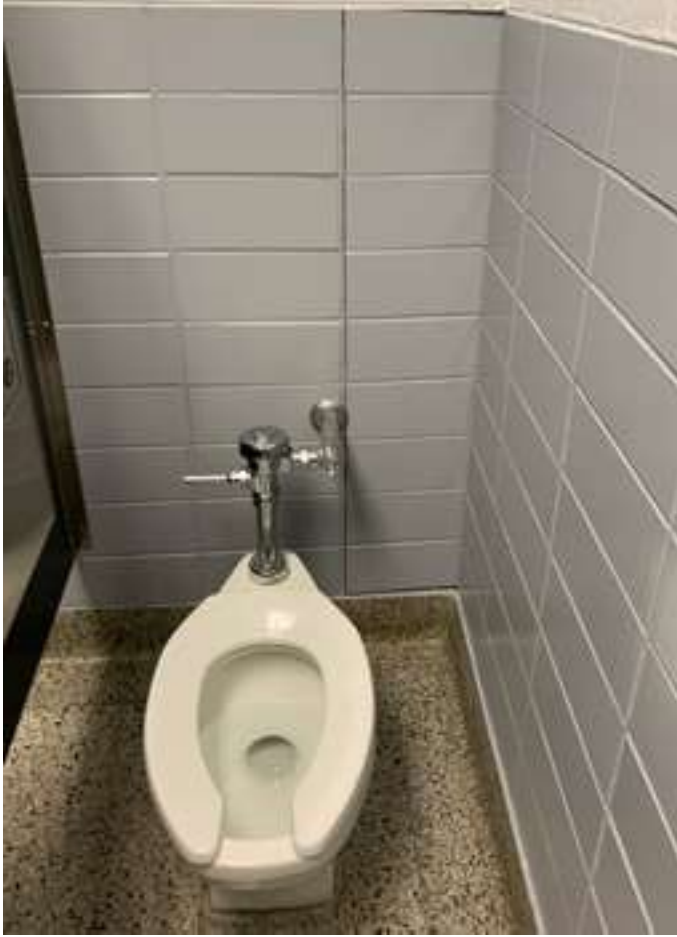
FIGURE 03 - Glazed block at high school restroom cracking at joints

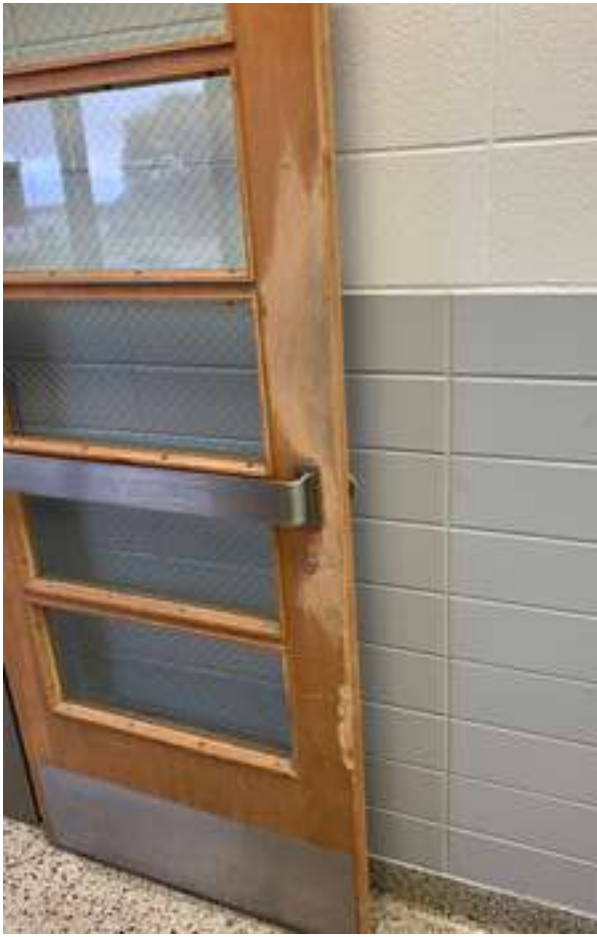
FIGURE 04 - High School wood doors at staircase showing wear

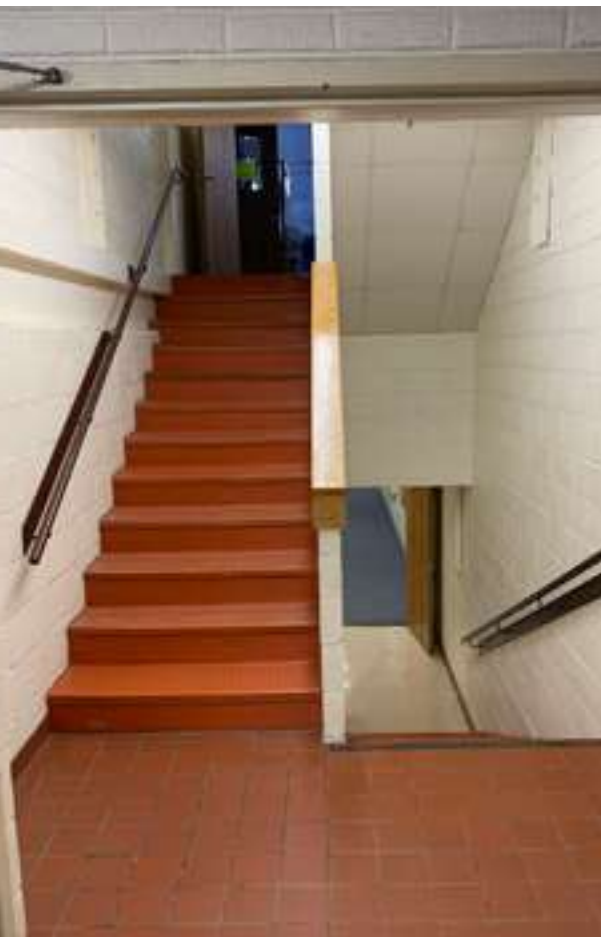
FIGURE 05 - Multiple changes in levels in high school

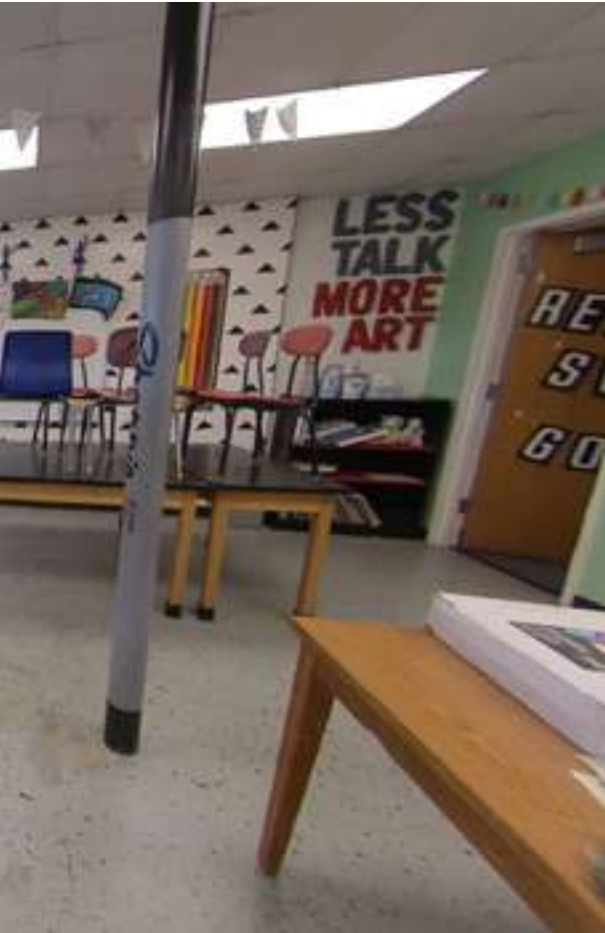
FIGURE 28 - Art room floor coating wearing through

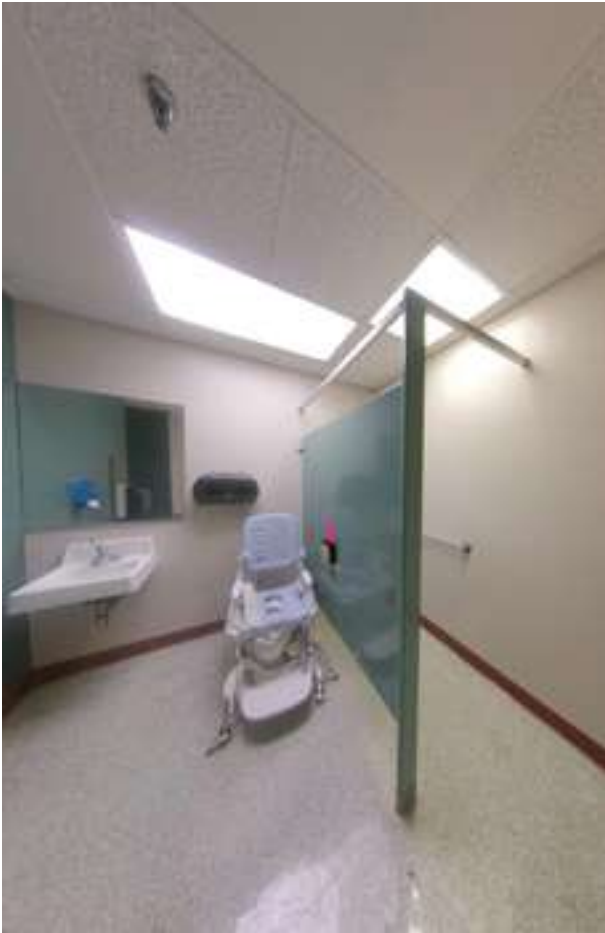
FIGURE 29 - Non ADA compliant restroom

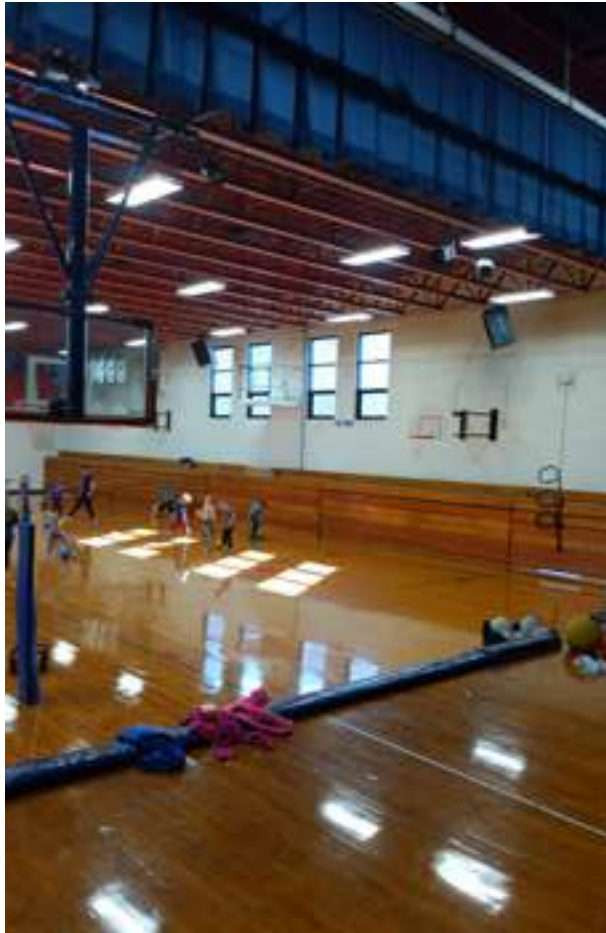
FIGURE 30 - View from stage into old gym - platform on gym wall appears unsafe

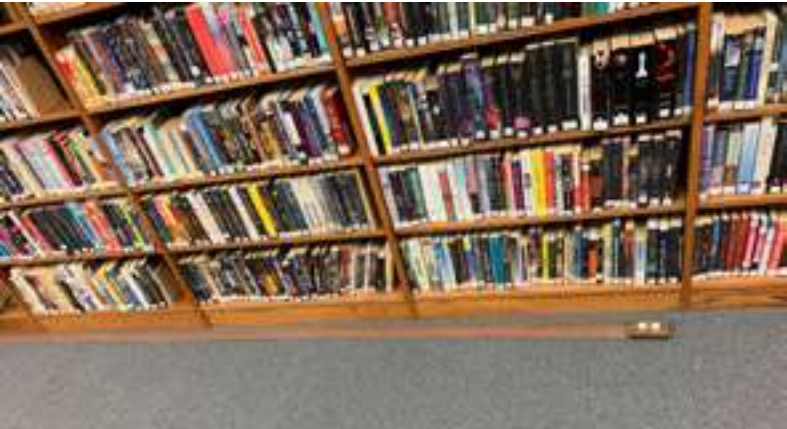
FIGURE 31 - In floor outlet creates trip hazard

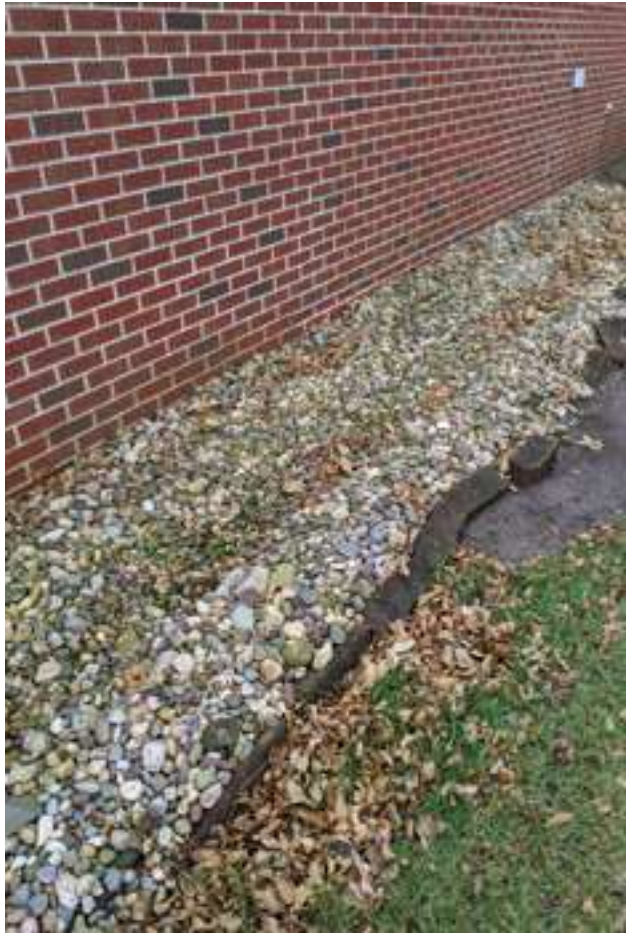
FIGURE 50 - Drainage issues - washout along foundation

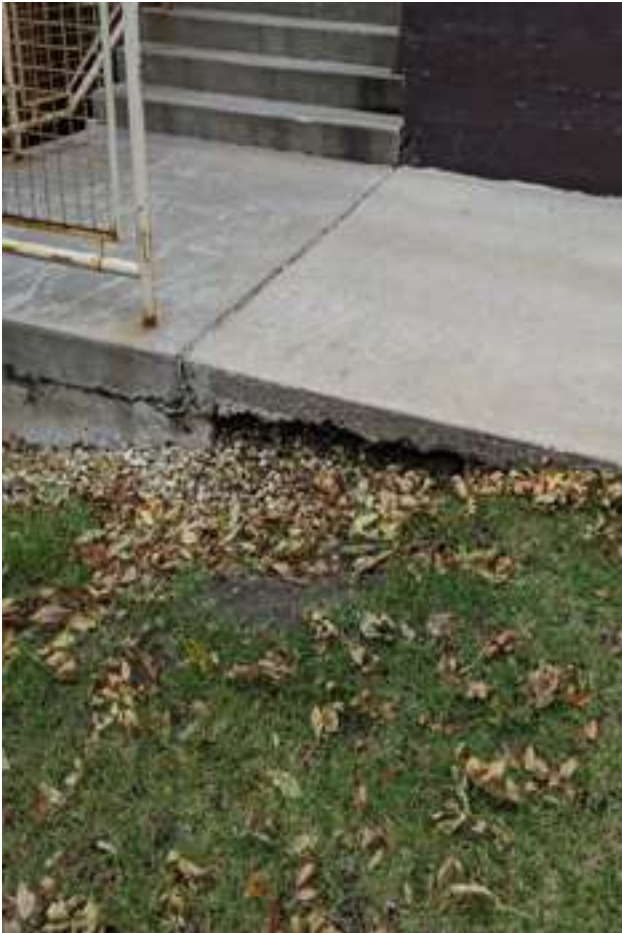
FIGURE 51 - Drainage issues - washout underneath concrete sidewalk

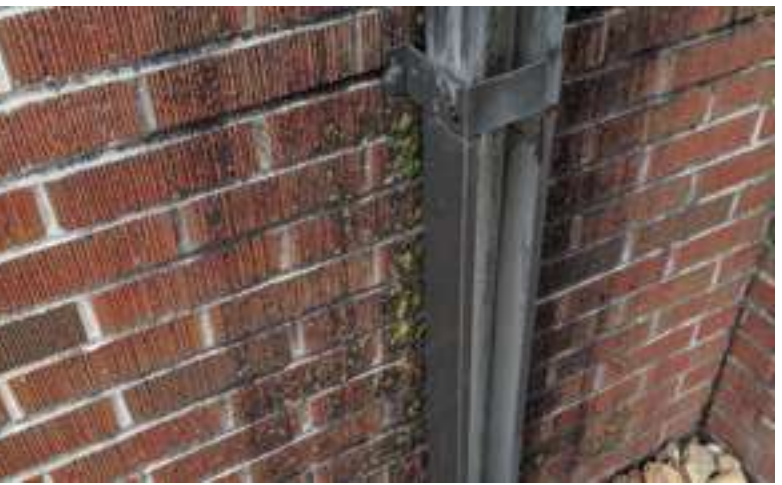
FIGURE 55 - Overspill at downspouts - moss and mortar damage

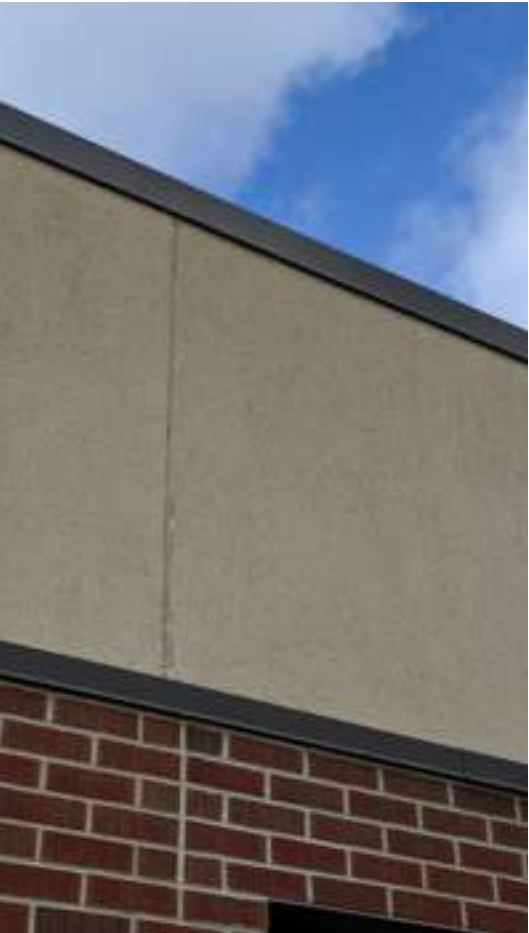
FIGURE 56 - EIFS at MS/ES joints cracking

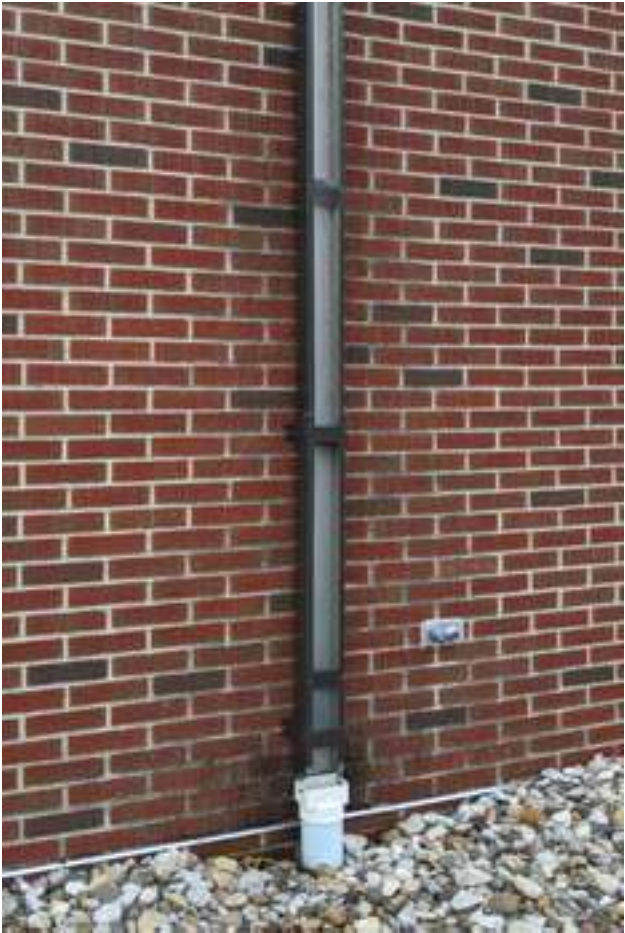
FIGURE 57 - Disconnected downspout at middle school. Several locations where grade/rock are above flashing

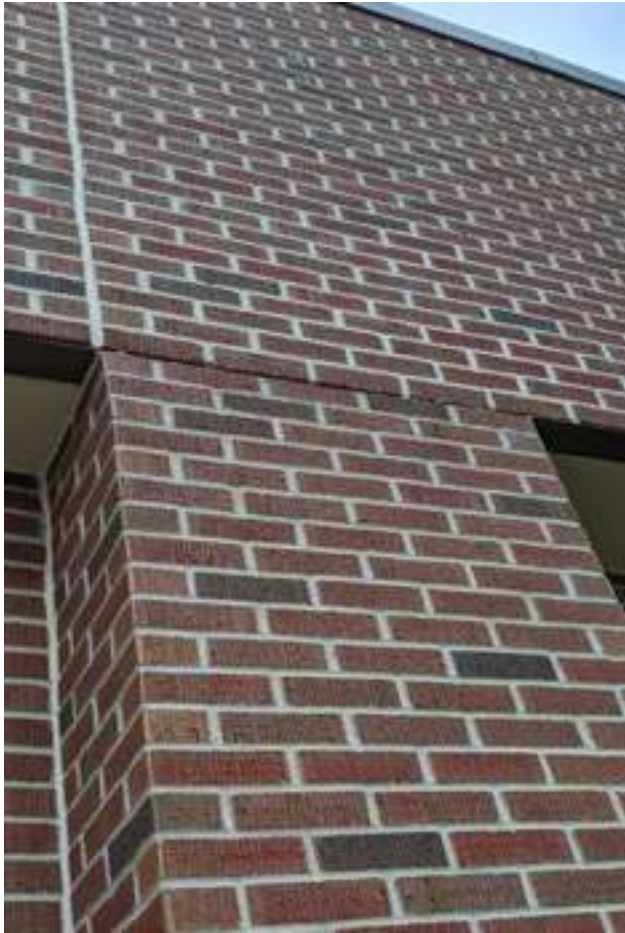
FIGURE 58 - Joint between windows deteriorating - replace with flexible joint

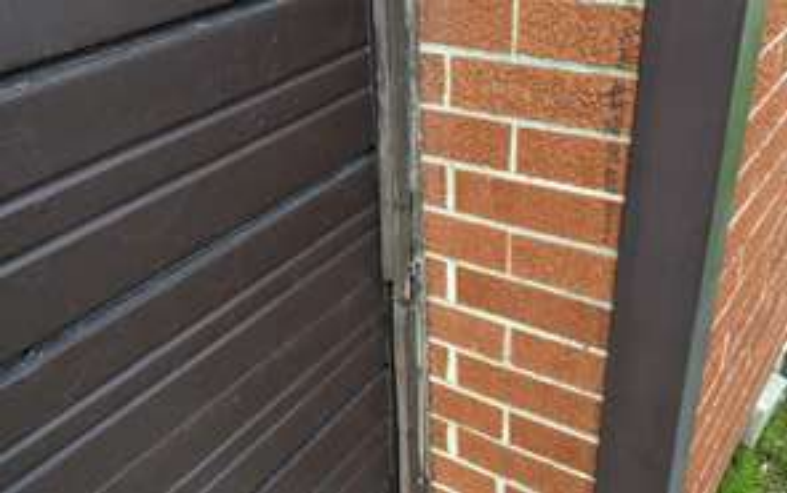
FIGURE59

FIGURE 59- Trim and seal around overhead door damaged at Ag building

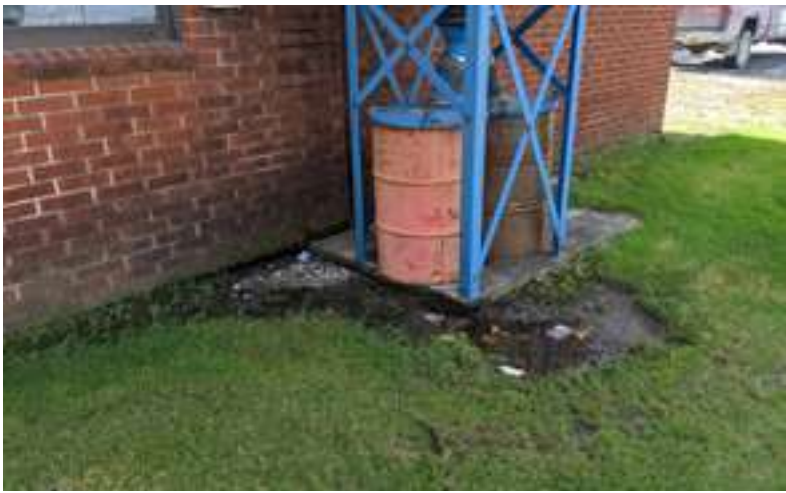
FIGURE 60 - Standing water at Ag building
