Brunswick Junior High School

Overview

The current Brunswick Junior High School was originally opened in 1959. Additions and/or renovations were completed in 1966, 1976 and 1983. The 1959 building included the admin wing, a classroom wing and the gym. The 1966 addition added a single story classroom wing to the west that includes the current music room. The 1976 project included renovations to the entire building plus four additions. The additions included a two story wing to the front of the building for special ed and science on the first floor and the library on the second floor; the industrial arts wing; locker rooms and an expanded cafeteria. The original two story classroom wing was fully renovated in 1983 after fire damaged the wing. Refer to the key plan below. Although there have been some upgrades and maintenance repairs over the years, no further major renovations or additions have been done to the school since 1983.

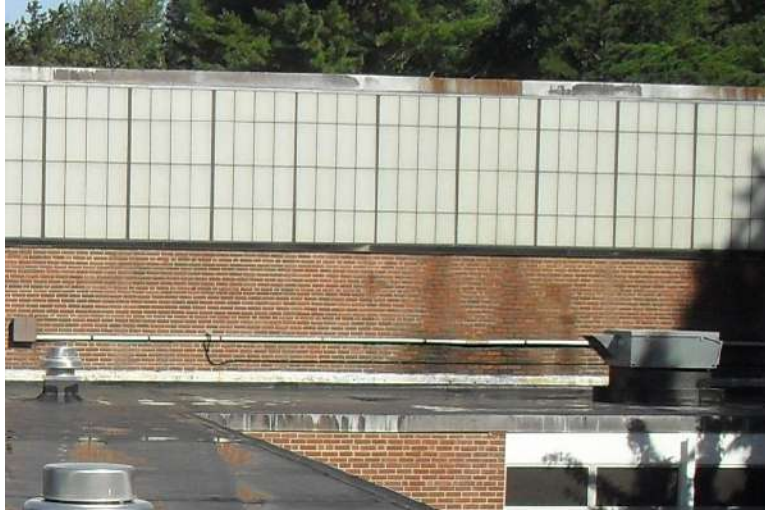
The exterior of the building is predominantly of brick veneer. There are a few locations of wood siding but it is limited. Overall, the brick is in good condition although some areas need to be cleaned and repointed where moisture has caused discoloration of the brick (potential mold issues) and deterioration of the mortar from water draining over the roof edge and down the face of the wall. Correcting the roof drainage should be a priority to eliminate the continuing moisture problems, which will only continue to be detrimental to the brick veneer as well as to the windows.

Staining of brick
at south wall of Gym

(Note: Wall panels
at gym were installed
in 2000)

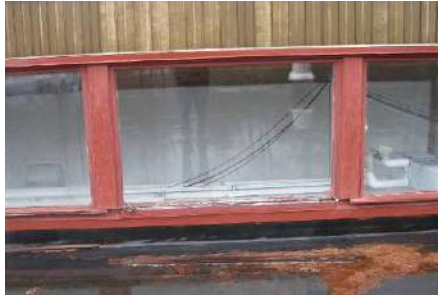
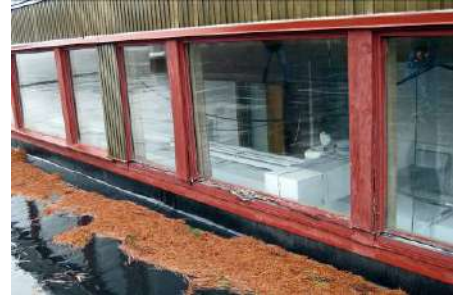
There have been a variety of window types used relative to the different additions and renovations. Aluminum windowwall was used on the original 1959 building along with the 1966 classroom addition. The 1976 additions and the 1983 renovations used non-clad wood windows. There is glazed aluminum storefront at the main and gym entrances. All glazing appears to be insulated glass. It has been reported that much of the original windowwall is leaking. In addition, some of the wood windows are rotting. This is particularly evident at the clerestory windows of the 1976 classroom addition. The windows in the gym are translucent wall panels – Kalwall - that were installed in 2000. Replacement of the original windowwall and the rotting wood windows should be a priority and are currently included in the capital improvement budget. Replacement of the remaining wood windows in the two story wing, although not a high priority, should be considered for a future project.

Rotting wood windows

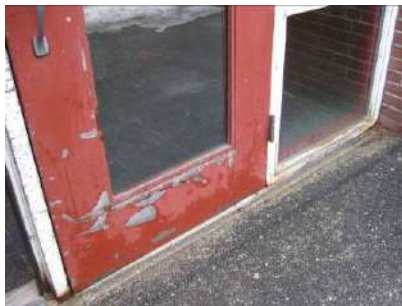
Exterior Hollow Metal
Doors & Frames

Many of the exterior hollow metal doors and frames that are not in protected locations are showing signs of rust and deterioration of the finish. The hollow metal doors and frames that are in the worst condition should be considered for replacement. Those doors that are currently unprotected and most vulnerable to damage caused by moisture and rusting may want to be replaced with heavy duty aluminum doors and frames. Other doors and frames that are in more protected locations may be able to be repaired and repainted depending on the level of rust damage.

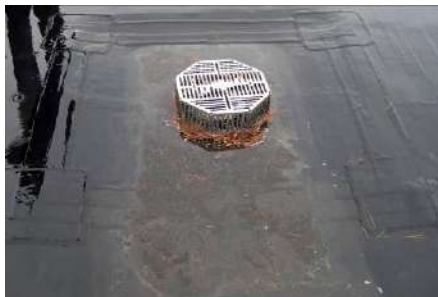
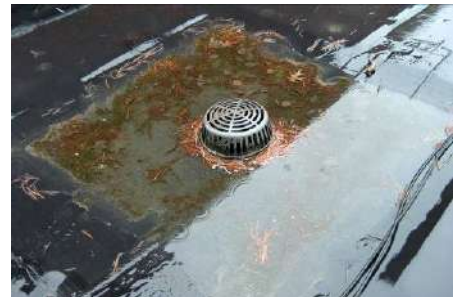
Typical roof drains
set in sumps

The roofs all drain internally to roof drains that are installed in sumps. There was a reroofing project done in 1992 that originally included installation of tapered insulation to improve drainage to the drains but apparently much of the tapered insulation was deleted around the outer areas of roof that has resulted in those areas being flat with no pitch. It is not known why areas of the tapered insulation were deleted. The lack of tapered insulation over much of the roof is a contributing factor to water draining over the edge of the roof and down the face of the building impacting the windows and the brick. Consideration should be given to correcting this condition in the near future to eliminate the drainage problems by adding a raised curb or parapet or reroofing the affected areas and adding tapered insulation.

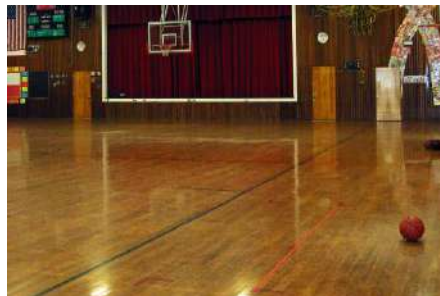
Main Gym – Wood Floor

The gym floor is wood and generally in good condition but is in need of refinishing to restore it to its original condition. The adjoining small gym has a resilient floor and is in reasonable condition. The fitness room and locker rooms are painted concrete while the toilet and shower areas are ceramic tile.

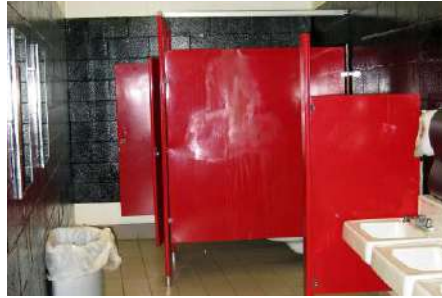
Non-Compliant Student Toilet Room

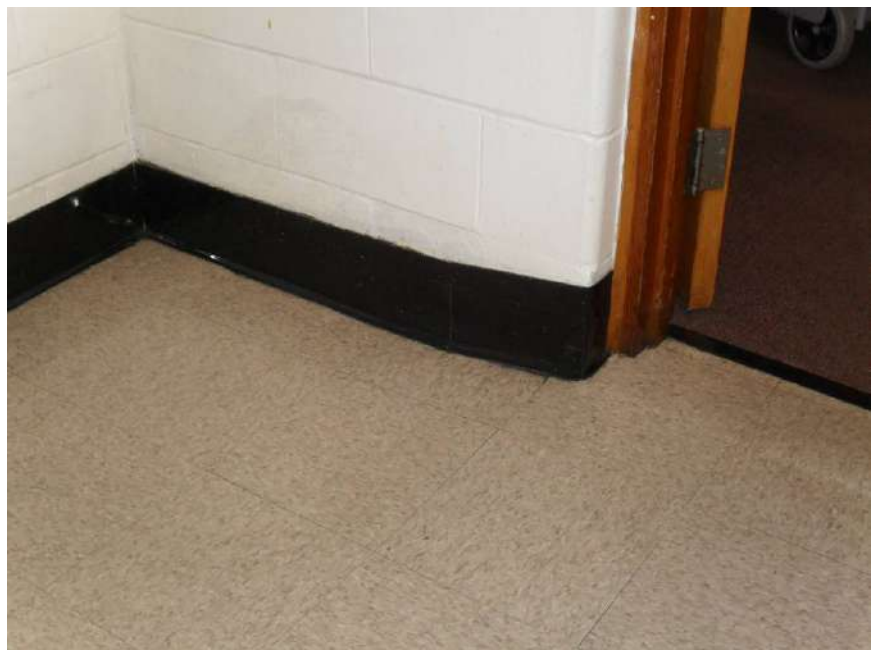
Slab Settlement in
Classroom Floor

It is our understanding that the floor settlement has been present for a very long time, and the flooring and wall base trim have been adjusted accordingly.

The slab settlement was likely due to poor compaction of the subgrade below the interior slabs. There are several ways to address the issue. One method would be to remove all floor finishes and place a leveling material on the slabs to bring them back to the correct elevation. This solution likely won't work since the extra weight of the new material will likely cause additional settlement to occur. We could also attempt to pressure-inject flowable grout under the slabs to raise them, but because the slabs have settled, it would suffer severe cracking if they are elevated as much as 5". The only real long-term solution would be to remove the existing slabs and properly compact and possibly replace the subgrade material prior to pouring new slabs. This would be very costly and an unwise investment for a building of this age and condition.

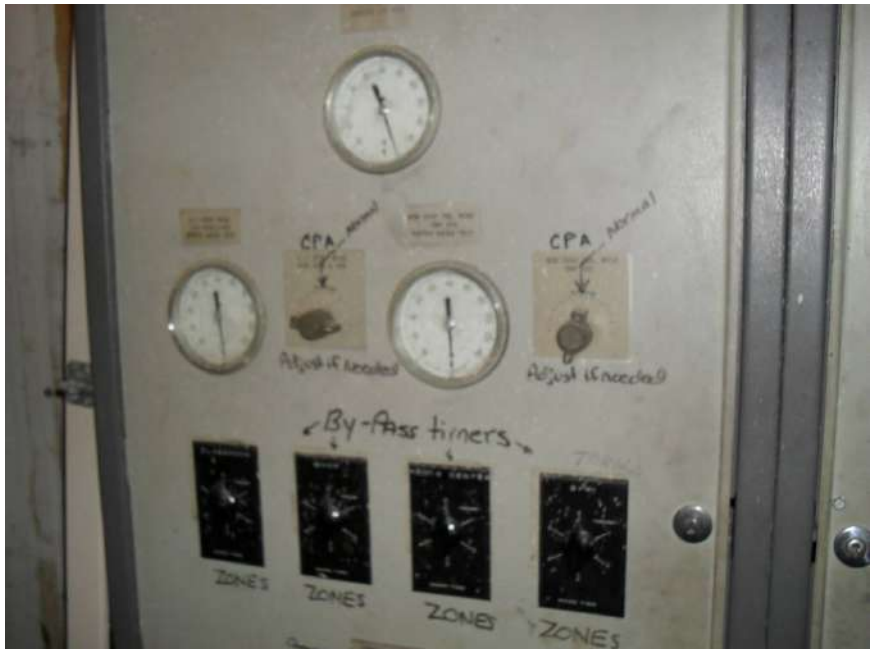
Figure 10 – Exist
Pneumatic Control Panel

The temperature controls in the facility are a combination of pneumatic and DDC control. Reports are that this system has not provided consistent temperature control throughout the facility. Some areas are quite warm while others can be quite cool. The system as installed is Siemens and is also being serviced by Siemens.

There are reports that the school has experienced areas where the temperature is not consistent. We believe that most of these issues can be resolved with modifications to the control strategies. We recommend removing any remaining pneumatic system control which includes all controllers, air compressor, dryers, tubing, actuators, sensors and all other associated accessories. These areas are primarily in the gymnasium wing. The Siemens Apogee DDC system should be expanded to cover the entire facility. This control system will be expanded by Siemens and will all be mapped back to the main head end in the Facility Director's office. Opinion of probable cost - \$50,000.

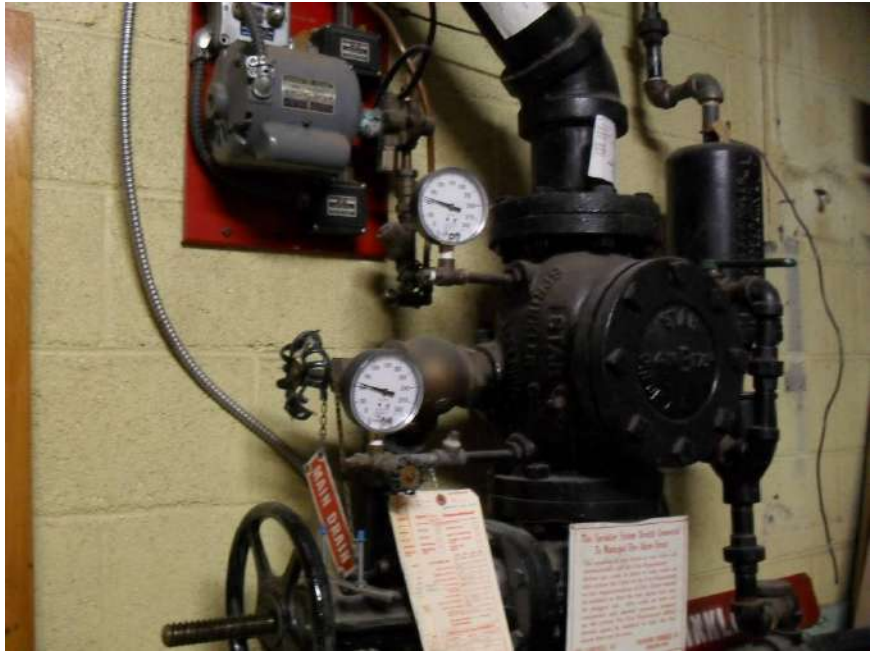
Figure 12 – Sprinkler
Entrance

The sprinkler system enters the building in the storage area adjacent to the kitchen. The line size coming in is 4". Based on conversations with staff and site observations, only the common areas are served by this sprinkler system such as the kitchen area, corridors and other sporadic areas around the school. Occupied spaces such as classrooms and offices are not outfitted with adequate sprinkler systems.

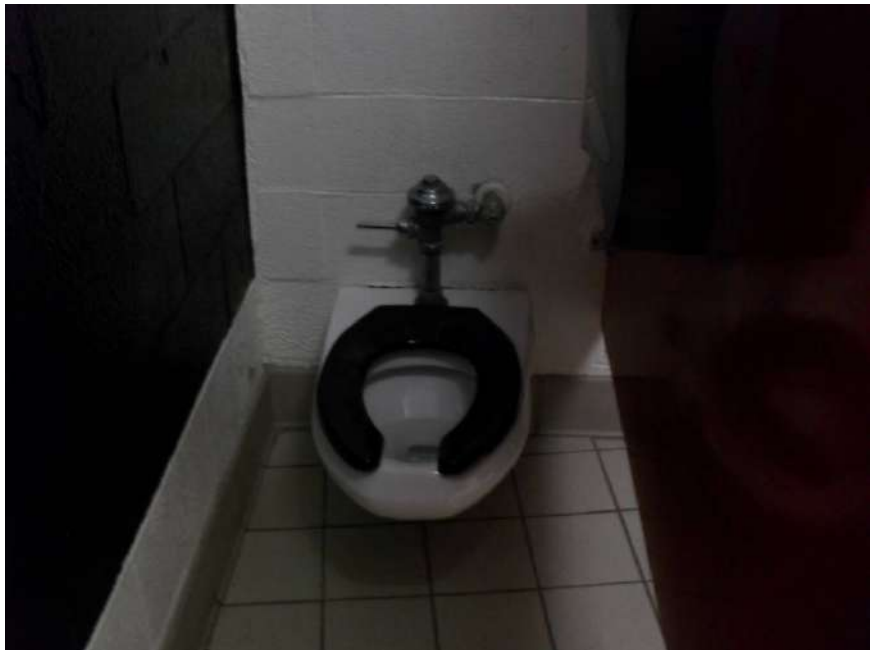
Figure 13 - Typical
Water Closet

The plumbing fixtures appear to all be original. The water closets are approximately flushing at 3.5 gallons per minute and the urinals are flushing at 1.25 gallons per minute. No handicap fixtures were noted throughout the school.

Plumbing	<p>Since all of the plumbing fixtures appear to be original, we would recommend replacing them with low flow fixtures. Even though there are several handicap stalls located throughout the facility the plumbing fixtures located within the stalls are not handicap accessible and will also be required to be brought up to comply with ADA requirements. Additional modifications will be required to make all lavatories and toilets accessible as well. Opinion of probable cost - \$1,000 per fixture.</p> <p>Reconnect DHW recirculation loop piping in the connecting corridor area of the 100, 200 and 300 wings. Opinion of probable cost - \$24,000.</p> <p>The existing gas fired domestic water heater located on the Mezzanine above the stage is not currently DDC automated. Recommend providing full automation. Opinion of probable cost – \$12,000.</p>

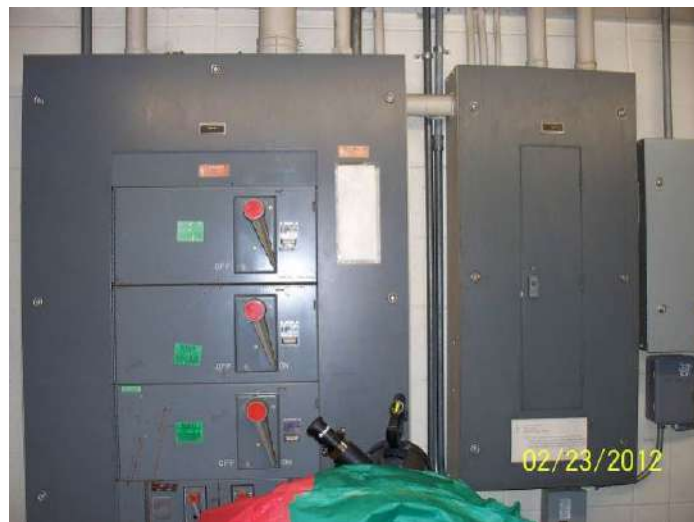
Distribution equipment
(MDP1) in Media
Center wing. (FPE
switch & fuse)

- § The equipment that comprises the service entrance is in violation of the National Electric Code because of lack of required clearances.
- § Also, there may be a mistake in the labeling of the mains for MDP1 and MDP2, this should be verified.

The existing service entrance equipment should be upgraded, reducing the number of mains and providing required clearances and additional capacity if necessary. All of the older sub-panels should be replaced with new panels providing additional circuit capacity and maintainable equipment. Additional transformer capacity will be required if additional loads are added to the building.

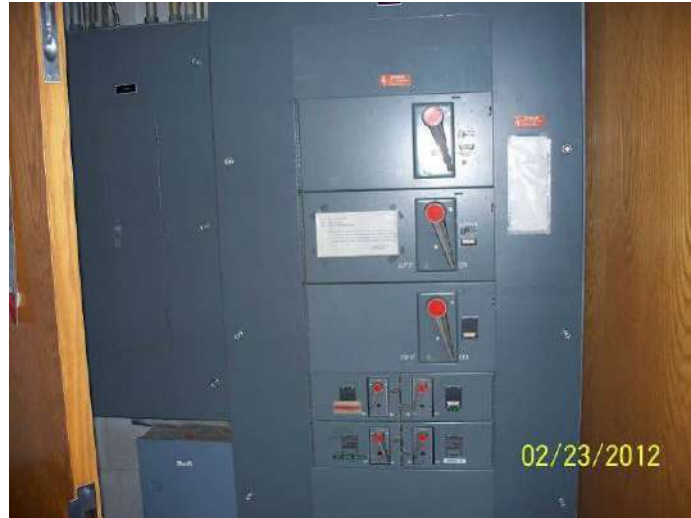
Distribution equipment
(MDP2) in Shop wing.
(FPE switch & fuse)

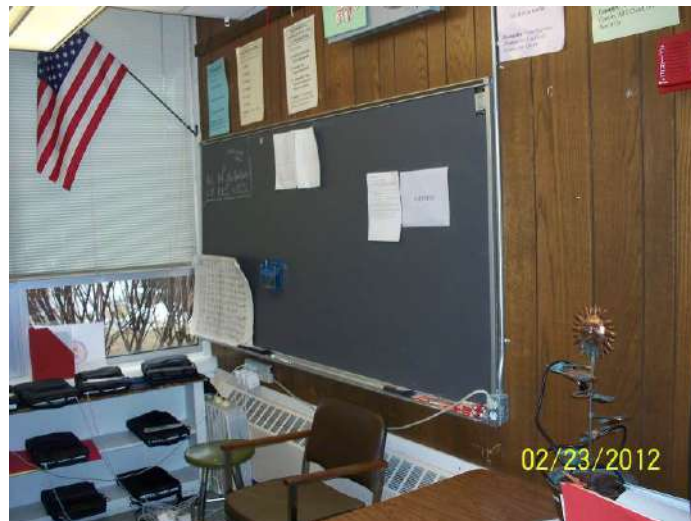
There are wall mounted grounded receptacles located throughout the school but there are many areas that do not have a sufficient quantity to provide receptacle service where needed. In many locations extension cords and plug strips are being used to overcome the lack of receptacles. The NEC does not allow extension cords to be used for permanent connection of equipment. Extension cords have been identified as a fire hazard and plug-strips increase the probability of over-loading circuits. No exterior outlets were observed in the site survey.

Surface receptacle has been added, but, plug-strip is still required to provide power for charging station.

Additional receptacles are required throughout the school to provide service where needed. In many locations this has been done, but, it appears (from the use of cords/power strips) there are many more areas that need additional receptacles. Exterior receptacle outlets should be added as needed to provide service for maintenance purposes. Also, it was noted that Romex has been used throughout this facility; current codes do not allow the use of this wiring method in this type of construction. If wiring is added to this school in the future, it should be done with an approved non-combustible material type. Also, the NEC requires the removal of all discontinued wiring. And as wiring/circuits are revised and no longer needed they should be removed completely back to the source.

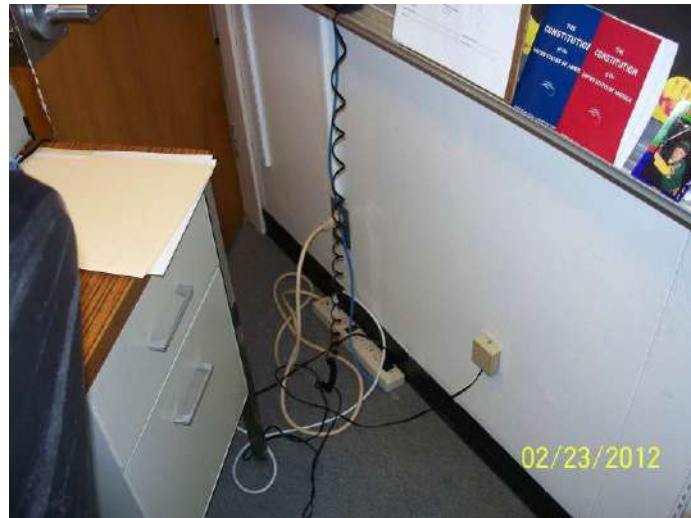
Plug-strip being used to serve desk area.

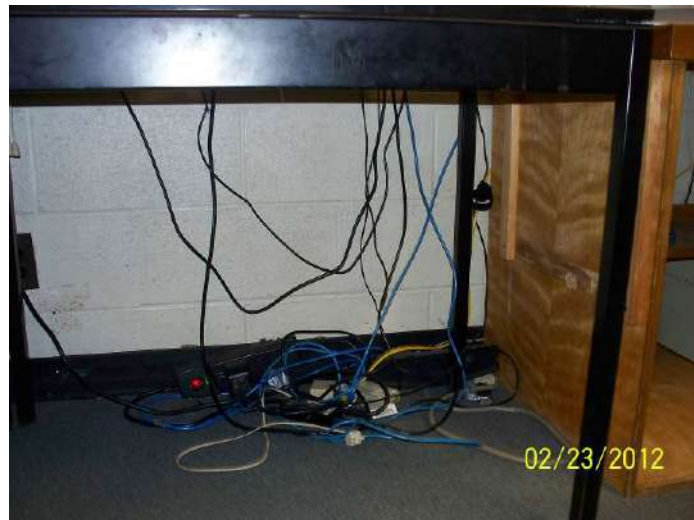
Wiring hazard and 120V wires entwined with data wiring can cause interference.

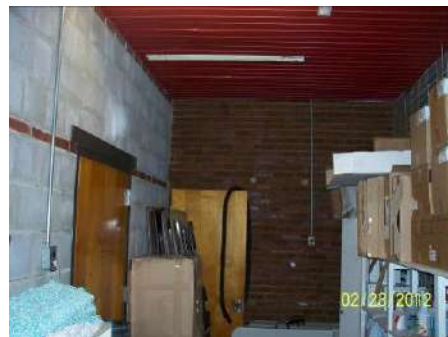
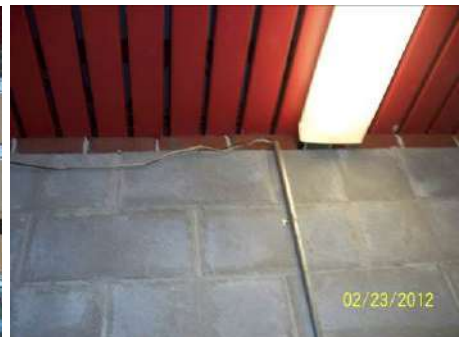
Surface mounted handy box and conduit (left-most) is fed with "free-air" THHN. This is a code violation.

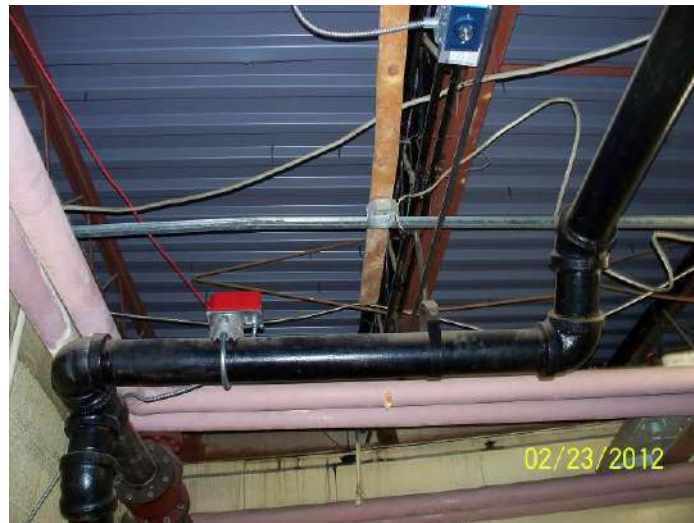
Open box with discontinued wiring?

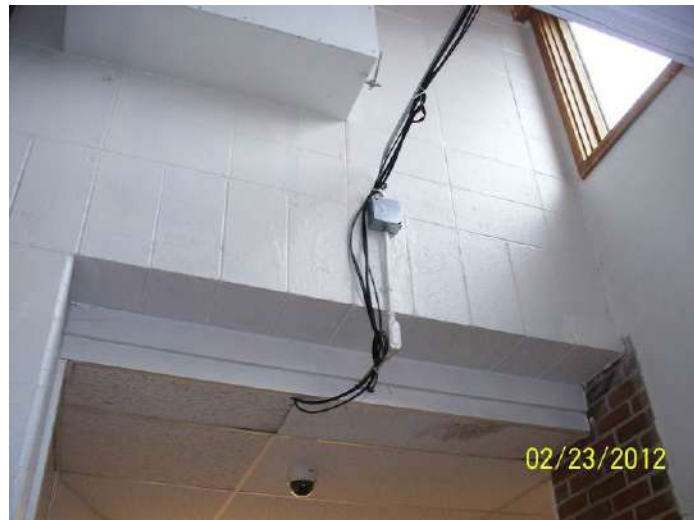
CCTV Camera in
corridor and exposed
wiring.

The existing CCTV camera system is quite complete and appears to be very functional. It is located in a room that is very small, and needs more space. Much of the wiring has been strung down the halls and runs through the suspended ceiling system. This creates a potential for damage to the cables and is very insecure.
