Coffin Elementary School

Overview

The school is a single story masonry building of approximately 57,440 sf. There are two parallel classroom wings connected at the center by a multi-purpose space. To the rear of the building is the cafeteria and kitchen. Each wing is a double loaded corridor with classrooms on one side and support spaces on the other side. The multi-purpose room has an elevated stage at one end. Below the stage is a basement work room that was originally the boiler room. There was a small storage room addition for the nutrition program added around 1990 adjacent to the kitchen at the rear of the building. Refer to Tab 7 for a plan of the existing building.

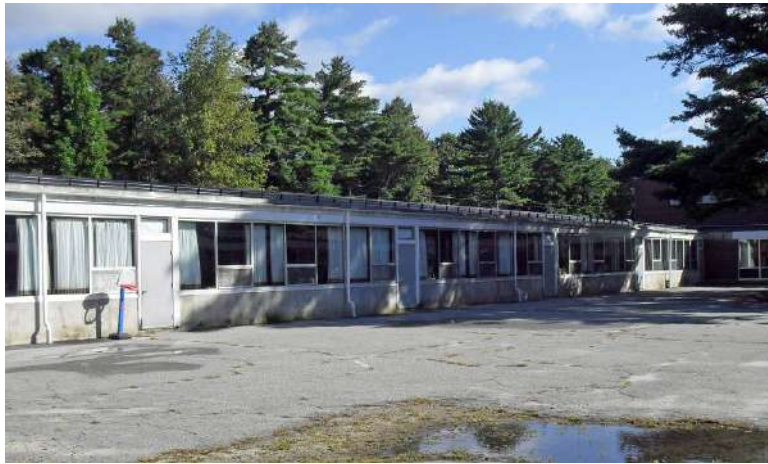
The exterior of the building is a combination of brick veneer and window wall construction. The brick veneer appears to be in sound condition. The window wall is located on the south face of all the classrooms as well as the south and west sides of the cafeteria. Below the window wall system is a concrete stem wall. The classrooms also have a clerestory band of windows on the north side of the rooms. However, some of these windows have been blocked as a result of the ventilation improvements, such as piping and ductwork that were done a few years ago. See photos below.

Typical Classroom
Windowwall System

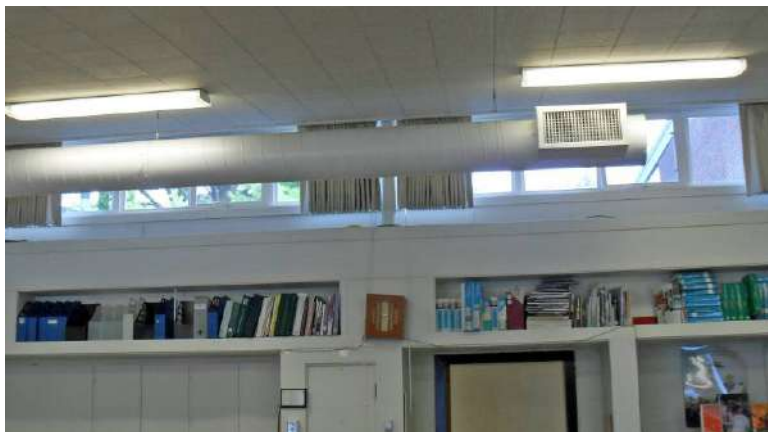
Typical Classroom
Clerestory Windows
blocked by ductwork

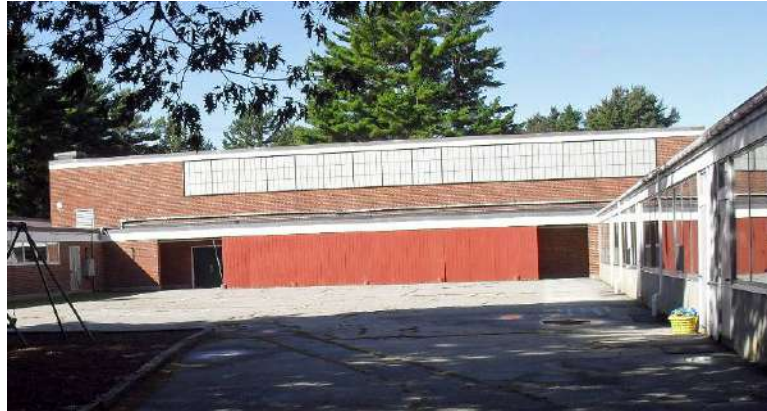
Exterior of Gym
(Note infill storage with
plywood siding)

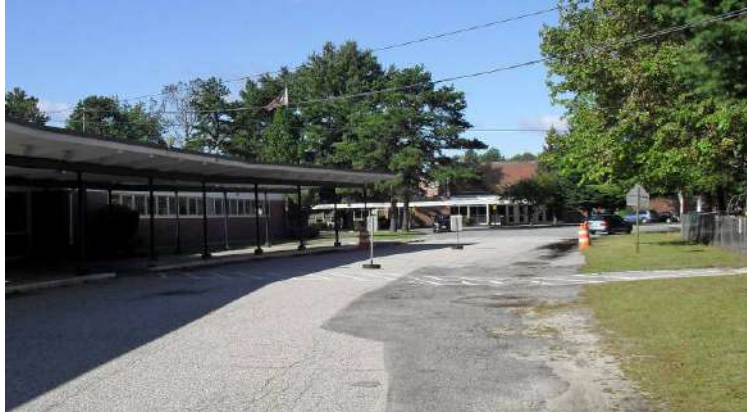
Main driveway
in front of Coffin School

The main entrance drive is the primary route for the buses to drop off and pick up students for the school. This also serves as a parent vehicle drop-off area, which adds to the traffic congestion twice each day. Separating parent vehicles from the bus drop-off area would improve traffic movement and greatly enhance safety.

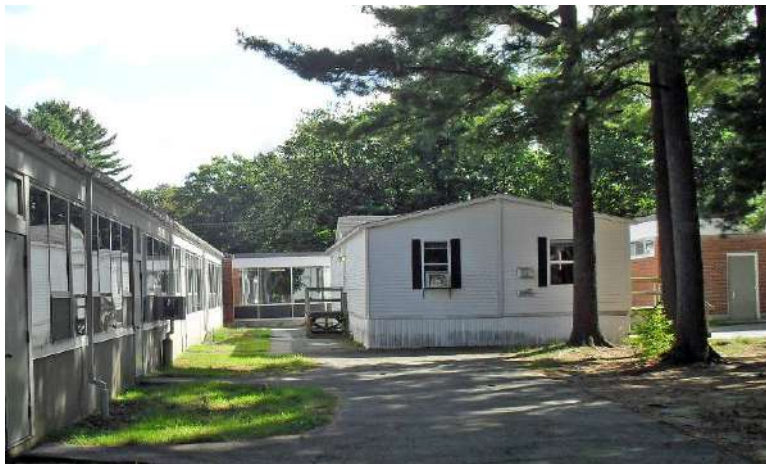
Double Portables
Adjacent to Classrooms

While the portables have ramps to make them accessible, the fact that students must travel outside the building to get to the portables, limits the accessibility to those programs, particularly during inclement weather and more specifically the winter months.. Eliminating the portables and moving the programs into the main building would solve the accessibility issue.

- § Eliminate all six portables and provide appropriate program space within the building for the programs that are currently located within the portables.

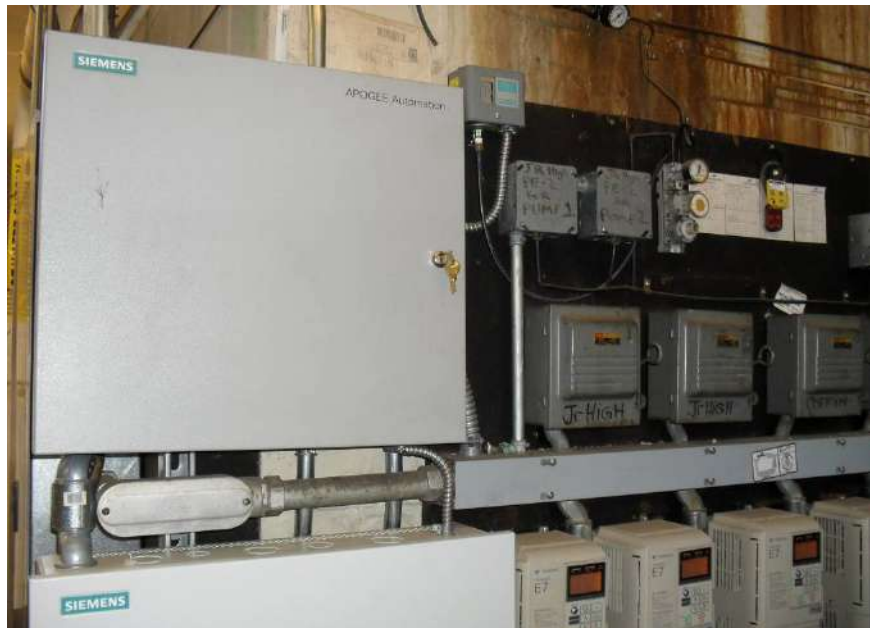
The temperature controls in the facility are a combination of pneumatic and DDC controls. Reports are that this system has not provided consistent temperature control throughout the facility. Some areas are quite warm while others can be quite cool. The system as installed is Siemens and is also being serviced by Siemens.

Figure 7 - DDC
Controller

Remove all of the pneumatic control system accessories.

There have been reports that the school has experienced areas where the temperature is not consistent. We believe that most of these issues can be resolved with modifications to the control strategies. We recommend removing any remaining pneumatic system control which includes all controllers, air compressor, dryers, tubing, actuators, sensors and all other associated accessories. The Siemens Apogee DDC system should be expanded to cover the entire facility. This control system will be expanded by Siemens and will all be mapped back to the main head end in the Facility Director's office.

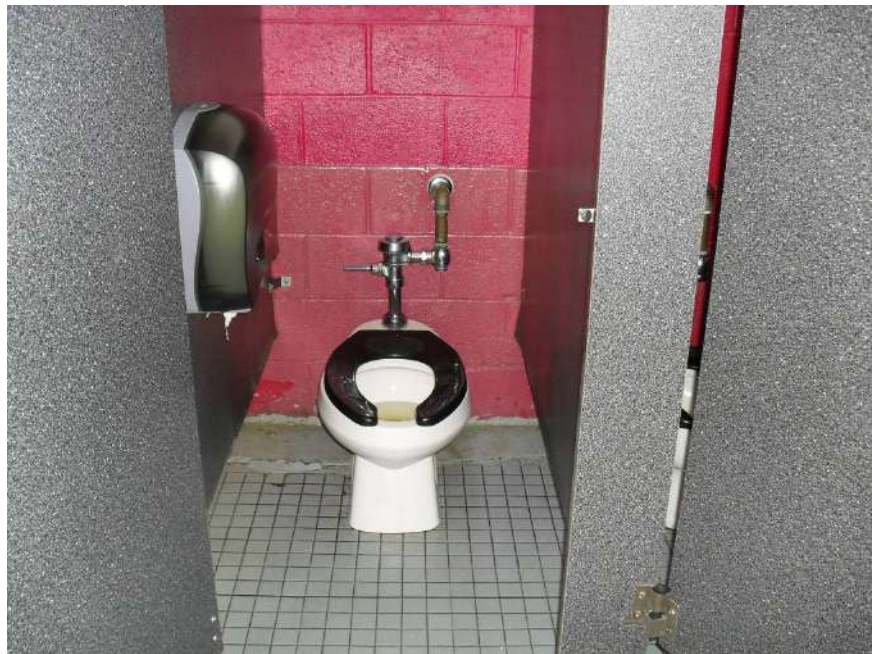
The plumbing fixtures appear to all be original. The water closets are approximately flushing at 3.5 gallons per minute and the urinals are flushing at 1.25 gallons per minute. No handicap fixtures were noted throughout the school.

Figure 8 - Typical closet

Since all of the plumbing fixtures appear to be original, we would recommend replacing them all with low flow fixtures. Handicap fixtures will also be required throughout the facility to bring it in compliance with ADA requirements. Additional modifications will be required to make all toilets accessible.

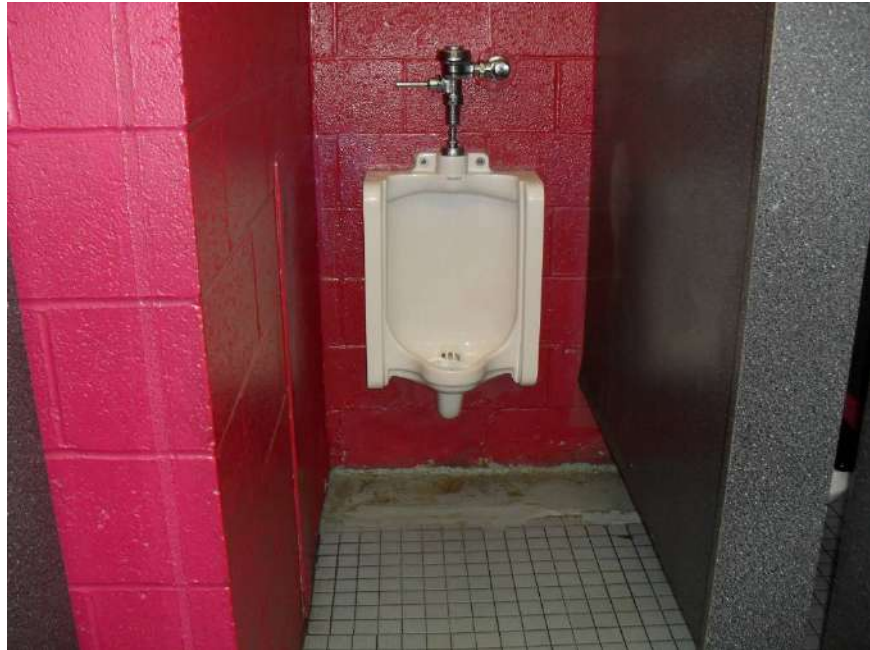
Figure 9 - Typical Urinal

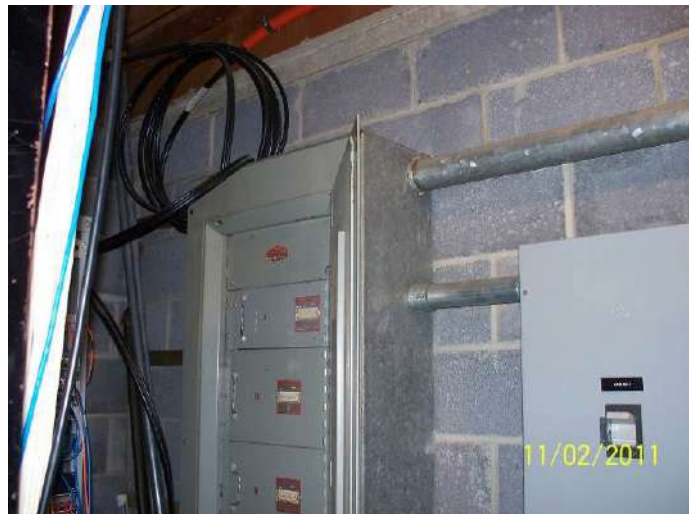
The electrical service entrance is made up of a variety of equipment with multiple mains, Main #1, Main #2, Main #3 (mobiles), and Main #4 (mobiles). None of this equipment has the clearances required by NEC. Main #1 & #2 are circuit breakers and the rest are fused switches.

The equipment that comprises the service entrance is in violation of the National Electric Code because of lack of required clearances. Also, the configuration of multiple main breakers may be a safety concern as it is quite confusing as to which main controls which sub-panels. The capacity of the existing service is currently limited by the transformers located in the vault to 150kVA, but, the equipment when totaled (Main #1 - 400A @ 208V/3Ø), (Main #2 - 400A @ 208V/3Ø), (Main #3 - 200A @ 208V/1Ø), (Main #4 - 200A @ 208V/1Ø) is capable of approximately 297kW. This is very low for a building of this size (57k SF +/-). Most of the existing sub-panels are relatively new and in good condition, but, the panels in the Kitchen area are not in good condition and have been modified.

The existing service entrance equipment should be upgraded to combine distribution and eliminate mains, provide required clearances and additional capacity if deemed necessary. The main distribution panel is very old and unsafe and should be replaced as soon as possible. The electrical needs in the Kitchen should be evaluated and the panels upgraded accordingly. Replacing the existing service entrance equipment and getting the required clearances is going to be difficult as there is limited space available to work with.

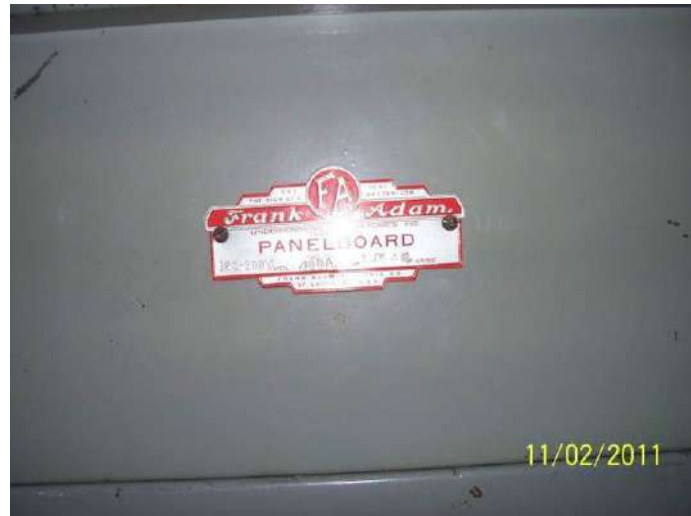
Frank Adam Equipment,
no longer manufactured

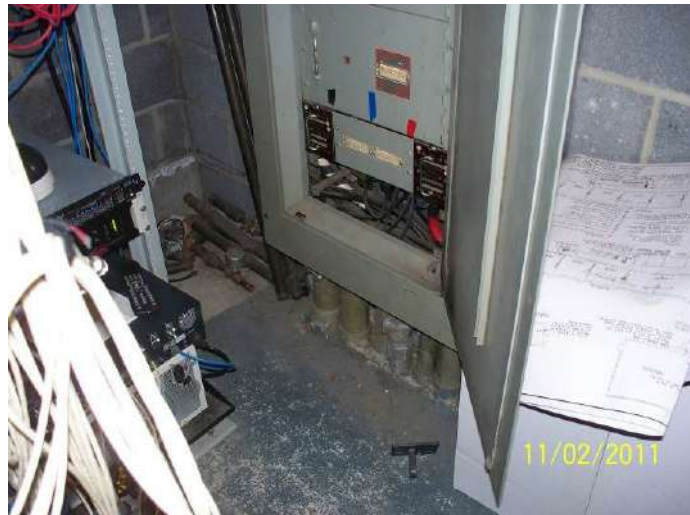
Interior cover missing

The main distribution panel is a very old fuse type panel, with some dead-front panels missing that expose live parts when the door is opened. Sub-panels are located in the corridors of each wing, multi-purpose space, boiler room, and kitchen. This is a good distribution that limits the lengths of branch circuits to acceptable distances. Most sub-panels appear to be in serviceable condition. The panels in the kitchen have been modified indicating the original panels do not provide the necessary circuitry.

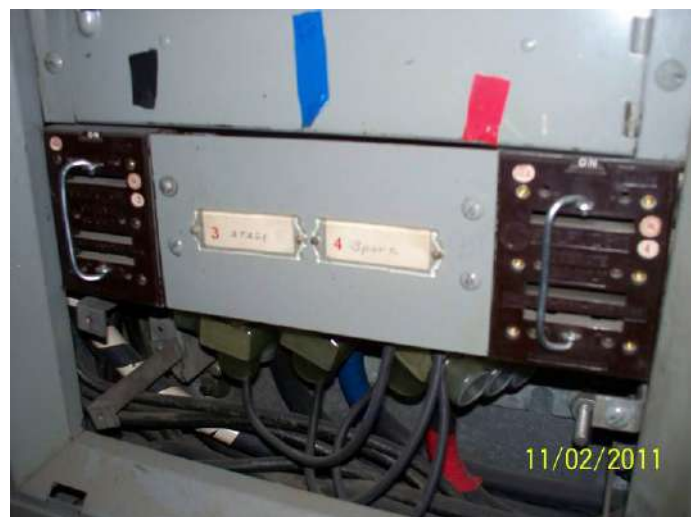
Conductors tapped off
main lugs

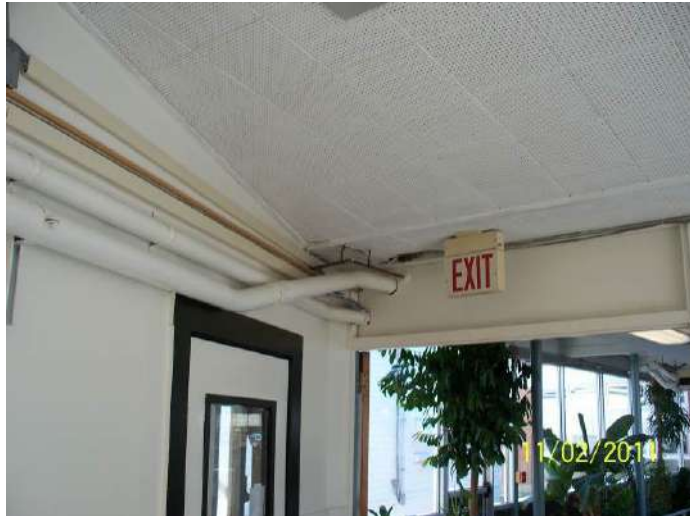
The Coffin Elementary School is served with self-contained (each unit has its own battery) exit signs and emergency life safety lighting throughout the building. Many of the exit signs do not appear to be working under normal conditions.

Typical self-contained exit sign (ON??)

All battery units should be tested to verify proper operation. Internally illuminated exit signs should be added at all required egress doors and units that are in poor condition should be replaced. Emergency lighting units and exit signs should be added so that all paths of egress are properly marked and illuminated.

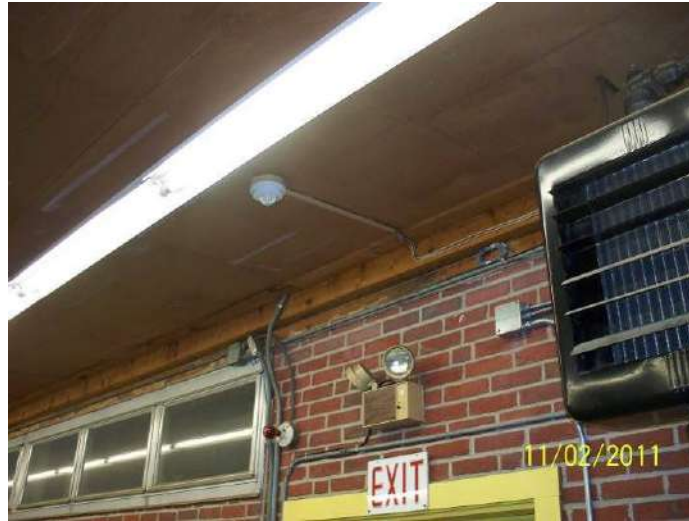
Typical emergency light
and non-illuminated exit
sign

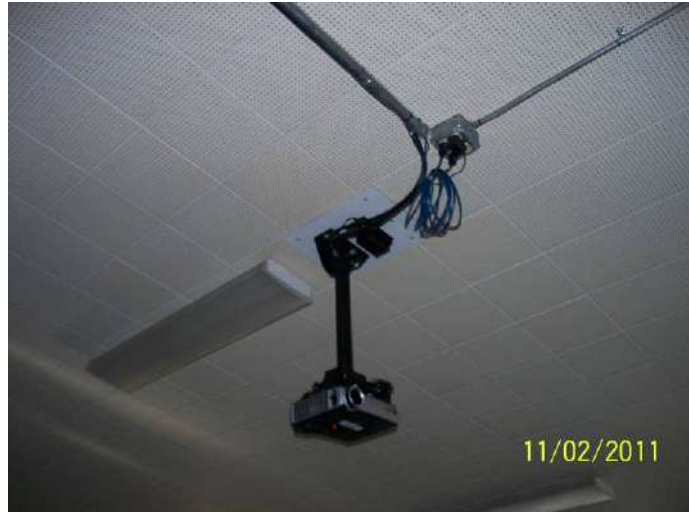
Quad Receptacle added to serve projector

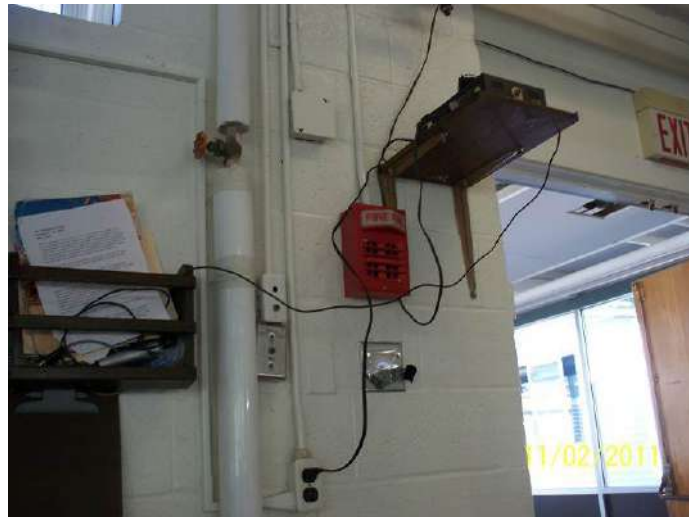
Surface receptacle with wiremold serving adjacent receptacle

Additional receptacles are required throughout the school to provide service where needed. In many locations circuits have been extended with surface wiring to provide service for specific equipment. Exterior receptacles outlets should be added as needed to provide service for maintenance purposes. Receptacles should be added in locations as necessary to reduce or eliminate the need for extension cords.

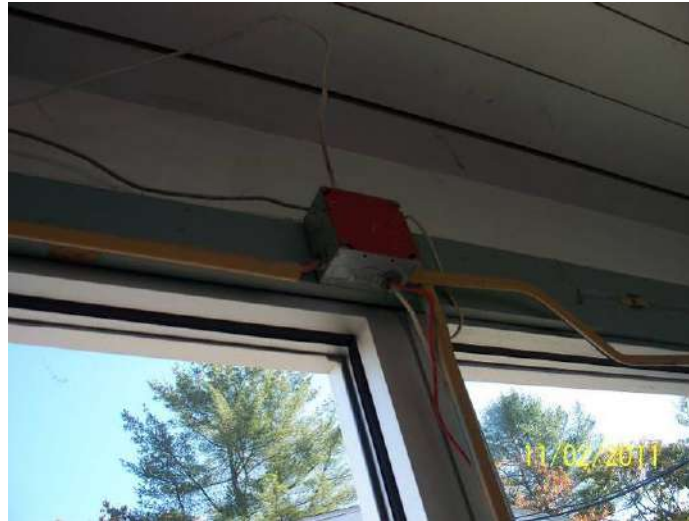
Fire alarm cabling
susceptible to damage

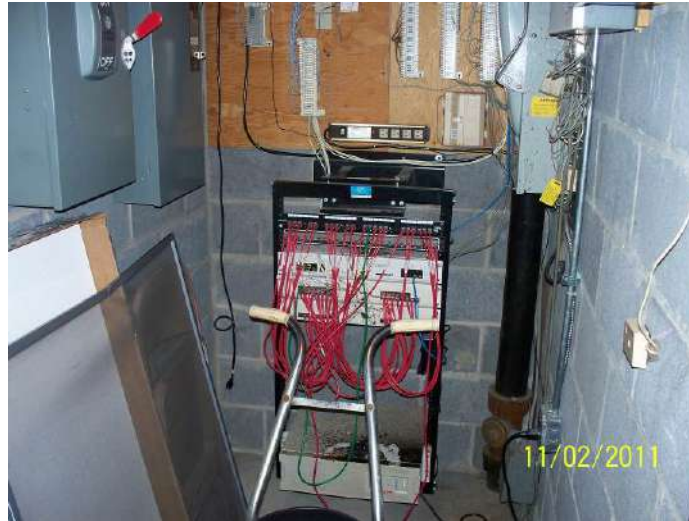
Phone System

The phone system is by Avaya and is rack mounted in the Electrical room between Main #3 and Main #4. This system is impeding on the required clear space in front of the electrical equipment. This system appears to be in service able condition. Also, the school network fiber connection to the internet was noted at this location. connection to the internet. There is also a data rack at the opposite end of the room that is floor mounted in front of the electrical main distribution panel, impeding the required clear space in front of that panel. Voice/data outlets appear to have been added throughout the school as needed, with cabling strung and run haphazardly. In locations where multiple PC's are located, wireless hubs have been installed.

The existing phone system appears functional, but, the space it occupies is needed for required clearance for electrical equipment. Voice/data cabling is in very poor condition in this building. All cables are run on building surfaces, many without raceways. These cables are very susceptible to damage. Also, it appears that most spaces are lacking sufficient “drops” for telephone and data when compared to modern schools.

A new space should be allocated for voice/data equipment to provide clear space in front of the electrical equipment. The existing cabling system should be replaced with new cables that are properly supported and protected. Connectivity should be upgraded to at least Cat 5e and to Cat 6 if budget allows.

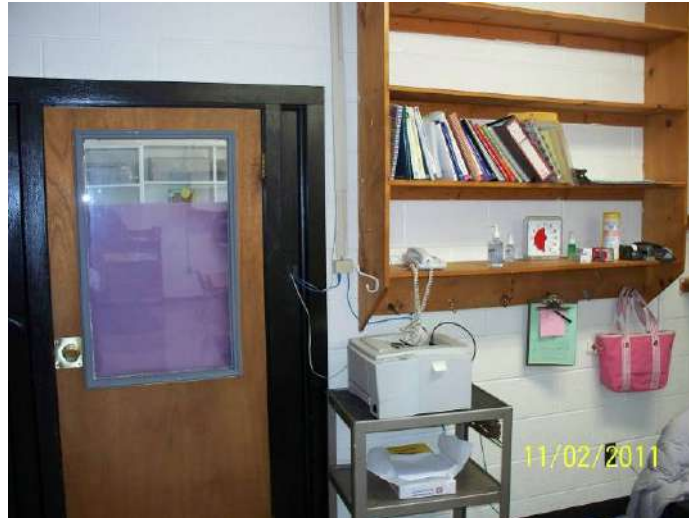
Typical surface wiring for voice/data cabling.
Note cables running through door frame

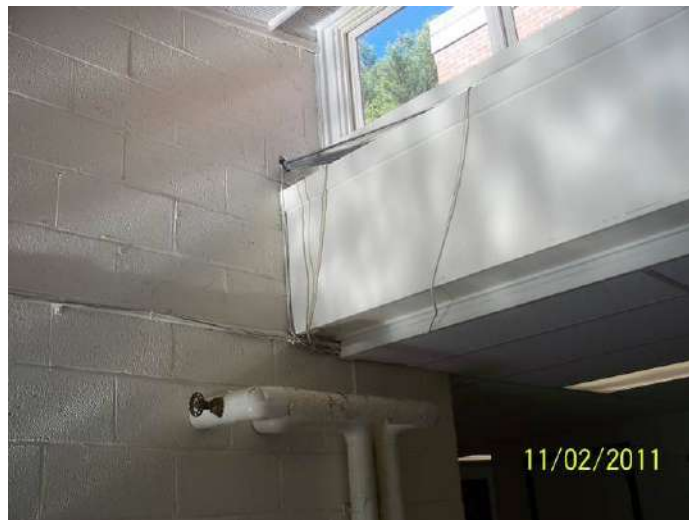
Voice/data cables run surface on block and through block unprotected

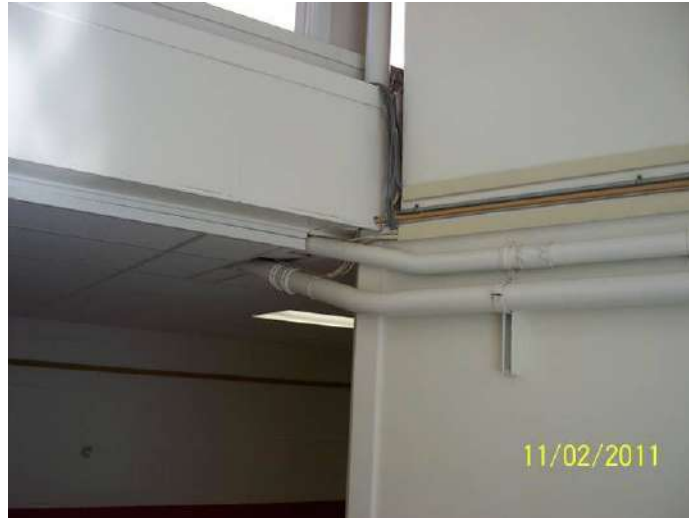
Voice/data cabling run surface on wall

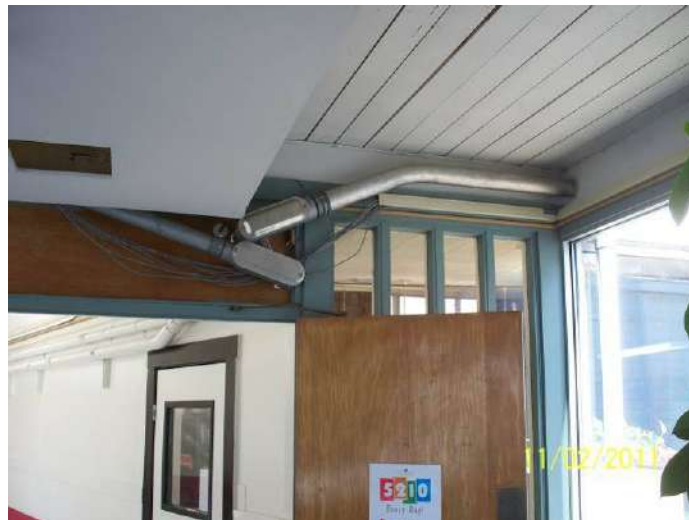
Voice/data cabling unsupported

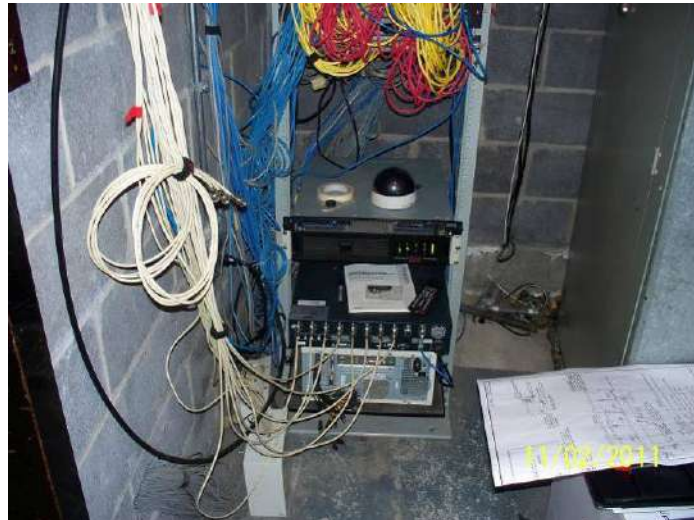
Head-End equipment

The existing camera system head end equipment is rack mounted in front of the electrical main distribution panel in the Electrical Room.

We were unable to determine if the camera system was functional and it is possibly not functioning at this time.

The system should be evaluated by a camera system vendor to determine operability and repair as required. Wiring for this system should be addressed to provide reliability and increase maintainability.
