Jordan Acres Elementary School

Overview

Part of the goal of this analysis is to assist the Brunswick School Department in determining whether Jordan Acres should be reopened or be closed permanently. And if the school is reopened, determine what the grade configuration and student population should be.

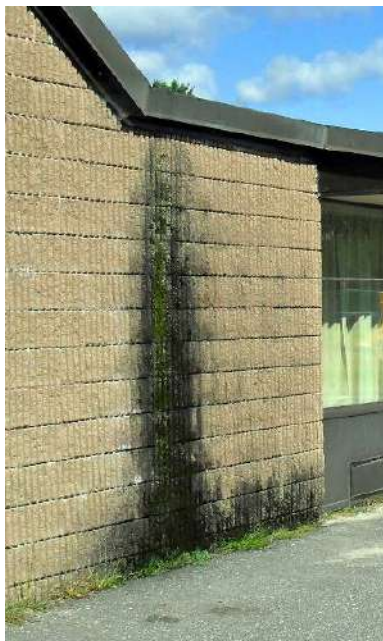
The exterior of the building consists primarily of scored, split-face concrete block, which is regarded as a highly absorbent material that is not recommended for use due to moisture problems. Some areas have smooth face concrete block, which is less absorbent. Many areas of the exterior walls that have the scored, split-faced block have turned black from moisture infiltration and in some instances moss is growing vertically up the walls. Some of the walls receive plenty of sun, while others receive limited sun.

Previous reports have indicated that runoff from the roof was a major cause of the moisture in the walls and that reroofing the building did little to help eliminate the problem. The exterior walls need to be opened up, inspected and tested to accurately determine the cause and the extent of the moisture problem. Depending on the results of the testing, the walls should be thoroughly cleaned with possibly other corrective action being taken to eliminate the problem from reoccurring. Corrective action may include extending the roof overhang, adding gutters and downspouts as well as possibly replacing the exterior masonry to a less absorbent material.

Moisture problems at the exterior walls

Southeast side with sun exposure

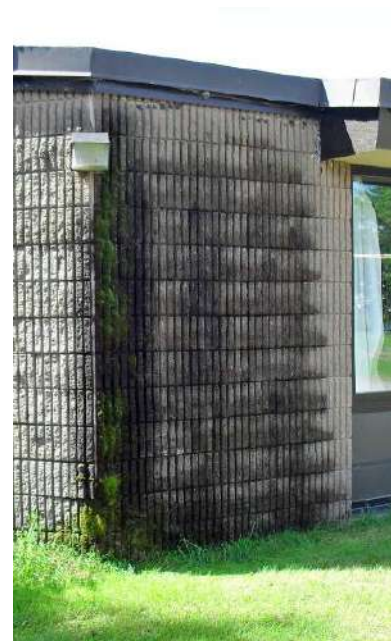
Northeast corner with no sun

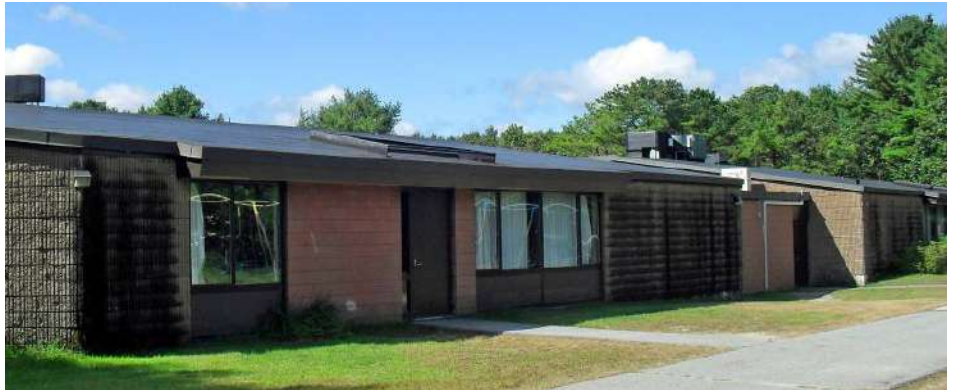
Moisture problem on scored,
split-faced block

No moisture problems on
smooth faced block

Water from roof runs down
face of scored, split-faced
block. Note overhang at
windows and smooth block.

Northeast facing wall with no sun exposure

Drainage from the roof and drainage around the building need to be improved to help eliminate the problems that have been continuing for many years. Issues related to water draining down the face of the building and moisture accumulating at the base of the exterior wall need to be corrected. Removing and replacing the affected concrete masonry may be necessary to eliminate mold issues around the exterior of the building.

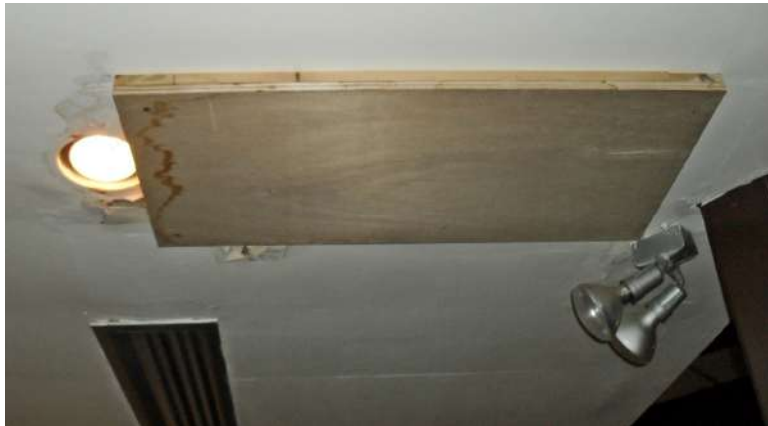
The building has been reroofed since it was originally constructed. The current roof is EPDM and appears to be in relatively good condition, although there was a report of one area leaking in the library.

Water damaged ceiling in Library

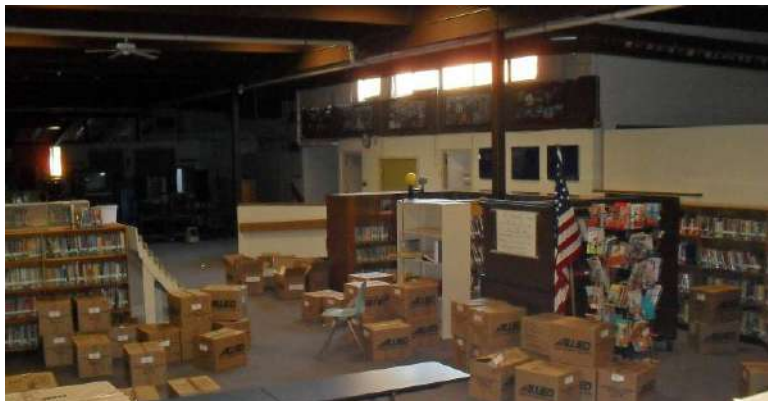
Jordan Acres is a single-story building that is considered reasonably accessible with the main entrance being at grade level and fully accessible. The library, however, at the center of the building is at a lower elevation from the main floor by about 18” but can be accessed by a ramp albeit from one side of the building only. The library also includes a depressed reading area with stepped risers that start flush with the main floor of the library. Each of the amphitheaters is at the same elevation as the main floor of the classrooms but each has three stepped risers. The seating capacity of the amphitheaters does not require distribution of handicap seating among the different levels but access to the amphitheaters is restricted due to inadequate clearances at the doors.

Access to the library is limited to the right side of the building only, meaning a person in a wheelchair would have to travel from the left side of the building through the multi-purpose space to get to the right side of the building in order to use the ramp down into the library. If the building configuration is maintained, an additional ramp should be added to provide access from both sides of the building. General circulation from one side of the building to the other side of the building is also impeded because travel requires going through the multi-purpose space or through the library.

Library is at lower elevation than rest of building. Ramp is behind shelving in center of picture.

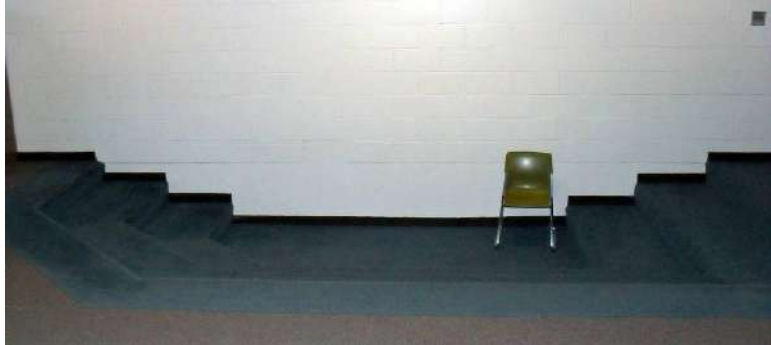
Stepped reading area in Library

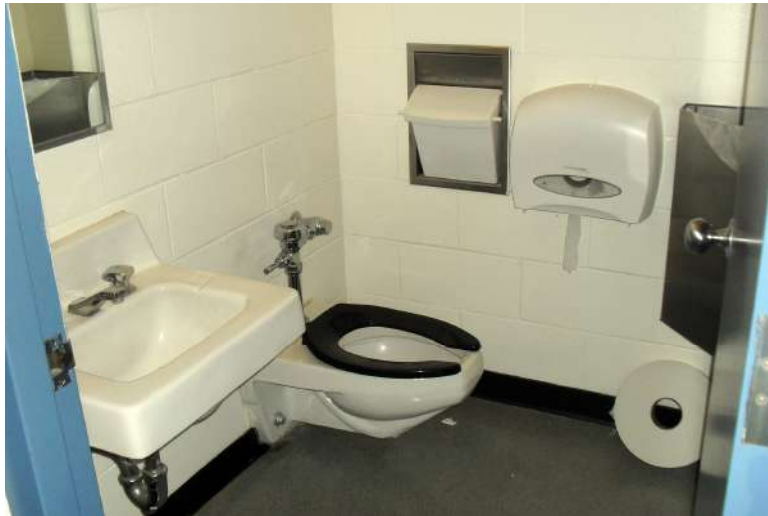
With the exception of one or two toilet rooms, none of the staff or student toilet rooms are compliant with ADA requirements. Even the toilet rooms that have been partially modified are not be fully compliant. All toilet rooms would need to be completely renovated and enlarged to provide proper fixtures and adequate clearances. In lieu of fully renovating all toilet rooms, at least one accessible toilet room per gender should be provided in each wing. However, fully renovating the toilet rooms would also update the plumbing fixtures with water conserving fixtures as described in the mechanical section of this report.

Non-compliant single user toilet room

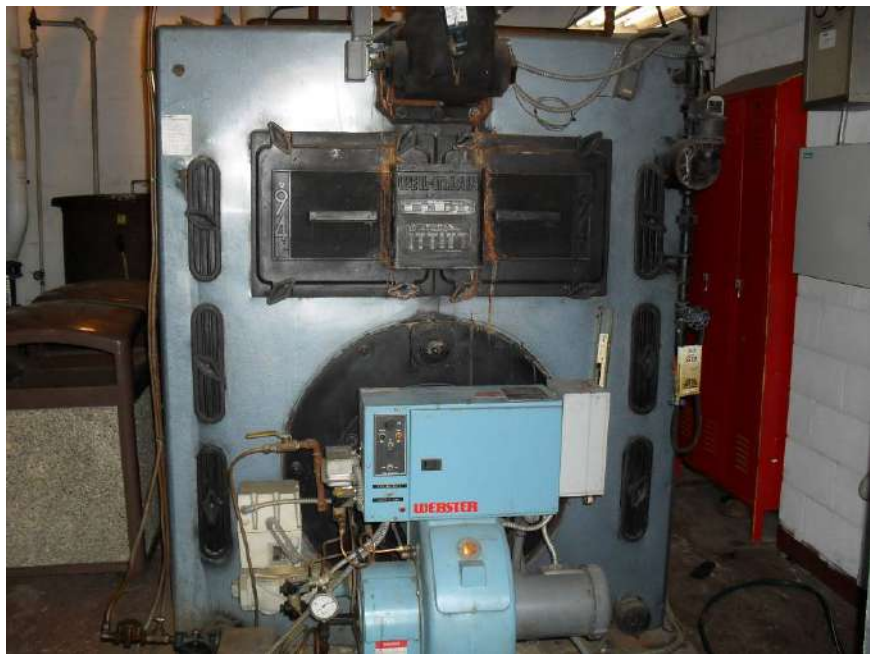
Figure 1 – Cast Iron Boiler

The existing school was built in 1972 and the original boiler is still in place. The main boiler plant consists of a Weil McLain, 16 section, cast-iron boiler. The boiler model is 1694 and has a net capacity of 3,385.1 mbh.

Because the existing cast iron boiler and oil burner is almost 40 years old and clearly showing its age, we would recommend replacing the boiler with a high-efficiency boiler capable of dealing well with low return water temperatures. The removal of this boiler would include all connecting HWS & R piping, induced draft fan, breeching, five horizontal expansion tanks, and oil piping. This replacement type of boiler design would allow us to save significant energy on typical standby losses normally associated with “hot” boilers. New breechings, engineered combustion air system, insulated HWS & R piping, oil piping, expansion tanks and controls would also be included in this installation.

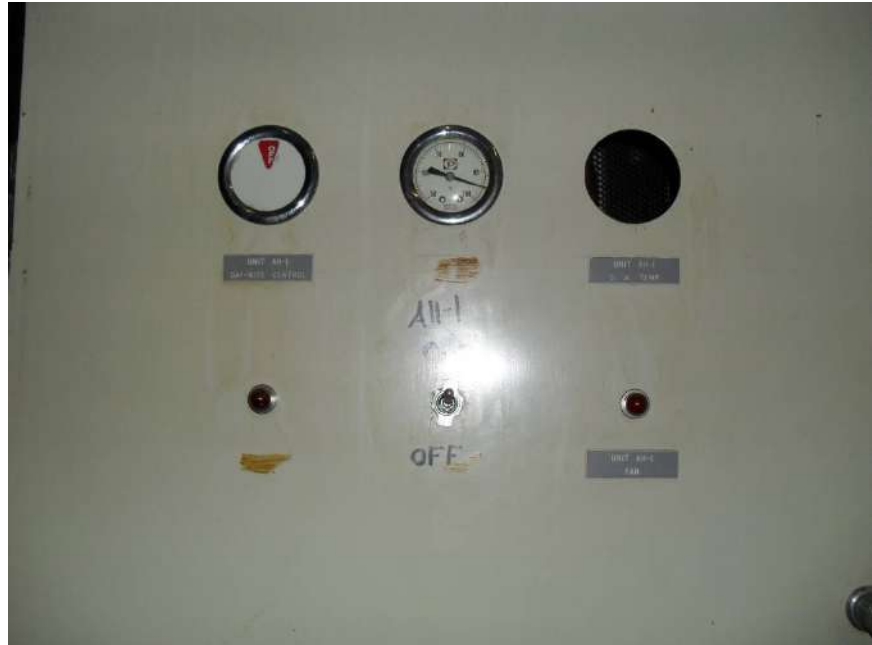
Figure 11 - Pneumatic control panel

The temperature controls in the facility are primarily pneumatic with a bit of updated DDC control as well. It has been reported that this system has not provided consistent temperature control throughout the facility. Some areas are quite warm while others can be quite cool.

The existing pneumatic control system in the facility is also clearly showing its age. Although a pneumatic control system was virtually the only viable control option available when the school was originally designed and constructed, these systems have proven over time to be quite inefficient and difficult to control and maintain. We recommend removing the complete pneumatic control system which includes all controllers, air compressor, dryers, tubing, actuators, sensors and all other associated accessories. A new direct digital control (DDC) will be provided for the entire facility. This control system would be provided by Siemens and would be tied back into the main head end in the Facility Directors office.

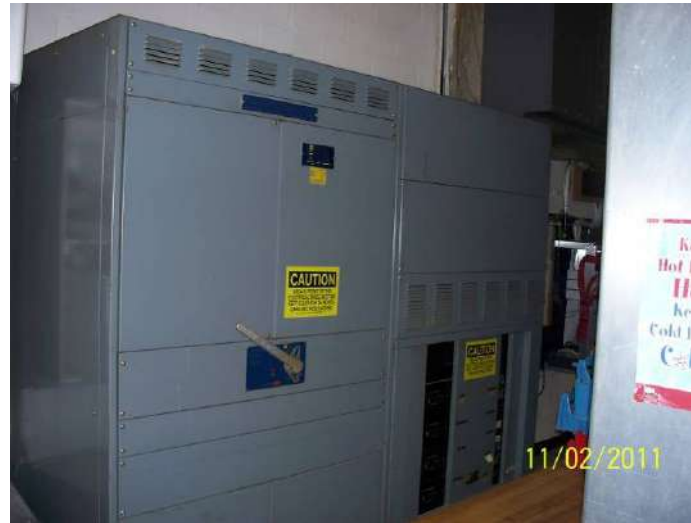
Service Entrance
Switchboard

The electrical service entrance is a Square D 1600 amp, 120/208V, 3Ø, 4W bolted pressure contact switch. Our experience is and the Schneider/Square D website <http://ecatalog.squared.com/pubs/Electrical%20Distribution/Services/1910HO0804.pdf> confirms that periodic maintenance, cleaning and lubrication of a bolted

pressure contact switch is required to provide reliable operation. Failure to properly maintain the switch could result in downtime if operation of the switch is necessary. In many cases, bolted pressure contact switches have been installed without maintenance for many years, and fail to operate properly or re-engage after being de-energized or “shut-off”.

The existing service entrance equipment should be inspected and tested by Square D service technicians to verify condition and proper operation. A shut-down of the service is required for this procedure. This inspection/test costs between \$3,000 and \$5,000. Parts found to be damaged or non-functional are charged separately in addition to the testing fee.

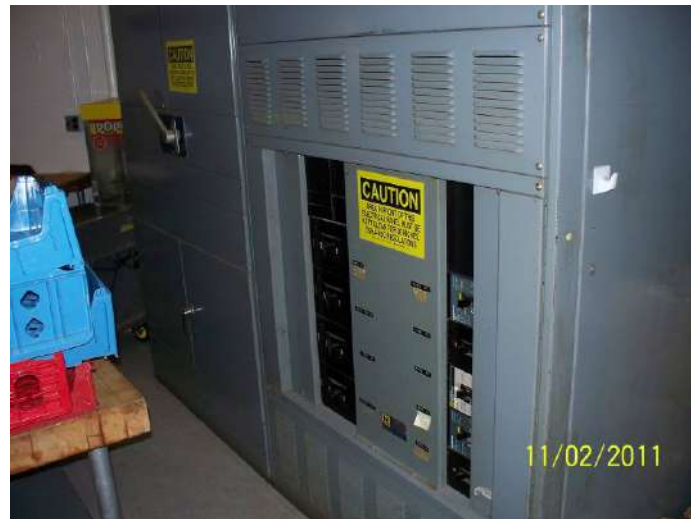
Distribution Section

The main switch and adjacent I-Line distribution section, both rated at 1600A, appear to be “original” equipment (1972 - 40 years), but are in good serviceable condition. The distribution section has a variety of breaker sizes serving the existing sub-panels and some limited space for future breakers.

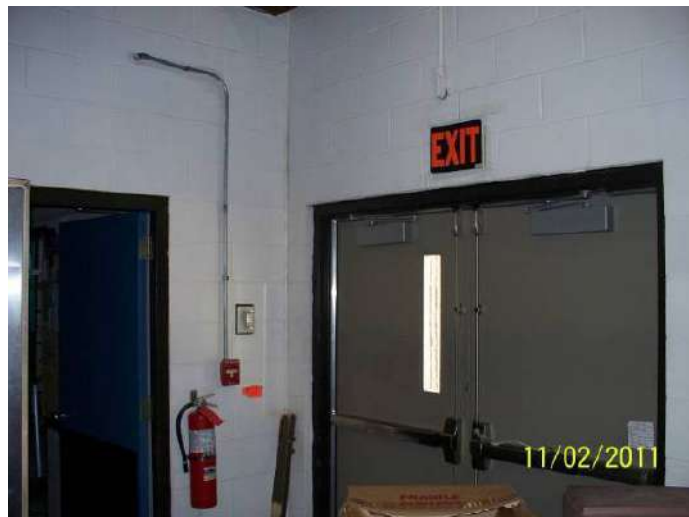
Non-illuminated exit sign

Exit signs appear to have been upgraded with LED retro-fit kits but are not very evenly illuminated and some are in poor condition. This may be of concern to the local code officials. Also, some signs are not internally illuminated and do not have an emergency lighting fixture nearby to illuminate in case of a power outage. It is a code requirement that all non-internally illuminated signs be illuminated with emergency lighting during a power outage. No record of testing of the emergency units was observed. It is very possible that the emergency battery units will not function properly if a strict testing and maintenance policy is not being followed. Also, emergency lighting fixtures are spaced such that they will not provide an average of 1 fc throughout all paths of egress.

All battery units should be tested to verify proper operation. Internally illuminated exit signs should be added at all required egress doors and units that are in poor condition should be replaced. Emergency lighting units should be added so that all paths of egress are properly illuminated.

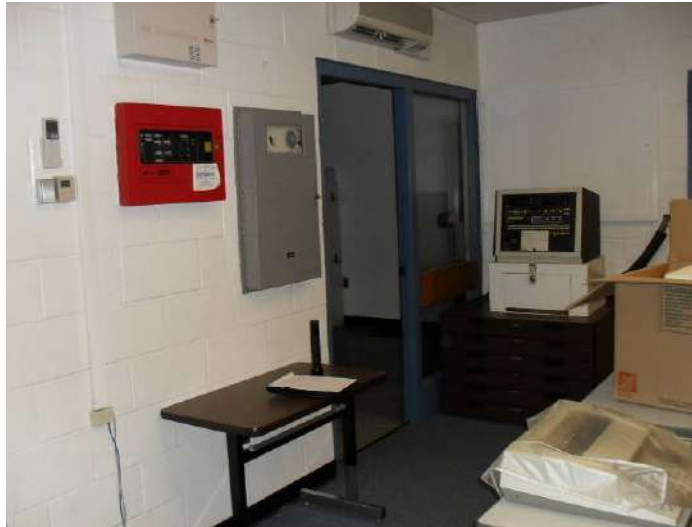
The fire alarm control panel is a Simplex 2001 and is located in the Main Office, it appears to be original equipment (1972 – 40 years). This system communicates with Seacoast Security using a Silent Knight dialer (located near the Electrical Service Entrance). If/when an alarm condition is reported Seacoast contacts the Brunswick Fire Department. There are smoke detectors throughout the corridors and spaces that are open to corridors. Heat detectors are installed in private offices and other storage type spaces. There are pull stations located at all egress doors. Audio/visual devices are located throughout the school.

Fire alarm control panel
In Main Office

The fire alarm control panel is now obsolete and is no longer supported by the manufacturer. Although, additional audio/visual devices have been added since the school was built there are some locations that are not properly covered. This system is beyond its life expectancy and should be replaced.

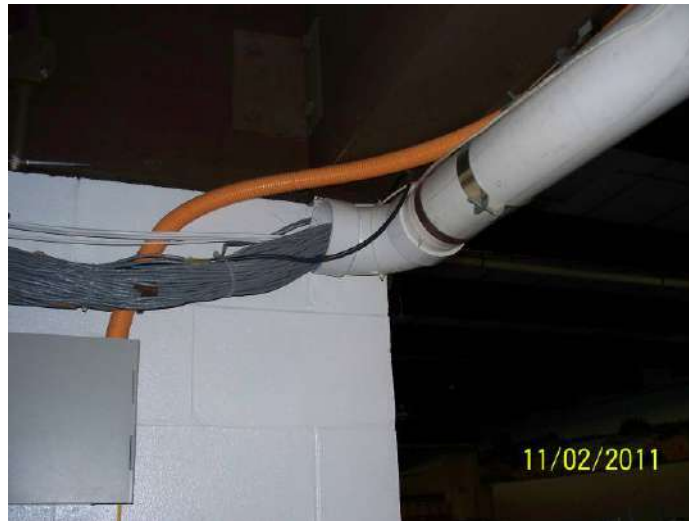
Data Cabling run in
DWV pipes

The existing phone system appears relatively new and functional, however the phone wiring is in worse condition. Most if not all cables are run in surface raceways, with many not extended completely to the point of use. Data cabling has been run through the “Open Concept” space in drain waste and vent pipe. This is not a proper use for this “piping system”. Conduit rated for electrical cables should be used. Also, it appears that most spaces are lacking sufficient “drops” for telephone and data when compared to modern schools.

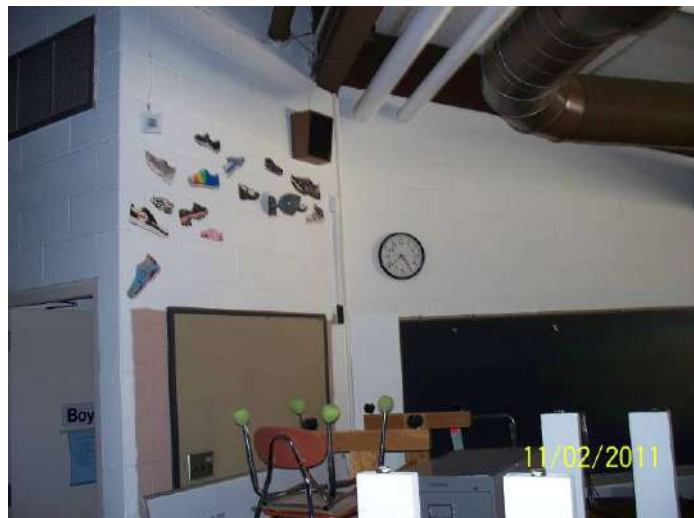
4:40 – Not working

Clocks throughout the school indicate a different time, some may be controlled by the central system whereas others are not.

The existing system should be removed and replaced with a new system if it is deemed necessary to have a central clock system in the building.

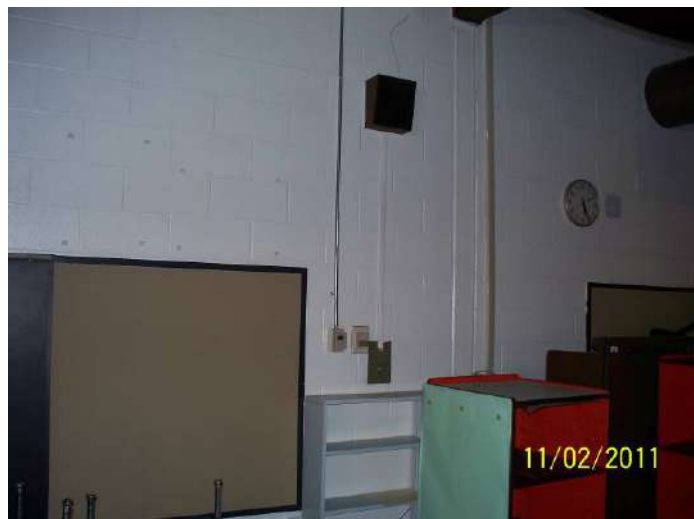
5:25 – Not working

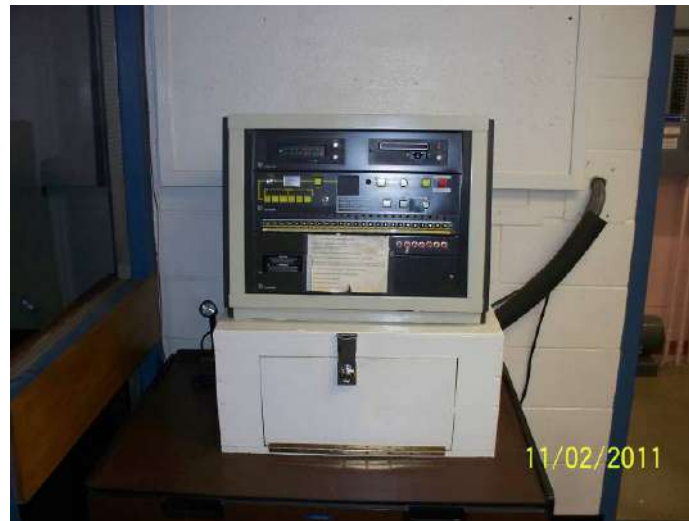
Main Console

The existing Dukane Intercom system is beyond its useful life and much of the surface wiring to the speakers is susceptible to damage. Dukane no longer manufactures parts for switch-bank type systems, therefore, any repairs requiring parts could lead to lengthy down time. Spare parts come from “old stock” and salvaged parts from old consoles.
