## Structural Distress Evaluation

**PROJECT FILE NO.**  
19828

**CLAIM NO.**  
E7K5861

**STRUCTURE IDENTIFICATION**  
Linderman Gymnasium  
Western States School Program  
312 4<sup>th</sup> Avenue East  
Polson, Montana 59860

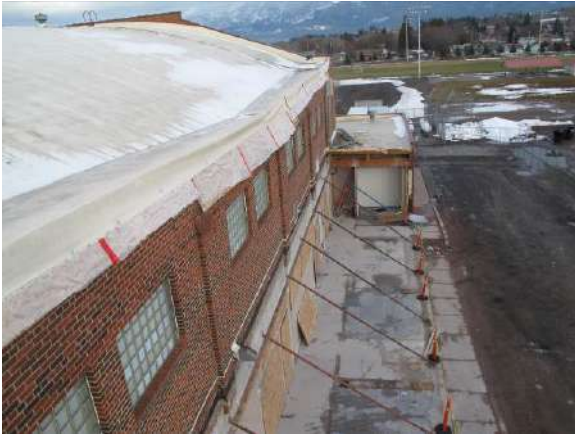
- ❑ Missing portion of the one-story structure along the south wall of the gymnasium (**Figure 5**);
- ❑ Missing parapet wall at the south side of the gymnasium roof, with tarps covering the openings in the wall where the parapet was located (**Figure 6**);

**Figure 5:** Missing portion of structure at south side of gymnasium

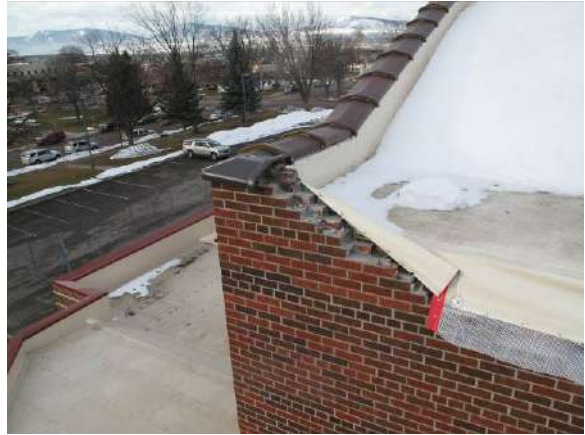
**Figure 6:** View of parapet wall at southwest corner of gymnasium roof

In Nelson's opinion, the collapse of the south parapet wall, outward lean of the south masonry wall, and the fractures/separations in the masonry wall mortar joints are the result of overturning of the south masonry wall as the result of snow movement during recent snow storm events. Weather data indicates that snow accumulation likely occurred at the roof in conjunction with winds originating from the north prior to the reported date of loss. The slope of the barrel-vaulted roof in conjunction with the aforementioned winds would have caused southward movement of the snow, applying horizontal, out-of-plane forces at the parapet wall. Overturning occurs when these horizontal loads impose an out-of-plane rotational force (overturning moment) which is greater than the element is capable of resisting. At brick masonry elements such as the gymnasium's south brick masonry wall, overturning moments induce tensile stresses, which are typically resisted by reinforcing bars spaced at regular intervals in the brick masonry wall. However, no reinforcement was observed by Nelson at the remaining top portion of the masonry wall. As a result, the tensile forces from the overturning moment were resisted by the bond of the brick masonry mortar, which is relatively weak in tension. The tensile forces from the aforementioned snow movement induced overturning moment exceeded the capacity of the mortar, which caused the outward lean of the wall, the observed fractures/separations at the mortar joints adjacent to the structures southeast corner, and the subsequent collapse of the parapet wall.

Nelson recommends removal and resetting of the south masonry wall that is still in place and replacement of the brick masonry where collapse of the parapet wall occurred.

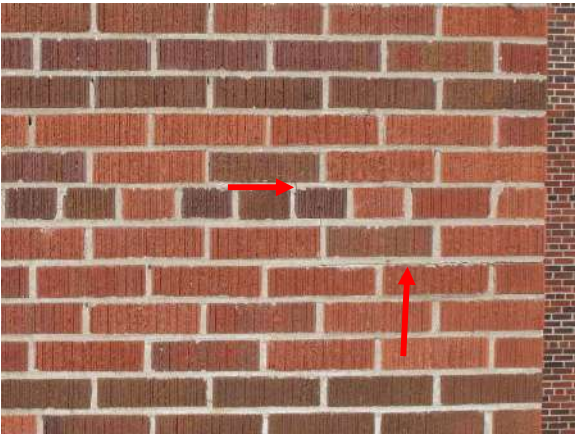
- ❑ No visible reinforcement at the top portion of the south masonry wall still in place;
- ❑ Stair-step separations in the mortar joints at the east and south exterior walls, at the gymnasium's southeast corner. The separations were located just below the parapet wall location and at the same approximate level as the upper gymnasium windows (**Figure 7**);

**Figure 7:** Close-up view of stair-step separations in mortar joints at south wall, southeast corner (annotated by Nelson)

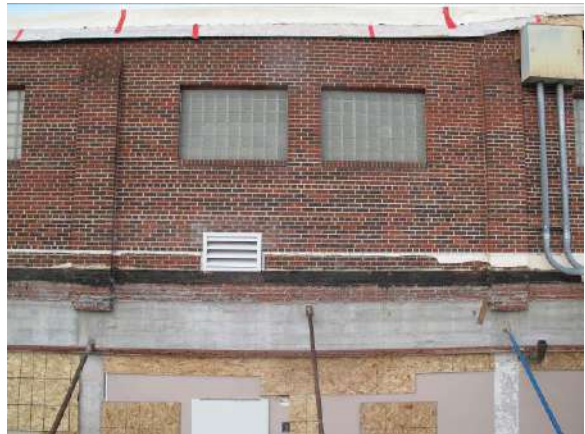
- ❑ Exposed concrete columns and beam at the location of the missing one-story structure (**Figure 8**);
- ❑ Fractures in the exposed concrete beams. The fractures were vertically and diagonally oriented, evenly spaced between the columns, and discontinuous. Additionally, the fractures were wider at the top of the beams (**Figures 9-10**);

**Figure 8:** Exposed concrete columns and beam near southeast corner of gymnasium

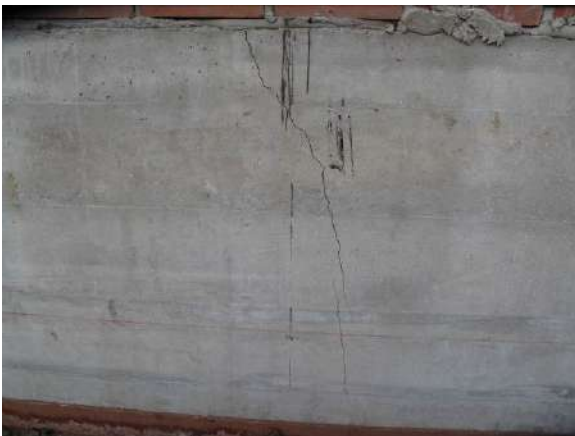
**Figure 9:** View of fracture in exposed beam near east end of south gymnasium wall

In Nelson's opinion, the fractures and out-of-plumbness measurements at the south concrete beams are unrelated to the aforementioned snow event and outward lean/collapse of the south brick masonry wall. Roof loads such as from the accumulation of snow at the parapet wall are carried by the concrete columns, not the beams. Reviewed information indicates that the beams are unreinforced, making them susceptible to cracking from shrinkage and thermal movement. Further, the observed fractures are not consistent with overstressing of the beams as the result of vertical loading or twisting of the beam as the result of outward movement of the supported masonry. The out-of-plumbness measurements are consistent with as-built conditions and not outward movement of the supported masonry wall. If the out-of-plumbness measurements had been the result of movement of the south wall, Nelson would have expected corresponding out-of-plumbness measurements at the columns. Additionally, Nelson observed that the level rocked about the centerline of the beam when plumbness measurements were obtained at the beam locations, which is characteristic of inadequate forming construction when the concrete for the beams was placed. Inadequate construction of the concrete forms for the beam would have allowed concrete pressures during placement of the concrete to rack the forms, resulting in the observed out-of-plumbness measurements.

While unrelated to recent snow storm events and the outward lean/collapse of the south masonry wall, the concrete beams should be retrofitted with reinforcement to prevent further exasperation of the observed fractures and/or additional fracturing from occurring. The installation and proper attachment of a steel member, such as a steel channel, to the north and south sides of the concrete beams is a potential method of retrofit reinforcement of the beams. The steel member and corresponding attachment should be designed by a design professional licensed in the state of Montana.

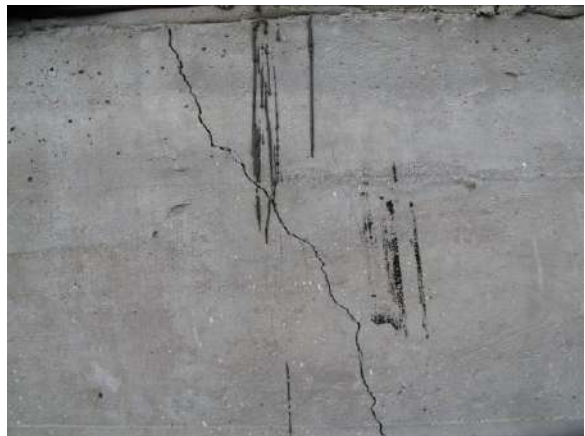
**Figure 10:** Closer view of top portion of fracture shown in Figure 9

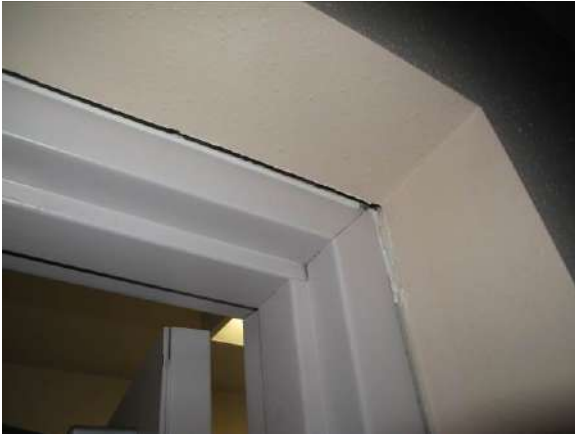
- Door frame/wall interfaces at the southeast classroom, custodial room, and northeast entryway (**Figure 11**);
  - Two of the windows along the east library wall;

**Figure 11:** Separation at door frame/wall interface at doorway to southeast classroom

In Nelson's opinion, the fractures/separations observed at door and window opening locations, ceiling finishes, and wall-to-wall interfaces are unrelated to the aforementioned snow event and outward lean/collapse of the south brick masonry wall. The aforementioned distress locations were isolated from one another and were not in direct proximity to the south brick masonry wall. Additionally, there is no clear load path connecting the observed distress to the outward lean/collapse of the south masonry wall.

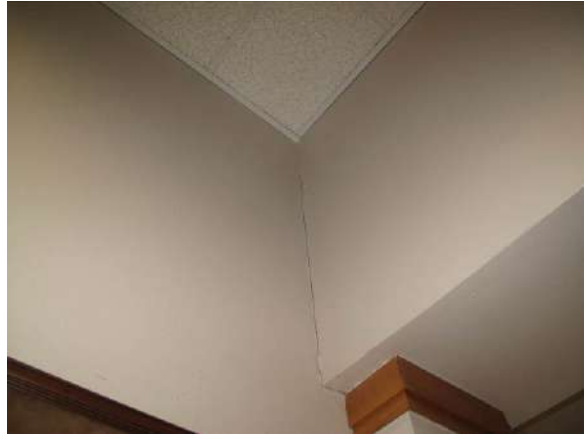
- In the field of and at a wall-to-wall interface at the west library wall (**Figure 12**);
  - CMU wall/gypsum board wall interface at the south wall of the northeast locker room;

**Figure 12:** Wall-to-wall separation at west library wall

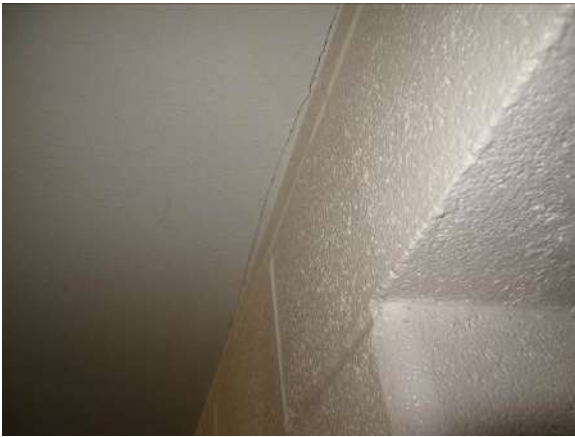
- Ceiling adjacent to northwest locker room shower (**Figure 13**);
  - Interior concrete column for the bleachers and masonry wall interface at the northwest and southwest corners of the gymnasium (**Figure 14**);

**Figure 13:** Fracture in ceiling finishes adjacent to showers of northwest locker room

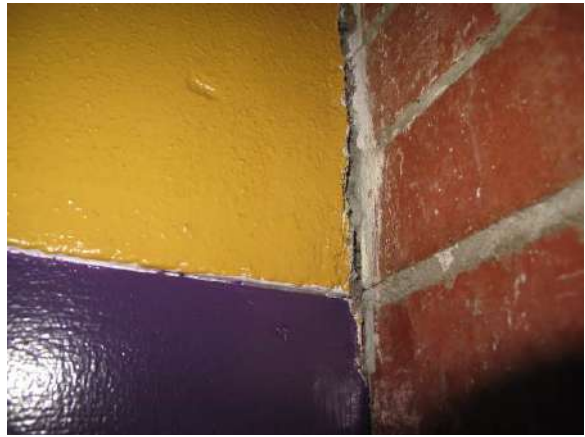
**Figure 14:** Separation at concrete column/masonry wall interface, southwest corner of gymnasium

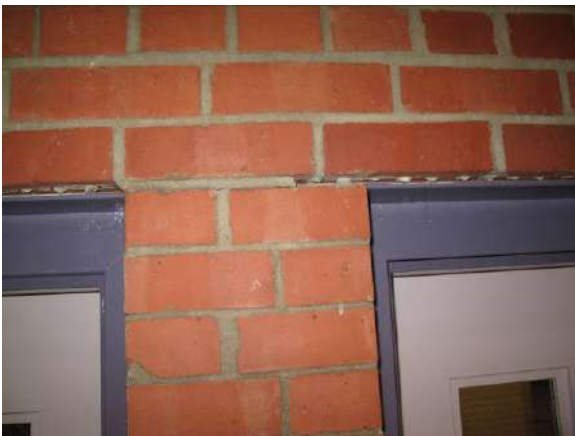
- Steel lintel/masonry interface over the west gymnasium doors (**Figure 15**);
- ❑ Stair-step mortar joint separations and fractures in the brick masonry at the east gymnasium wall, adjacent to the southeast corner. The fractures/separations corresponded to the location of the aforementioned exterior mortar joint separations (**Figure 16**);

**Figure 15:** Separations at lintel/masonry interface of south doorways, west gymnasium wall

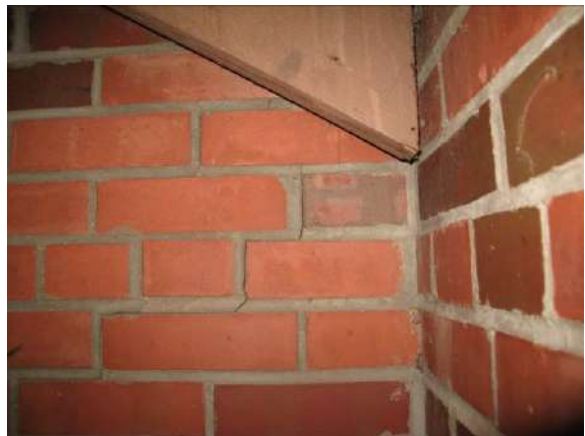
**Figure 16:** Stair-step mortar joint separations at east wall, southeast corner of gymnasium

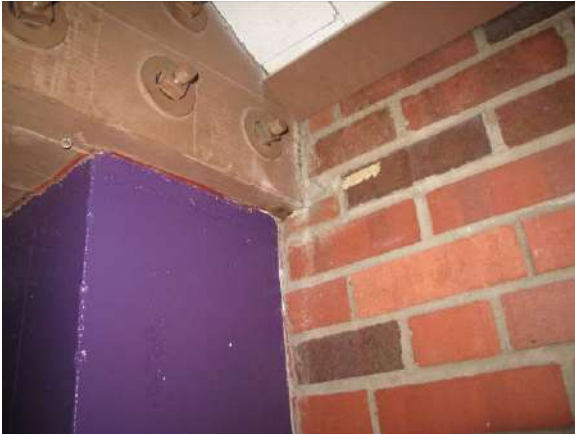
- ❑ No visible separations at the south masonry/exterior column interfaces;
- ❑ Unpainted wood at the roof truss bottom chord/masonry interfaces. This condition was observed at the north and south ends of the first, fourth, and fifth trusses from the east gymnasium wall. There were no abrasions in the unpainted wood and the wood was aged in appearance (**Figures 17-18**);

**Figure 17:** Unpainted wood at south end of truss bottom chord, first truss from east gymnasium wall

In Nelson's opinion, the unpainted/exposed wood at the ends of some of the trusses is unrelated to outward lean/collapse of the south brick masonry wall. If the aforementioned condition had been the result of movement of the masonry wall, Nelson would have expected to observe unpainted/exposed wood to be isolated to the south end of the trusses and be present at all truss locations. Nelson would have also expected to see abrasions in the unpainted/exposed wood if movement of the masonry wall/trusses in relation to one another had occurred. The exposed unpainted/exposed wood is at both ends of the affected trusses, which is consistent with inward movement of the truss heels. Long-term deflection of the trusses and/or slip of the mechanical connections at splice locations would have caused/allowed the aforementioned inward movement to occur. Additionally, the trusses are located adjacent to the east and west parapet walls and are more susceptible to drift loads. Repeated loading and unloading of the trusses due to multiple snow events since the construction of the gymnasium would have contributed to long-term deflection of the affected trusses.

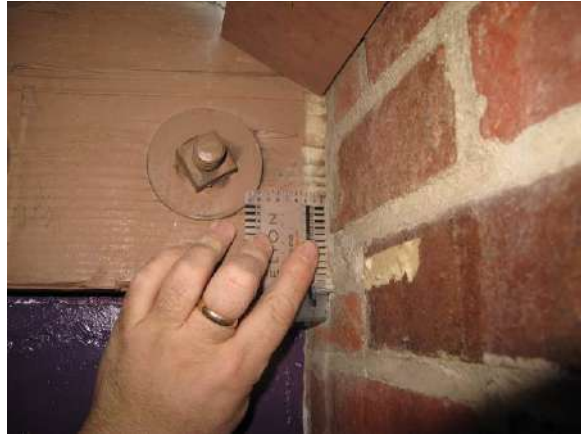
**Figure 18:** Closer view of unpainted wood shown in Figure 17

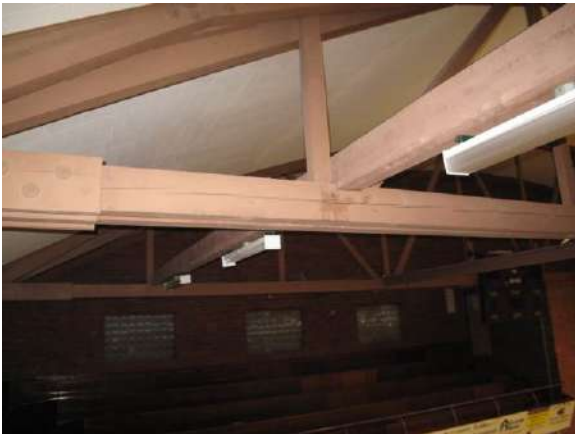
- ❑ Checking in the bottom chord of the fourth truss from the east wall, with paint within the separations (**Figure 19**);
- ❑ Moisture-stained ceiling tiles at multiple locations along the north and south walls of the gymnasium (**Figure 20**).

**Figure 19:** Checking in bottom chord of fourth truss from east wall

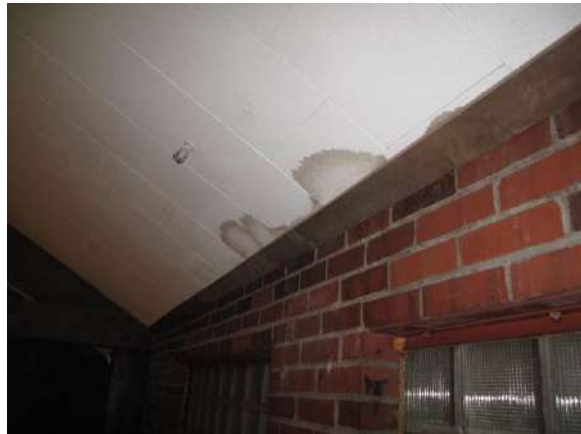
**Figure 20:** Moisture-stained ceiling tiles along south gymnasium wall

In Nelson's opinion, the moisture stains at the gymnasium ceiling are the result of the south parapet wall collapse. The roofing membrane would have been anchored to the inside face of the parapet wall and would have been pulled by the parapet wall as it leaned outwards and when it eventually collapsed. This would have allowed the roofing membrane to tear as tensile forces from the parapet wall movement exceeded the capacity of the membrane. Further, Nelson's review of received information indicates that tears were observed in the roofing membrane after out-of-plane movement of the south parapet wall was first observed. Tears in the roofing membrane as the result of movement of the south masonry wall would create openings in the gymnasium's roof, and would provide a direct pathway for moisture to the gymnasium's interior.

After remediation of the south masonry wall has been completed, the roofing membrane should be evaluated to determine whether the membrane can be repaired or should be replaced.

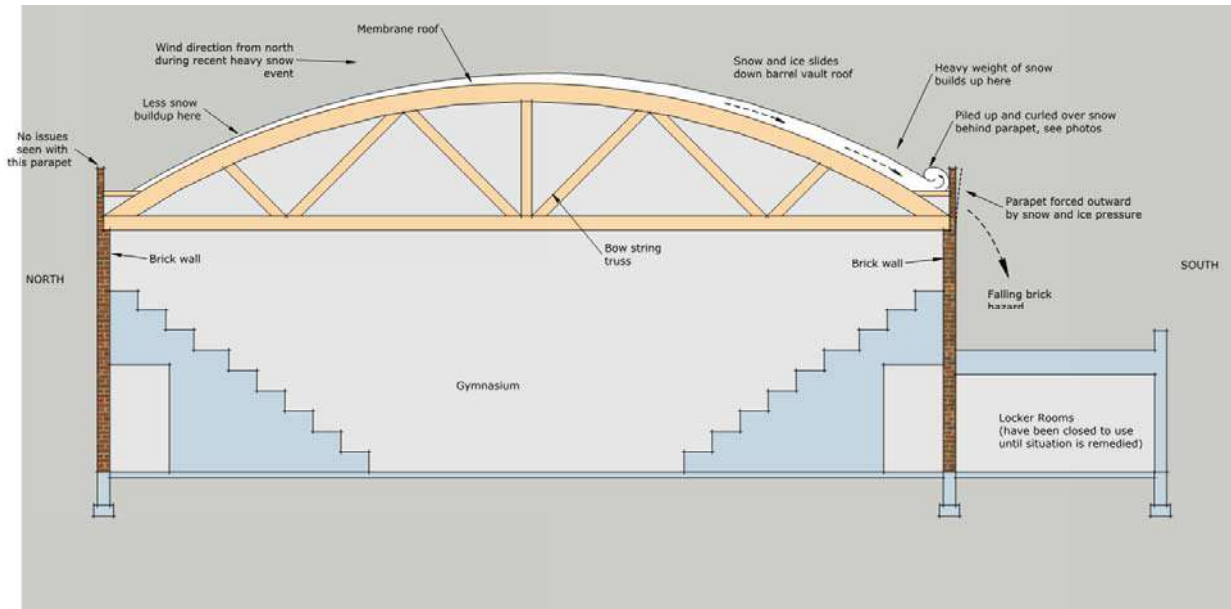
**Figure 21:** Building section showing Paradigm's opinions regarding cause of outward bowing of south parapet wall (Paradigm 2018)

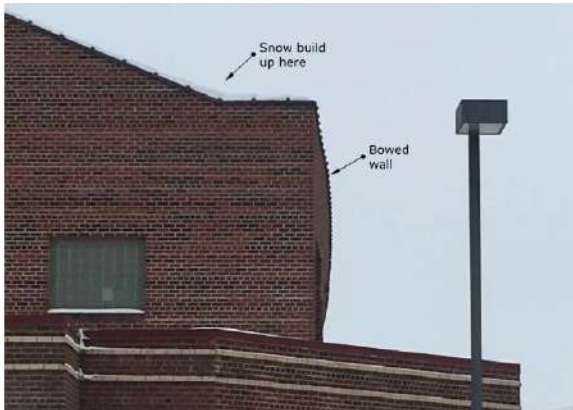
**Figure 22:** Paradigm photograph showing outward bow at parapet wall (Paradigm 2018)

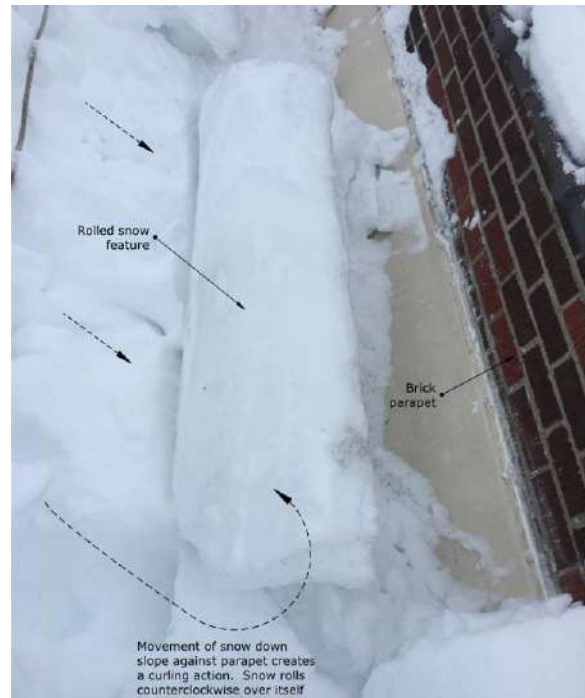
**Figure 23:** Paradigm photograph showing "curling action" of snow at parapet wall (Paradigm 2018)
