## Structural Distress Evaluation

**PROJECT FILE NO.**  
19828

**STRUCTURE IDENTIFICATION**  
Linderman Gymnasium  
312 4<sup>th</sup> Avenue East  
Polson, Montana 59860

At your request, Nelson Forensics, LLC (Nelson) is issuing this report as a supplement to Nelson's *Structural Distress Evaluation*, dated March 2, 2018 (Report 1). The opinions in Nelson's Report 1 remain unchanged.

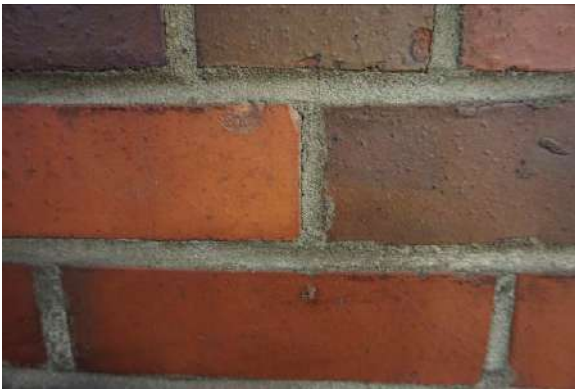
- ❑ Isolated linear mortar joint separations in the fields of the brick masonry walls (**Figure 1**);
- ❑ Separations in the mortar joints at the interfaces of some of the north concrete columns and the adjacent masonry wall. The separations were aged and rounded in appearance and did not extend down the full length of the interface (**Figures 2-3**);

**Figure 1:** Isolated linear fracture in field of east masonry wall

In Nelson's opinion, the fractures/separations indicated by Mr. Wright at the masonry elements are not indicative of lateral movement of the gymnasium, nor are they the result of the south parapet wall collapse on the reported date of loss. The fractures/separations were isolated, linear in shape, and discontinuous, which are not consistent with lateral movement of a brittle structure such as an unreinforced masonry wall. Nelson would have expected to observe stair step fractures at or adjacent to the reported locations of distress had the reported distress been the result of lateral movement of the gymnasium. The isolated and discontinuous nature of the fractures/separations are consistent with drying shrinkage of the mortar and/or normal volumetric changes (i.e., thermal expansion/contraction between dissimilar elements).

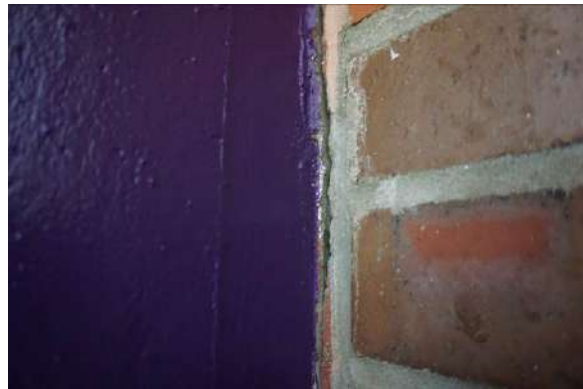
**Figure 2:** Separation in mortar joint at north concrete column/masonry wall interface

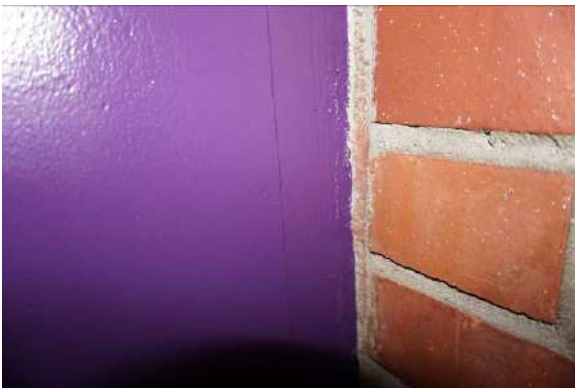
**Figure 3:** No separation in mortar joint directly below separation shown in Figure 2

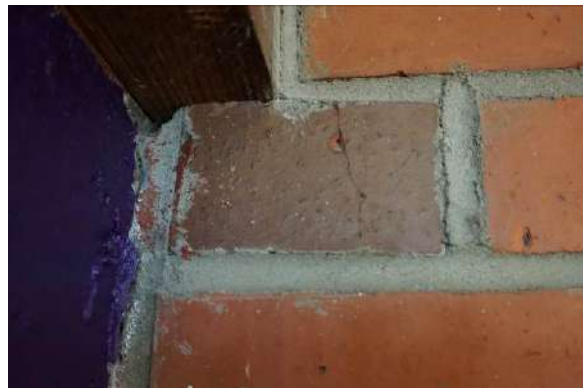
- ❑ Isolated fracture in a masonry brick adjacent to a north concrete column. The fracture did not extend to the adjacent mortar joints or bricks (**Figure 4**);

**Figure 4:** Isolated fracture in masonry brick adjacent to north concrete column

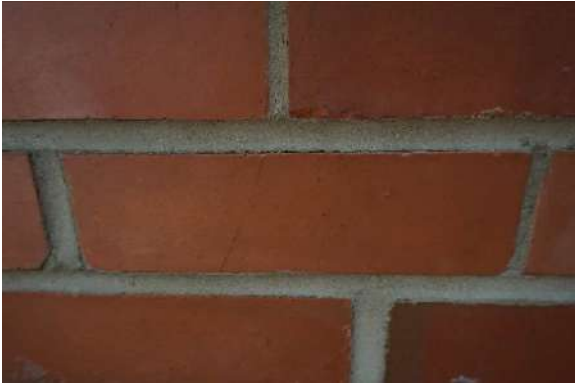
- ❑ Discontinuous and isolated separations in the mortar joints below the windows in the north masonry wall (**Figure 5**);
- ❑ Isolated stair step fracture in the mortar joints below the bleachers at the north portion of the west masonry wall. The stair step fracture did not continue up above the bleachers;

**Figure 5:** Discontinuous/isolated separation in horizontal mortar joint below east window in north masonry walls

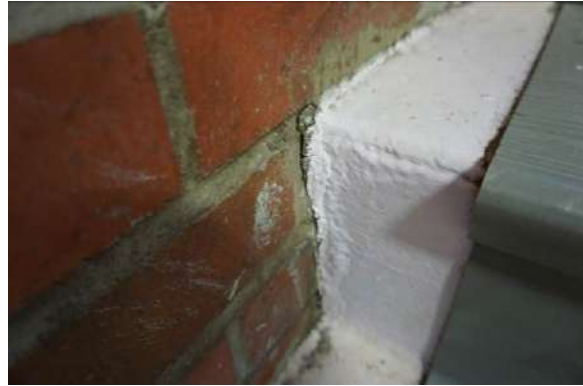
- ❑ Discontinuous separations at the interfaces of the concrete bleacher stairs and the adjacent masonry walls (**Figure 6**);
- ❑ Separations at the interfaces of the CMU infill wall and the adjacent brick masonry columns at the gymnasium's east wall (**Figure 7**);

**Figure 6:** Discontinuous separation at interface of concrete stair/masonry wall at southeast corner of gymnasium

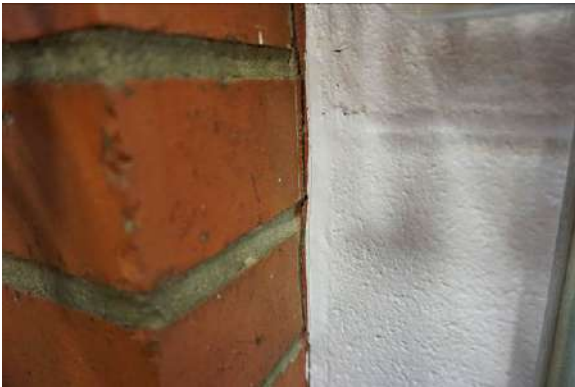
**Figure 7:** Separation at interface of brick masonry column/CMU wall

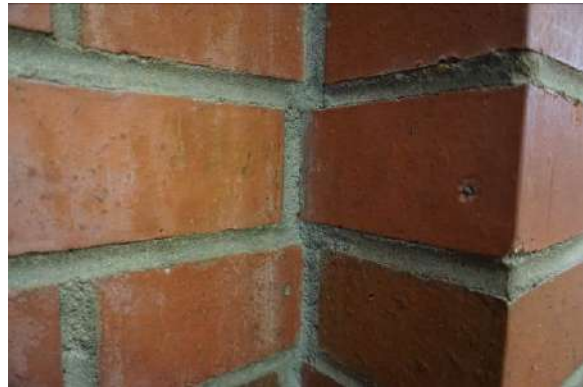
- ❑ Discontinuous separations at the interfaces of the aforementioned brick masonry columns and the adjacent brick masonry walls (**Figure 8**);
- ❑ Discontinuous separations at the interfaces of the west exterior masonry wall and the east/west oriented interior masonry walls (**Figure 9**);

**Figure 8:** Condition of brick masonry column/adjacent wall interface opposite side of column shown in Figure 7

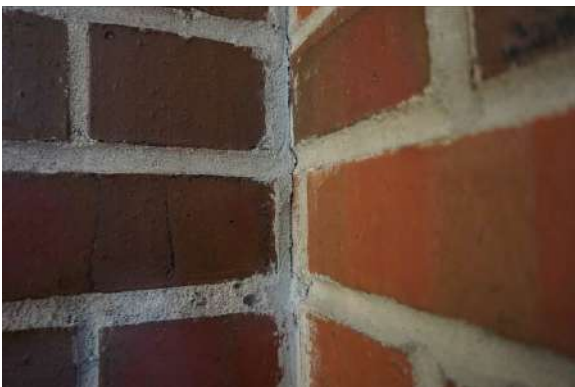
**Figure 9:** Discontinuous separation at interface of west exterior masonry wall and interior masonry wall

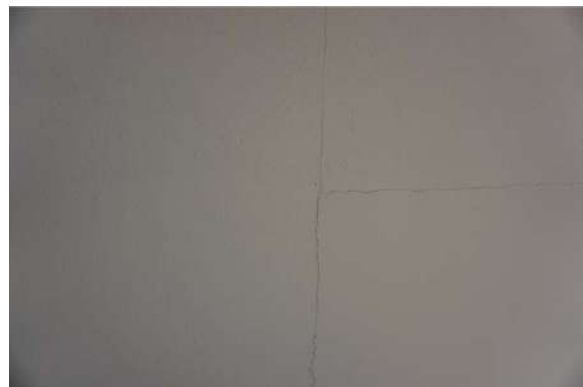
- ❑ Evenly spaced separations in the gypsum board ceiling finishes at the hallway located at the south side of the gymnasium. The separations created 90 degree corners where they intersected (**Figure 10**);

**Figure 10:** Separations in gypsum board ceiling finish at east end of south hallway

In Nelson's opinion, the fractures/separations in the ceiling and wall finishes at the south hallway and music room are not indicative of lateral movement of the gymnasium. The pattern of distress at the ceiling and the isolated diagonal fracture in the wall finishes are not characteristic of lateral structural movement. Had lateral movement occurred, Nelson would have expected to observe separations at the ceiling/wall interfaces in conjunction with the observed ceiling finish distress and fractures in the wall finishes at multiple wall opening locations.

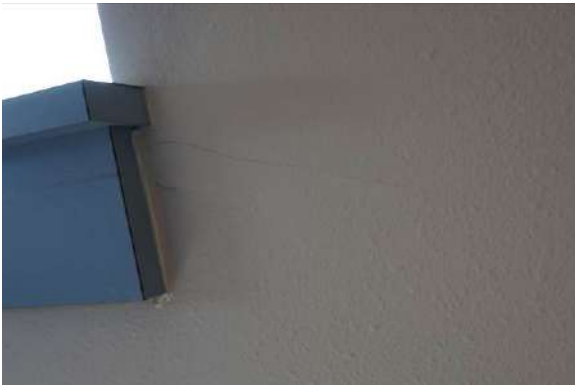
- ❑ Isolated diagonal fracture in the wall finishes at the bottom right-hand corner of a south-facing window at the music room (**Figure 11**);

**Figure 11:** Isolated diagonal fracture in wall finishes at bottom right-hand corner of south-facing music room window

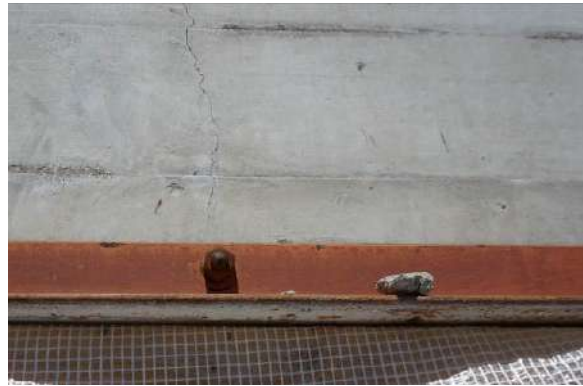
- ❑ Vertically and diagonally oriented, evenly spaced, and discontinuous fractures in the exposed concrete beams at the south elevation. The fractures were coincident with angle ledger anchors at some isolated anchor locations. Where the fractures were coincident with anchors, the fractures did not continue into the portion of the concrete beam below the ledger (**Figures 12-13**);
- ❑ No displacement of or wrinkles in the thermoplastic membrane at the location of the missing south parapet wall (**Figures 14-15**);
- ❑ Localized tears in the thermoplastic membrane at holes along the south edge of the membrane. The holes correspond to the locations of the anchors for the parapet termination bar (**Figure 16**).

**Figure 12:** Vertical, discontinuous fracture in concrete beam coincident with ledger anchor

In Nelson's opinion, the fractures in the south concrete beams are unrelated to the parapet wall collapse on the reported date of loss. As indicated in Report 1, the fractures in the concrete beams are characteristic of cracking as the result of shrinkage and thermal movement, and not consistent with an impact load as the result of the parapet wall collapse. Had the fractures been the result of the aforementioned impact load, Nelson would have expected to see a concentration of fractures at the ledger anchors adjacent to the impact location. Additionally, Nelson would have expected the fractures to extend downward from the anchor points to the bottom of the beams.

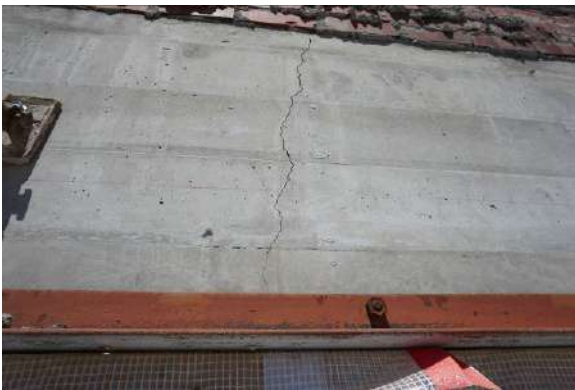
**Figure 13:** Fracture in concrete beam between ledger anchors

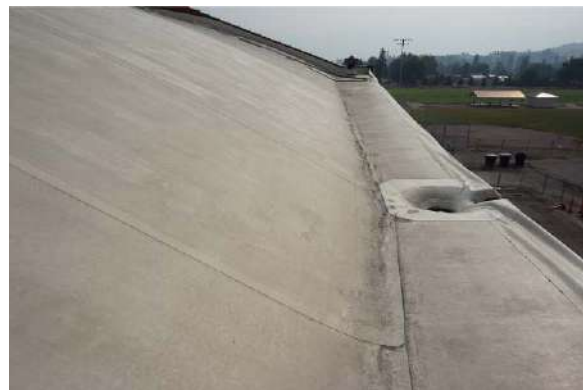
**Figure 14:** View of thermoplastic membrane at location of missing/collapsed parapet

In Nelson's opinion, the parapet wall collapse on the reported date of loss did not result in the application of an impact load on the bow-string trusses. If a tensile load in the thermoplastic membrane had resulted in the aforementioned impact load, as reported by Mr. Wright, the thermoplastic membrane would have been pulled taut. This would have resulted in upward displacement of the membrane at the roof's south edge due to the geometry of the roof as shown in **Figure 14**. Once the parapet wall pulled free from the membrane, the membrane would have relaxed. However, it is unlikely that the membrane would have returned to its original installed location and Nelson would have expected areas of displaced and/or wrinkled membrane along the roof's south edge. Additionally, upward displacement of the membrane would have resulted in tearing of the membrane at roof penetrations. However, the aforementioned conditions were not observed by Nelson at the subject structure's roof. Nelson's observations indicate that tears in the thermoplastic membrane were limited to the anchor hole locations, where the membrane would have been attached to the parapet wall. This indicates that the membrane failed at the parapet connection and further corroborates that no tensile loads was transferred into the field of the thermoplastic roof as a result of the parapet wall collapse.

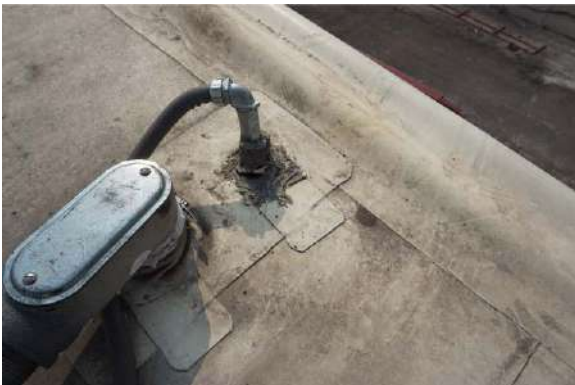
**Figure 15:** Condition of thermoplastic membrane at pipe penetration at roof edge shown in Figure 14

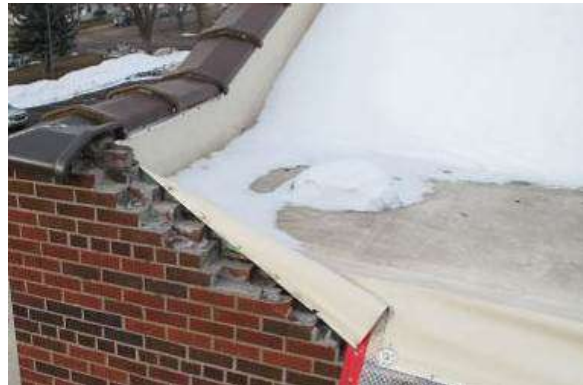
**Figure 16:** Tears in thermoplastic membrane at holes along south edge of membrane
