FACILITY STUDY REPORT

WHITEFORD AGRICULTURAL SCHOOLS **ELEMENTARY + MIDDLE/HIGH SCHOOLS** 6655 CONSEAR ROAD OTTAWA LAKE, MI 49267

Presented by:
JAMES S. JACOBS ARCHITECTS, PLLC.

Report Date:
January 14, 2018

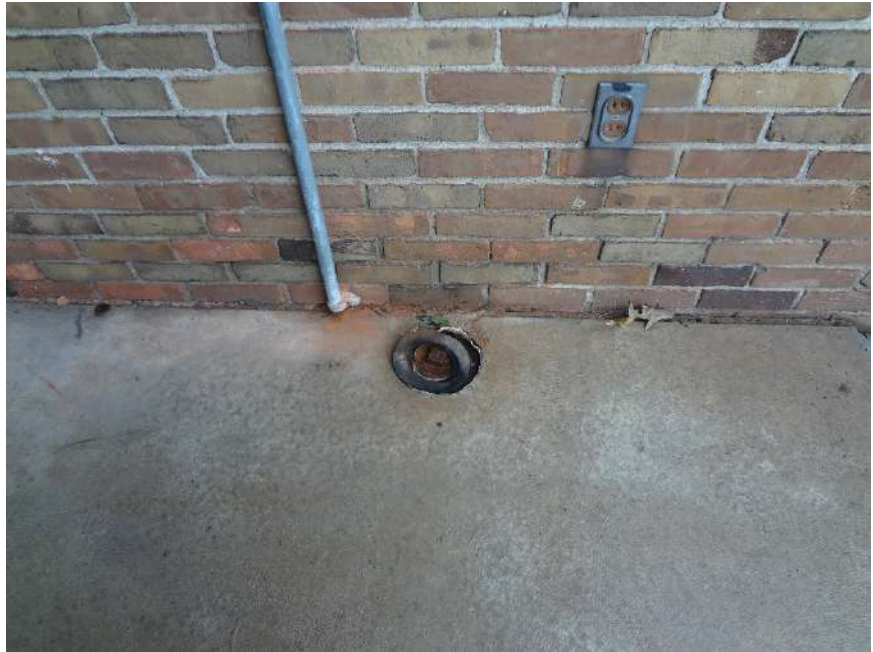
1. CLEANOUT CASKET DRYROTTED + DISLODGED FROM CONCRETE ENCLOSURE
- REPLACE RUBBER GASKET AND PROVIDE CLEANOUT COVER

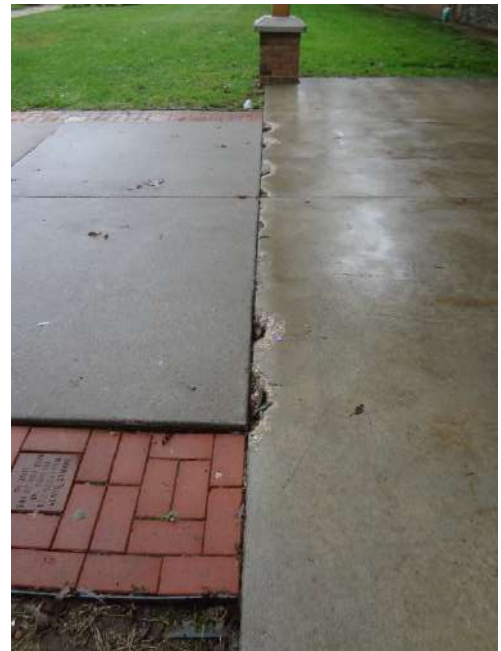
2. BROKEN CONCRETE ENTRY SLAB @ CONCRETE SIDEWALK - MAIN ENTRY
- REPLACE BROKEN CONCRETE

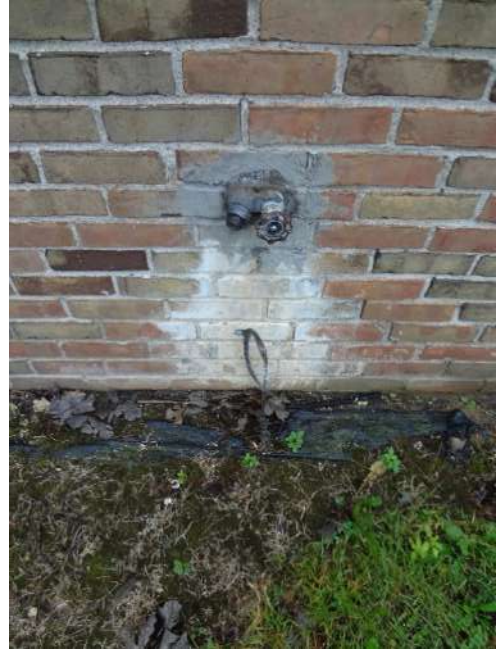
3. EXTERIOR WATER BIB, RESIDUE ON FACE OF BRICK INDICATES LEAKING WATER
 - CLEAN ORGANIC MATTER FROM BRICK, INSPECT WATER BIB AND REPAIR AS REQUIRED

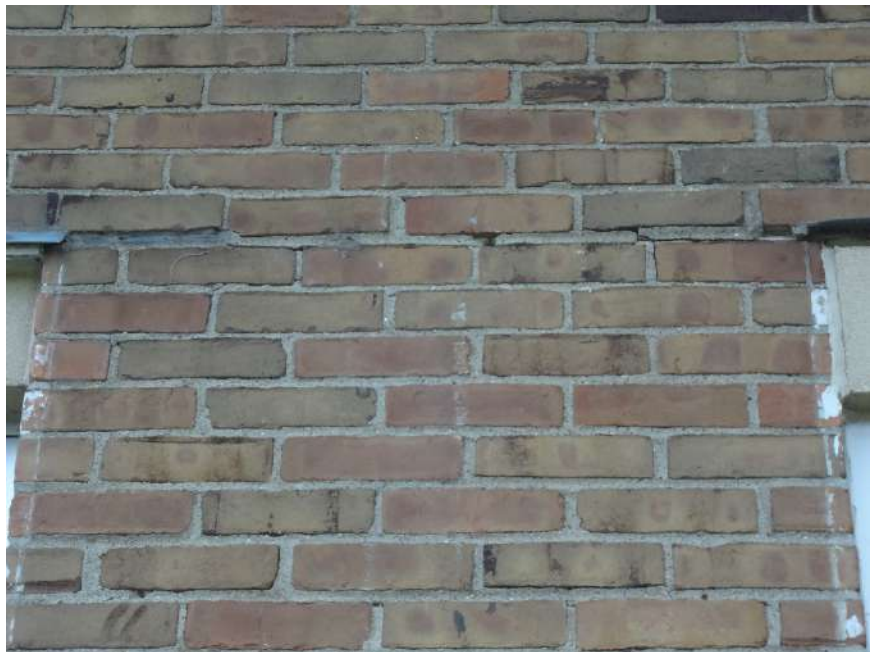
4. ERODED + LOOSE GROUT, TYPICAL AT DOOR + WINDOW FLASHING
 - CLEAN & REPOINT MASONRY AS NEEDED FOR DAMAGED JOINTS. INSPECT ANNUALLY.

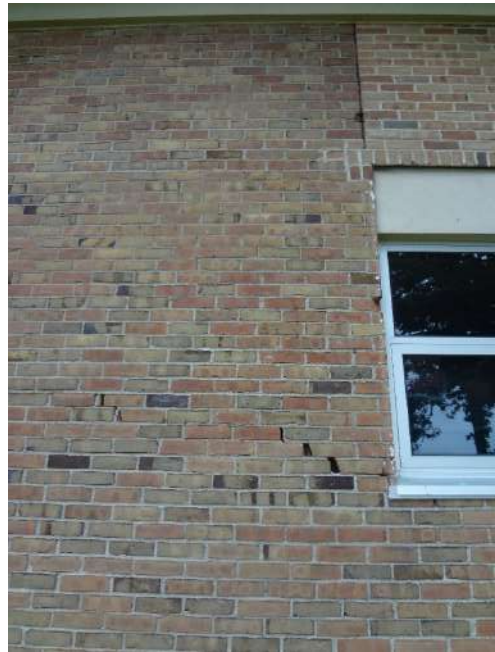
5. BROKEN + MISSING BRICK THROUGHOUT AREA OF FAÇADE
- CLEAN & REPOINT MASONRY AS NEEDED. INSPECT ANNUALLY.

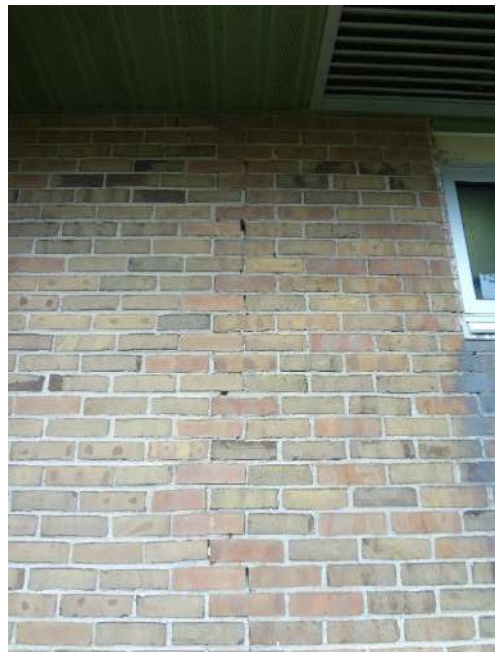
6. BROKEN + MISSING BRICK + ERODED GROUT THROUGHOUT AREA OF FAÇADE
- CLEAN & REPOINT MASONRY AS NEEDED FOR DAMAGED JOINTS. INSPECT ANNUALLY.

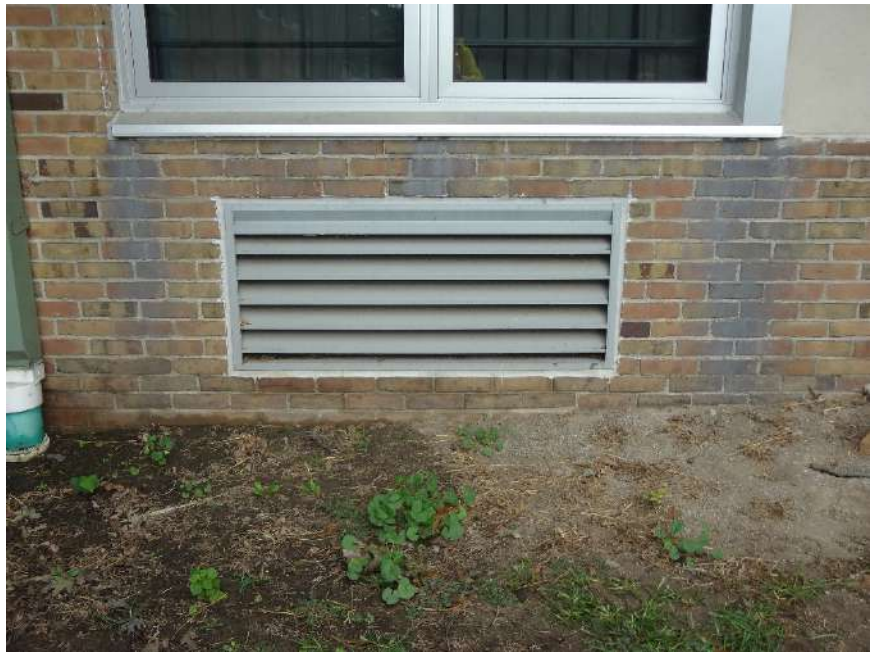
7. ALUMINUM STAINS ON BRICK, TYPICAL AT ALL WINDOWS THROUGHOUT FACILITY
- CLEAN AND SEAL MASONRY AS NEEDED IN ALL SIMILAR LOCATIONS.

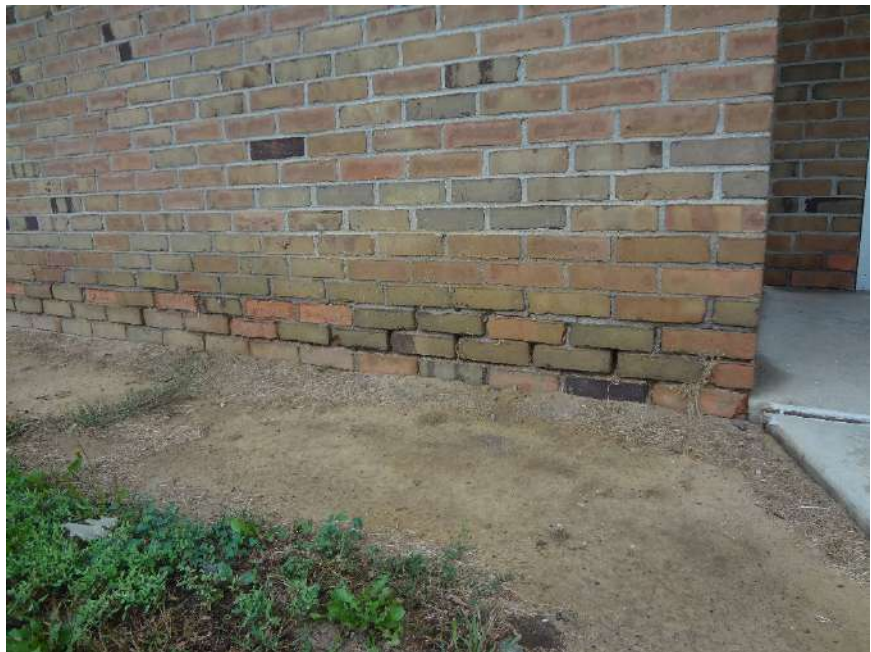
8. BROKEN + ERODED GROUT, 2'-0" ABOVE GRADE AND BELOW, TYPICAL
- CLEAN & REPOINT MASONRY AS NEEDED FOR DAMAGED JOINTS. INSPECT ANNUALLY.

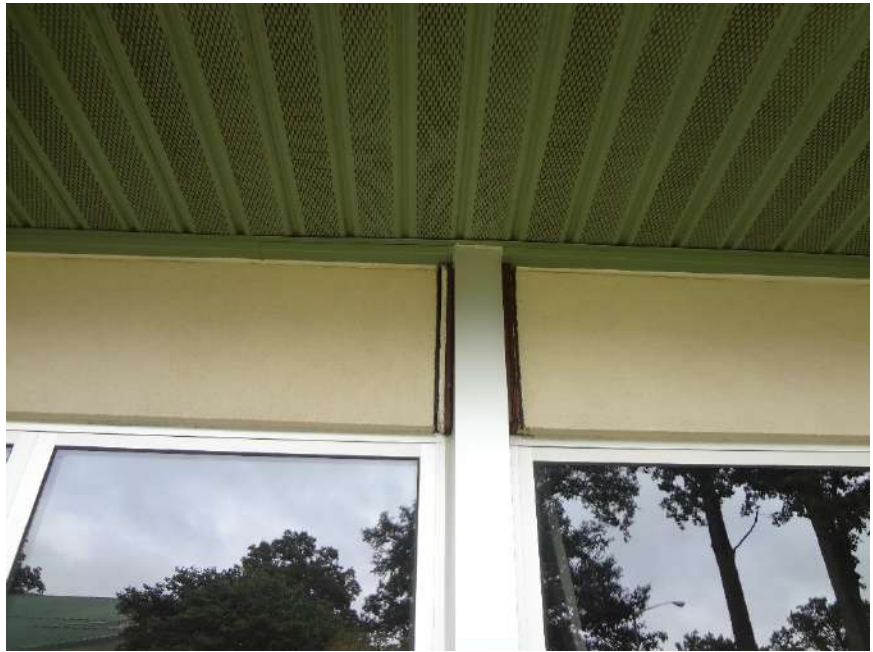
9. PLYWOOD + GYPSUM BOARD EXPOSED TO EXTERIOR ELEMENTS
 - CUT-BACK PLYWOOD AND GYPSUM, INFILL OPENING FOR WEATHER TIGHTNESS

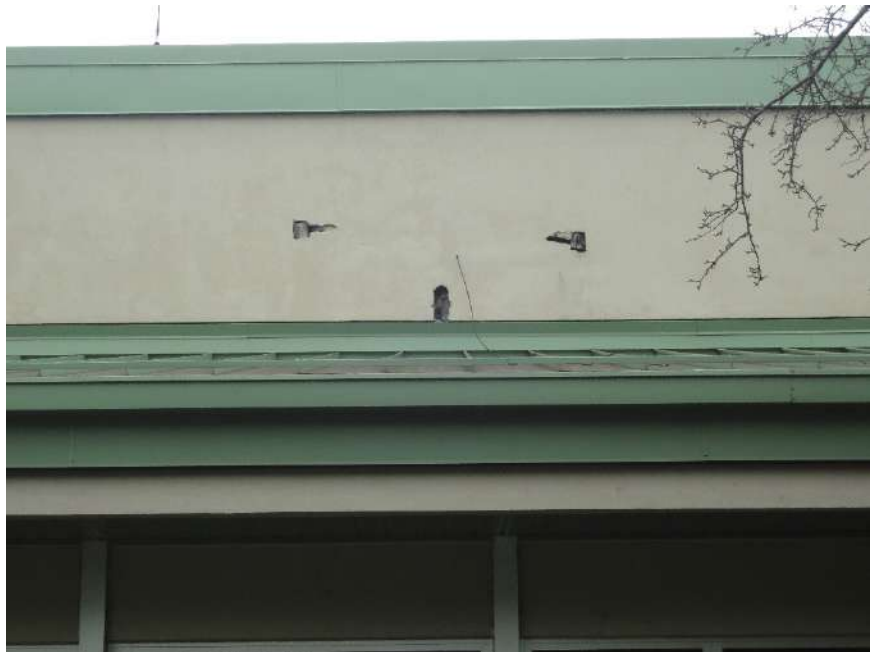
10. PUNCTURES IN EIFS, ALLOWING AIR + WATER INFILTRATION INTO ROOF CAVITY
 - PATCH AND REPAIR EIFS, FINISH TO MATCH EXISTING

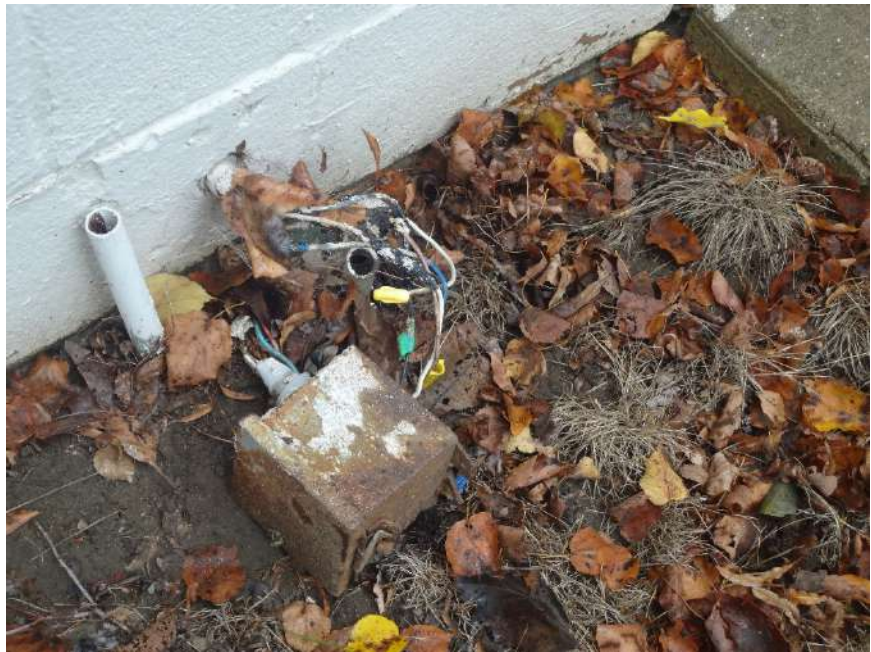
11. BROKEN CONDUIT + EXPOSED WIRING OF ABANDONED JUNCTION BOX
 - DISCONNECT JUNCTION BOX AND CAP ELECTRICAL AS REQUIRED

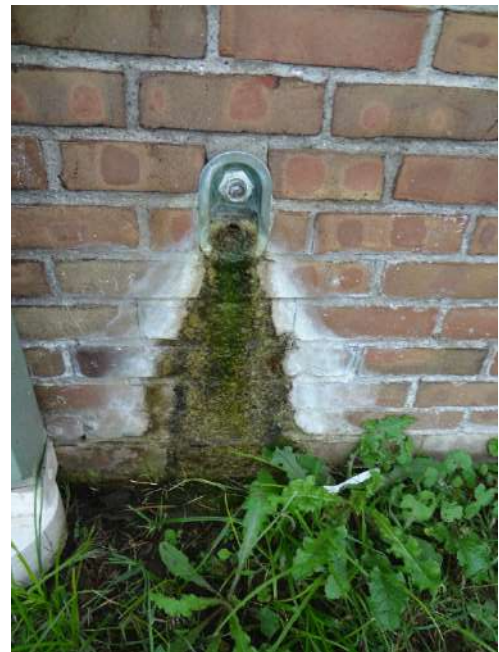
12. ORGANIC GROWTH + STAINING BELOW BROKEN WATER BIB
 - CLEAN ORGANIC MATTER FROM BRICK, INSPECT WATER BIB AND REPAIR AS REQUIRED

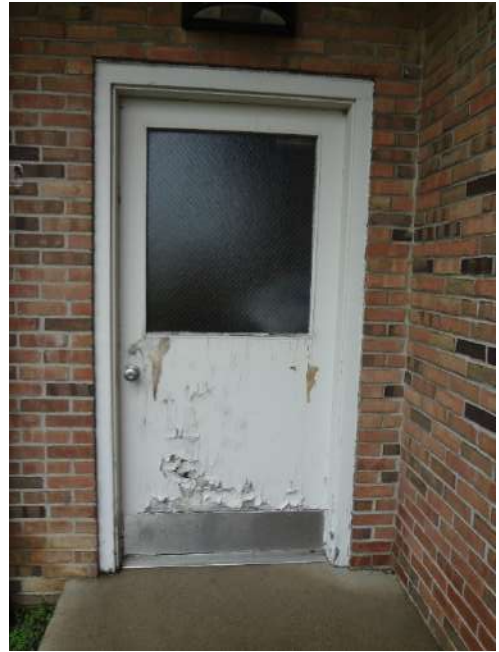
- 13. PEELING PAINT + DAMAGED WOOD SERVICE DOOR**
 - REPLACE EXISTING WOOD SERVICE DOOR WITH NEW STEEL DOOR AND FRAME

We would recommend replacement of all service doors with steel doors and frames.

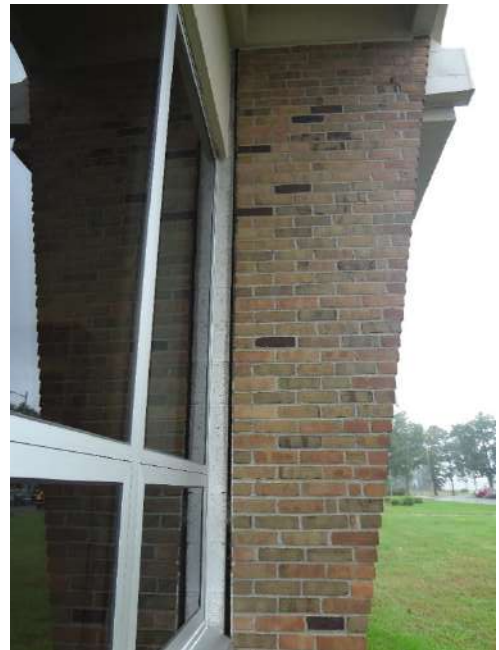
- 14. OPEN EXPANSION JOINT, SHOULD BE FILLED WITH BACKER ROD + SEALANT**
 - INSTALL BACKER ROD AND CAULK AROUND FRAME, INSPECT WEATHERSTRIPPING

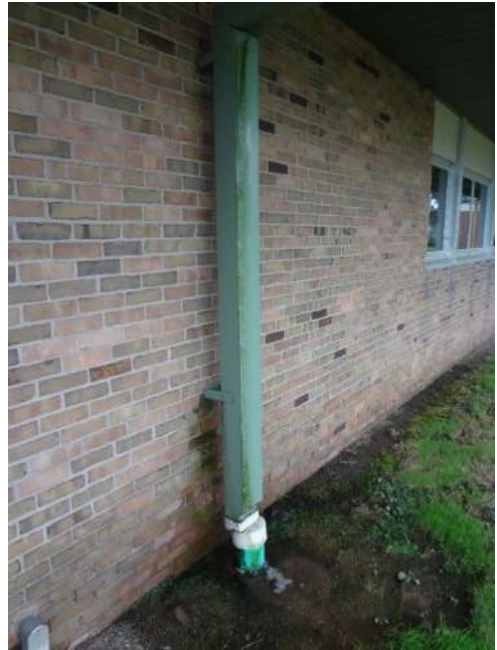
15. WATER LEAKING FROM TOP OF DOWNSPOUT, ORGANIC GROWTH ON FACE
- CLEAN, INSPECT AND REPAIR DOWNSPOUT CONNECTION AS REQUIRED

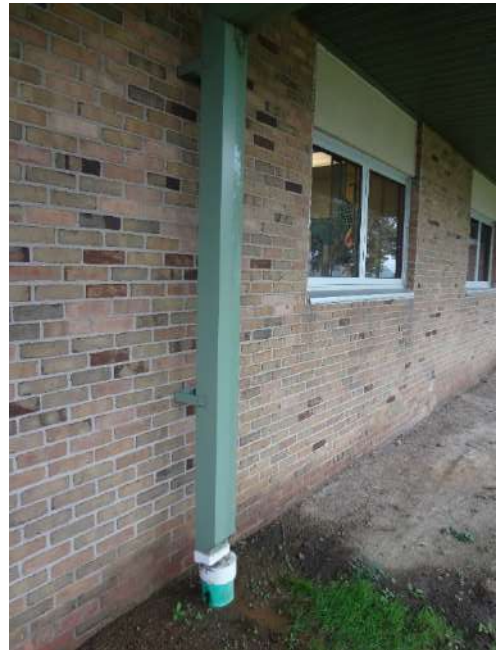
16. ANOTHER DOWNSPOUT LEAKING FROM SEAM AT TOP OF DOWNSPOUT
- CLEAN, INSPECT AND REPAIR DOWNSPOUT CONNECTION AS REQUIRED

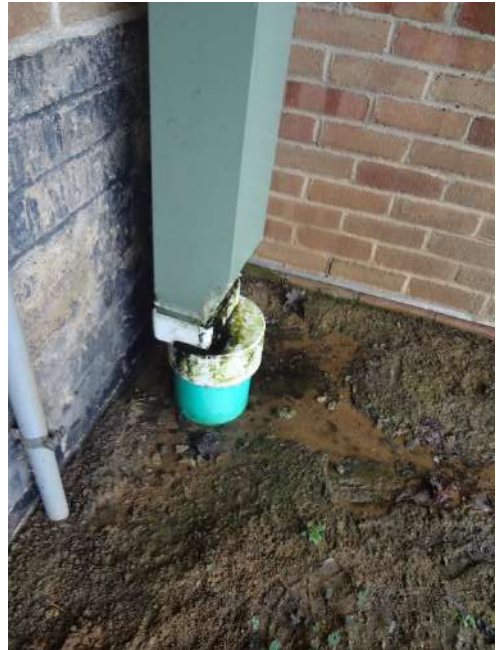
17. OVERFLOWING DOWNSPOUT AT CONNECTION TO UNDERGROUND LEADER, TYPICAL
- CLEAN, INSPECT AND REPAIR DOWNSPOUT CONNECTION AS REQUIRED

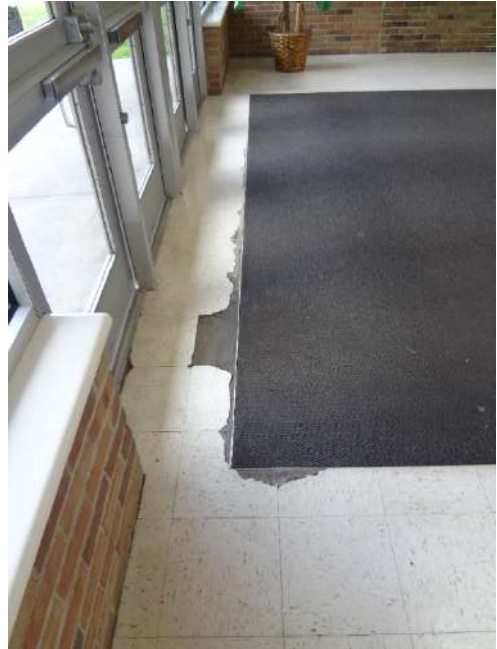
**18. BROKEN VCT AT VESTIBULE ENTRY FROM WATER INFILTRATING UNDER DOORS, TYPICAL
- STOP WATER INFILTRATION. FLOOR REPLACEMENT IN 2019, PART OF SINKNG FUND PROJECT**

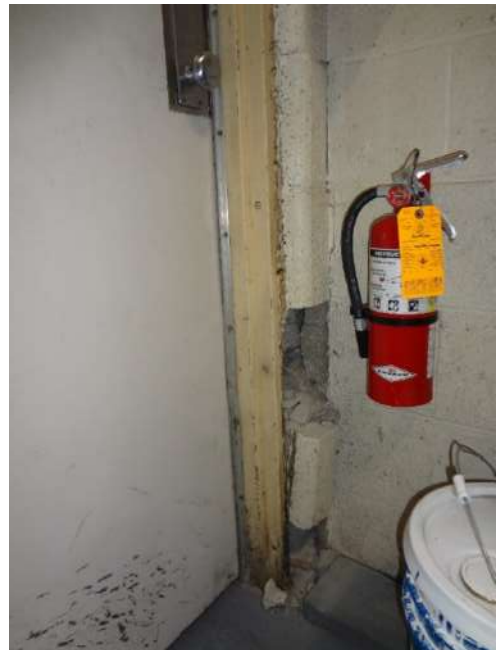
**19. BROKEN + MISSING CMU AT EXTERIOR DOOR FRAME
- CONSULT STRUCTURAL ENGINEER TO MONITOR AND DETERMINE REPAIR SOLUTION**

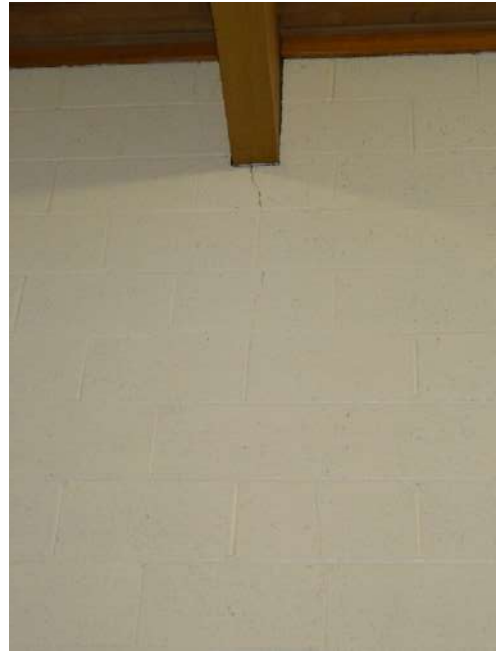
We did not observe any visible structural concerns; however, we would suggest a Structural Engineer be consulted with to assess the purpose of jack posts at various locations throughout the facility, and wall cracking within storage rooms located on the High School Stage. See photos 20 & 21 for documentation.

20. MASONRY CRACK OBSERVED ON SOUTH WALL AT LAMINATED WOOD BEAM
 - CONSULT STRUCTURAL ENGINEER TO MONITOR AND DETERMINE REPAIR SOLUTION

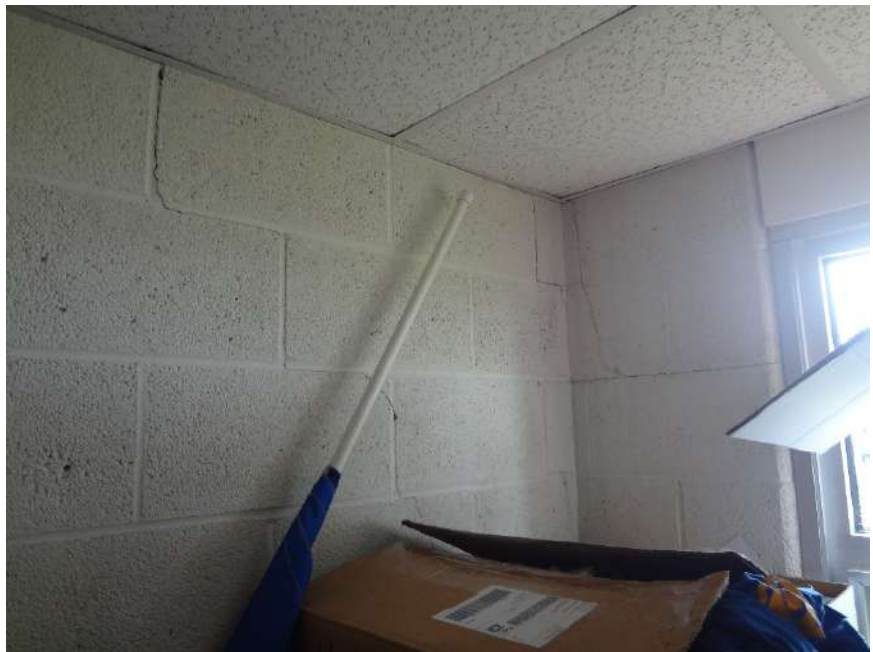
21. MASONRY CRACKS THROUGHOUT SOUTHEAST CORNER OF STORAGE ROOM
 - CONSULT STRUCTURAL ENGINEER TO MONITOR AND DETERMINE REPAIR SOLUTION

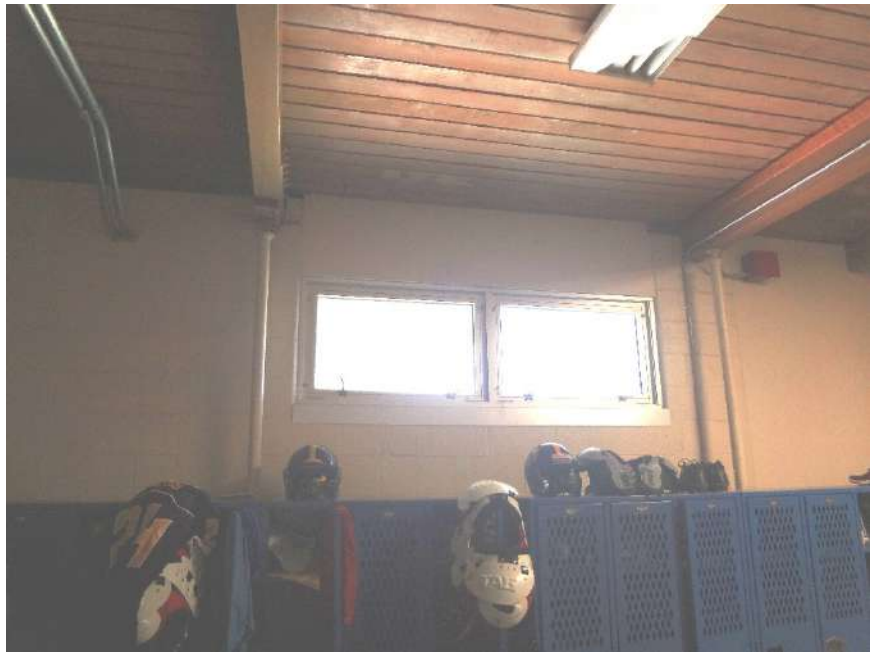
22. TWO RETROFIT STEEL JACKPOSTS AT LAMINATED WOOD BEAMS
 - CONSULT STRUCTURAL ENGINEER. TO BE REPAIRED/REPLACED DURING 2019 REMODEL

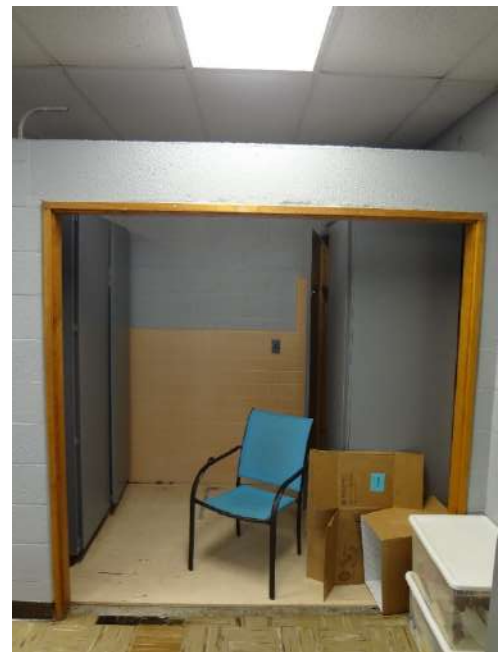
23. UNFINISHED DEMOLITION AND RENOVATION OF FORMER TOILET ROOM
 - COMPLETE DEMOLITION OF SPACE, FINISH TO MATCH EXISTING CLASSROOM

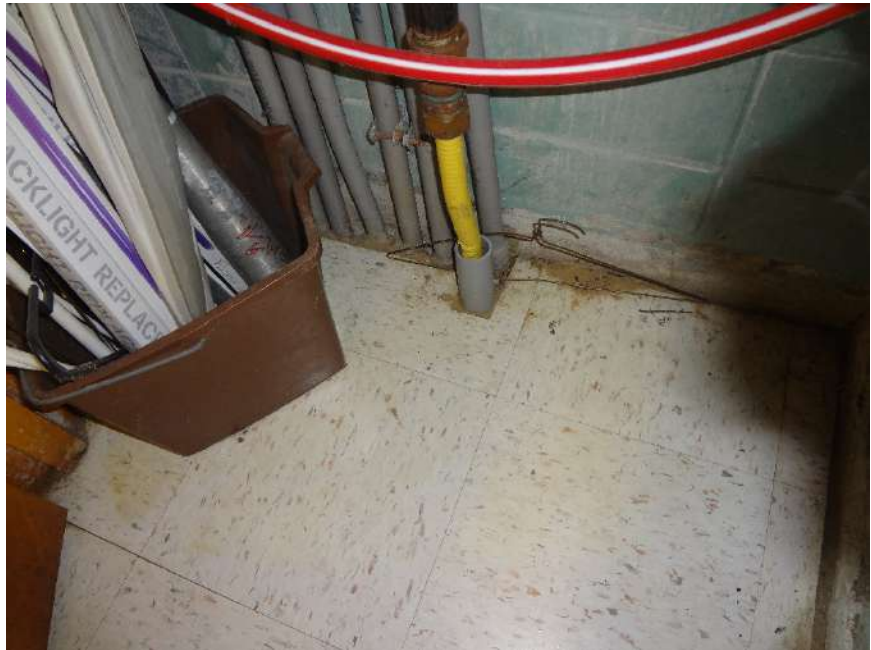
During discussion with Staff it was reported that in Room #8, water infiltrates the room from below the floor during times of heavy rainfall. This issue should be investigated and repaired with urgency. We suggest starting with Camera Inspection of the under-slab roof storm pipe to determine cause of issue.

24. AREA OF WATER AND SAND INFILTRATION INTO CLASSROOM DURING HEAVY RAINS
- CAMERA (INSPECT) UNDERGROUND STORM LINE TO DETERMINE CAUSE, REPAIR

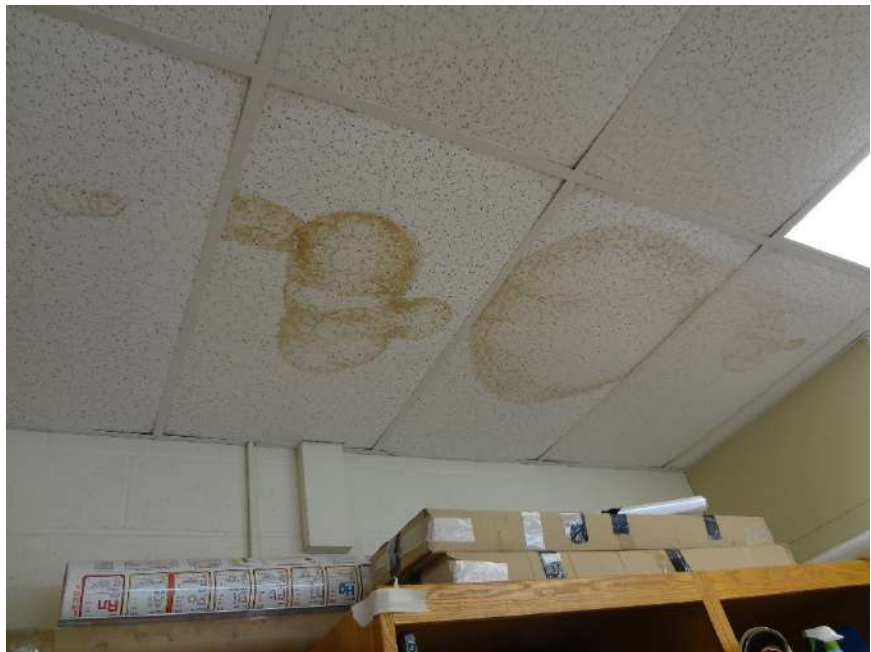
25. WATER STAINED CEILING TILES INDICATE A POTENTIAL OF WATER INFILTRATION AT ROOF
- INVESTIGATE SOURCE OF MOISTURE AND REPAIR. REPLACE CEILING TILES

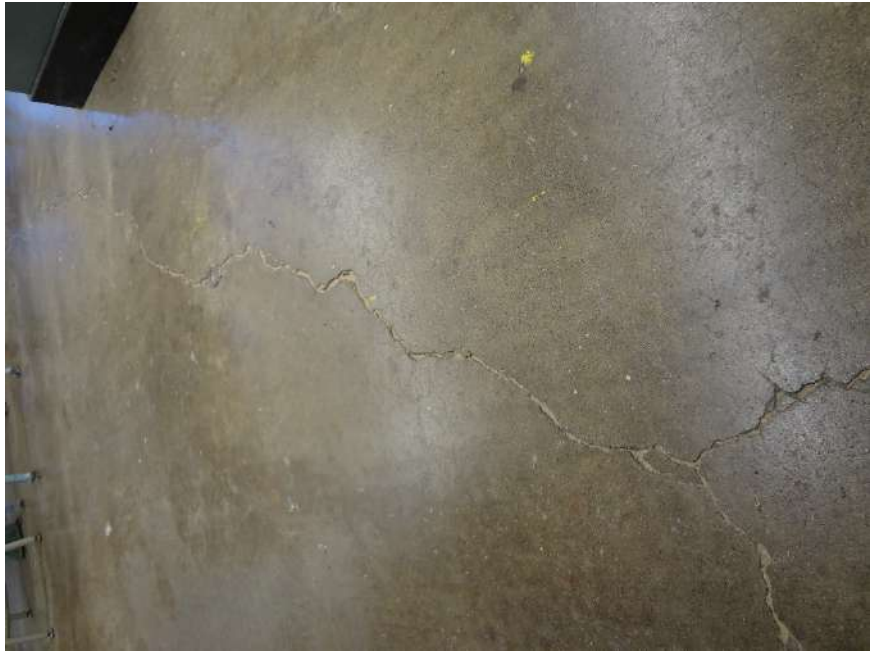
26. CRACKING IN CONCRETE FLOOR THROUGHOUT SHOP AREA
- CRACKING IS INHERENT IN CONCRETE. MONITOR FOR MOVEMENT, FINISH IF DESIRED

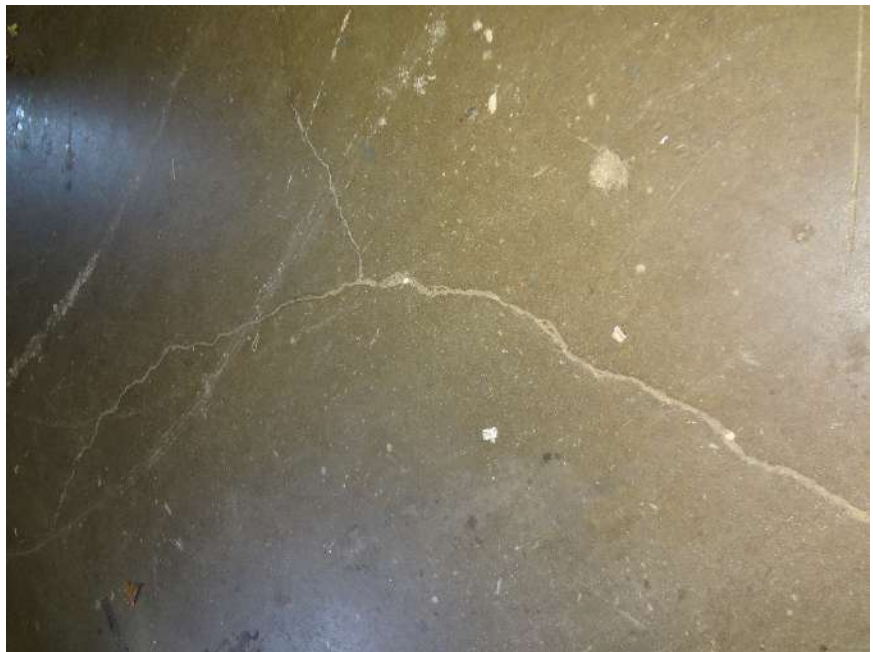
27. CRACKING IN CONCRETE FLOOR THROUGHOUT STORAGE AREA
- CRACKING IS INHERENT IN CONCRETE. MONITOR FOR MOVEMENT, FINISH IF DESIRED

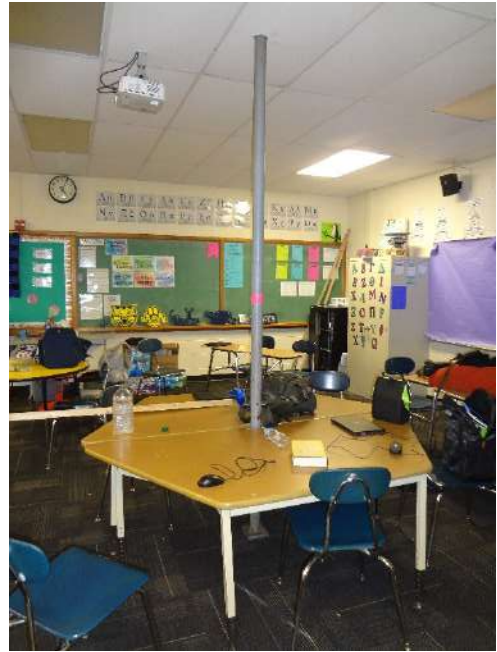
28. RETROFIT STEEL JACKPOST AT CENTER OF CLASSROOM
 - CONSULT STRUCTURAL ENGINEER TO MONITOR AND DETERMINE REPAIR SOLUTION

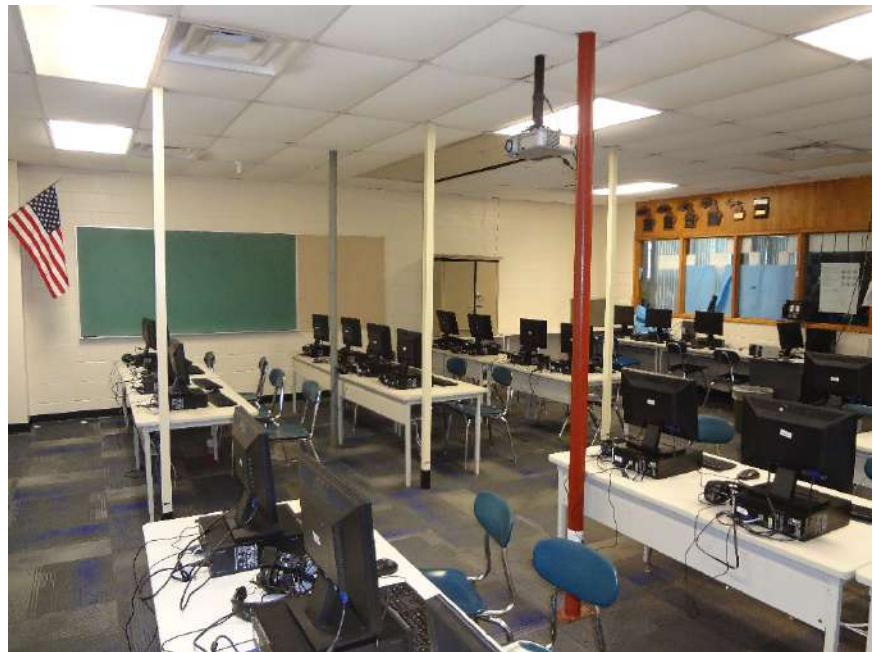
29. TWO RETROFIT STEEL JACKPOSTS AT CENTER OF COMPUTER LAB
 - CONSULT STRUCTURAL ENGINEER TO MONITOR AND DETERMINE REPAIR SOLUTION

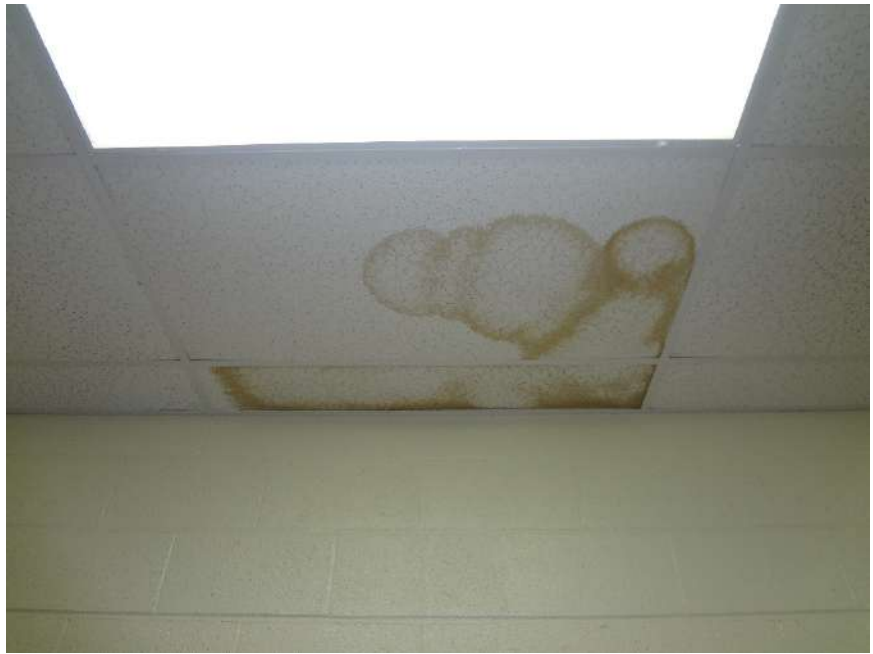
30. WATER STAINED CEILING TILES INDICATE A POTENTIAL OF WATER INFILTRATION AT ROOF
- INVESTIGATE SOURCE OF MOISTURE AND REPAIR. REPLACE CEILING TILES

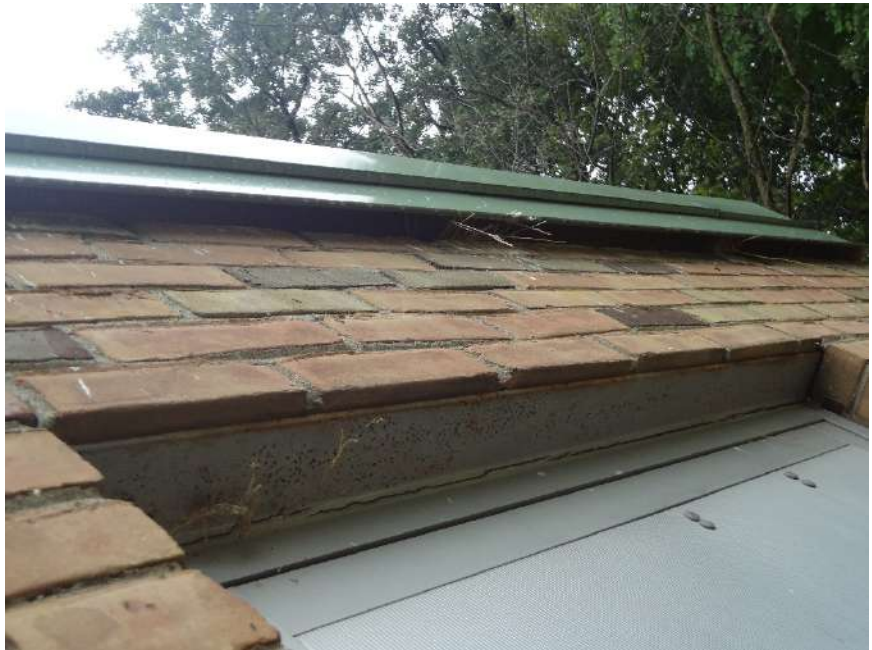
31. WIDE OPENING AT METAL ROOF FLASHING ALLOWING WEATHER INFILTRATION + NESTING
- CLEAN DEBRIS FROM OPENING AND INFILL FLASHING TO CLOSE AREA OF INFILTRATION

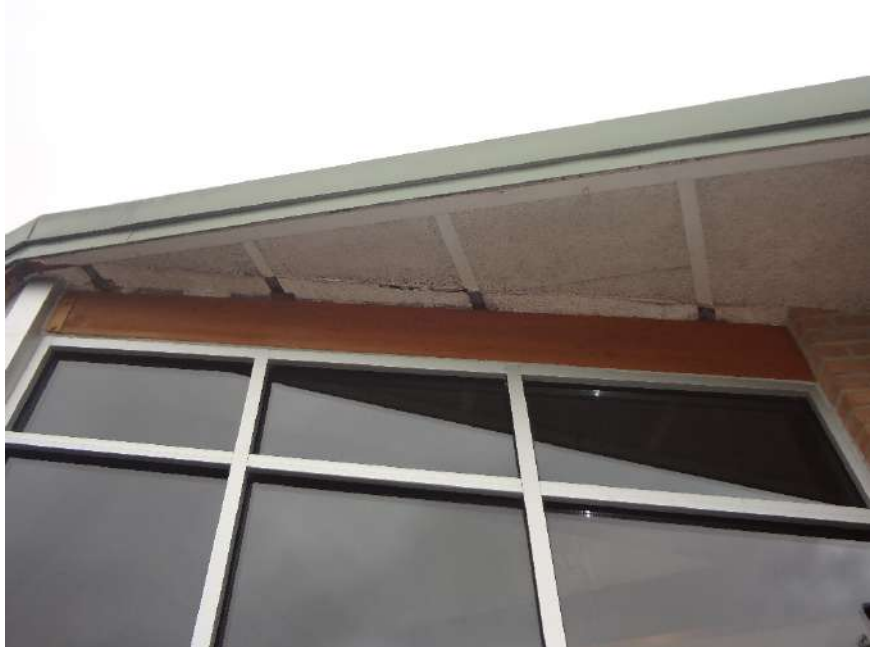
32. MISSING TRIM AT EAVE SOFFIT EXPOSING STRUCTURE TO CORROSION + INFILTRATION
- REPLACE METAL SOFFIT TRIM AND ENSURE OPENING IS WEATHER TIGHT

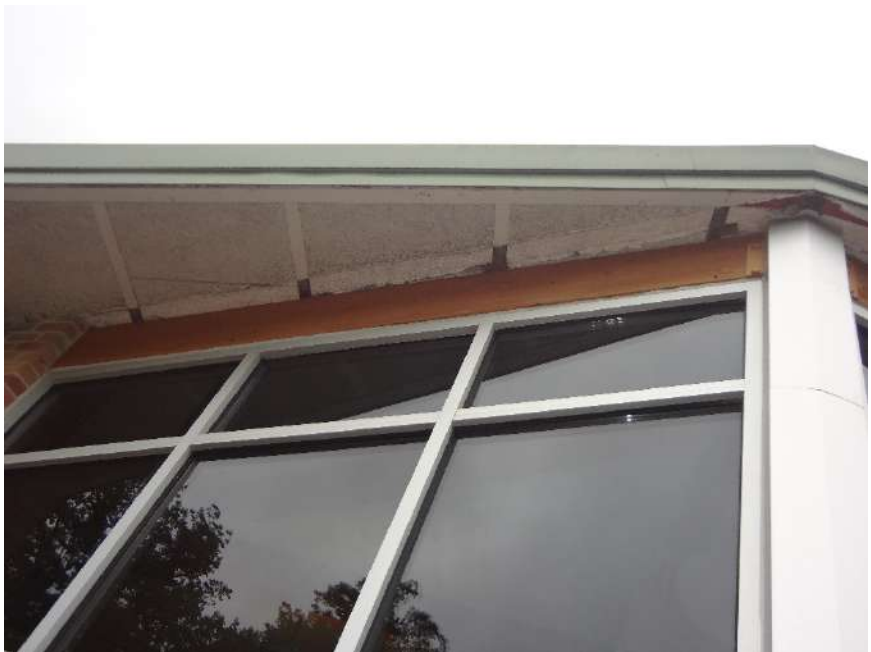
33. MISSING TRIM AT TECTUM SOFFIT EXPOSING STRUCTURE TO CORROSION + INFILTRATION
 - REPLACE METAL SOFFIT TRIM AND ENSURE OPENING IS WEATHER TIGHT

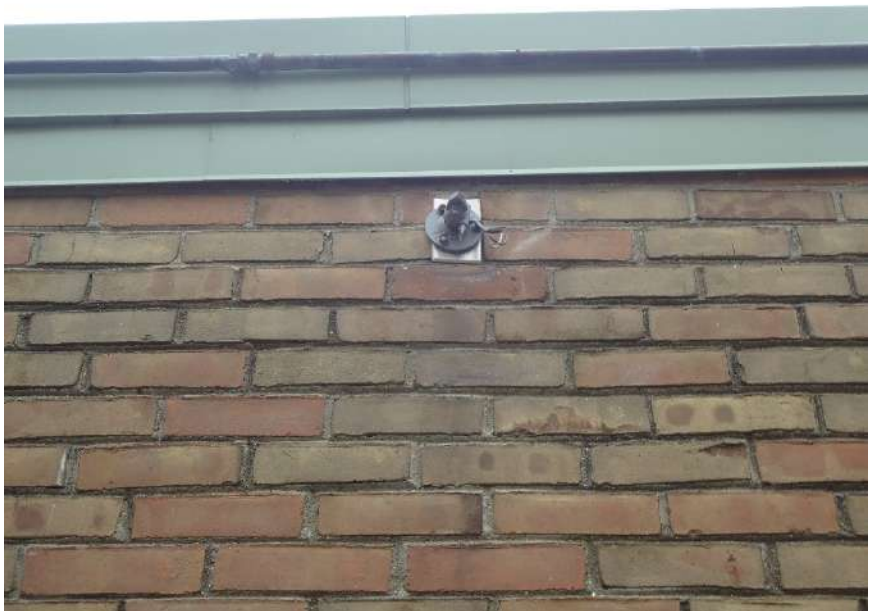
34. BROKEN EXTERIOR LIGHT FIXTURE ARM + MISSING EXTERIOR LIGHT FIXTURE
 - REPLACE EXTERIOR LIGHT FIXTURE

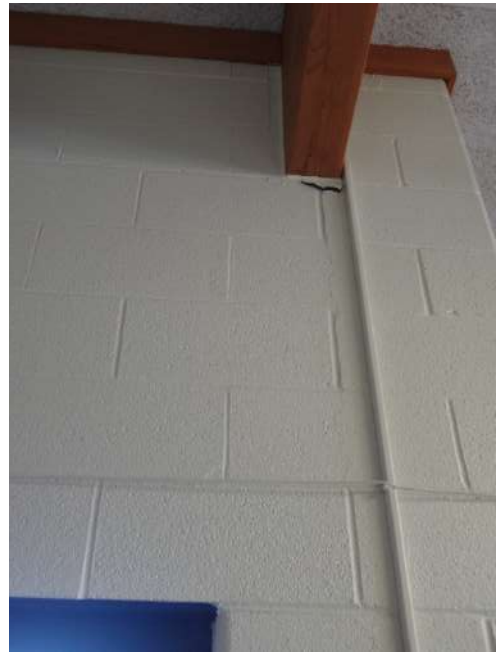
35. MASONRY CRACK OBSERVED ON WEST WALL OF ROOM 19 – ART.
- CONSULT STRUCTURAL ENGINEER TO MONITOR AND DETERMINE REPAIR SOLUTION

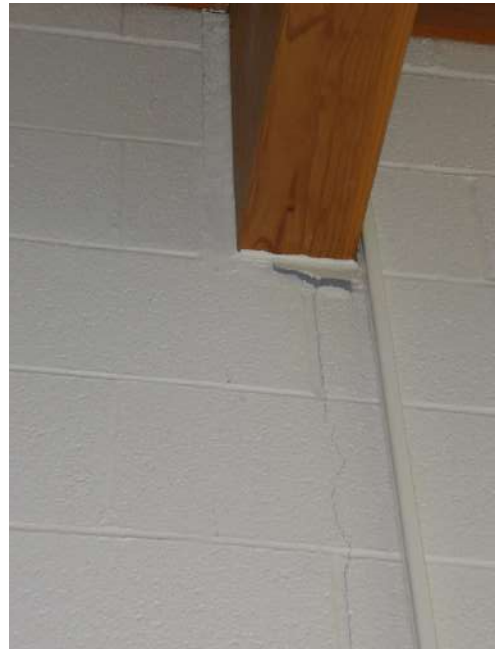
36. ENLARGED IMAGE OF MASONRY CRACK OBSERVED ON WEST WALL OF ROOM 19 – ART.
- CONSULT STRUCTURAL ENGINEER TO MONITOR AND DETERMINE REPAIR SOLUTION

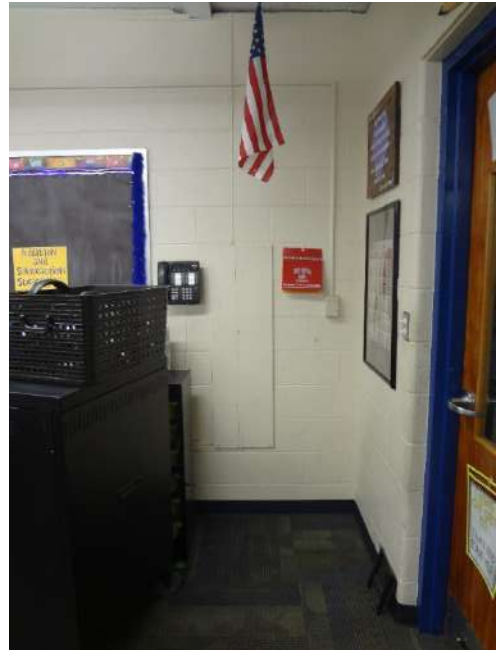
37. WOOD PANEL COVERING CMU WALL OPENING
 - REMOVE PANEL, INVESTIGATE PURPOSE, REPAIR OPENING WITH MASONRY

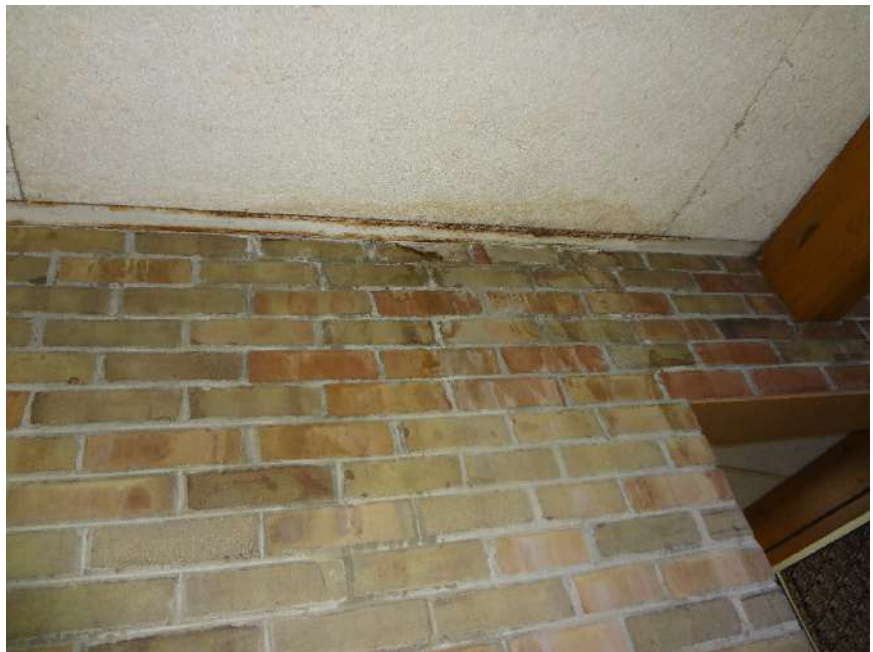
38. CORROSION OF METAL FRAMING, STAINING FROM MOISTURE INFILTRATION
 - INVESTIGATE SOURCE OF MOISTURE AND REPAIR. CLEAN BRICK AND CEILING ASSEMBLY

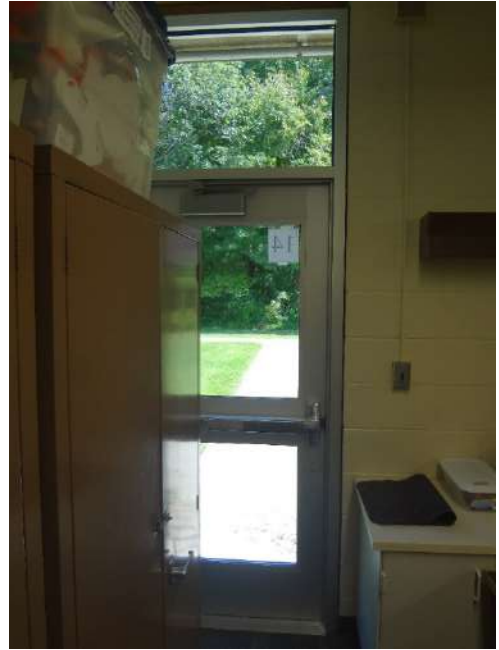
39. MISSING BACKER ROD + SEALANT AROUND ENTIRE DOOR FRAME
 - INSTALL BACKER ROD AND CAULK AROUND FRAME, INSPECT WEATHERSTRIPPING

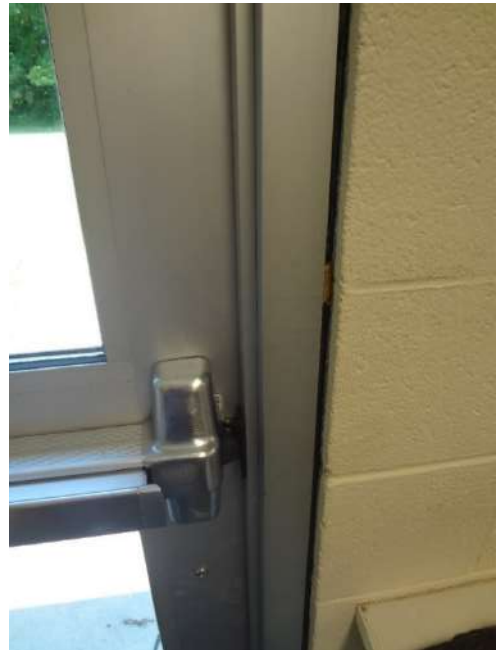
40. ENLARGED IMAGE OF MISSING BACKER ROD + SEALANT AROUND DOOR FRAME
 - INSTALL BACKER ROD AND CAULK AROUND FRAME, INSPECT WEATHERSTRIPPING
