# **A.H.E.R.A.**

## **Management Plan for Asbestos Containing Building Materials**

Willamette Primary  
1403 S.E. 12th Street  
West Linn, OR 97068

TRE Project No. 1020-90

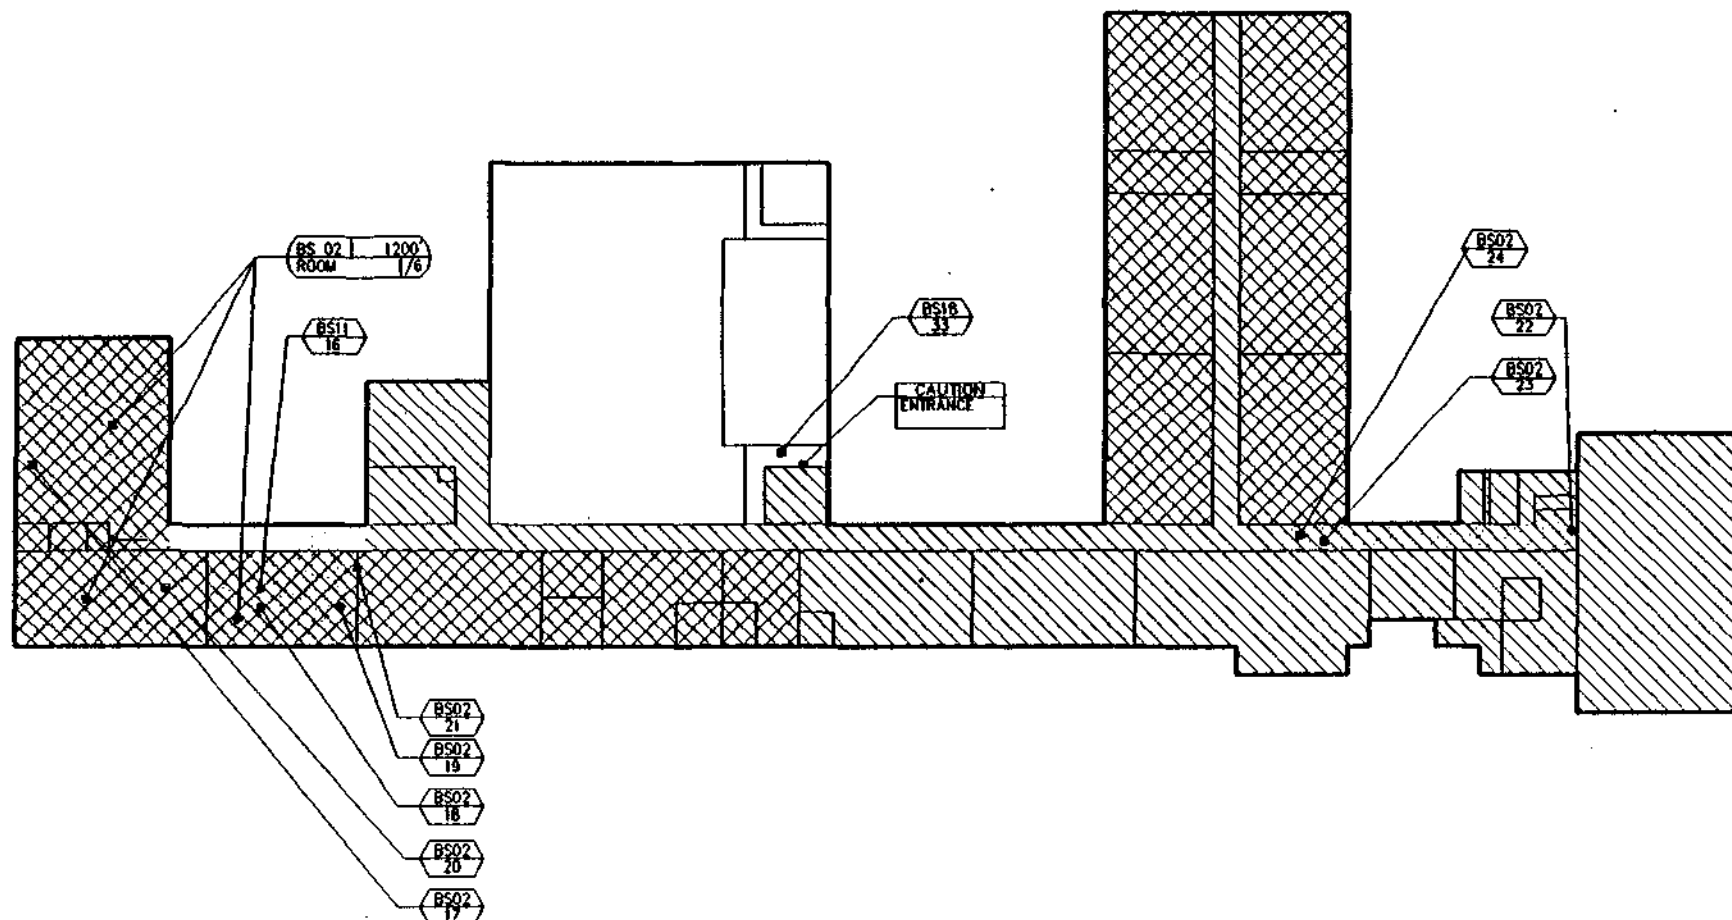
BSCODE QUANTITY LOCATION DAMAGE AREA RESPONSE CODE	<b>RAIL-ROADRELL</b> ENVIRONMENTAL SERVICES 4840 WEST FIFTEENTH STREET LAWRENCE, KANSAS 66044 DATE 10/04/88 006001A	<b>AHERA COMPLIANCE PROGRAM</b> 37-0050-006-001 WEST LINN SCHOOL DISTRICT WILLAMETTE SCHOOL BOILER ROOM
--	---	--	--	--	---
