Jefferson High School Building Condition Report

312 S Main Street, Boulder, Montana 59632 July 30, 2020

| BUILDING CONDITION REPORT |

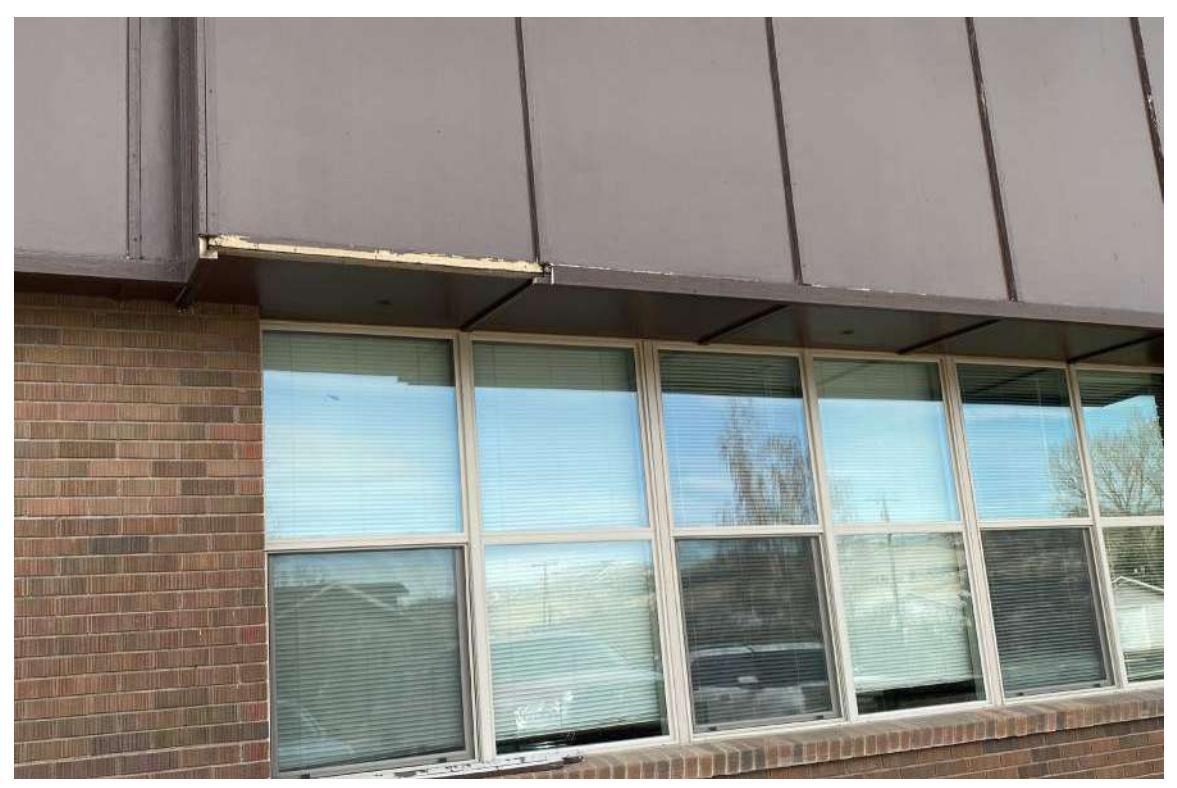
Wood fascia that is worn and coming apart.

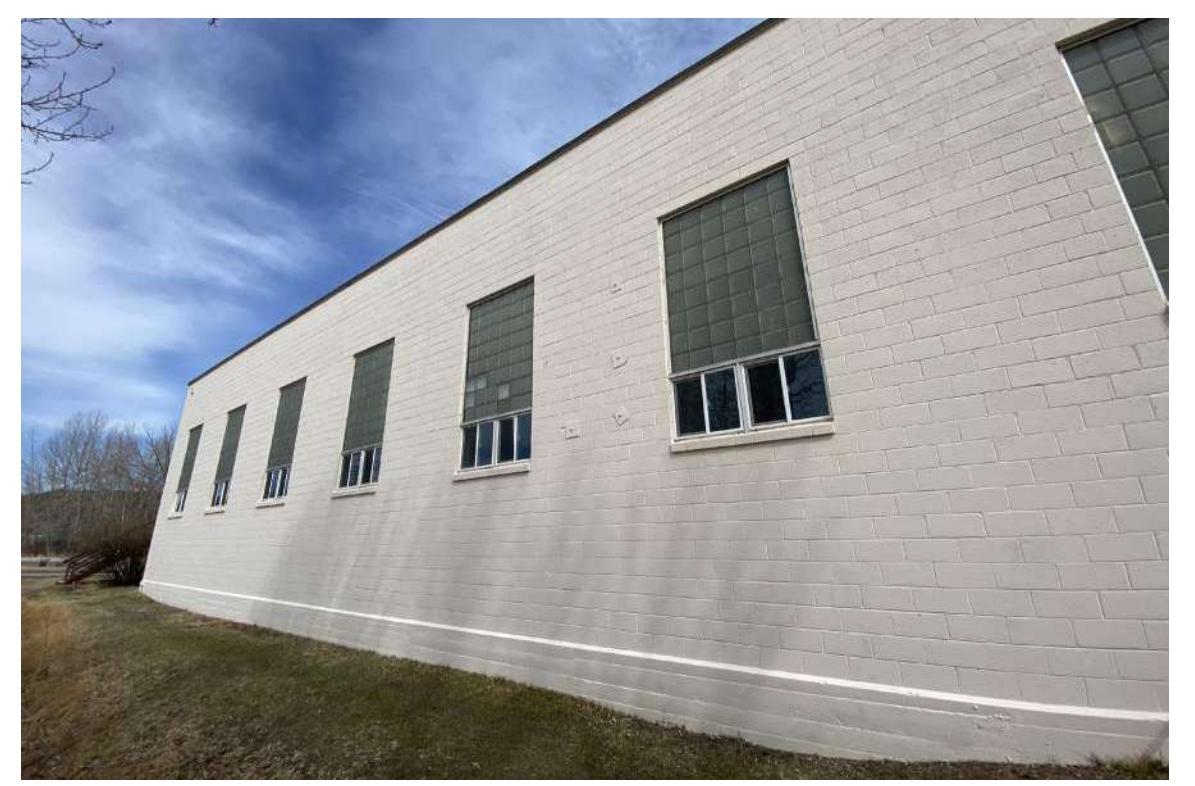
South side of Existing Gym, next to irrigation canal from the Boulder River. Masonry block is holding up well, and paint appears new.

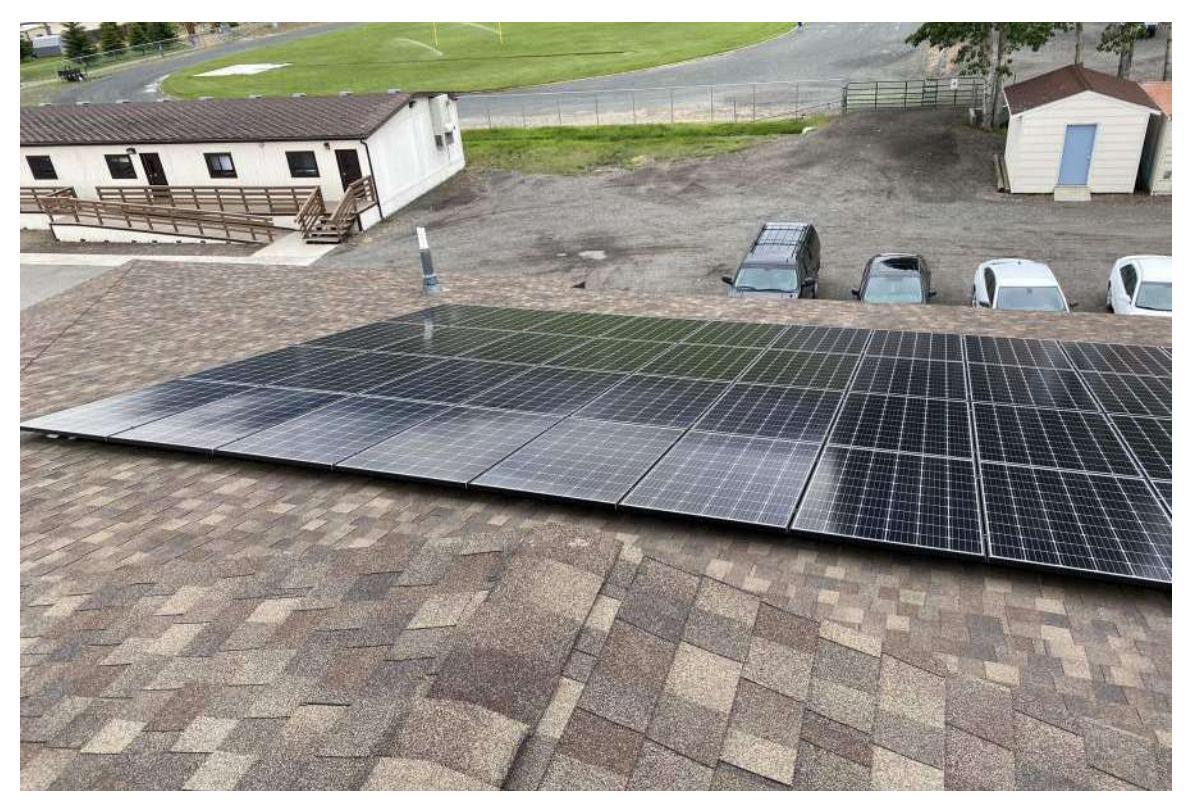
South Library roof, looking towards modulars and storage sheds. Shingles on the Library roof appeared in good condition. Modular roofs had shingles damaged and torn off, mostly from high winds over the previous weekend. Solar panels did not appear damaged.

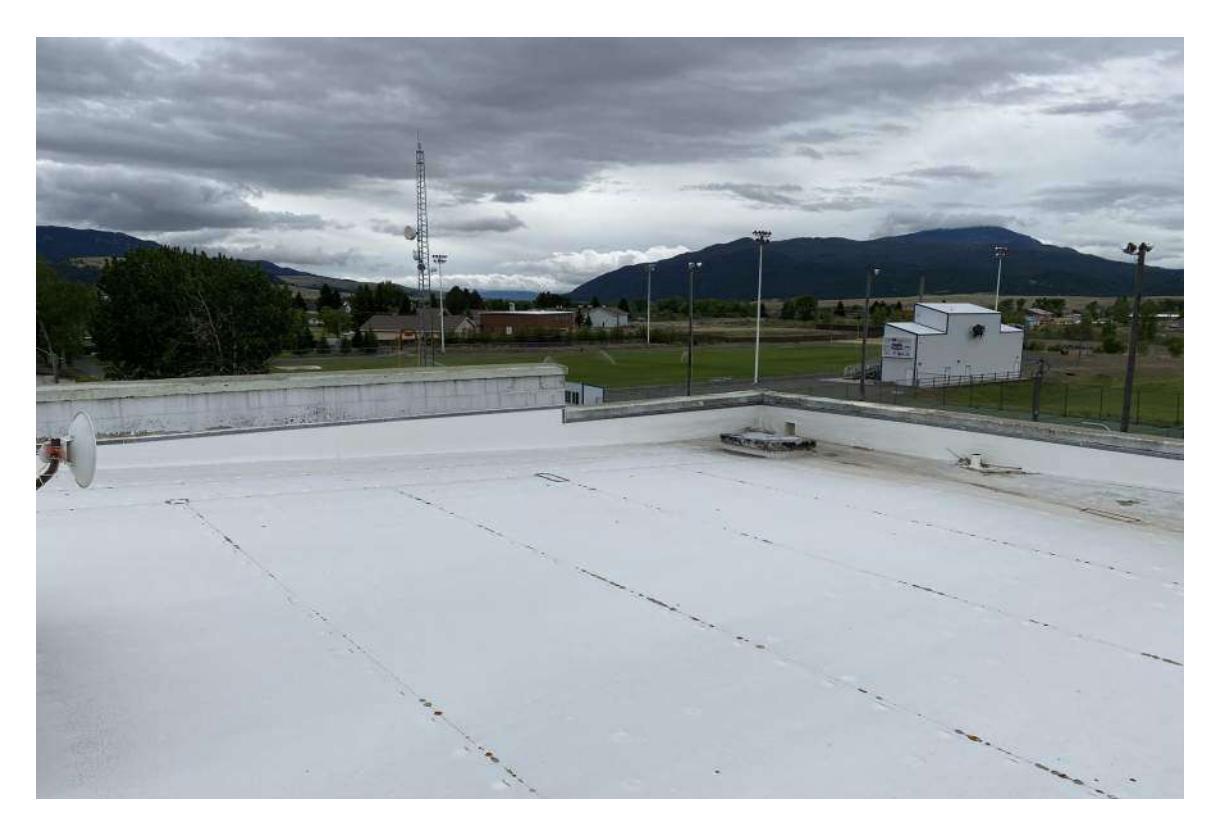
The majority of the existing roofs appeared to be in good condition. This roof, over the Existing (South) Gym, had very little damage and transitions and termination bars were in good working order.

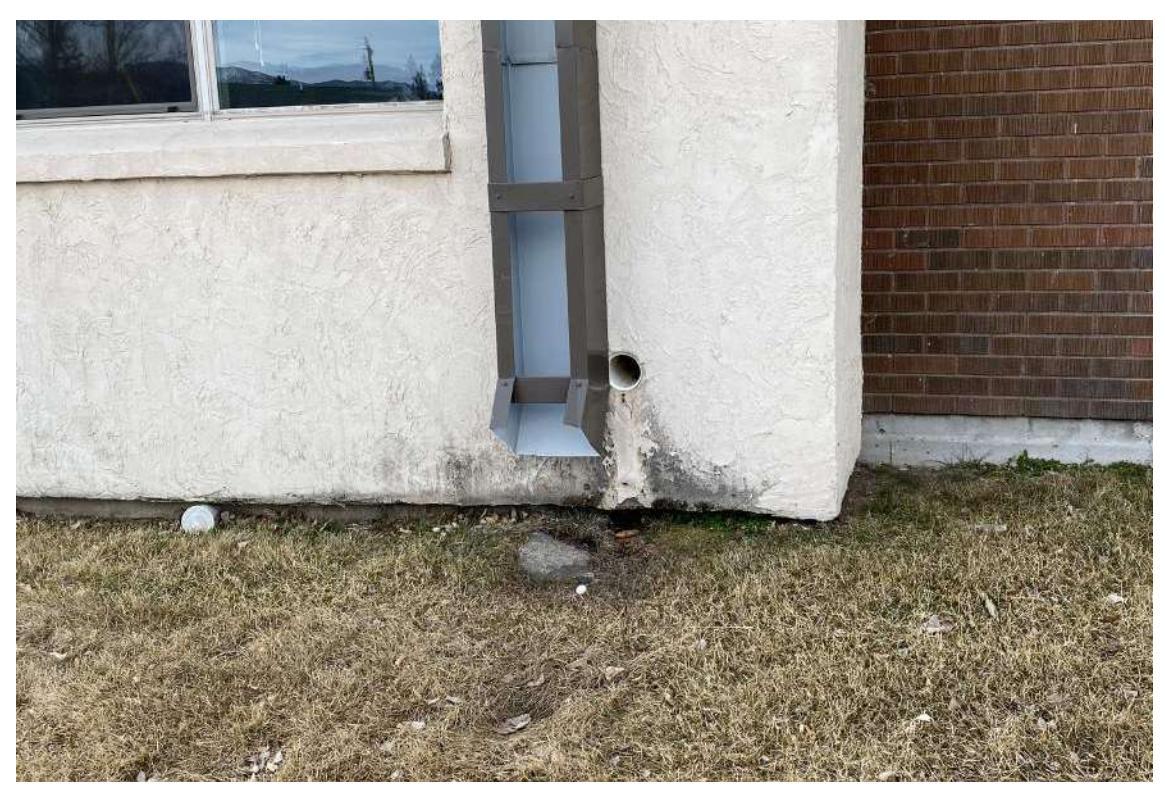
A large roof downspout and overflow on the north side of the building. Most of these large downspouts did not have a splash block or other method of diverting large quantities of water away from the foundation, and most runoff soaks into the grass area.

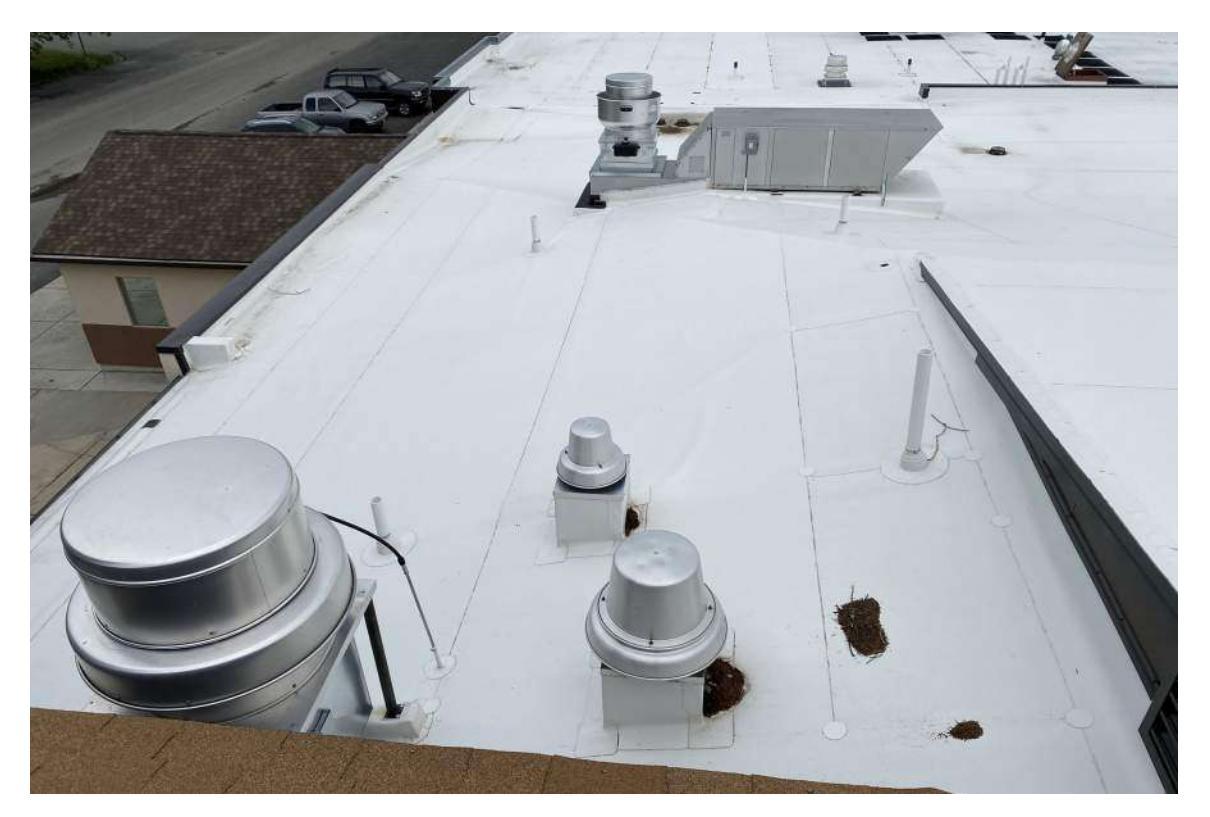
The roof looks relatively new. This area over the Kitchen space had welds and wrapping of membrane applied correctly.

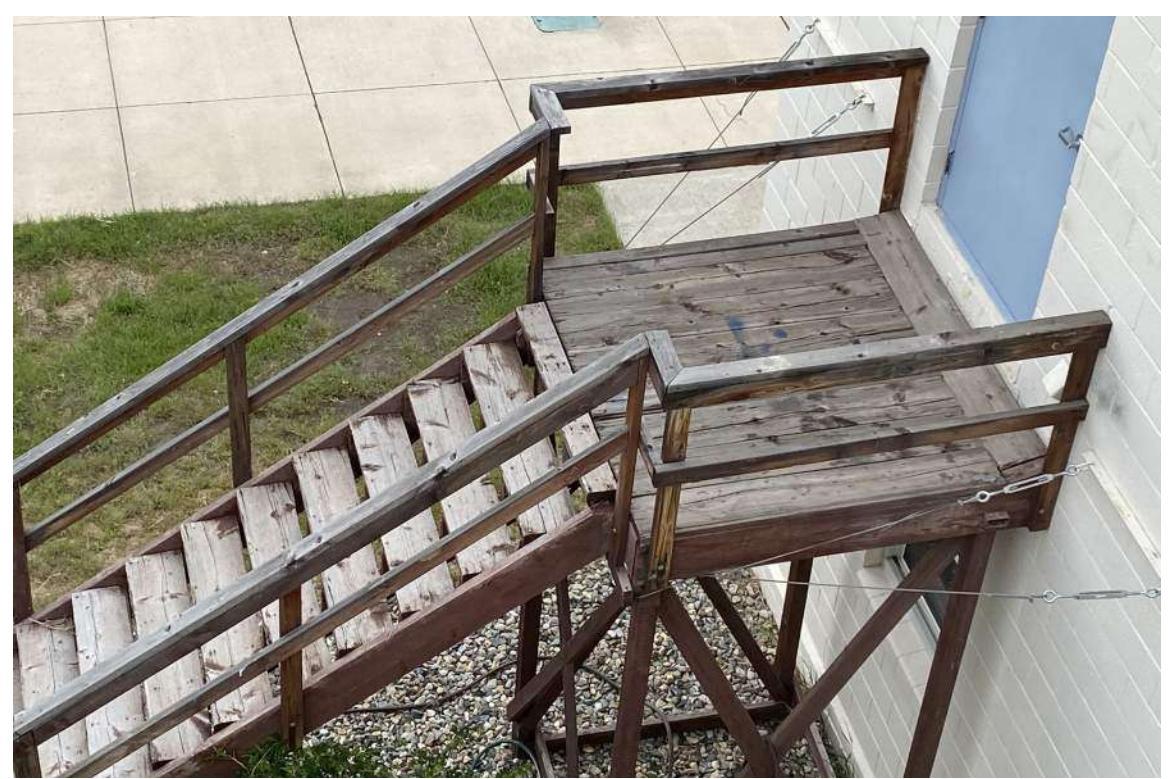
The egress stairs from the Art Room, as seen from the South Gym roof. The wood appears deteriorated and is secured to the building with cables. This stair does not comply with current accessibility codes and needs to be replaced with a more permanent stair.

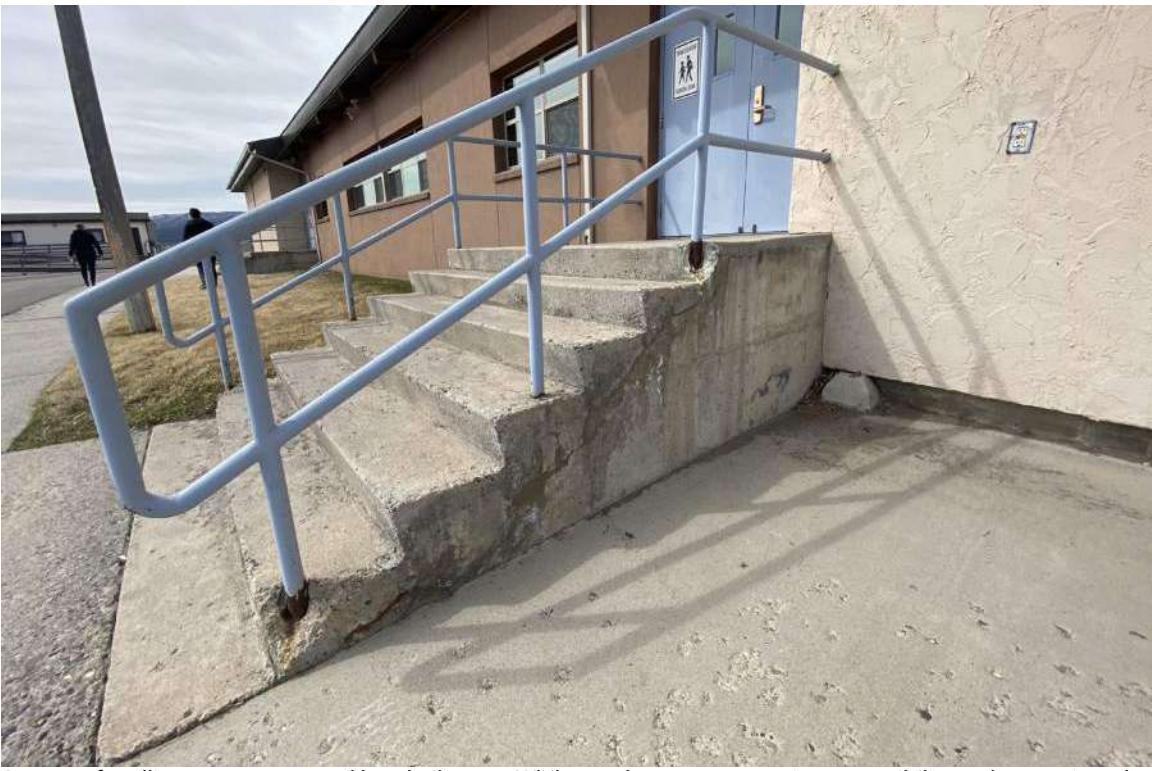
An area of spalling concrete around handrail posts. While not dangerous or against accessibility codes, continued wear will eventually lead to the handrail dislodging from the concrete. This could give way under lateral load when in use and cause injury.

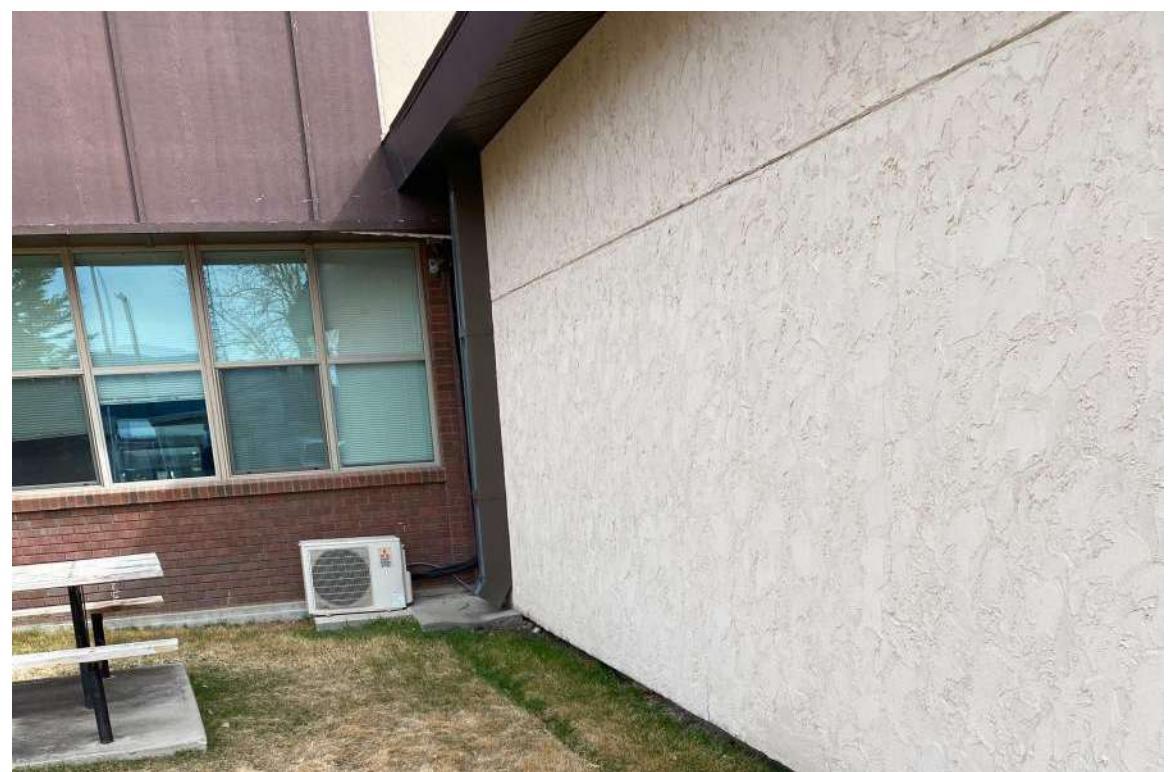
Another large downspout that drains to a splash block in the back of the building. This spout is partially shaded by the wall adjacent to it. During heavy rains, water could flood around the condenser unit here. The drainage swale is visible in the grass leading out to the parking lot.

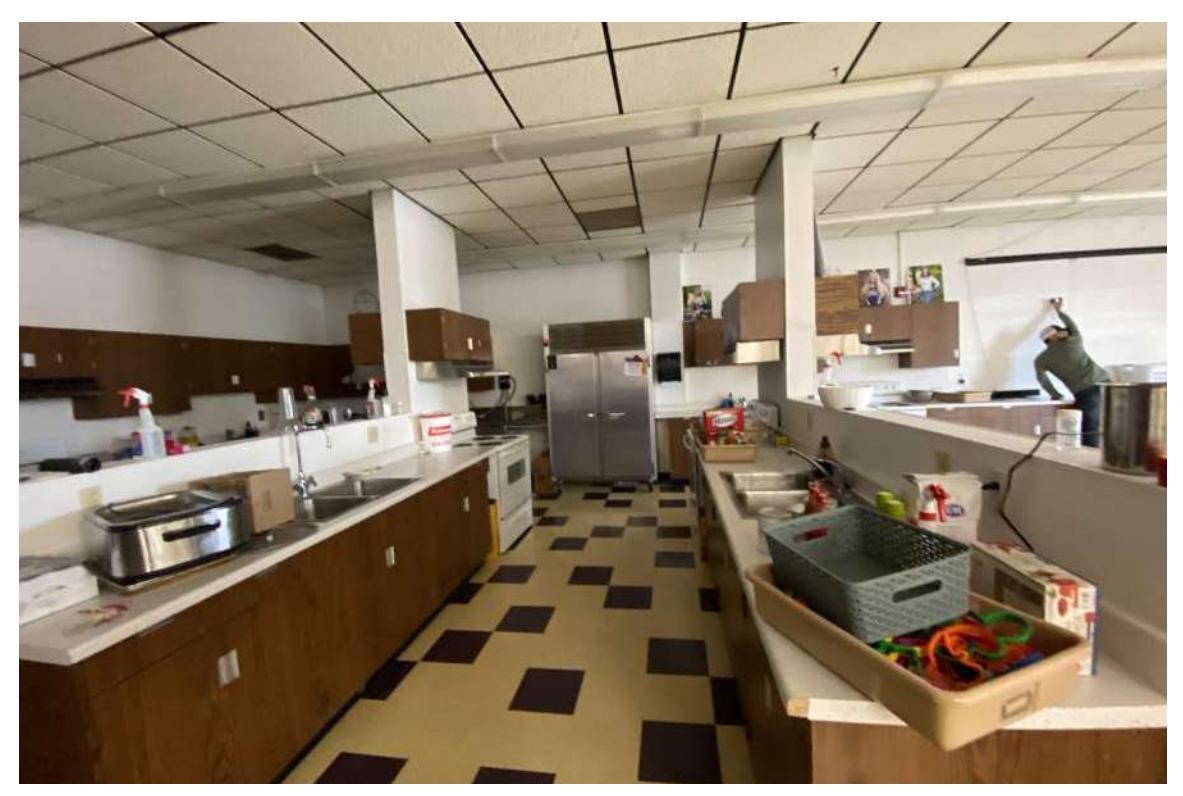
The FCS room. This space was noted to have ventilation problems and the finishes were slightly dated. However, the room had ample space for students and functions.

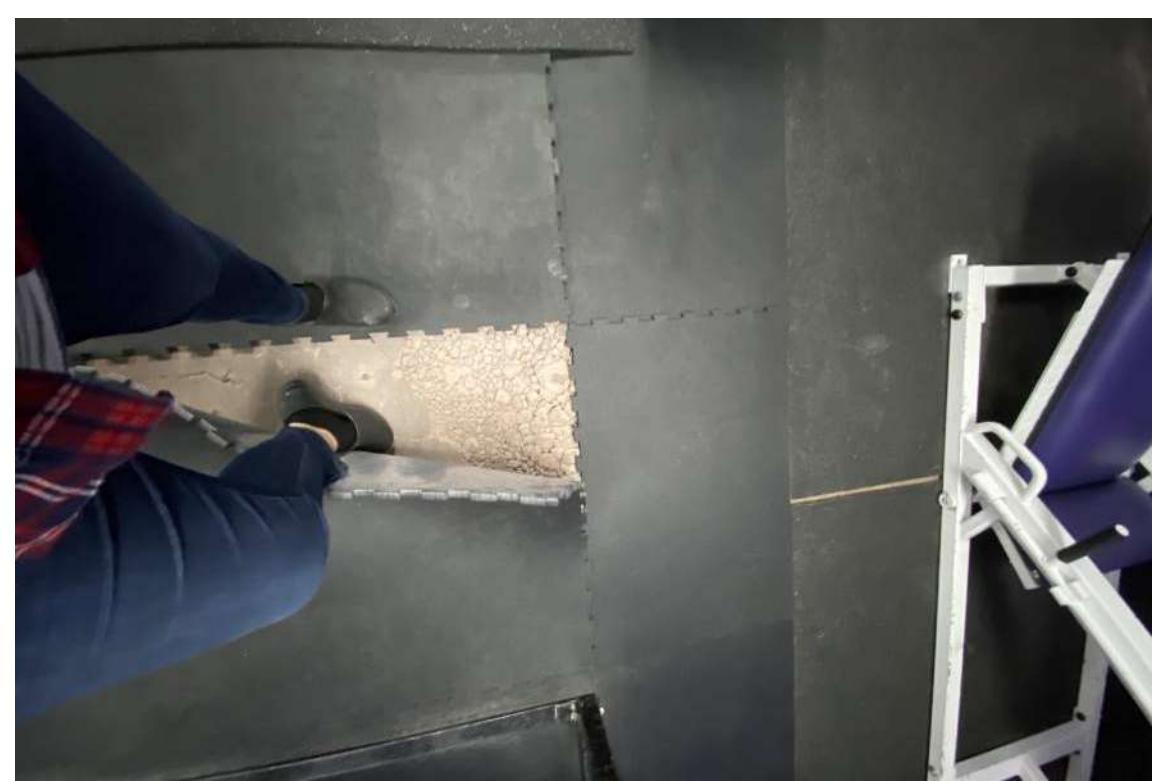
Crumbling composite concrete deck of weight room. Heavy plates and dropping of weights has resulted in severe deterioration of the deck. While this is not a structural problem, it is recommended that the weight room be moved to a floor with a thicker concrete slab.

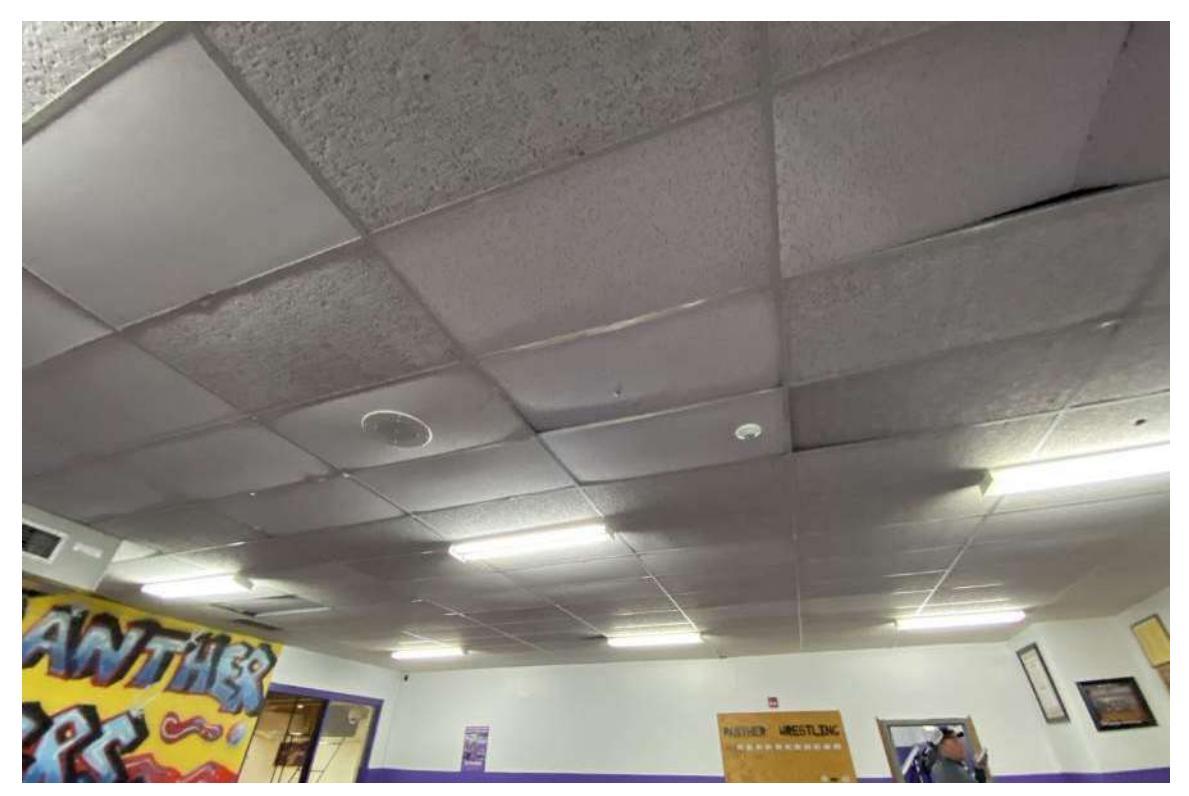
Ceiling tiles in the wrestling room are severely warped and discolored, from previous roof leaks and excessive moisture. Many areas in the school have the same issue and need to have the tiles replaced.

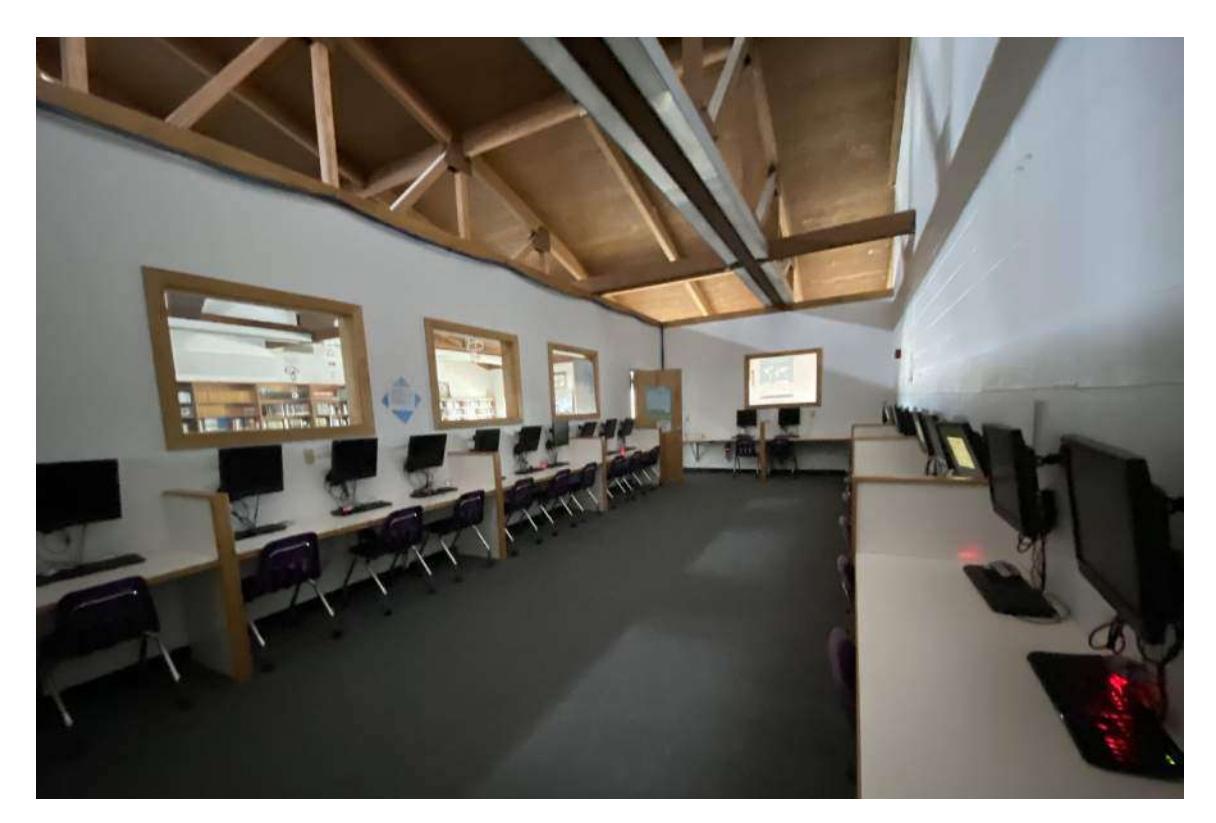
View of computer lab within library space. The large gap above the walls allows sound to travel between spaces.

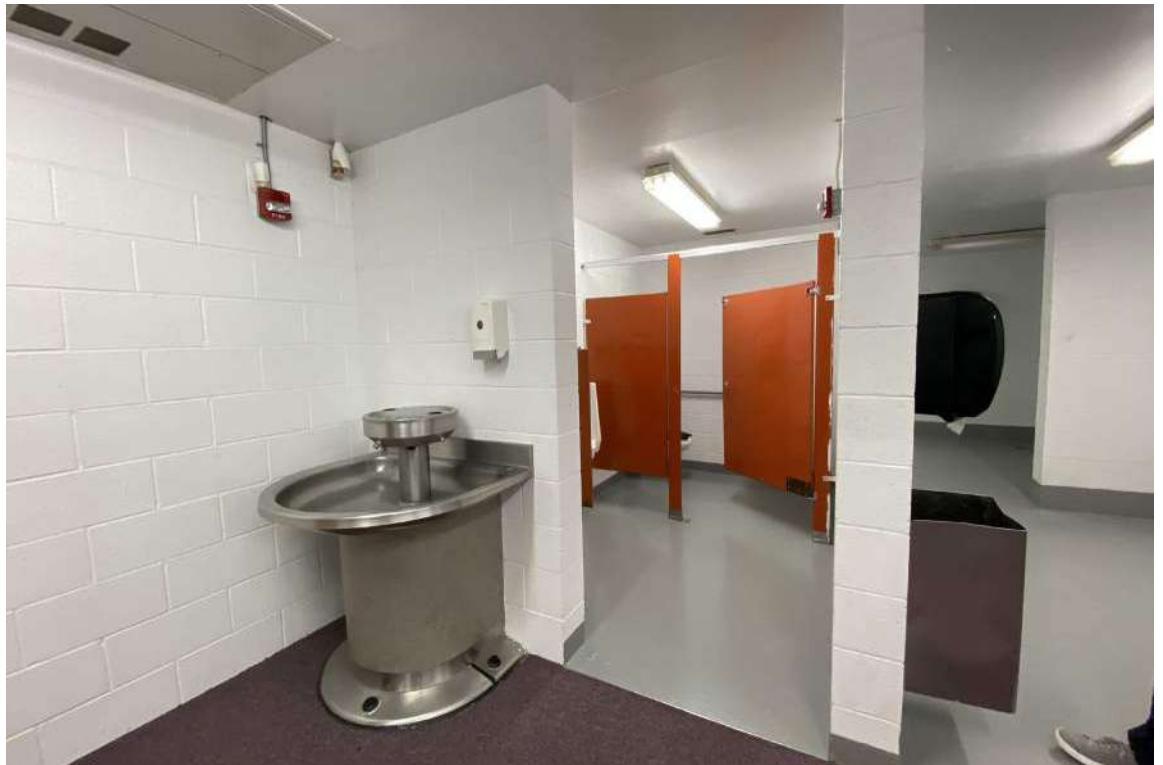
The main floor locker rooms with hand wash station. These stations are designed to serve students around its perimeter, but placement next to the CMU block wall limits access. This reduces the number of required lavatories per the International Building Code (IBC) and amendments per the Administrative Rules of Montana.

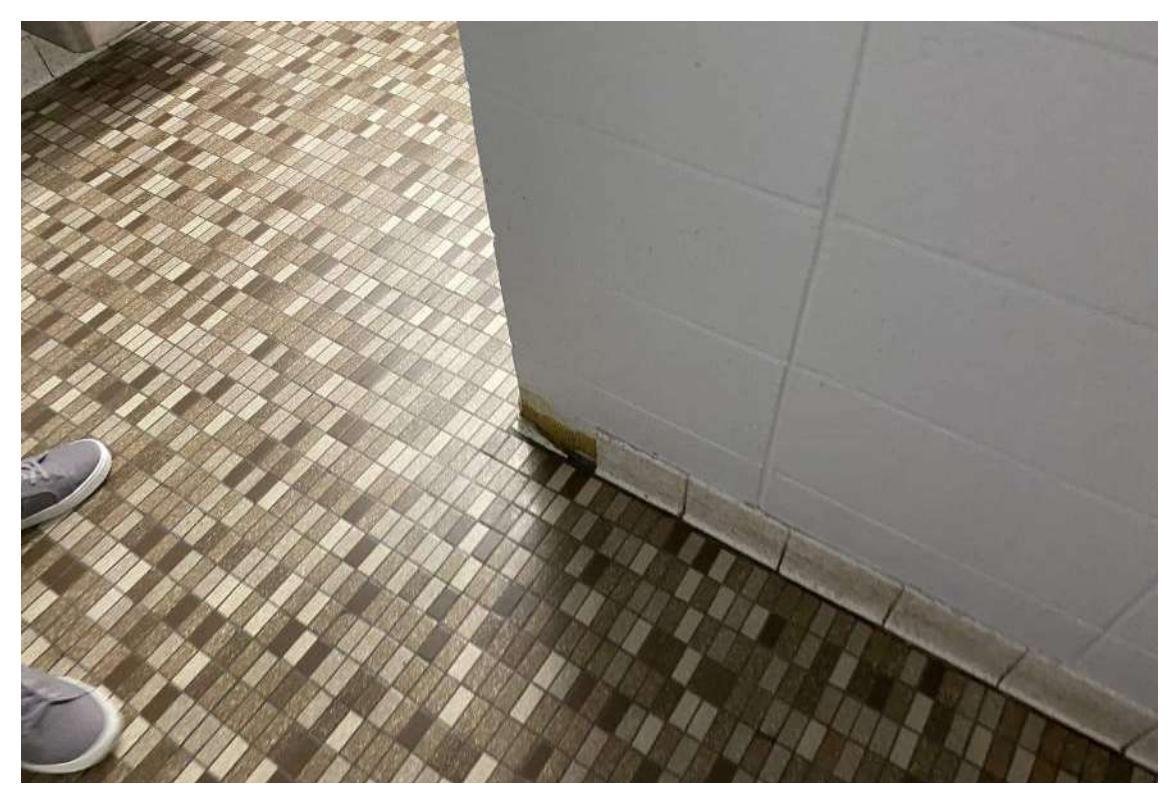
Most restrooms were in good condition, with minor areas of repair needed. However, this CMU block wall makes accessibility difficult for wheelchair users.

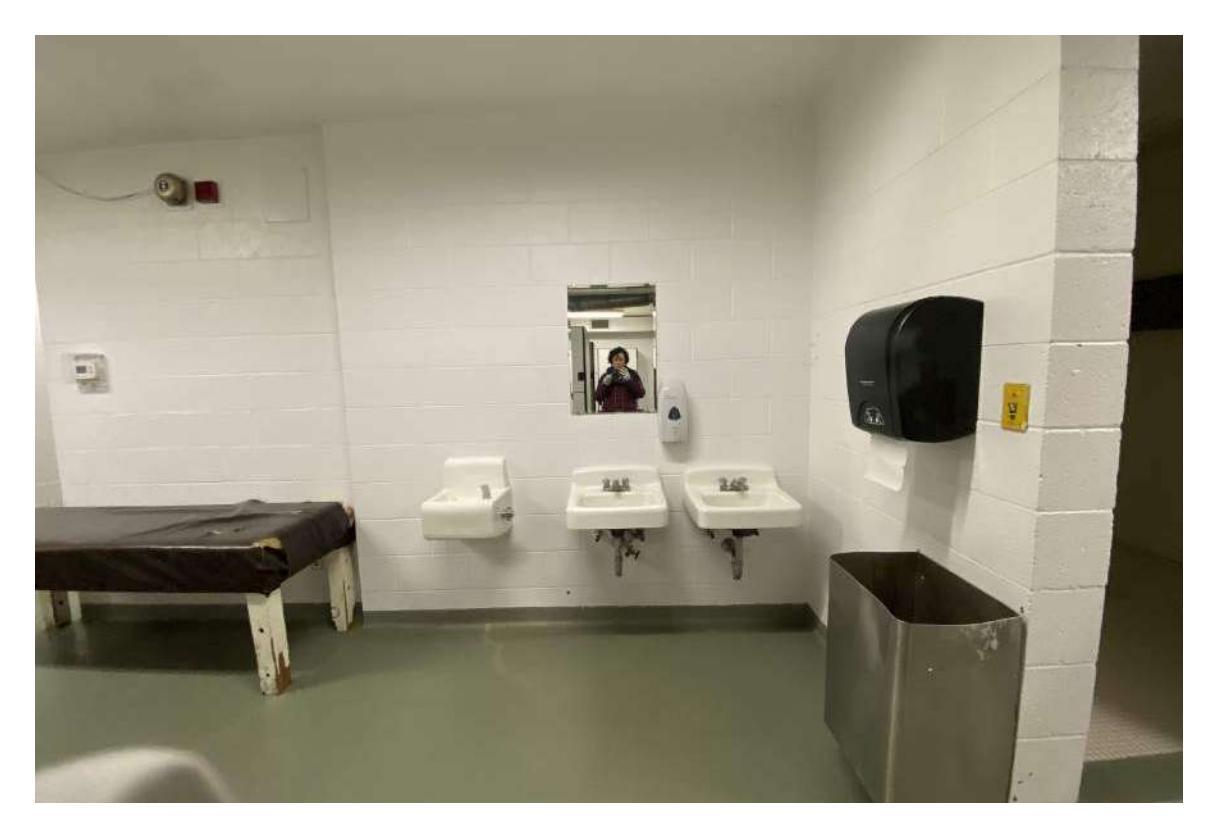
Women's lower level locker room. Floor and walls are in good condition but the training bench is very worn.

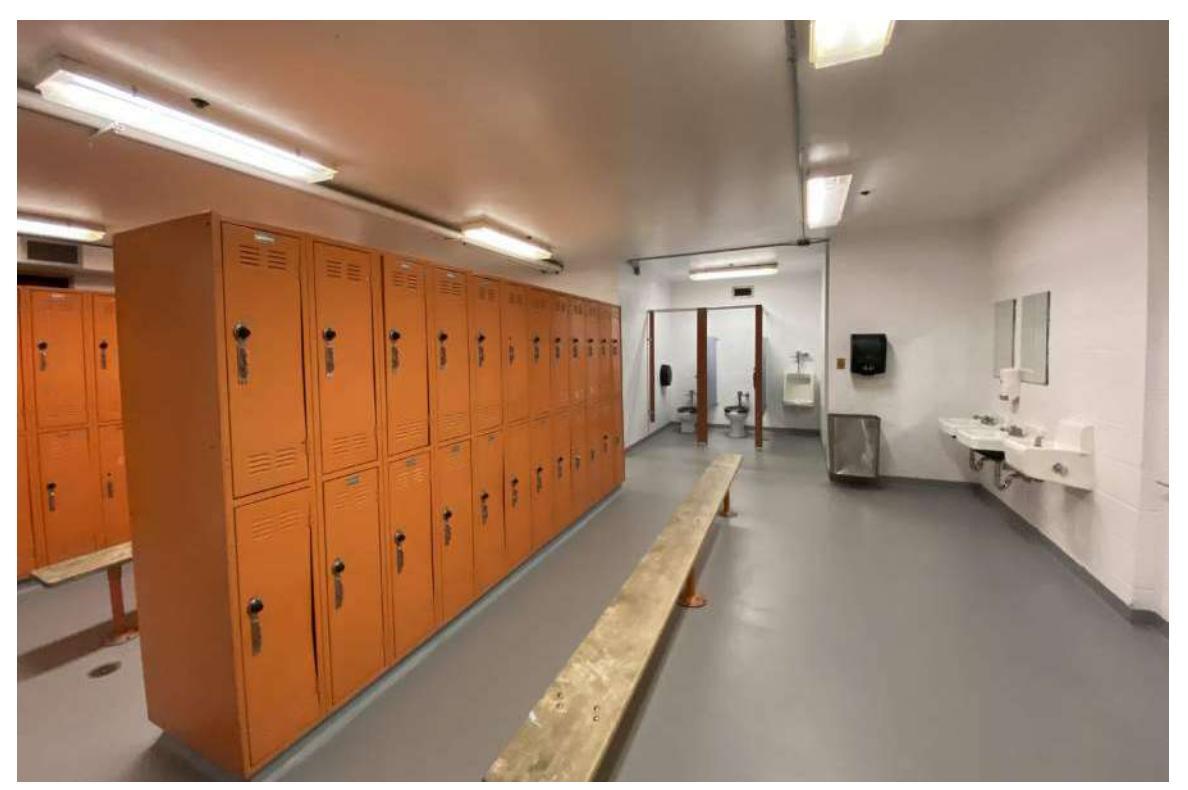
Men's locker room in the lower level of the gym. There are multiple issues in this space, such as accessibility, ventilation problems and doors missing from the stalls. Equipment storage outside this room poses potential Title IX problems.

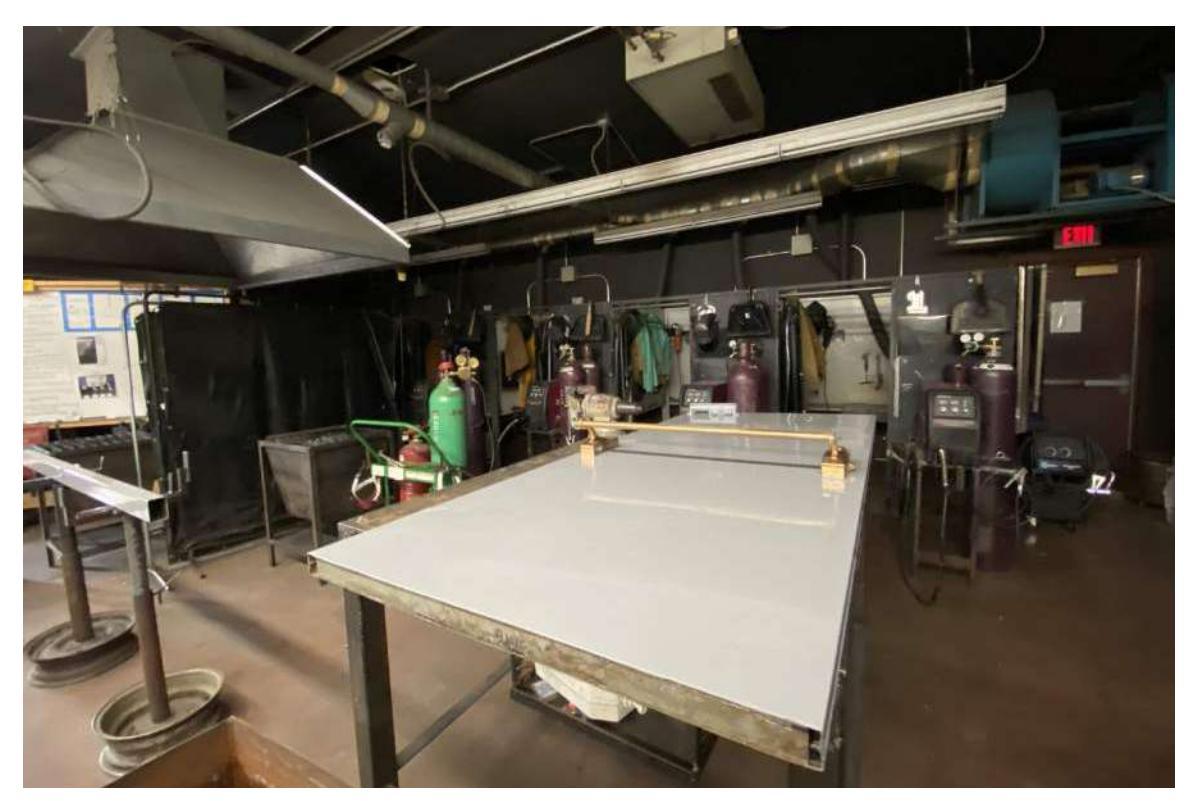
The welding space has a close proximity to the small engines space. Gas fumes are smelled in this room and there are questions of flammability.

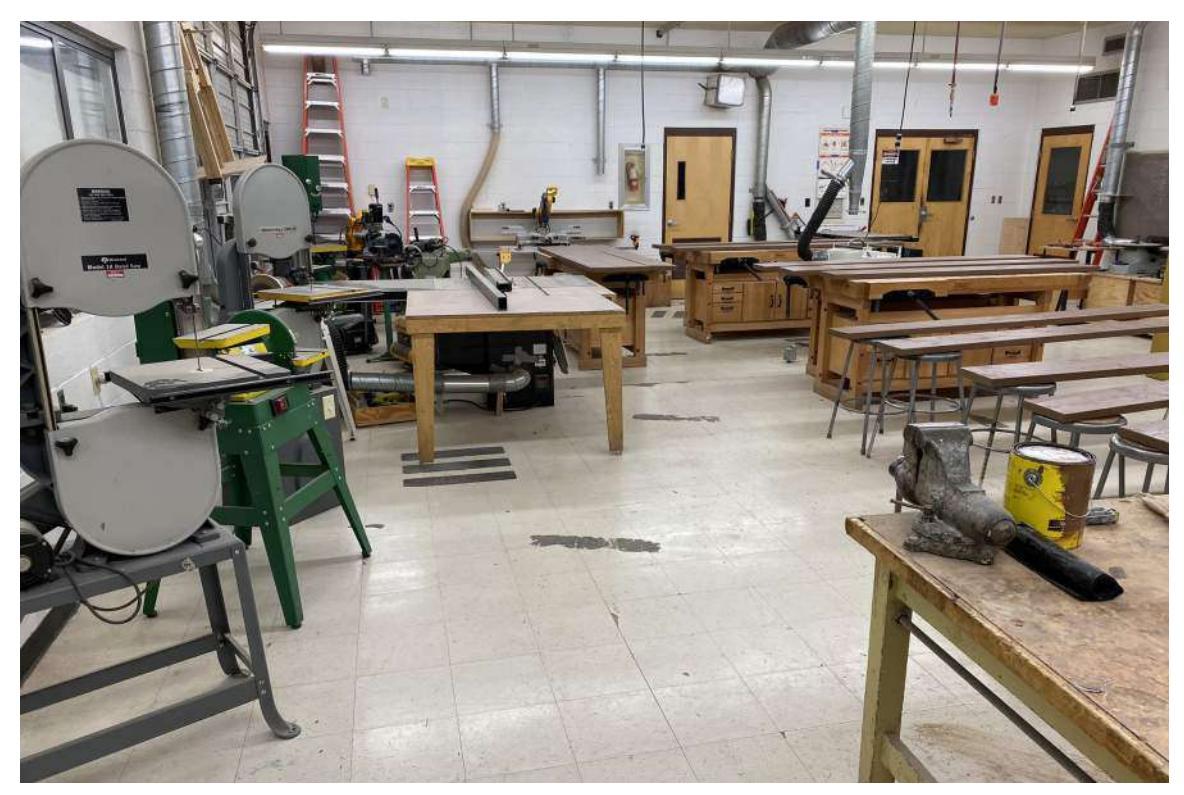
Another view of the shop space. Flooring and tables are worn as expected. The users of this space report slick floor surfaces when covered in sawdust.

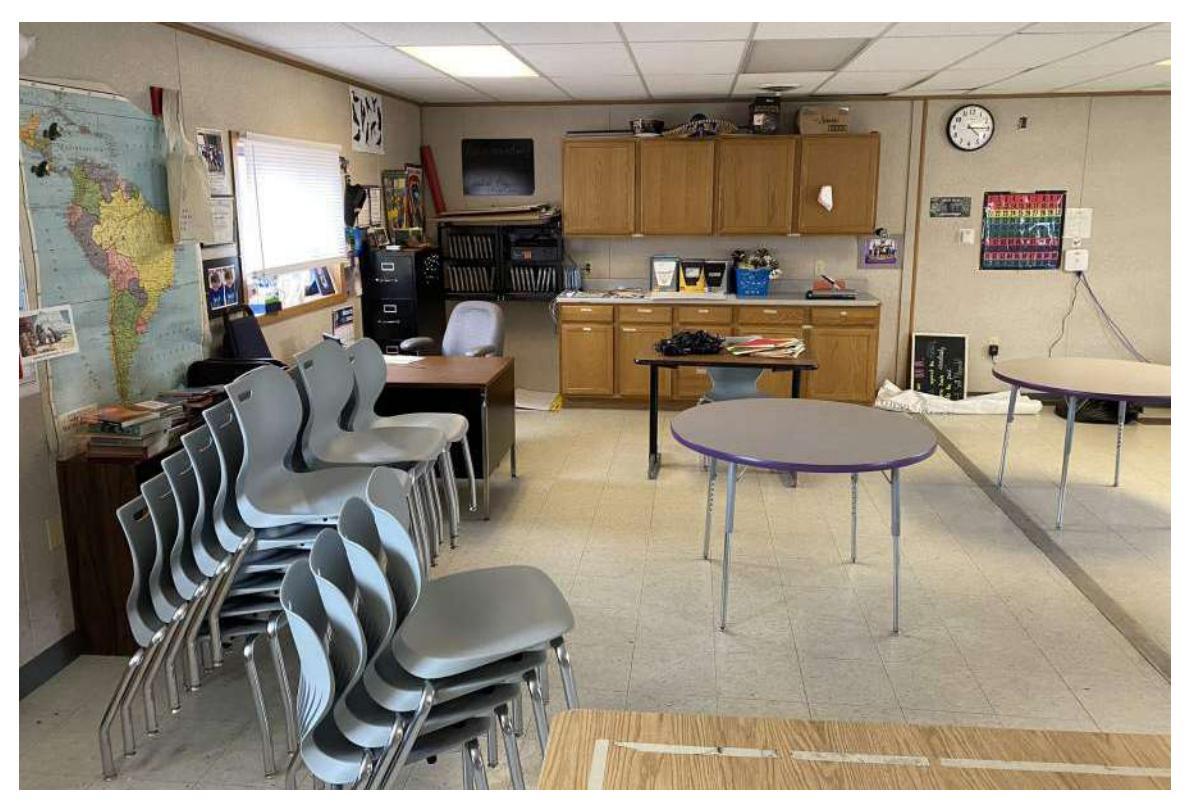
View of one of the modular classrooms. These classrooms are detached from the school building, which poses major security issues.

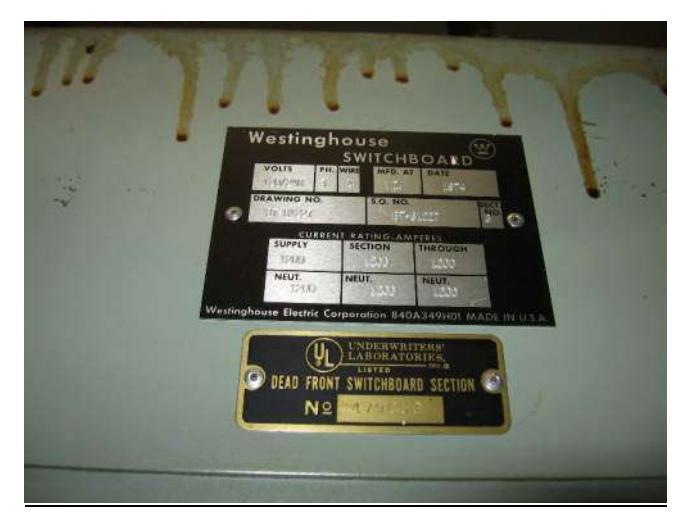
E1: Main Distribution Board showing liquid substance leaking from/onto equipment.

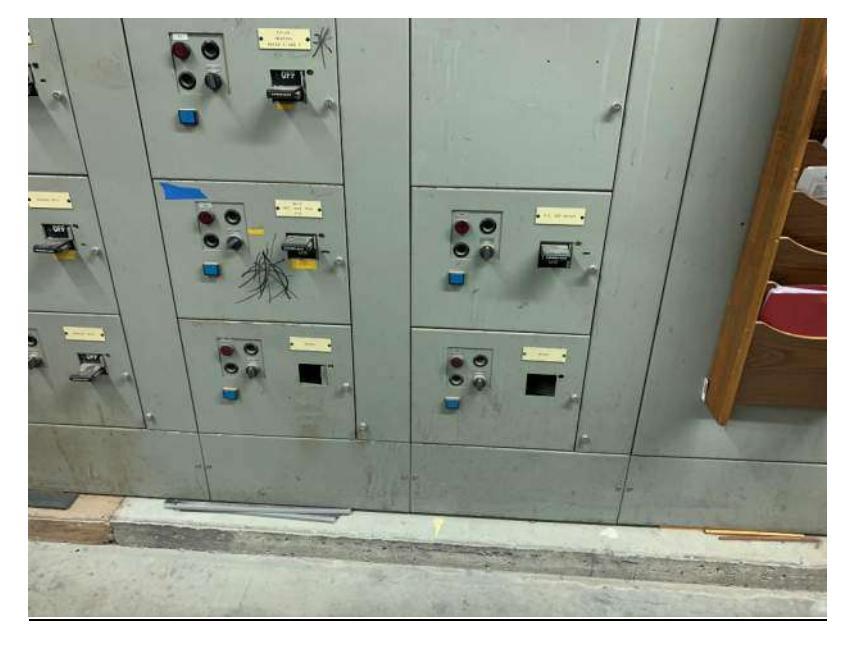
E2: Missing cover plates on MCC buckets need to be repaced.

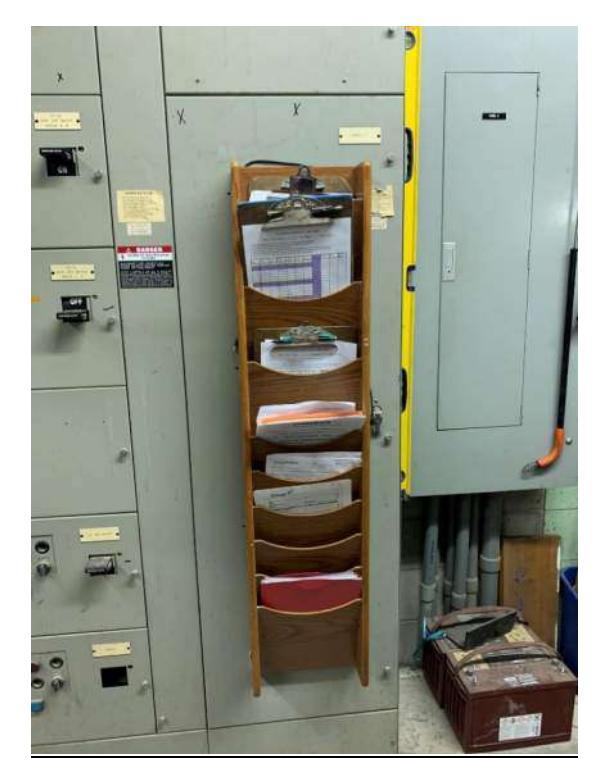
E3: File cabinet mounted to front of Motor Control Center

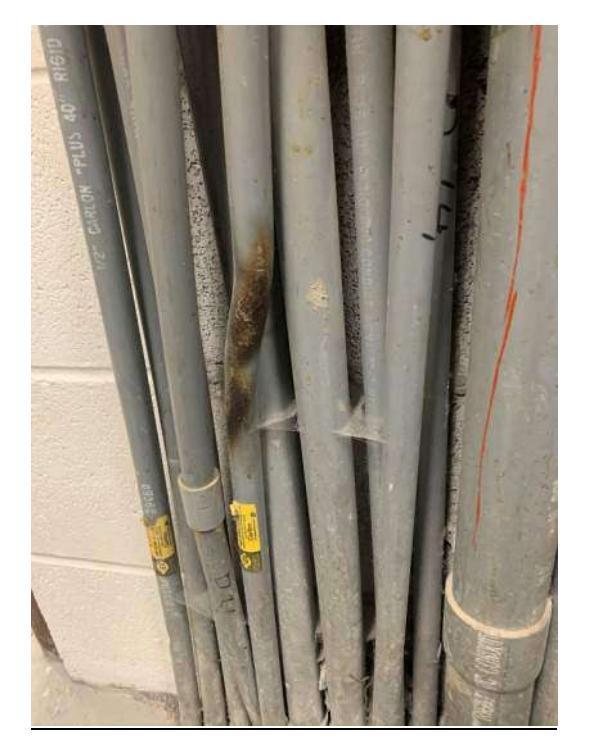
E5: Conduit shows signs of electrical fire and should be investigated by Electrician and replaced.

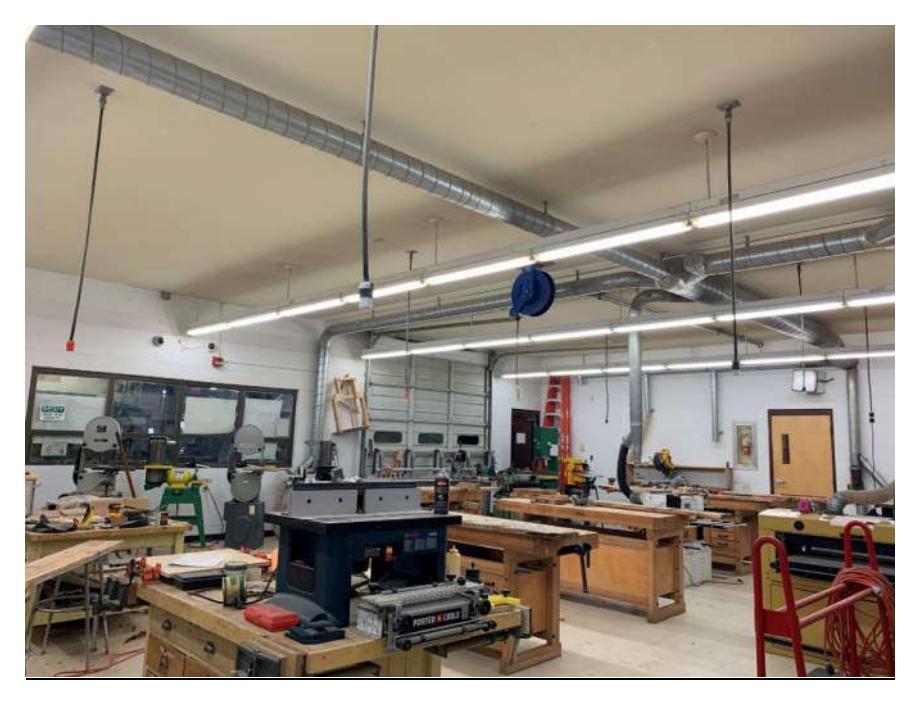
E8: Image of lighting in wood shop.Wire Guards are recommended.

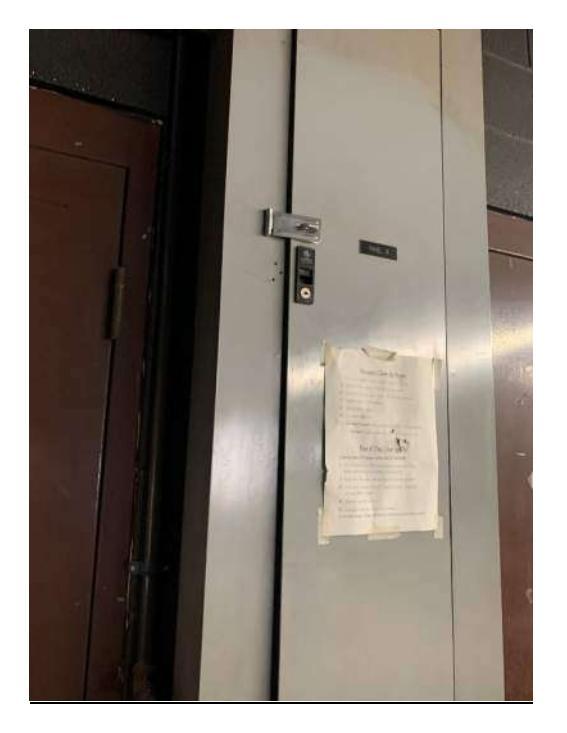
E9: Panel in Metal shop with door latch not properly working.
