Jefferson High School Building Condition Report

312 S Main Street, Boulder, Montana 59632 July 30, 2020

| BUILDING CONDITION REPORT |

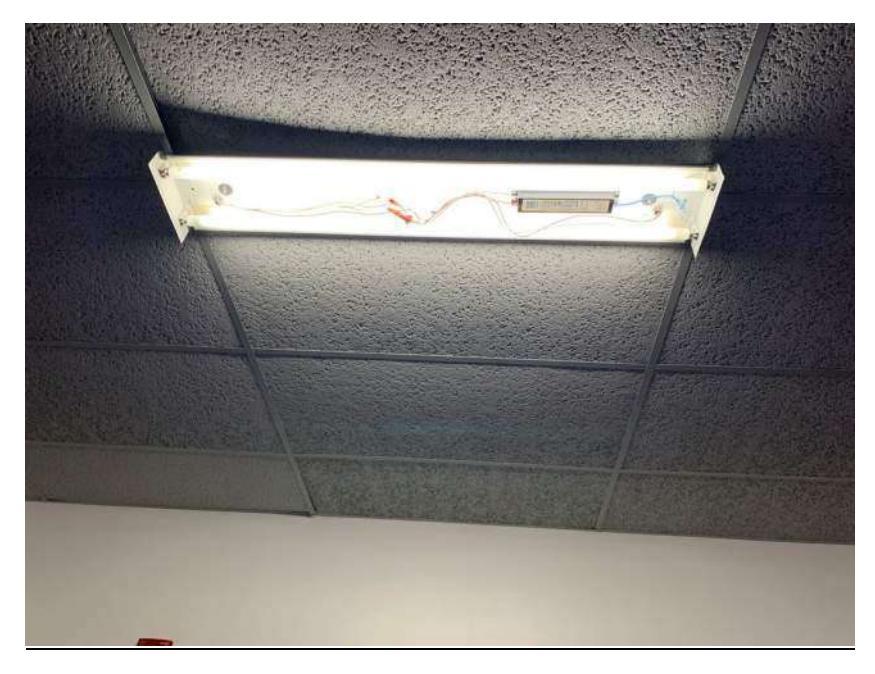
E12: Light in Locker room missing lens

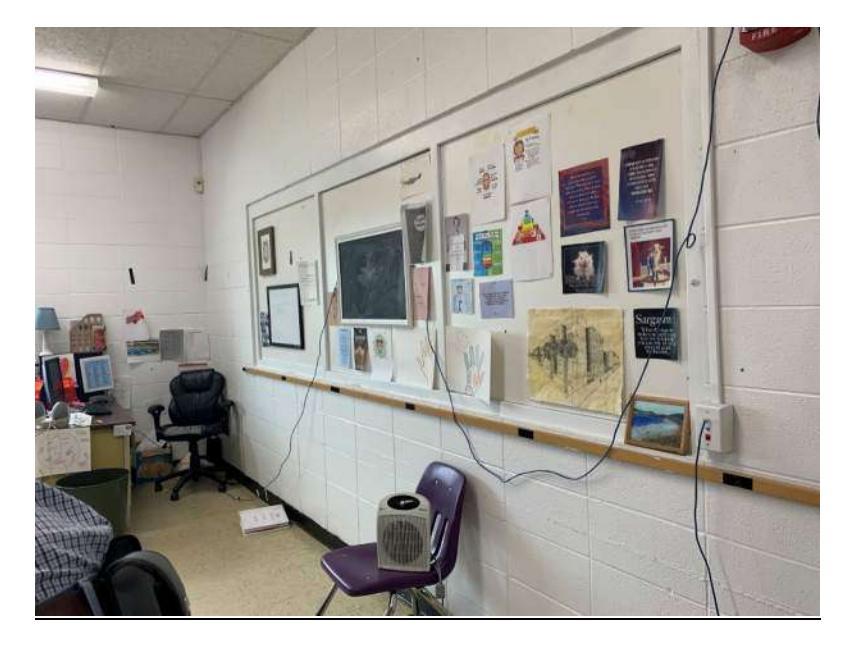
E13: Communication cable draped across teaching wall to desk.

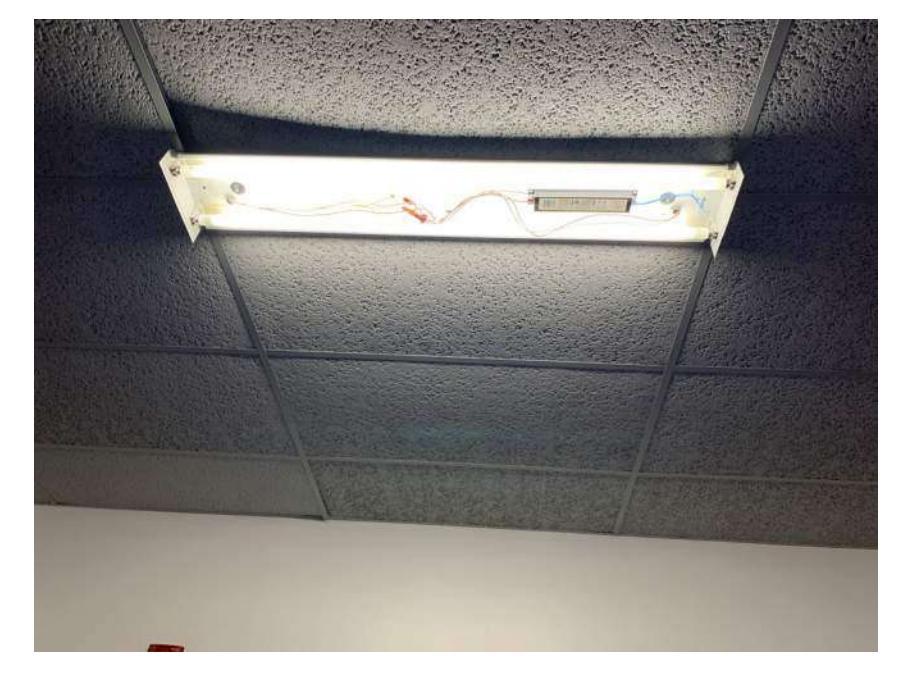
E15: Damaged fixture in weight room.

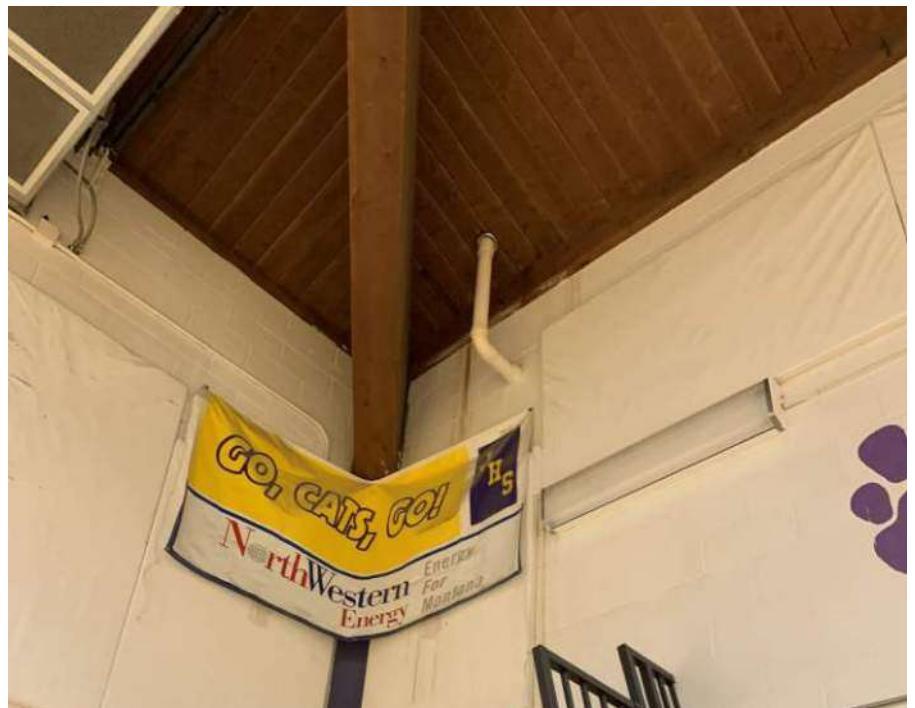
Figure 4. Water Stains on south CMU wall of 1985 Gym

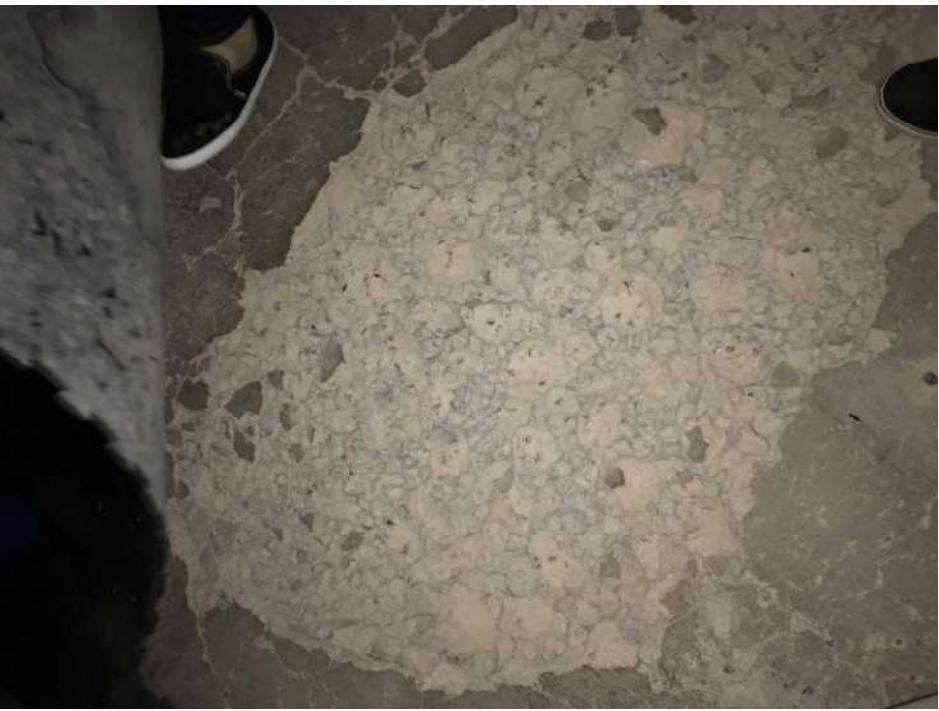
Figure 5. Deteriorated Concrete Floor Slab in Weight Room (1985 Addition)

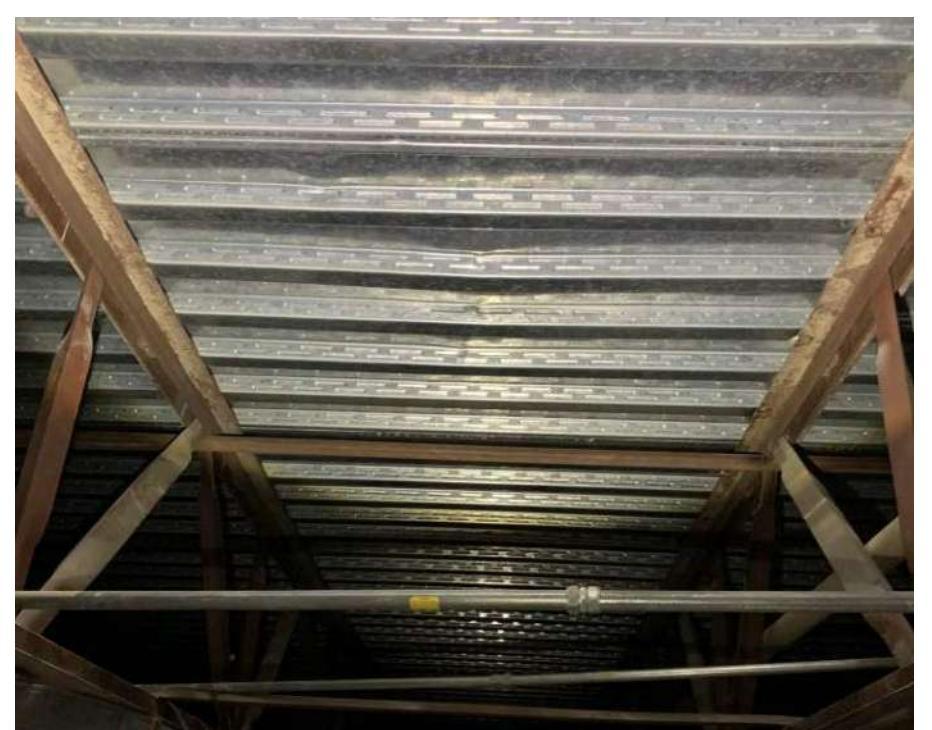
Figure 6. Deformed Metal Deck Below Weight Room (1985 Addition)

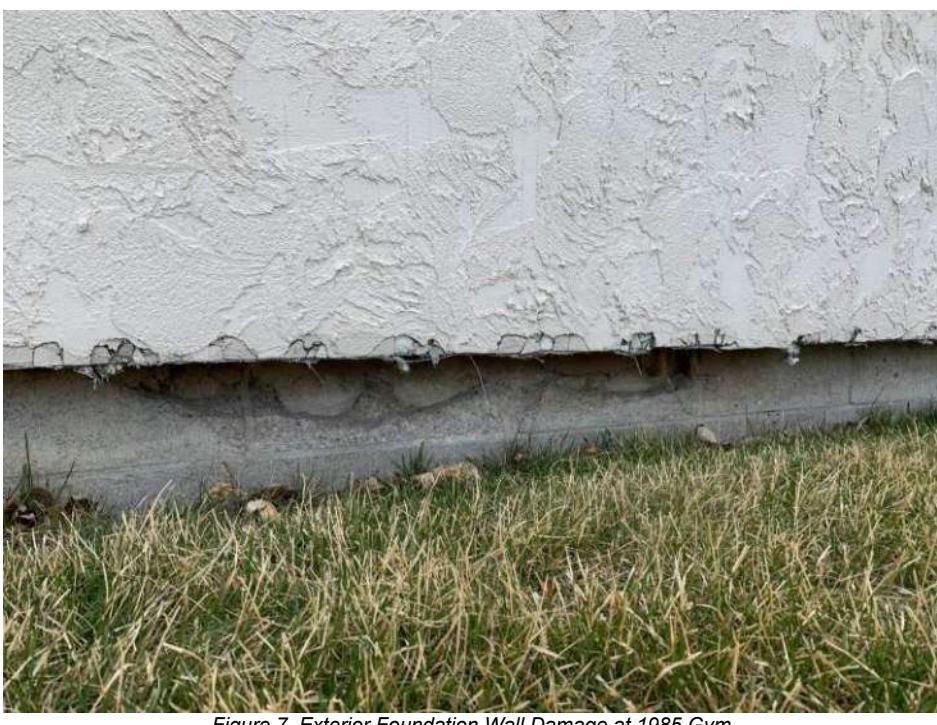
Figure 7. Exterior Foundation Wall Damage at 1985 Gym

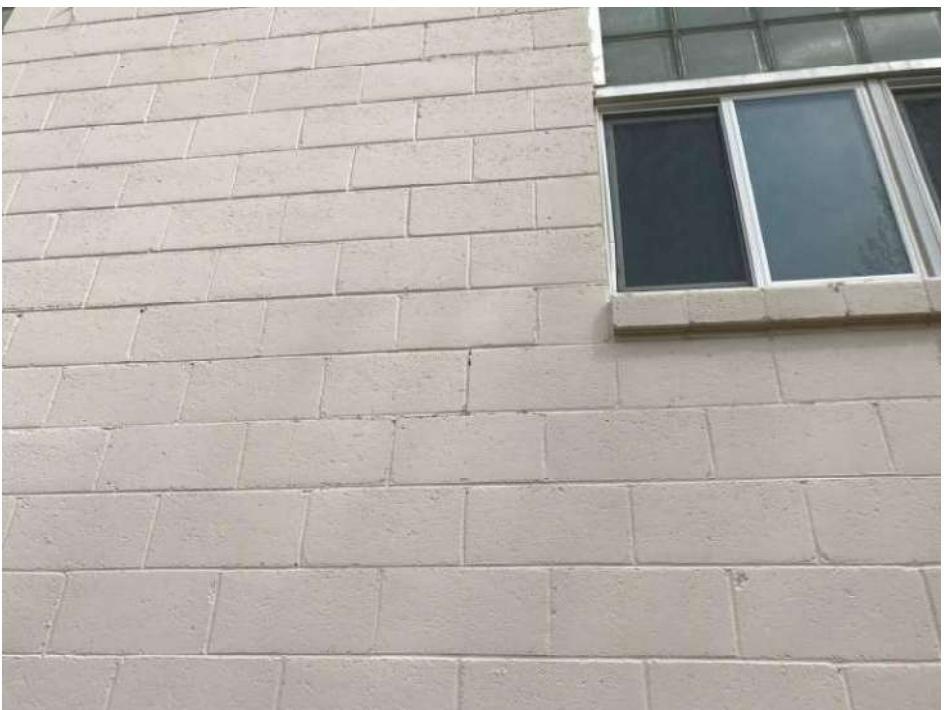
Figure 18. Cracking in Exterior Wall Along Mortar Joints (1956 Addition)

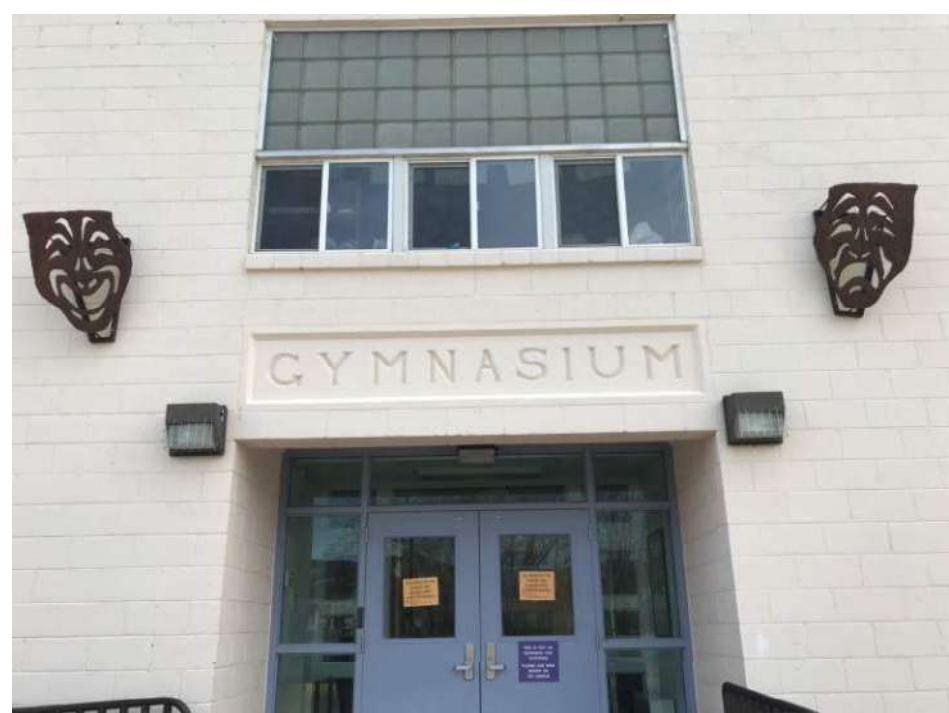
Figure 19. Cracking in Exterior Wall Around Plaque (1956 Addition)
