Performance of Thin Jointed Concrete Pavements Subjected to Accelerated Traffic Loading

4th INTERNATIONAL CONFERENCE ON ACCELERATED PAVEMENT TESTING

Minnesota Department of Transportation

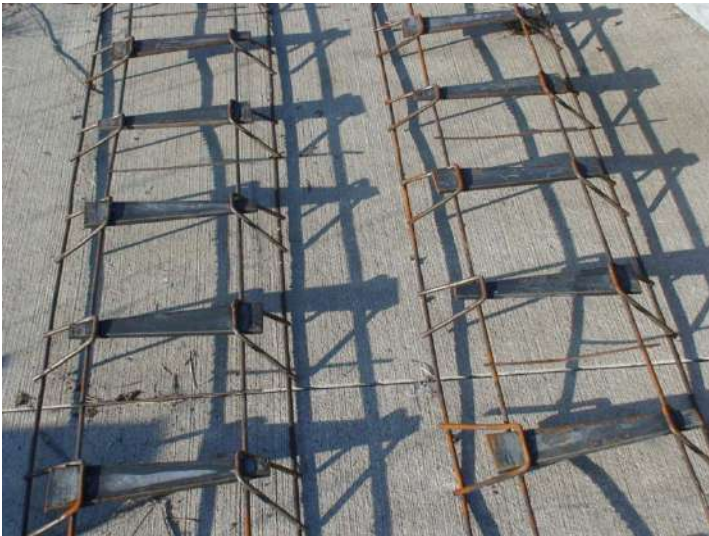
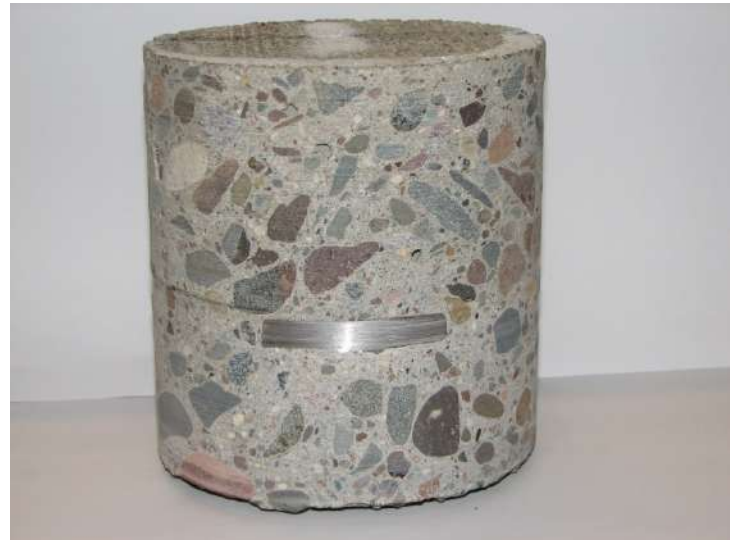
Joint Load Transfer Devices

- ❑ Standard 25 mm (1") dia. x 381 mm (15") long epoxy coated steel dowels for Cells 113-413
 - ACI 302.1R-04 recommends against 25mm dowels in slabs < 178 mm (7") thick
 - This experiment > recommendations in all test cells

- ❑ Plate dowels for Cell 513
 - 9.5 mm (3/8") x 305 mm (12") long tapered width

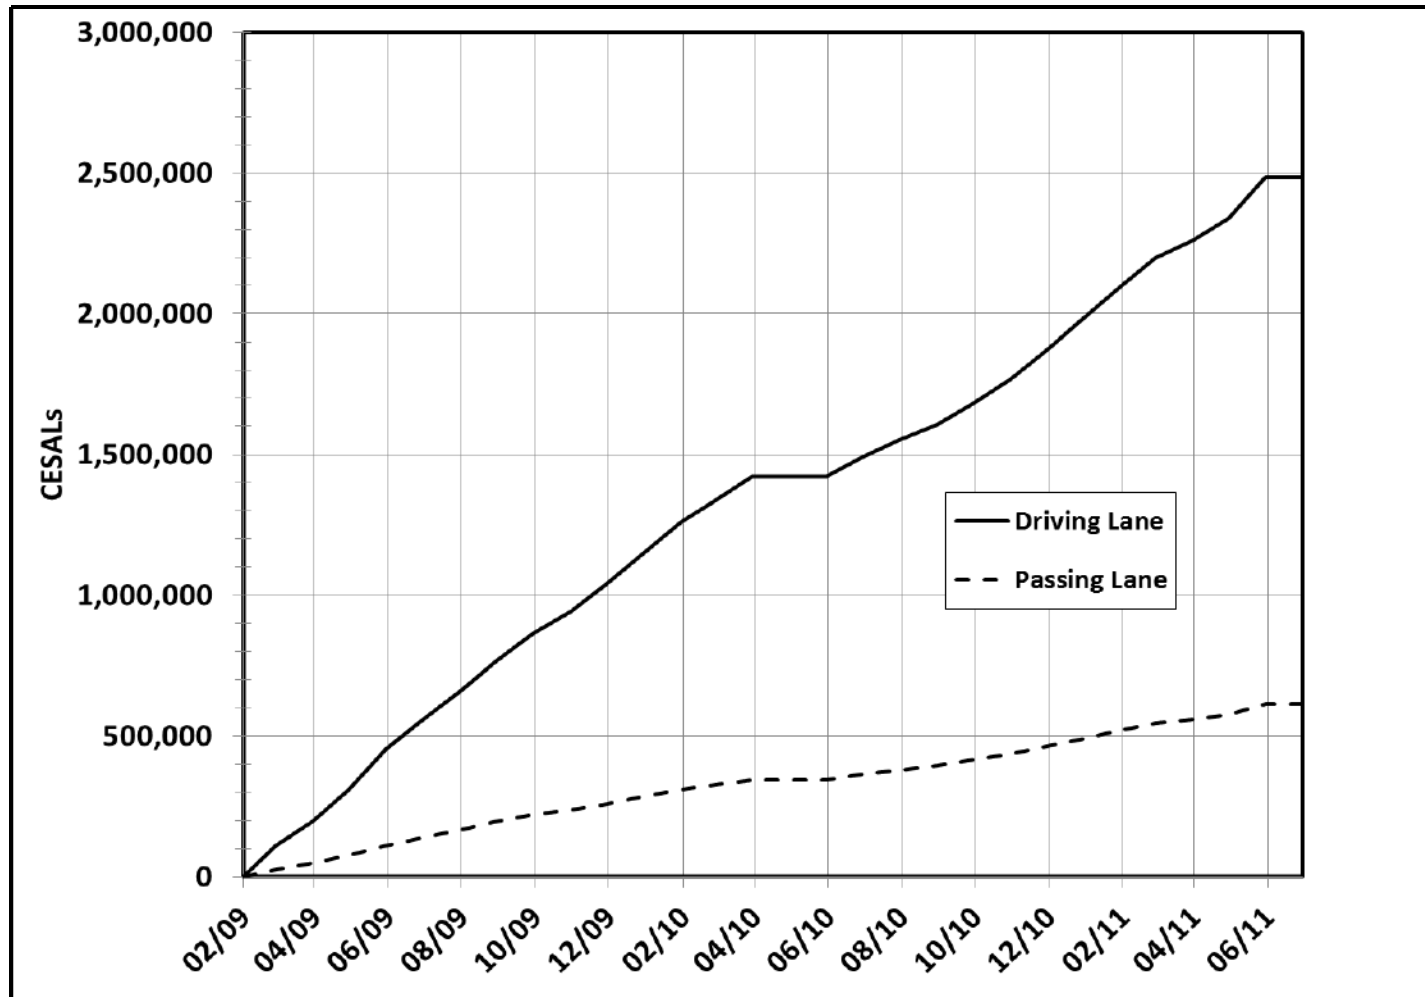
MnROAD Traffic Load History

Live interstate traffic = “Accelerated” for thin PCC designs

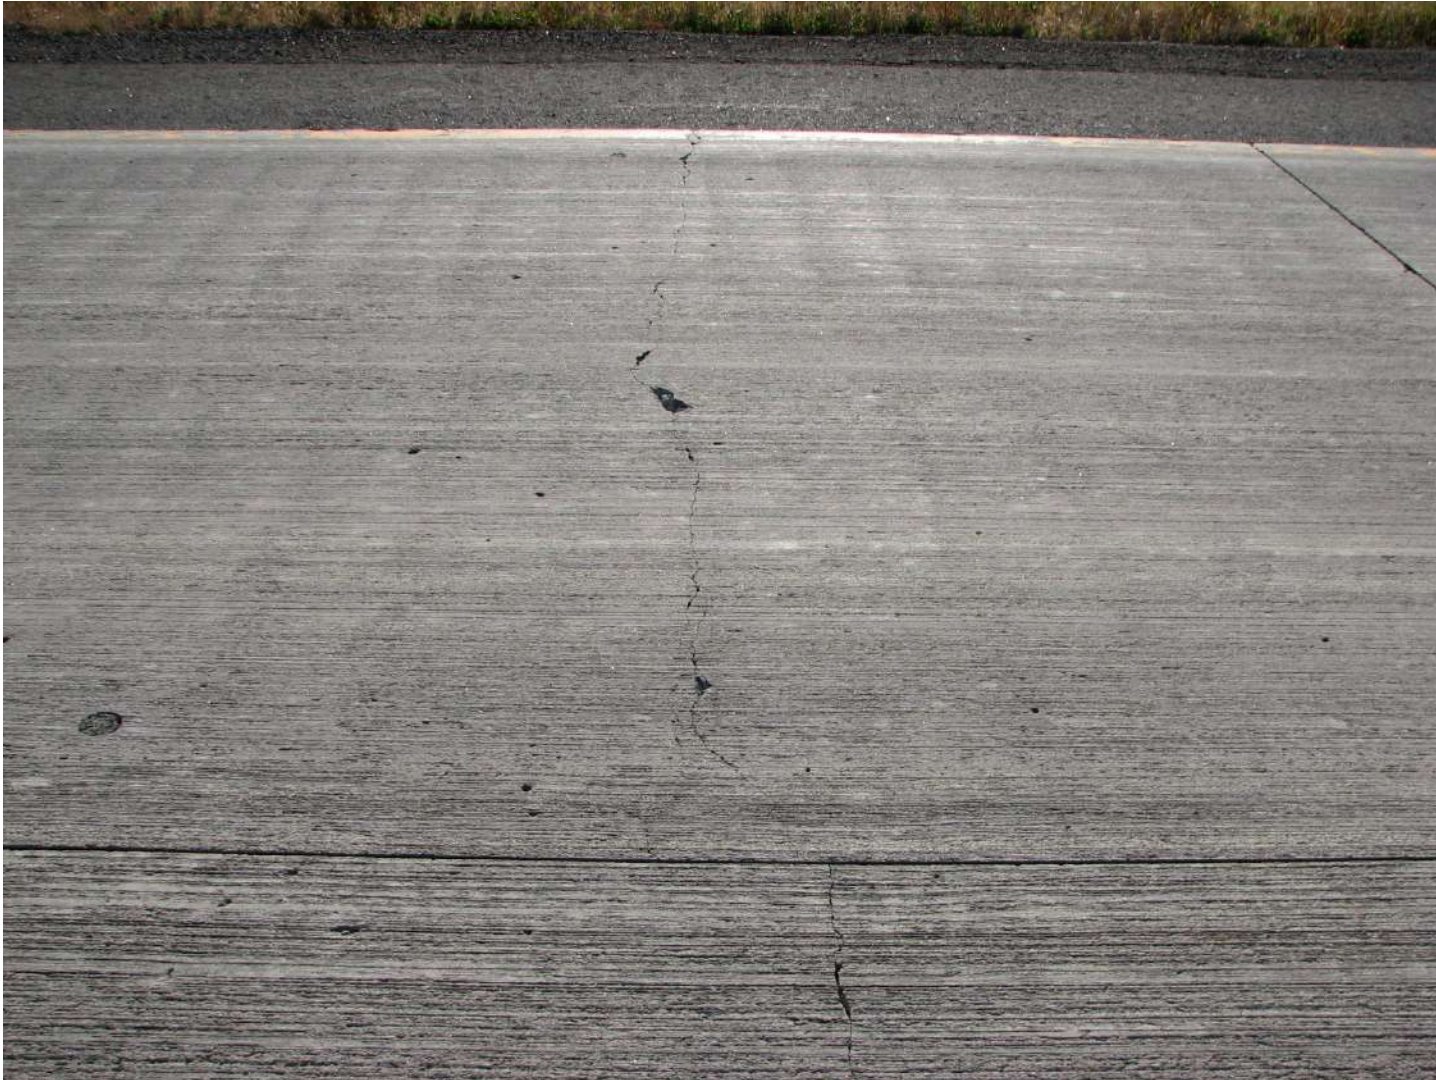
Cell 213 transverse crack, Oct 2010

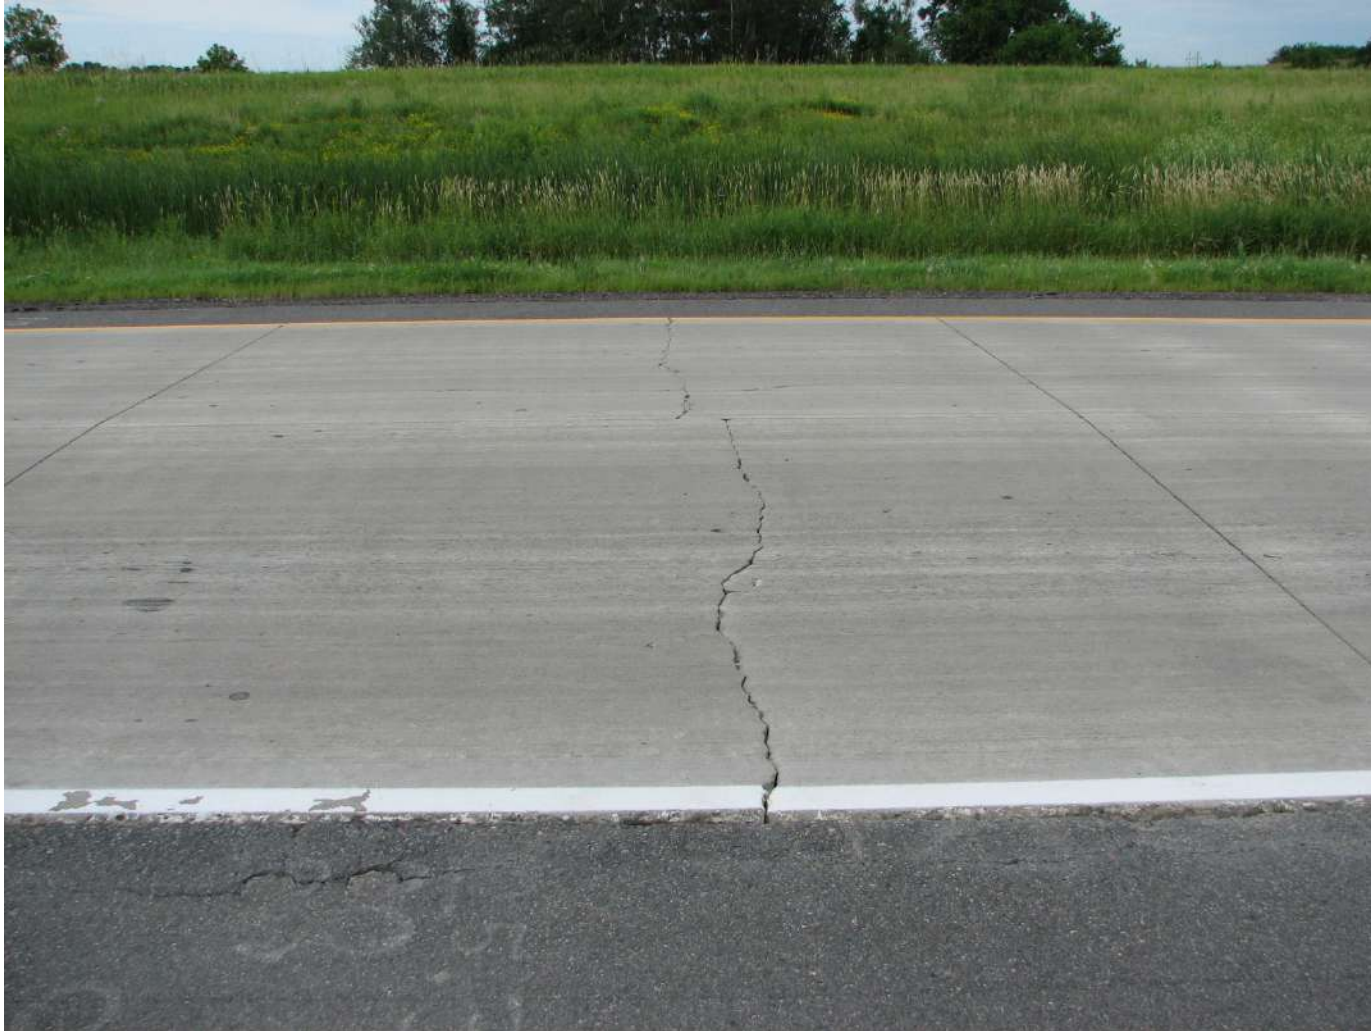
Cell 213 transverse crack, Oct 2011

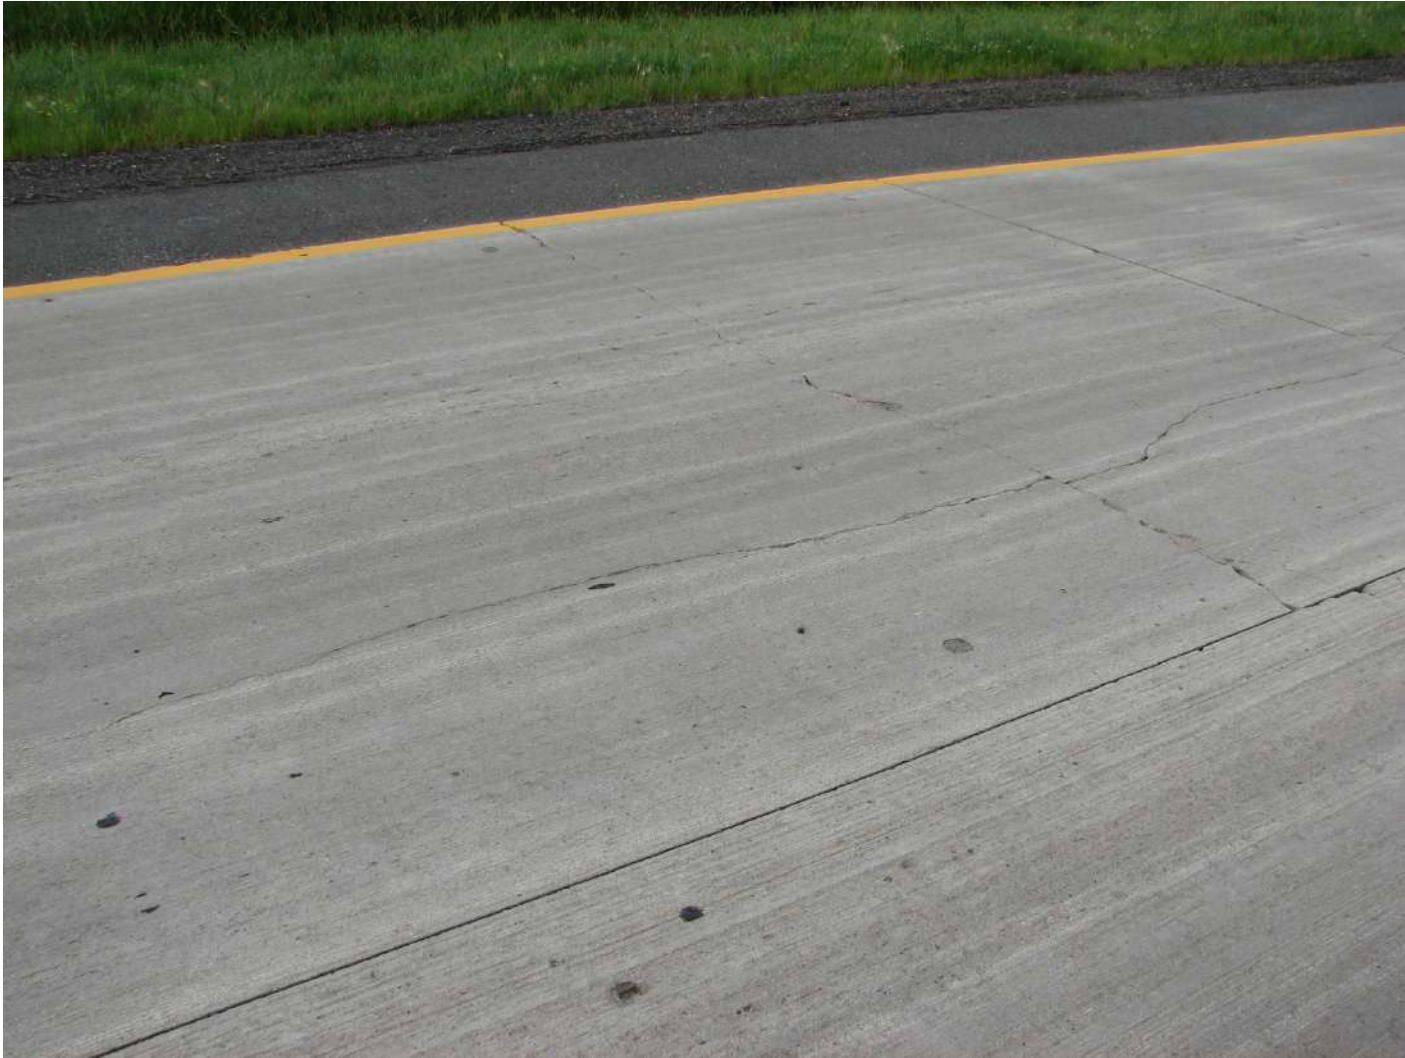
Cell 213 passing lane cracks, July 2011

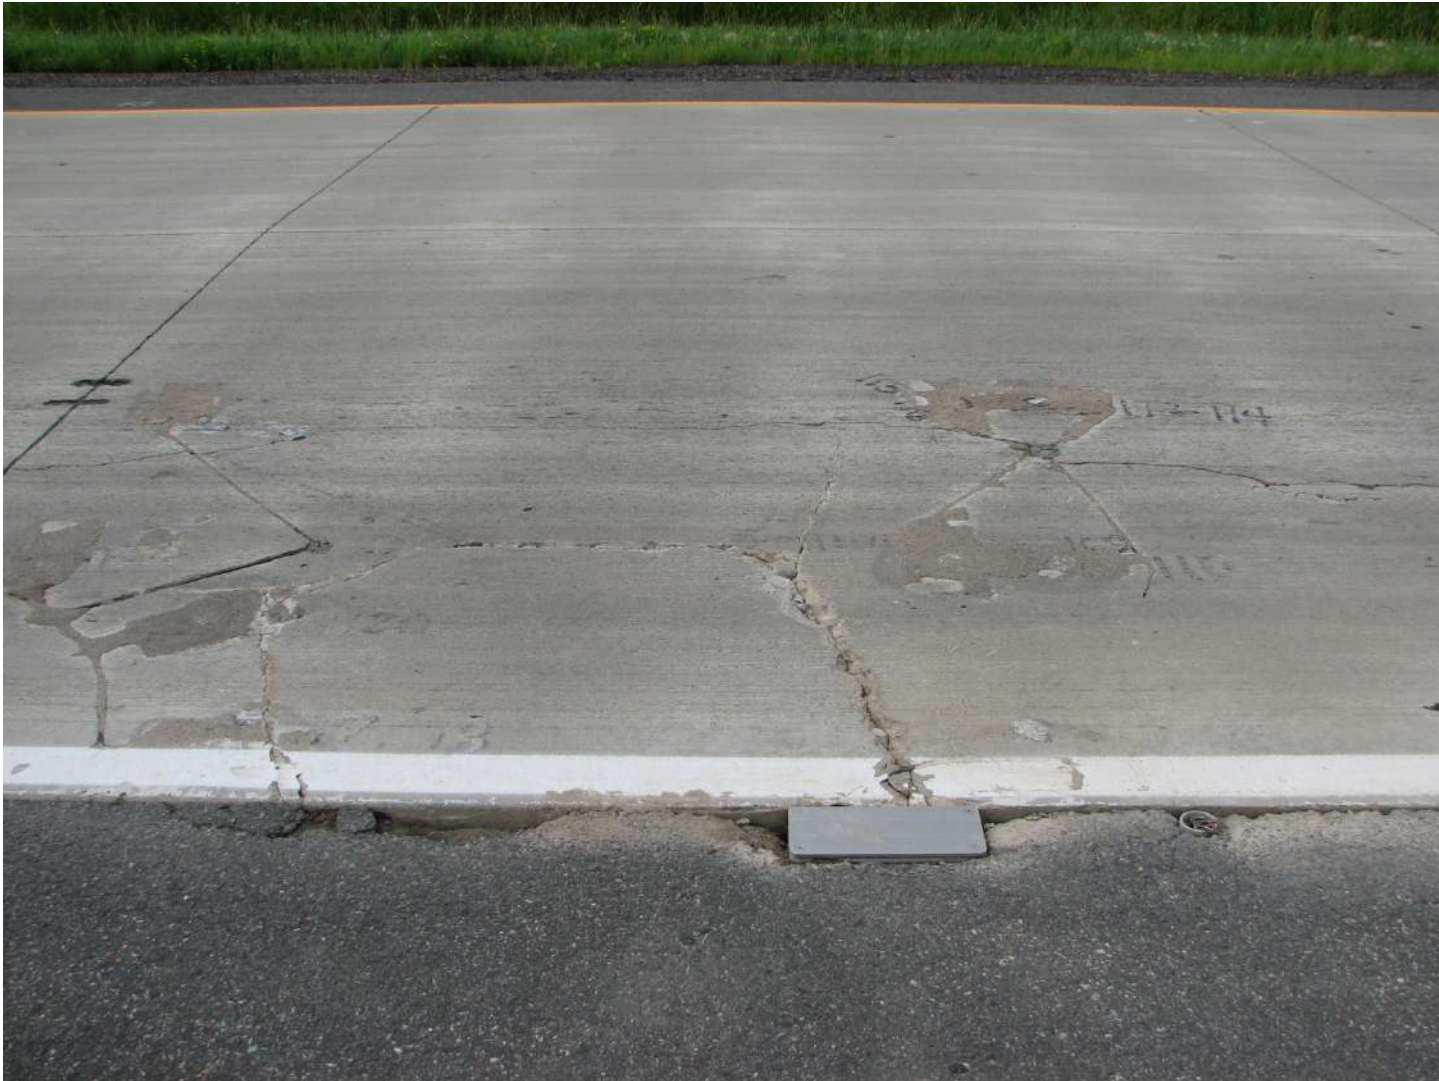
Cell 113 cracks in sensor area, July 2011

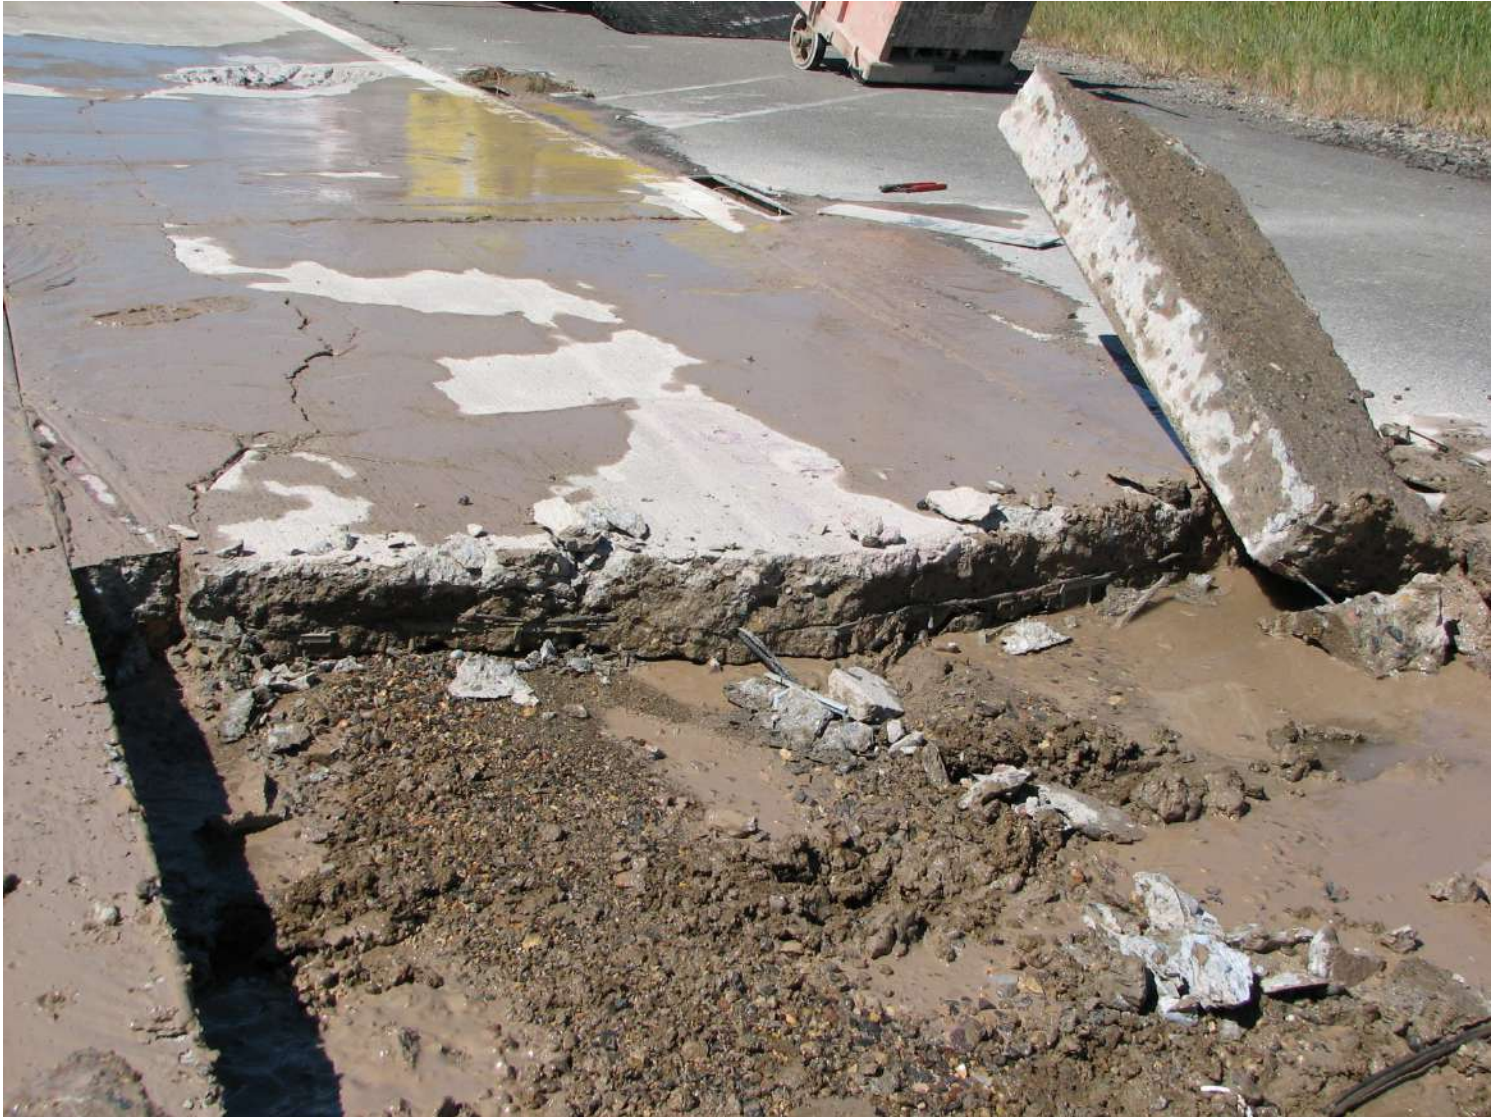
Distress from sensor leads?

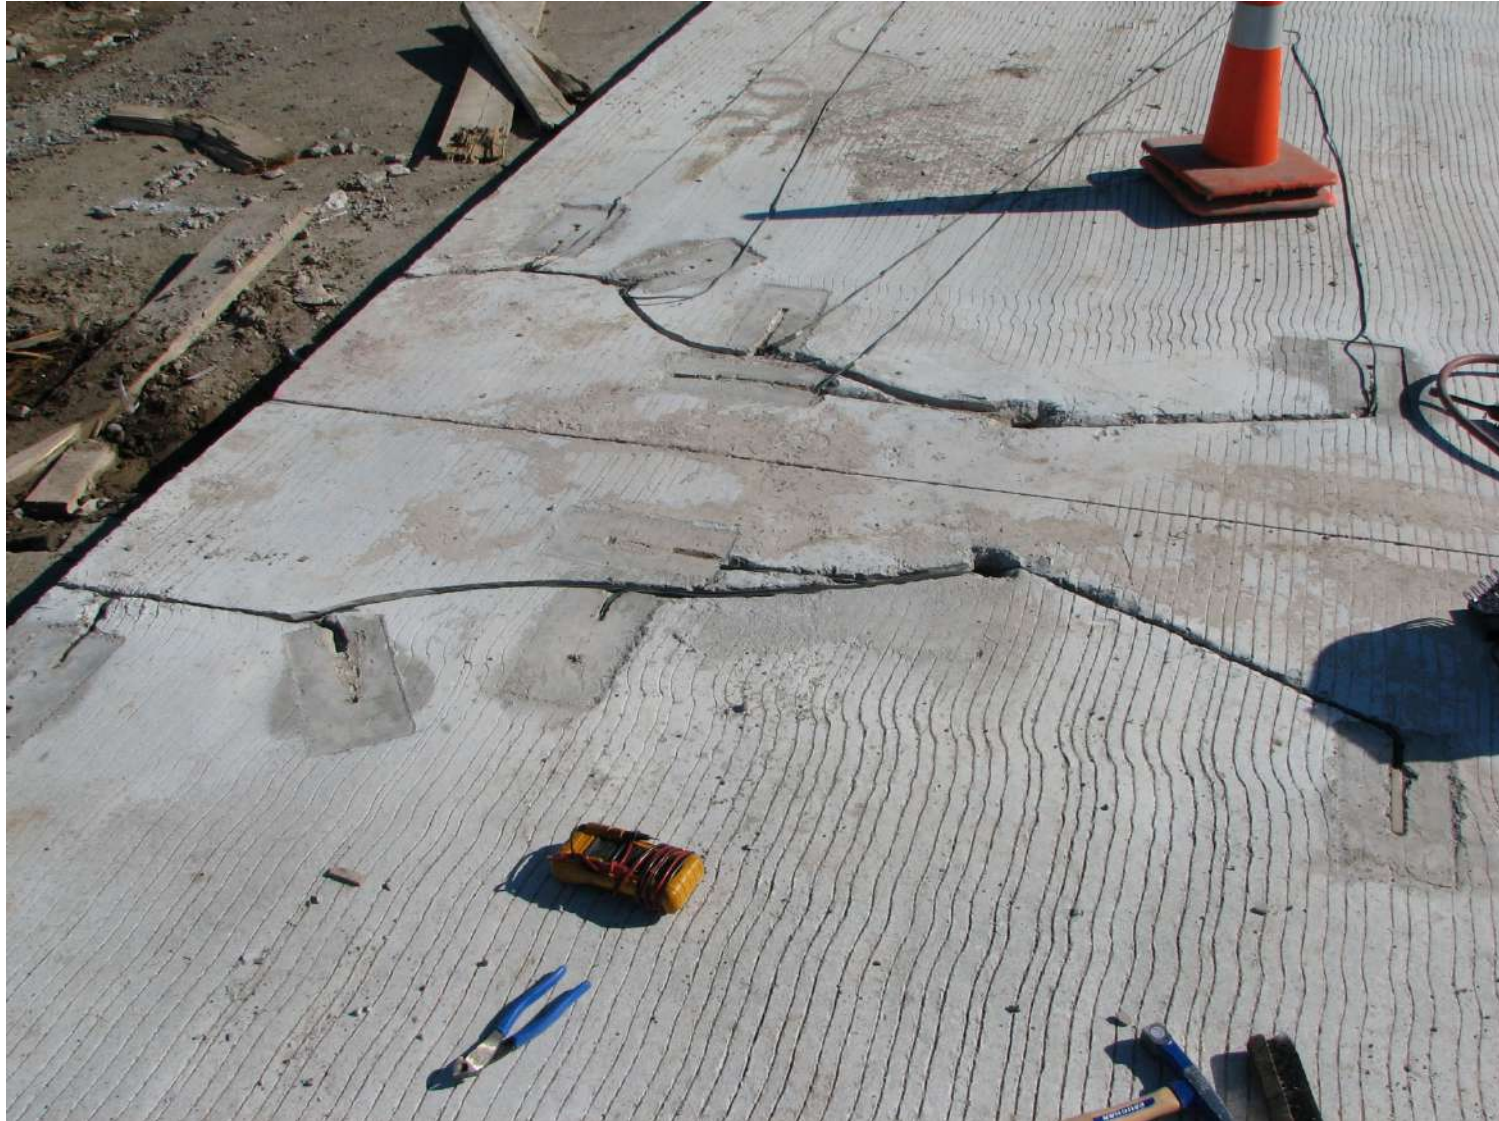
New Sensor Installation Technique

Sensor indicates when cracking occurred

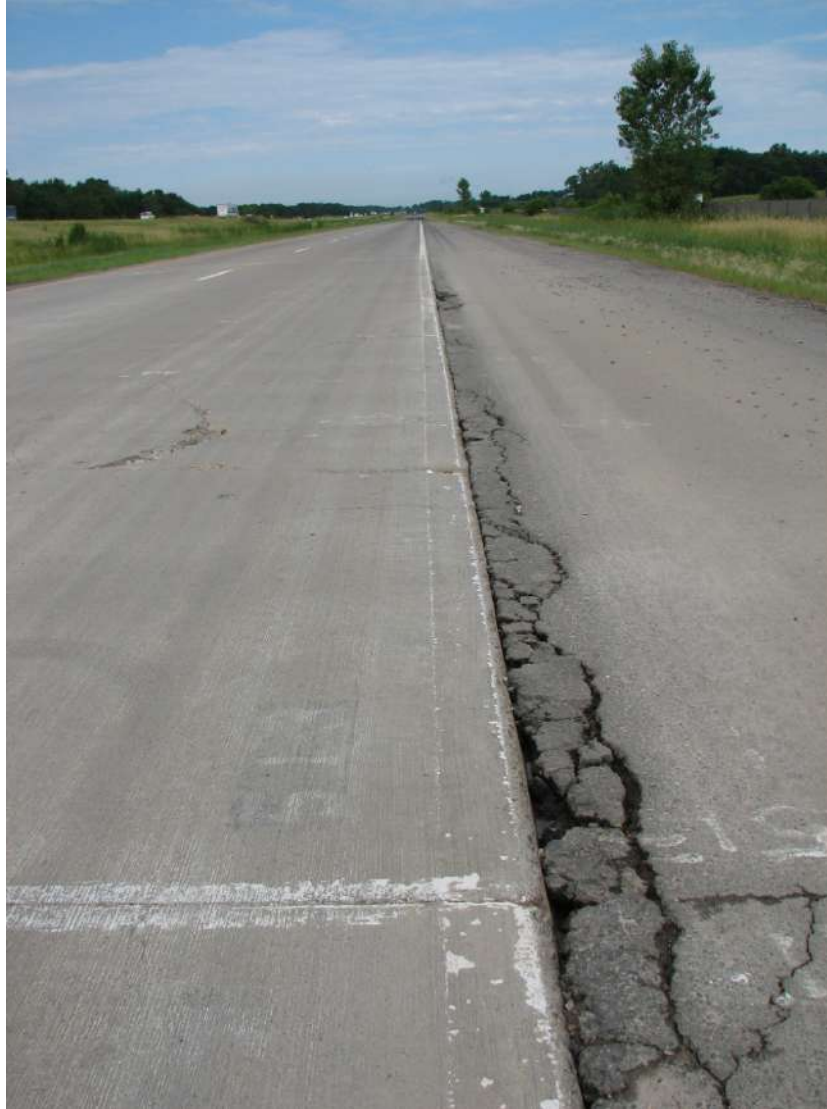
Pumping from shoulder joint, July 2011

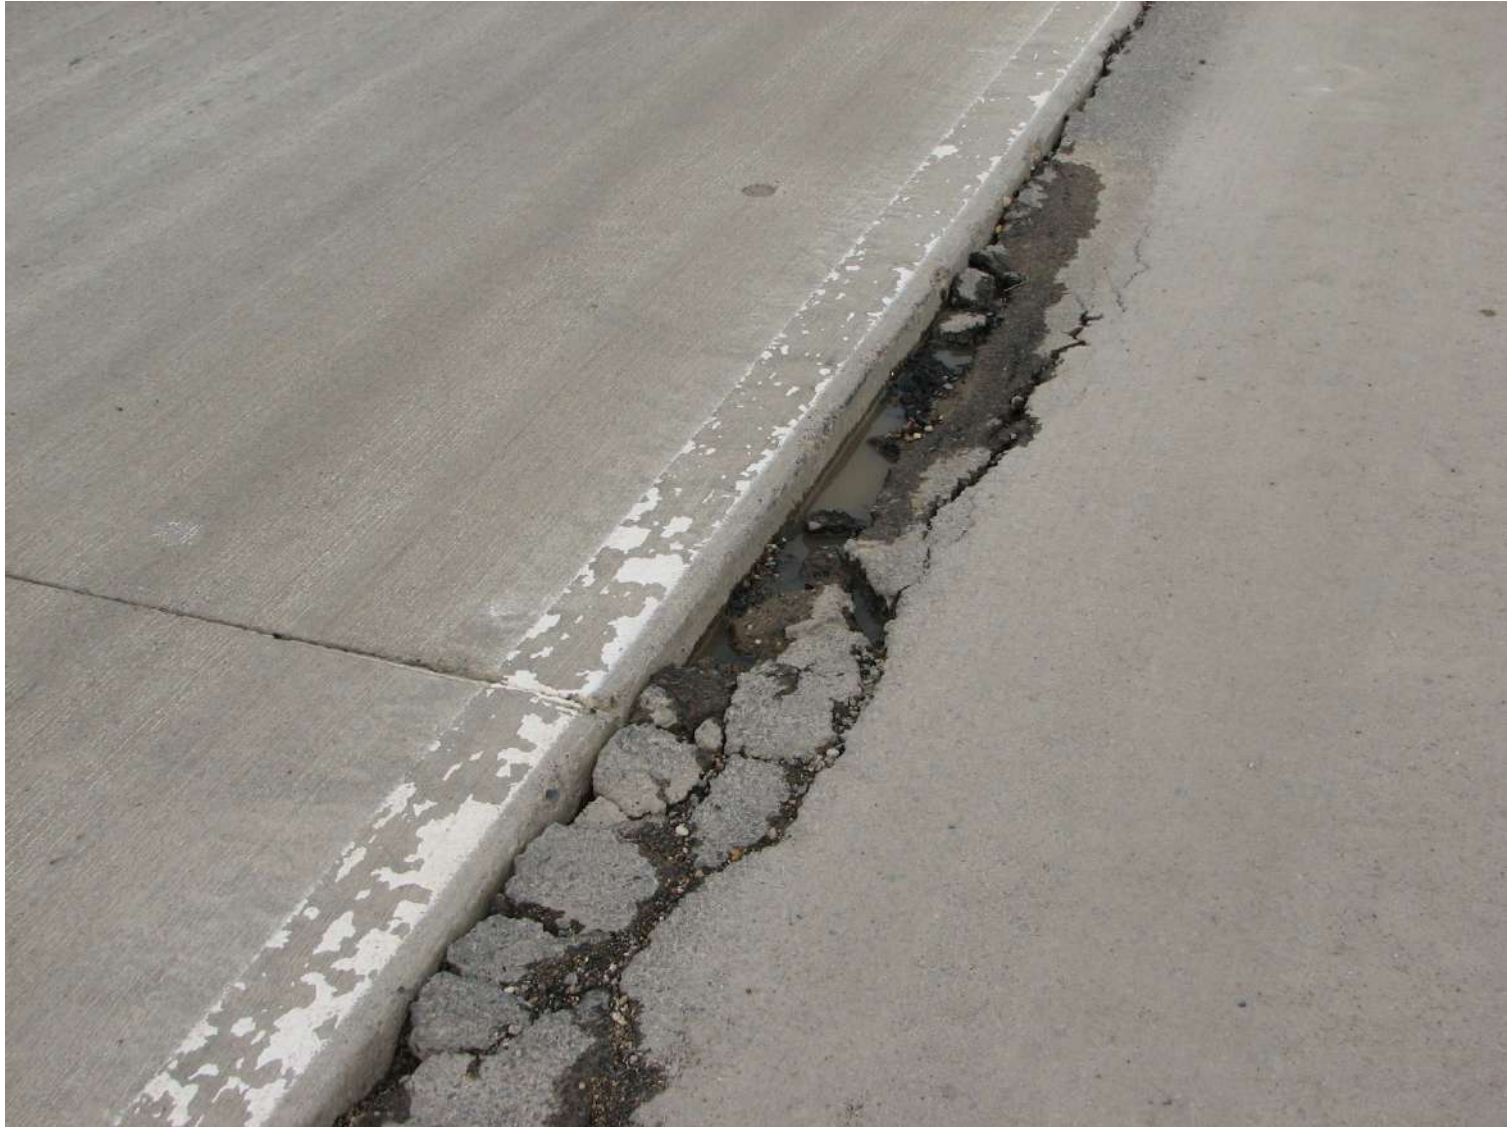
Slow draining base

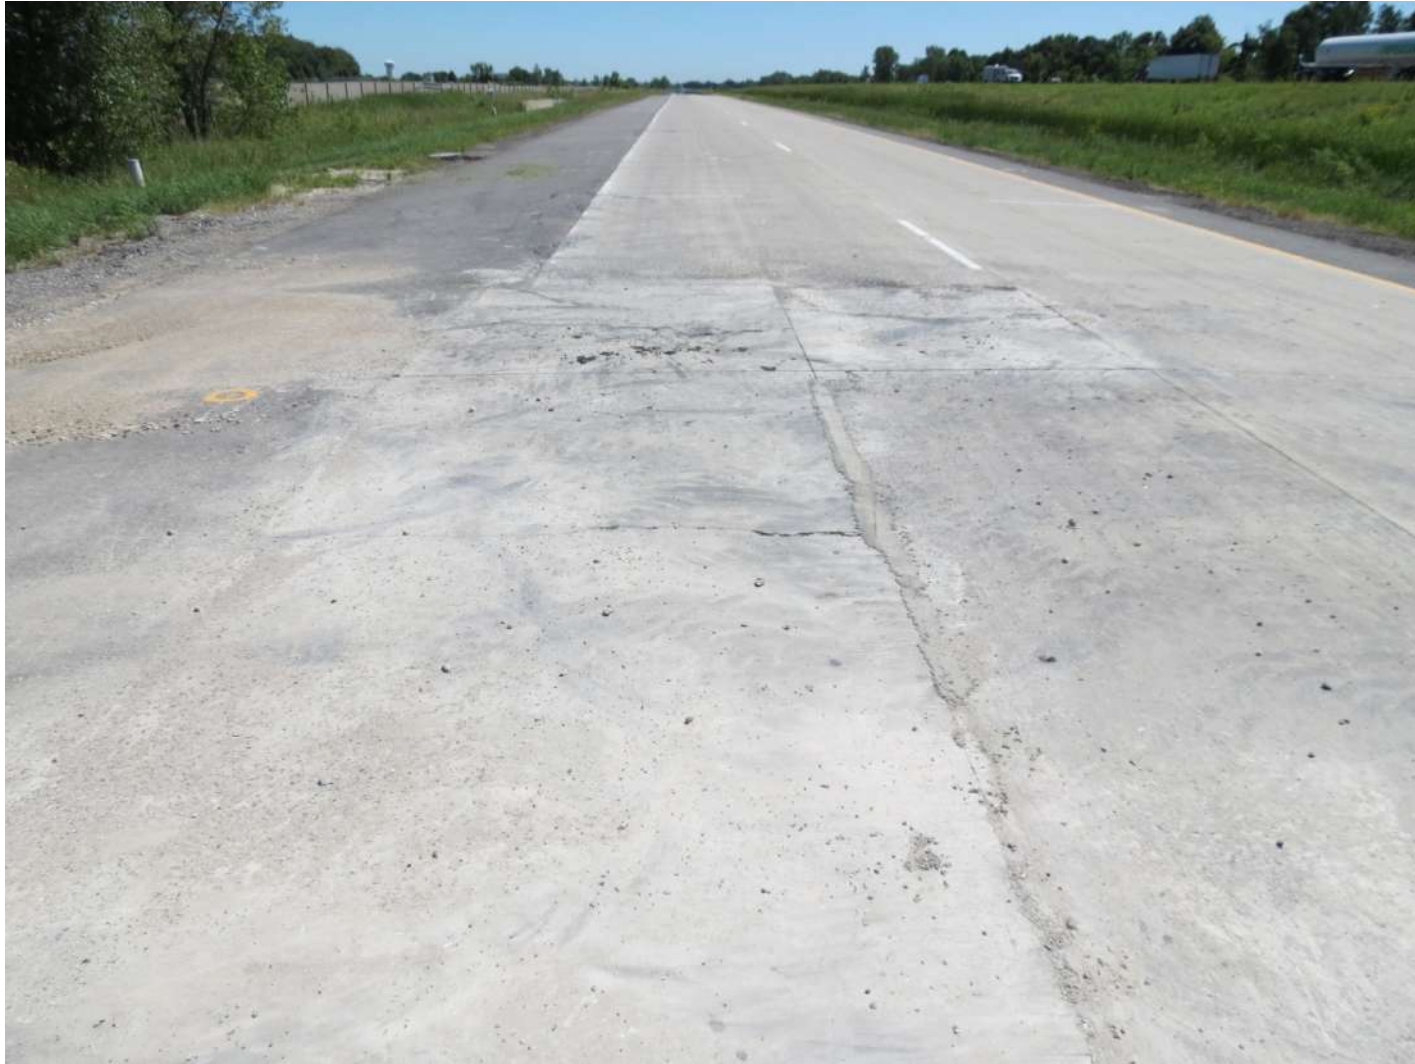
Difficult to repair such thin slabs!

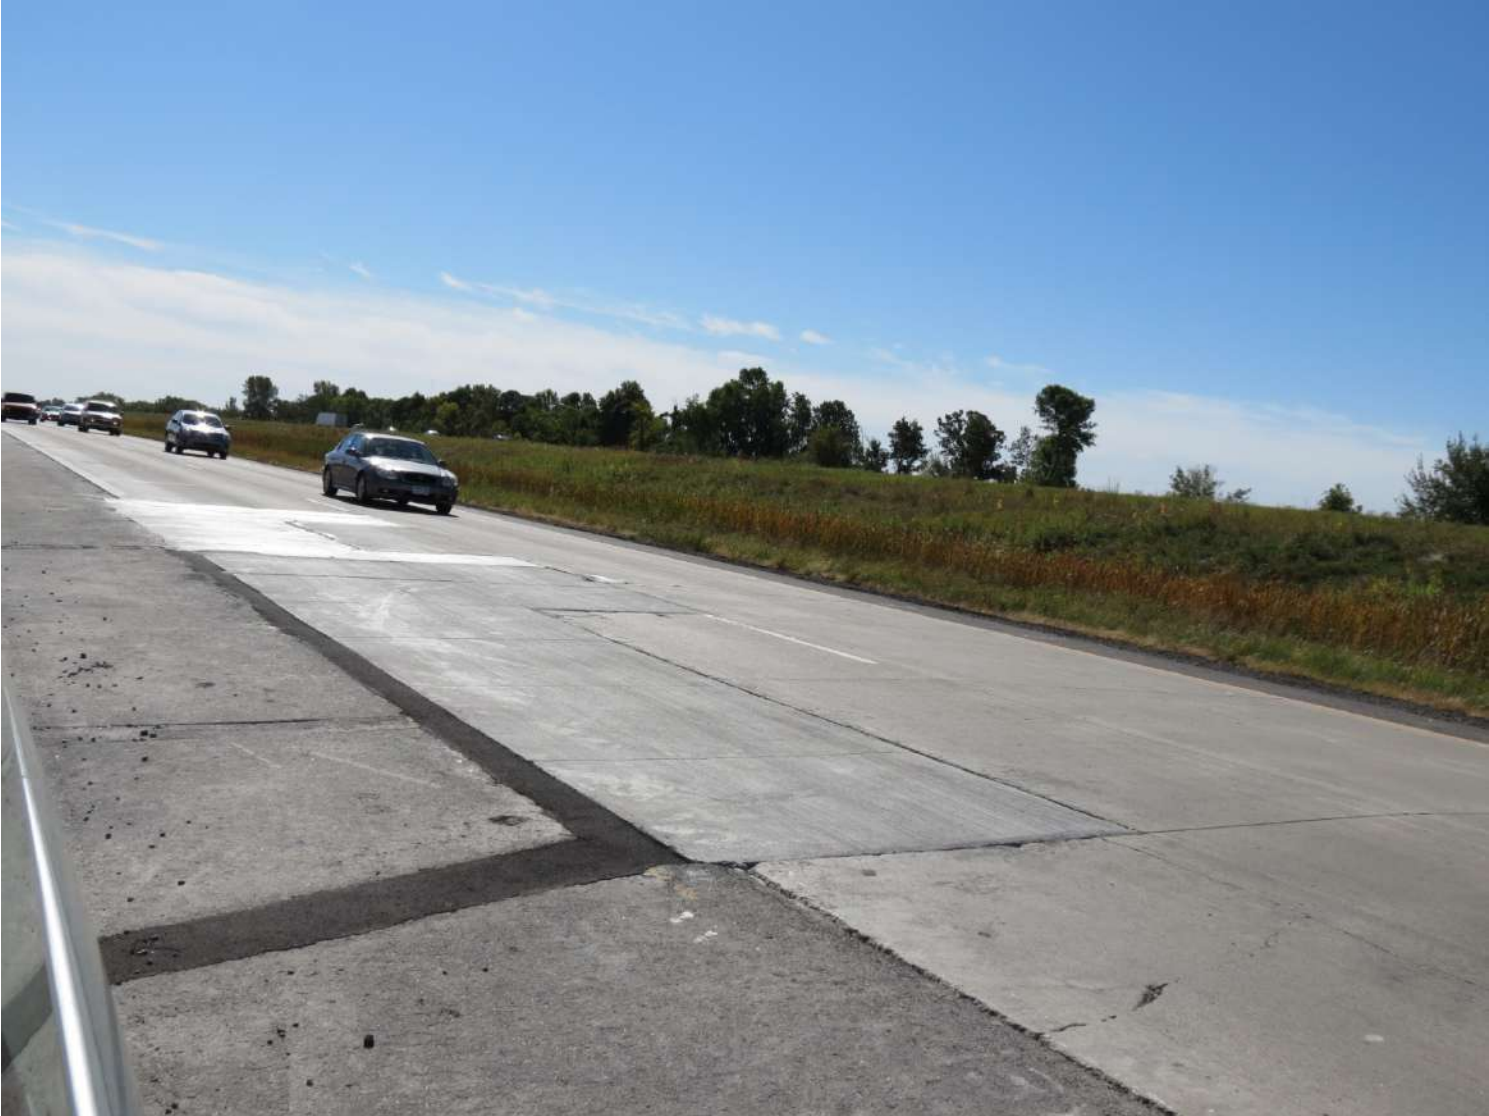
Drainage and smaller slabs work better

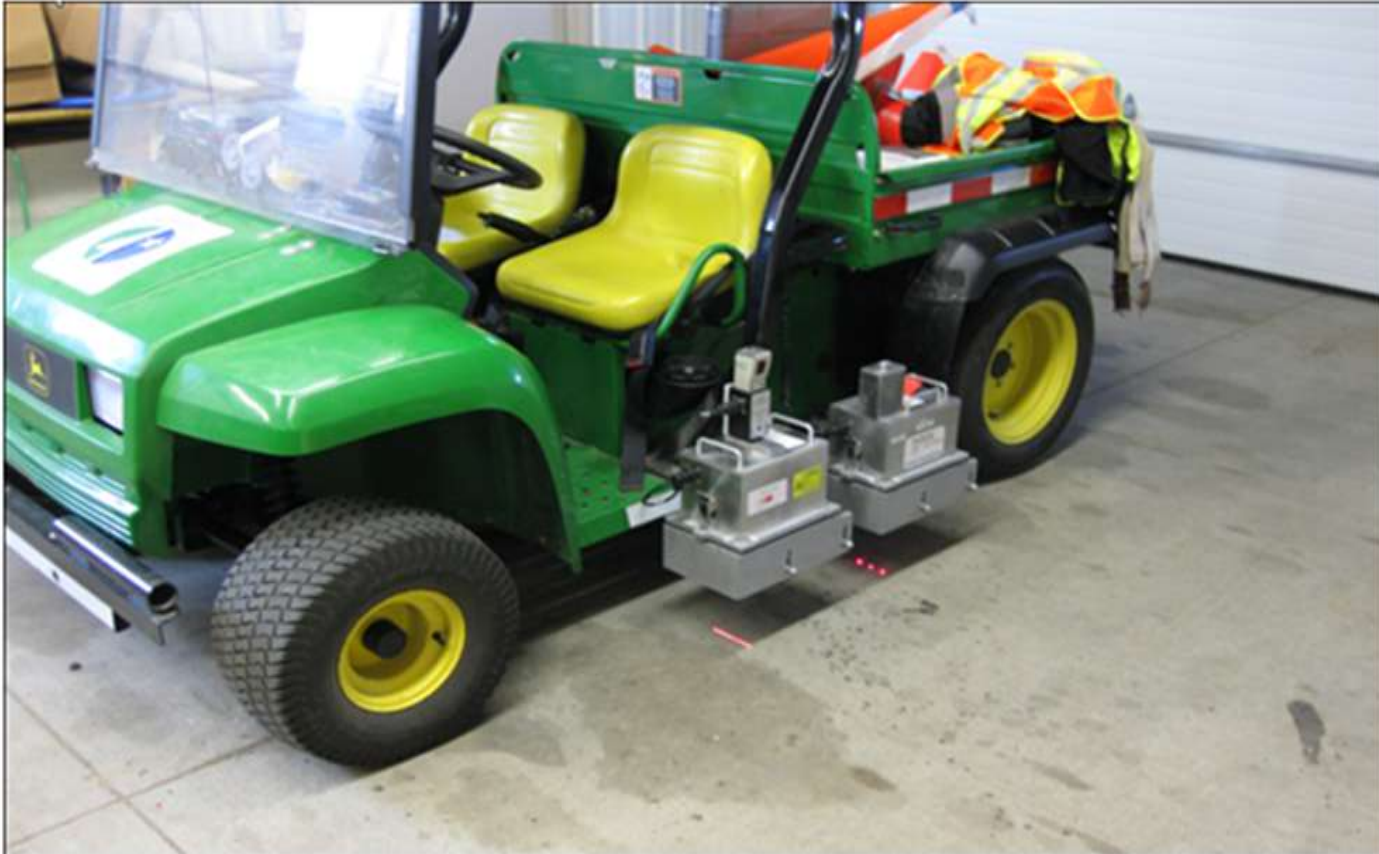
IRI AND RN MEASURING DEVICE (LIGHTWEIGHT PROFILER)

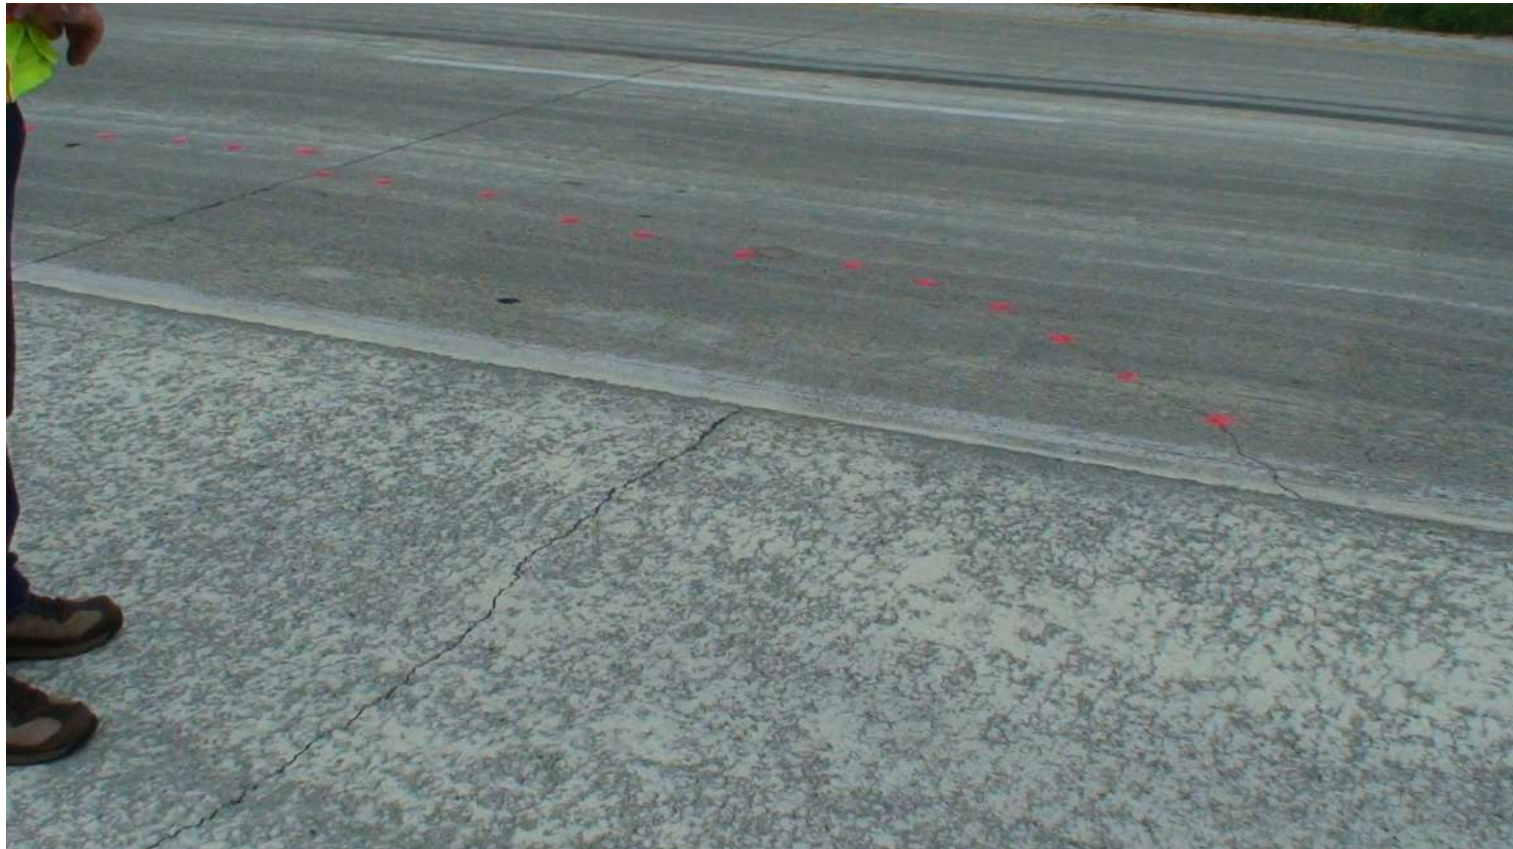
Cells 306-406 Performance

- **6" PCC constructed in 2011**
- **Design based on "good" performance of Cell 313**
- **Cracking within 6 months (base related?)**
