## Montoursville Area School District

District-Wide Facility Study

May 2020 **PROGRESS DRAFT**

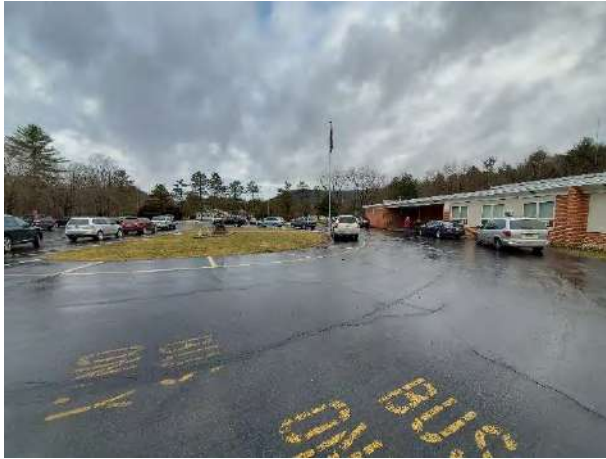
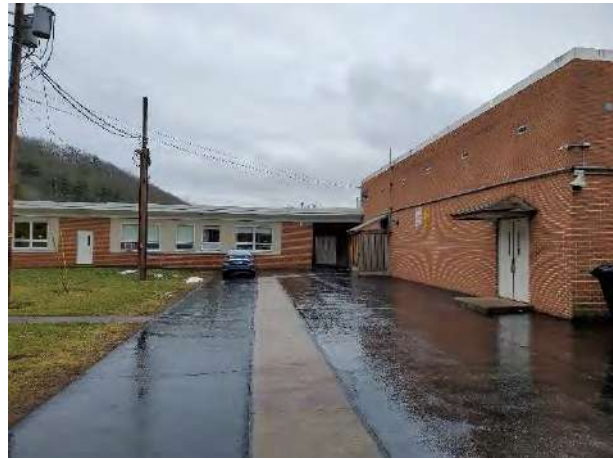
The drives and parking are bituminous material which are showing significant signs of wear and are in poor condition.

Walkways are and are in fair condition.

- Mill and Resurface all bituminous paving including hard surface play area.

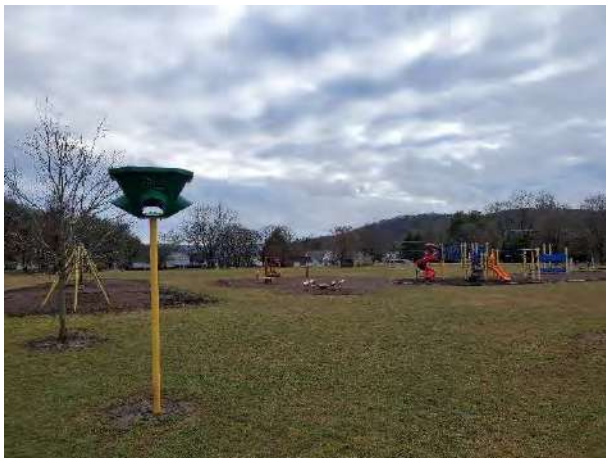
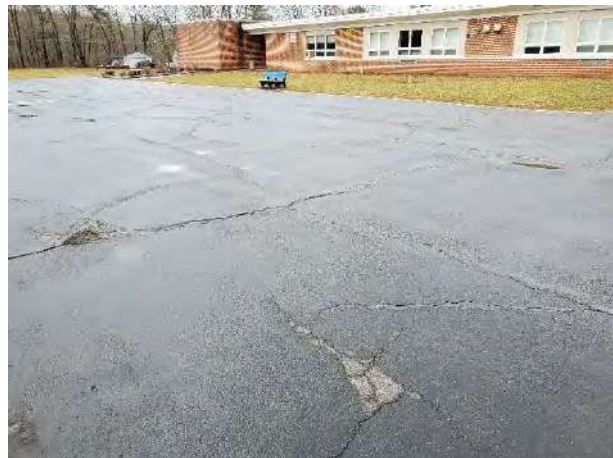
The hard surface playground is in poor condition. The playground equipment is in good to fair condition and should be re-evaluated in 5 years.

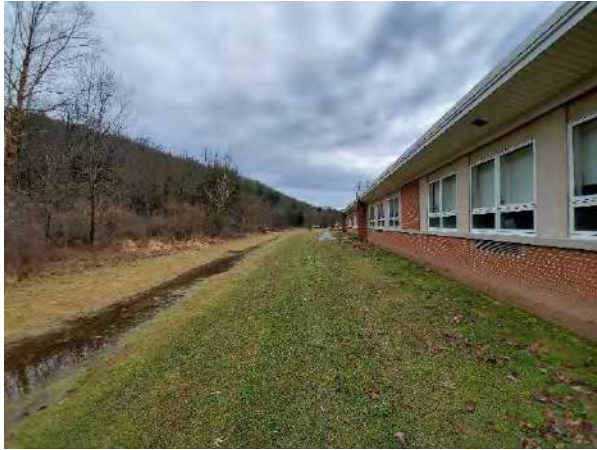
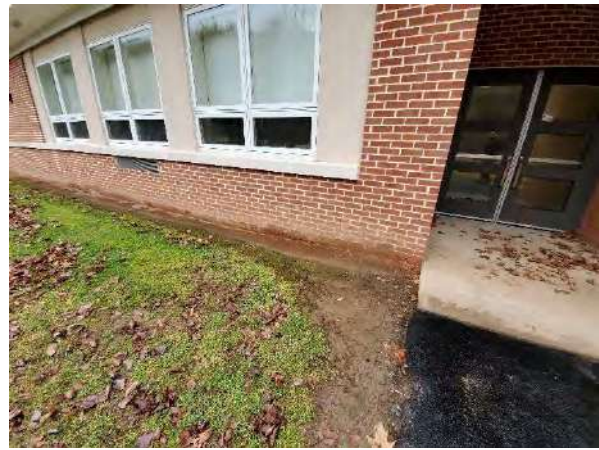
Exterior walls are comprised of brick and stucco. These materials are in fair condition.

Water infiltration is occurring in the below grade exterior walls of the water storage tank room.

Humidity issues have also been reported along the classrooms to the rear of the school (along the tree line). This could be due to exterior envelop integrity, adjacent ground water issues, building orientation, HVAC Systems, or a combination of two or more of these factors. A more in-depth analysis needs to occur to determine the exact cause of the humidity.

- Correct humidity issues in classrooms
- Replace exterior doors

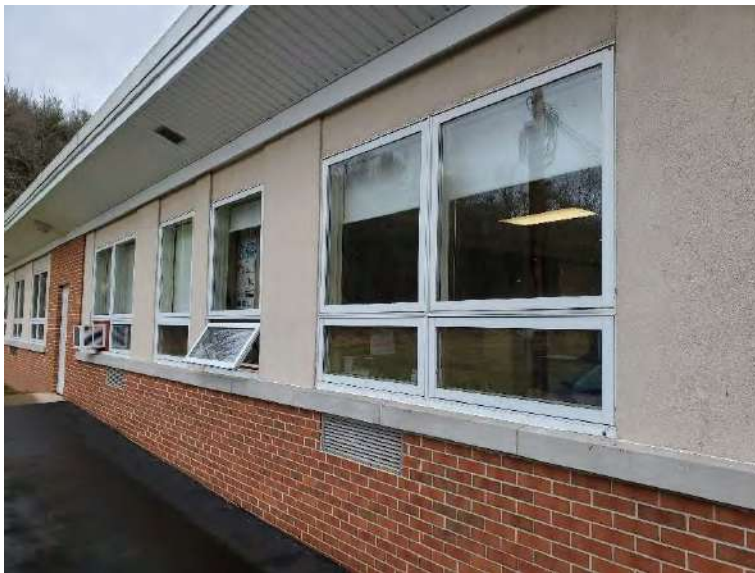
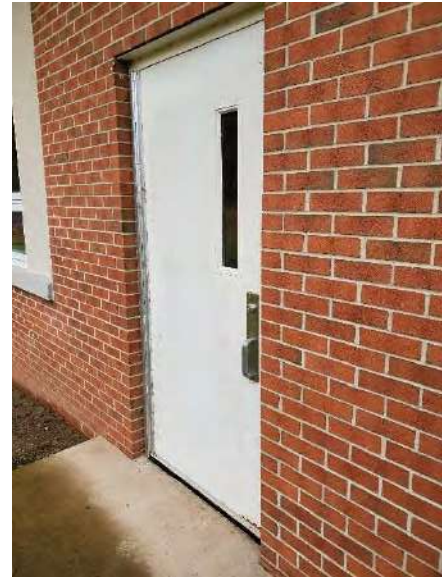
Exterior doors are a combination of aluminum framed storefront with glazing and hollow metal. Aluminum frames are in fair condition. Hollow metal doors are in poor condition. Exterior windows are aluminum clad vinyl windows with insulated glazing. Windows are in fair condition and should be re-evaluated in 5 years.

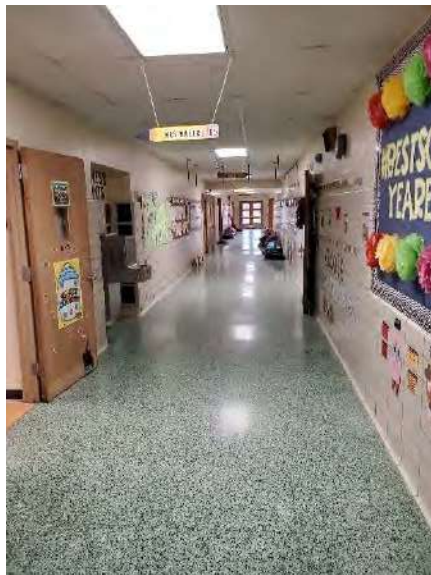
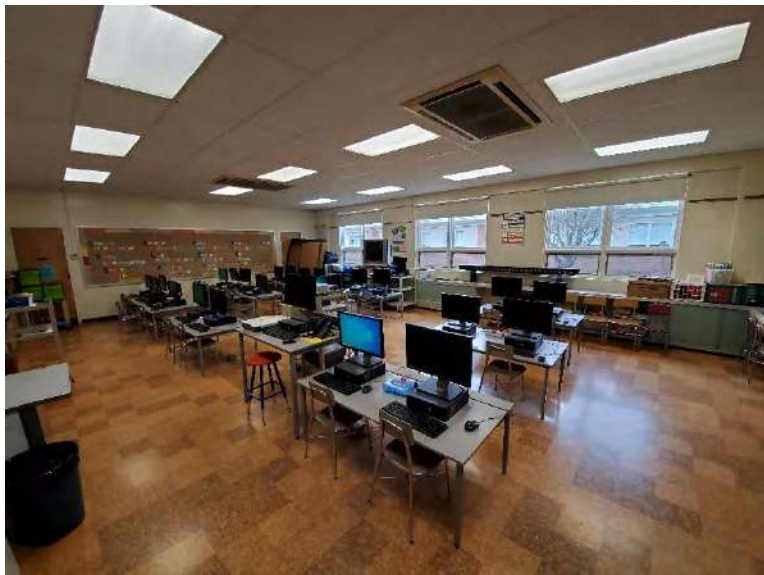
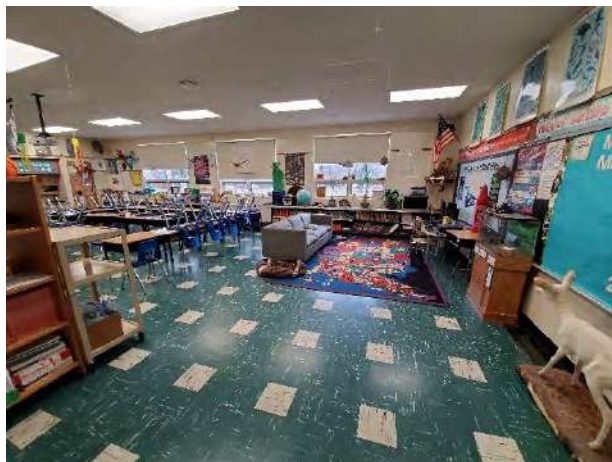
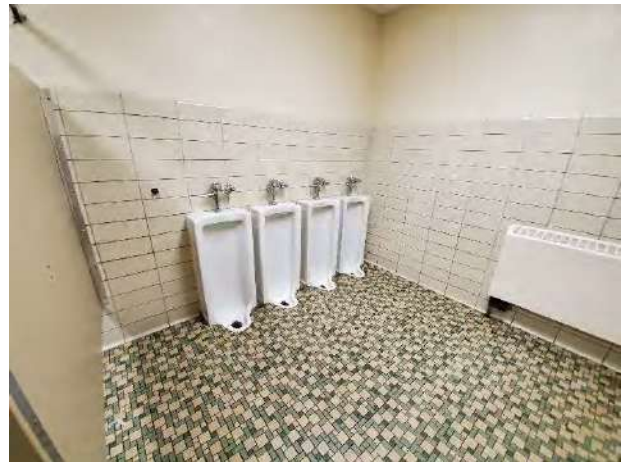
Interior walls consist of painted concrete masonry units, glazed masonry units, and painted plaster. Wall finishes are in fair to poor condition.

Floors consist of terrazzo, VCT, VAT, and ceramic tile, and carpet. Terrazzo floors and newly installed VCT is in good condition. VAT, ceramic tile, and carpeted floors are in poor condition.

Ceilings are primarily suspended ceiling tiles. Ceilings are in fair to poor condition. Recently replaced ceilings are in good condition.

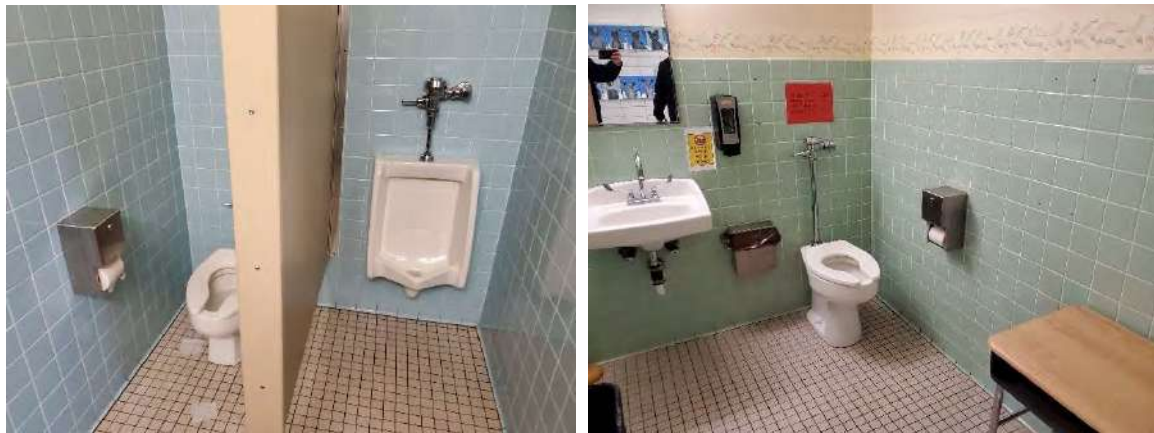
Toilet rooms do not meet current accessibility standards and are generally in poor condition.

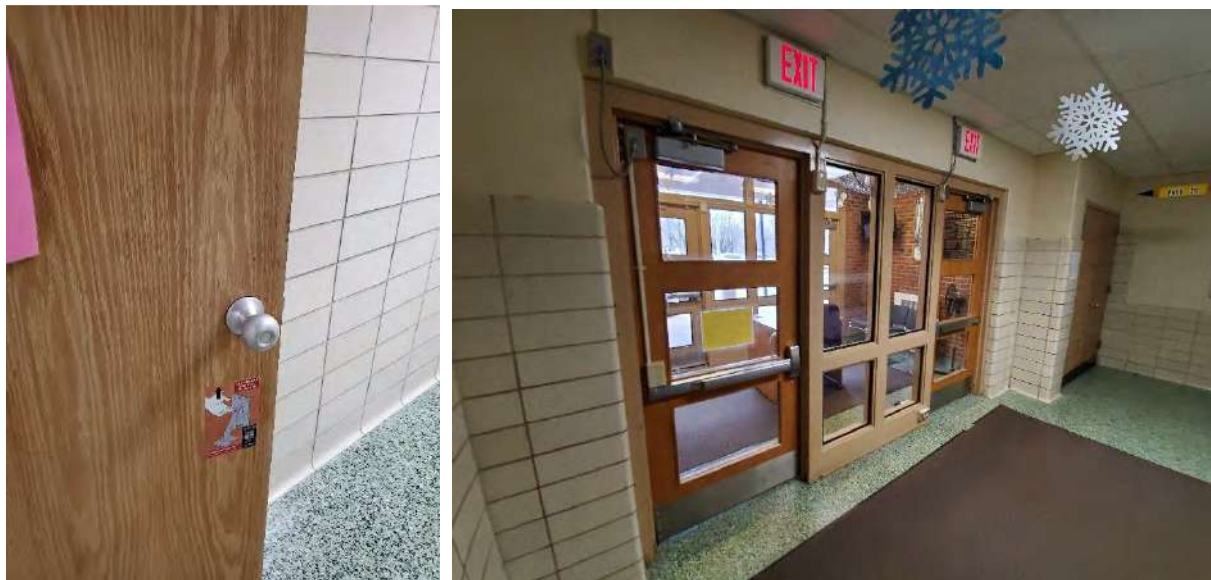
Doors are primarily solid wood core with aluminum frames. Doors are in fair to poor condition. Door hardware is in poor condition and the majority do not meet current codes.

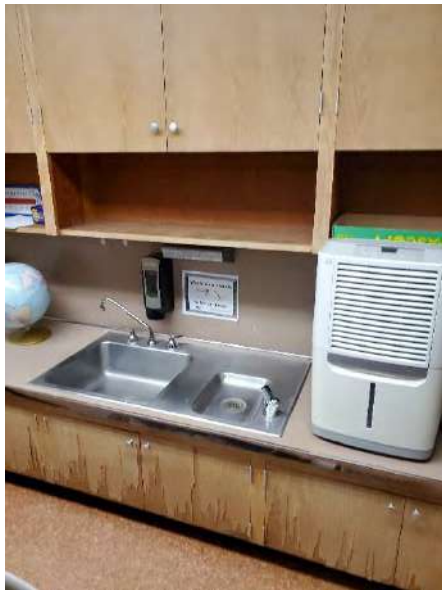
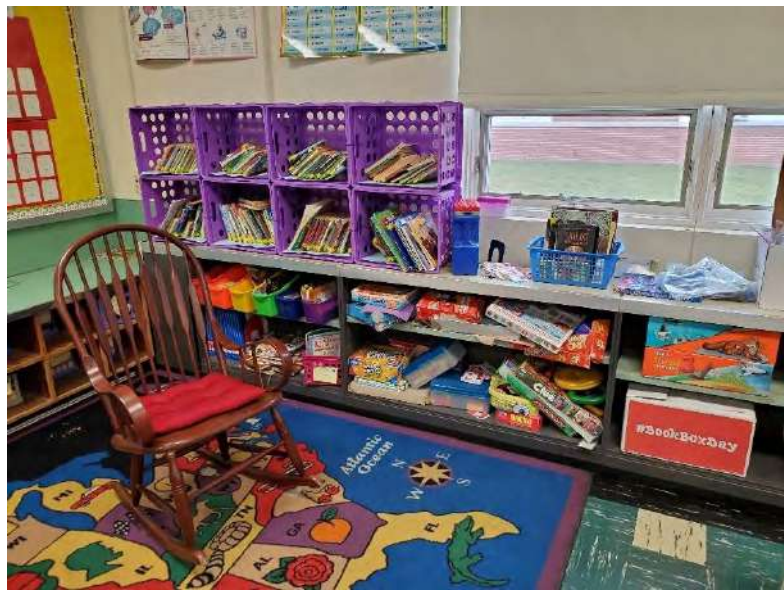
Casework is a combination of plastic laminate and metal. The plastic laminate is delaminating from the majority of the surfaces and the metal casework is in poor condition.

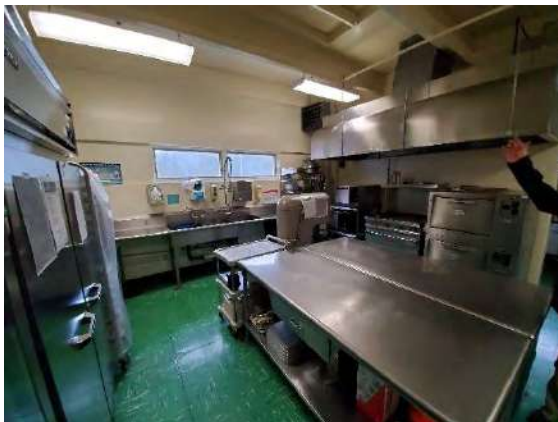
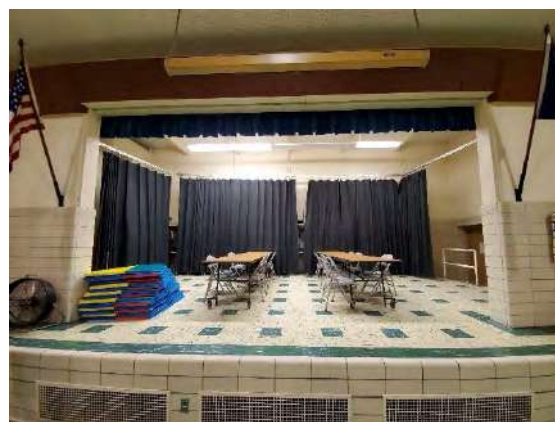
Food service equipment is outdated, in poor condition, and not functional for today's standards. The stage rigging and curtains are in fair condition.

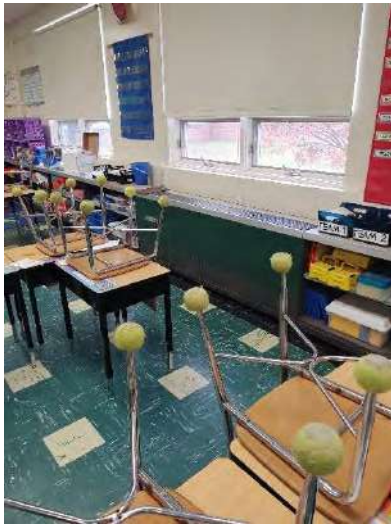
Classroom Unit Ventilators

The building utilizes a hot water heating system for space heating. The existing heating system consists of floor mounted unit ventilators in each classroom. The unit ventilators have an outside air intake louver for ventilation air. Offices and storage rooms utilize terminal heating units (finned tube and cabinet unit heaters) as a source of heat. The offices and storage rooms do not have ventilation air being introduced into the spaces.

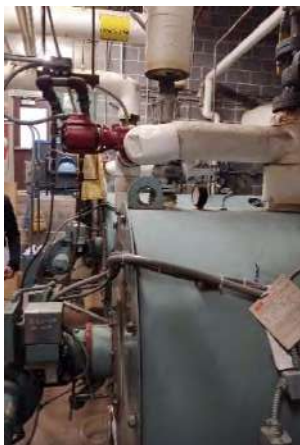
Heating Boilers

There are two hot water heating boilers located in the mechanical room. The boilers utilize #2 fuel oil as a source of fuel. The boilers do not have adequate capacity to provide heat and ventilation air to the facility. The boilers struggle to maintain space temperatures during periods of extreme cold weather. The boilers are over 30 years old and in need of replacement. A set of pumps distribute heating hot water throughout the facility. The pumps are over 20 years old. The piping consists of copper and steel. Majority of the piping is steel and original to the building. The piping is starting to have frequent leaks. The piping needs to be replaced.

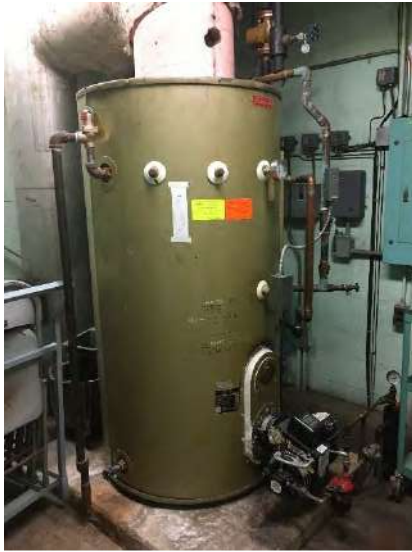
The existing water heater is an oil-fired tank type heater with approximately 80 gallons of storage. The oil burner was recently replaced. A circulator pump circulates hot water throughout the building. The pump is not on a time clock.

*Oil fired water heater*

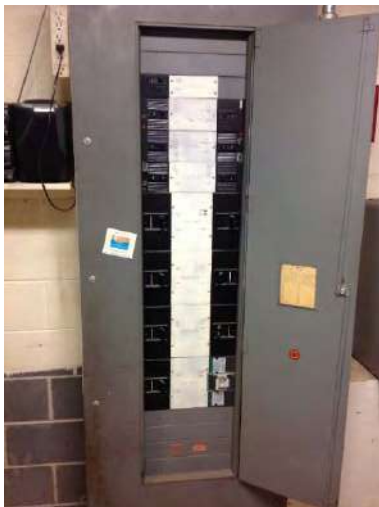
Main Distribution Panelboard

The Elementary School is served by a 208/120V 600 Amp Main distribution panelboard (MDP). Branch devices are circuit breakers. The unit was installed during the 1960's. Spare space is available. Typical usable life for this type of switchboard is 30-40 years. The MDP is fed from overhead transformers. The MDPS feeds various building 208V distribution equipment via conduit and wire feeders. Branch circuit panels were in poor condition with limited spare circuits available.

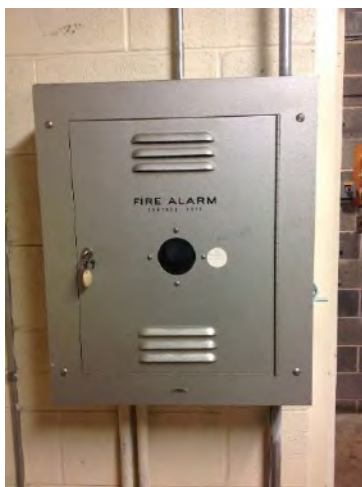
Fire Alarm Panel

The main building is served by a Simplex system from the 1960s in poor condition and not code compliant. Alarms only consist of Bells. The intercommunications system is in poor condition. Cat-5 data structured cabling is provided throughout the building and is in average condition. A Video surveillance is installed throughout the building and is in good condition. An Access Control system is installed in the building and is in good condition.

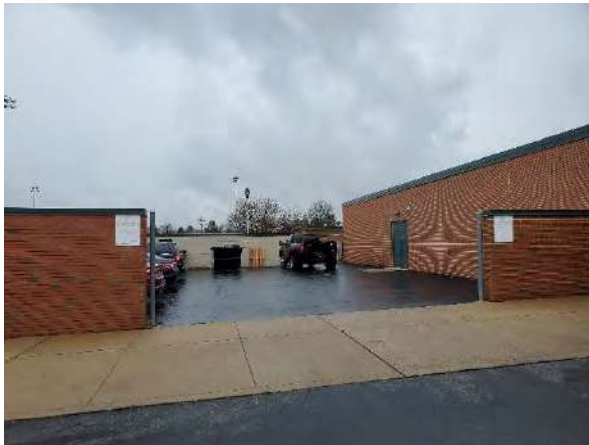
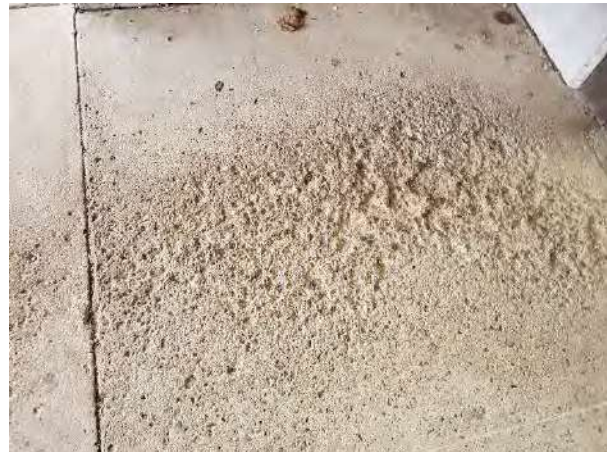
Paving for parking and drive is bituminous and is in fair condition. Sidewalks are concrete in fair to poor condition. Sidewalks in the front of the building are deteriorating.

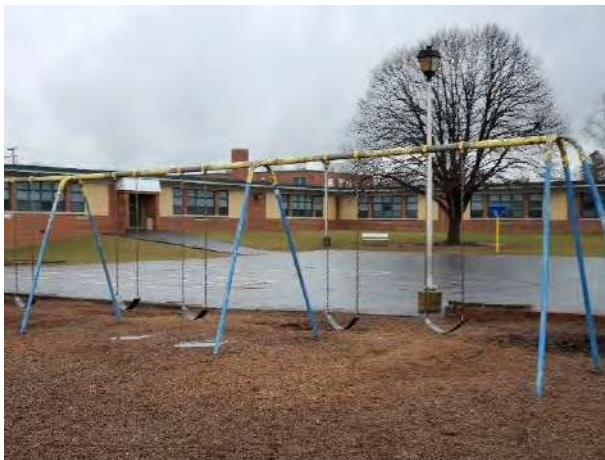
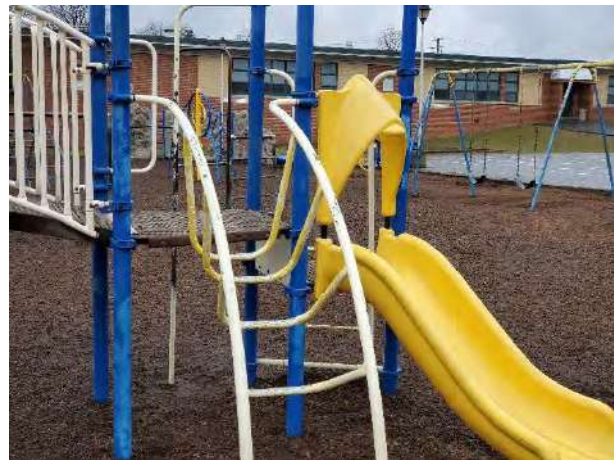
The ballfields on the property are in good to fair condition. The hard surface play area is bituminous and in fair condition. Both are in need of ongoing maintenance. The playground equipment is outdated and nearing the end of its useful life.

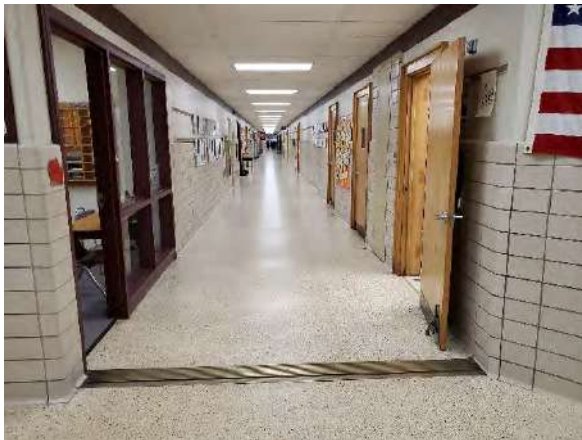
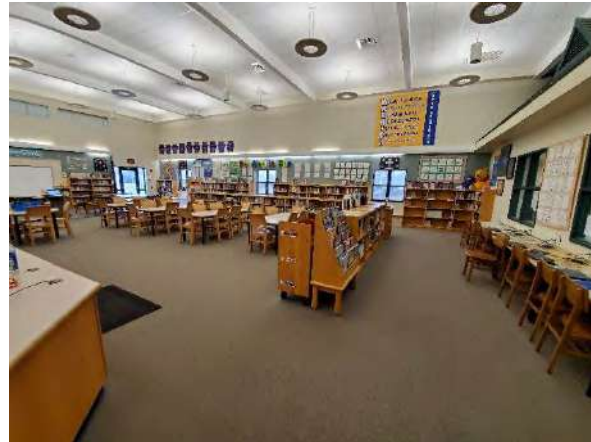
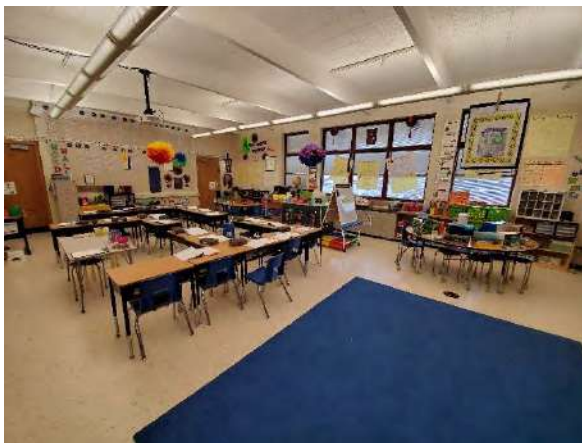
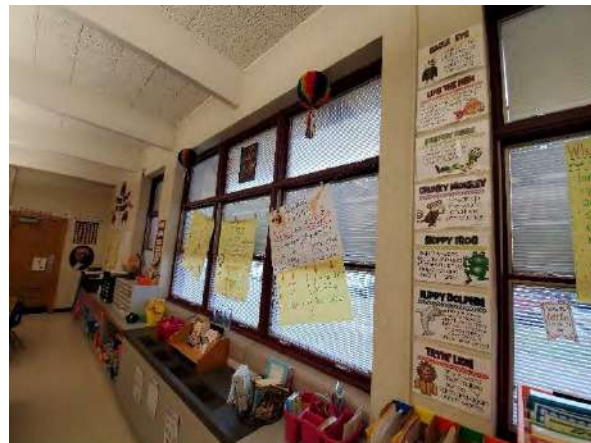
Ceilings are a combination of suspended ceiling tiles and gypsum board. It was noted that some original plaster ceilings remain in place above the more recent installed suspended ceilings. These plaster ceilings should be removed in the future when the acoustical ceilings are replaced. The kitchen ceiling is porous ACT and not appropriate for the function of the space.

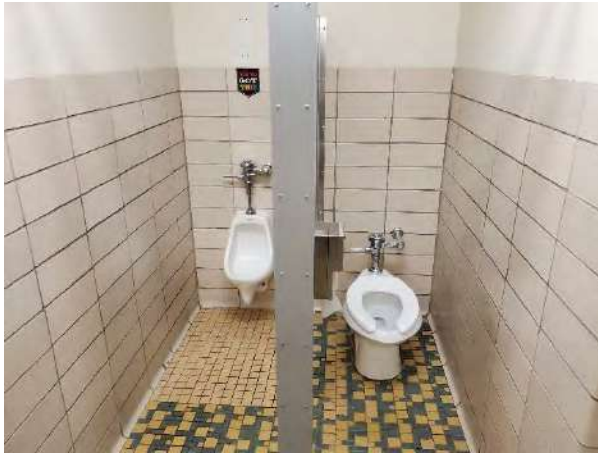
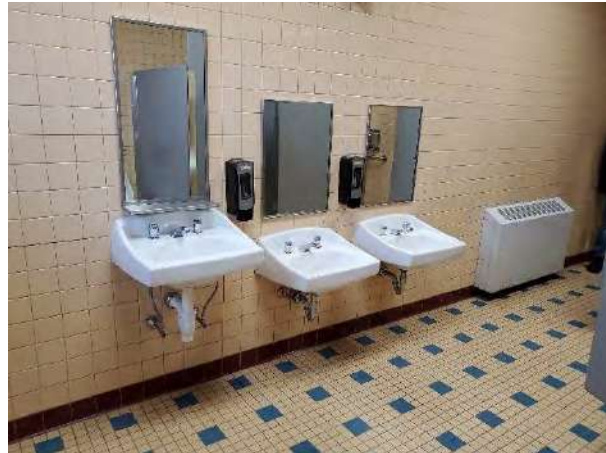
The majority of the toilet rooms are of adequate size and configuration. Some of the single occupancy toilet rooms in the classrooms do not meet required clearances for accessibility.

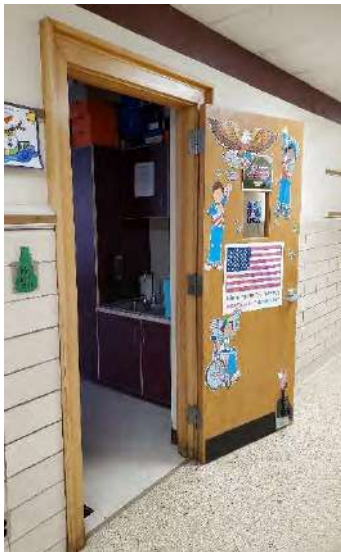
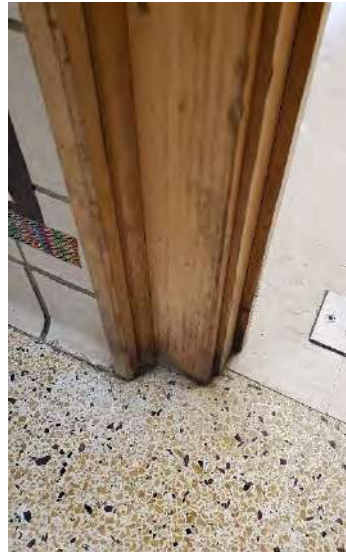
Interior doors are a combination of wood with wood frames and wood with hollow metal frames. The doors and hardware are in fair to poor condition.

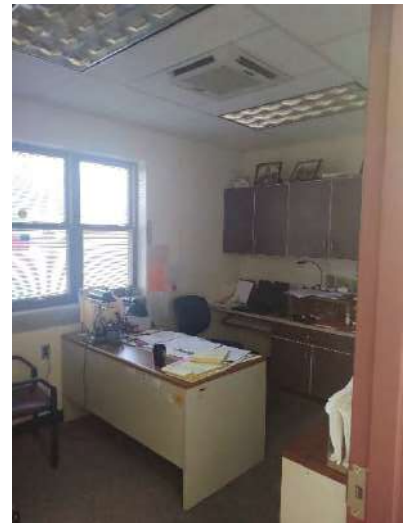
Administration offices utilize split systems for air conditioning. The offices utilize ductless ceiling and wall mounted units. The condensers are located on the roof. The library utilizes a central air handling unit with a remote air-cooled condenser to serve the space. The central air handling unit provides air conditioning to the library. The condensing unit is located on the roof.

Office with ceiling mini split AC

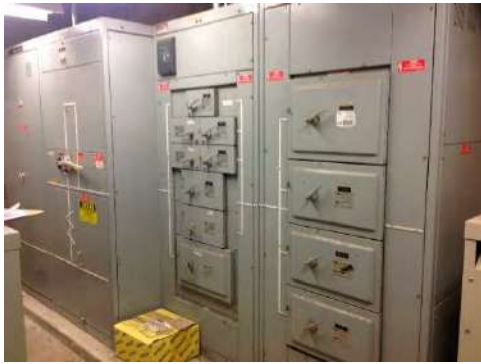
Switchboard

The Elementary School is served by a 480/277 volt, 3 phase, 4 wire 1200 amp main distribution switchboard (MDS). Branch devices are fused switches. The unit was installed during the 1990's renovation. Spare switches are available. Typical usable life for this type of switchboard is 30-40 years. The MDS is fed from an outdoor pad mounted transformer. The MDS feeds various building 480V distribution equipment via conduit and wire feeders. Branch circuit panels were in good condition and have spare circuits available.

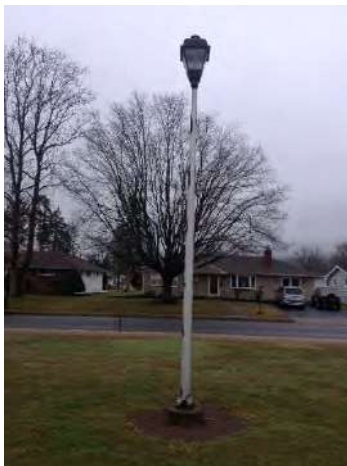
Site Lighting Fixture

General lighting in the facility consists of T8 Fluorescent fixtures in average condition. The District is currently in the process of a LED lamp replacement. Occupancy sensors are provided in the classrooms and are due for replacement. Emergency lighting is sparse and needs upgraded in the building. Exit signs were in satisfactory condition. Site lighting consisted of Metal-Halide type in average to poor condition. The district is converting to LED

- Replace existing fire alarm panel/system.
- Replace existing intercommunications system (clock/bell/intercom)
- Replace the remaining T-8 fixtures with LED.
- Install lighting controls in the remaining spaces in the building and replace existing.
- Replace the existing T5HO gymnasium fixtures with new LED highbay fixtures.

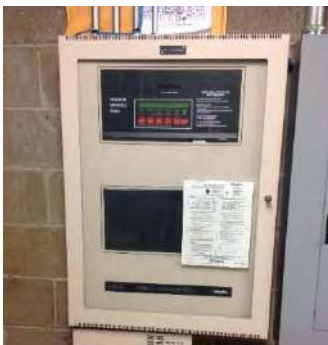
Fire Alarm Panel

The main building is served by a Simplex 4020 fire alarm system installed during the 1990's renovations/additions in average condition, but due for replacement. Note that system upgrade will require a voice notification system.

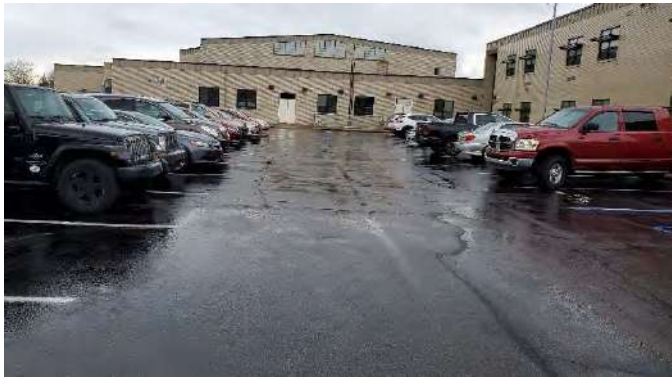
Drives and parking areas are bituminous, and sidewalks are concrete. Both are in fair condition with some areas of cracking. Ongoing maintenance is required.

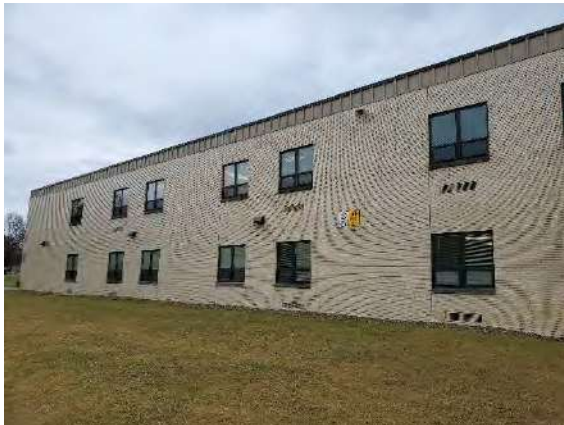
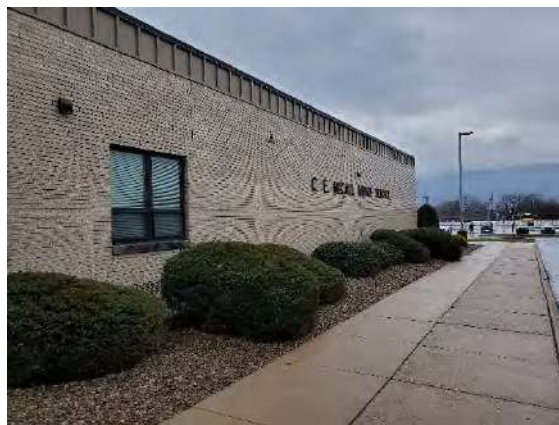
Exterior walls are face brick. The brick is in good condition.

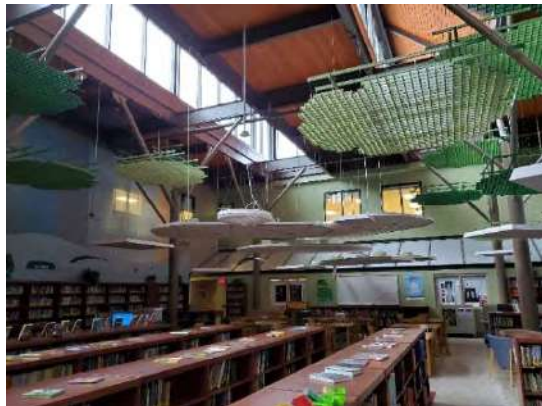
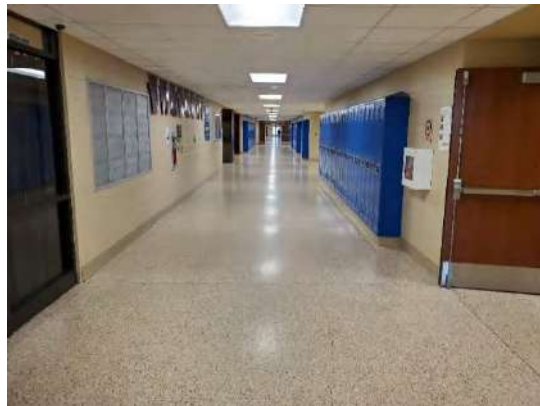
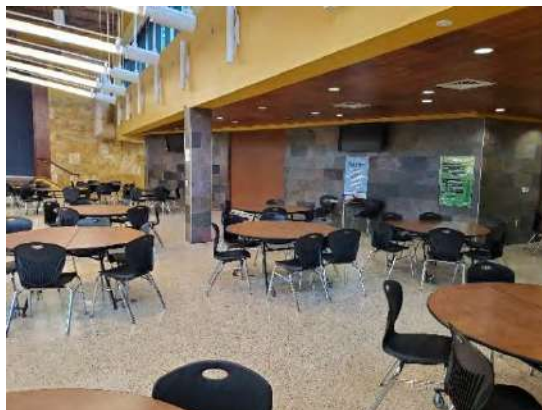
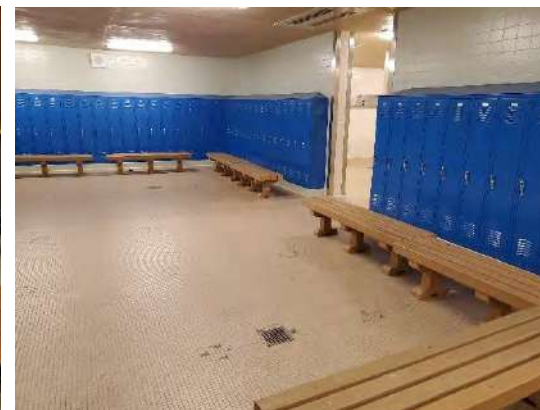
Ceilings are primarily acoustical ceiling tile and are in good to fair condition. High end specialty ceiling systems are present in the library.

Walls are a combination of painted CMU, painted gypsum board, and specialty tile. Walls are in good condition.

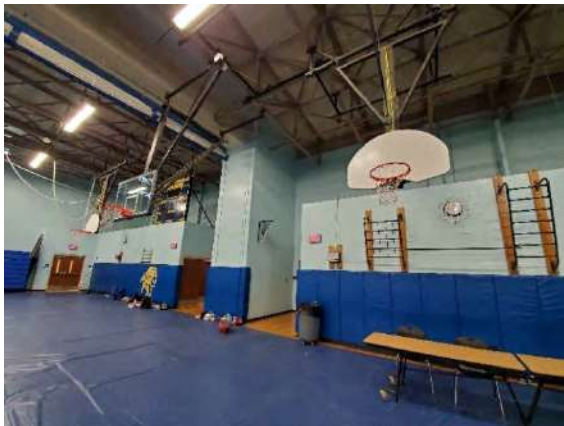
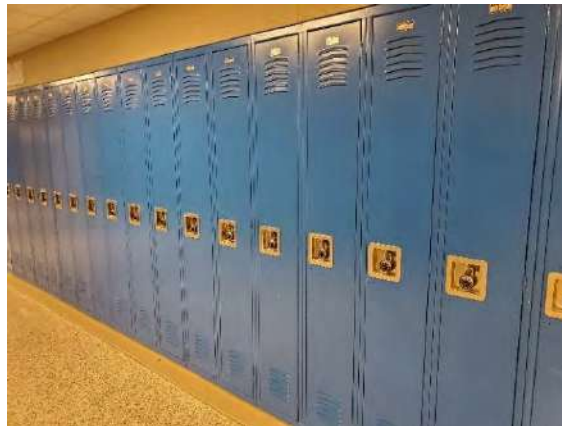
Food service and stage equipment is in good condition. Gymnasium equipment is outdated and nearing the end of its useful life. The TV studio equipment has failed and is in need of repair or replacement. Lockers are in poor condition.

- Replace ceramic tile in locker rooms.
- Replace gymnasium equipment.
- Replace TV studios AV equipment
- Refurbish or Replace student lockers

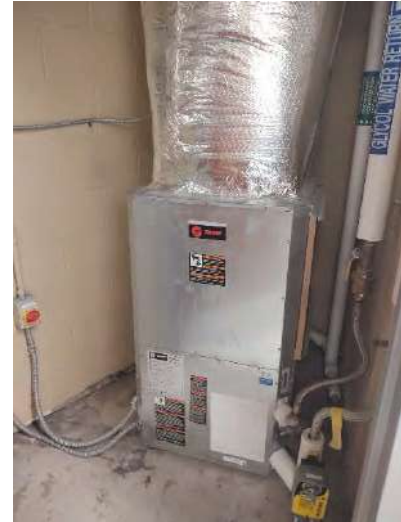
Classroom Heatpump

Heat pump loop water is circulated through the building with two 100 hp circulating pumps. The pumps utilize a variable speed drive to match the building load. The pumps and speed drives are in good operating condition.

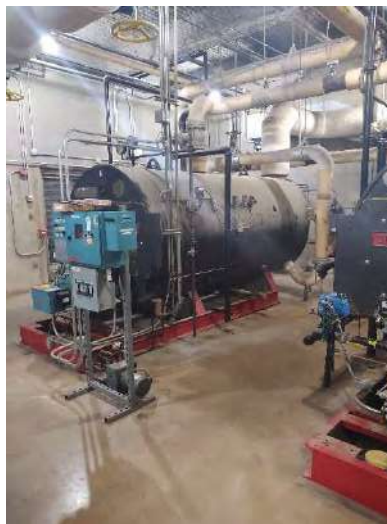
Heating Hot Water Boilers

A pair of hot water heating boilers are utilized for heating the corridors, entrance vestibules and storage rooms. The boilers are set up with both natural gas and fuel oil. The boilers are in good operating condition.

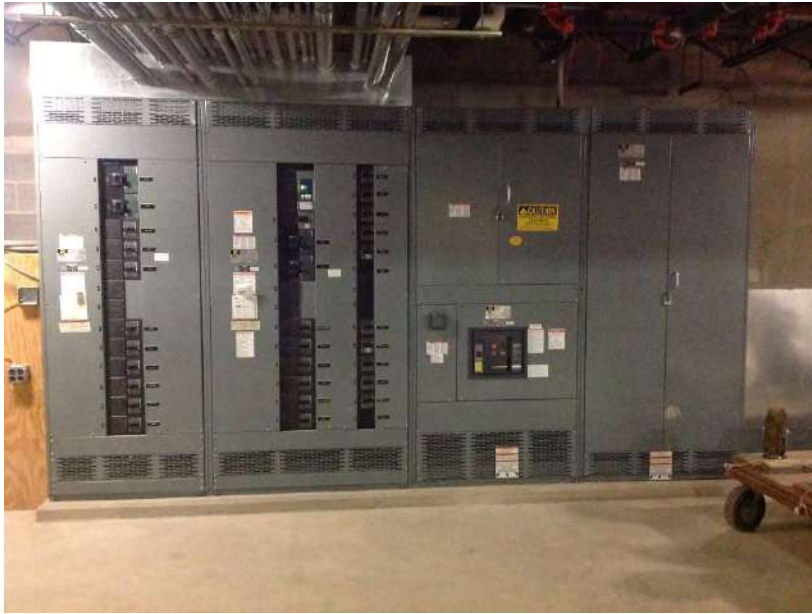
Switchboard

The High School is served by a 480/277 volt, 3 phase, 4 wire 2500 amp main distribution switchboard (MDS). Branch devices are circuit breakers. The unit was installed during the 2012 renovation. Spare breakers and space are available. Typical usable life for this type of switchboard is 30-40 years. The MDS is fed from an outdoor pad mounted transformer. The MDS feeds various building 480V distribution equipment via conduit and wire feeders. Branch circuit panels were in good condition and have spare circuits available.

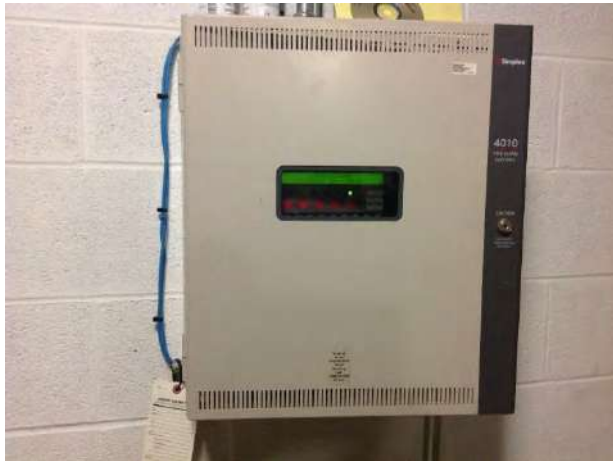
Fire Alarm Panel

The main building is served by a Simplex 4010 fire alarm system installed during the 2012 renovations/additions in good condition. Note that any additions/alterations to the building may require an upgrade to this panel/system due to current code requirements of voice notification systems.

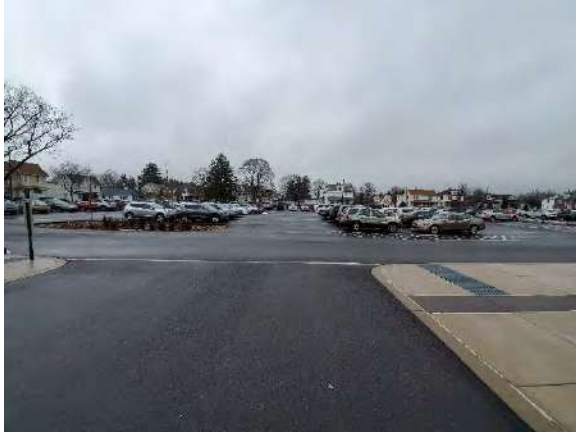
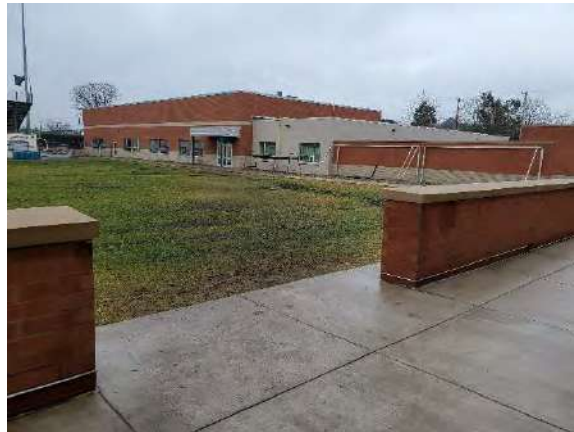
A section of grass area between the main building and the Tech Ed building is wearing due to student traffic. Traffic can be diverted to avoid this.

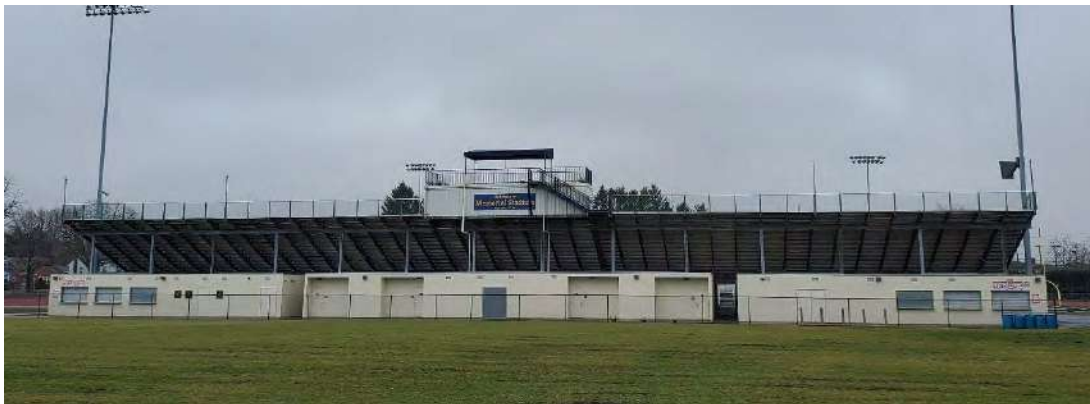
A stadium with a synthetic turf field and synthetic running track exists on the property. The field and track are in good condition. Aluminum bleachers are used for spectator seating. The aluminum bleachers are in good condition. A concrete masonry structure exists under the bleachers and contains space for toilet rooms, storage, and concessions. This building is in fair condition.

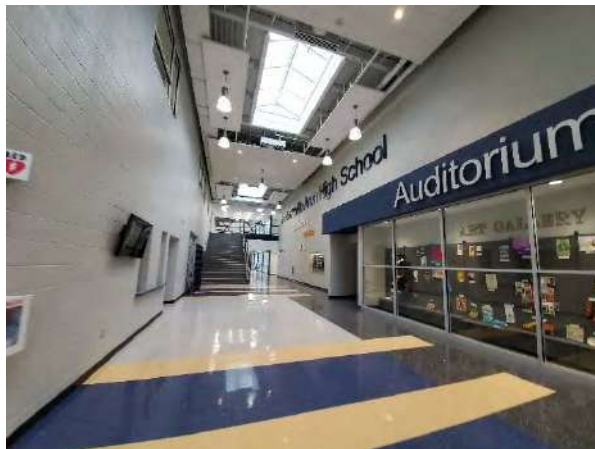
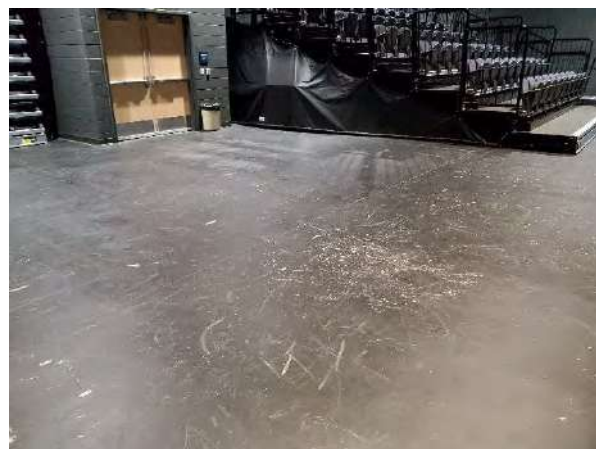
Flooring consists of terrazzo, VCT, quartz tile, carpet tile and resinous. Overall the flooring is in good condition and on-going maintenance is recommended. The stained concrete floor in the auditorium is showing signs of wear.

Walls are primarily painted concrete block with some painted gypsum wall board. Walls are in good condition. The paint on the main gymnasium walls and ceiling are in fair condition.

Ceilings are a combination of ACT and gypsum board. Ceilings are in good condition.

- Paint main gymnasium.
- Re-seal auditorium flooring or install VCT flooring.

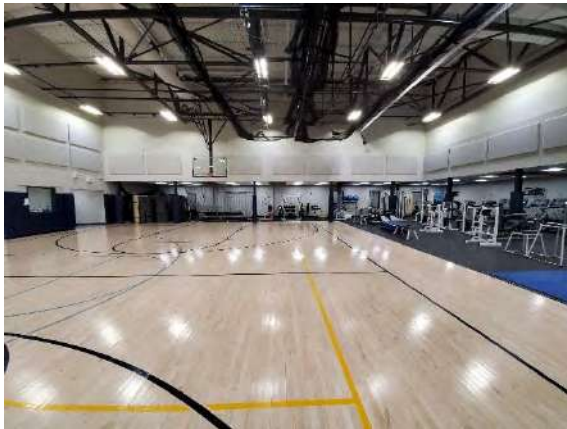
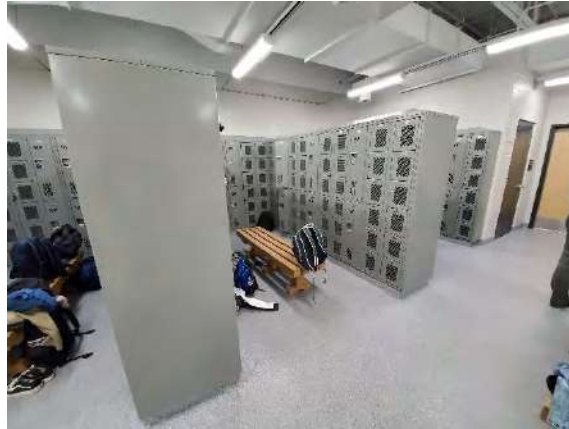
Food Service, Auditorium/Stage, Gymnasium equipment is up to date and in good condition. Lockers are also in good condition.

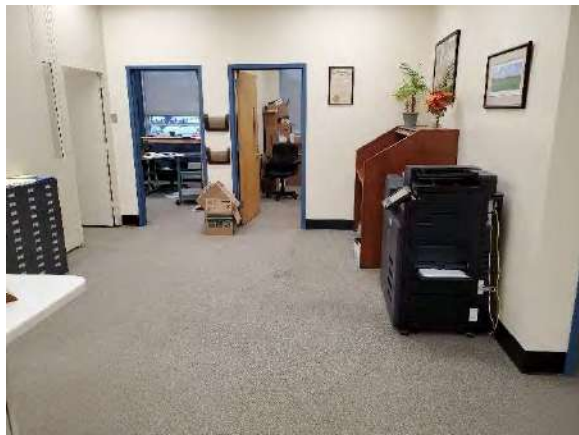
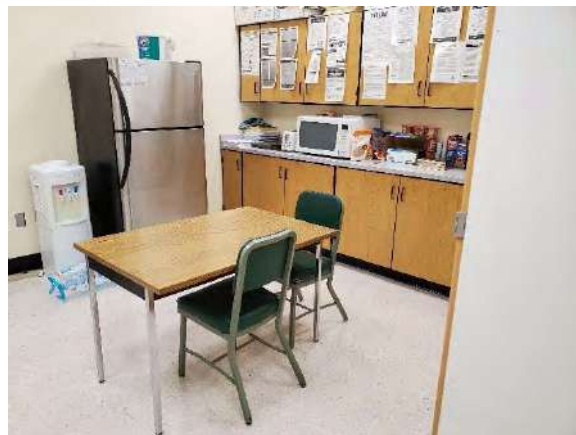
Flooring is carpet and VCT. Flooring is in poor condition. Walls are painted gypsum wallboard and are in fair condition. Ceilings are acoustical tile and are in good to fair condition.
