## 2024 Infrastructure and Energy Reduction Project

Prepared for: School Administrative Unit (SAU) 19  
11 School St  
Goffstown, NH 03045

Prepared by: Energy Management Consultants, Inc.  
55 Industrial Way  
Portland, ME 04021

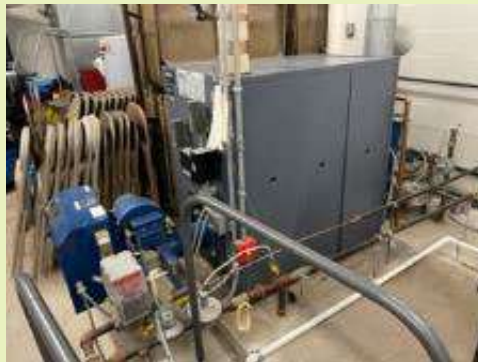
*Glen Lake School Aging Boiler*

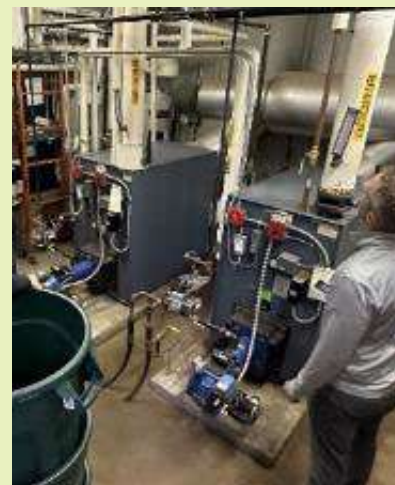
(2) cast iron Weil McLain natural gas boilers are operating at an average of 83% efficiency. Boilers would be replaced with (2) natural gas high-efficiency condensing boilers. The new system would include outside air temperature reset, automatic lead/lag operation, and building automation integration capabilities. The numerous single speed zone pumps serving different circuits of the hot water system would be combined into a variable speed duplex pump arrangement with automatic lead/lag changeover for complete redundancy. Scope would also include cleaning and sealing the boiler room floor to create a cleaner working environment.

*Bartlett Elementary School Boilers*

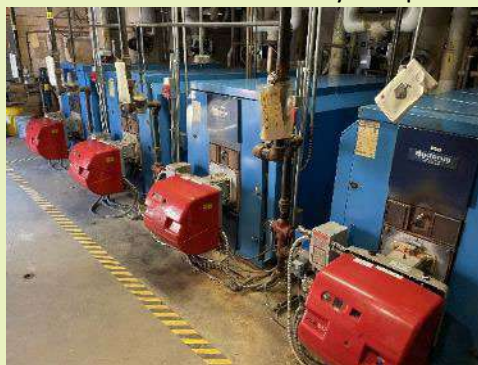
The High School is currently heated with four Buderus dual-fuel capable boilers which can operate on either oil or propane. The boilers are low efficiency compared to the technology available in high efficiency condensing boilers and for this reason it is recommended that they are replaced. It has been noted that the 2" propane supply line frosts up during the winter and causes the boilers to trip often. The propane supply piping and tanks will be studied during the development of this measure to ensure the propane supply piping is properly sized so that this does not happen. Another reason to replace these boilers is to remove the underground oil tank which has proven very difficult to get inspections completed for. With the new propane boilers, the oil tank could be removed.

*Goffstown High School Boiler System*

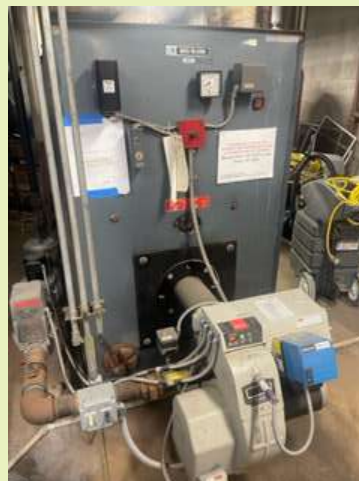
One of the existing boilers has been replaced. The remaining boiler has been tagged out of service and the requirement for the fire department to be notified before attempting to use the boiler. This leaves the school without heating redundancy while solely relying on a single boiler. The older boiler has reached its life expectancy and should be replaced. By replacing it with a high efficiency modulating boiler, efficiency gains would be realized which would lower the school's energy costs associated with the heating system. A new modulating boiler would also provide more consistent temperatures for the hot water loop providing smoother operation of the system. Scope would also include cleaning and sealing the boiler room floor to create a cleaner working environment.

*Maple Avenue Elementary Aging Boiler*

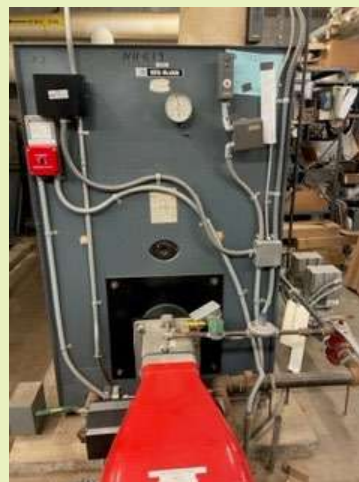
A single cast iron Buderus oil boiler serves the building. This boiler is operating at an average of 86% efficiency and provides no redundancy in the event of a failure. The boiler would be replaced with (2) propane high-efficiency condensing boilers. Existing hot water circulation pumps would remain. Scope would include completing the piping that was started for the second indirect domestic hot water tank. Scope would also include cleaning and sealing the boiler room floor to create a cleaner working environment.

*Mountain View Middle School Boiler*

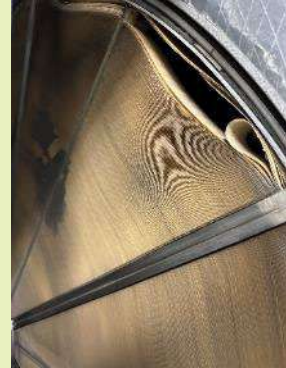
The wheel for ERV-1 was found to be in very poor condition and should be replaced. Inspections found that the wheel was very dirty which will cause a high pressure drop across the wheel and drastically reduces the ventilation airflow for the cafeteria/gym space. The wheel was also found to be delaminating along the edges of the wheel. If this deconstruction continues, pieces of the wheel could be pulled into the fan causing a fan failure. These conditions also reduce the energy recovery efficiency of the unit which results in higher utility costs than normal.

*Bartlett Elementary School  
ERV-1 Energy Wheel*

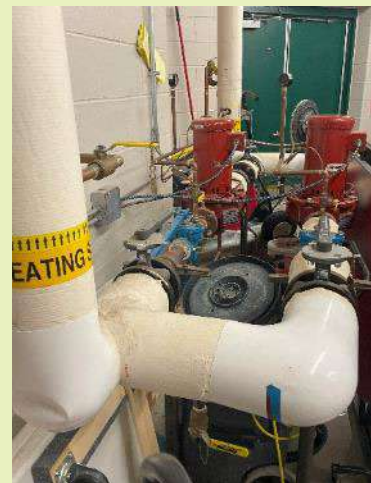
*Glen Lake School Hot Water Pumps*

motors are rated to handle VFDs and it is recommended that VFDs are installed. This will provide the system with soft-start capabilities and the ability to reduce speeds during warmer months when full flow is not required. Reducing the pump speed will reduce the electrical consumption associated with these large pumps.

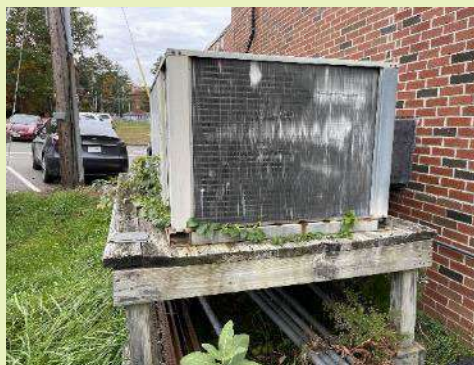
The air handling units at the High School are past their useful life and are showing signs of deterioration. These units provide heating, cooling and ventilation throughout the building and should be replaced proactively to ensure a quality indoor environment for the students and faculty. Much of the roof mounted equipment has insulation that has degraded to the point that it is hanging off the ductwork and laying on the roof. This increases the energy load of the unit since some of the energy is being transferred to the ambient air where there is the lack of insulation. The insulation would be replaced as part of the equipment replacement to restore the required insulation value of the duct. Overall, new equipment serving ventilation to the building would incorporate energy recovery, optimal start scheduling, demand control ventilation and variable frequency drives on the fans to optimize the energy expended with this equipment.

*Goffstown High School Air Handling Unit Past Its Useful Life*

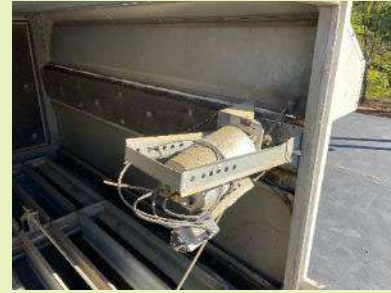
The heating ventilator unit located on the roof has passed its useful life and is in very poor condition. The controls associated with this unit are pneumatic which are also in poor condition and are likely not controlling temperatures accurately. This old control system is also not capable of modern high-efficiency sequence of operations such as demand control ventilation based off CO<sub>2</sub> in the building. By replacing this equipment with an energy recovery ventilator, VFDs and new controls, a great amount of energy can be saved while also improving the temperature control of the building. Overall, new equipment serving ventilation to the building would incorporate energy recovery, optimal start scheduling, demand control ventilation and variable frequency drives on the fans to optimize the energy expended with this equipment.

*Maple Avenue Elementary Air Handler with Pneumatic Actuator*

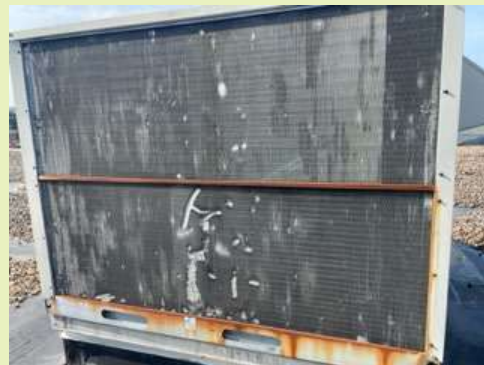
The air handling equipment at the Middle School is comprised of (2) roof top units (RTU) and (3) heating ventilators (HV). The RTUs serve the office spaces with heating, cooling, and ventilation air while the HV units serve heating and ventilation to general spaces and interior rooms that are not served directly by the classroom unit ventilators. All of these air handlers have hit their life expectancy and should be replaced before an equipment failure occurs. In general, new equipment serving ventilation to the building would incorporate energy recovery, optimal start scheduling, demand control ventilation and variable frequency drives on the fans to optimize the energy expended with this equipment.

*Mountain View Middle School Roof Top Unit in Poor Condition*

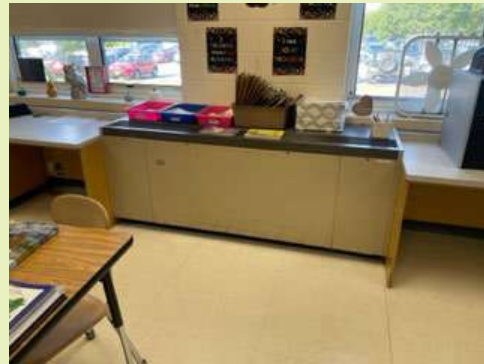
The classroom unit ventilators in the Mountain View Middle School are past their useful life and should be replaced with a modern model of the same footprint. These units serve the classroom with heating and ventilation. Modern units couple with a new control system have energy reducing features such as variable speed fan motors, demand control ventilation based off CO<sub>2</sub>, and optimal start scheduling which all reduce energy consumption and provide a better classroom environment than the equipment currently in use.

*Mountain View Middle School Classroom Unit Ventilators*

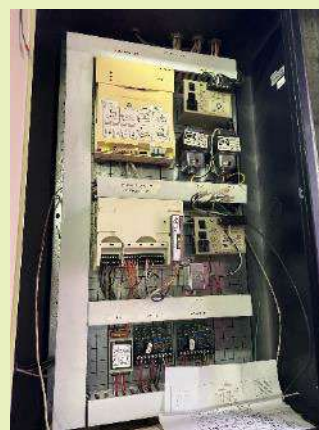
Bartlett Elementary School has a very old Honeywell building automation system that has long surpassed its useful life. The existing system is likely hard if not impossible to get replacement parts for. The proprietary nature of this control system leaves little options for the district to source competitive pricing if they needed to source a replacement controller. Although direct digital controls (DDC) serve the major equipment within the building, much of the building is still served by an ancient pneumatic controls system. Pneumatic systems are inherently standalone systems which offer zero insight into how the system is operating and if any problems are present. Also, a pneumatic system requires an air compressor which results in costly operation and maintenance. It is recommended that the existing Honeywell CBUS controllers and all pneumatic devices be removed, and a new BACnet DDC controls system be installed to fully automate the building. This would create an open architecture and remove all proprietary controllers from the building. The Niagara existing JACE 8000 controller should be upgraded to the latest version of software and firmware.

*Bartlett Elementary School  
Boiler Room Controller*

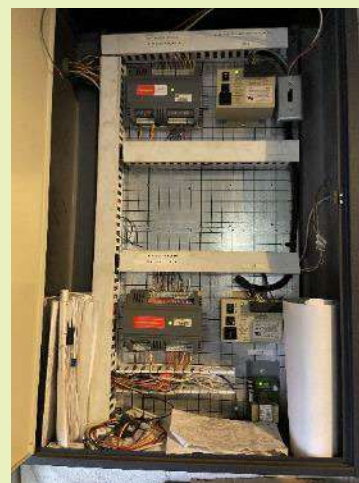
The existing control system in the High School is a Honeywell Comfort Point system. This system is proprietary and greatly limits the district's ability to have it serviced from multiple vendors. There are about 50 controllers on site communicating on the LON protocol. LON is considered a legacy communications protocol which has been surpassed by ASHRAE's BACnet protocol which is used by every control manufacturer at this point. It is recommended that the existing controllers be replaced with BACnet controllers with a new BACnet communications bus extended throughout the school. This would create an open architecture and remove all proprietary controllers from the building. The existing Niagara JACE 600 controller should be replaced with the latest model JACE 8000 (soon to

*Goffstown High School Controllers*

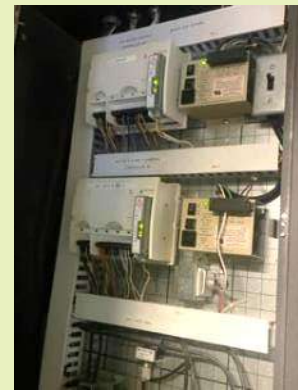
Much of the HVAC system in this school is still served by an aging pneumatic control system which is greatly passed the end of its useful life. Pneumatic control systems are inherently simplistic with the operations they can perform and costly to operate due to the need for an air compressor to continually operate. Modern building automation systems allow the latest in energy reduction strategies to be utilized in the sequence of operations of the systems being served. This translates to energy savings associated with the HVAC system which is typically a large portion of the building's energy usage. It is recommended that the existing Honeywell CBUS controllers and all pneumatic devices be removed, and a new BACnet DDC controls system be installed to fully automate the building. This would create an open architecture and remove all proprietary controllers from the building. The existing Niagara JACE 8000 controller should be upgraded to the latest version of software and firmware.

*Maple Avenue Elementary  
Controls*

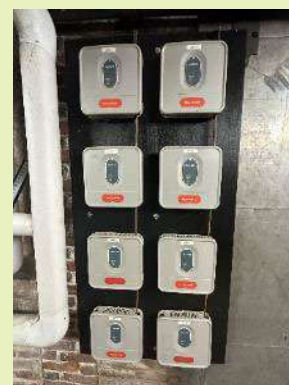
The SAU Office does not currently have a building automation system. The heating system currently operates via Honeywell thermostats which wirelessly communicate with modules in the basement boiler room. While this does provide heating control, there is no way to monitor the system or receive alarms when something is not working. A new Niagara based automation system would be installed to properly monitor and control the building. This includes monitoring the boiler and domestic hot water temperatures and boiler status and fault conditions.

*SAU Office Controls*

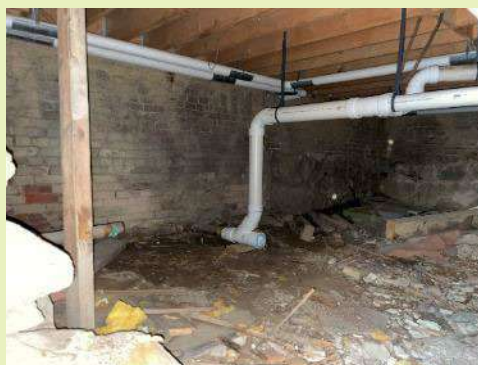
The SAU Office basement is within the building envelope but is not insulated in any way. The basement has the distinct “musty” smell of an older residential basement which is an indication of high humidity. Although the space is not typically occupied, most of the paper file storage for the school district is shelved in the basement. With the lack of proper insulation and air sealing, the basement is subject to being a high-humidity environment which could damage the paper files. Insulating the basement will indirectly keep the floor of the floor above a warmer temperature which will create a more comfortable environment in the occupied areas above which will also save on heating costs. The exterior foundation would be insulated with spray foam paying close attention to any pipe or wire penetrations, windows, and cracks.

*SAU Office Basement Conditions*

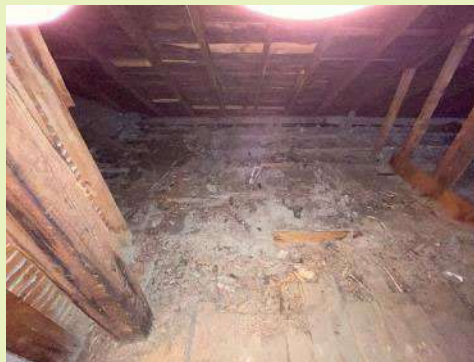
The SAU Office has minimal attic insulation and poor air sealing throughout. The eaves were noticed to have almost no insulation which may cause ice dams on the roof during the winter which could cause water to infiltrate under the shingles of the roof and cause water damage inside the building. Adding a proper layer of cellulose insulation across the floor and potentially spray foaming the eaves would add a highly efficient insulation value to the attic of the building.

*SAU Office Attic Insulation*

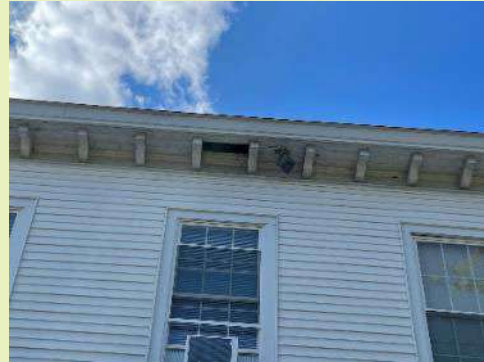
Overall, for the age of the building, the SAU office is in good condition. However, it was noticed during the exterior portion of the site walk that there are a few areas of concern regarding weatherization. Most of the concerns are associated with the soffit of the building. This area shows signs of peeling paint, rotting wood, and even an open hole in one section. The open hole is most concerning since this is a direct entry for small animals and insects to get into the building. There were multiple yellow jacket nests around the building and eventually an infestation of the attic may occur. The hole is also the most susceptible to weather getting into the unprotected portion of the building. The brick foundation also has some portions requiring some mortar repair. The bricks in some areas are just sitting with large voids around them lacking mortar. These areas should be repaired to maintain the integrity of the building.

*SAU Office Hole in Soffit*

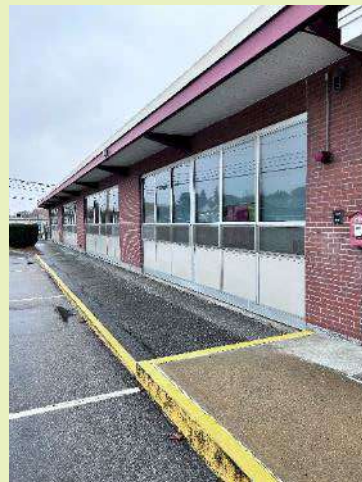
Many of the windows at Bartlett Elementary have been replaced over the recent years and there are still many remaining windows to replace. The windows that have been identified as having the largest efficiency gains associated with them are windows like the front windows as shown in the photo. This floor to ceiling window unit severely lacks quality insulative properties as modern energy efficient models would offer. Due to the size of these windows, there would be noticeable temperature improvements in the classroom spaces which have these windows. With better insulated windows (and most of the wall) the heating system would also not be required to produce as much heat which would save on heating plant energy consumed. It is recommended to replace the remaining windows in this school with a highly efficient window option.

*Bartlett Elementary Front Windows*

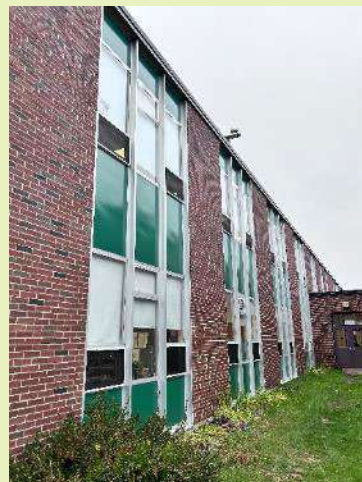
Many of the windows at the High School have been replaced over the recent years and there are still many remaining windows to replace. Some of the older windows have begun to lose seals which severely degrades the windows ability to insulate the outside temperature from the inside. This causes cool temperatures near the windows during the winter months and puts an extra load on the heating system which increases the costs associated with the heating plant. To stay ahead of window failures, it is recommended to complete a window replacement for the remainder of the school. This will ensure that energy is not being wasted due to faulty windows and will ensure a better indoor environmental comfort level for the students.

*Goffstown High School Windows*

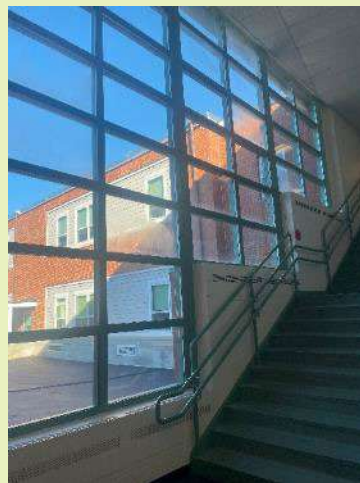
The Maple Avenue Elementary School has recently received new windows and most of them are in great condition. There is a section of windows that is of concern, however. The window section shown in the photo generally does not provide enough insulation value in the winter months for the existing heating that is available in the space. This causes cool temperatures in the spaces adjacent to this area and puts an extra load on the heating system. At first, adding additional heat was a logical solution. A deeper review of the windows determined that some of the window seals have failed, which is indicative of moisture buildup in some of the windows. Overall, this window structure has replacement options that can provide much better temperature resistance (R-Value) which would potentially eliminate the need for additional heat in the space (and the added costs to generate and distribute that heat). It is recommended that this window section be replaced with a more energy-efficient option.

*Maple Avenue Elementary Windows  
Cause Cold Conditions in Vicinity*

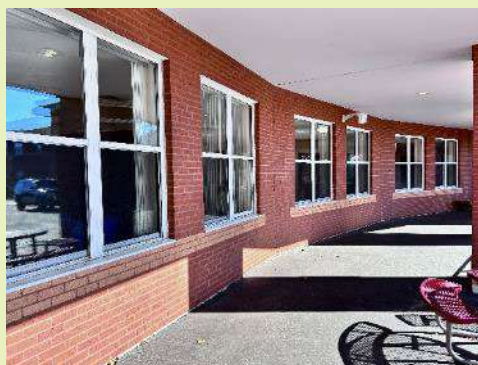
The windows in the Mountain View Middle School are original to the building and some of them have begun to fail over the years. Some of the windows have lost their seals and moisture can be found between the panes of glass. Other windows have failed in ways that prevent the user from safely operating the window without it wanting to fall out of its track. Since all the windows are the same age, they are likely in similar conditions and for this reason it is recommended to replace all the windows which will provide energy efficiency gains with the increased R-Value found in modern windows. If replacing all the windows at once is too much to take on financially, it is recommended to at least replace the windows that have already failed as phase 1 with a plan in place to phase a complete window replacement over the next few years.

*Mountain View Middle School Existing 30-Year-  
Old Windows*

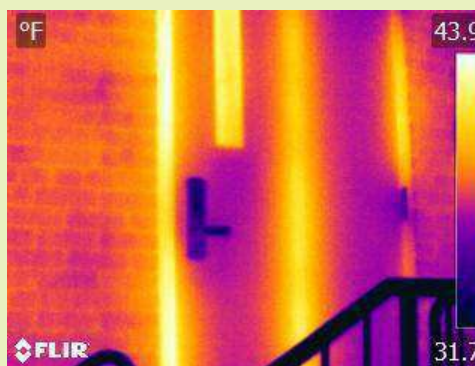
The exterior doors at Bartlett Elementary, for the most part, are structurally and cosmetically in good condition. The air sealing around the doors is what is lacking for most of the doors. A good air seal is vital to keep the outside air out and the conditioned air in. When air sealing has been compromised or does not exist altogether, this threshold between indoors and outdoors approaches zero. On cold windy days the areas in proximity to the doors will feel drafty and cool. This will cause the heating system to heat more than should be required while raising energy consumption. By adding weather stripping around the doors, door sweeps and astragal (the seal between the doors), the doors will perform much better and help lower the energy consumption of the building.

*Bartlett Elementary Exterior Door Heat Loss*

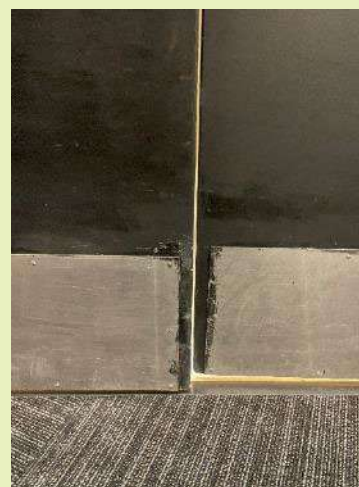
Many of the exterior doors in the High School have been replaced in previous years. About 11 doors remain to be replaced. These remaining doors have various condition levels. Some of them have large air gaps around them which will cause a significant amount of air infiltration. This will likely cause the area to be drafty and cold during the winter months, which will put an unnecessary load on the heating system. The four (4) access doors for the auditorium are also in poor shape and should be replaced. While these doors are not all exterior doors, the condition of the doors are poor. They show excessive signs of wear and use, and some have large gaps between them.

*Goffstown High School Exterior Door  
Showing a Large Air Gap*

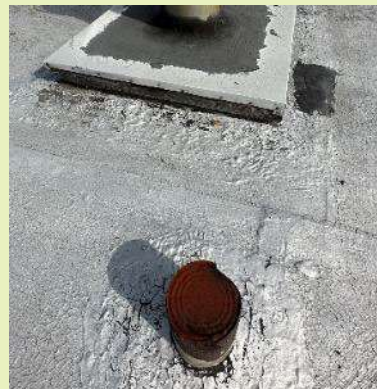
There are numerous sections of roofing that are well beyond its usable life. The roofing material has dried out and is cracking leaving the weatherproofing protection in jeopardy. The flashing and edges are also in poor condition and should be replaced. Any existing roof penetrations that are no longer used would be removed and properly sealed. The insulation thickness in one part of the roof was only about 1-1.5" thick. This is well below the 5.2" thickness to achieve an R30 rating required by the state energy code. Insulation would be added above the roof deck while the roof membrane was being replaced. Proper pitches would be installed under the new membrane to direct water towards the existing roof drains to prevent pooling of water.

*Bartlett Elementary School Upper Roof*

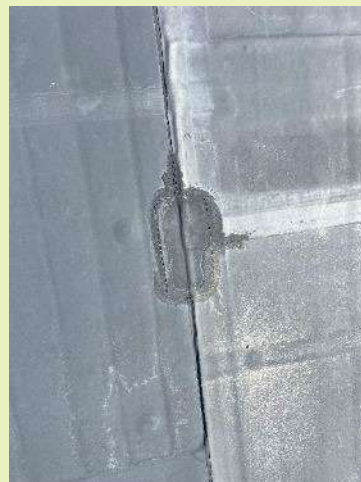
With some immediate repairs, this roof should last another 5-10 years. Some seams are showing signs of drying out which will lead to cracking and leaking. These seams should be repaired. This is mostly seen around roof patches and other penetrations such as around roof mounted HVAC equipment. The flashing on the chimney needs to be replaced or at least sealed with caulking. The roof drains need to be cleaned as leaves, pine needles and moss have mostly clogged some of the drain grates. One of the roof drain grates appears to be missing and should be replaced before the drainpipe becomes clogged with debris. The large satellite dish on the roof is mounted via cinderblock ballast with an extra layer of rubber matting under the blocks to protect the EPDM from damage. While this is all fine, the rim of the dish is sitting on the unprotected EPDM. When the wind blows the dish likely moves and will wear out the unprotected roofing eventually causing a failure to the material. The dish should be repositioned to be self-supported without laying on the unprotected EPDM. When this roof is replaced, the roof pitching should be improved to help remove the standing water that was present during one of the walk throughs. While a core sample of the roof was not taken in time for this report, it is expected that some insulation will be required to meet R30 requirements and should be added when the roof is replaced.

*Goffstown High School Roof Showing Signs of Deterioration*

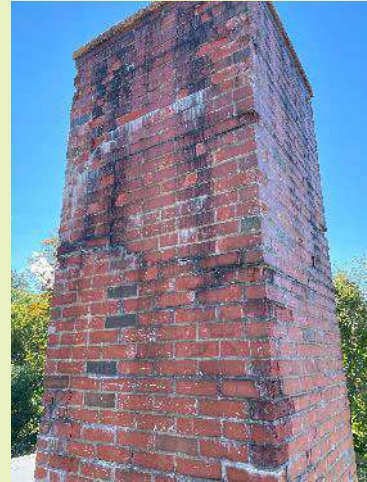
*Maple Avenue Elementary Chimney Condition*

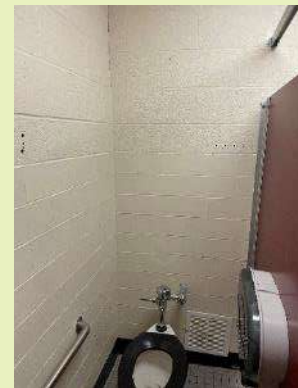
*Maple Avenue Elementary  
Bathroom Stall not ADA  
Compliant*

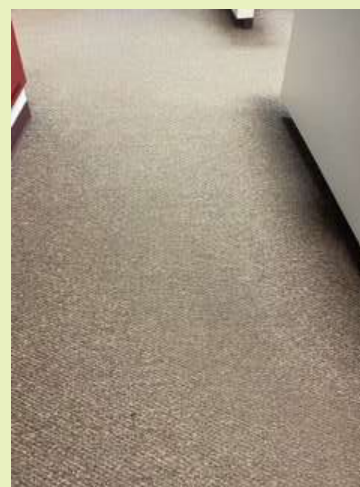
*Goffstown High School Carpet  
Showing Signs of Wear and Tear*

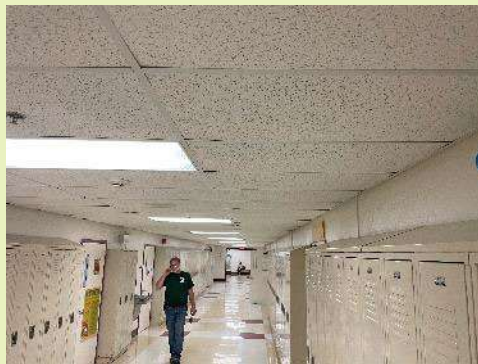
*Goffstown High School Ceiling Tiles Curling in the Corners*

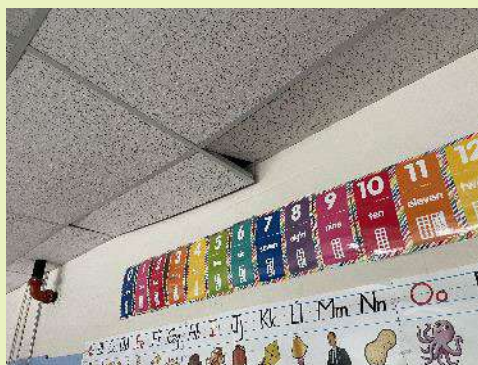
*Maple Avenue Elementary Ceiling Tiles with Large Gap*

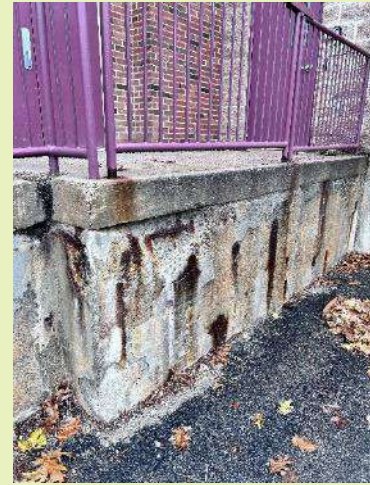
*Goffstown High School Loading dock area concrete in need of repairs*

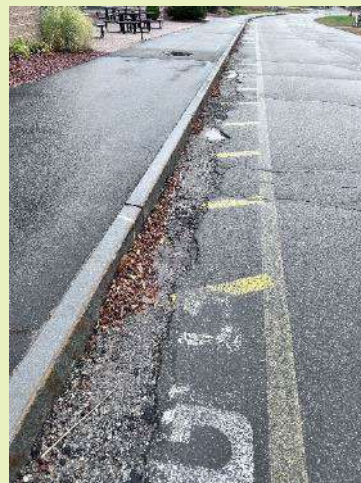
*Goffstown High School Pavement  
Showing Signs of Deterioration*

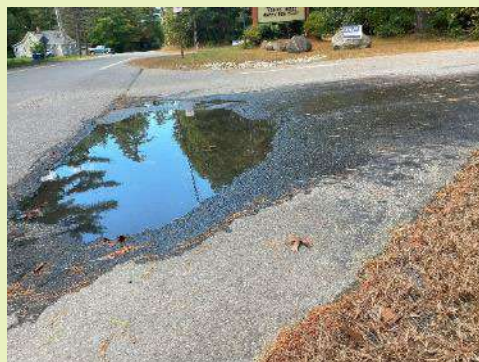
*Glen Lake School Roadway Entrance Pooling*

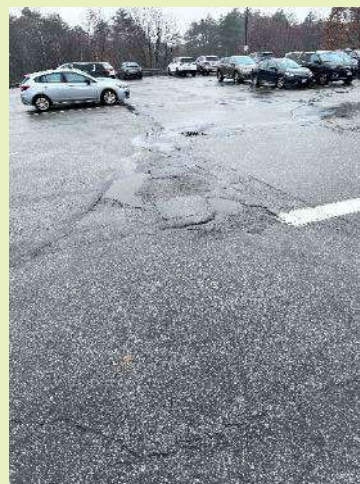
*Mountain View Middle School  
Parking Lot Deterioration*

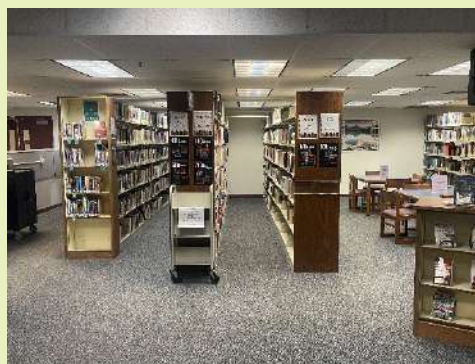
*Goffstown High School Library Furniture in Poor Condition*

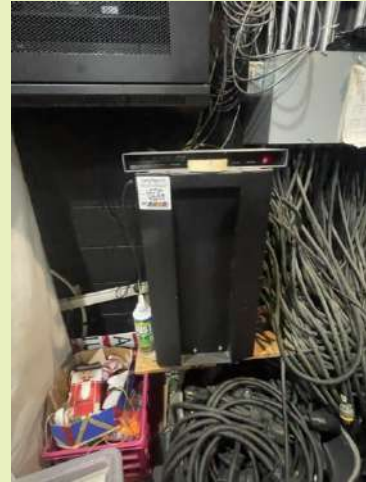
*Goffstown High School Lighting  
Controller*

stage crew. It is recommended to replace the existing lighting controller with a new controller that meets the current and future needs of the stage crew.
