Lowell Public Schools
Comprehensive Facilities Assessment
Lowell, Massachusetts

Final DRAFT Master Plan Report
February 28, 2014
Volume 1

OMR Architects
543 Massachusetts Avenue
Acton, MA 01720

Project No. 1308.00

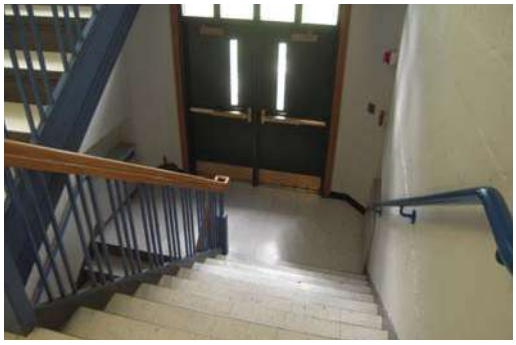
Many of the building stairs have non-complying code issues with nosings, guards, handrails, extensions, and handrail profiles.

Sagging and damaged ACT systems throughout. Condensation and/or roof leaks above ceilings require repair.

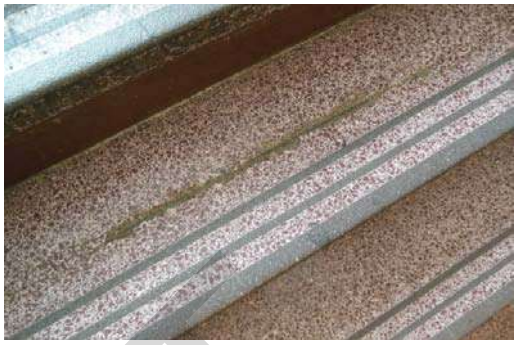
Existing ashalt paving is in poort to fair condition and requires replacement. Overgrown vegetaion needs to be trimmed and removed from fencing.

Typical terrazzo floor finish stress fractures in stairs. Other locations include, cafetorium, selected corridors and toilet rooms.

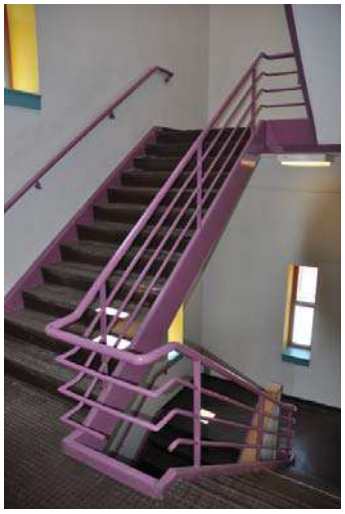
Renovated circa 1985, typical classrooms are generally in good condition with only specific deficiencies that vary to address.

Stairs were renovated and for the most part in good condition. There is work required to rails and nosing to bring some of them up to current code.

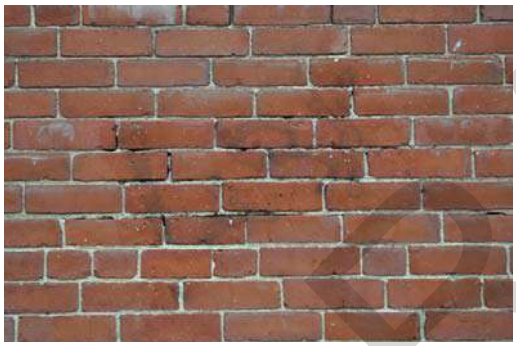
Window and panning were replaced circa 1985. Both are in fair condition; finish is chalking. Solid masonry exterior walls.

Older masonry is failing in places and should be repaired and repointed as required. This is typical of the older of the two buildings only.

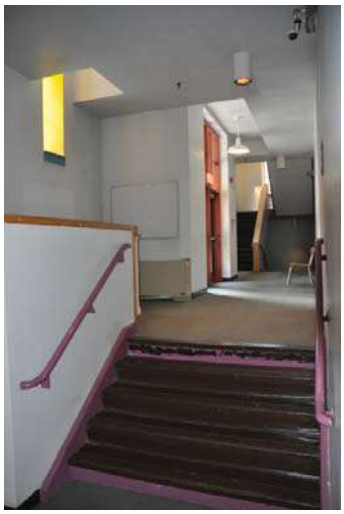
An example of a space that was renovated in 1985 and still looks and functions well. Three monitors are post mounted in the center of the room. This is a fairly typical installation.

The main entrance to the Theatre from the street is not accessible.

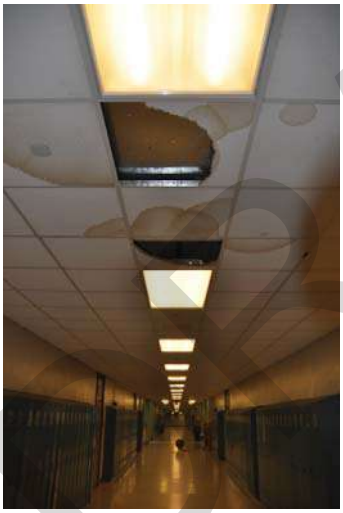
Damaged, stained or missing ceiling tiles is a fairly common occurrence throughout all the buildings. The cause varies from failed flashing and roofing to leaky pipes and to a lesser degree vandalism.

Typical older classroom. Painted wood trim and wainscoting. Carpet needs to be replaced. Ceiling and lighting in good condition; exhaust air grill needs to be cleaned.

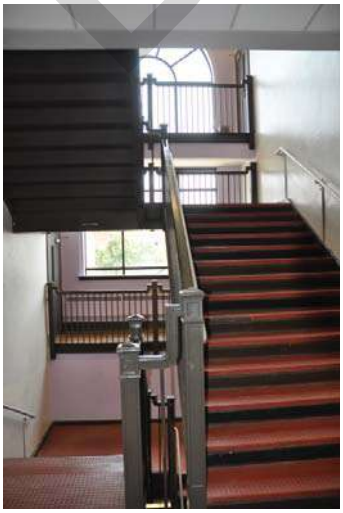
A stair in the 1922 Building. The treads, risers, and railings all need to modified to meet current code. Nosing are no longer permitted at stair risers. Finishes worn and in some cases missing altogether.

A typical toilet room with tile floors and walls and painted gypsum board ceilings all dating to a renovation in 1995. The toilet partitions are new as of the summer of 2013.

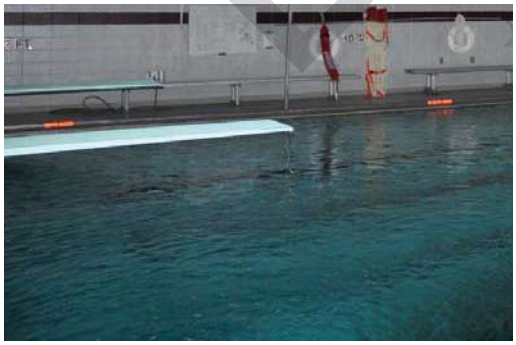
Large field house. Bleachers do not conform to latest accessibility codes. Synthetic floor is original and needs to be replaced.

Natatorium finishes are in fair condition, but dated. Mechanical systems need to be replace and pools systems should be checked.

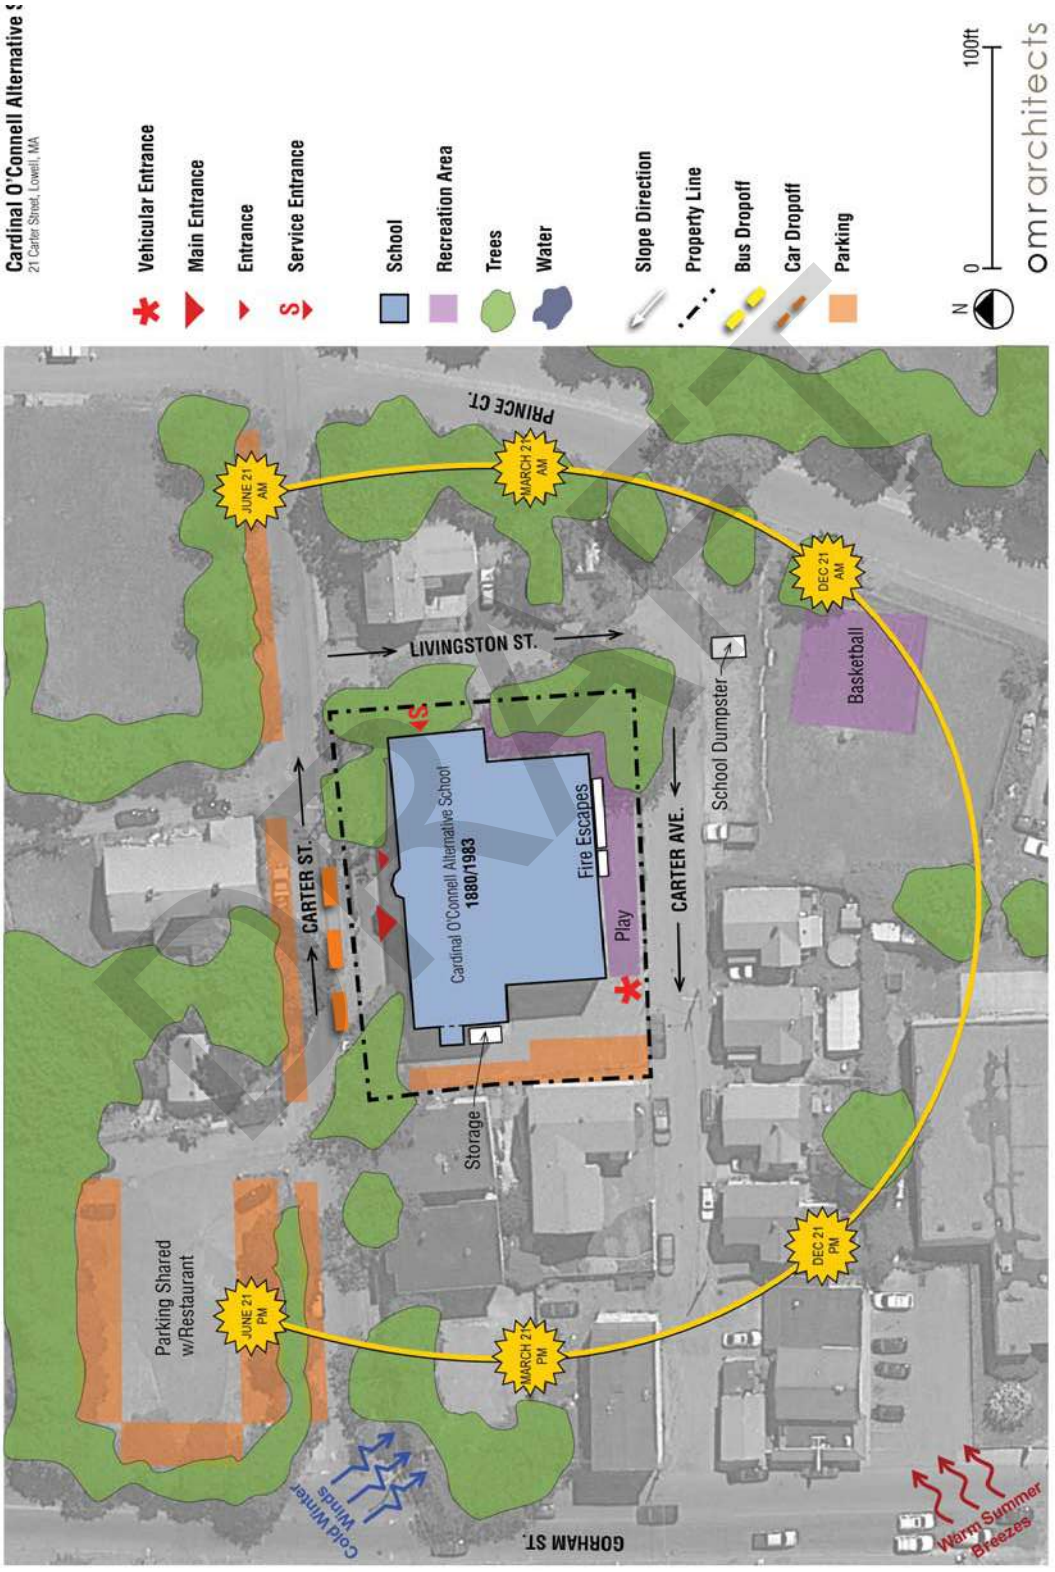
Site Analysis Graphic

Main Facade: Exisiting brick is overall in good condition but requires cleaning & some repointing.

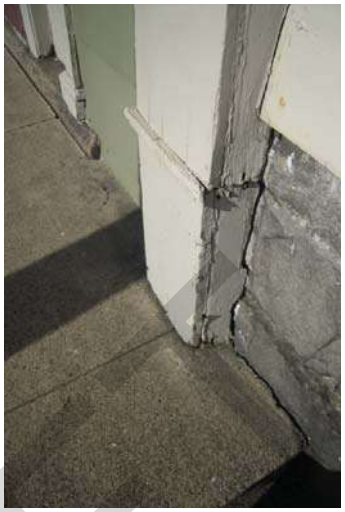
Typical deteriorated roof wood eave.

East main entrance portico columns and pilasters need repair – possible structural concern at columns.

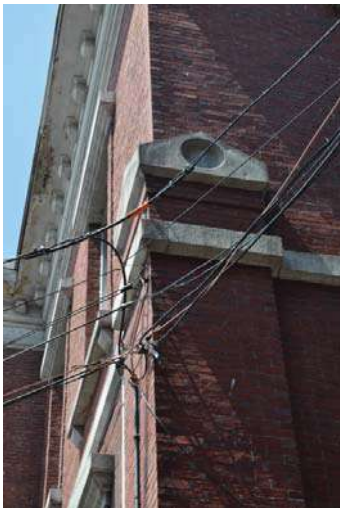
It is evident from this photo the building is in need of extensive restoration of all exterior components.

Much of the construction remains original with the exception of ceilings and lighting. The flooring is not original, but has failed and requires replacement.
