WIGGINS SCHOOL DISTRICT RE-50J 2016 DISTRICT MASTERPLAN

JULY 2016

hord | coplan | macht

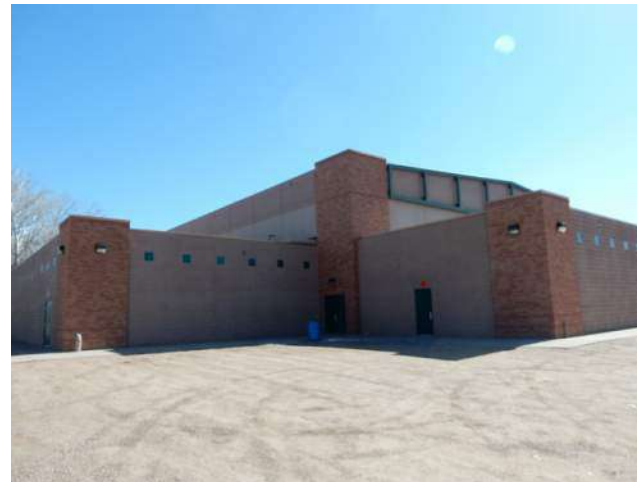
The exterior envelope is in overall good condition and is well maintained.

The exterior wall is constructed of highly durable material and is in good condition.

The roof is EPDM membrane over insulation over metal roof deck. The roof is in good condition.

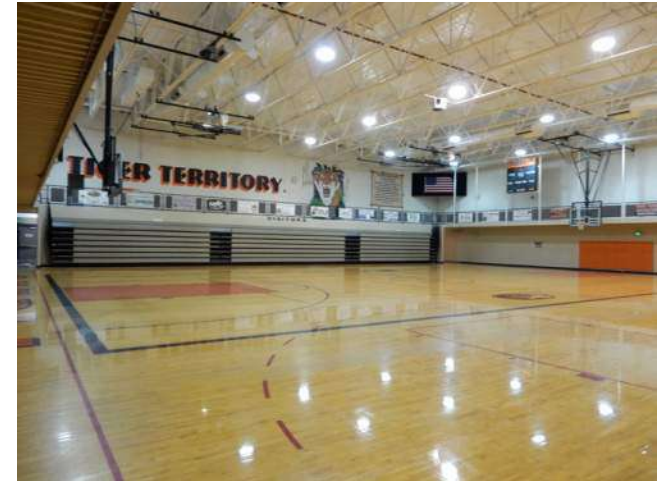
Fire alarm was upgraded approximately ten years ago to Simplex 4100, appears functional. Does not appear any detection was installed in the gymnasium. Present code is voice evacuation, which the present system does not meet and an upgrade would be required (FACP is upgradeable to voice, however, replacement of hornstobes to speaker strobes throughout would be necessary).

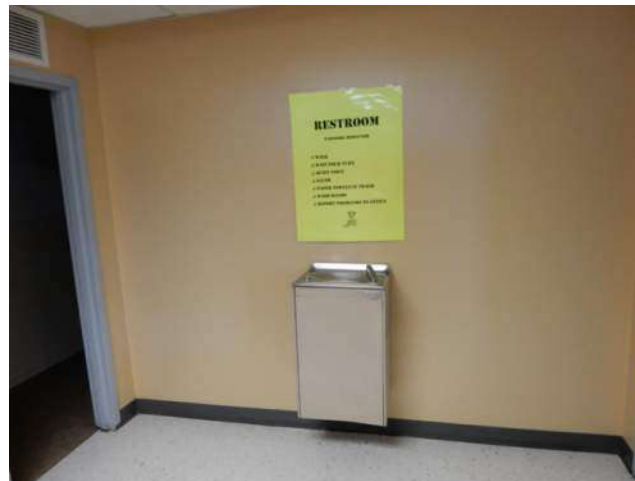
The exterior of the building is accessible, including an ADA-accessible front entrance. However, there is not an adjacent parking lot with accessible parking spaces near the elementary school. It is recommended to stripe dedicated handicap parking spaces in the drop-off lane in the front of the school for accessible parking. These will have to

be parallel parking spaces and will impact the queuing length of the pick-up / drop-off lane at the front of the school. The exterior classroom doors around the perimeter are located above grade, with stoops and steps to the accessible egress path. These doors are not required for exiting and are not required to be accessible. Door hardware throughout the building has been upgraded to compliant lever-sets and exit doors have upgraded panic hardware. There is one unisex ADA accessible restroom serving the entire school. The remainder of the student restrooms do not have an accessible toilet stall, do not have an accessible lavatory and do not have the required maneuverability clearances. Significant renovation would be required to bring these restrooms into code compliance and ADA accessible. Likely plumbing fixture would need to be removed to create an accessible toilet stall, which could impact the number of toilet stalls required by building code.

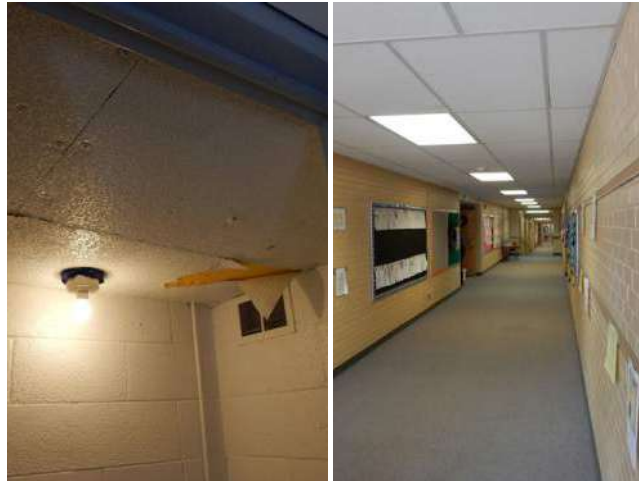
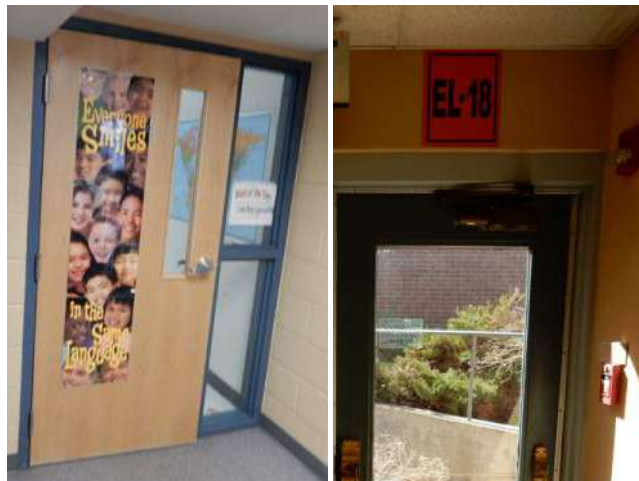
The main entrance is aluminum storefront, with the remainder of the exterior doors hollow metal with hollow metal frames. Interior doors are wood with hollow metal frames. The classroom doors have vision lites. The exterior hollow metal doors are a combination of solid doors and those with vision lites. The hardware throughout has been upgraded to ADA accessible lever sets and panic bars. There are some exterior doors that have the original panic bars. Several of the exterior classroom doors do not have adequate weather-stripping and are difficult to latch closed. This creates both a security issue and a thermal comfort issue. It is recommended to repair the doors to improve the latching and install perimeter weather-stripping to eliminate infiltration of cold, dirt and leaves.

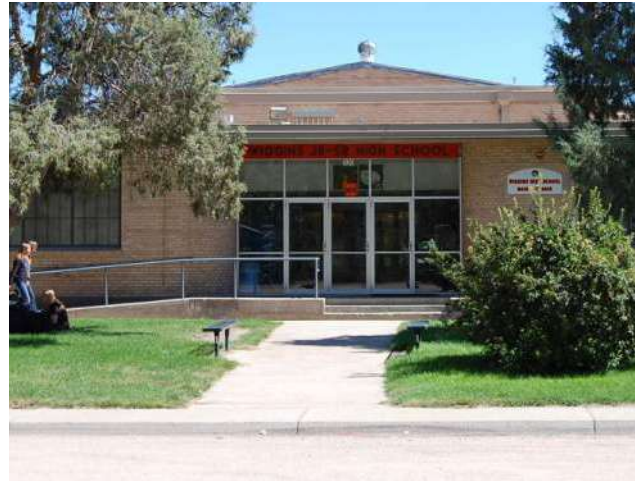
The structural systems of the building are in generally good condition. There are no visible signs of cracking or settlement at the foundation elements, basement walls, or the interior load-bearing walls. There are vines covering the entire north elevation of the gym which can contribute to masonry deterioration over time. It is recommended to remove the vines and repair any damaged mortar joints. There are also holes in the masonry of the gym visible from the roof, likely from pipe penetrations that have since been removed. It is recommended to fill these holes with compatible mortar to eliminate water infiltration into the masonry cavity.

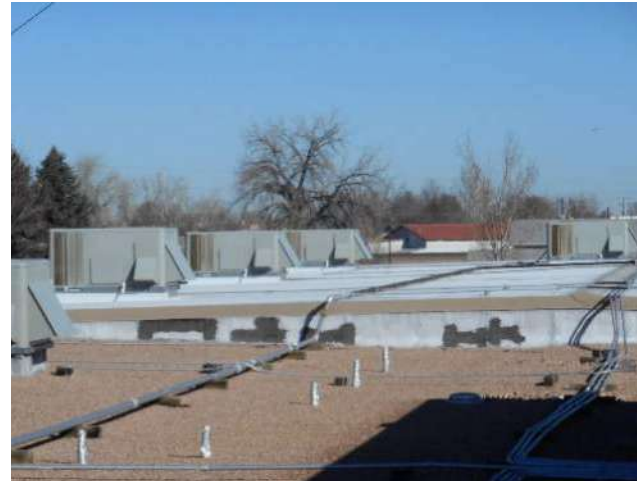
The rooftop units are nearing the end of their serviceable life of 15 years. The serviceable life of the equipment is a measure of equipment life to a point where component parts are no longer available or the service of the equipment will be of little benefit to the operation of the equipment. Envision Mechanical Engineers Inc. (EME) recommends upgrading Rooftop Units and Integrating Direct Digital Controls (DDC) with new high efficiency equipment with CO2 control that will enhance occupant comfort and increase energy savings.

The water supply is original to the building and well beyond its serviceable life, with a mixture of cast iron with lead-oakum sealed drainage pipe, galvanized water supply and intermittent copper, PVC and PEX. There is severe corrosion and numerous plumbing code issues. Bathroom and plumbing fixtures are original and beyond their 20 year serviceable life. There appears to be an insufficient fixture count for the facility. There are no ADA accommodations in the main high school.

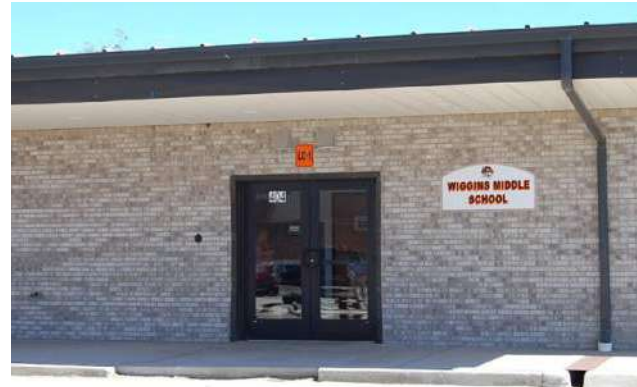
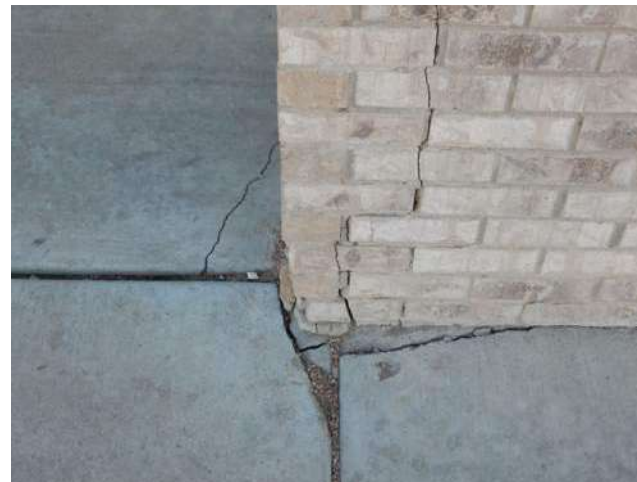
The structural system of the building is in generally good condition. There are minimal signs of cracking or settlement at the foundation elements. There is evidence of foundation settling at the northwest corner of the building which has led to cracking in the exterior veneer. It is recommended to stabilize the soils beneath the foundation, divert any storm water which may be contributing to the sinking and repair the masonry joints.

The exterior envelope is in overall good condition and is well maintained. Specific deficiencies and recommended maintenance are listed below.

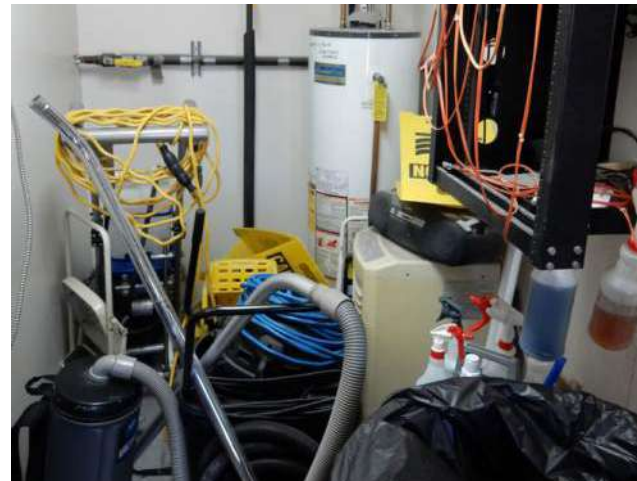
Cabling appears to enter the building through the side wall overhead with no physical protection of cabling through the wall. The voice data closet shares space with mechanical equipment and washer dryers creating a high temperature/humidity environment. Storage adequacy

There is little to no dedicated curriculum or teacher storage space other than that which is provided by the casework in each classroom. Lack of current storage was not identified by the staff of the school during recent interviews Interior finishes & ease of maintenance

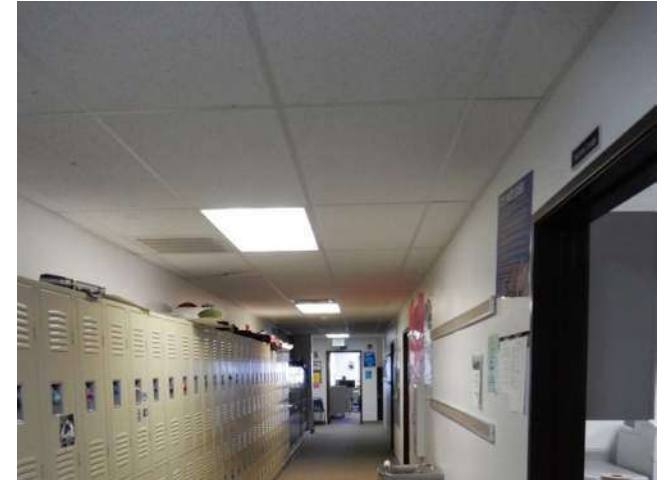
All of the interior walls are painted gypsum board. Interior floors are carpet in the classrooms, corridors and work room, VCT in the science classroom and restrooms. The carpet tile is worn and stained, with some of the seams between tiles becoming more visible. This carpet is at the end of its anticipated life and it is recommended to replace. The interior gypsum board walls do not provide the needed durability for a middle school and are showing minimal damage and wear. Overall, the interior finishes are in good condition.

The majority of the ceilings are finished with suspended acoustical ceiling tile, with the restrooms having painted gypsum board ceilings. The tile and grid is in good condition, showing normal wear and tear for a 15 year old building.

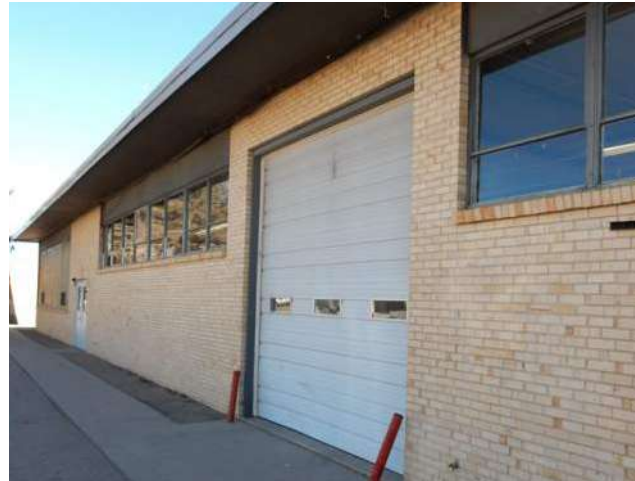
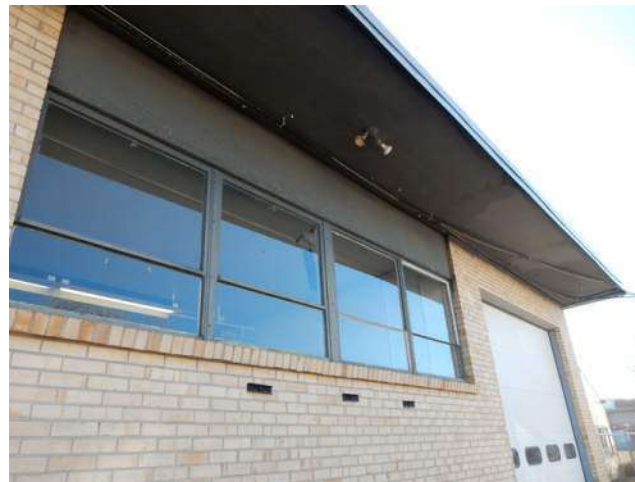
The structural system of the building is in generally good condition. There are no visible signs of cracking or settlement at the foundation elements. (ag shop DSCN1708)

The exterior envelope is in overall good condition and is well maintained. Specific deficiencies and recommended maintenance are listed below.

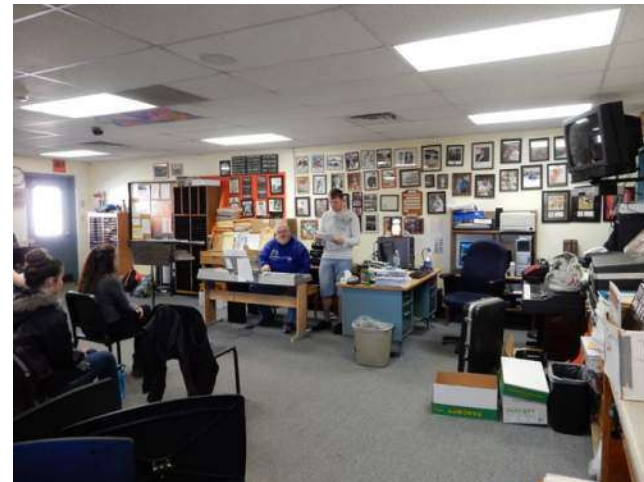
All of the interior walls are painted gypsum board or CMU. Interior floors are carpet in the music classroom, vinyl tile in the shop classroom and poured concrete throughout the shop spaces. The carpet is at the end of its anticipated life and it is recommended to replace. The interior gypsum board walls do not provide the needed durability for a middle school and are showing minimal damage and wear. Overall, the CMU walls are durable and are in good condition. The interior finishes are in fair condition based on the abuse they receive as a shop building.

The shop building has a painted gypsum board ceiling that is in good condition. This is a hard ceiling which affects the acoustics of the space. It is recommended to add acoustic panels to help absorb sounds from the equipment. The shop and music classrooms have suspended acoustic tile. The tile and grid is in good condition, showing normal wear and tear. The acoustics also need to be improved in the music classroom, as well as between the music and shop spaces. Both are very active programs and constant sound transfer between the two creates educational challenges.

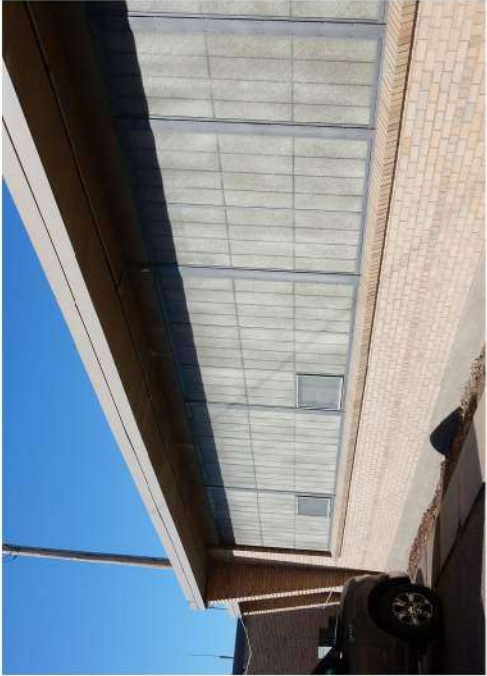
The current high school windows do not allow adequate light and are not weatherproof.

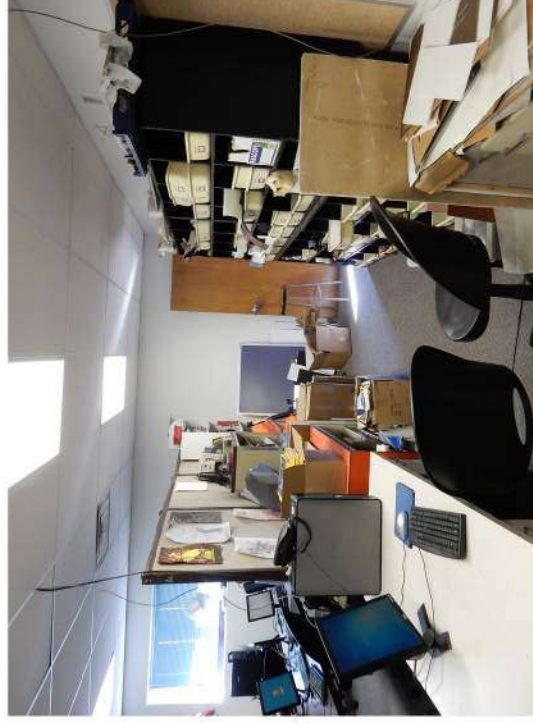
The middle school building is not being used as it was originally intended and the building is crowded and disorganized as a result.

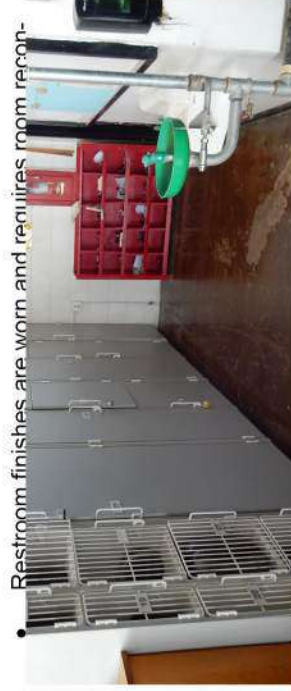
Music class is held in the shop building. Instruments are now stored in the woodshop, and must be cleaned of sawdust each day as part of class time.

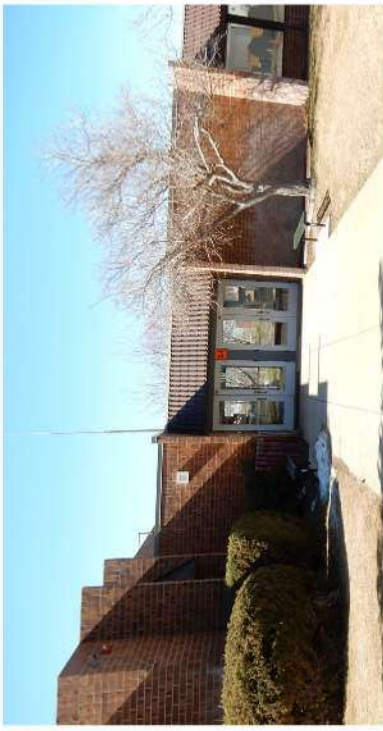
From the front door, visitors to the Elementary School can gain access to the whole building without facing an adult administrator

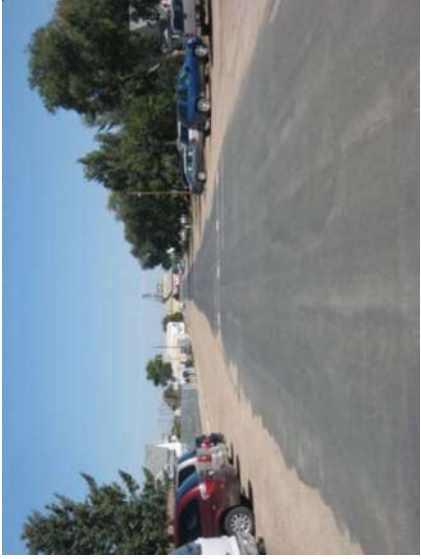
System: G2010 - Roadways

Analysis: The system age is either beyond expected life or does not meet its intended performance under the Guidelines. The system may be in service and functioning but it is recommended to be replaced due to probable increased condition budget needs, the potential failure of its components, or in order to meet the performance Guidelines for this system. The system was installed in 1960. It has a 50-year service life which expired in 2009.

Location: Site
Distress: Beyond Useful Life
Category: Deferred Maintenance
Priority: 3 - 3 Necessary- 2-5 Yrs
Correction: Renew System
Qty: 1-Ea.
Condition Budget: \$88,431

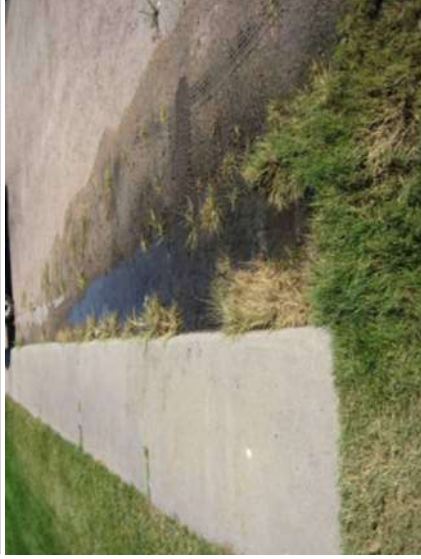
System: G2020 - Parking Lots

Analysis: The system age is either beyond expected life or does not meet its intended performance under the Guidelines. The system may be in service and functioning but it is recommended to be replaced due to probable increased condition budget needs, the potential failure of its components, or in order to meet the performance Guidelines for this system. The system was installed in 1960. It has a 50-year service life which expired in 2009.

Location: Site
Distress: Beyond Useful Life
Category: Deferred Maintenance
Priority: 3 - 3 Necessary- 2-5 Yrs
Correction: Renew System
Qty: 1-Ea.
Condition Budget: \$162,016

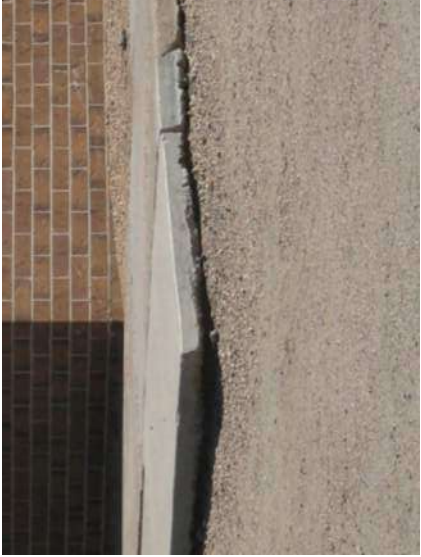
System: G2030 - Pedestrian Paving.

Analysis: The system age is either beyond expected life or does not meet its intended performance under the Guidelines. The system may be in service and functioning but it is recommended to be replaced due to probable increased condition budget needs, the potential failure of its components, or in order to meet the performance Guidelines for this system. The system was installed in 1960. It has a 50-year service life which expired in 2010.

Location: Site
Distress: Beyond Useful Life
Category: Deferred Maintenance
Priority: 3 - 3 Necessary- 2-5 Yrs
Correction: Renew System
Qty: 1-Ea.
Condition Budget: \$41,153

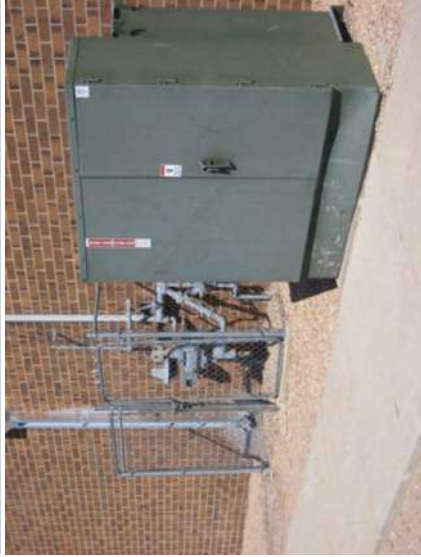
System: G2040 - Site Development.

Analysis: The system age is either beyond expected life or does not meet its intended performance under the Guidelines. The system may be in service and functioning but it is recommended to be replaced due to probable increased condition budget needs, the potential failure of its components, or in order to meet the performance Guidelines for this system. The system was installed in 1960. It has a 30-year service life which expired in 2009.

Recommendation: The system should be replaced.

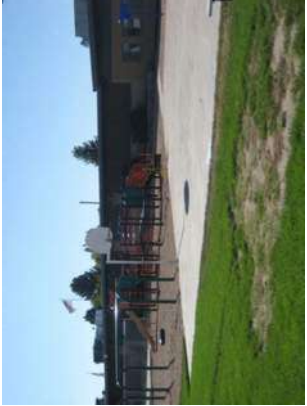
Location: Site
Distress: Beyond Useful Life
Category: Deferred Maintenance
Priority: 3 - 3 Necessary- 2-5 Yrs
Notes: Landscaping is mature, but has some bare spots due to inadequate sprinkler system coverage.
Correction: Renew System
Qty: 1-Ea.
Condition Budget: \$149,338

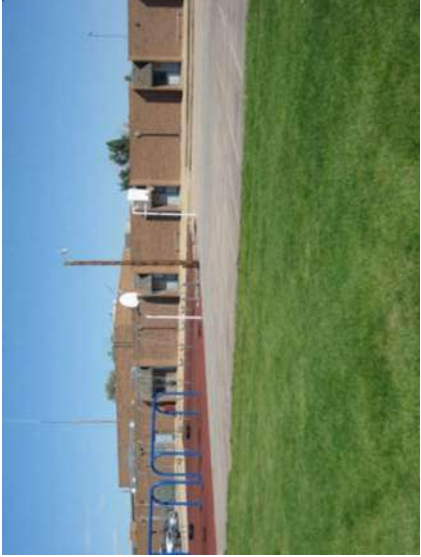
System: G4020 - Site Lighting

Analysis: The system age is either beyond expected life or does not meet its intended performance under the Guidelines. The system may be in service and functioning but it is recommended to be replaced due to probable increased condition budget needs, the potential failure of its components, or in order to meet the performance Guidelines for this system. The system was installed in 1960. It has a 30-year service life which expired in 2009.

Location: Site
Distress: Beyond Useful Life
Category: Deferred Maintenance
Priority: 3 - 3 Necessary- 2-5 Yrs
Correction: Renew System
Qty: 1-Ea.
Condition Budget: \$70,987

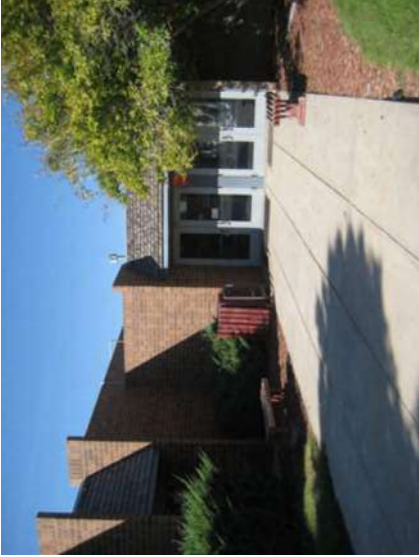
System: G4030 - Site Communication and Security

Analysis: The system age is either beyond expected life or does not meet its intended performance under the Guidelines. The system may be in service and functioning but it is recommended to be replaced due to probable increased condition budget needs, the potential failure of its components, or in order to meet the performance Guidelines for this system. The system was installed in 1960. It has a 30-year service life which expired in 2009.

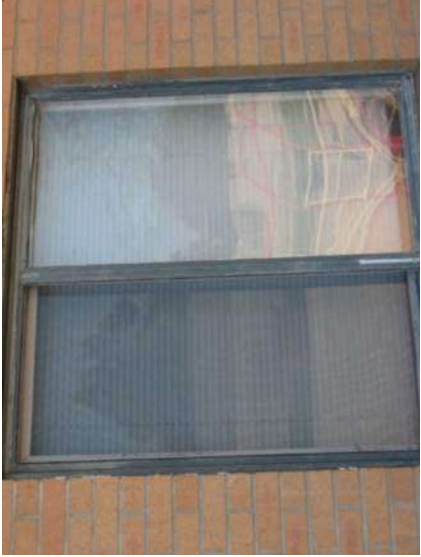
System: B2020 - Exterior Windows

Analysis: The system age is either beyond expected life or does not meet its intended performance under the Guidelines. The system may be in service and functioning but it is recommended to be replaced due to probable increased condition budget needs, the potential failure of its components, or in order to meet the performance Guidelines for this system. The system was installed in 1974. It has a 30-year service life which expired in 2009.

Location: Main
Distress: Beyond Useful Life
Category: Deferred Maintenance
Priority: 3 - 3 Necessary- 2-5 Yrs
Correction: Renew System
Qty: 1-Ea.
Condition Budget: \$495,342

Recommendation: The system should be replaced.

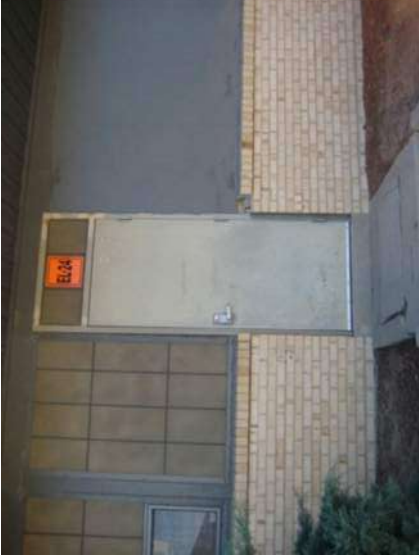
System: B2030 - Exterior Doors

Analysis: The system age is either beyond expected life or does not meet its intended performance under the Guidelines. The system may be in service and functioning but it is recommended to be replaced due to probable increased condition budget needs, the potential failure of its components, or in order to meet the performance Guidelines for this system. The system was installed in 1974. It has a 30-year service life which expired in 2009.

Location: Main
Distress: Beyond Useful Life
Category: Deferred Maintenance
Priority: 3 - 3 Necessary- 2-5 Yrs
Correction: Renew System
Qty: 1-Ea.
Condition Budget: \$42,068

Recommendation: The system should be replaced.

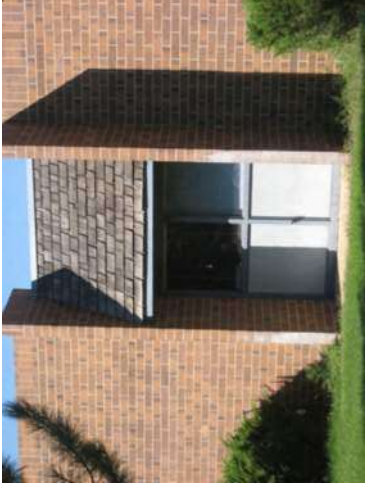
Location: Main
Material: Roof Covering
Distress: Failing
Category: Deferred Maintenance
Priority: 3 - 3 Necessary- 2-5 Yrs
Notes: Wood shingle roofing over windows presents a significant fire hazard. Recommend removal of shingles and replacement with metal panels.
Correction: Roof and flashing repair.
Qty: 1,000-S.F.
Condition Budget: \$11,101

Location: Main
Distress: Beyond Useful Life
Category: Deferred Maintenance
Priority: 3 - 3 Necessary- 2-5 Yrs
Notes: Client reported, "The roof system was installed in 1980. A partial re-roof project is currently underway over the Library wing. The remainder of the Elementary School roof is in need of replacement due to age, in addition to the wood shingle roofing over windows." See separate deficiency for roofing replacement over windows.
Correction: Renew System
Qty: 1-Ea.
Condition Budget: \$895,793

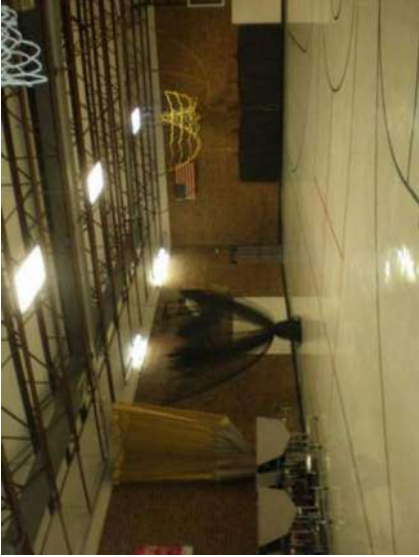
System: C1030 - Fittings

Analysis: The system age is either beyond expected life or does not meet its intended performance under the Guidelines. The system may be in service and functioning but it is recommended to be replaced due to probable increased condition budget needs, the potential failure of its components, or in order to meet the performance Guidelines for this system. The system was installed in 1974. It has a 20-year service life which expired in 1994.
Recommendation: The system should be replaced.

Location: Main
Distress: Beyond Useful Life
Category: Deferred Maintenance
Priority: 3 - 3 Necessary- 2-5 Yrs
Correction: Renew System
Qty: 1-Ea.
Condition Budget: \$170,499

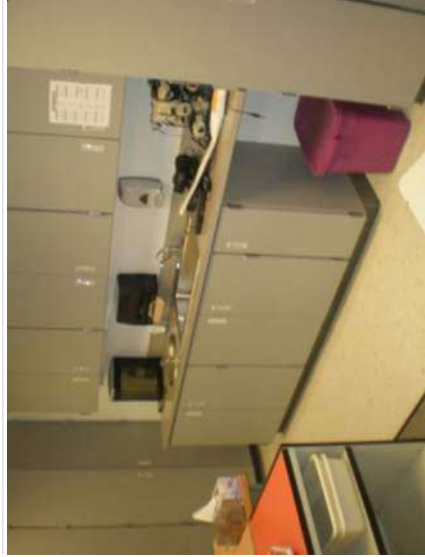
System: D2010 - Plumbing Fixtures

Analysis: The system age is either beyond expected life or does not meet its intended performance under the Guidelines. The system may be in service and functioning but it is recommended to be replaced due to probable increased condition budget needs, the potential failure of its components, or in order to meet the performance Guidelines for this system. The system was installed in 1974. It has a 30-year service life which expired in 2009.
Recommendation: The system should be replaced.

Location: Main
Distress: Beyond Useful Life
Category: Deferred Maintenance
Priority: 3 - 3 Necessary- 2-5 Yrs
Notes: The plumbing fixtures have reached the end of their expected useful life, in addition, the building does not comply with fixture count required by code, the installation of additional plumbing fixtures including bathroom expansion is necessary.
Correction: Renew System
Qty: 1-Ea.
Condition Budget: \$570,026

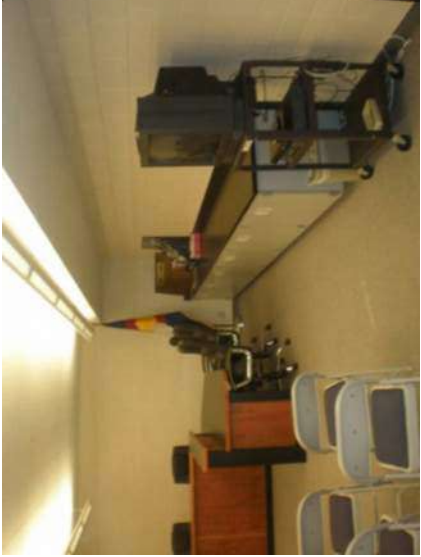
System: E1020 - Institutional Equipment

Analysis: The system age is either beyond expected life or does not meet its intended performance under the Guidelines. The system may be in service and functioning but it is recommended to be replaced due to probable increased condition budget needs, the potential failure of its components, or in order to meet the performance Guidelines for this system. The system was installed in 1974. It has a 20-year service life which expired in 1994.

Recommendation: The system should be replaced.

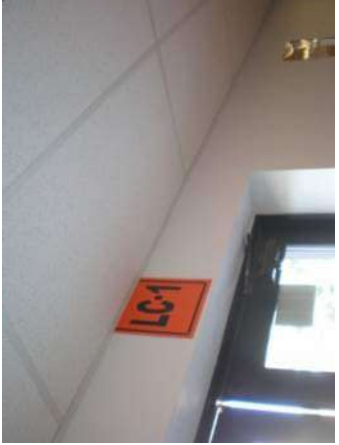
Location: Main
Distress: Inadequate
Category: Deferred Maintenance
Priority: 5 - 5 Does Not Meet Current Code and/or Guidelines
Notes: Building lacks exit signs and emergency lighting. Install emergency battery powered exit lighting.
Correction: Renew System
Qty: 1-Ea.
Condition Budget: \$6,977

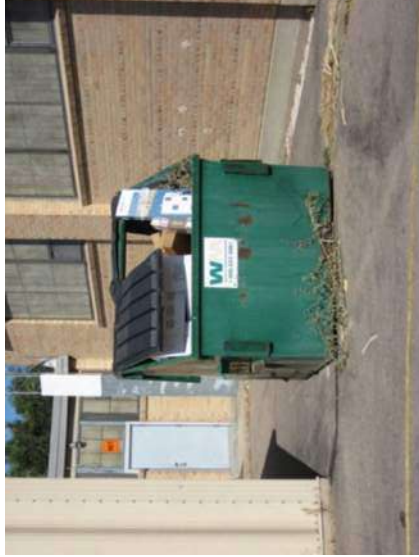
System: G2040 - Site Development

Analysis: The system age is either beyond expected life or does not meet its intended performance under the Guidelines. The system may be in service and functioning but it is recommended to be replaced due to probable increased condition budget needs, the potential failure of its components, or in order to meet the performance Guidelines for this system. The system was installed in 1974. It has a 30-year service life which expired in 2009.

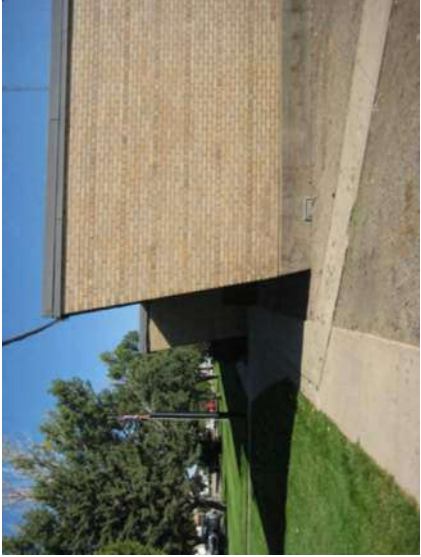
System: G2050 - Landscaping.

Analysis: The system age is either beyond expected life or does not meet its intended performance under the Guidelines. The system may be in service and functioning but it is recommended to be replaced due to probable increased condition budget needs, the potential failure of its components, or in order to meet the performance Guidelines for this system. The system was installed in 1974. It has a 10-year service life which expired in 2009.

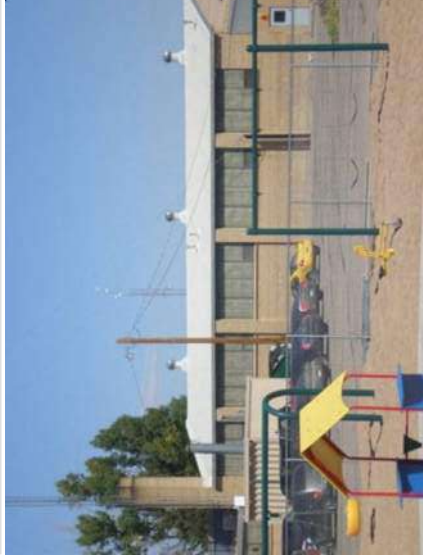
System: B3010 - Roof Coverings

Analysis: The system age is either beyond expected life or does not meet its intended performance under the Guidelines. The system may be in service and functioning but it is recommended to be replaced due to probable increased condition budget needs, the potential failure of its components, or in order to meet the performance Guidelines for this system. The system was installed in 1995. It has a 20-year service life which expired in 2009.

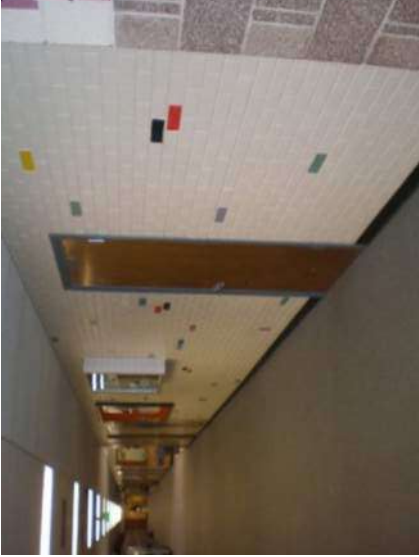
System: C1020 - Interior Doors

Analysis: The system age is either beyond expected life or does not meet its intended performance under the Guidelines. The system may be in service and functioning but it is recommended to be replaced due to probable increased condition budget needs, the potential failure of its components, or in order to meet the performance Guidelines for this system. The system was installed in 1948. It has a 40-year service life which expired in 2009.
Recommendation: The system should be replaced.

Location: Main
Distress: Beyond Useful Life
Category: Deferred Maintenance
Priority: 3 - 3 Necessary- 2-5 Yrs
Correction: Renew System
Qty: 1-Ea.
Condition Budget: \$170,080

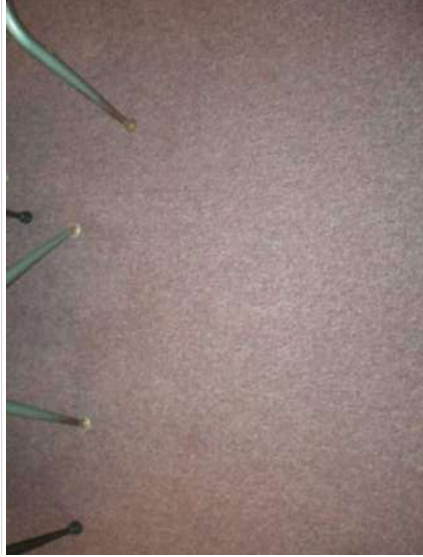
System: C3020 - Floor Finishes

Analysis: The system age is either beyond expected life or does not meet its intended performance under the Guidelines. The system may be in service and functioning but it is recommended to be replaced due to probable increased condition budget needs, the potential failure of its components, or in order to meet the performance Guidelines for this system. The system was installed in 1960. It has a 20-year service life which expired in 2009.

Location: Main
Distress: Beyond Useful Life
Category: Deferred Maintenance
Priority: 3 - 3 Necessary- 2-5 Yrs
Notes: Client reported, "There is suspect friable material (ACM) installed underneath the current 2-layers of carpeting." Recommend an engineering study be performed to determine abatement plan for removal of all friable material prior to beginning work on replacing floor coverings. See additional deficiency for study contained in F1040 for abatement plan.
Correction: Renew System
Qty: 1-Ea.
Condition Budget: \$614,919

Recommendation: The system should be replaced.

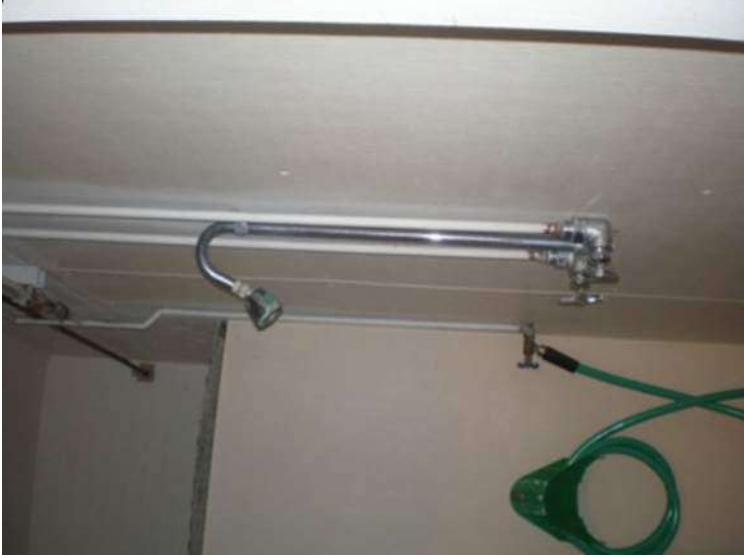
System: D2010 - Plumbing Fixtures

Analysis: The system age is either beyond expected life or does not meet its intended performance under the Guidelines. The system may be in service and functioning but it is recommended to be replaced due to probable increased condition budget needs, the potential failure of its components, or in order to meet the performance Guidelines for this system. The system was installed in 1948. It has a 30-year service life which expired in 2009.

Recommendation: The system should be replaced.

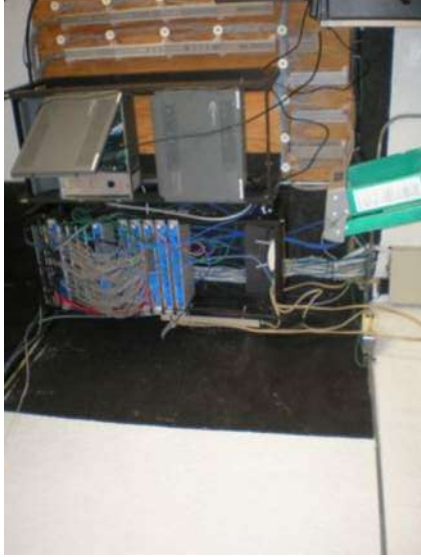
System: D3050 - Terminal & Package Units

Analysis: The system is missing.
Recommendation: The system should be installed.

Location: Main
Material: Terminal and Package Units
Distress: Missing
Category: Deferred Maintenance
Priority: 3 - 3 Necessary- 2-5 Yrs
Notes: Computer server lacks independent cooling.
Correction: Install CRCU for equipment protection
Qty: 300-Each
Condition Budget: \$2,966

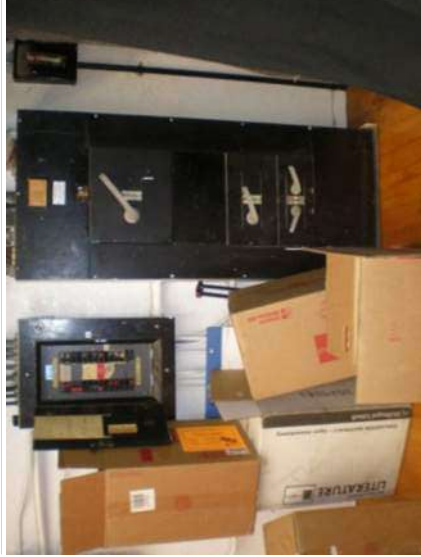
System: D5010 - Electrical Service/Distribution

Analysis: The system age is either beyond expected life or does not meet its intended performance under the Guidelines. The system may be in service and functioning but it is recommended to be replaced due to probable increased condition budget needs, the potential failure of its components, or in order to meet the performance Guidelines for this system. The system was installed in 1948. It has a 30-year service life which expired in 2009.

Recommendation: The system should be replaced.

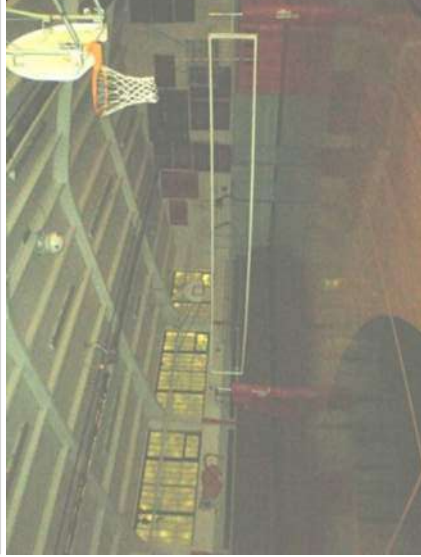
System: E1020 - Institutional Equipment
Analysis: The system age is either beyond expected life or does not meet its intended performance under the Guidelines. The system may be in service and functioning but it is recommended to be replaced due to probable increased condition budget needs, the potential failure of its components, or in order to meet the performance Guidelines for this system. The system was installed in 1948. It has a 20-year service life which expired in 1968.
Recommendation: The system should be replaced.

Location: Main
Distress: Beyond Useful Life
Category: Deferred Maintenance
Priority: 3 - 3 Necessary- 2-5 Yrs
Correction: Renew System
Qty: 1-Ea.
Condition Budget: \$8,590

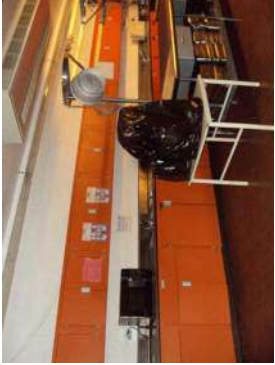
System: E1090 - Other Equipment
Analysis: The system age is either beyond expected life or does not meet its intended performance under the Guidelines. The system may be in service and functioning but it is recommended to be replaced due to probable increased condition budget needs, the potential failure of its components, or in order to meet the performance Guidelines for this system. The system was installed in 1948. It has a 20-year service life which expired in 1968.
Recommendation: The system should be replaced.

Location: Main
Distress: Beyond Useful Life
Category: Deferred Maintenance
Priority: 3 - 3 Necessary- 2-5 Yrs
Notes: Replace kitchen equipment as required.
Correction: Renew System
Qty: 1-Ea.
Condition Budget: \$52,593

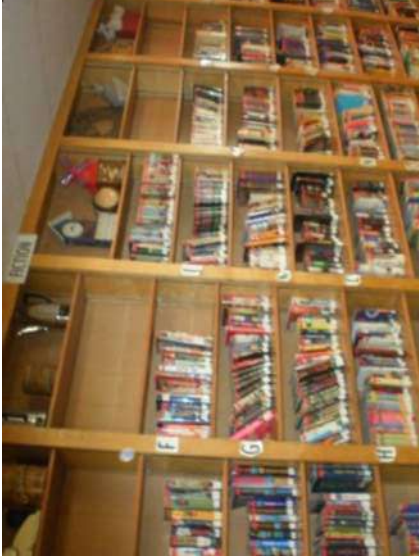
System: E2010 - Fixed Furnishings

Analysis: The system age is either beyond expected life or does not meet its intended performance under the Guidelines. The system may be in service and functioning but it is recommended to be replaced due to probable increased condition budget needs, the potential failure of its components, or in order to meet the performance Guidelines for this system. The system was installed in 1948. It has a 20-year service life which expired in 1968.
Recommendation: The system should be replaced.

Location: Main
Distress: Beyond Useful Life
Category: Deferred Maintenance
Priority: 3 - 3 Necessary- 2-5 Yrs
Correction: Renew System
Qty: 1-Ea.
Condition Budget: \$121,789

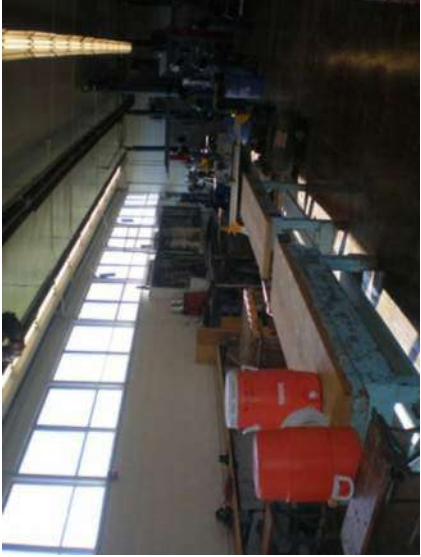
System: B2020 - Exterior Windows

Analysis: The system age is either beyond expected life or does not meet its intended performance under the Guidelines. The system may be in service and functioning but it is recommended to be replaced due to probable increased condition budget needs, the potential failure of its components, or in order to meet the performance Guidelines for this system. The system was installed in 1949. It has a 30-year service life which expired in 1979.
Recommendation: The system should be replaced.

Location: Agriculture
Distress: Beyond Useful Life
Category: Deferred Maintenance
Priority: 3 - 3 Necessary- 2-5 Yrs
Correction: Renew System
Qty: 1-Ea.
Condition Budget: \$102,413

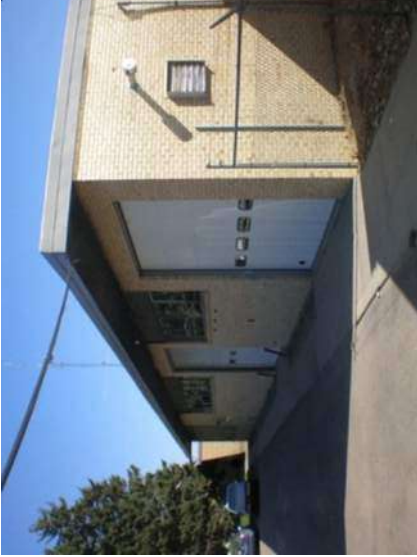
System: B2030 - Exterior Doors

Analysis: The system age is either beyond expected life or does not meet its intended performance under the Guidelines. The system may be in service and functioning but it is recommended to be replaced due to probable increased condition budget needs, the potential failure of its components, or in order to meet the performance Guidelines for this system. The system was installed in 1949. It has a 30-year service life which expired in 1979.
Recommendation: The system should be replaced.

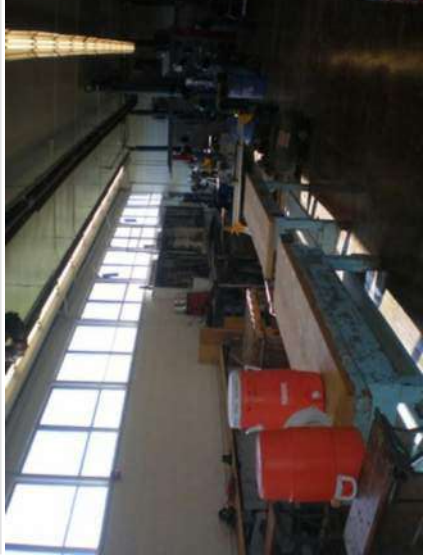
System: C3010 - Wall Finishes.

Analysis: The system age is either beyond expected life or does not meet its intended performance under the Guidelines. The system may be in service and functioning but it is recommended to be replaced due to probable increased condition budget needs, the potential failure of its components, or in order to meet the performance Guidelines for this system. The system was installed in 1949. It has a 20-year service life which expired in 1969.

Location: Agriculture
Distress: Beyond Useful Life
Category: Deferred Maintenance
Priority: 3 - 3 Necessary- 2-5 Yrs
Correction: Renew System
Qty: 1-Ea.
Condition Budget: \$59,238

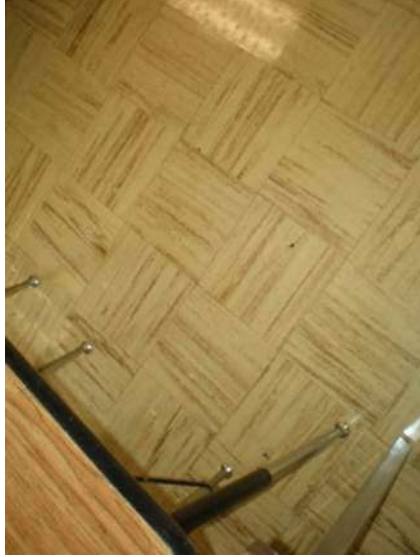
System: C3020 - Floor Finishes.

Analysis: The system age is either beyond expected life or does not meet its intended performance under the Guidelines. The system may be in service and functioning but it is recommended to be replaced due to probable increased condition budget needs, the potential failure of its components, or in order to meet the performance Guidelines for this system. The system was installed in 1949. It has a 20-year service life which expired in 1969.

Location: Agriculture
Distress: Beyond Useful Life
Category: Deferred Maintenance
Priority: 3 - 3 Necessary- 2-5 Yrs
Correction: Renew System
Qty: 1-Ea.
Condition Budget: \$117,254

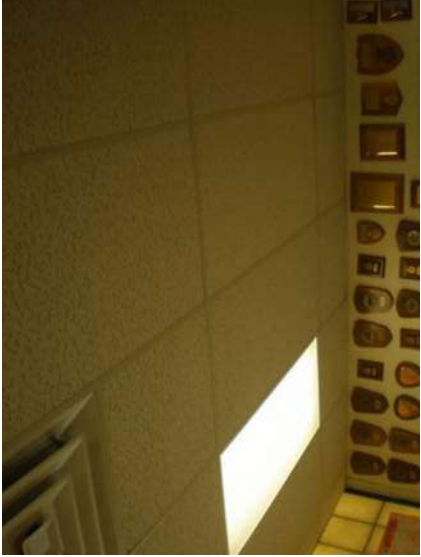
System: C3030 - Ceiling Finishes

Analysis: The system age is either beyond expected life or does not meet its intended performance under the Guidelines. The system may be in service and functioning but it is recommended to be replaced due to probable increased condition budget needs, the potential failure of its components, or in order to meet the performance Guidelines for this system. The system was installed in 1949. It has a 20-year service life which expired in 1969.
Recommendation: The system should be replaced.

Location: Agriculture
Distress: Beyond Useful Life
Category: Deferred Maintenance
Priority: 3 - 3 Necessary- 2-5 Yrs
Correction: Renew System
Qty: 1-Ea.
Condition Budget: \$106,041

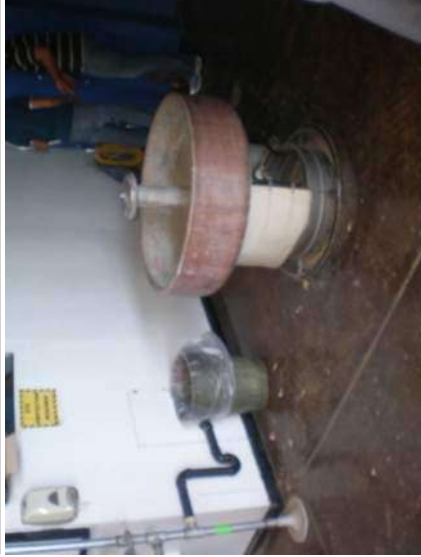
System: D2010 - Plumbing Fixtures

Analysis: The system age is either beyond expected life or does not meet its intended performance under the Guidelines. The system may be in service and functioning but it is recommended to be replaced due to probable increased condition budget needs, the potential failure of its components, or in order to meet the performance Guidelines for this system. The system was installed in 1949. It has a 30-year service life which expired in 1979.
Recommendation: The system should be replaced.
