CN / REFERENDUM SUPPORT ASSESSMENT

August 2019

Fearn Clendaniel Architects Inc

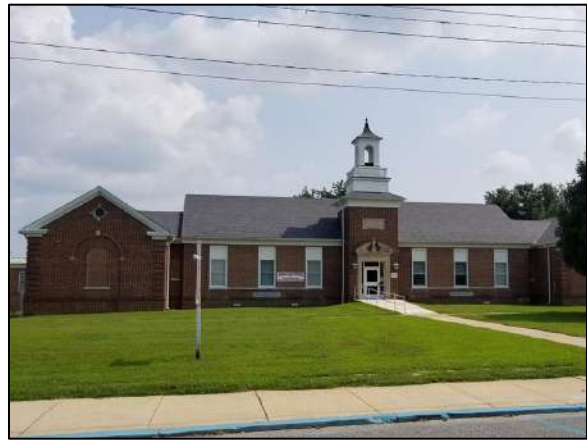
Clayton Elementary School consists of an original central building, with a series of additions throughout its history. The exterior envelope is predominantly brick with extensive areas of painted wood trim in older parts of the building. In general, masonry is in good to fair condition. Remaining exposed wood trim is weathering heavily. Windows are mostly serviceable throughout, but some exterior doors are worn and require replacement.

Structural systems and roof types vary by location, with mostly pitched roofs and some low-slope areas. Most pitched roofs have been shingled with a long-life synthetic slate material. Some low slope roof areas will require replacement in the near future.

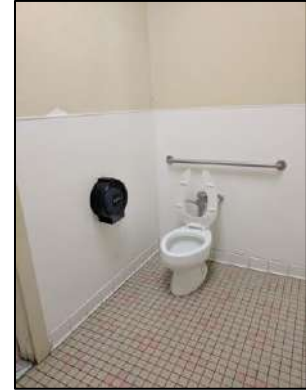
In general, accessibility is not a major problem, despite the school's age. Various minor accessibility issues require correction in order to be fully inclusive. This includes items like replacing non-compliant drinking fountains and sinks, installing undersink insulation or grab bars, and replacing door hardware with lever-style units.

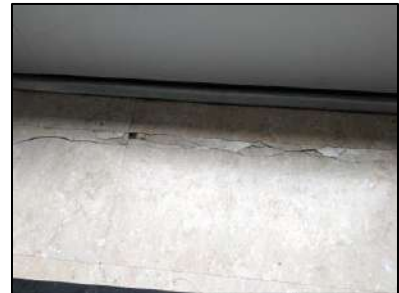
The majority of the floor finishes and base trims throughout the building are worn and dated. Classroom areas in the A Wing have been replaced recently (2016), and those in the B Wing extension are newer and remain in acceptable condition. The balance of the building should have a comprehensive floor finish replacement, including resilient tile, carpet, and resilient base trim.

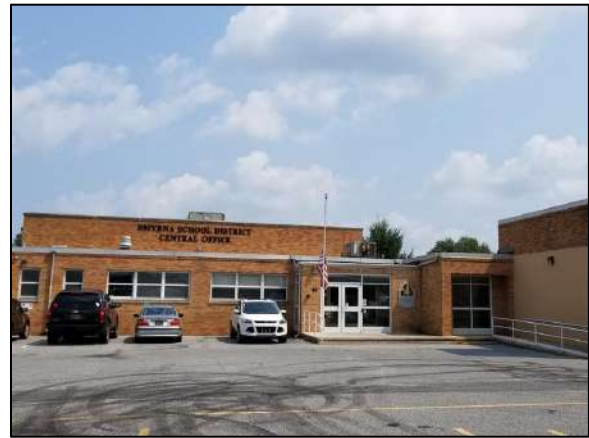
The District Central Office was originally a school before conversion to the district's administrative center. The building exterior is predominantly brick / CMU composite walls, which show significant weathering and deterioration. Moisture infiltration in / through exterior walls is problematic in numerous areas. Aluminum windows are aged but remain in service; long-range plans should include eventual replacement.

Structural systems vary by location, with low-slope / flat roofs throughout. All low slope roof areas are a ballasted modified bitumen or built-up roof system, which may be original. These are well past their expected service life and will require replacement in the near future.

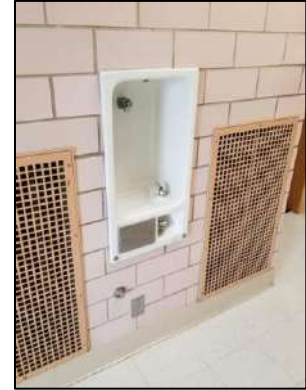
The building is generally accessible, comprising a single story. Ground floor elevation is relatively near grade level. Several ramps offer access to the building, though these vary in condition and compliance and should be replaced as priority indicates. Due to the date of original construction, some interior elements such as doorways are non-compliant. Various accessibility issues require correction in order to be fully inclusive. These include items like replacing non-compliant drinking fountains and sinks, and installing undersink insulation or grab bars.

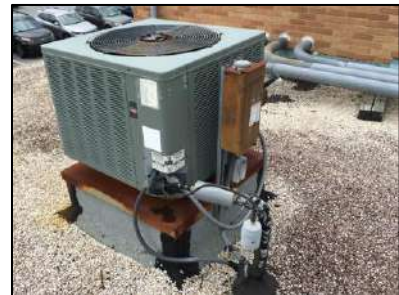
Detailed information concerning mechanical systems is included in a separate report. However, simply due to age, the administration building requires a significant amount of replacement and remedial work to plumbing and HVAC systems throughout older portions of the building.

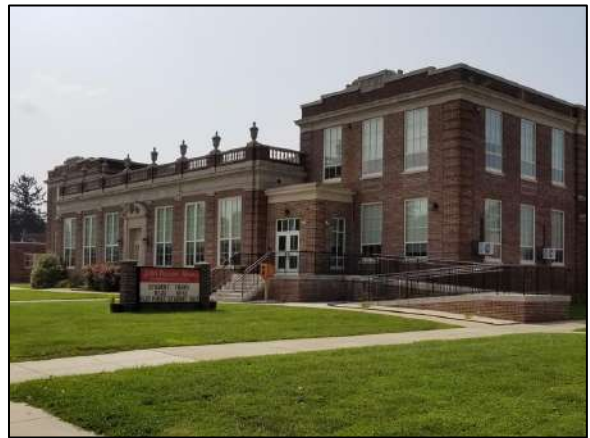
John Bassett Moore Intermediate School was originally built in 1881 as Smyrna High School, with several additions beginning in 1922. The building exterior is constructed brick / masonry walls with significant quantities of limestone trim. The school includes several accessory buildings, including the Gymnasium (across Frazier Street), Classroom Building A, and the adjacent services building.

Structural systems and roof types vary by location, with low-slope / flat roofs in most areas. Most original roofs in low-slope areas have been replaced with EPDM membrane roofing systems, some in 2014 and some prior. However, some roofing issues require attention, particularly in the older replacements. The Auditorium roof is a sloped structure and is shingled; shingles show sign of weathering. The Gymnasium has a barrel vaulted roof with an adhered EPDM membrane roofing system.

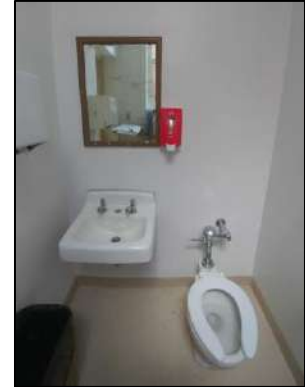
Given the age and configuration of the building, some interior and exterior elements are non-compliant. However, the building has been adapted to provide accessibility to all floors and public areas. Various accessibility issues require correction in order to be fully inclusive. These include items like replacing non-compliant drinking fountains, reconfiguring toilet stalls, modifying casework, and installing undersink insulation or grab bars.

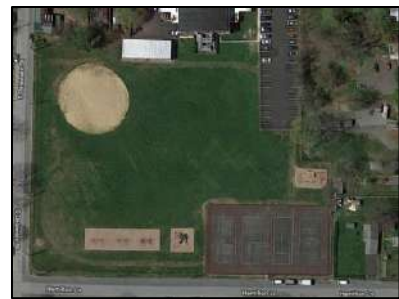
The JBM campus amenities are aged and inadequate for athletics and recreation. Required improvements include renovation and reorganization to provide a new tennis court, soccer field, outdoor basketball court, and playground area.

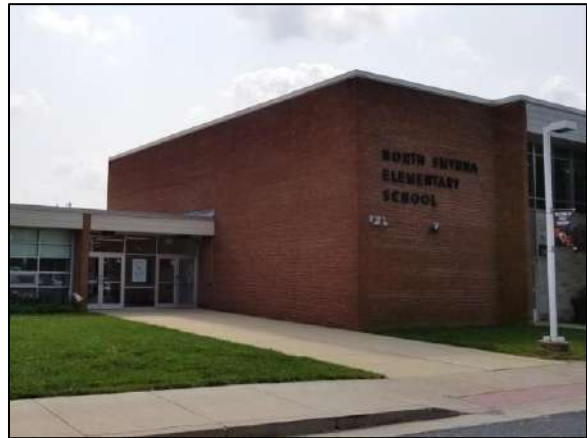
North Smyrna Elementary School is a single-story 1960s building with classroom additions attached to the rear via a long breezeway. The original central building houses common areas and administration, with the original classroom wing extending to the east. The exterior envelope is predominantly brick with large aluminum storefront windows. In general, masonry is in good condition, but metal wall panels and soffits are aging. Windows and exterior doors are mostly serviceable throughout.

Structural systems vary by location, but all are flat / low-slope areas with varying roof systems. Some low slope roof areas have been installed as or replaced with EPDM membrane systems, which are in very good condition and have plenty of remaining service life. However, the majority of the building has a modified bitumen roof system. The older roofs are in poor to very poor condition, and have long exceeded their service lives. All MBR areas will require replacement with new membrane in the immediate to near future. Given the age of the building, it would be highly cost-effective to increase the insulation thickness as part of this process.

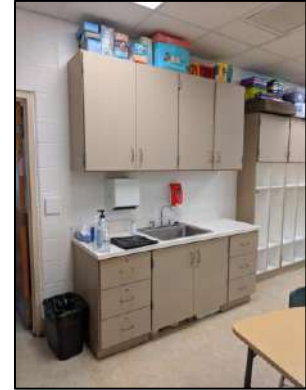
Vertical and horizontal circulation are not significant problems in this 1-story school. Recent modifications have addressed the most critical issues concerning access to restrooms and the stage area. Several remaining toilet rooms require modification or replacement of existing stall configurations. Casework in classrooms, including sinks, are worn and not accessible. These areas should be replaced with new, compliant items. Various other minor accessibility issues require correction in order to be fully inclusive. This includes items like replacing non-compliant drinking fountains, and installing undersink insulation or grab bars.

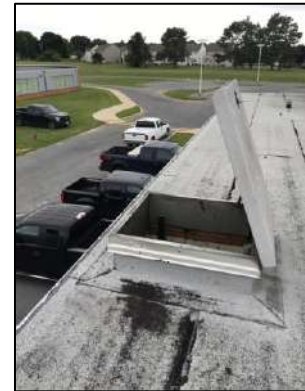
The roof access hatch is located immediately adjacent to the exterior wall and opens directly onto a significant sheer drop. This is a critical safety hazard and is not code compliant. A wall-mounted guard rail must be installed to provide fall protection for personnel using the hatch.

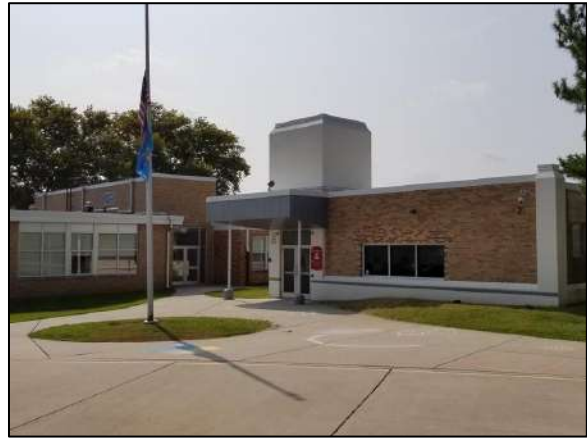
Smyrna Elementary School is a single-story building with several classroom wings and other additions. The original central building houses common areas and administration, with a basement mechanical room and crawl space. The exterior envelope is predominantly brick with large aluminum framed windows. In general, masonry is in good condition, but limestone / cast stone trim is weathering and some corrective action is required. Windows and exterior doors are mostly serviceable throughout. The building recently underwent an extensive interior renovation, including an addition to the kitchen / loading area.

Structural systems vary by location, but all are flat / low-slope roofs with EPDM membrane systems. The majority are white membrane, but older replacements are black. All roofs have been replaced as of this writing, and all are in new to very good condition with remaining service life far in excess of the projected timeline. Roofs only require typical maintenance.

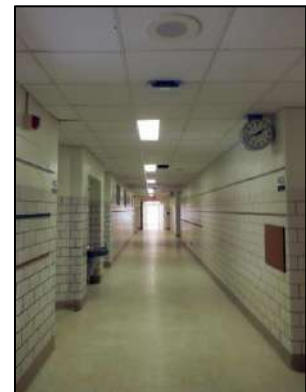
The majority of carpet and resilient floor finishes throughout the building are in good condition. Occasional areas of damage or cracking should be corrected on an as-needed basis.

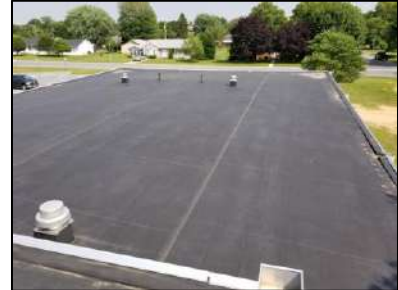
Original built-up or MBR roofs have all been replaced by EPDM membrane roofing systems. All roofs are in new to very good condition, and require only routine maintenance. D Wing roofs are oldest, but should have a remaining service life in excess of the timeframe of this assessment.

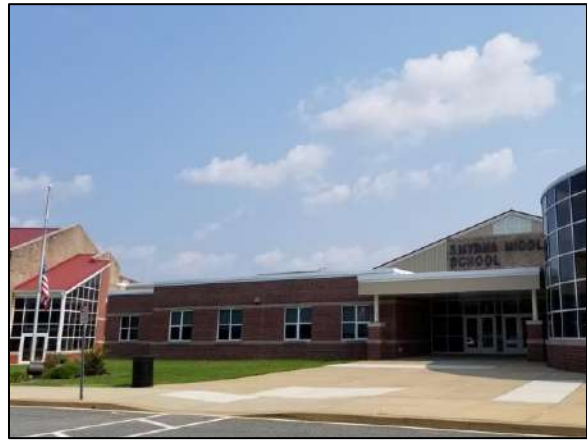
The building is constructed with structural steel framing (joists and / or beams), with pitched and flat / low-slope areas. Pitched roofs are prefinished metal standing seam panels, while low-slope areas are predominantly modified bitumen roof (MBR) systems.

Interior finishes and fixtures are worn in typical high-use areas, though most are still in good condition. The interior should be refreshed on an area-by-area basis as necessary. Casework is in good condition, with normal wear and tear in specific areas. Accessibility is good in general, but some compliance issues remain to be corrected.

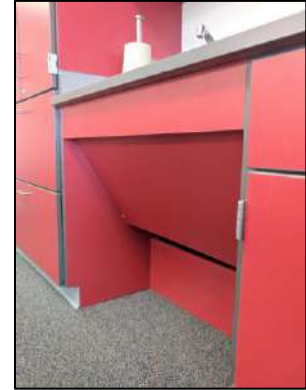
Because this school was built less than 20 years ago, accessibility is fundamentally designed into the facility. However, several items – some minor and some significant – require correction in order to be fully inclusive. Casework at many sinks, although intended to be accessible, is not compliant and does not offer proper clearance.

These should be modified and / or replaced with new, compliant items. Various other minor accessibility issues include items like replacing toilet accessories and installing undersink insulation or grab bars.

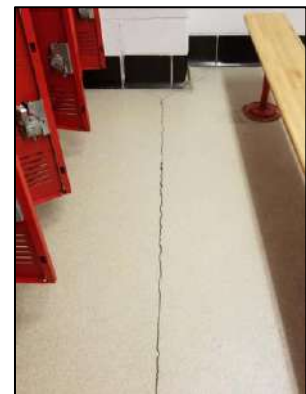
The majority of resilient floor finishes throughout the building are in good to serviceable condition. Occasional areas of damage or cracking should be corrected, including patching of concrete substrates where required. Areas of carpet in 300 and 400 Wings worn, stained, and damaged. They are past their expected service life, and should be replaced with new carpet and resilient base trim. Core area terrazzo floors are in good condition, with localized cracking that requires correction.

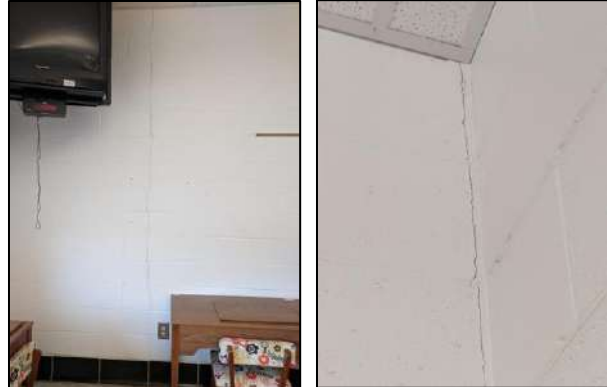
SMS.12, SMS.13, SMS.14, SMS.27, SMS.28, SMS.29, SMS.40, SMS.41, SMS.42, SMS.43, SMS.55, SMS.56, SMS.67, SMS.68, SMS.69, SMS.94, SMS.95, SMS.96, SMS.97

Interior walls are a mix of painted gypsum wallboard and painted masonry. Most walls in high-traffic or heavy duty areas, including corridors, toilet rooms, core amenities, and inside face of exterior walls are painted masonry. Interior walls are in good to fair condition. Select areas should be repainted, including incidental patching as required. Masonry walls and partitions show significant cracking in localized areas, which requires repair and repainting. This work is outside the scope of typical incidental touch-up by district personnel.

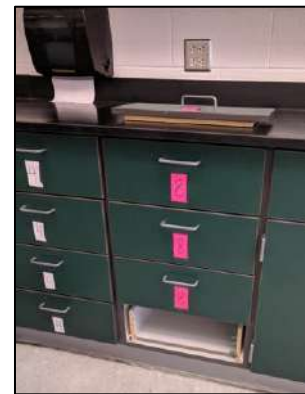
SMS.08, SMS.10, SMS.11, SMS.24, SMS.37, SMS.38, SMS.54, SMS.66, SMS.88, SMS.90

Casework (cabinets, countertops, and shelving) shows its age and is damaged in areas. Most rooms are still serviceable. Selected areas of damaged casework throughout the building should be repaired or replaced in kind. Vanity counters in toilet rooms are wearing and exhibit signs of water damage. See also Accessibility segment above for non-compliant casework modifications.

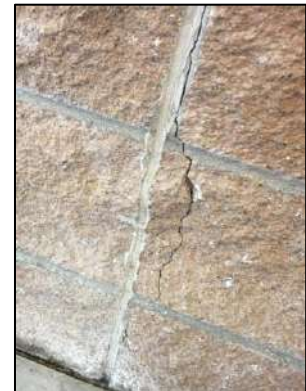
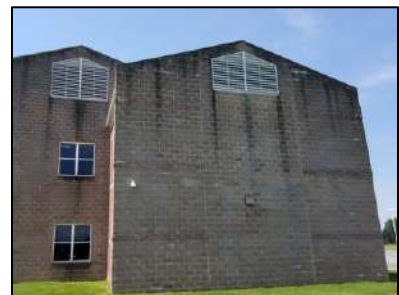
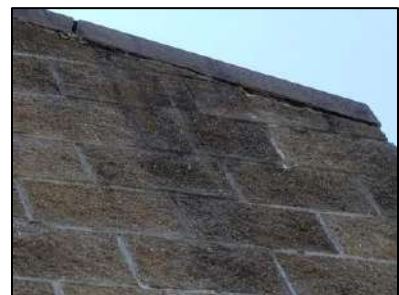
Exterior brick / CMU walls are in overall fair condition, and show localized cracking, weathering, and evidence of chronic wetness. At a minimum, cracks require repair and repointing. Approximately 20% of masonry window sills are significantly weathered and need repointing to prevent further deterioration.

The primary issue with exterior walls is extensive staining from water infiltration or overflow runoff. All split face masonry walls require cleaning to return them to appropriate appearance. To correct the underlying problem and prevent recurrence, the underlying issues must be resolved. One common source of water is exposed cast stone copings at parapet walls and other areas around the building. These show signs of extensive weathering and porosity. All stone copings should be covered with a prefinished aluminum parapet cap system to improve appearance and encourage shedding of water away from wall surfaces below.

Leaking gutters are another frequent source of staining and chronic wetness on the exterior walls. This will be discussed under the Roof heading below.

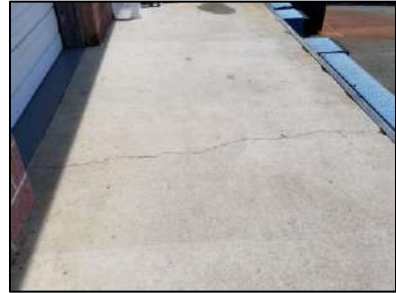
SMS.111

Existing concrete walk areas are in generally good condition. Regular maintenance with replacement of individual sections as necessary will keep them in service. Cracks in the loading dock area concrete require correction in the near future to prevent further deterioration.

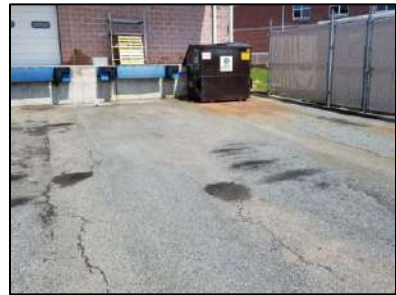
SMS.112

Asphalt paving around the site is in good condition. Paving has failed in the loading dock area due to excessive weight and duty cycle. Remove the existing asphalt in this area and replace with a concrete apron designed for the traffic load.

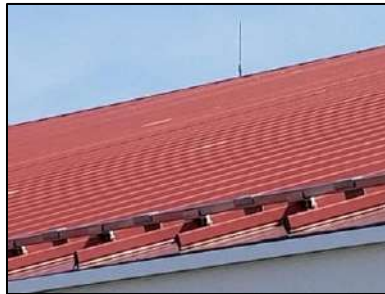
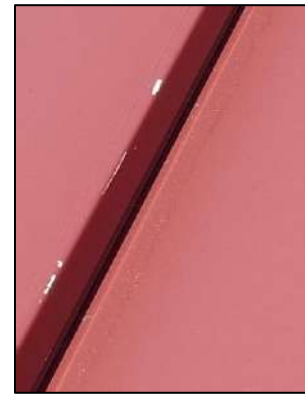
Standing seam metal roofs are typically in good condition throughout the building. Ice / snow guards are present and functional. Metal finish is chipped in minor localized areas, but no corrosion is evident.

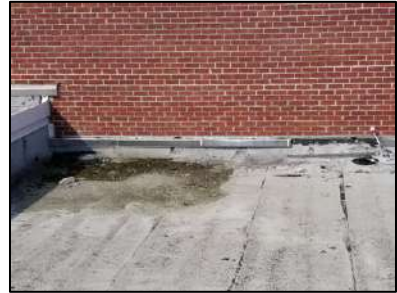
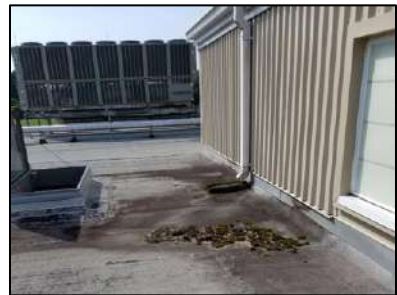
SMS.112, SMS.133

Original modified bitumen roof (MBR) systems date from 2002-2006. Low slope membrane roofs are still within their expected service life, but will require replacement in the long-term future. In the meantime, they require routine maintenance and localized areas of repair. Soft / wet spots and areas of ponding should be cut out (including insulation) and replaced in kind. Loose or missing flashings should be replaced.

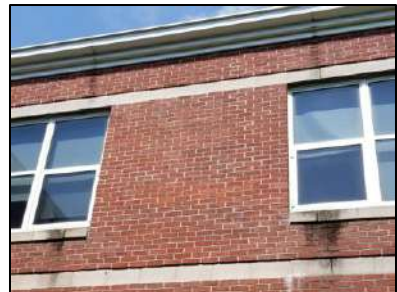
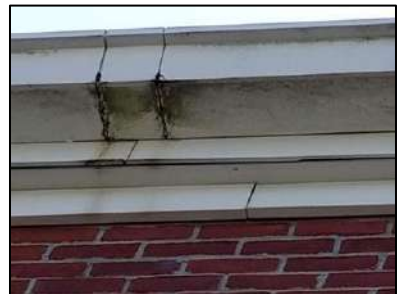
SMS.102

Aluminum gutters around the entire building perimeter are leaking at joints and seams. Water overflow stains walls, creates infiltration issues, splashes mud on lower walls, and erodes turf and grade.

Gutters and downspouts require a comprehensive re-sealing program to eliminate these symptoms and remove the underlying source of water.

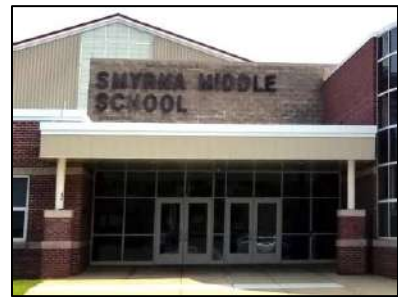
SMS.140

The building is relatively secure thanks to operational policy and existing systems. There are no immediate needs for additional measures. In the moderate future term, the District should consider additional protective measures such as ballistic window film or other hardpoint retrofits.

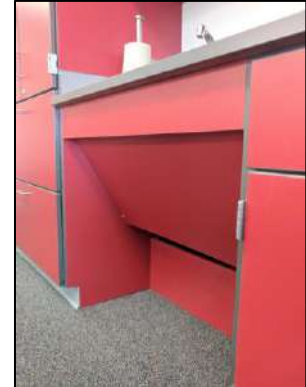
SHS.56

Most accessibility issues have been remediated as part of renovations and ongoing upgrades. A few unrenovated areas require modifications to toilet rooms. Various other minor accessibility issues include items like replacing toilet accessories and installing undersink insulation or grab bars. Remaining non-lever door hardware is recommended to be updated as part of a door replacement project as outlined below.

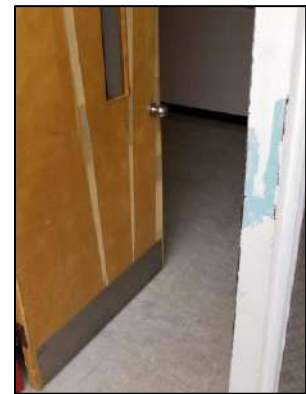
SHS.45, SHS.46, SHS.47, SHS.48, SHS.49, SHS.62, SHS.66, SHS.73

Most interior doors (solid core wood veneer, stained) and frames (hollow metal, painted) show minor wear and tear, but are in good condition. Doors and frames in high-traffic areas should be refinished as part of an ongoing interior painting program. Worn / damaged doors, frames, and / or hardware should be replaced in unrenovated areas (areas D, E, F, and G) to bring them up to par with the balance of the school. This will also eliminate most remaining knob locksets, to be replaced with ADA-compliant lever handles.

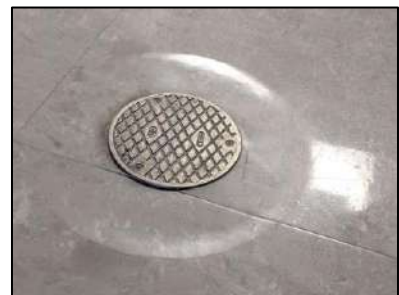
SHS.05, SHS.18, SHS.33, SHS.36, SHS.63, SHS.97, SHS.98

The majority of resilient floor finishes throughout the building are in good to serviceable condition. Occasional areas of damage, cracking, or uneven surfaces should be corrected, including patching of concrete substrates where required. Core area terrazzo floors are in good condition, with localized cracking that requires correction.

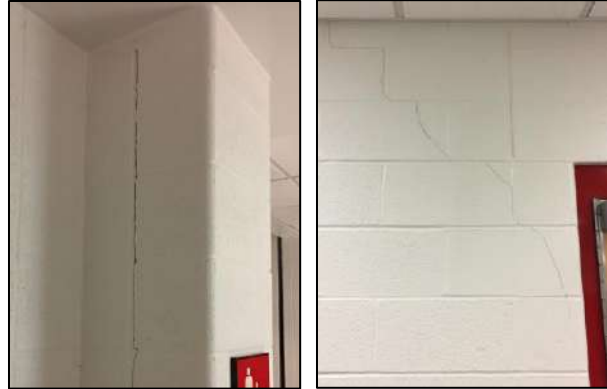
*SHS.06, SHS.22, SHS.54, SHS.70, SHS.71,
SHS.80, SHS.81, SHS.90, SHS.91, SHS.92,
SHS.93, SHS.94, SHS.95, SHS.99, SHS.100,
SHS.101*

Interior walls are a mix of painted gypsum wallboard and painted masonry. Interior classroom and support area walls are typically gypsum wallboard with paint or areas of ceramic tile. Most walls in high-traffic or heavy duty areas, including corridors, toilet rooms, core amenities, and inside face of exterior walls are painted masonry. Interior walls are in good to fair condition. Select areas should be repainted, including incidental patching as required. Masonry walls and partitions show significant cracking in localized areas, which requires repair and repainting. This work is outside the scope of typical incidental touch-up by district personnel.

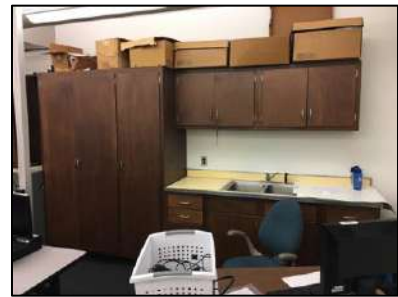
SHS.55

Casework (cabinets, countertops, and shelving) in renovated areas is in good condition and accessible, with only minor maintenance required. However, casework in unrenovated areas (areas D and E) is original to the building. These fixtures are well past their expected life span, show substantial wear and damage, and are not accessible. Casework in remaining unrenovated rooms should be replaced with new suite of fixtures to match renovated areas.

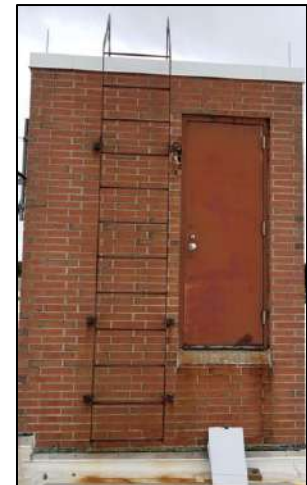
Exterior brick / CMU walls are in overall good condition, but show localized cracking or weathering. Cracks require repair and limited repointing. Some wall / roof joint flashings require minor repairs.

The chimney at Roof Area 2 is in poor to bad condition. The existing door and frame are deteriorated and should be filled in. This chimney is minimally used since major mechanical equipment was relocated to the new Central Plant. The District should consider demolishing it in the future to eliminate ongoing maintenance.

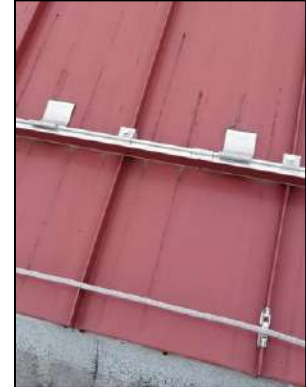
Standing seam metal roofs are typically in good condition throughout the building. Ice / snow guards are present and functional.

Metal roofing at the main front and rear additions (R1 and R21 – 2008) is showing unexpected corrosion. The cause is unknown at this time, but the material should be within the specified product finish warranty. It is recommended that the District contact the contractor and manufacturer to begin the investigation / claim process

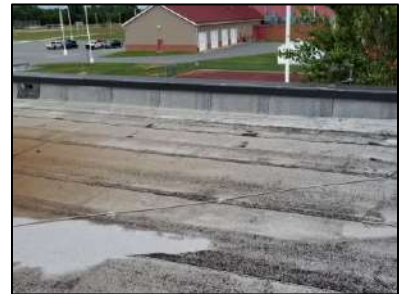
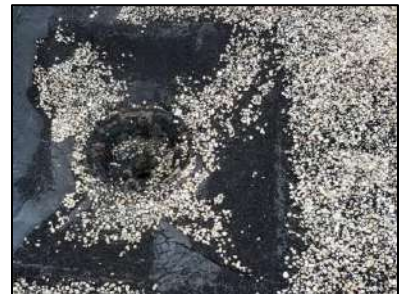
SHS.118, SHS.120, SHS.121, SHS.122, SHS.125, SHS.126, SHS.127, SHS.128

Due to the nature of the building and various expansions throughout history, the low-slope roofs are broken up into numerous areas. Many of these have been replaced with new EPDM or TPO membrane in the moderate past, and have plenty of service life left with typical routine maintenance.

Remaining modified bitumen roof (MBR) and gravel-ballasted built-up roof (BUR) systems are well past expected service lives, and require replacement. Priority varies from immediate to moderate future depending upon the condition of each area. In the meantime, they need routine maintenance and localized areas of repair.

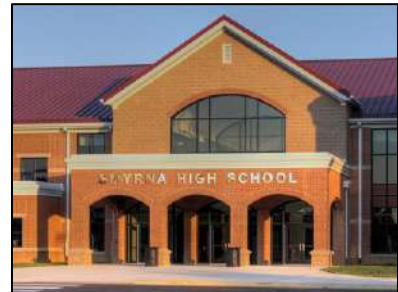
SHS.142, SHS.143

The building is relatively secure thanks to operational policy and existing systems, but the aging security network requires immediate upgrades and additional cameras in both interior and exterior areas. In the moderate future term, the District should consider additional protective measures such as ballistic window film or other hardpoint retrofits.

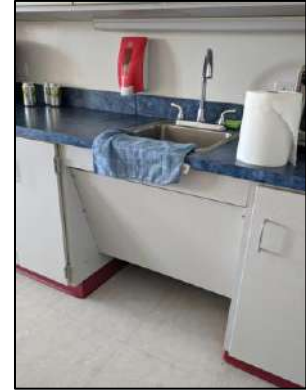
SSE.01

Built in the last 10 years, the building is fundamentally accessible throughout. Casework at some classroom and workroom sinks, though designed to be accessible, are not fully compliant. In the long term, these should be corrected for full inclusiveness.

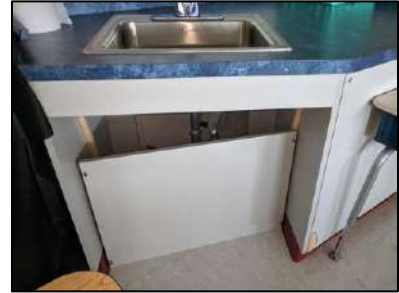
SSE.07, SSE.20, SSE.27

Casework (cabinets, countertops, and shelving) is in good condition and typically accessible, with only minor maintenance required. See also Accessibility heading above for clearance issues at sinks.

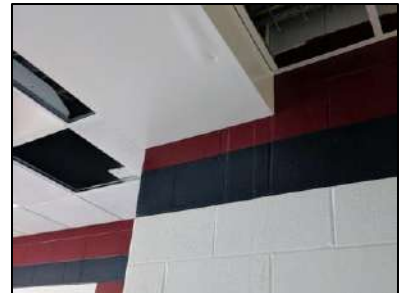
Ceilings are predominantly lay-in acoustical panel suspended grid systems, with areas of painted gypsum wallboard or exposed structure. Most are in good condition, but localized areas throughout the building show evidence of water infiltration or leaks. These must be investigated by District personnel, the water sources corrected as required, and damaged materials replaced.

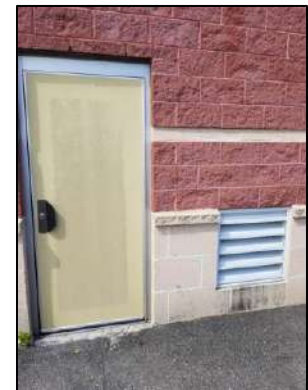
Exterior hollow metal doors, frames, and hardware are in generally very good condition, but finishes are beginning to weather. Selected exterior hollow metal doors and frames should be painted in the near future to protect against rust.

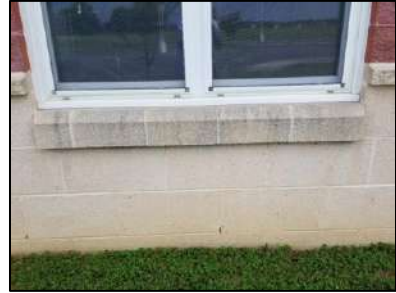
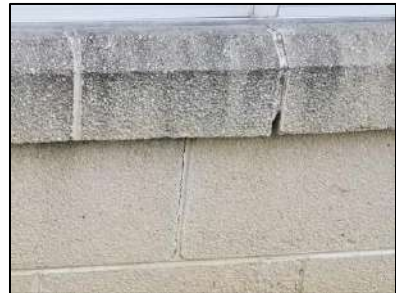
Exterior brick / CMU walls are in overall good condition, but show localized cracking or weathering, particularly around stone window sills. Cracks require repair and significant repointing. Cracked masonry units must be cut out and replaced in kind.

The building shows dirt staining on split face masonry walls. As part of the repair / repointing project, washing all exterior walls will maintain appearance and prevent permanent staining.

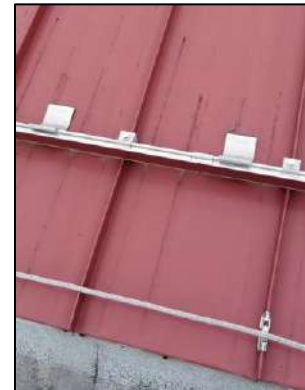
Metal roofing at the main front and rear additions (R1 and R21 – 2008) is showing unexpected corrosion. The cause is unknown at this time, but the material should be within the specified product finish warranty. It is recommended that the District contact the contractor and manufacturer to begin the investigation / claim process

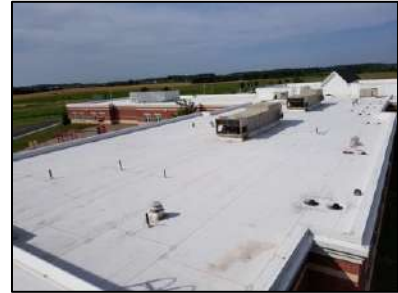
At 10 years old, original EPDM membrane roofing systems are approximately halfway through their expected service life. All roofs are in very good to good condition, and require only routine maintenance to remain in service beyond the timeframe of this assessment.

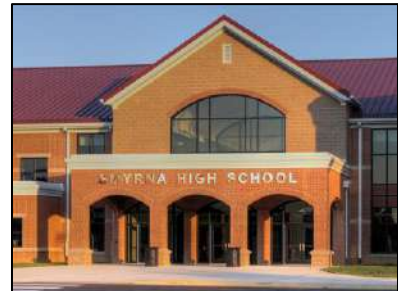
The building is relatively secure thanks to operational policy and existing systems, and does not have any immediate need for additional measures. In the moderate future term, the District should consider adding protective measures such as ballistic window film or other hardpoint retrofits.
