# BUILDING CONDITION REPORT

**JEFFERSON HIGH  
SCHOOL DISTRICT #1**  
July 21, 2020

# BUILDING CONDITION REPORT SUMMARY

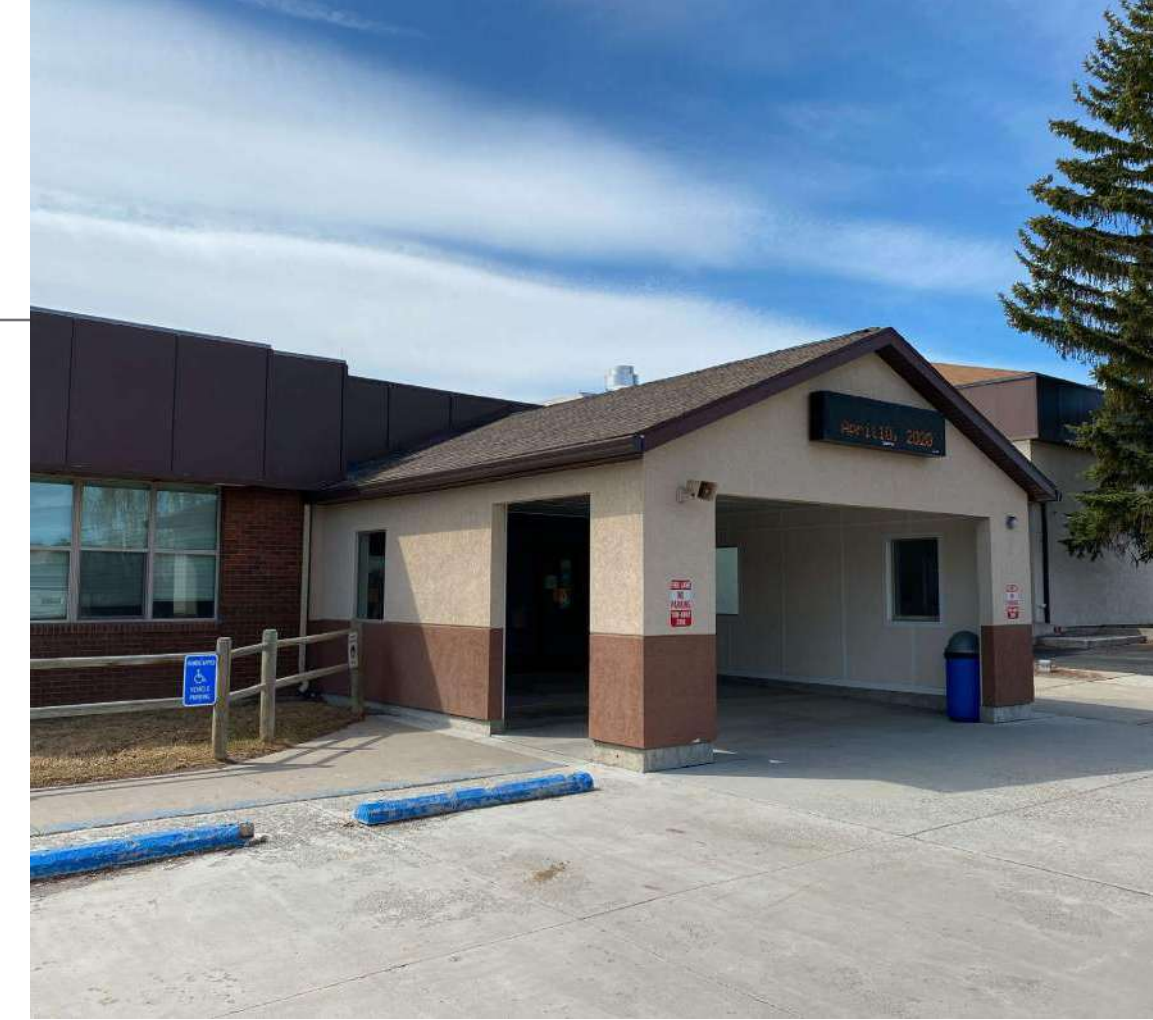
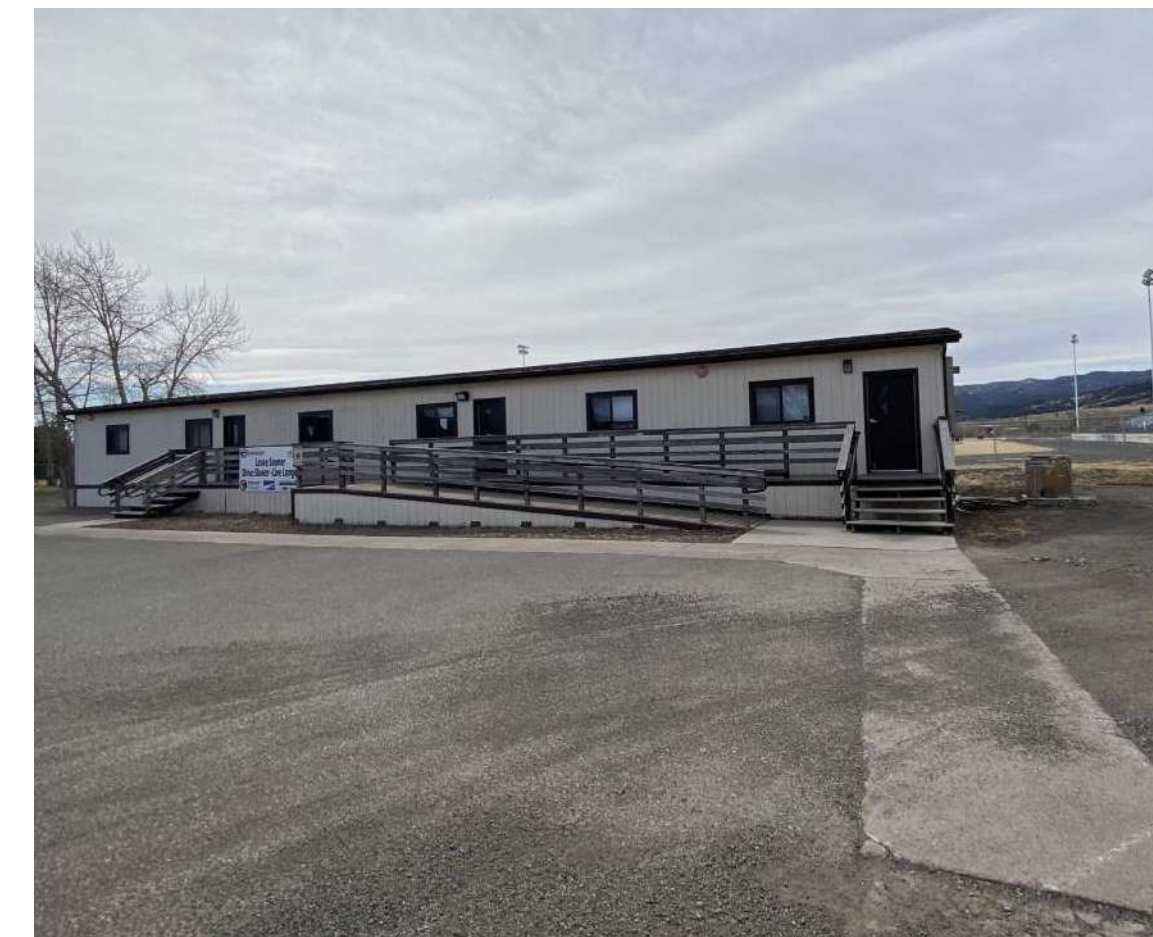
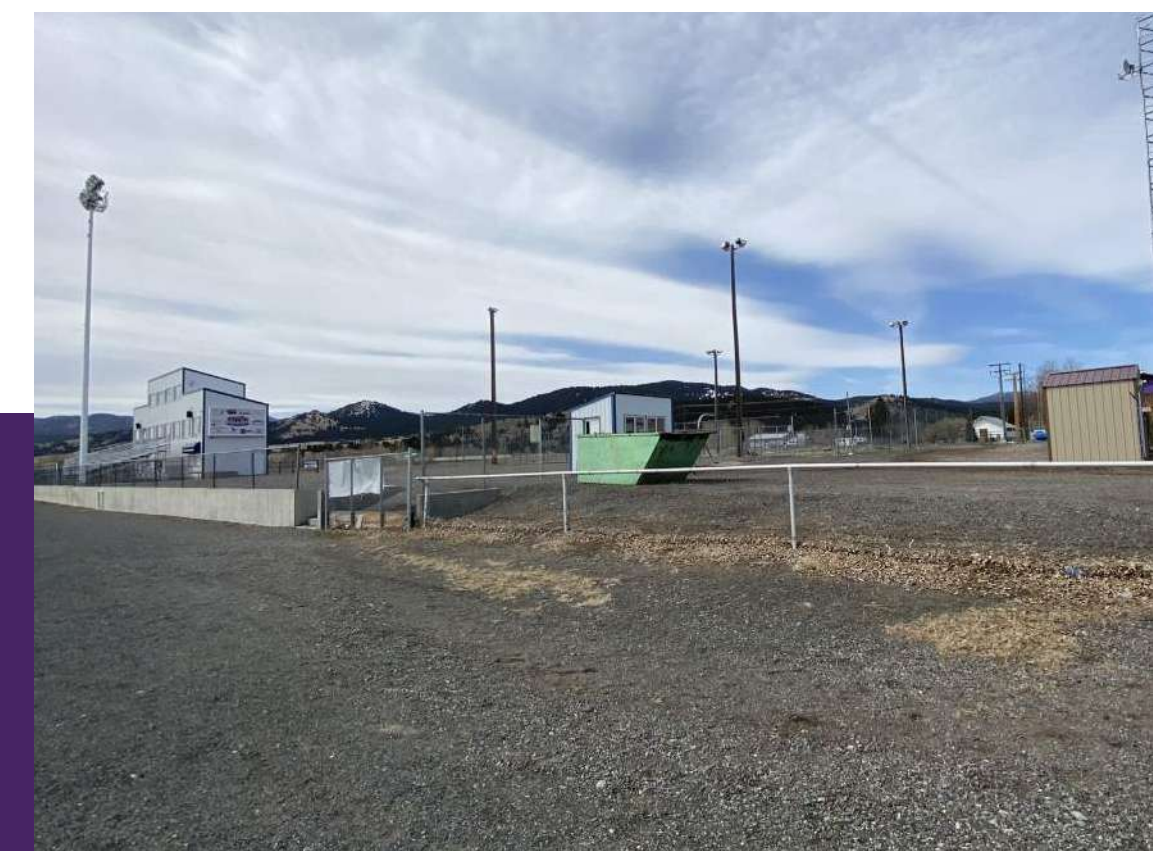
# EXTERIOR / SITE

- Overall in good shape with regular maintenance
- Modularity: Safety & Security
  - Construction quality only good for temporary, not long-term
  - Separated from other building functions and community
- Site & Athletics
  - Current 23 acre site considered small for number of students (recommend 30-33 acres for current enrollment; 1 acre/100 students + 30 acres for High School\*)
  - Site is constrained by tennis courts, pool, and irrigation ditch for future expansion. Some small opportunities still present.
  - Ex: EHHS is 35 acres for 600 students
- New Roof

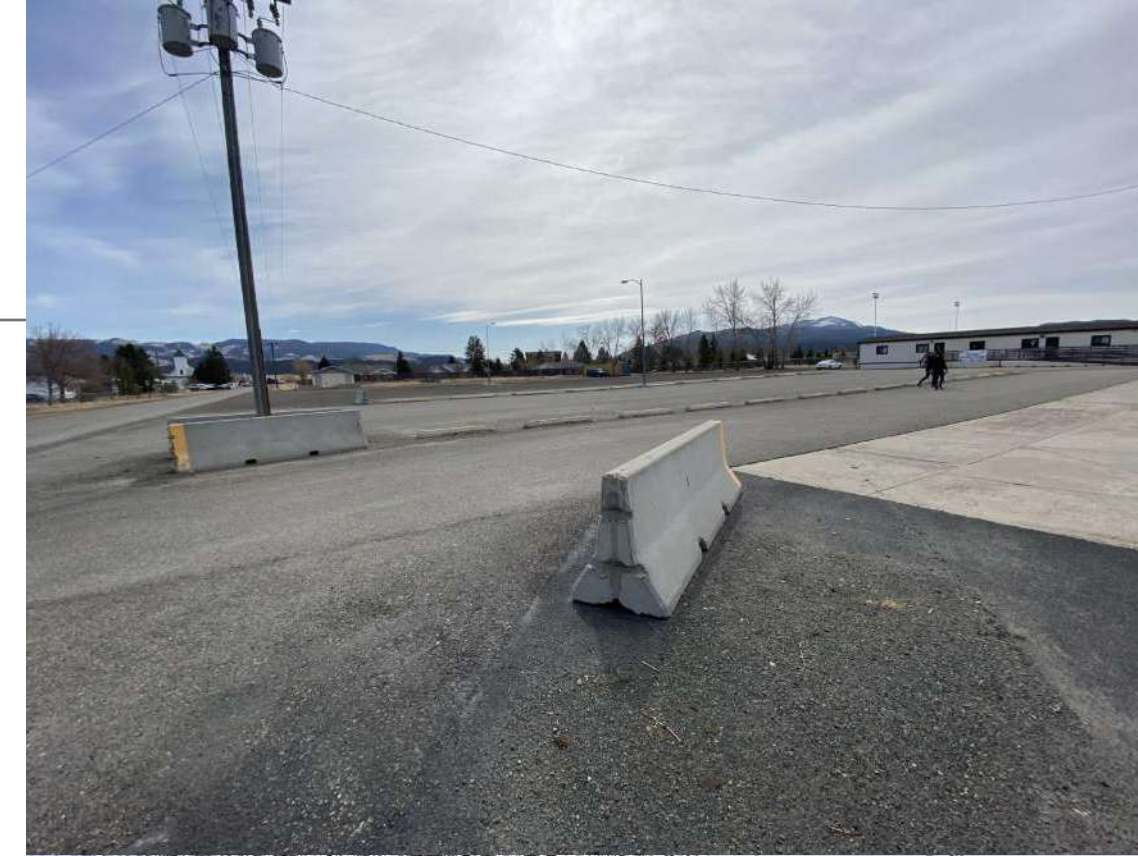
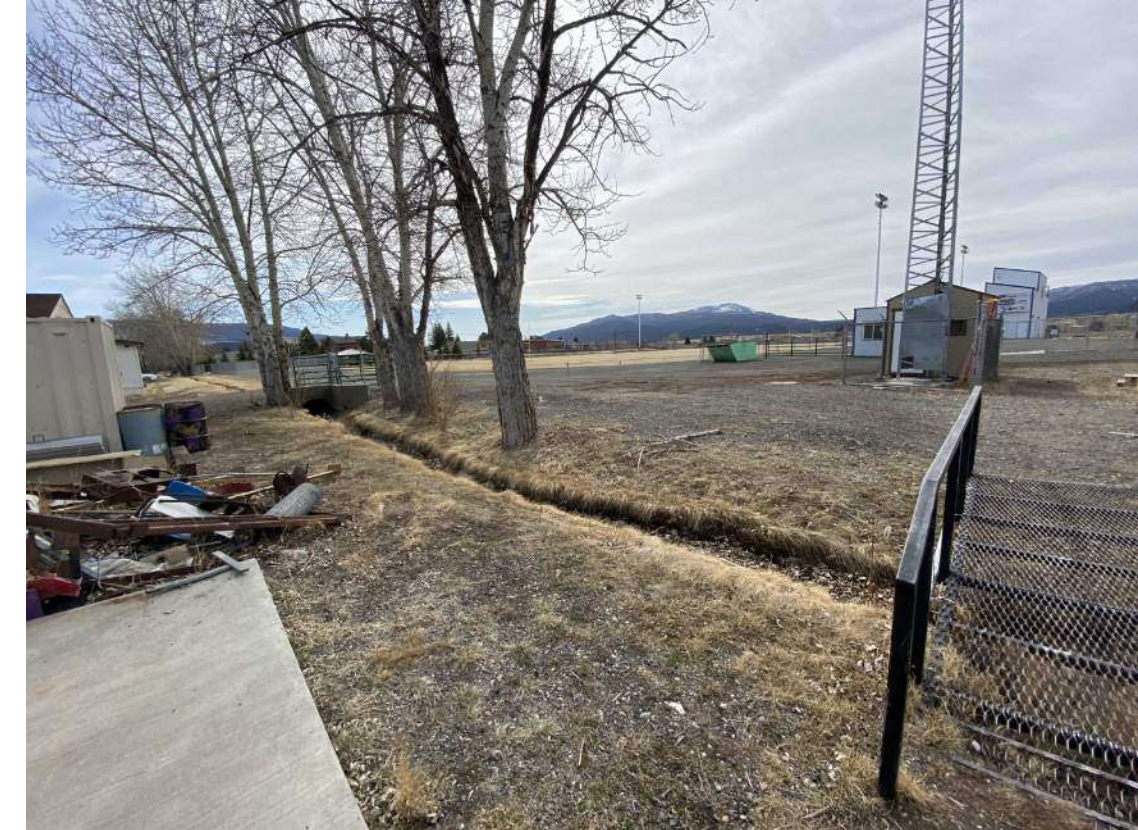
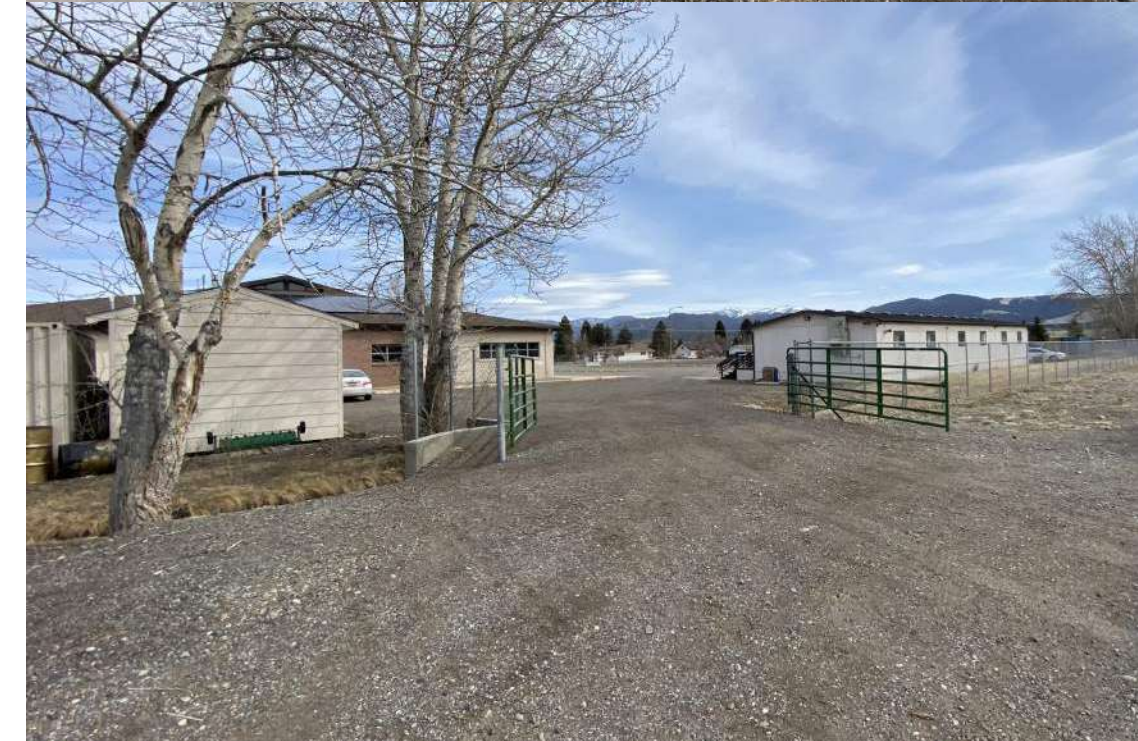
# EXTERIOR / SITE

- Current Site
  - Parking & Bus works well for the large part.
  - South Main Street entrance and surrounding green space provide good community access.
- Athletics
  - Track surface is not all-weather and cannot support large track events, i.e. divisionals/state meets.
  - Football field does not hold up to wear & tear, has mosquitoes.
  - Tennis courts are shared with the City, and in good condition, but do pose some scheduling conflicts.
  - Athletics are concerned over remaining competitive against Helena and East Helena High Schools with better athletic facilities.

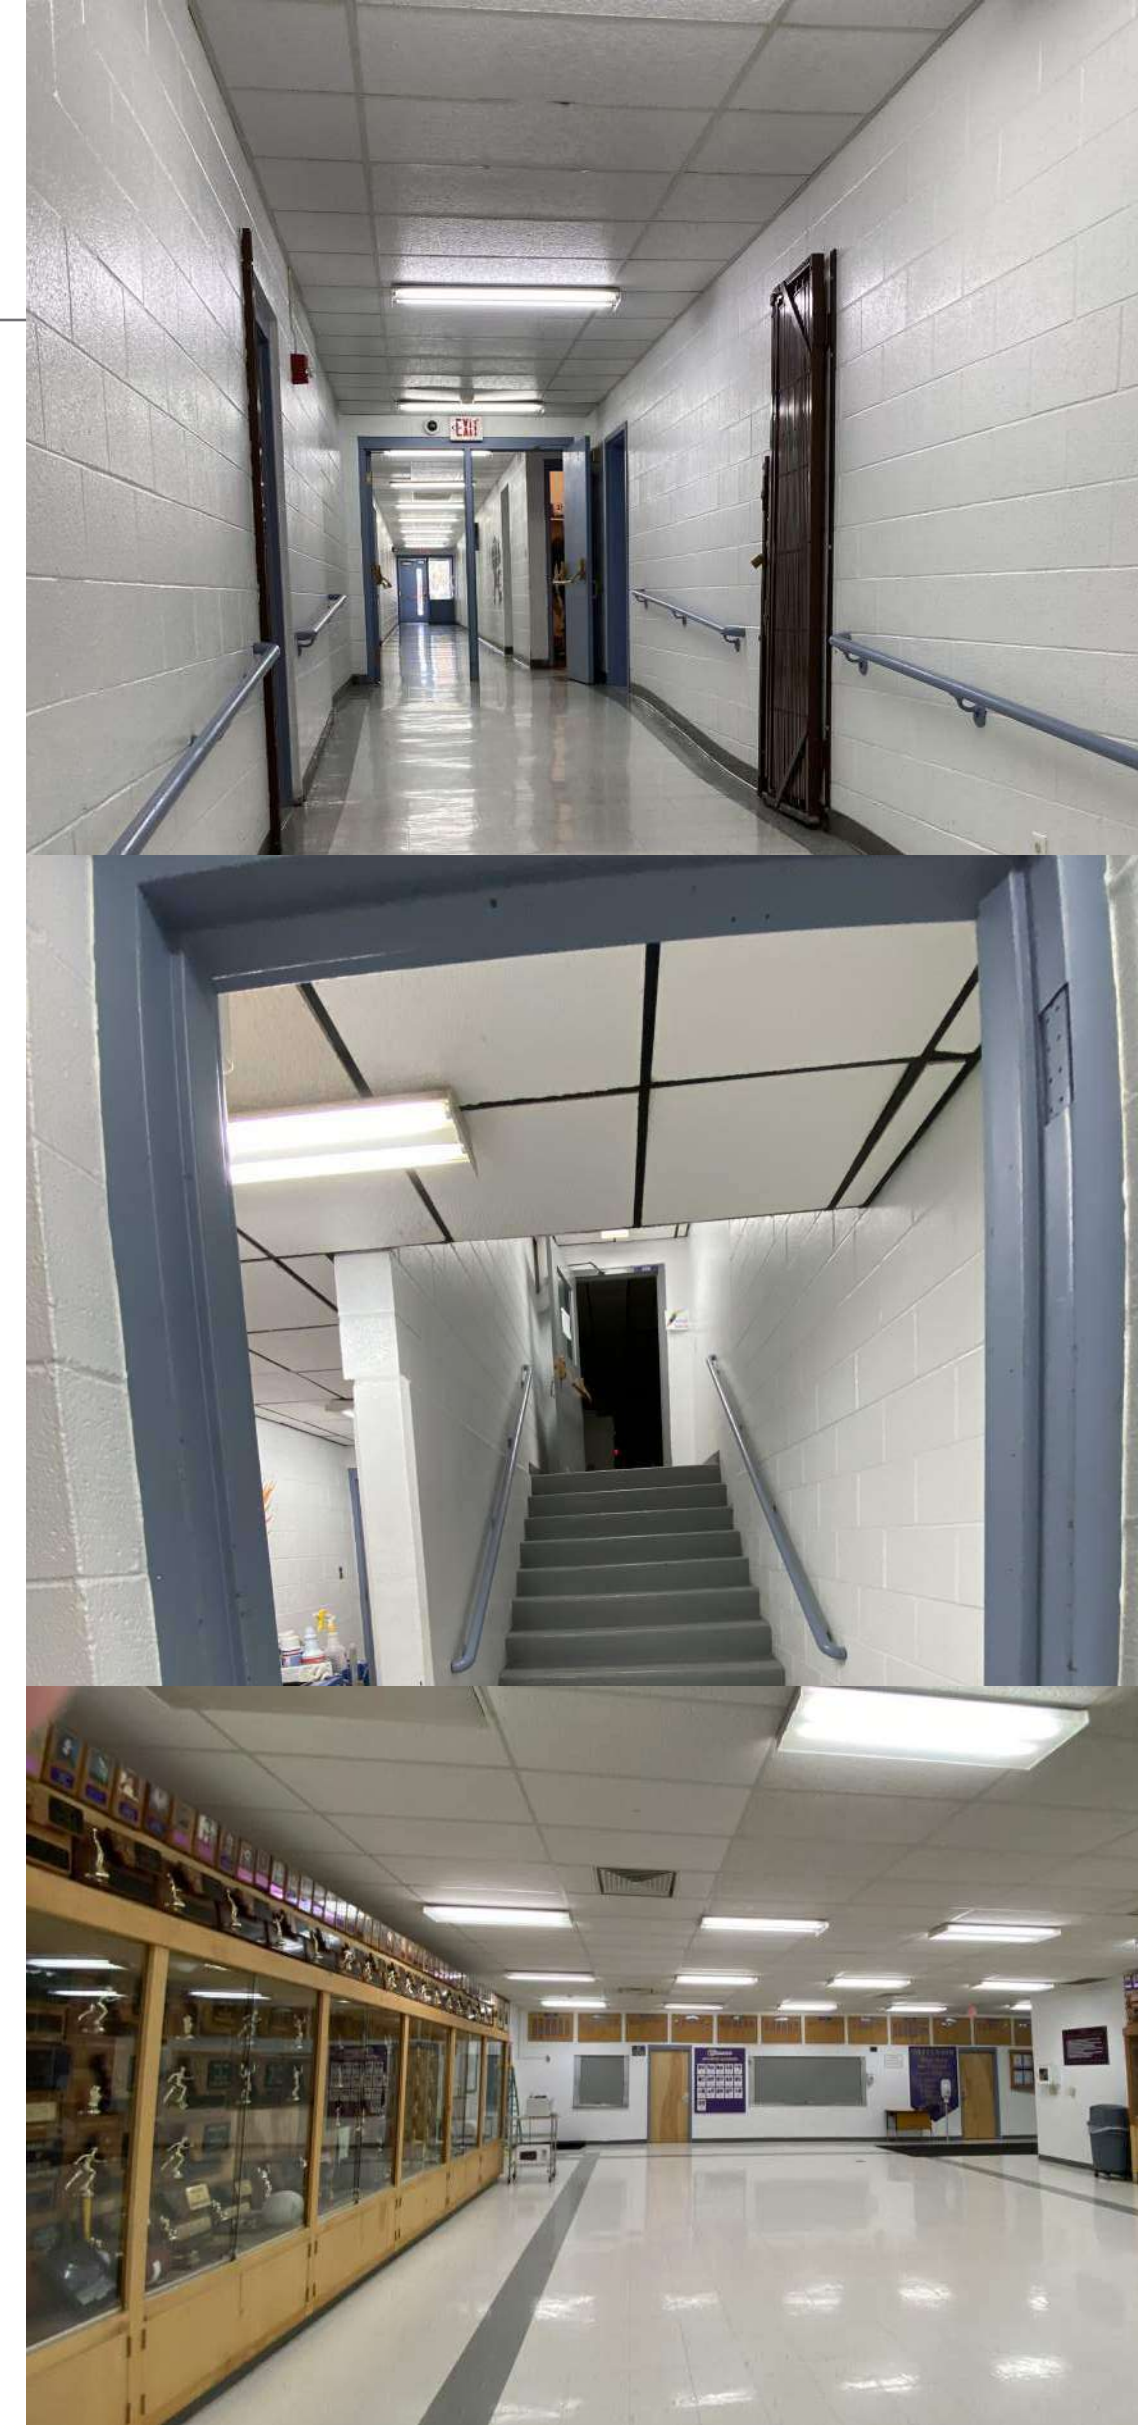
# INTERIOR | GENERAL

- Primarily in good condition, with regular maintenance.
- Cohesive feeling despite multiple additions
- Finishes overall fair to good
- Acoustical ceiling tiles are worn and need replacement in some areas.
- Flooring: mix of vinyl composition tile, wood gym, masonry block and gypsum board finishes.
- No Hazardous Material Inspection completed, however in our experience many are likely to be Asbestos Containing Materials.

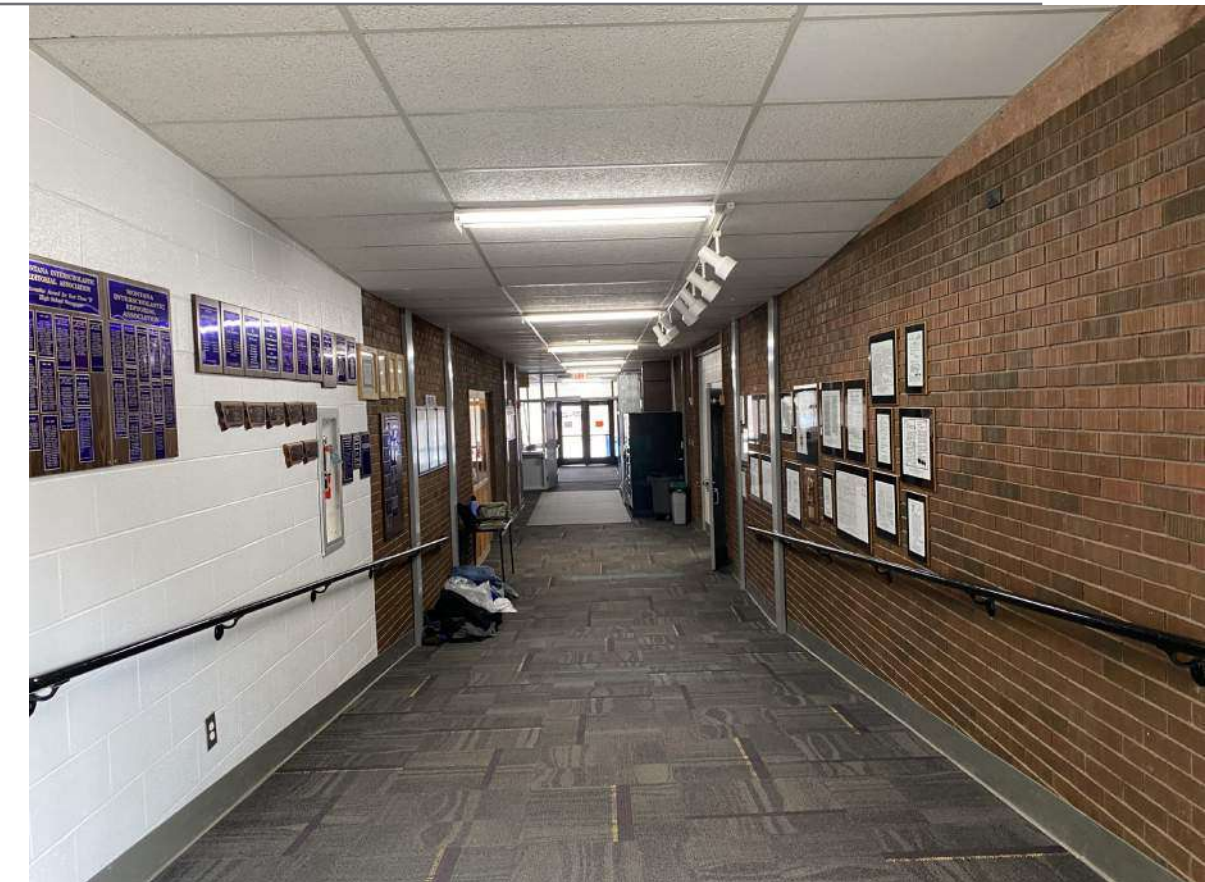
# HALLWAYS/CORRIDORS

- Width of hallways is narrow for modern school. Typical width: 8', with lockers on both sides 10'. East Middle School has 12' hallways.
- Ceiling tile showing age with moisture damage
- Walls are CMU block that is durable and vandal-resistant, but poses problems with echoing and an institutional look.
- Flooring is largely vinyl composition tile that holds up well but requires significant maintenance.
- Lockers in good condition.
- Hallways lack common or flexible “breakout spaces” that support many 21st Century Learning principles.
- Current Cafeteria/Multi-Purpose Space does not have exterior views, is fairly small, and is not very inviting.

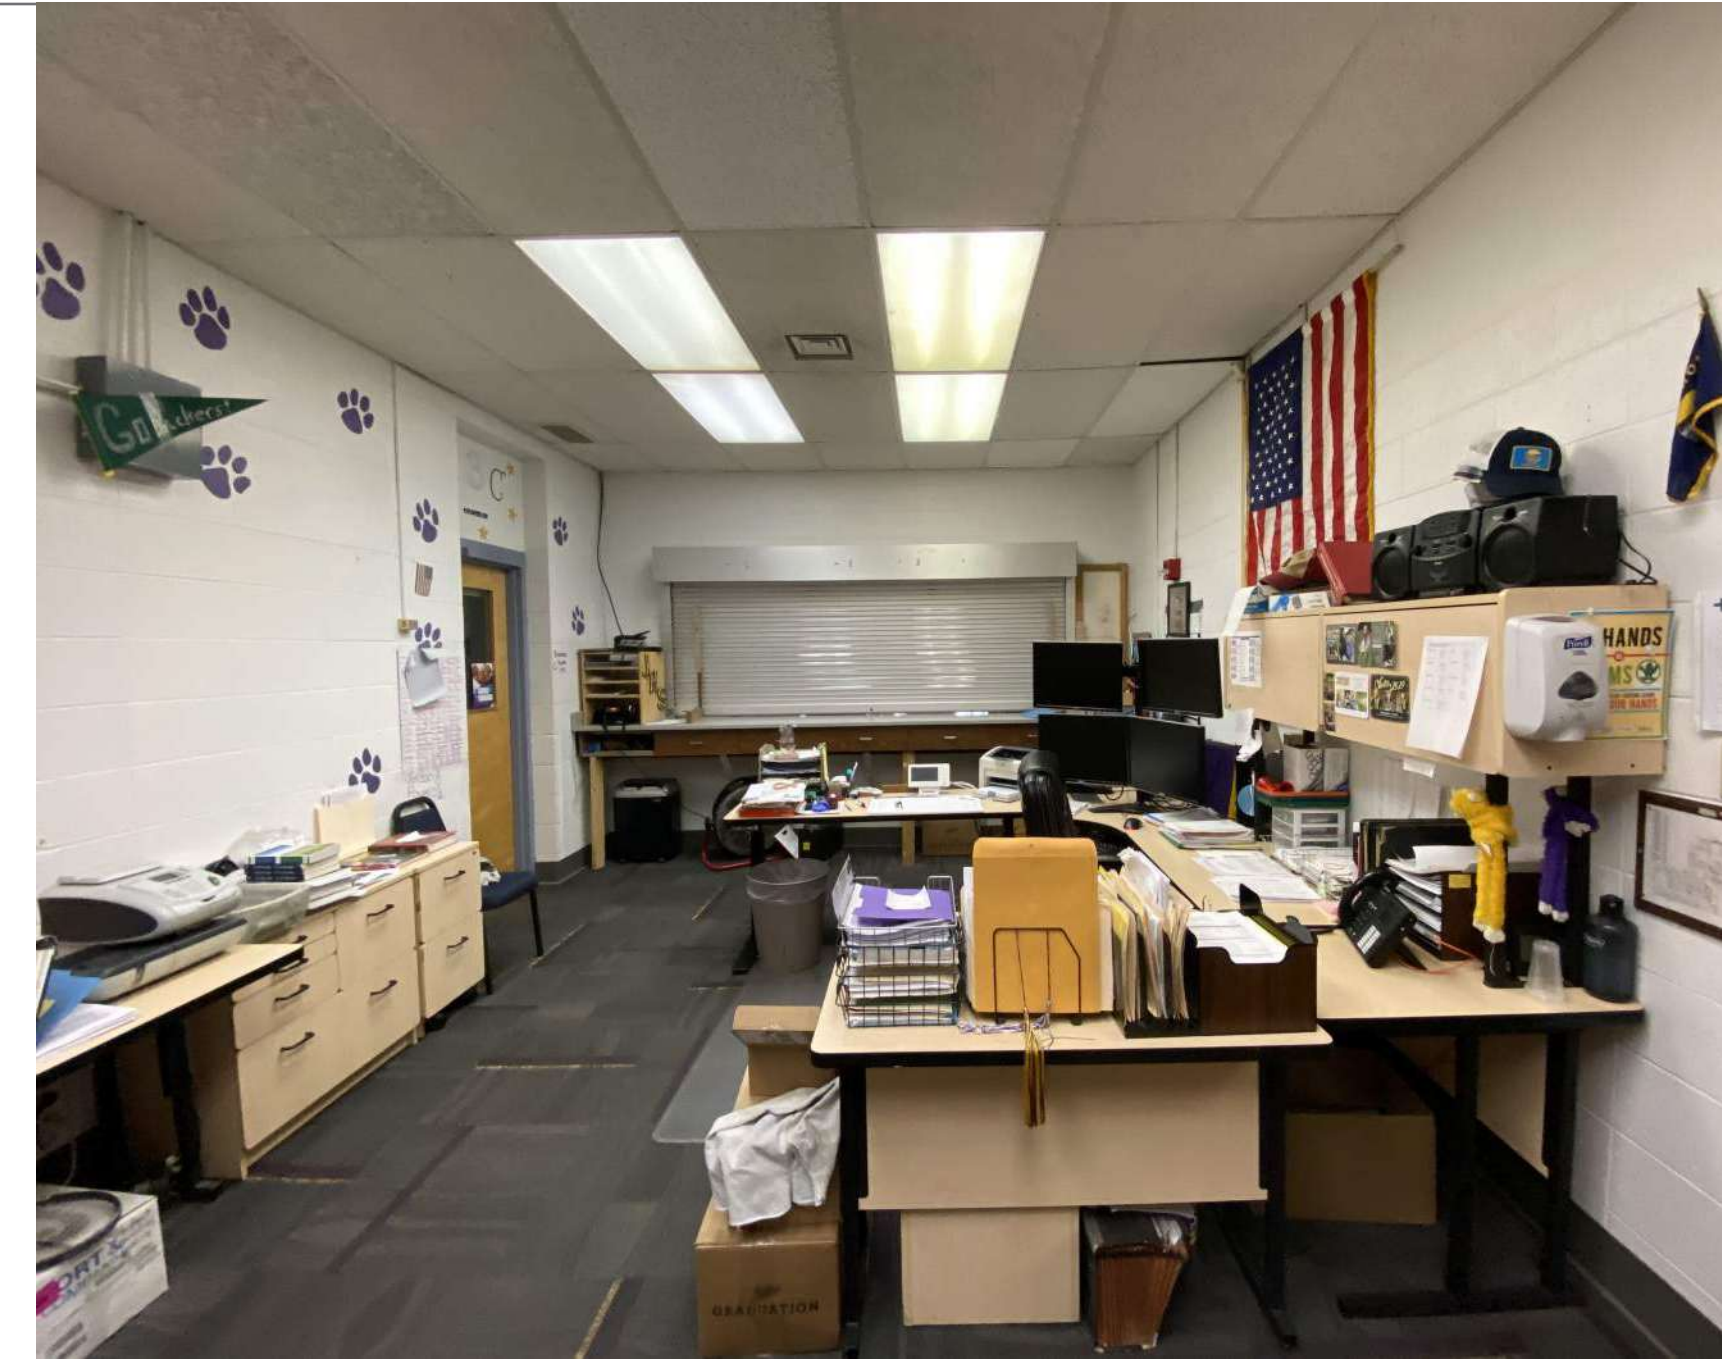
# MAIN OFFICE AREA

- Busy, central location with high traffic.
- Carpet helps acoustic control, as does acoustic ceiling.
- Ceiling is dated and worn.
- Seating/Waiting Area does not provide privacy
- No conference room for larger group meetings or private conversations
- Principal's office is small and could be more welcoming
- Office location does not meet typical security needed in a 21st Century School
- An intruder can access the school once allowed through main entry doors.
- Main office does not have secure interior vestibule to buzz visitors in.

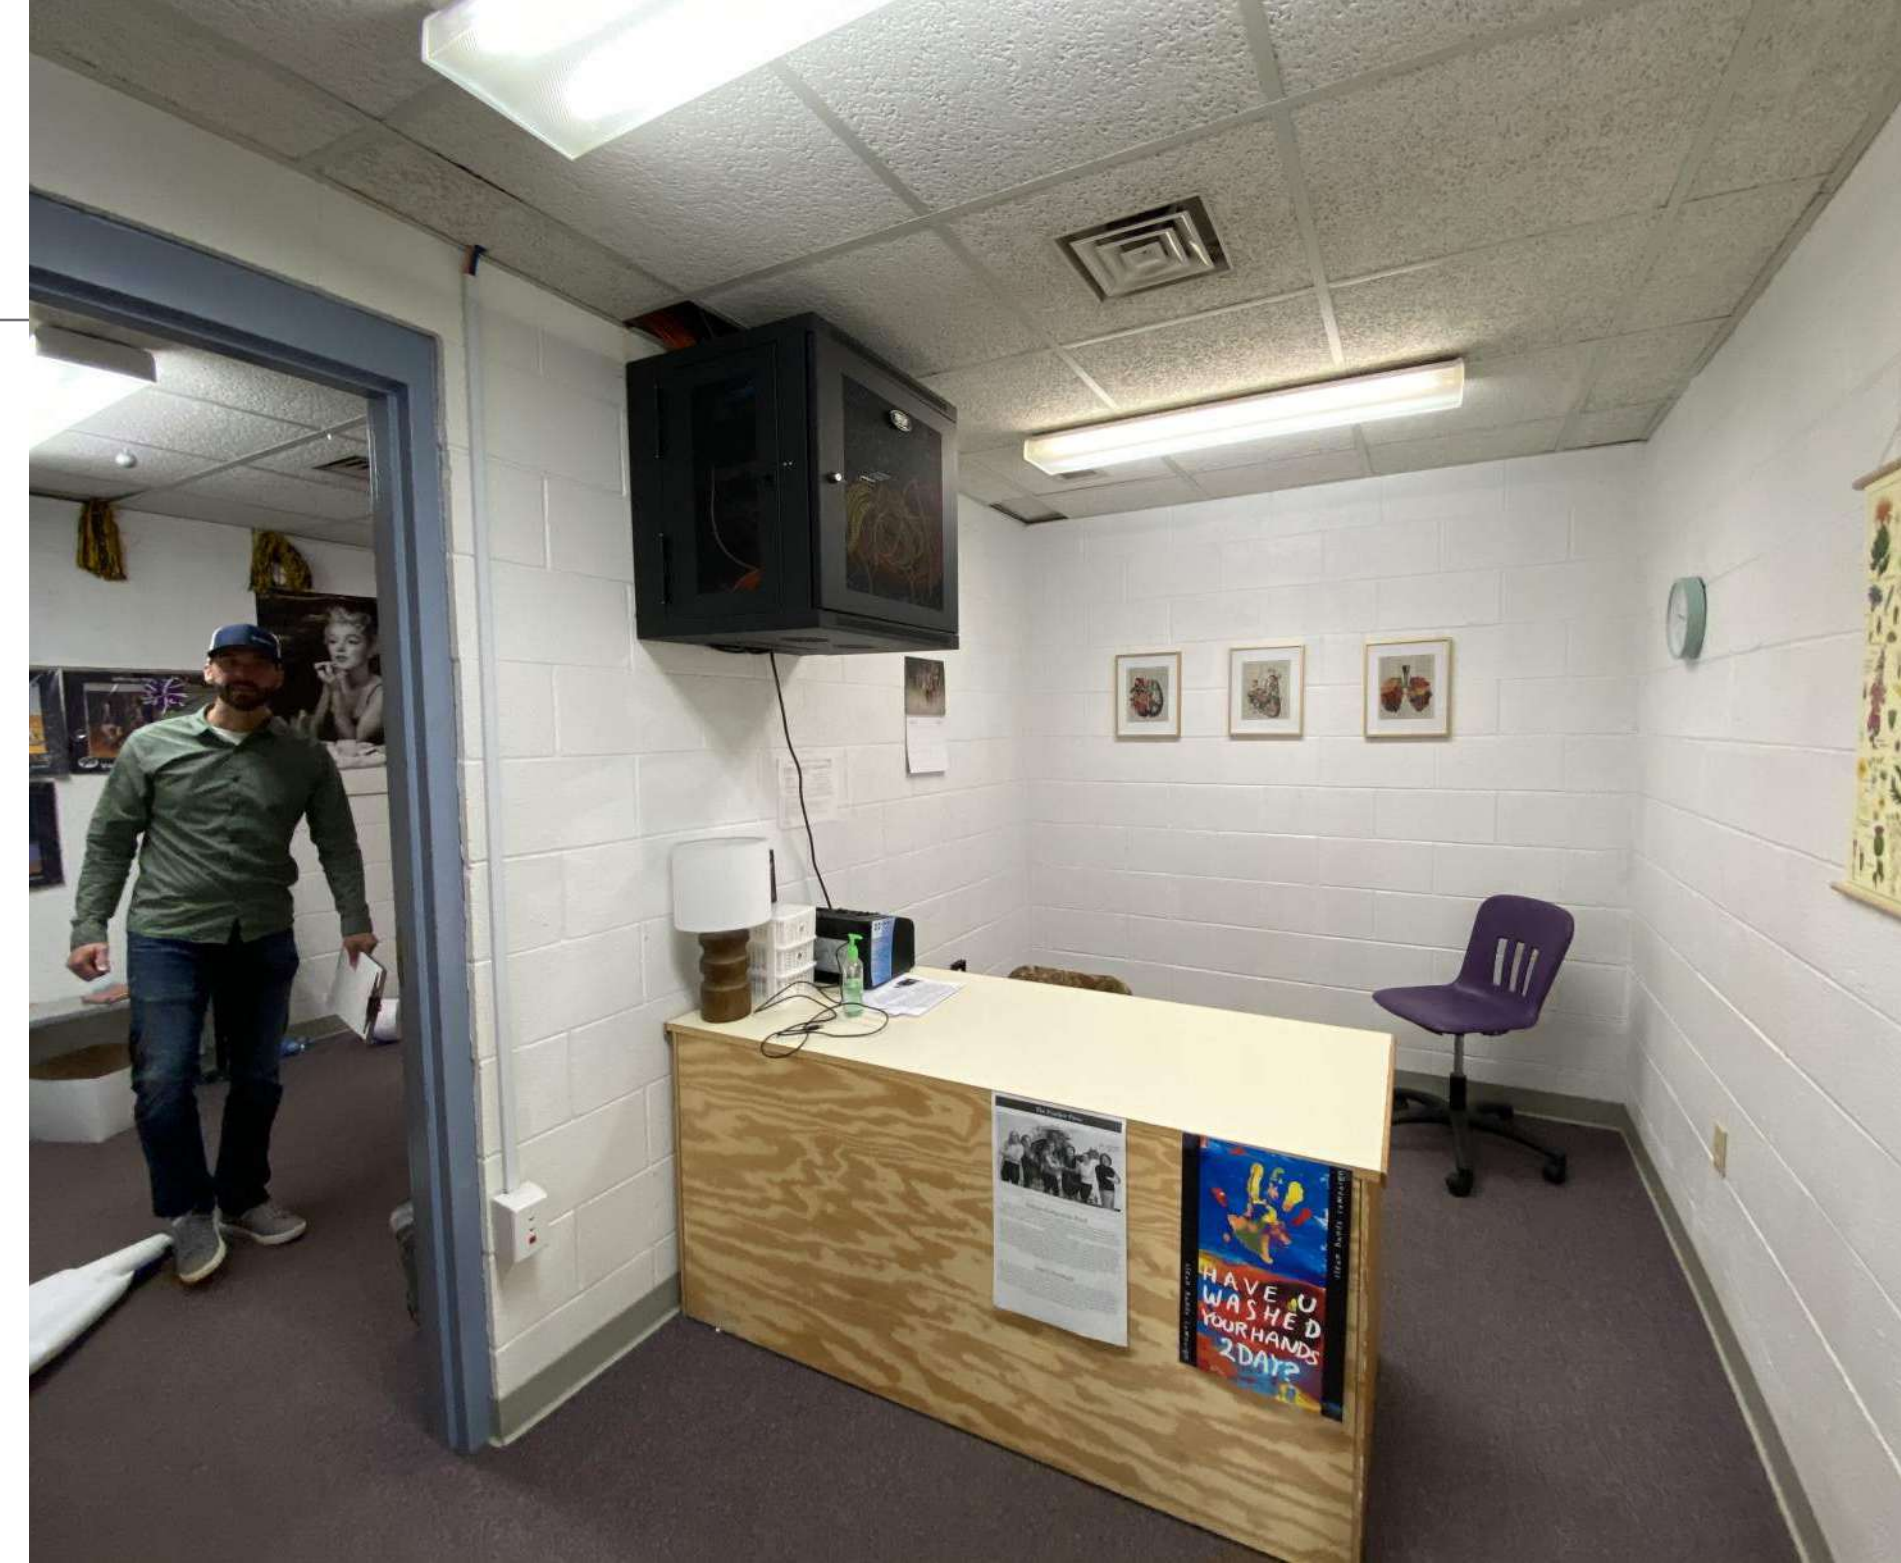
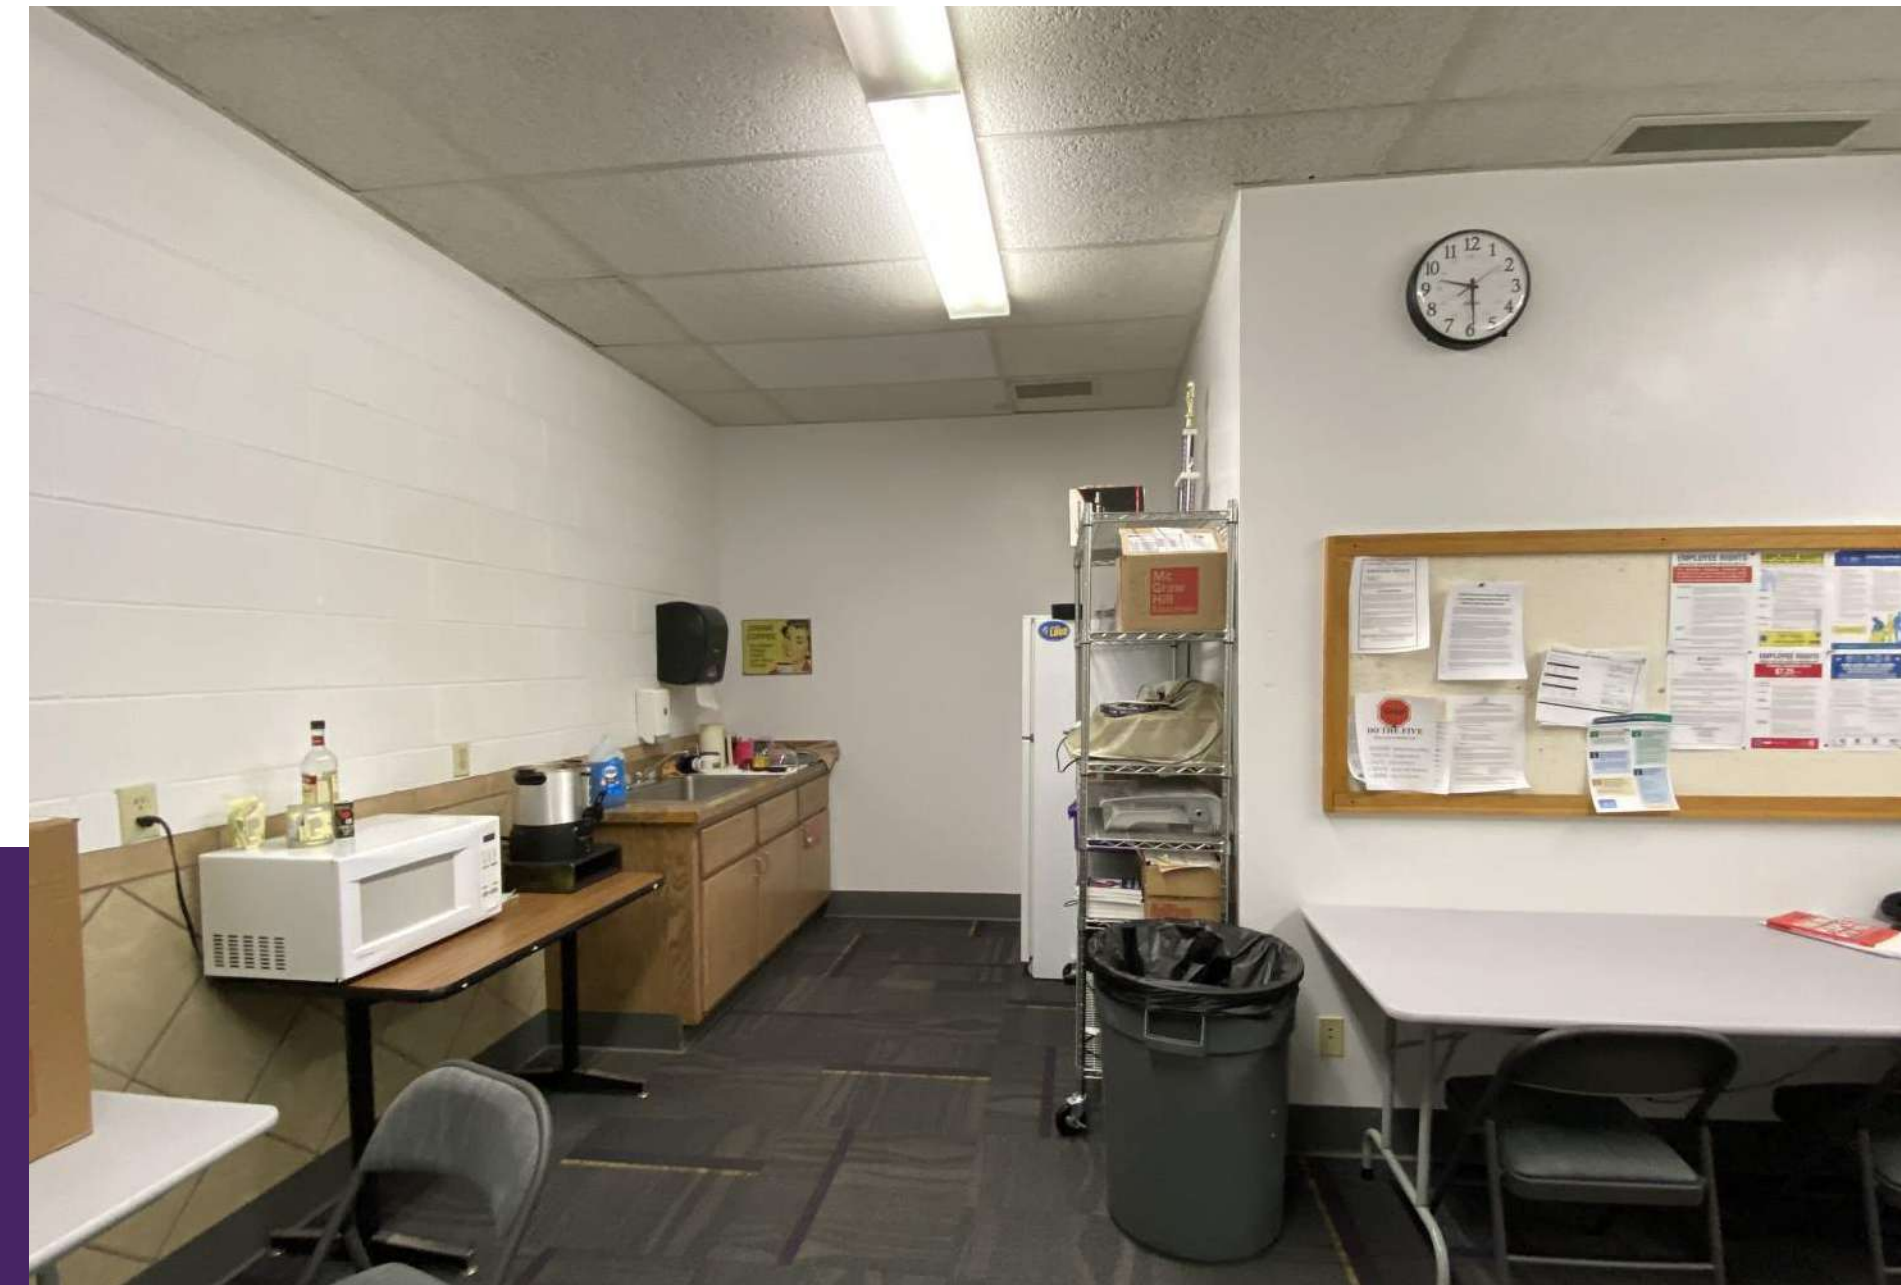
# ADMIN, COUNSELING & NURSE OFFICE

- Many of these rooms appear to have been retrofitted into existing rooms
- No visibility from front desk to sick bay for secretary to monitor while fulfilling both duties
- Lack of private conference area
- Central Office located here and is busy, difficult to get work done next to main circulation

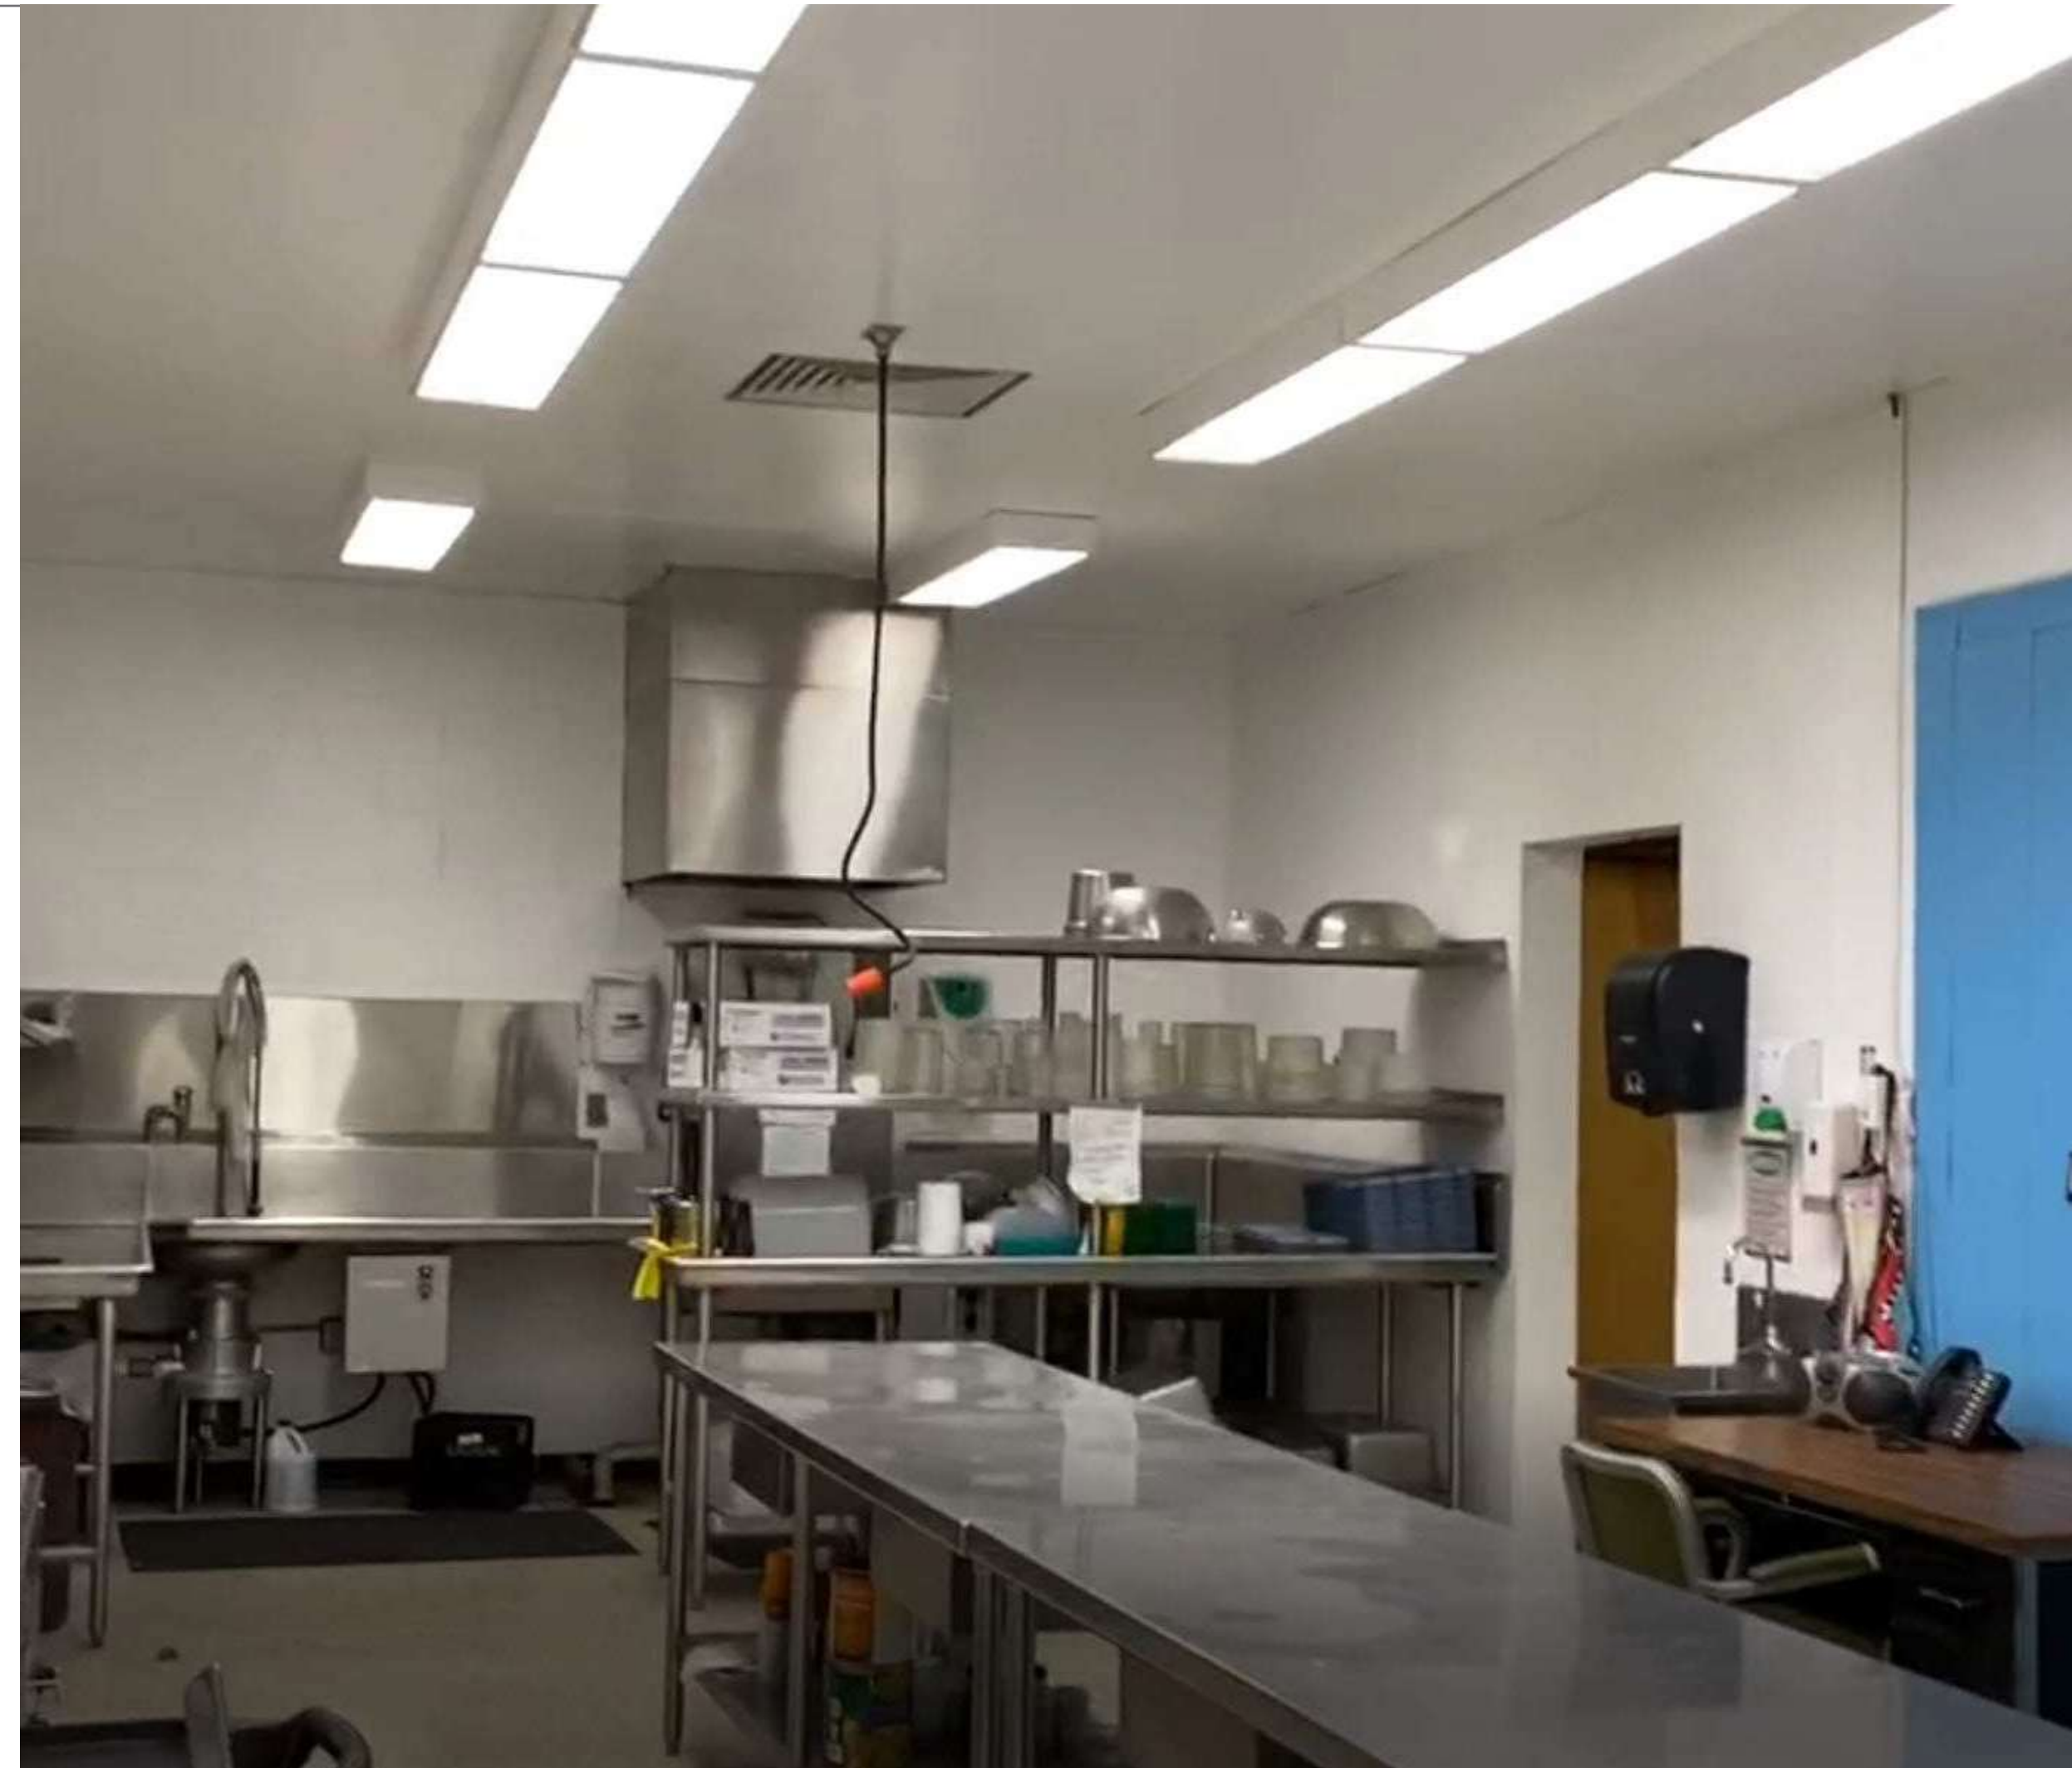
# KITCHEN & CAFETERIA

- Full during mealtimes, students often use classrooms to eat
- Finishes are same as rest of school
- Kitchen was clean, well-maintained with small recent renovations including:
  - Upgraded hoods with suppression system built-in
  - Three compartment sink
  - Loading dock and storage adequate
