# BUILDING CONDITION REPORT

**JEFFERSON HIGH  
SCHOOL DISTRICT #1**  
July 21, 2020

# BUILDING CONDITION REPORT SUMMARY

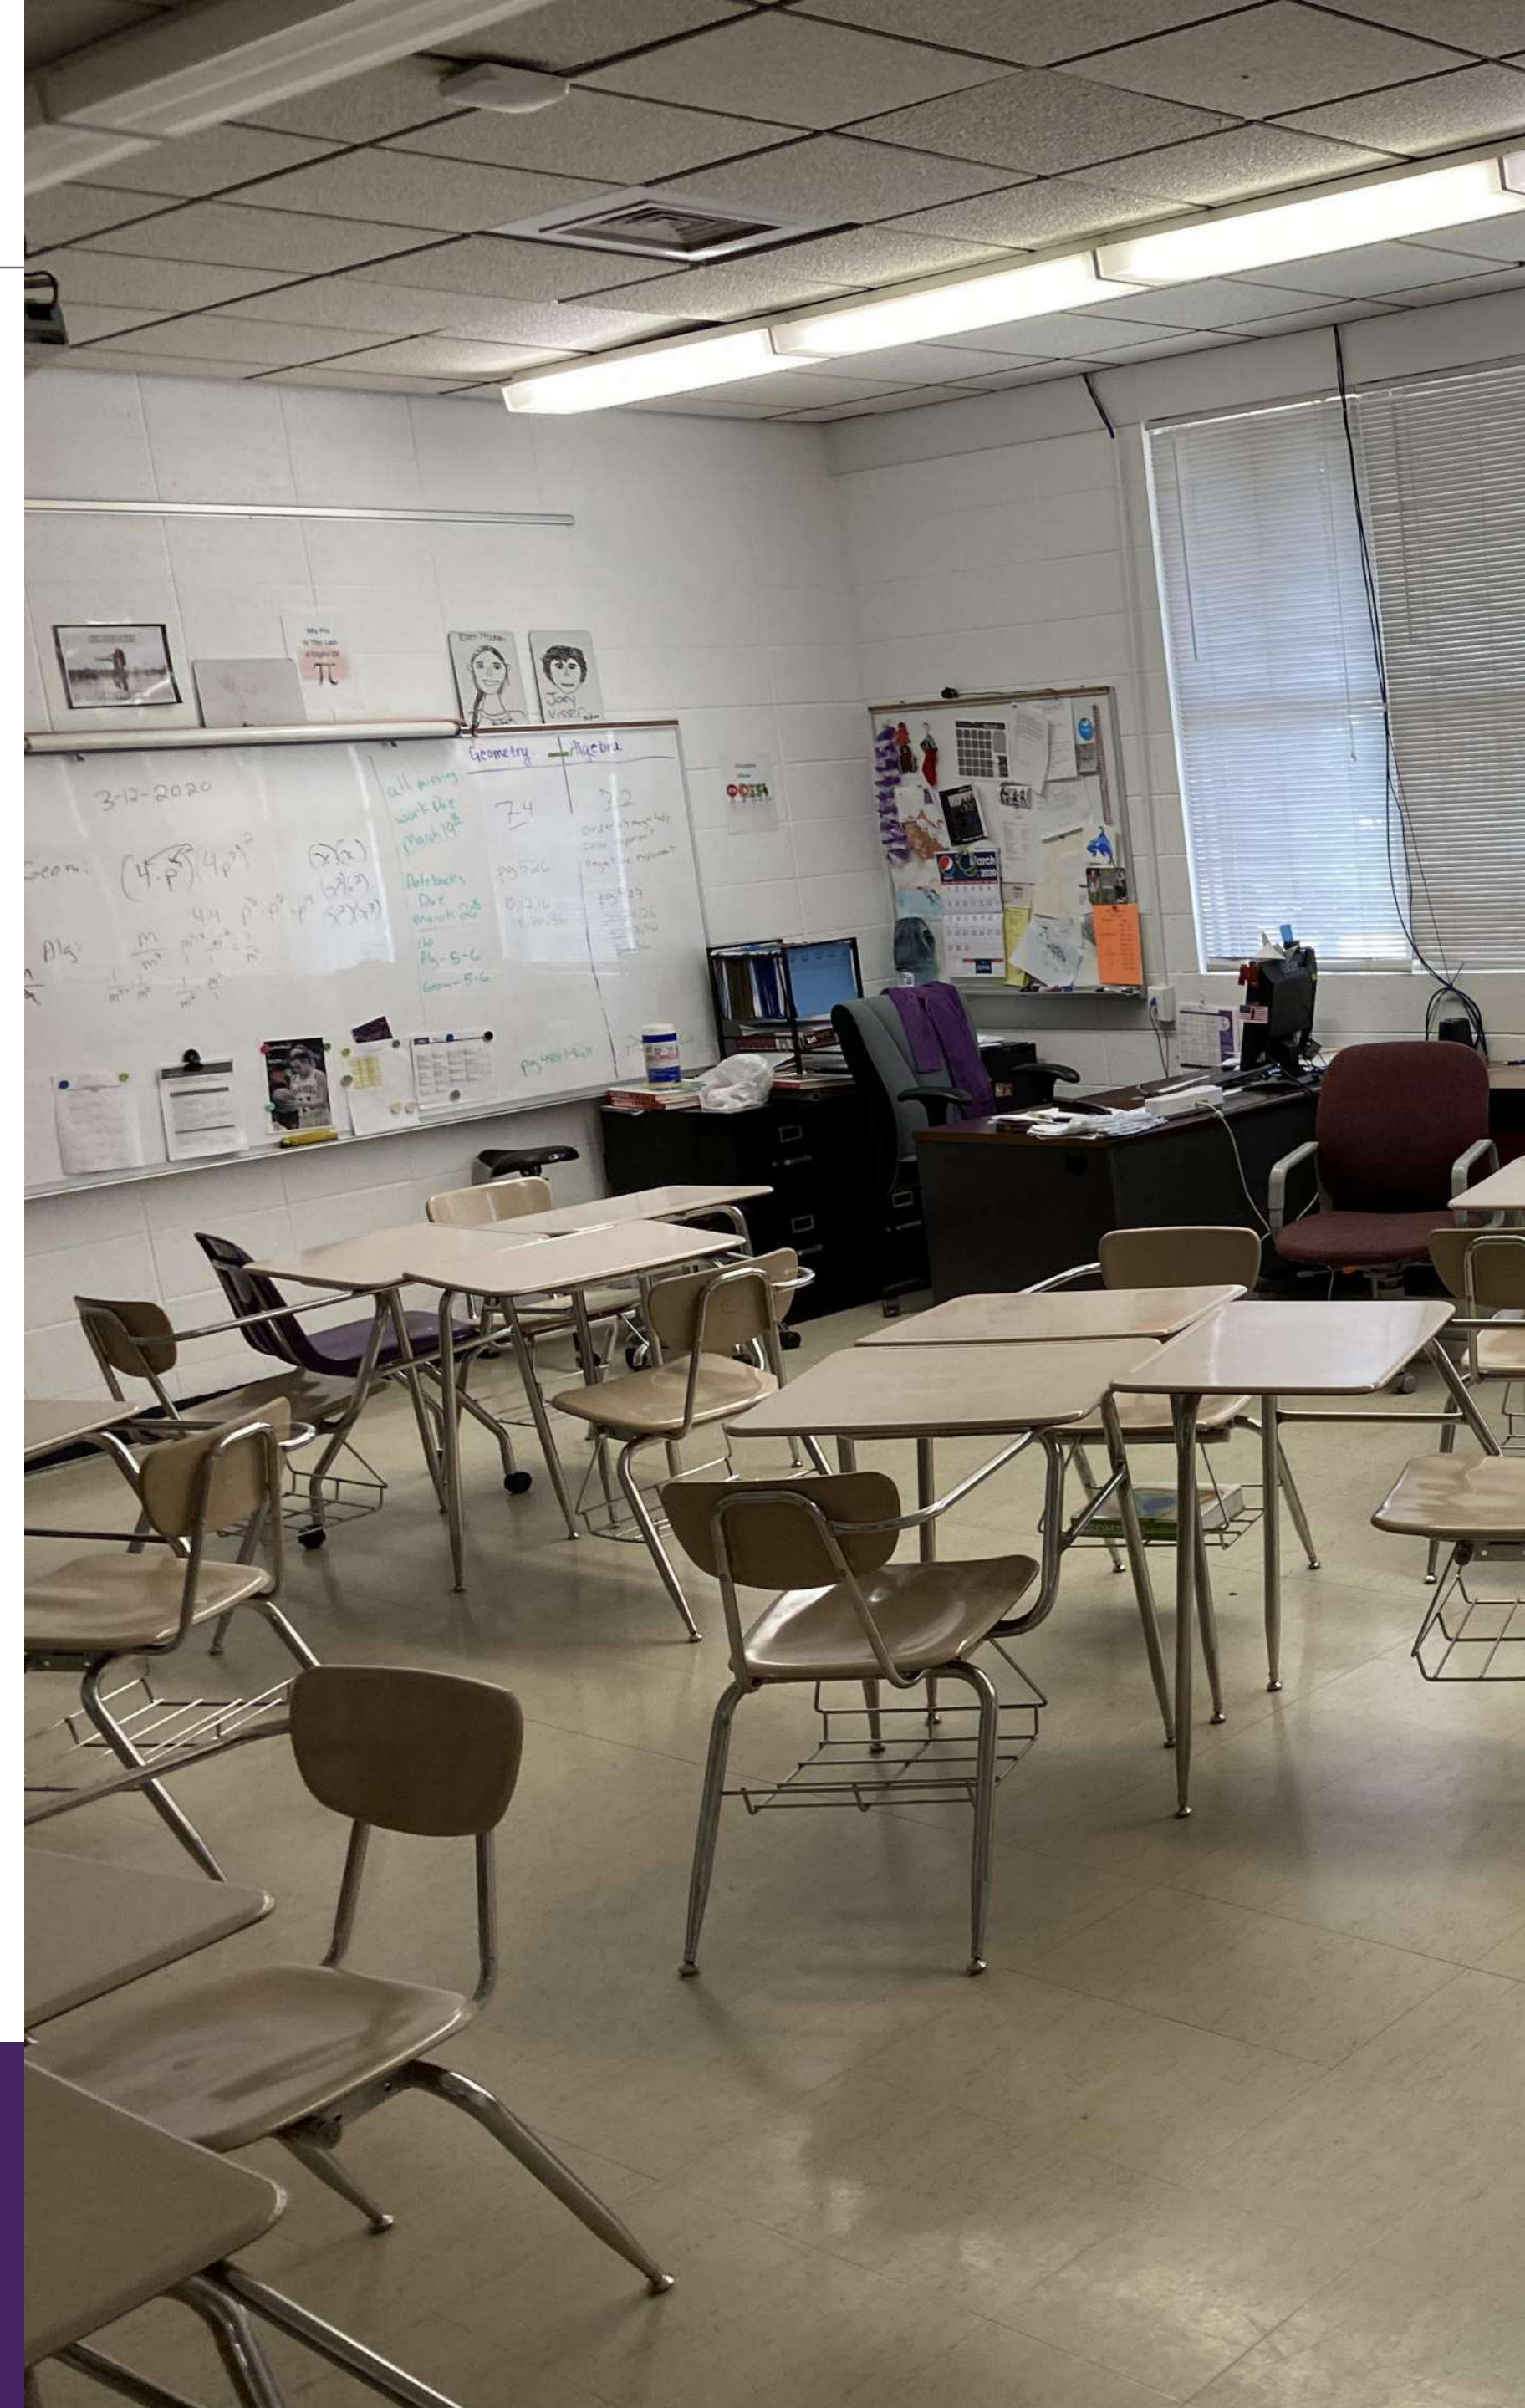
# CLASSROOMS | GENERAL

- In general, functioning well, most teachers spoke positively about their space
- Handful of teachers reported their classrooms are too small
- Current classroom SF are adequate for most class sizes, but do not meet 21st century classroom recommendations and cannot accommodate growing class numbers.
  - Maximum students per class, per State of MT is 30 students.
  - Recommended SF/student is 45-55sf for general classrooms per Association for Learning Environments.

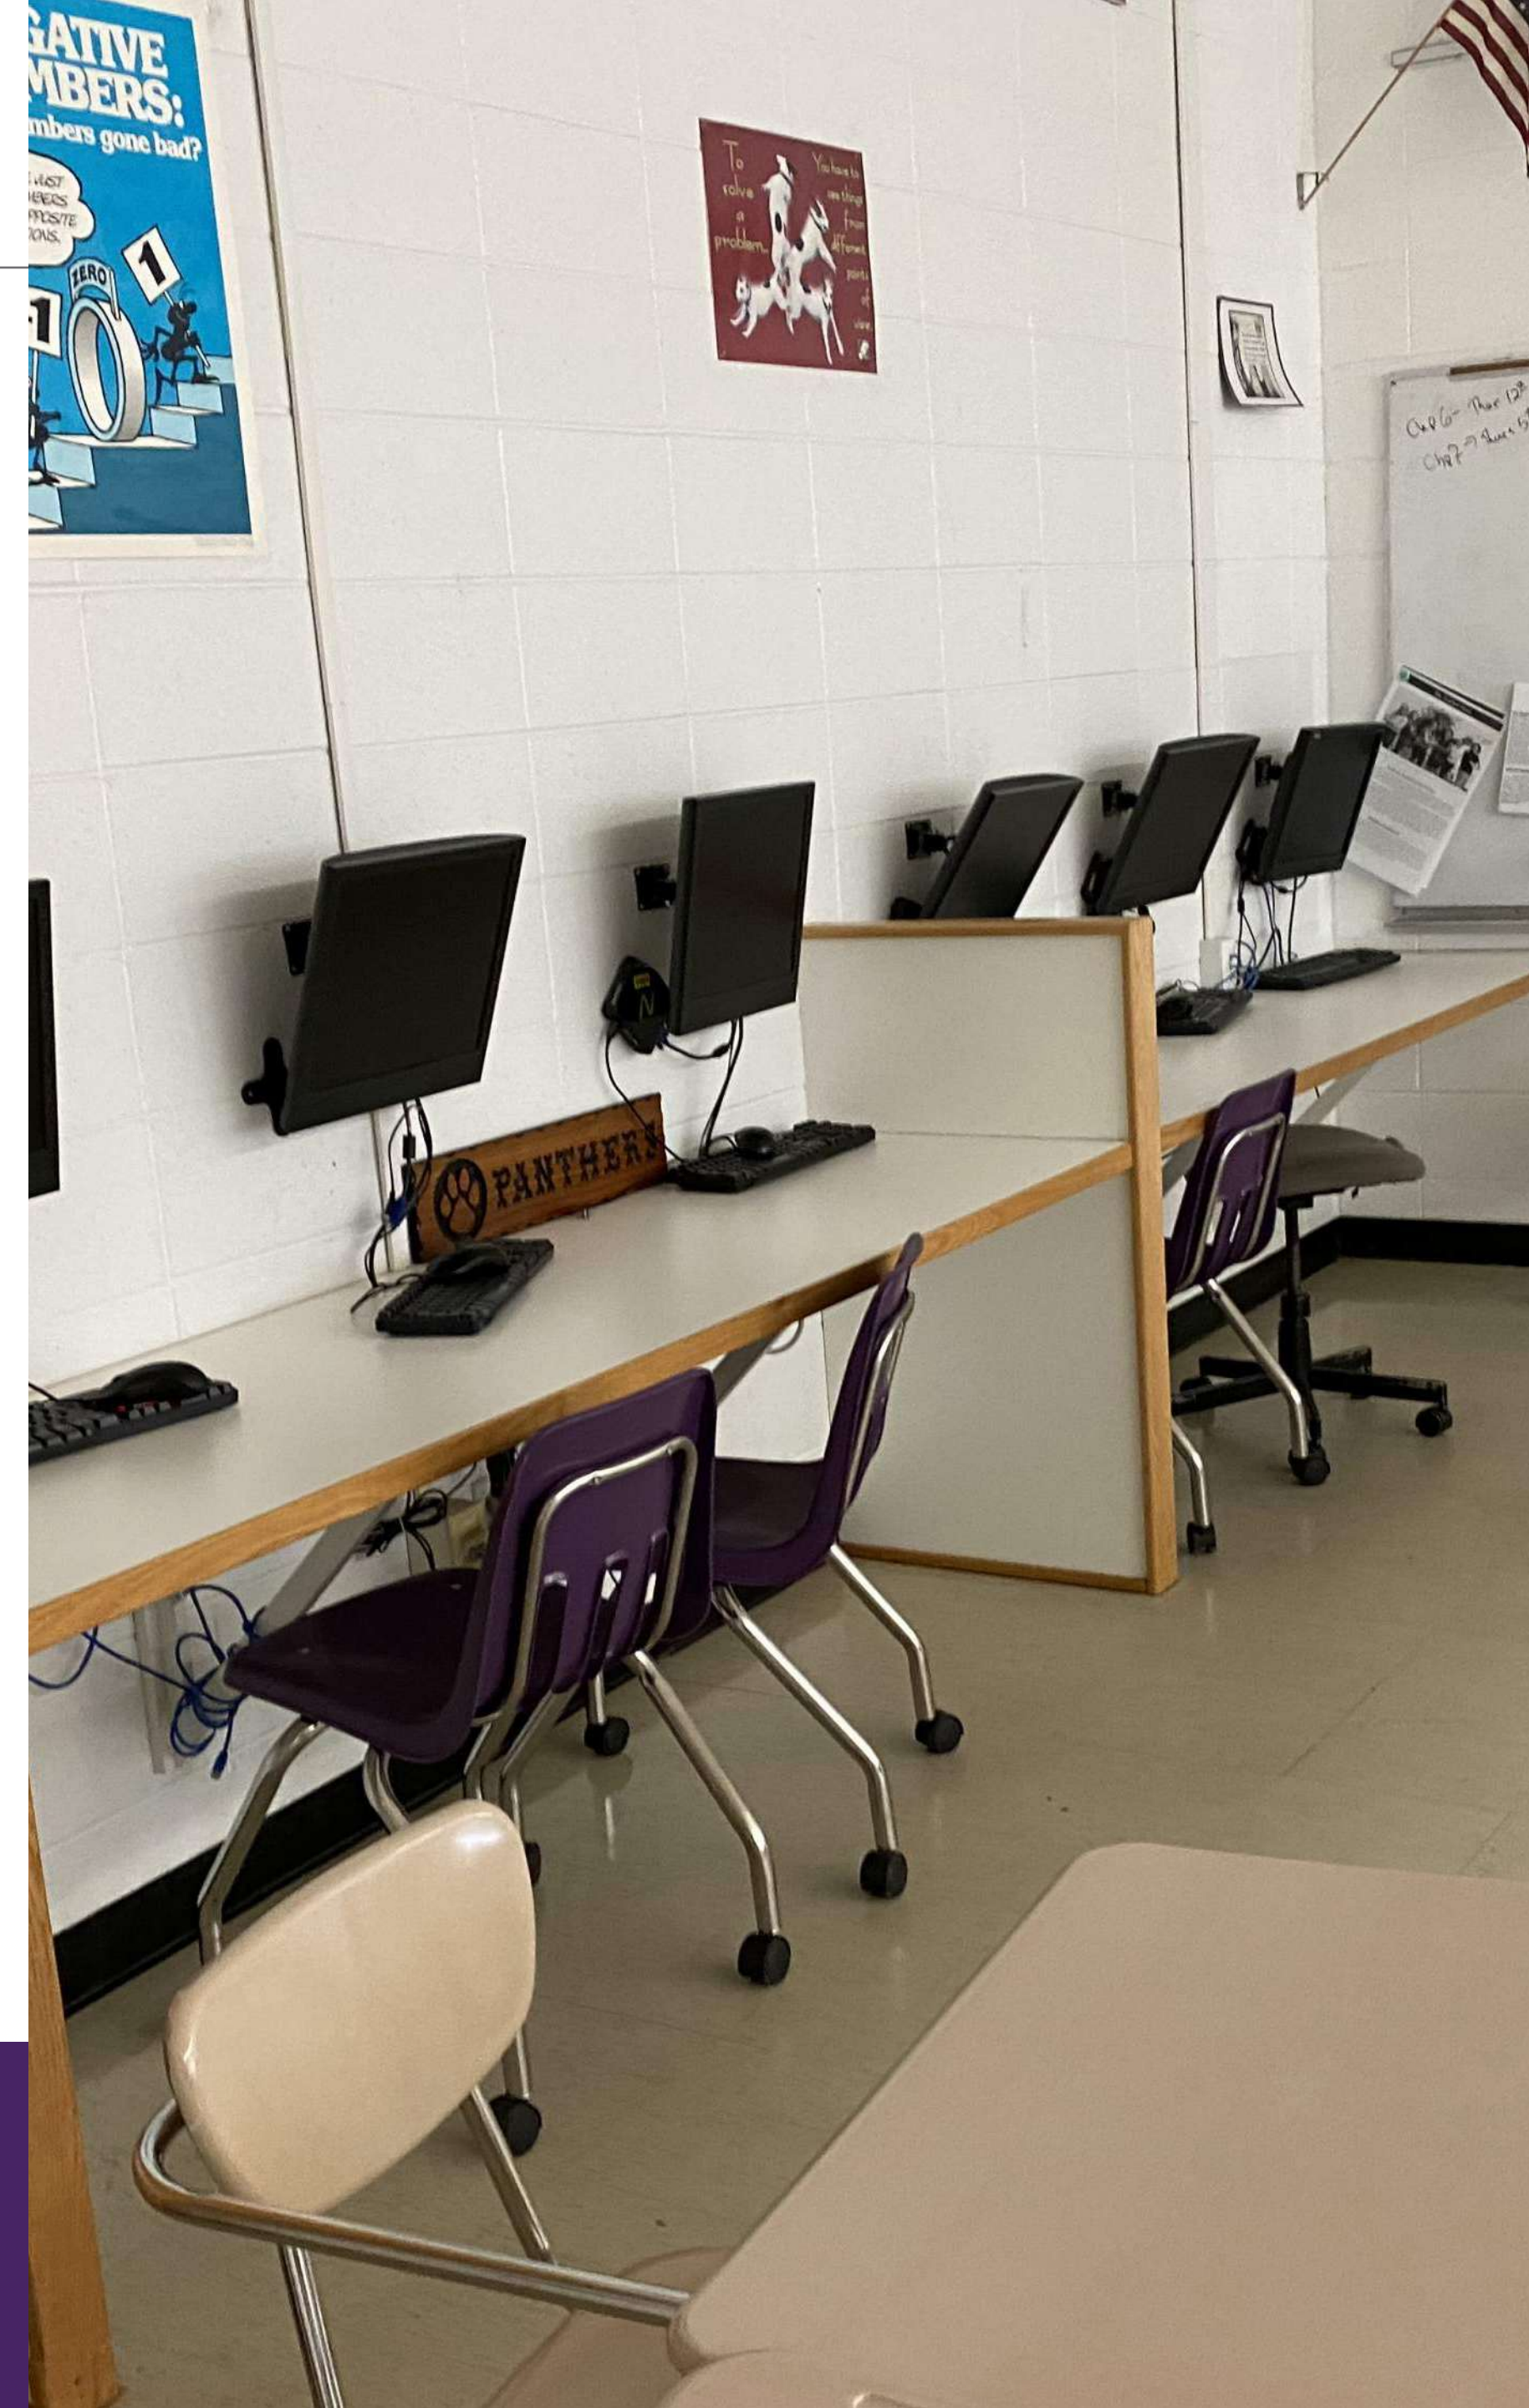
# CLASSROOMS | GENERAL

- District has retrofitted classrooms with many modern amenities, some technologies still lacking [ex: short throw projectors, USB, smart boards, TVs/AV systems]
- Clock/Bell system is aged
- Severe lack of electrical outlets throughout all classrooms – reported by teachers
- Ceiling tiles also have worn condition

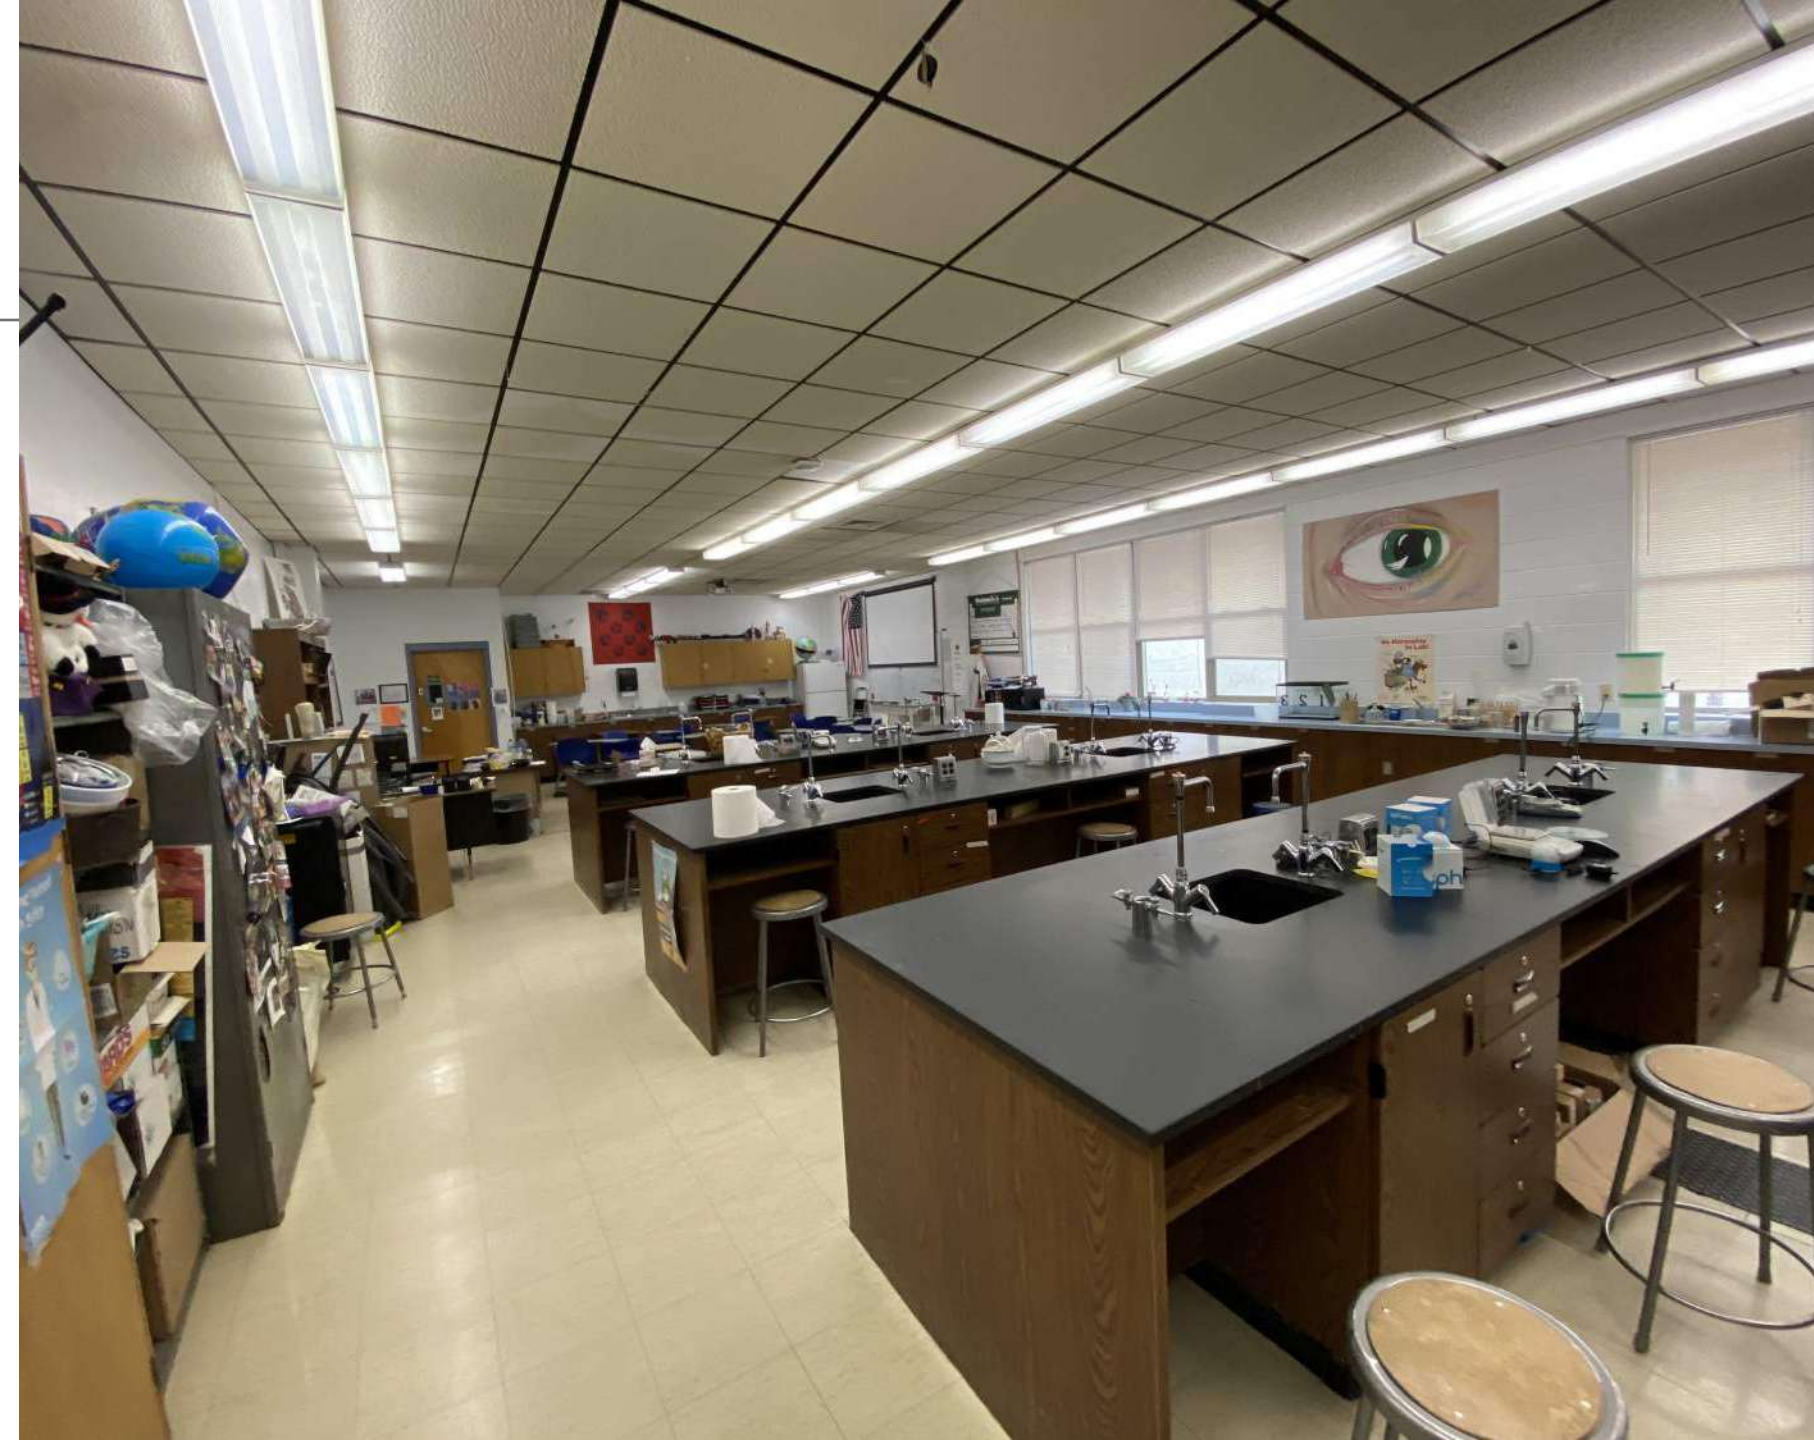
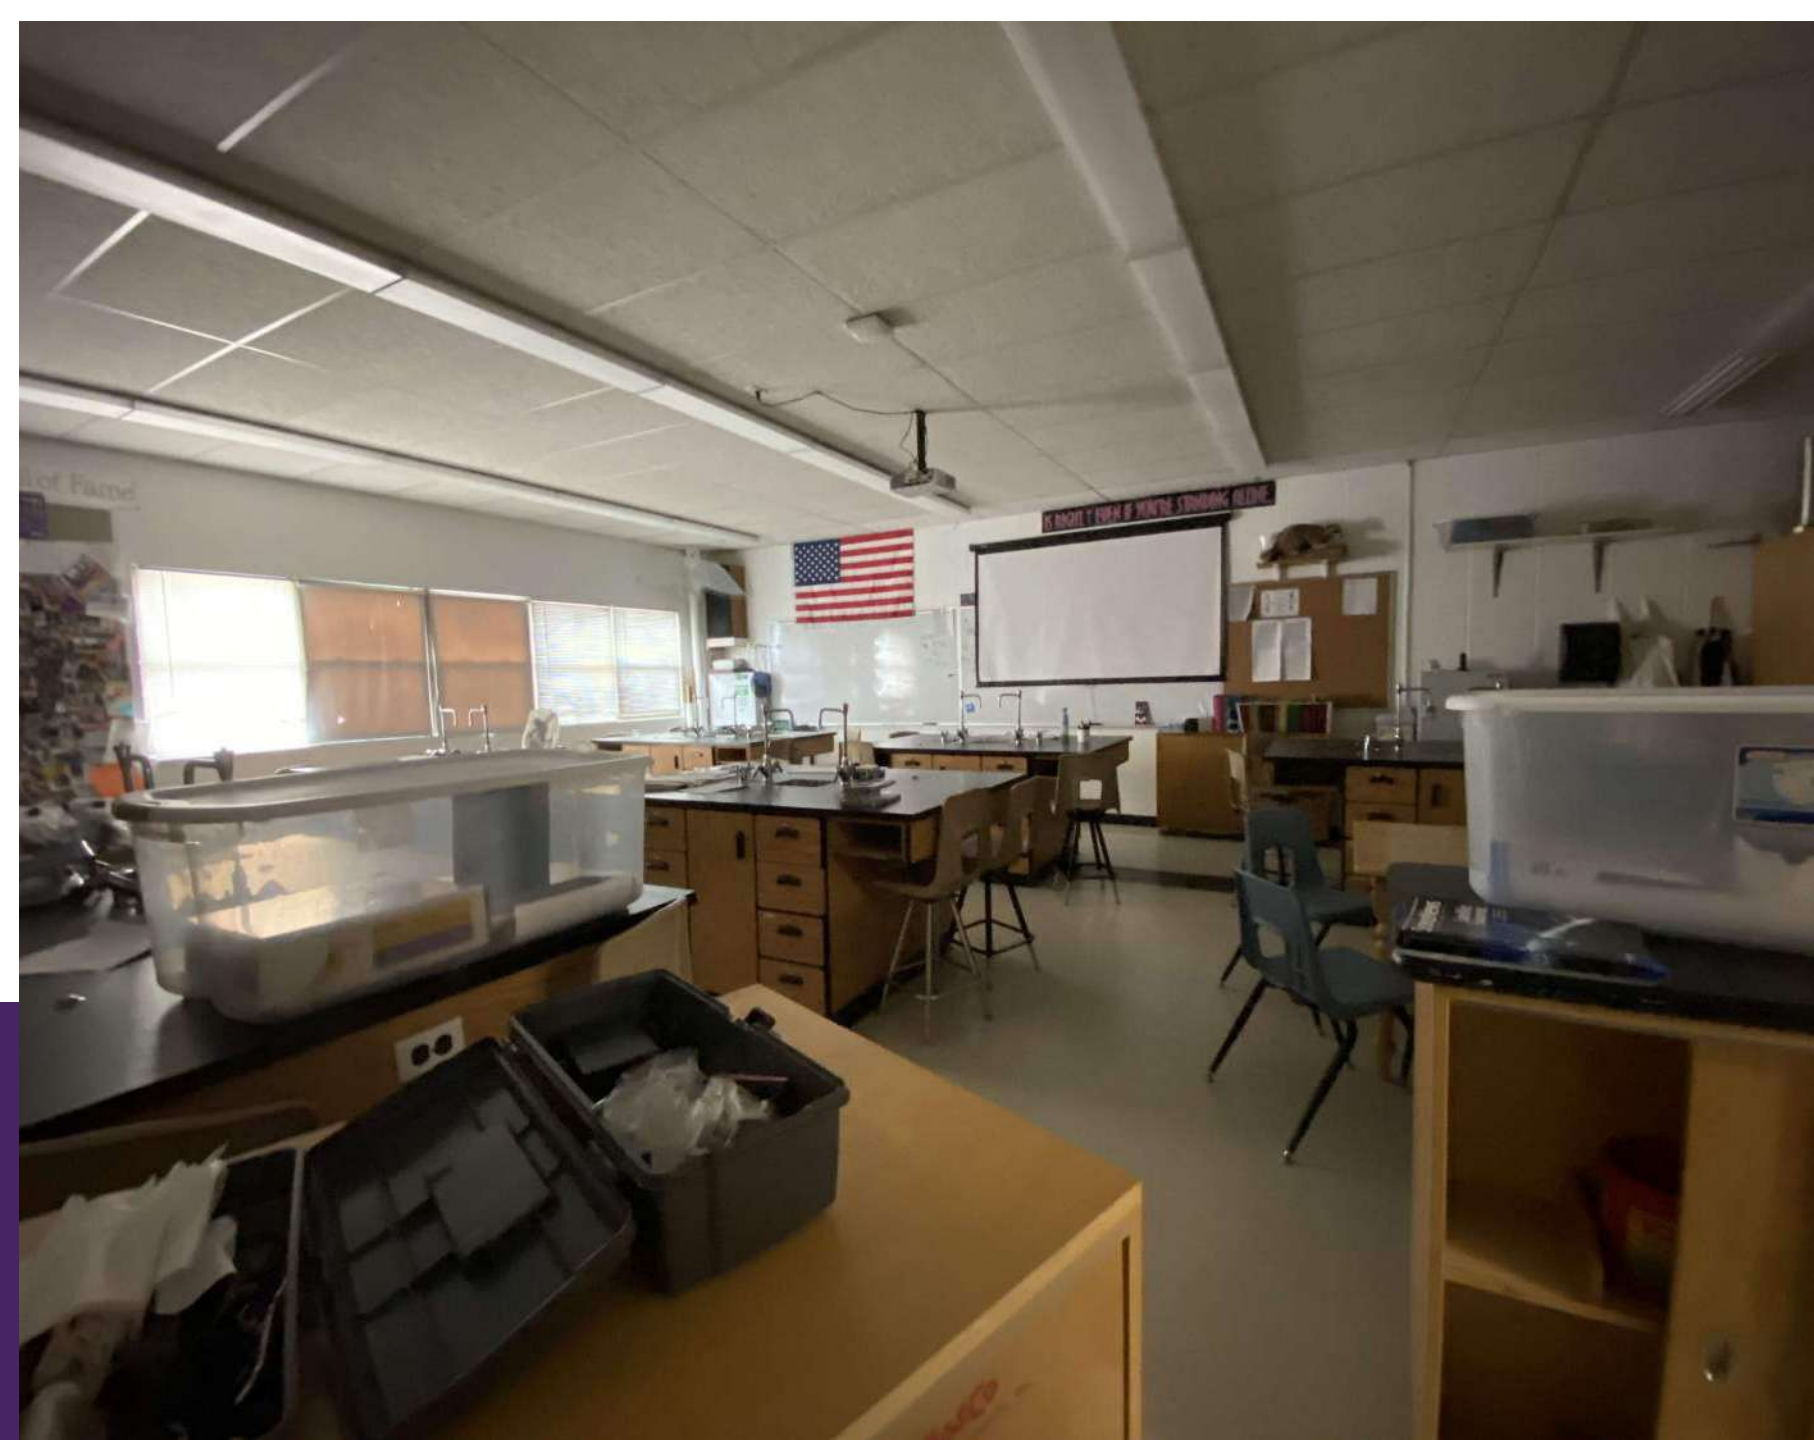
# CLASSROOMS | SCIENCE

- Physical Science room is sized closely to modern schools at 1450sf
- Adequately equipped with eyewash and 2 exit doors
- Life Science is much smaller at 885 sf, including lecture and lab space = severely undersized
- Recommend 60 sf/person for science activities [MT standards of 1800sf for 30 max students]
- Inadequate exhaust

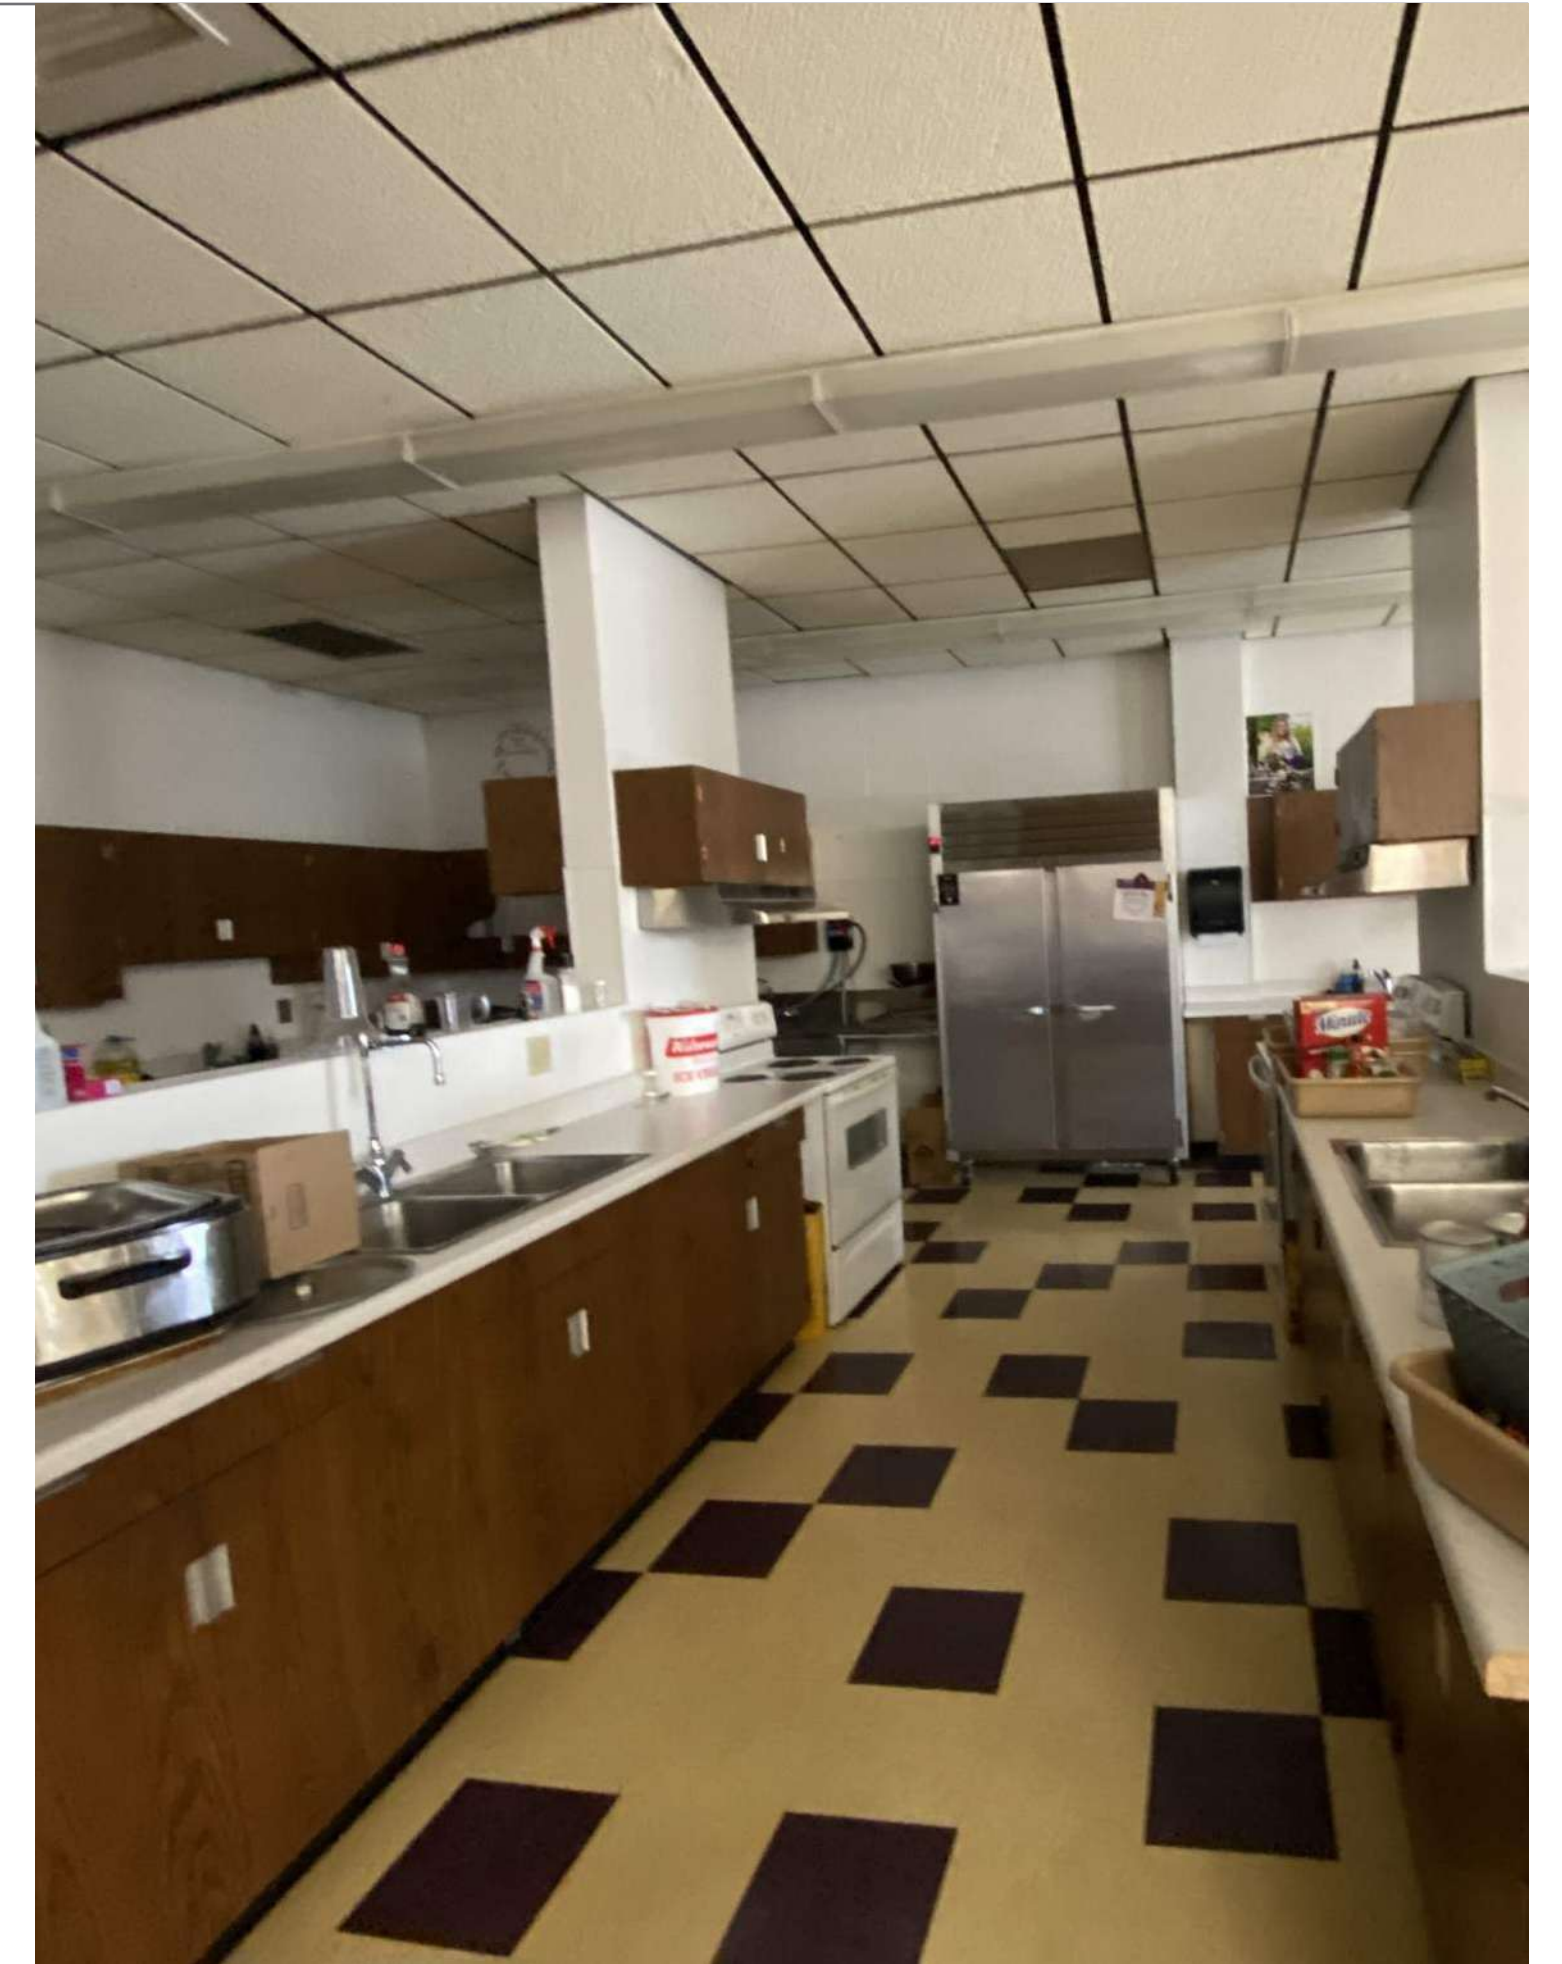
# CLASSROOMS | FAMILY & CONSUMER SCIENCE

- 1800 sf is adequate by modern standards [recommend 60-65 sf/student]
- Quantity of equipment and frequent use by food pantry and breakfast program increases usage
- Finishes in moderate to worn condition
- Combination of consumer-grade and commercial-grade equipment
- User groups indicated additional kitchen units are needed and ventilation is a concern
- Program is growing in popularity and will need continued investment

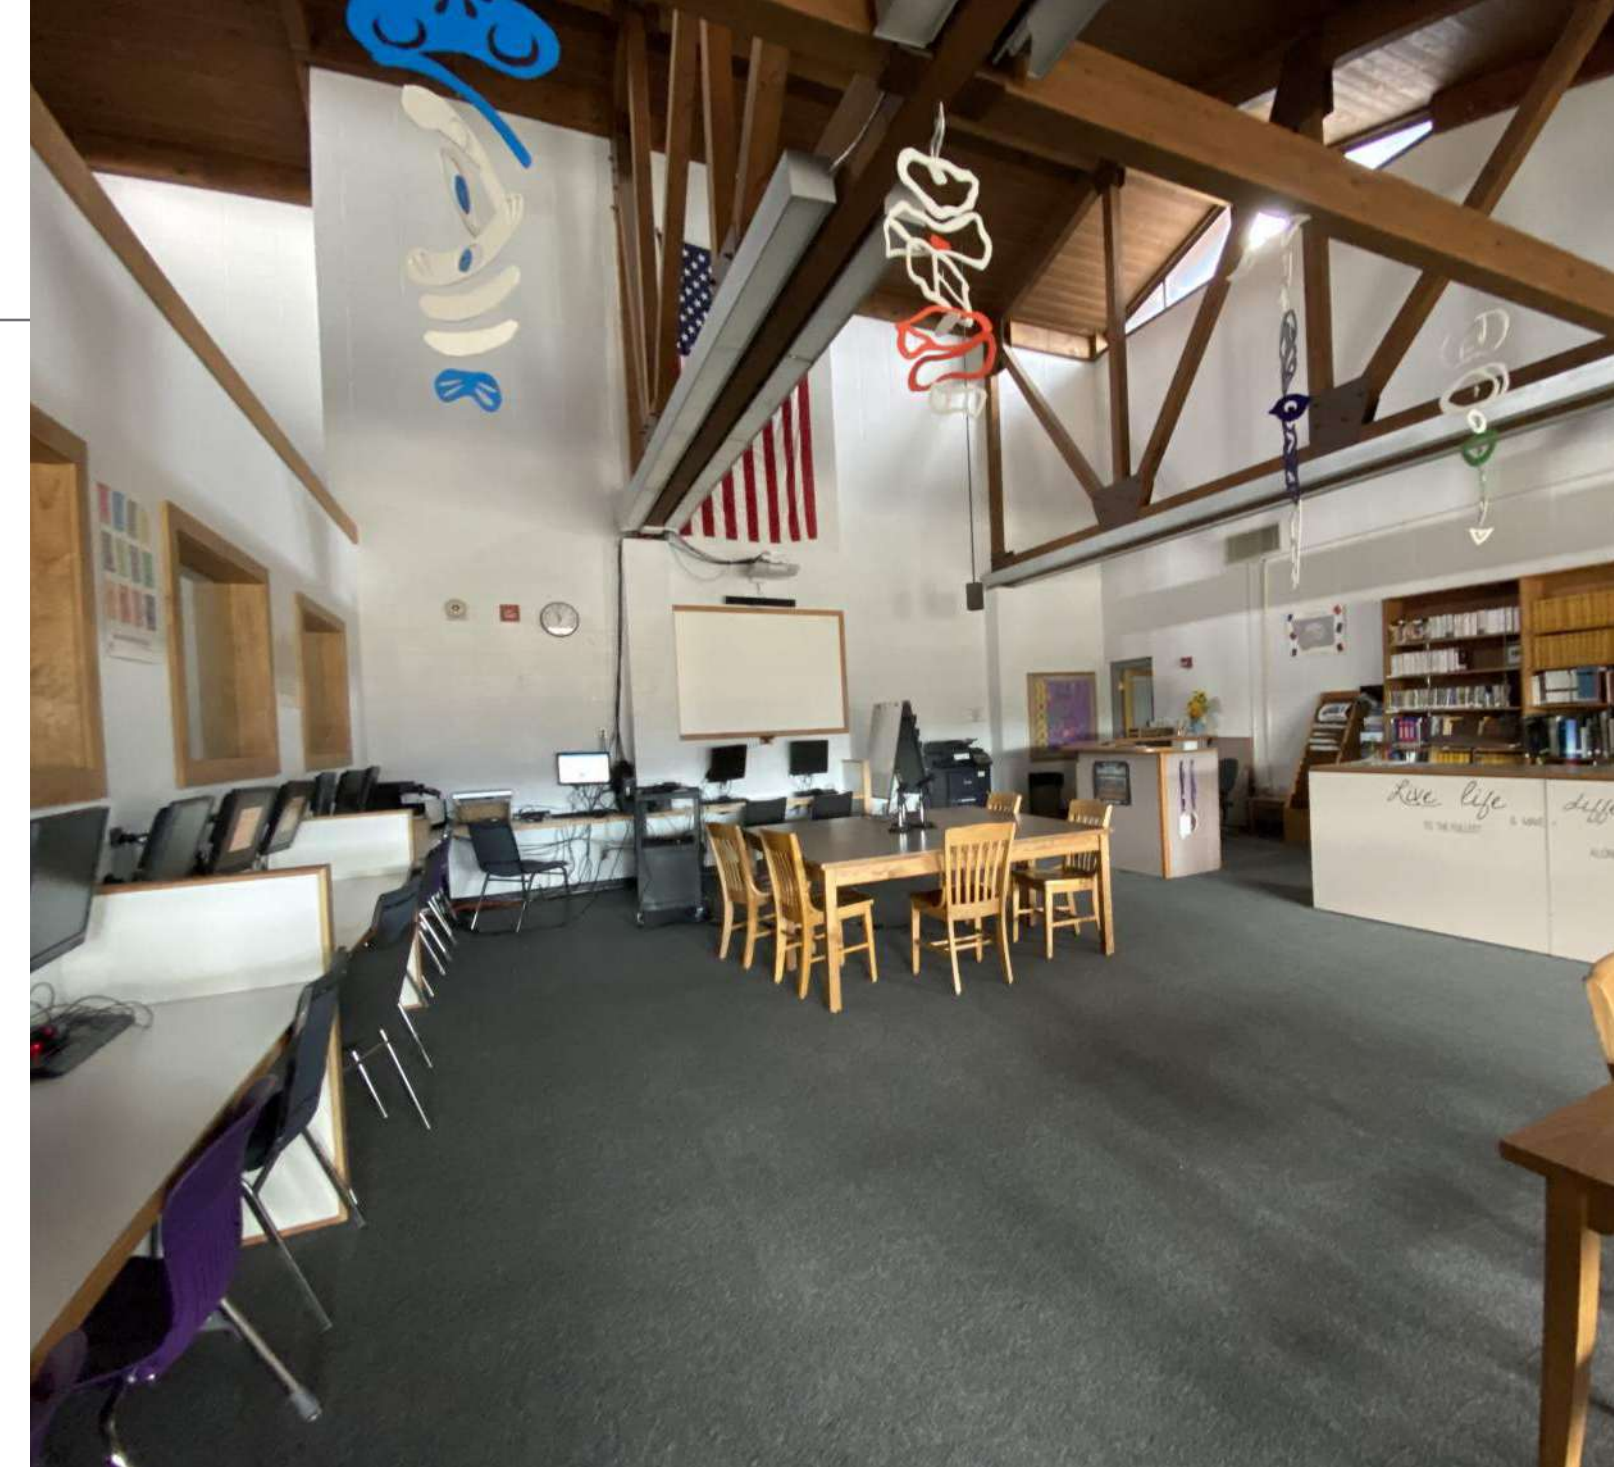
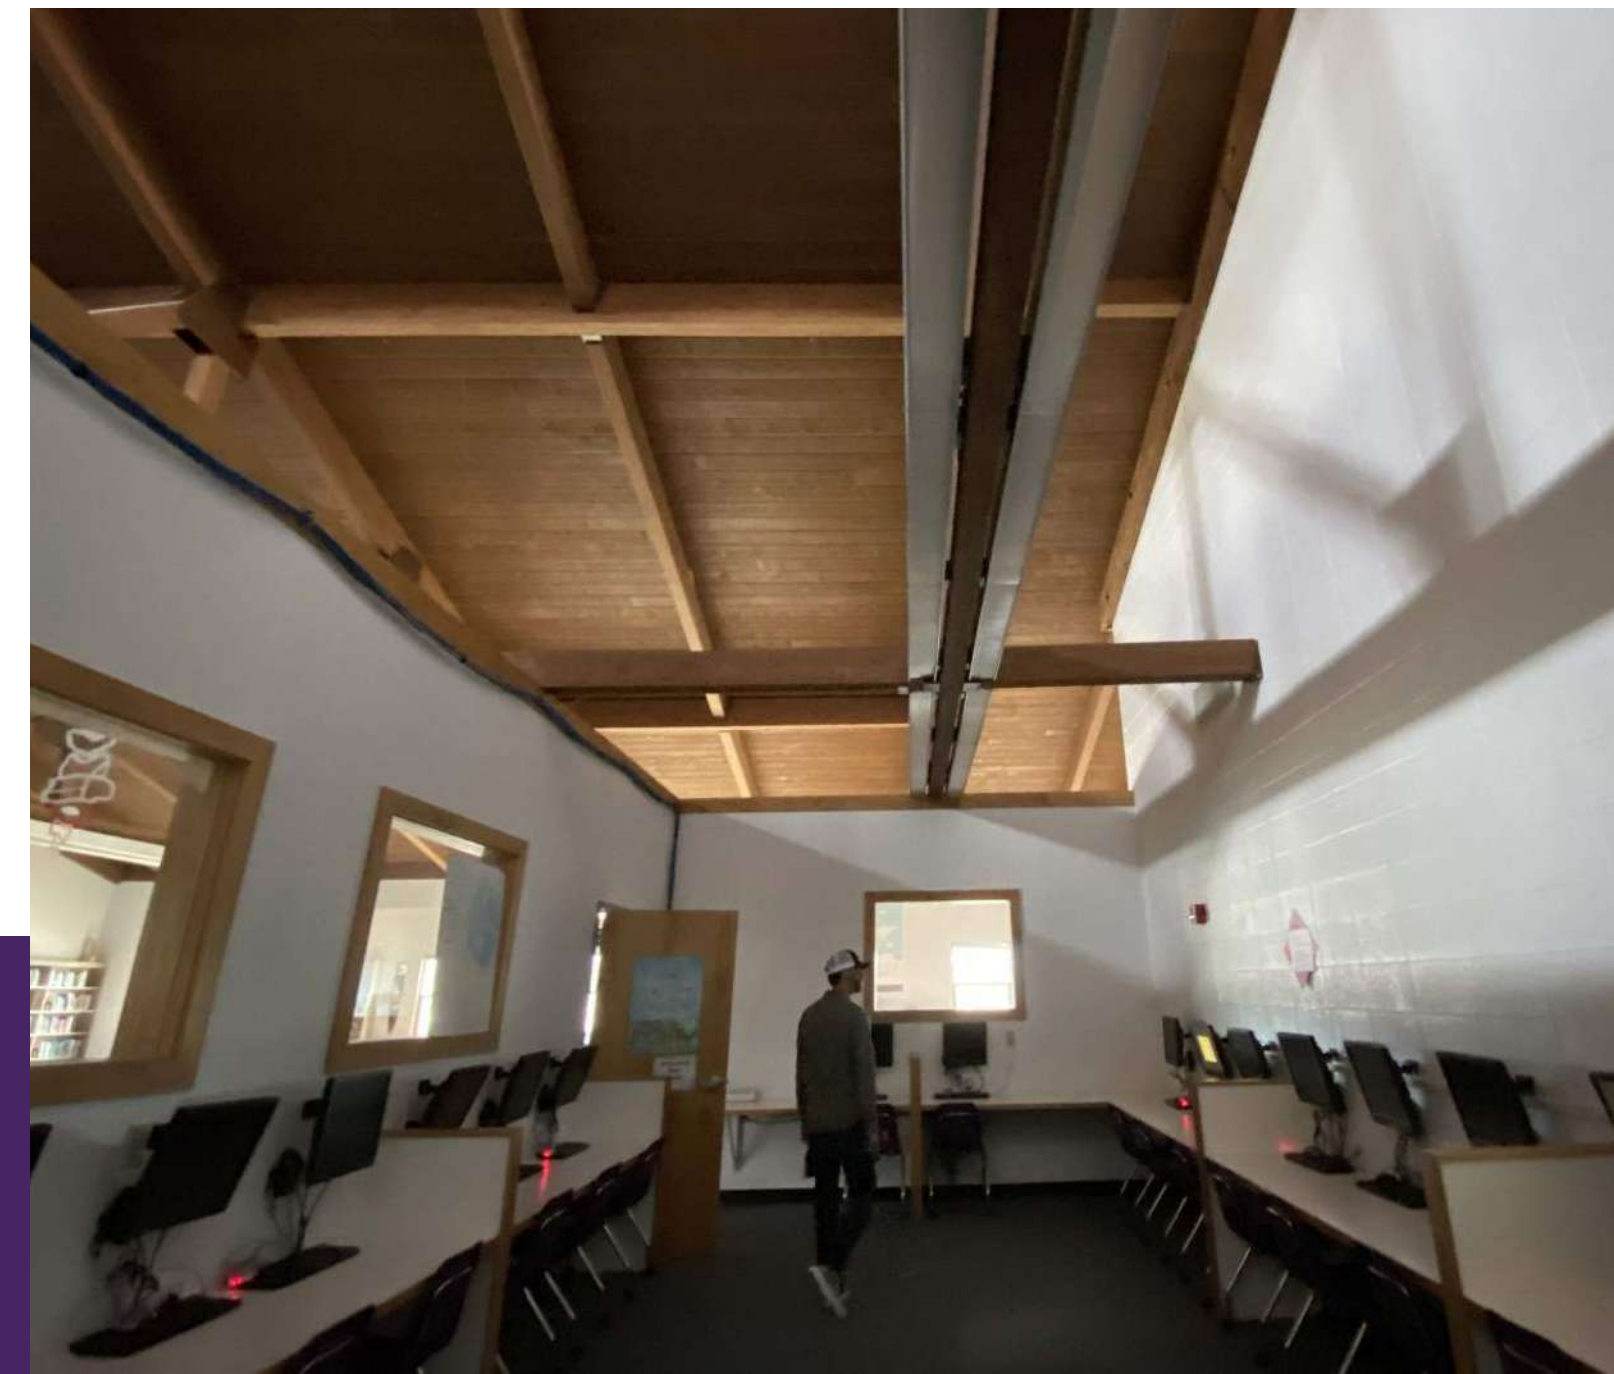
# LIBRARY & COMPUTER LAB

- Nice high ceilings, with nice finishes (wood truss and nice lighting)
- Main circulation counter not ADA
- Noise between the Library and Computer Lab are a common complaint
- Regulating temperature is difficult with computer and occupant heat. Unable to utilize windows if buses are queued outside
