# BUILDING CONDITION REPORT

**JEFFERSON HIGH  
SCHOOL DISTRICT #1**  
July 21, 2020

# BUILDING CONDITION REPORT SUMMARY

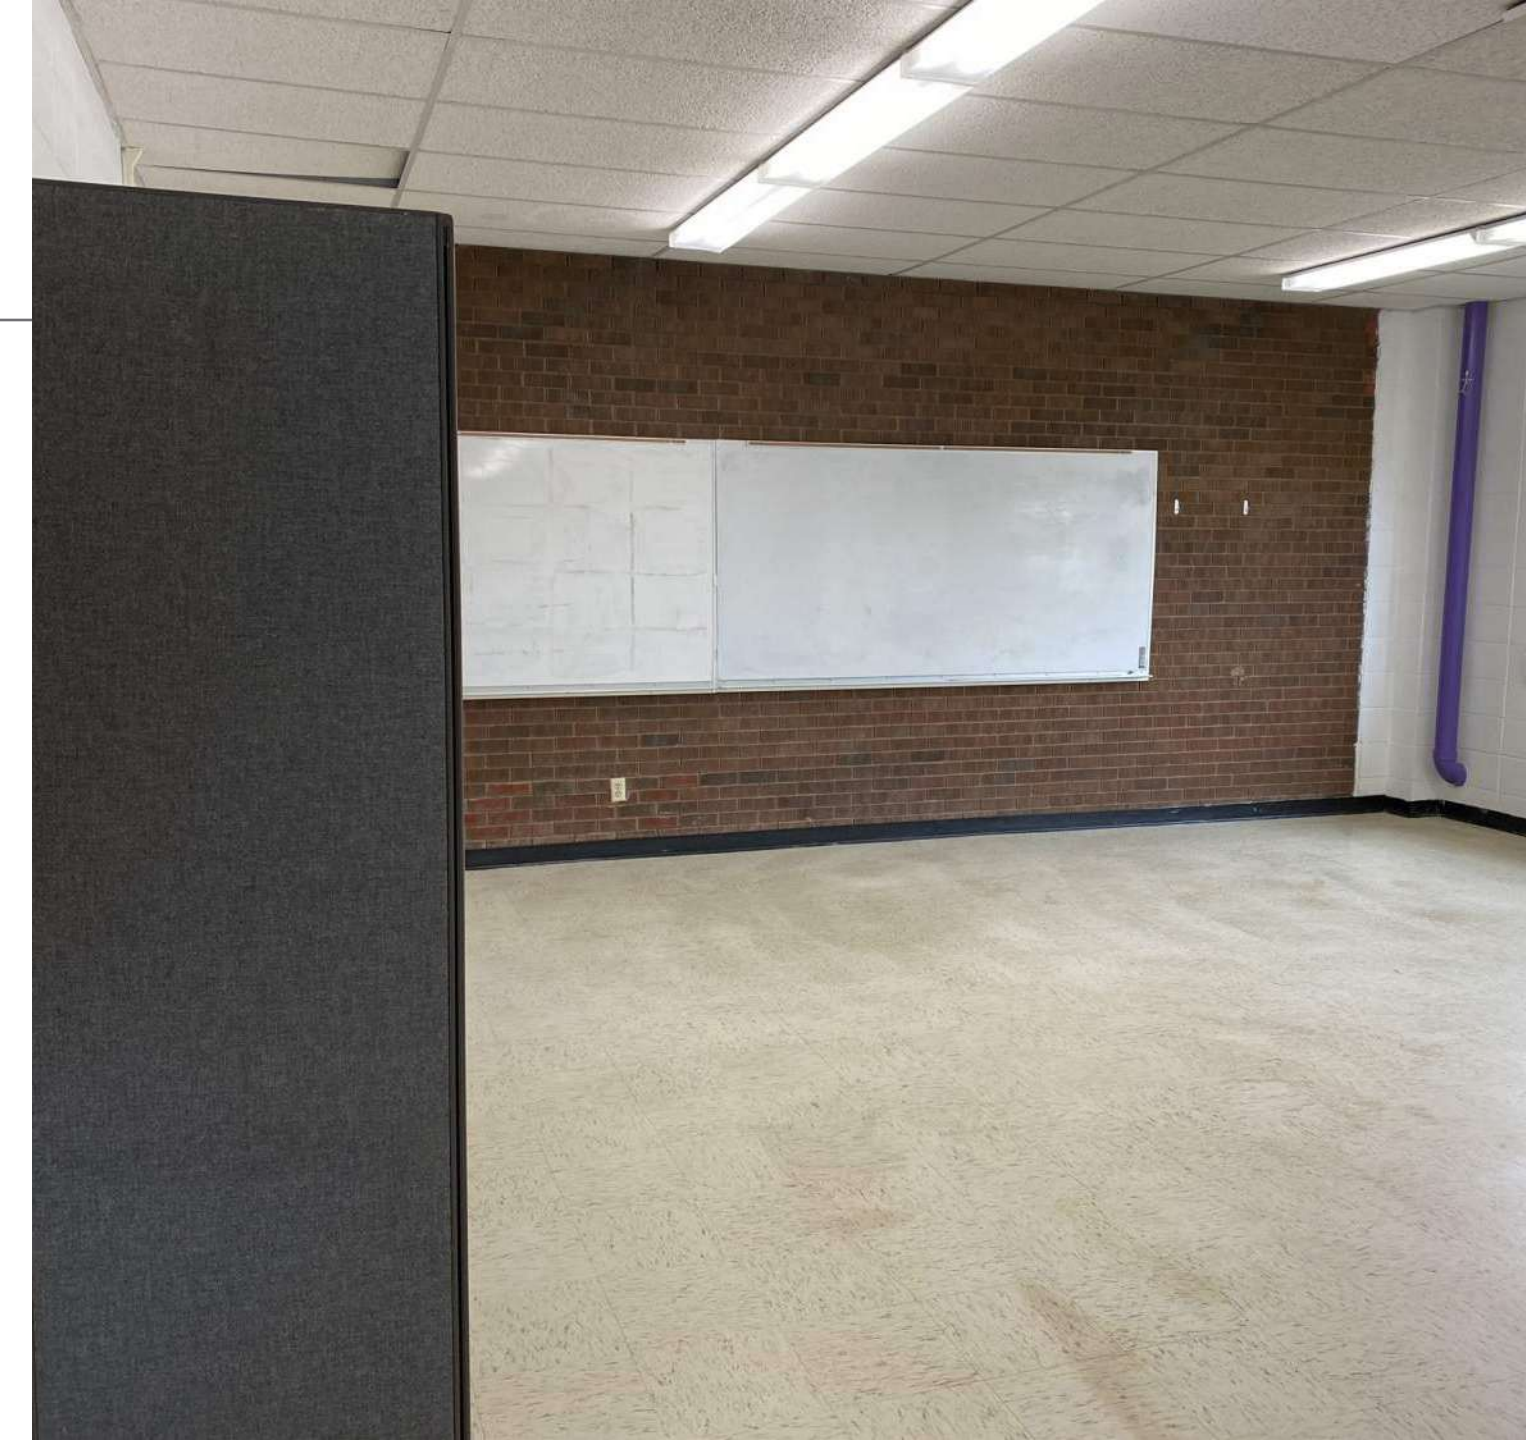
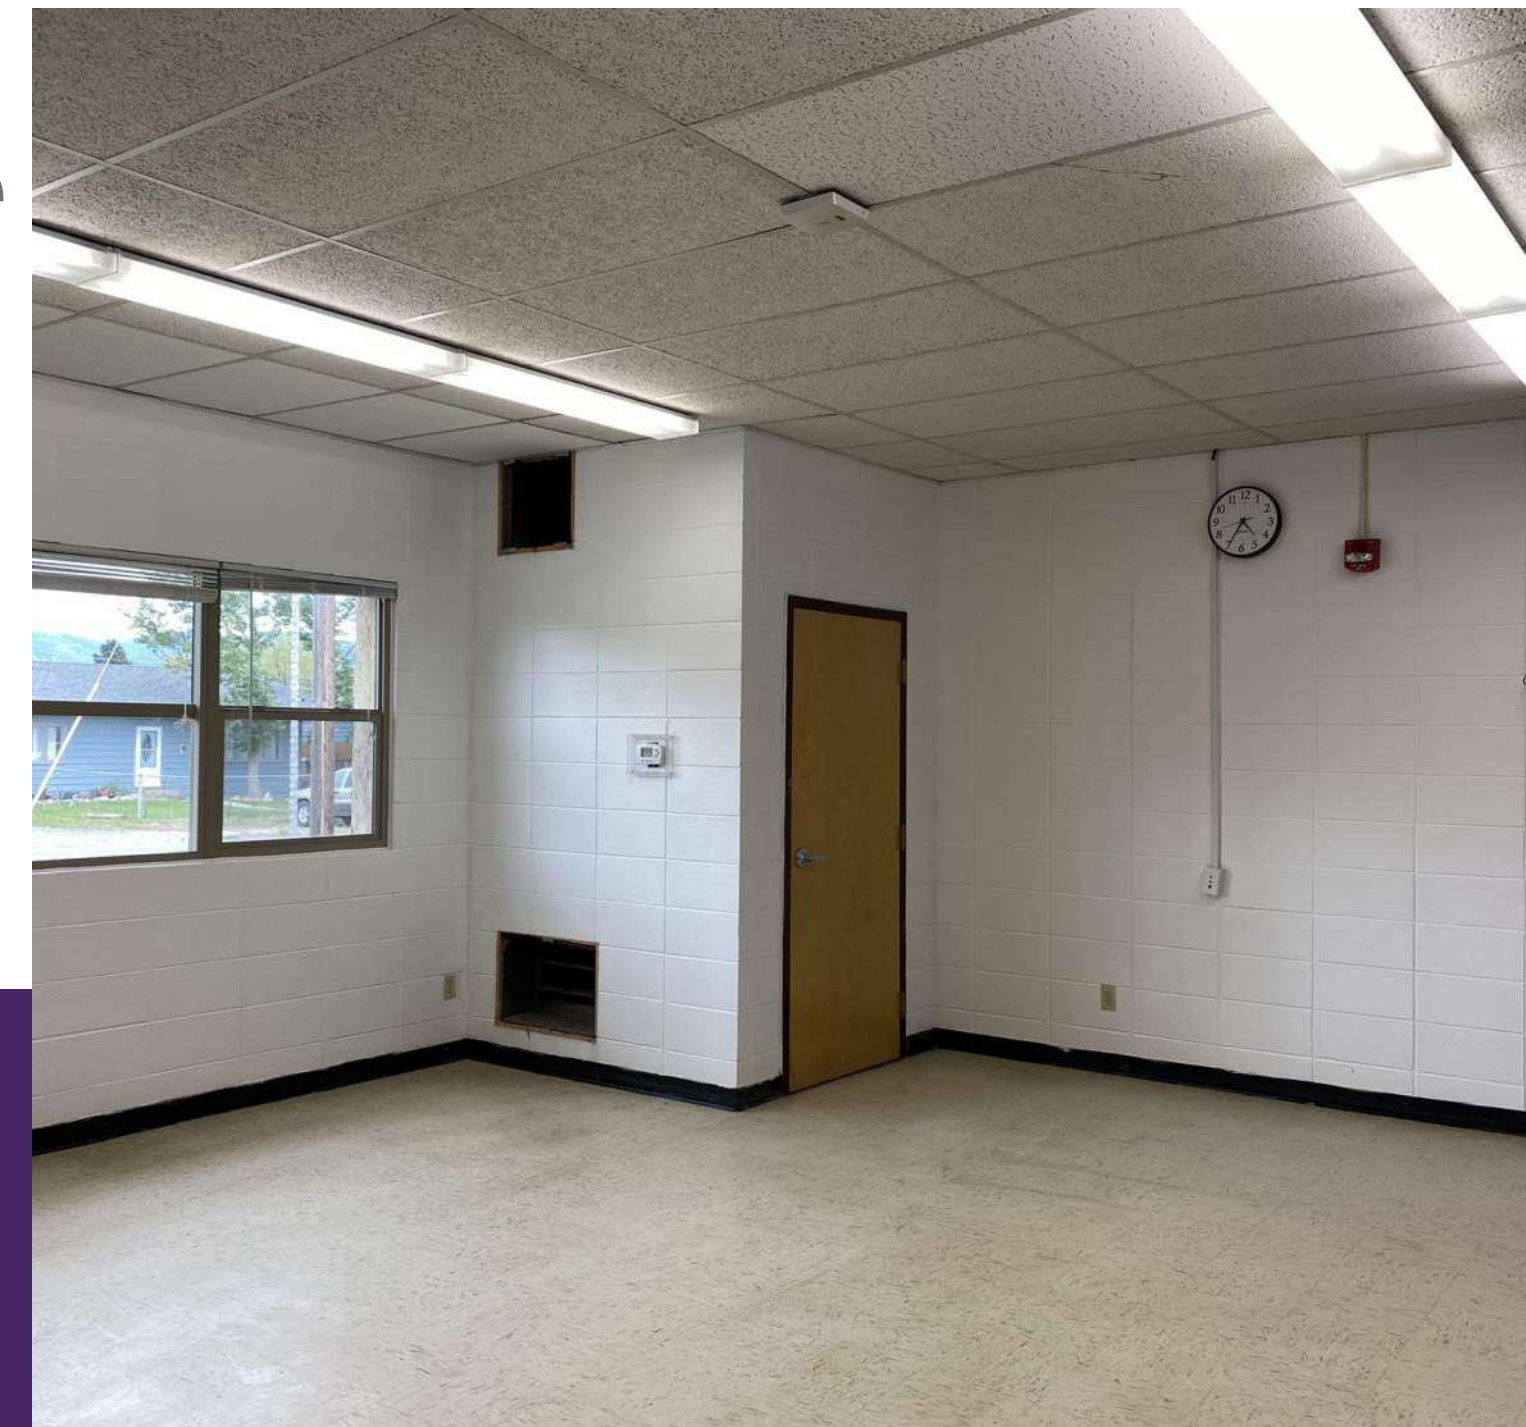
# CLASSROOMS | SPECIAL EDUCATION

- Special Ed is not equipped with the spaces many modern schools have, including: separation spaces, calming rooms, life skills, private bathroom
- Privacy and crowding were heavily cited concerns
- Need for dedicated sensory room
- Better ventilation needed
- Dedicated restroom needed
- Life Skills opportunities would be a benefit (kitchenette and washer/dryer)
- Overall space is too small for student population.
  - Current room is ~400sf. Helena Elementaries have 1500-2000sf, EHHS has 1650sf = 80-110sf/student.

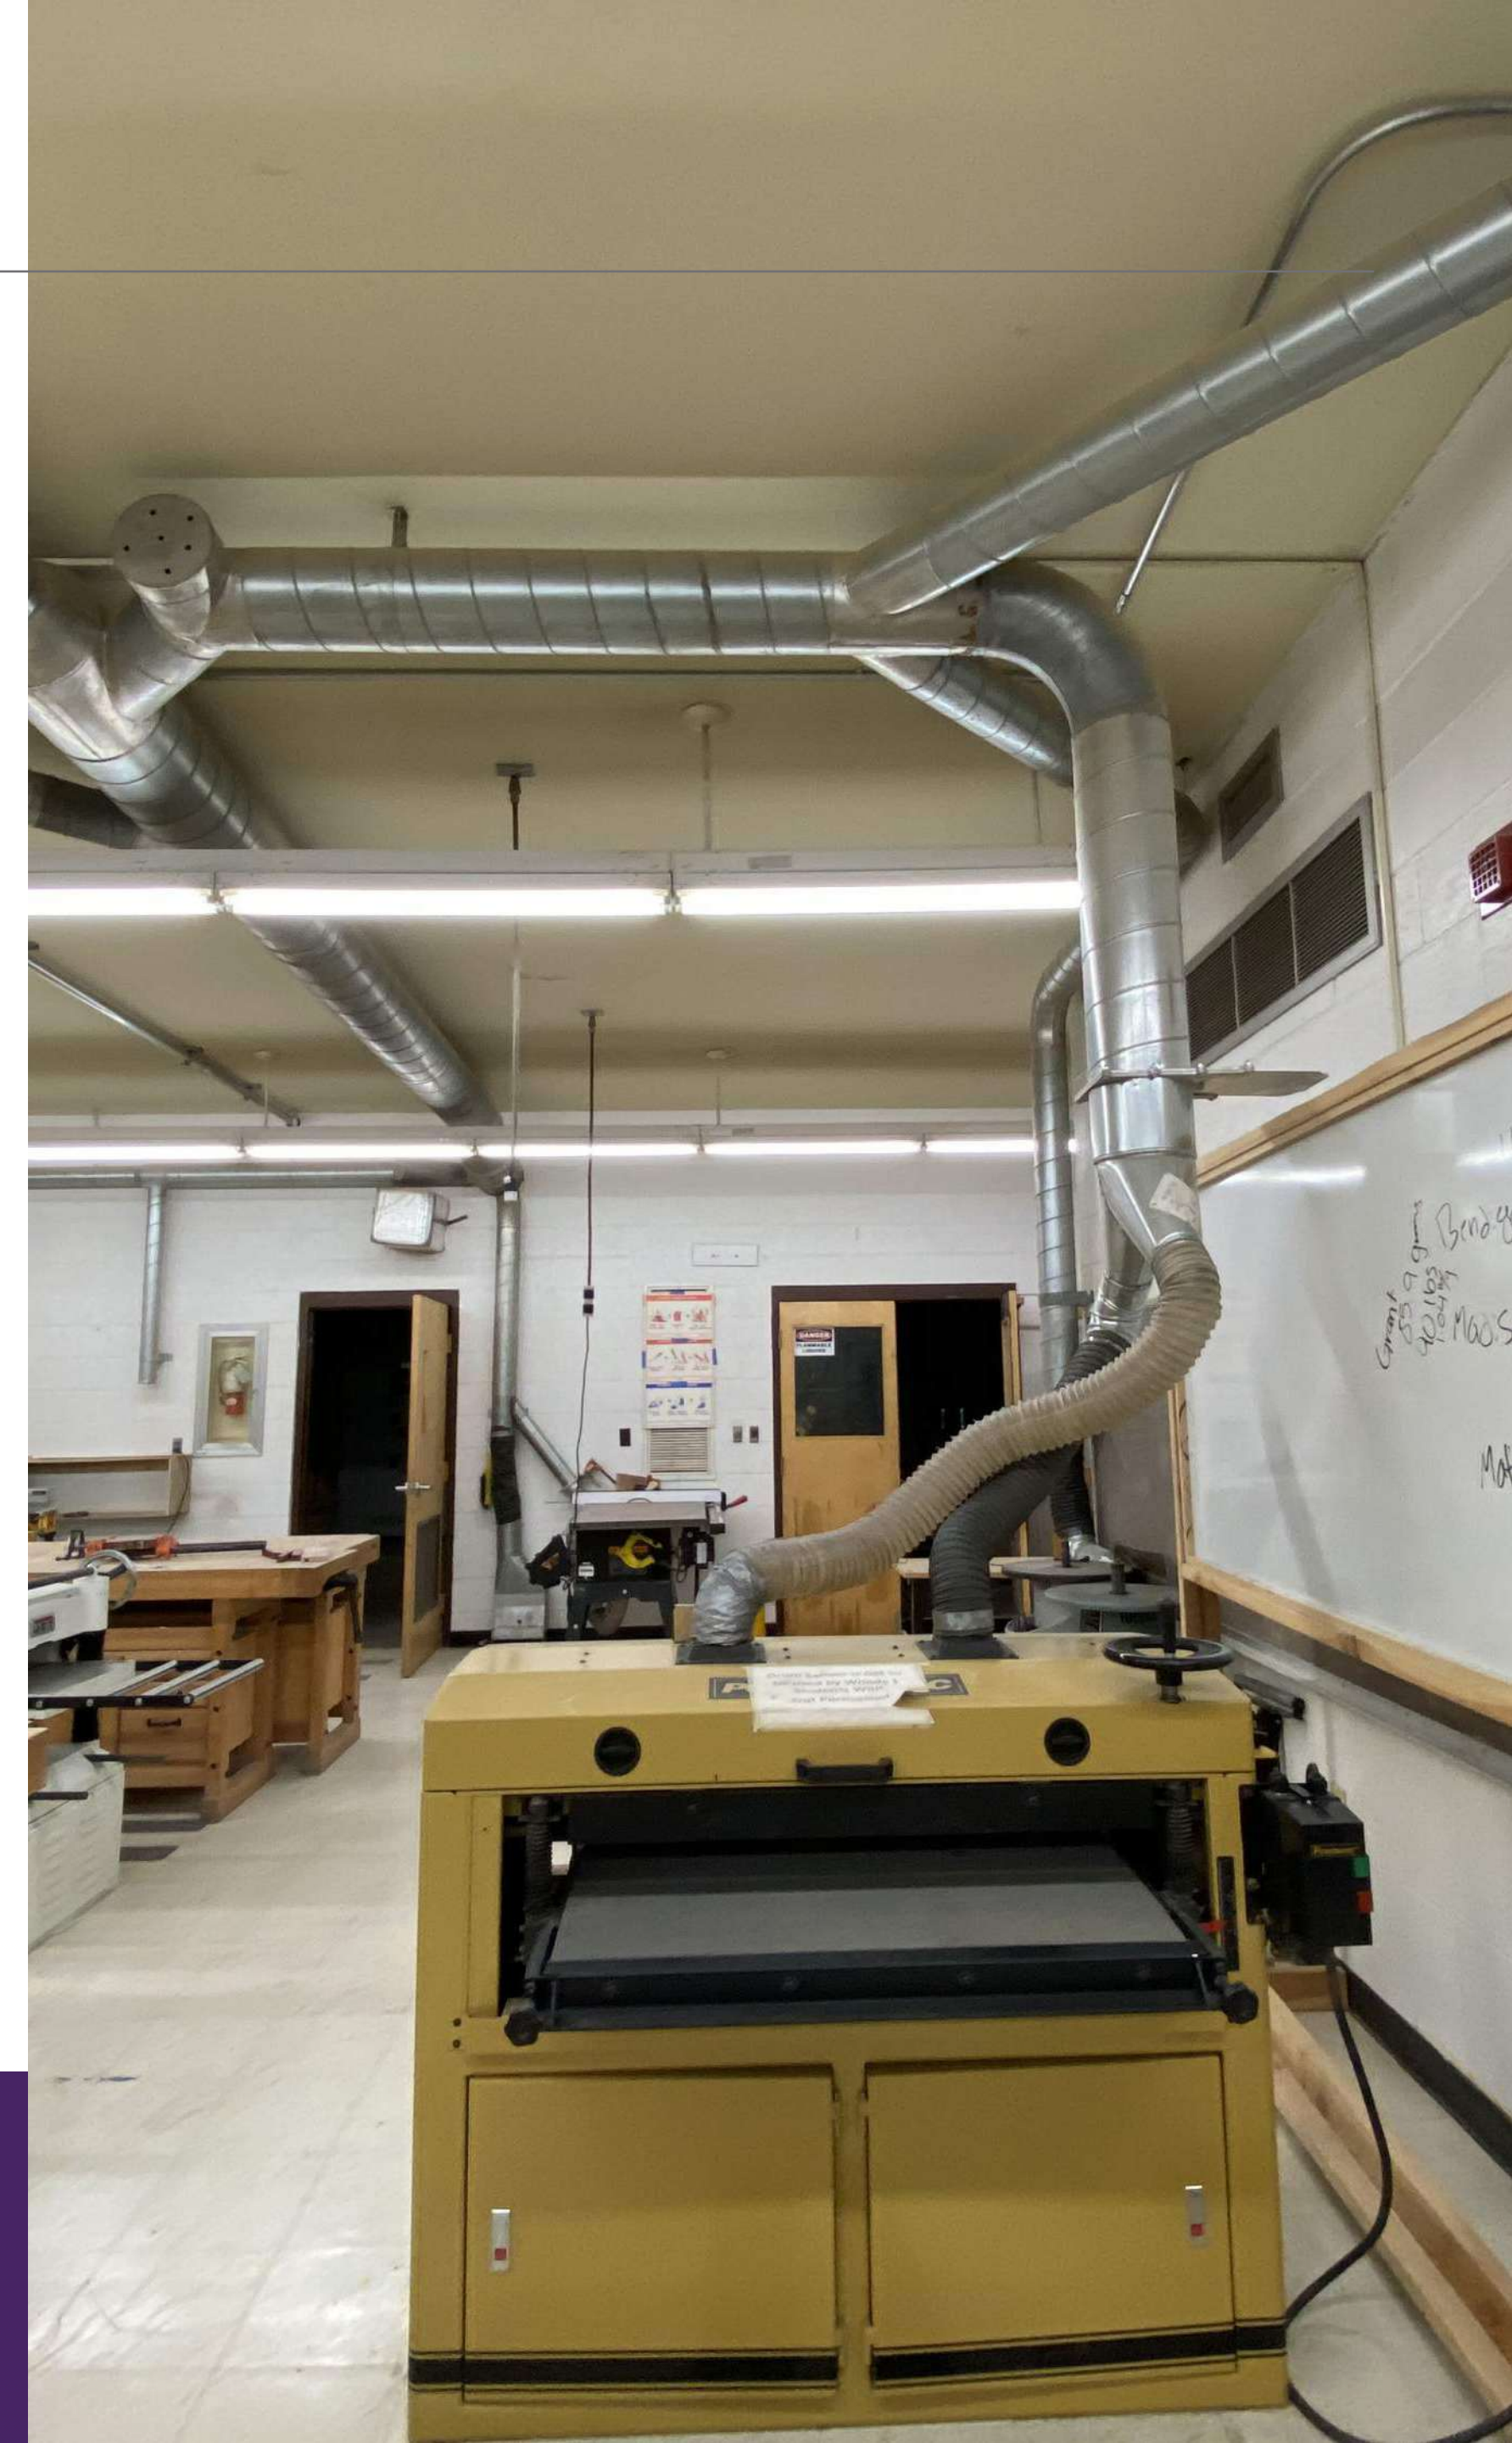
# CAREER & TECHNICAL EDUCATION (CTE)

- Location and spaces currently serving their uses well, have good equipment and overall a good space for the programs overall.
- Floor finish can be hazardous in work conditions with sawdust present
- Light control for video presentations is needed
- Storage / spray room combination causes overspray issues
- Size of spaces appropriate for current class numbers
- Small Engines: ventilation of fuel vapors concern for danger of fire or explosion near welding

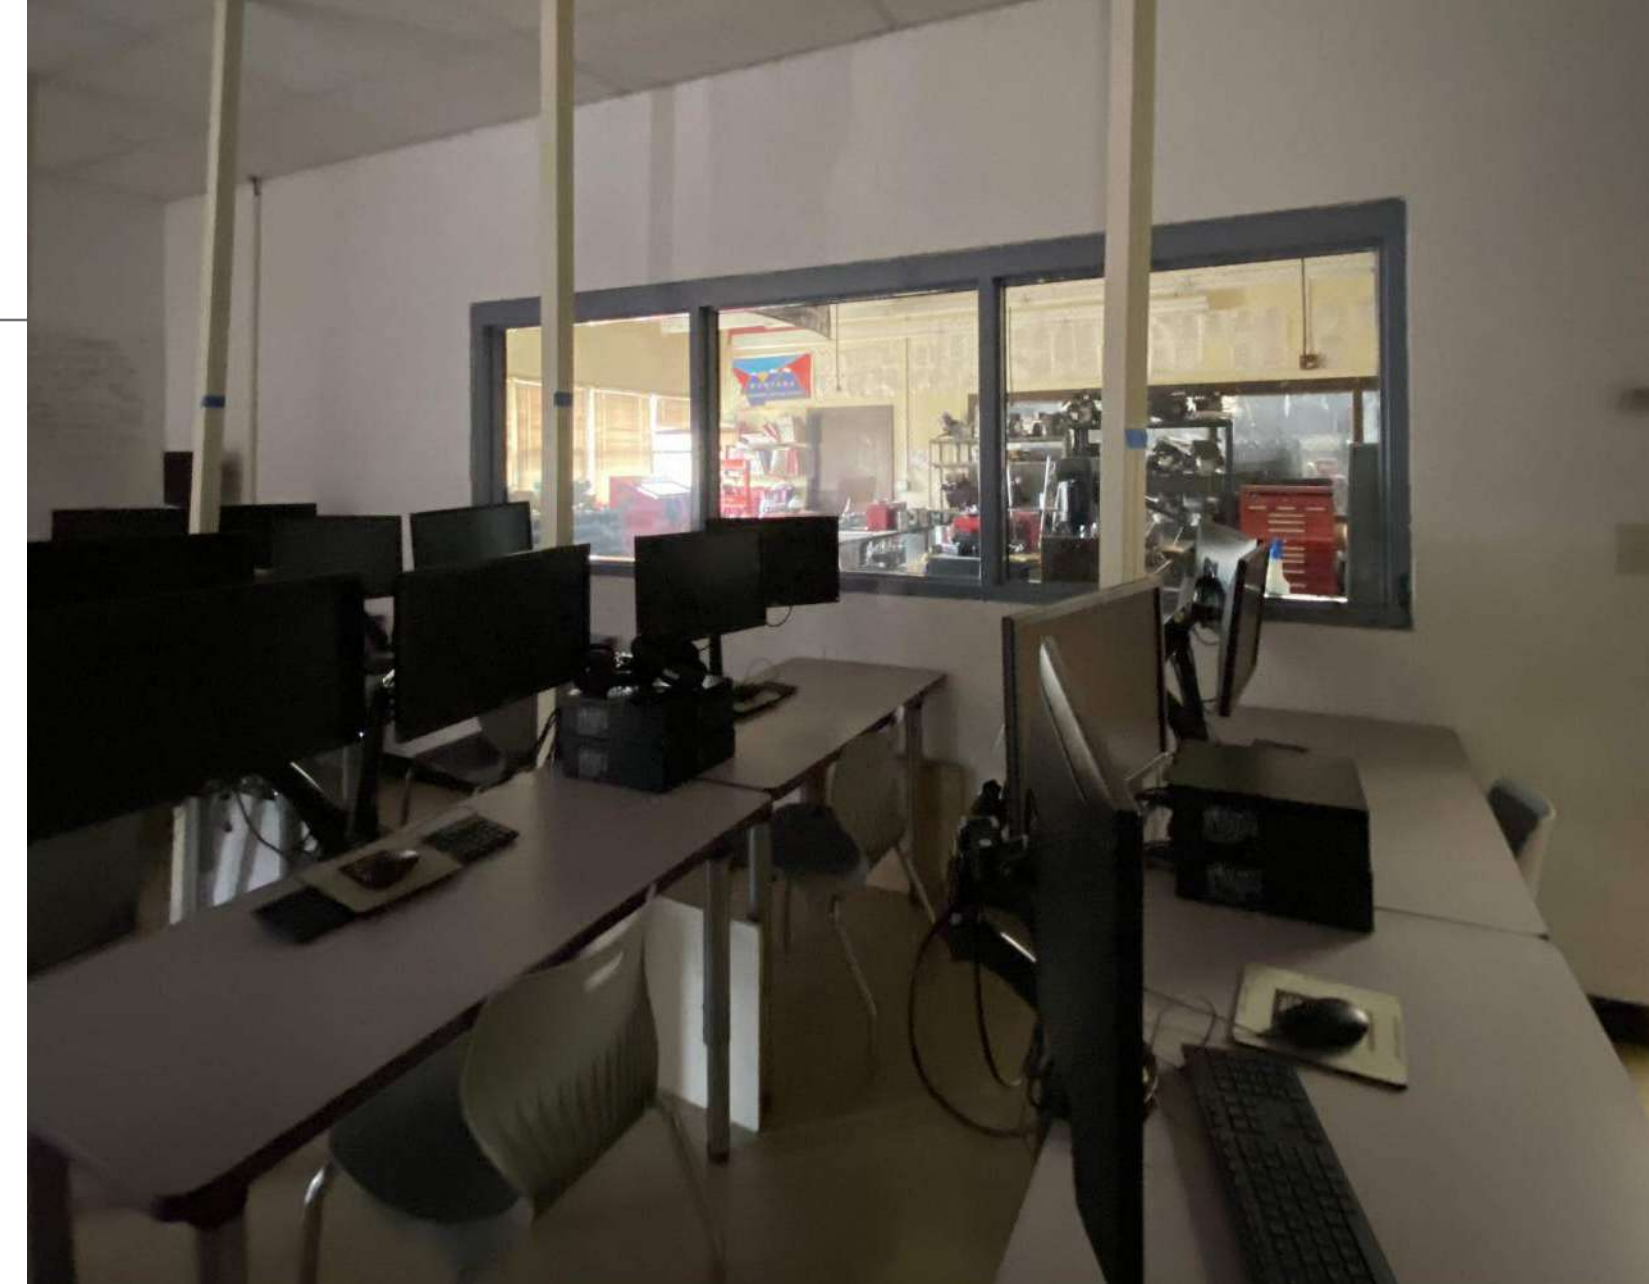
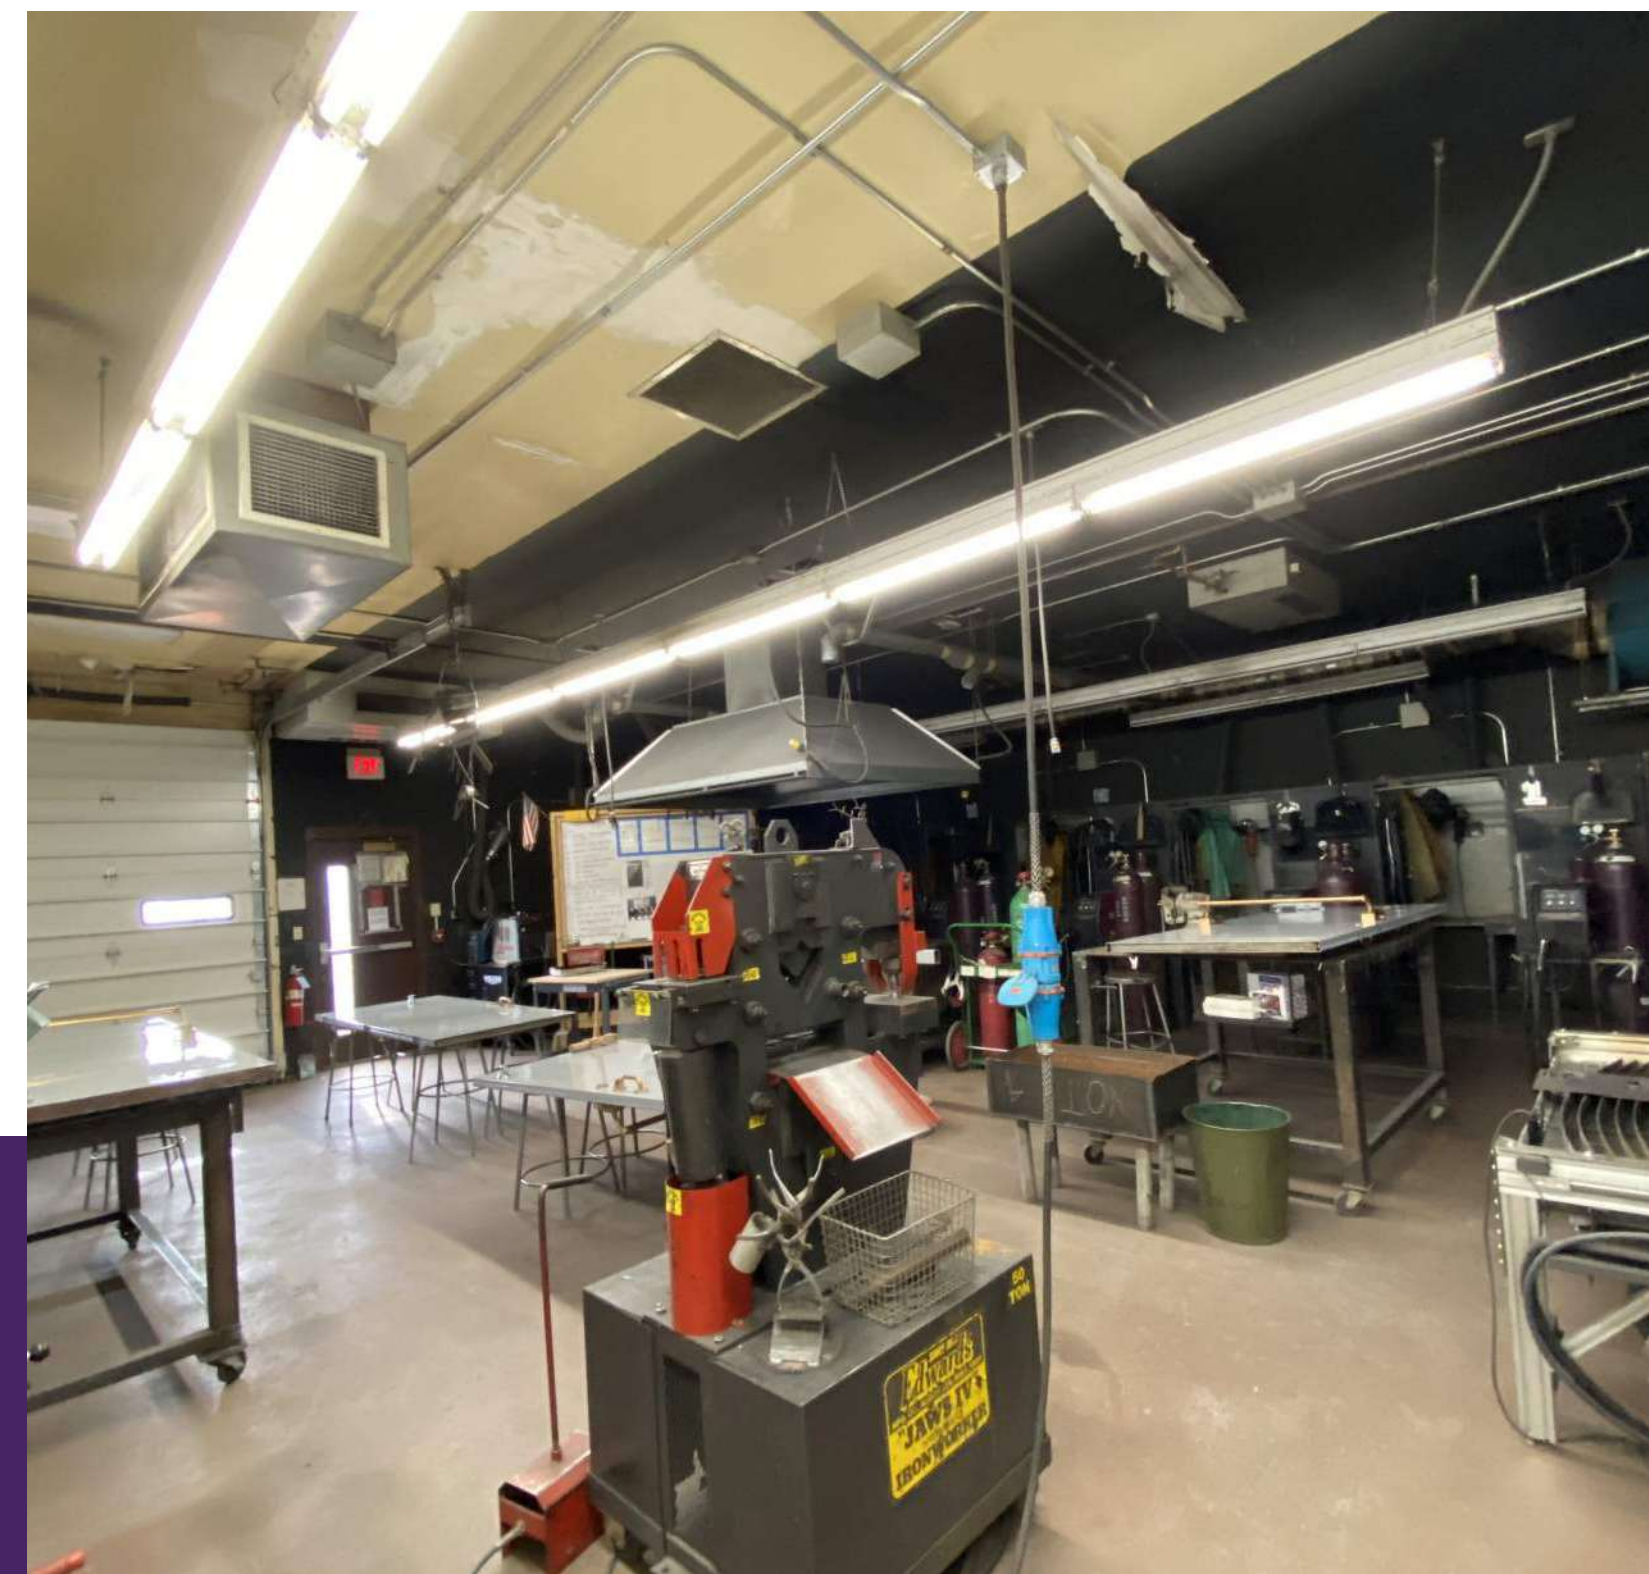
# CAREER & TECHNICAL EDUCATION (CTE)

- Welding: room limits arrangements, # of welding booths is not enough, fabrication capabilities limited
- CAD Lab: good equipment/technology, access and circulation due to floor plan is difficult and can be busy
- Overall
  - Electrical outlets severely limited
  - Lighting dated and inefficient
  - Storage is undersized
  - Number of breakers in shop area makes it difficult to track down a failure

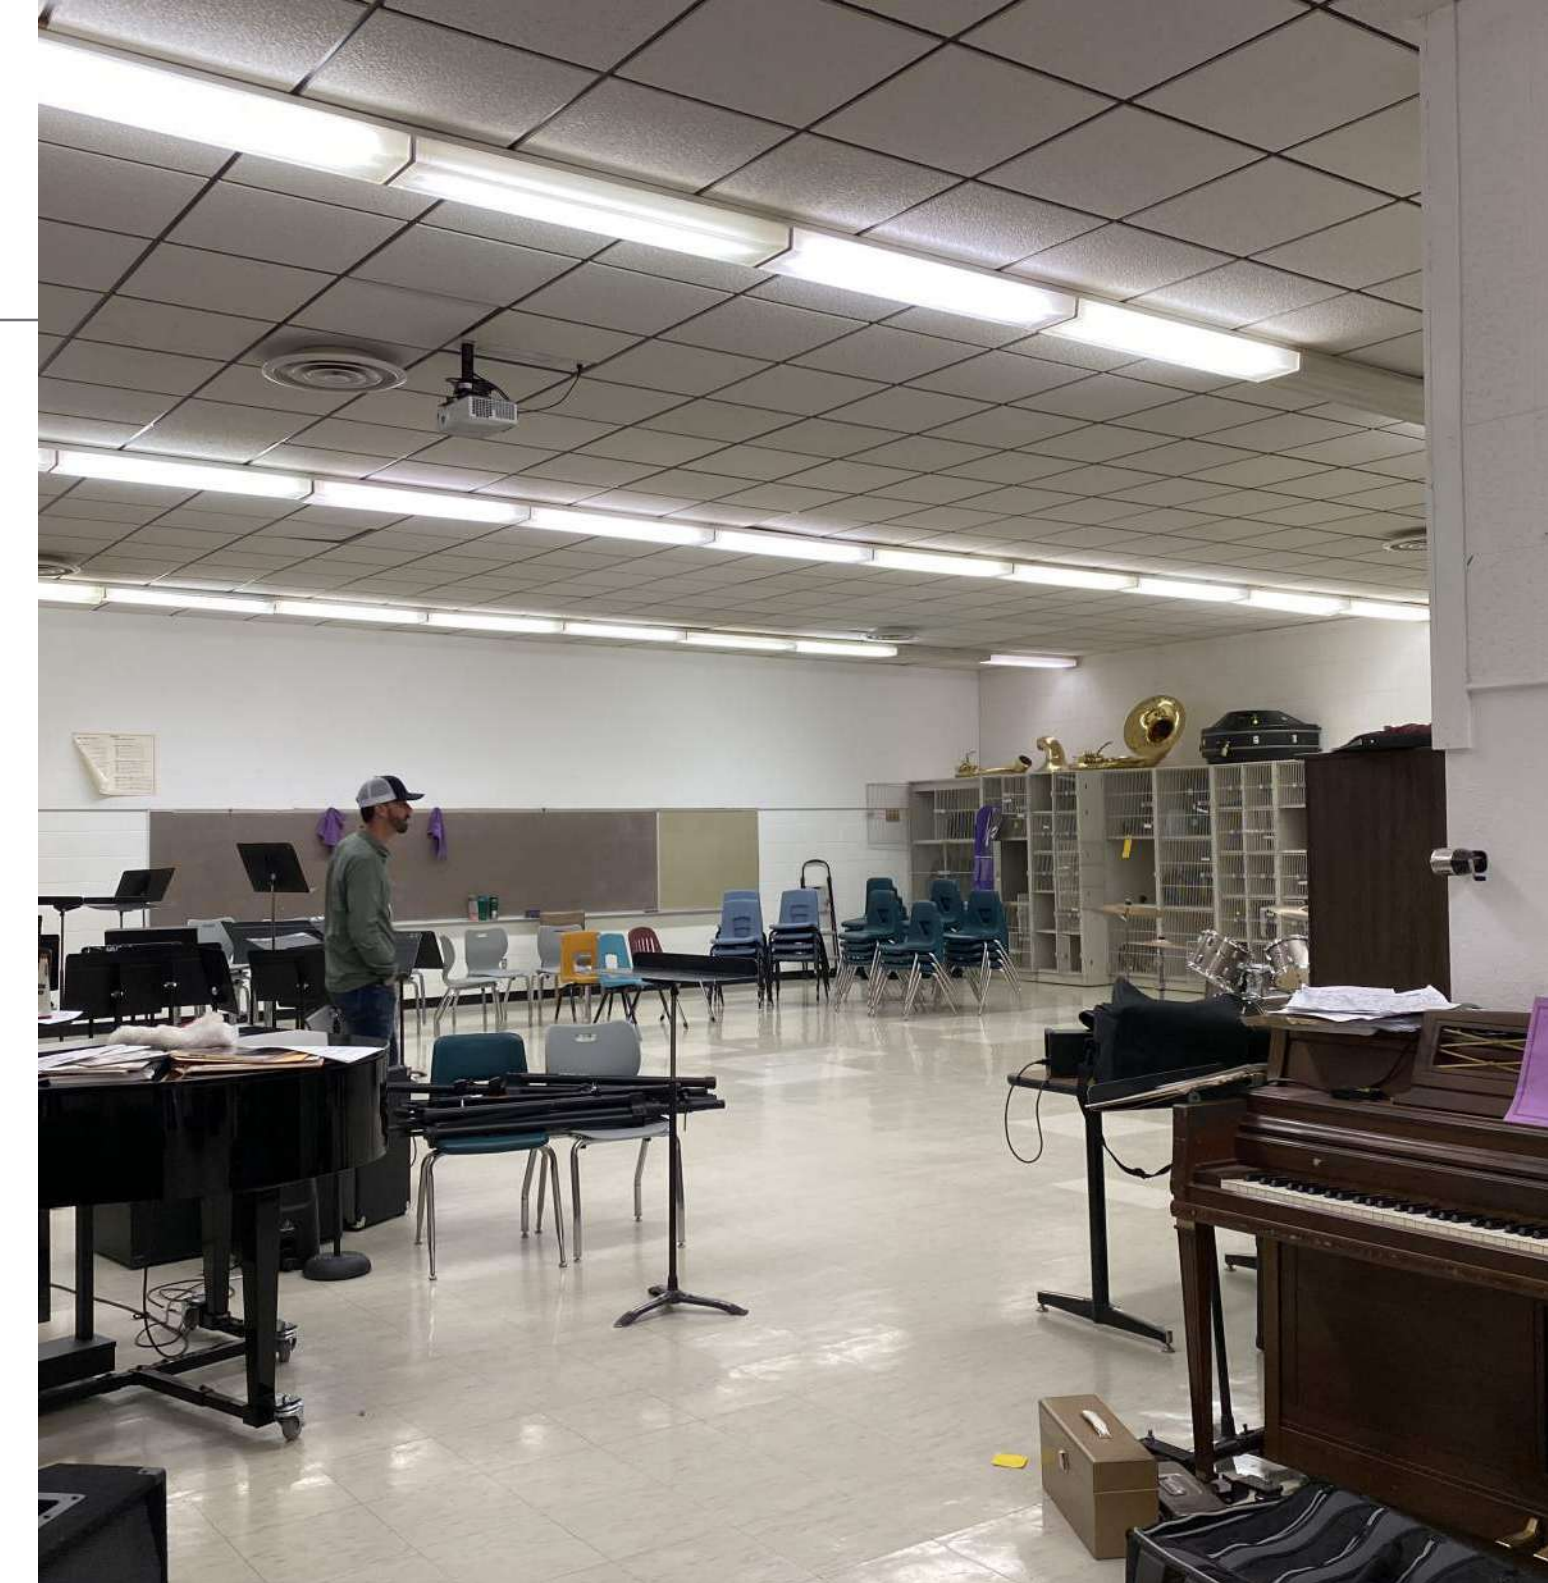
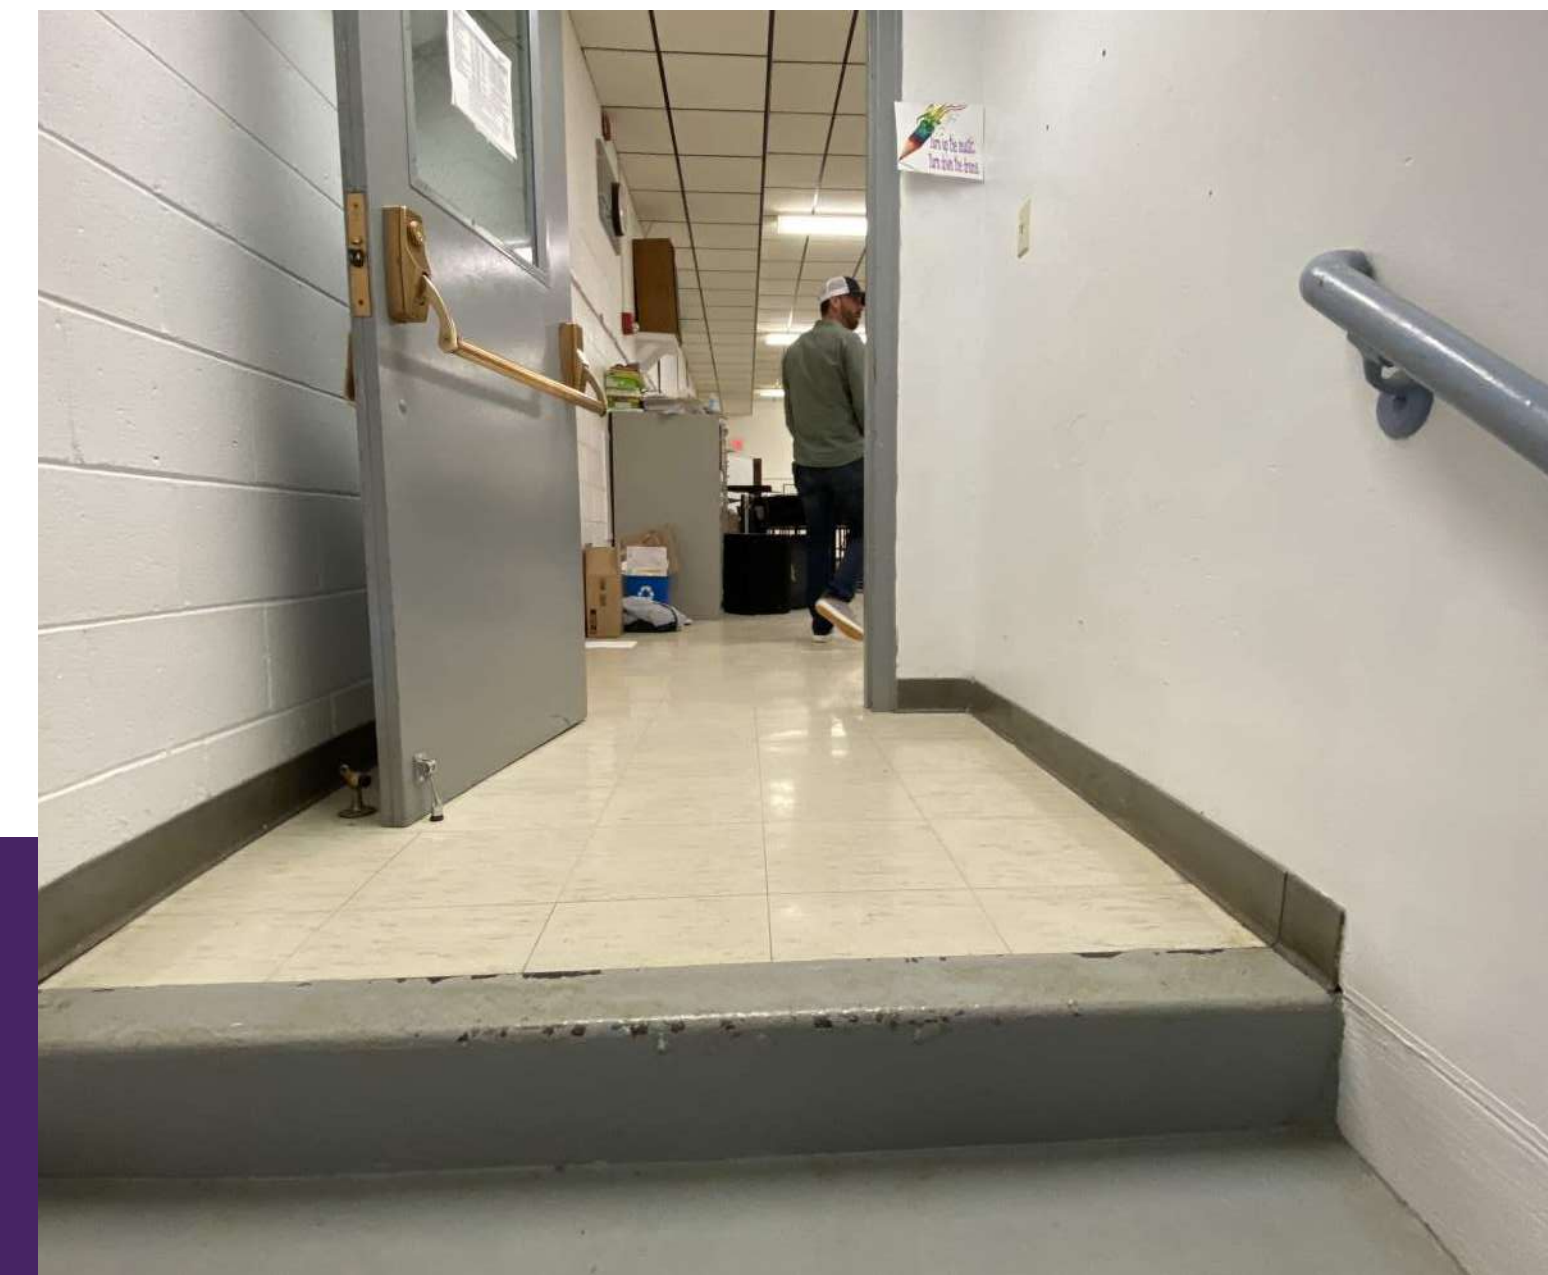
# MUSIC / BAND

- 2700 sf total with adequate space for seating, storage, chairs and office space
- Acoustical treatment is adequate but could use some improvements if sound quality dictated
- Room/s not ADA accessible

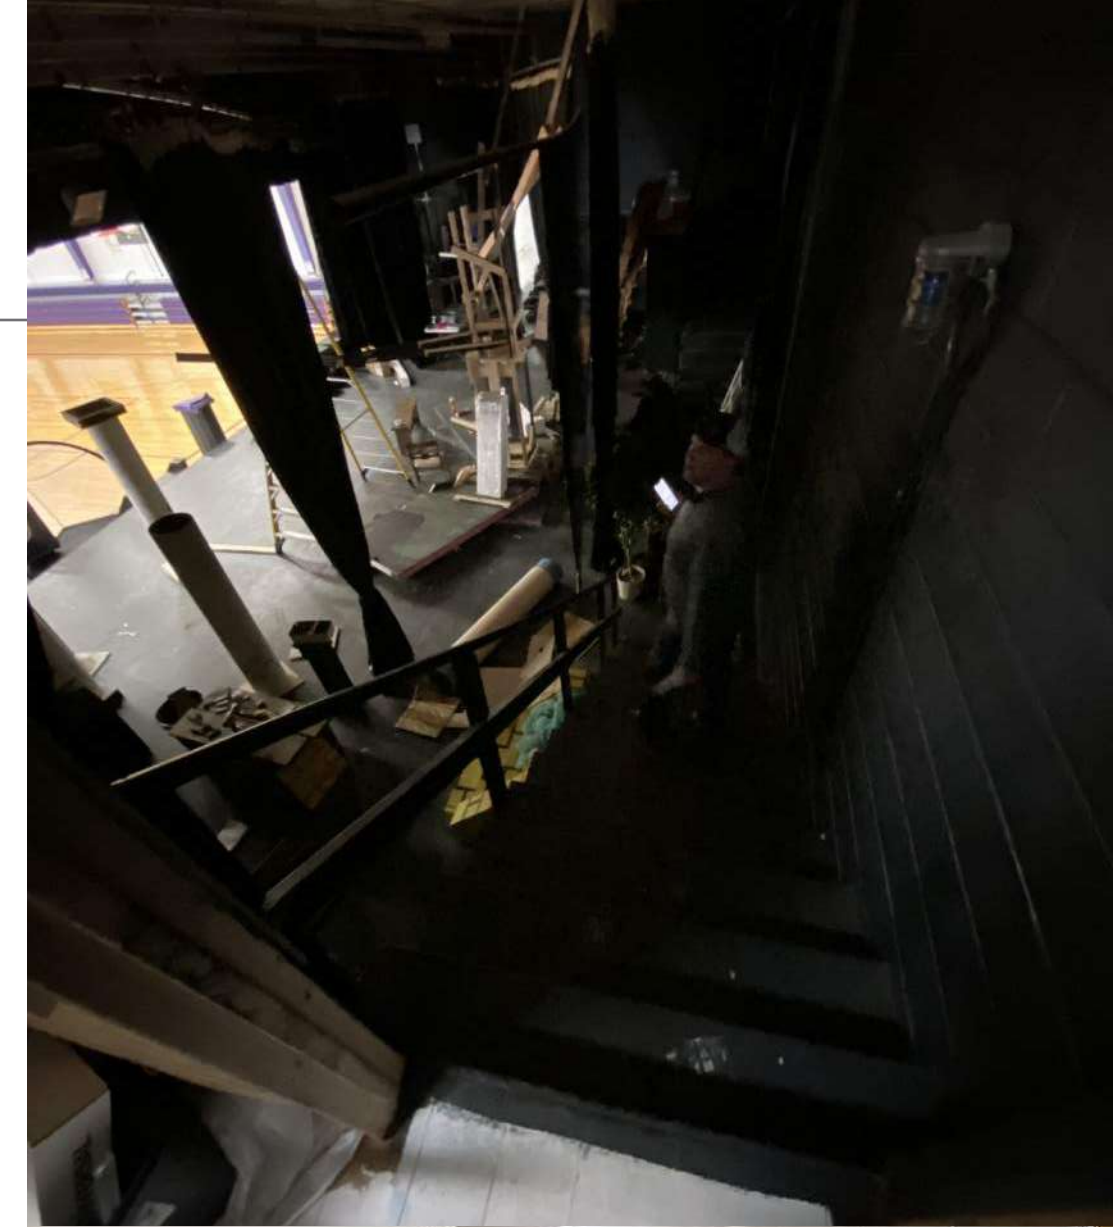
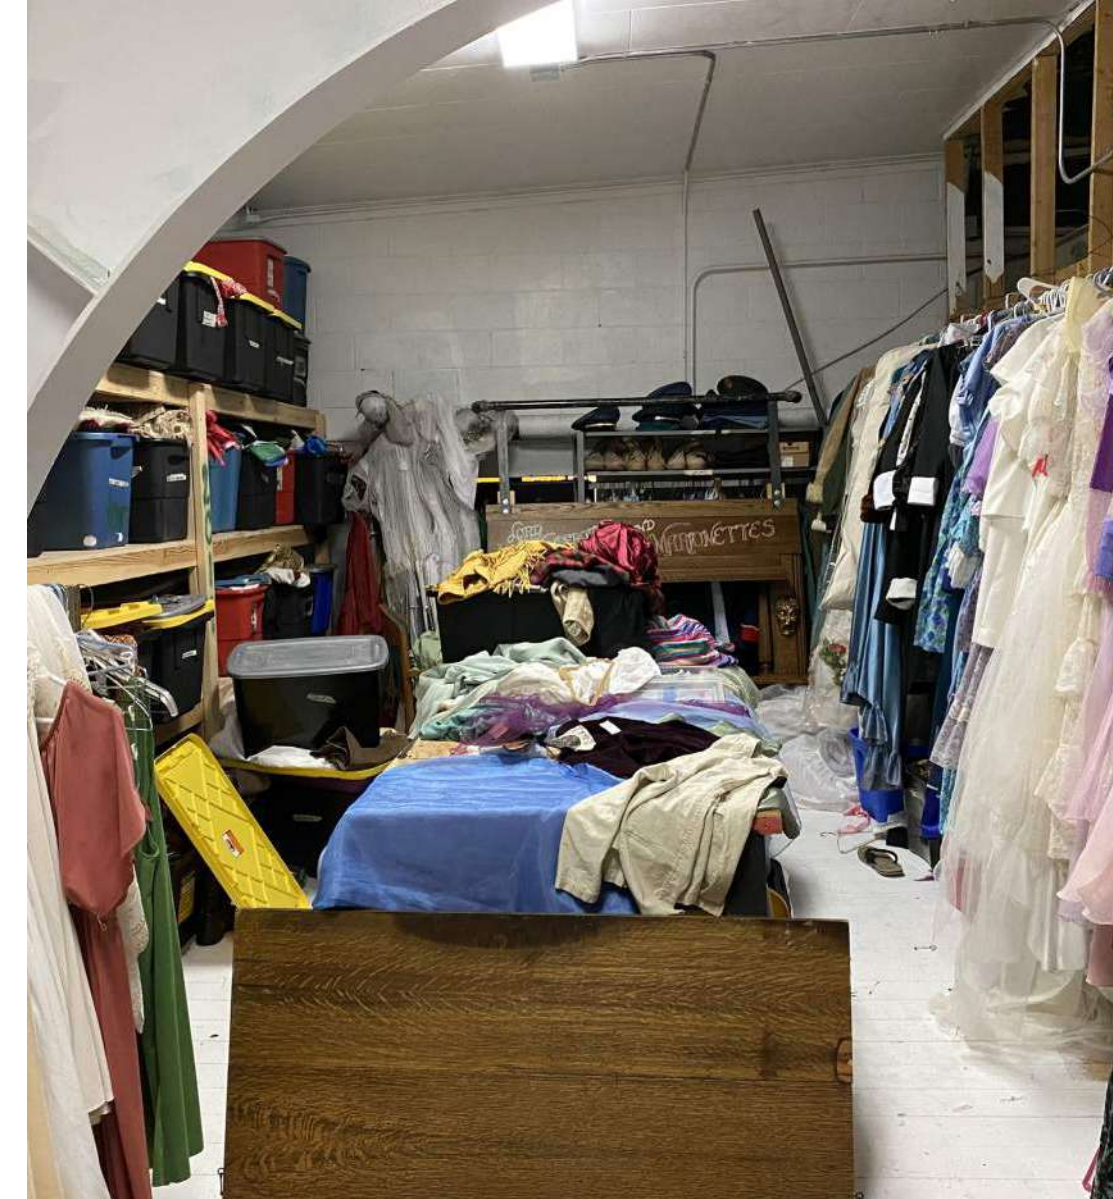
# DRAMA / THEATER

- Popular and successful program at school and within community
- Currently using stage in the original existing South Gym
- Gym/Stage area has reported acoustic challenges from the hard surfaces in the gym
- Space is limited on stage and in storage areas
- Wooden stairs to storage areas are aging and limit accessibility
- Access to construction materials for set design is limited and poses challenges
- Sound & lighting need upgrades
- Theater classes/rehearsals limit usability of gym purposes or athletic practices
