# BUILDING CONDITION REPORT

**JEFFERSON HIGH  
SCHOOL DISTRICT #1**  
July 21, 2020

# BUILDING CONDITION REPORT SUMMARY

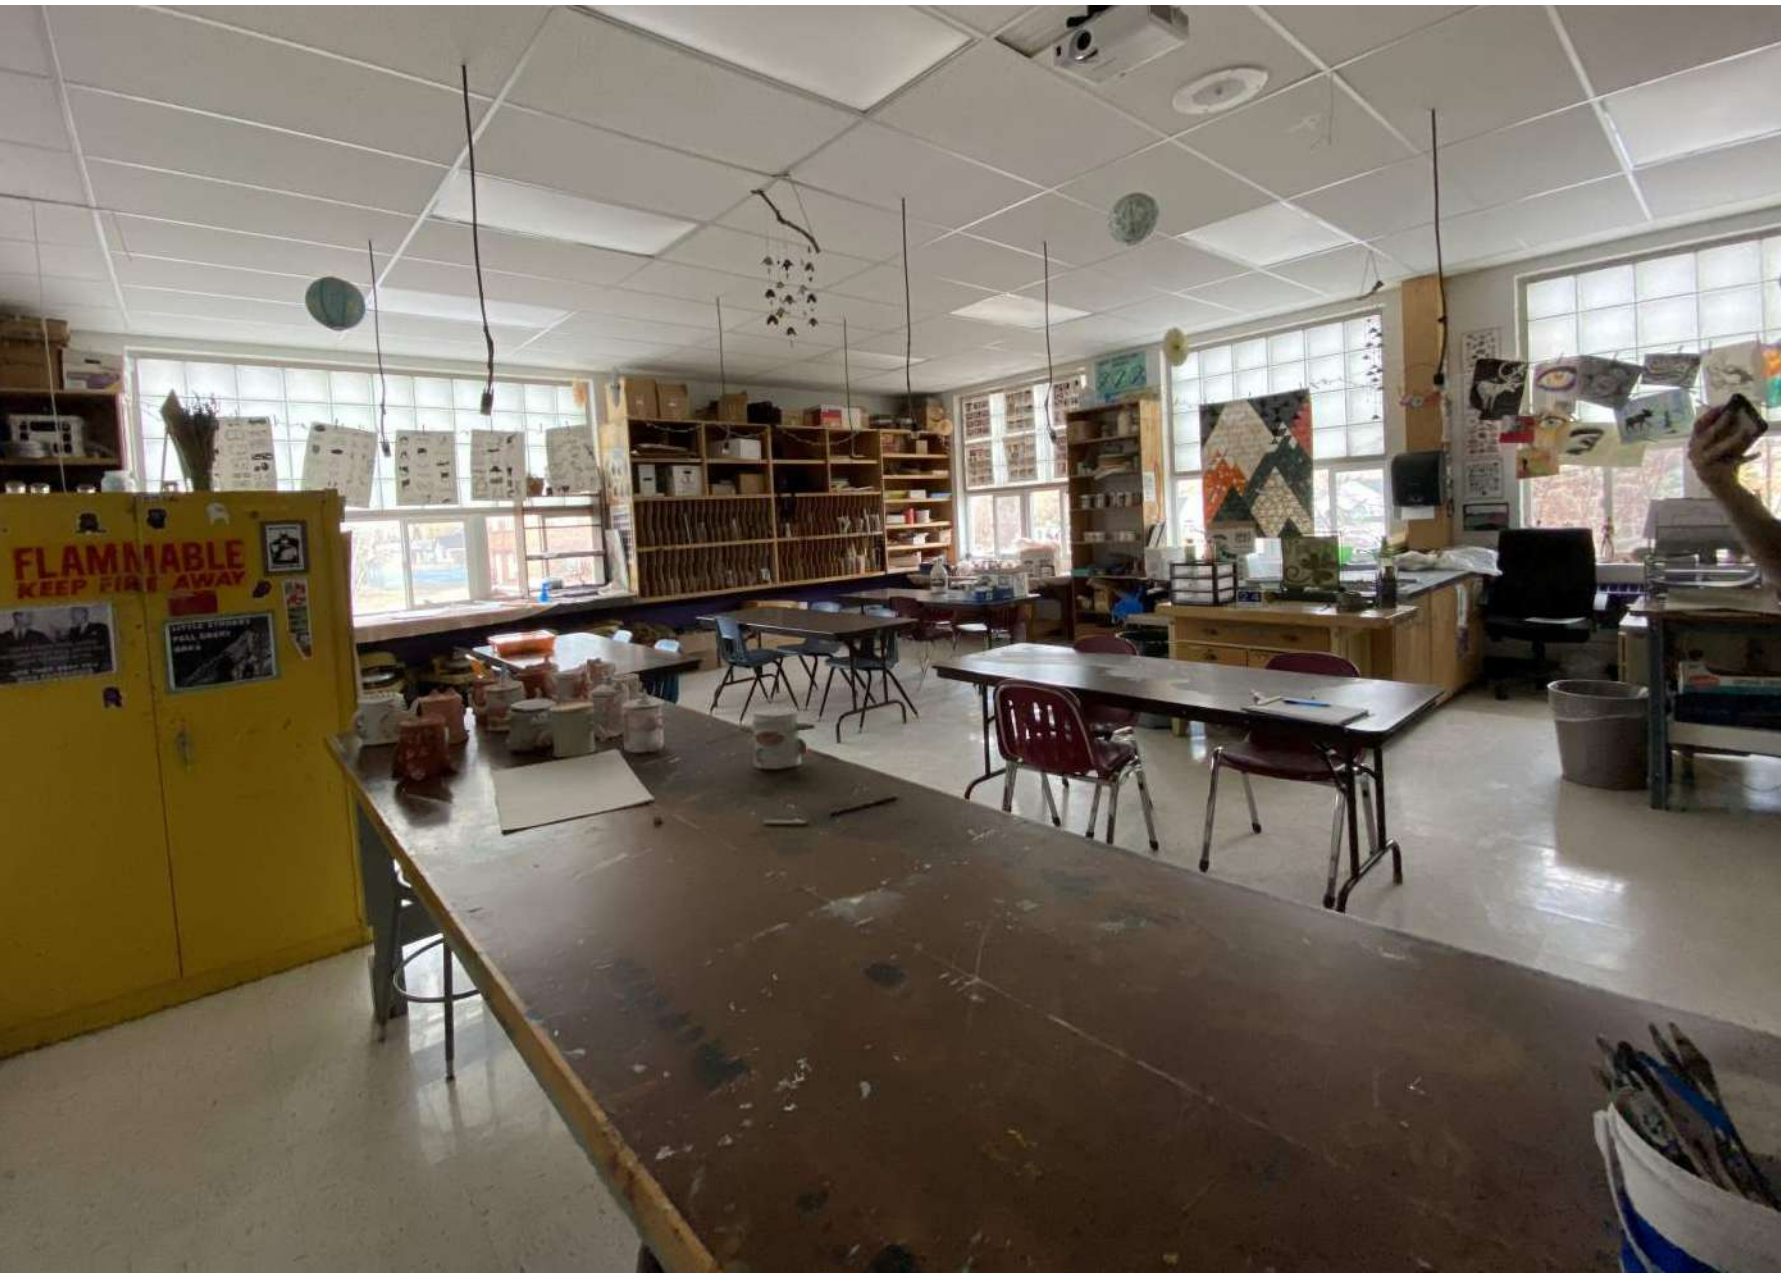
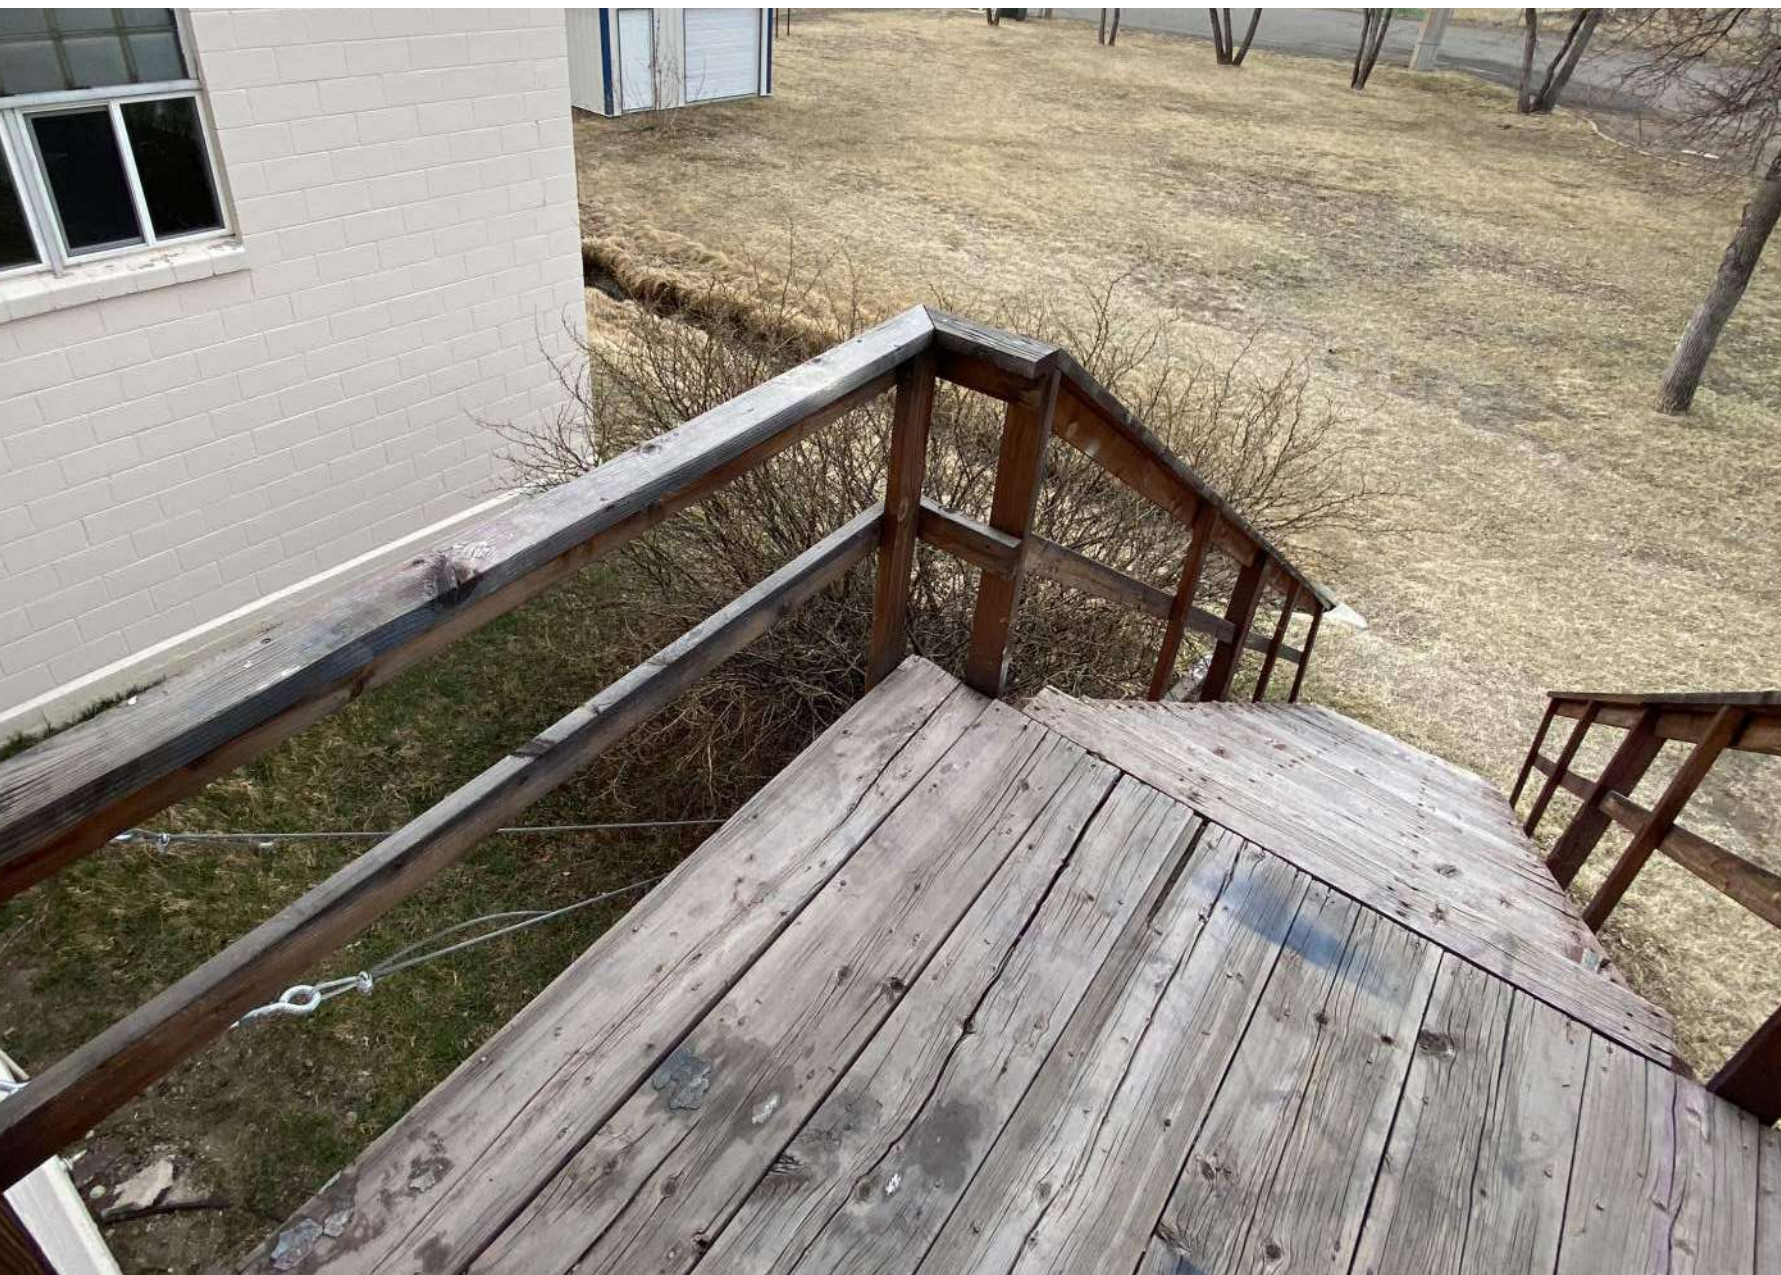
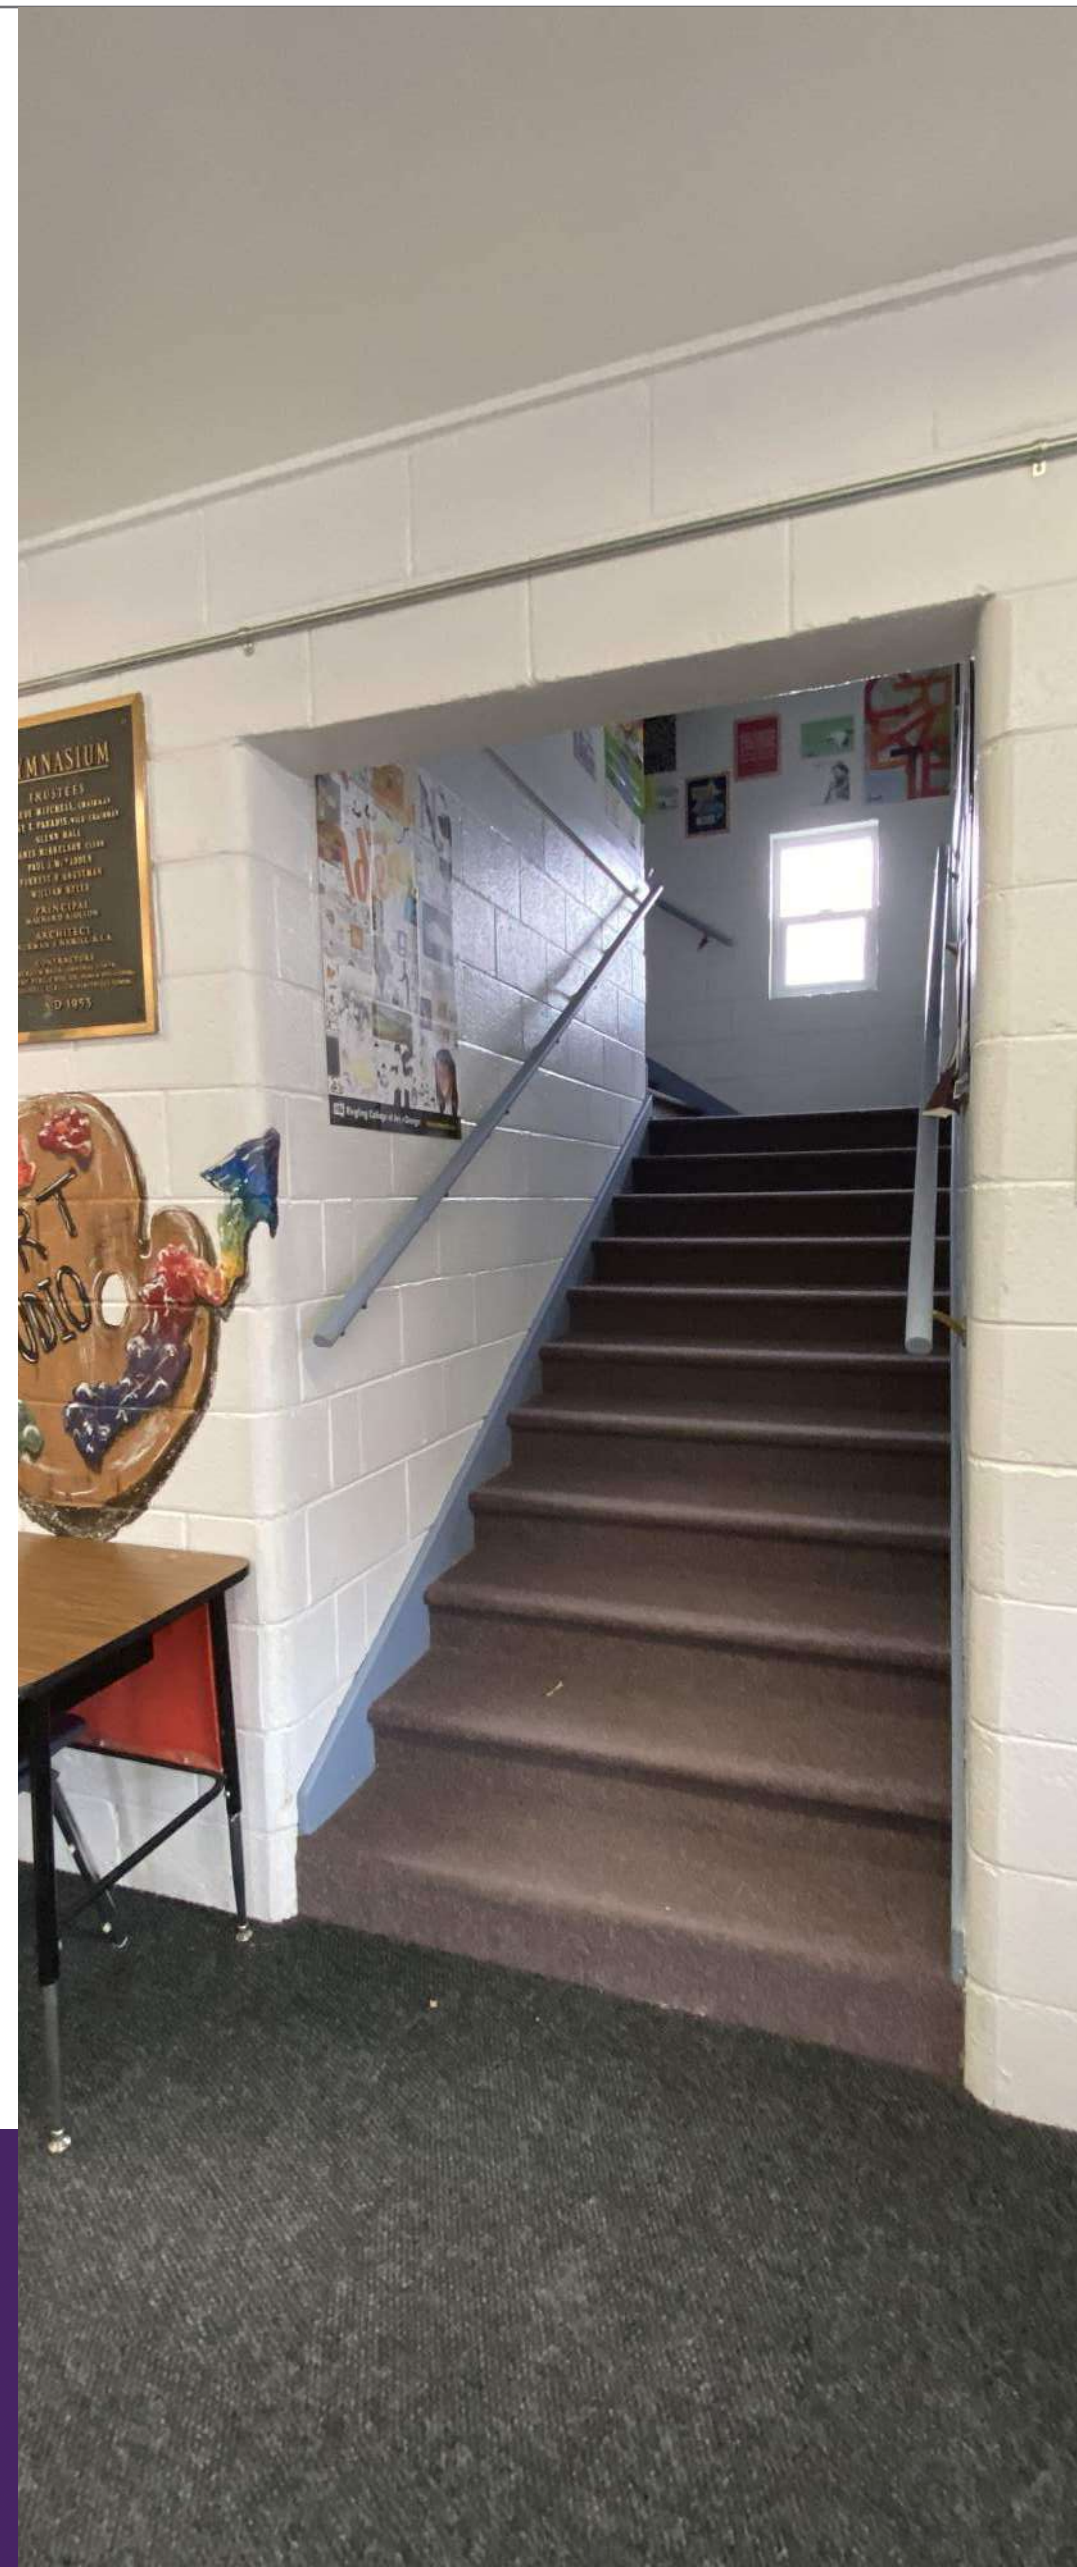
# ART ROOM

- Not ADA accessible
- Ample lighting
- Acoustical ceiling and recessed lighting is in new/good condition
- Other finishes also good
- Has suspended power outlets, which is likely adequate compared to power outlets in the rest of the building
- Exterior exit stairs aging

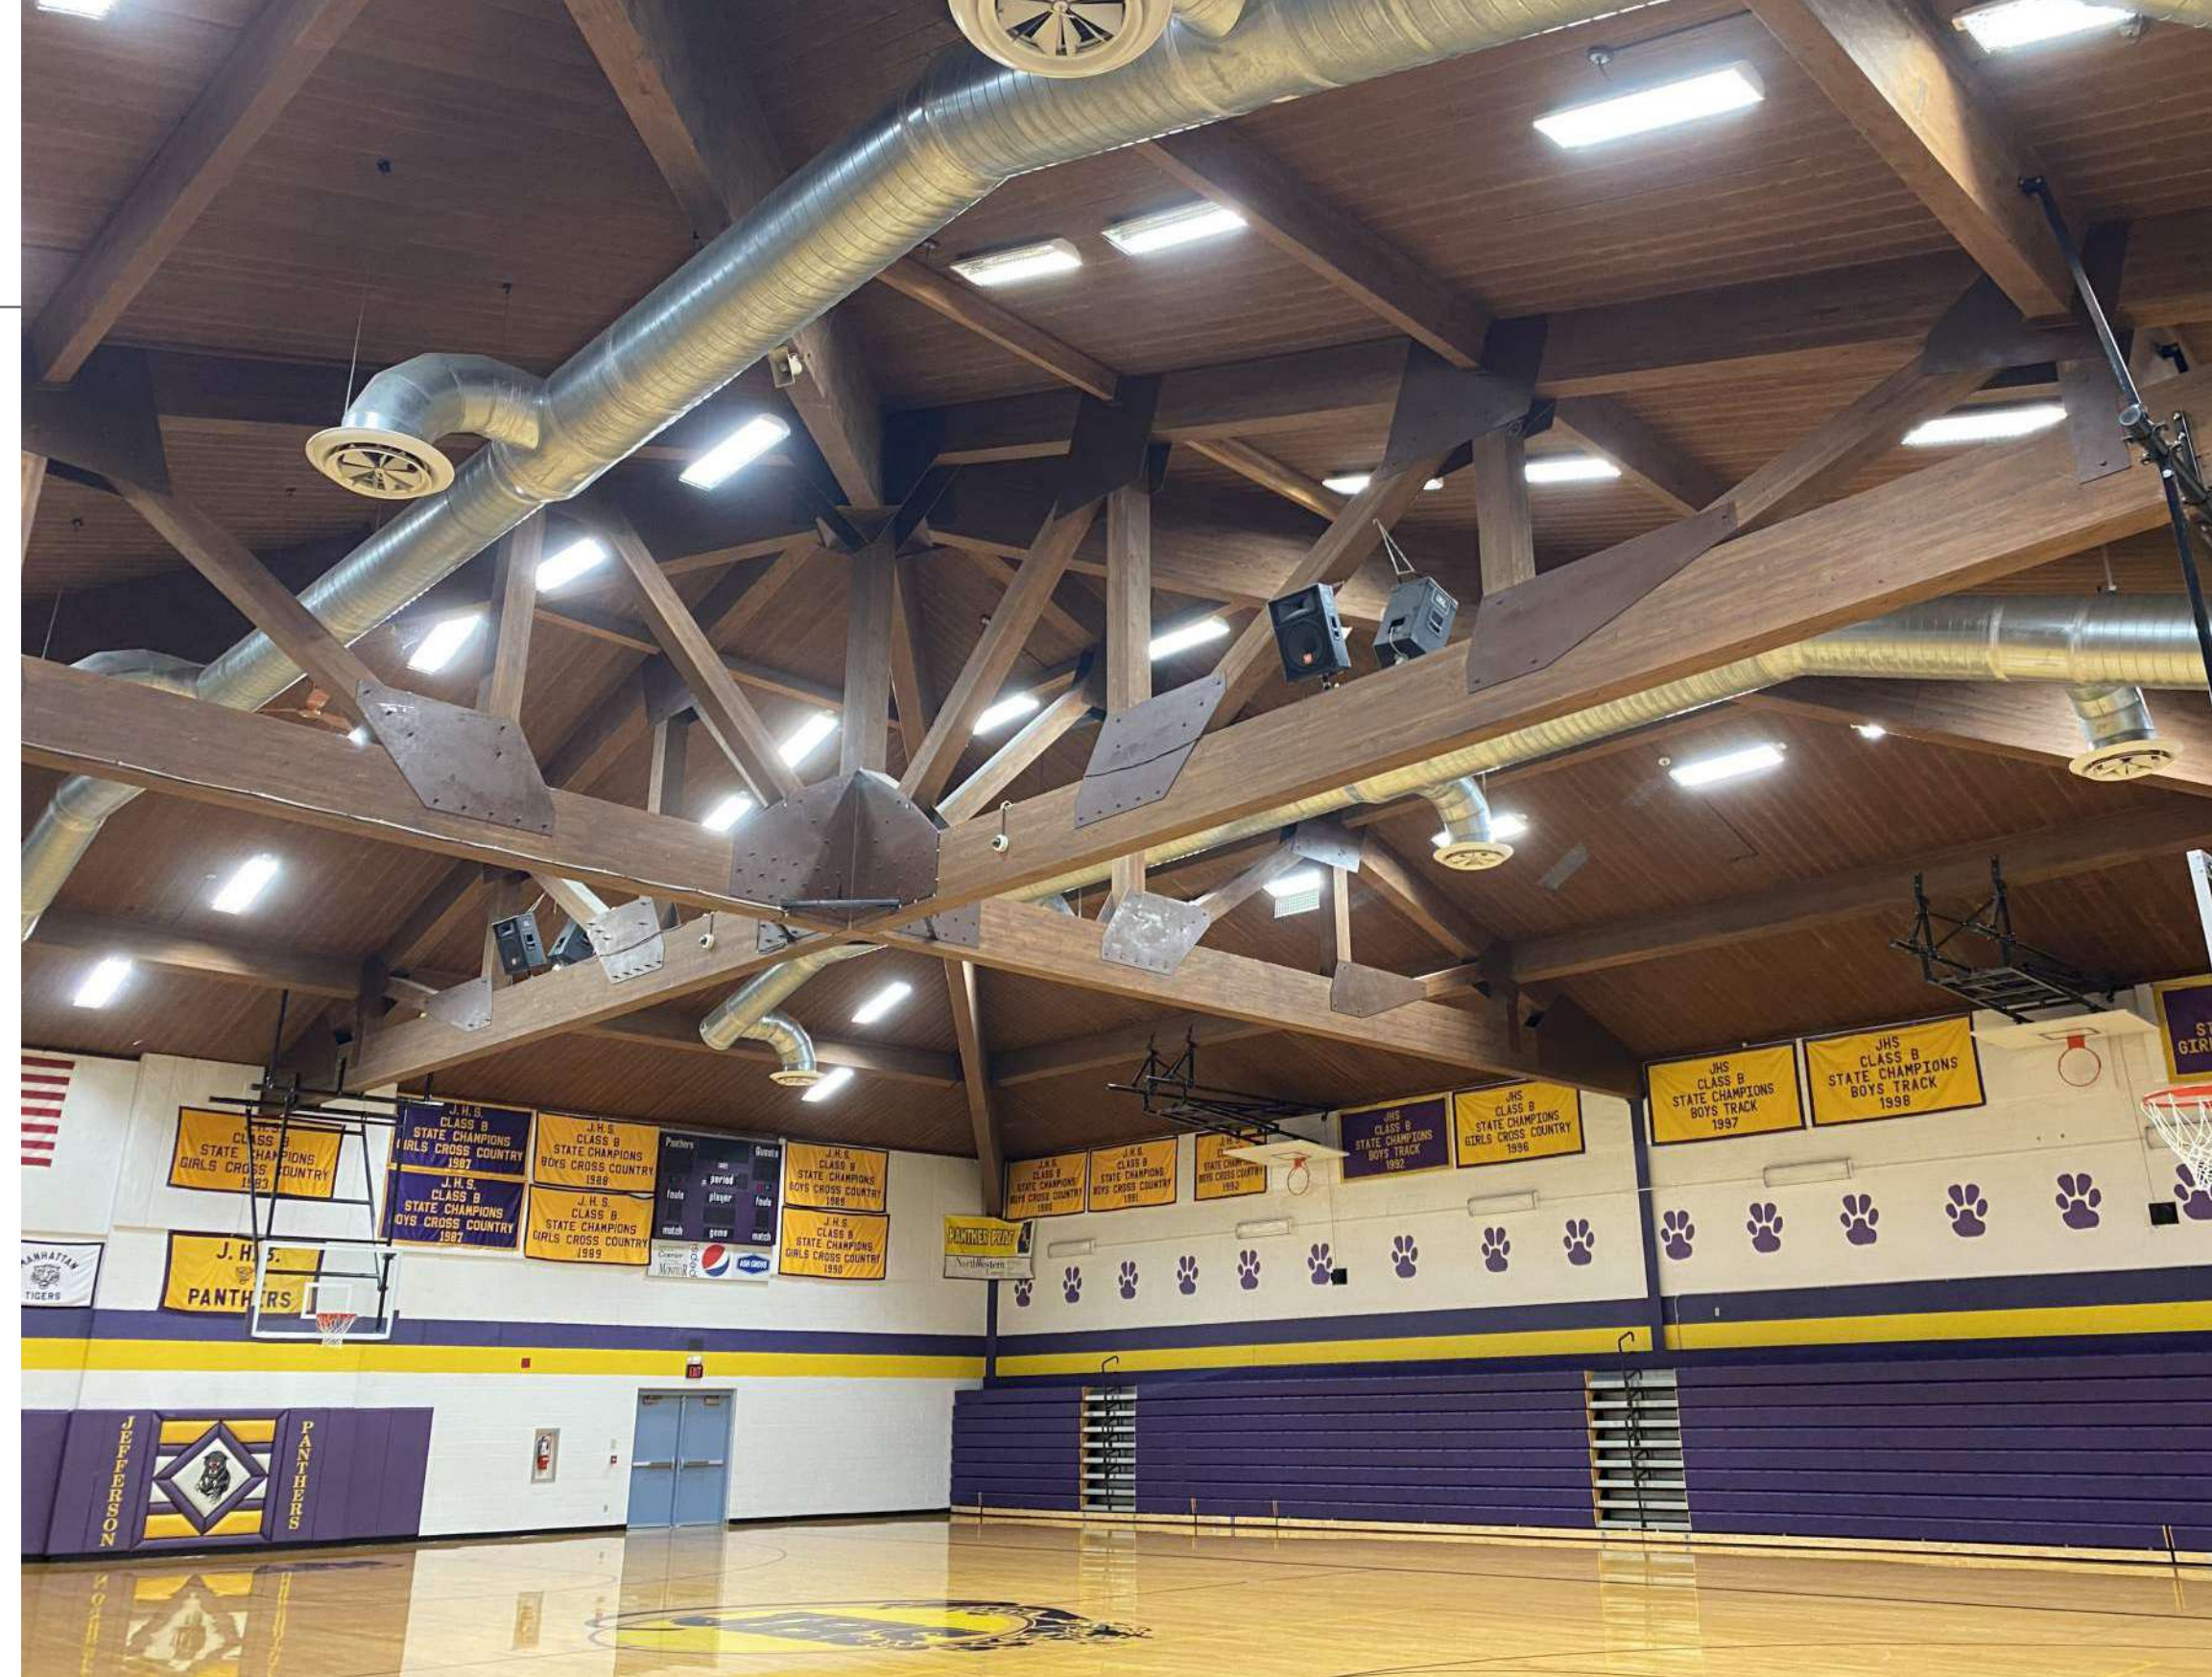
# MAIN GYMNASIUM

- Notable and beautiful asset to JHS; newest addition
- Accommodates full size and practice courts with bleacher system
- Exiting and access is good, as well as finishes, paint and lighting
- New gym reserved for athletics competitions, and older gym used for practice or smaller sports which causes challenges with scheduling due to demand from theater/drama in S. Gym area

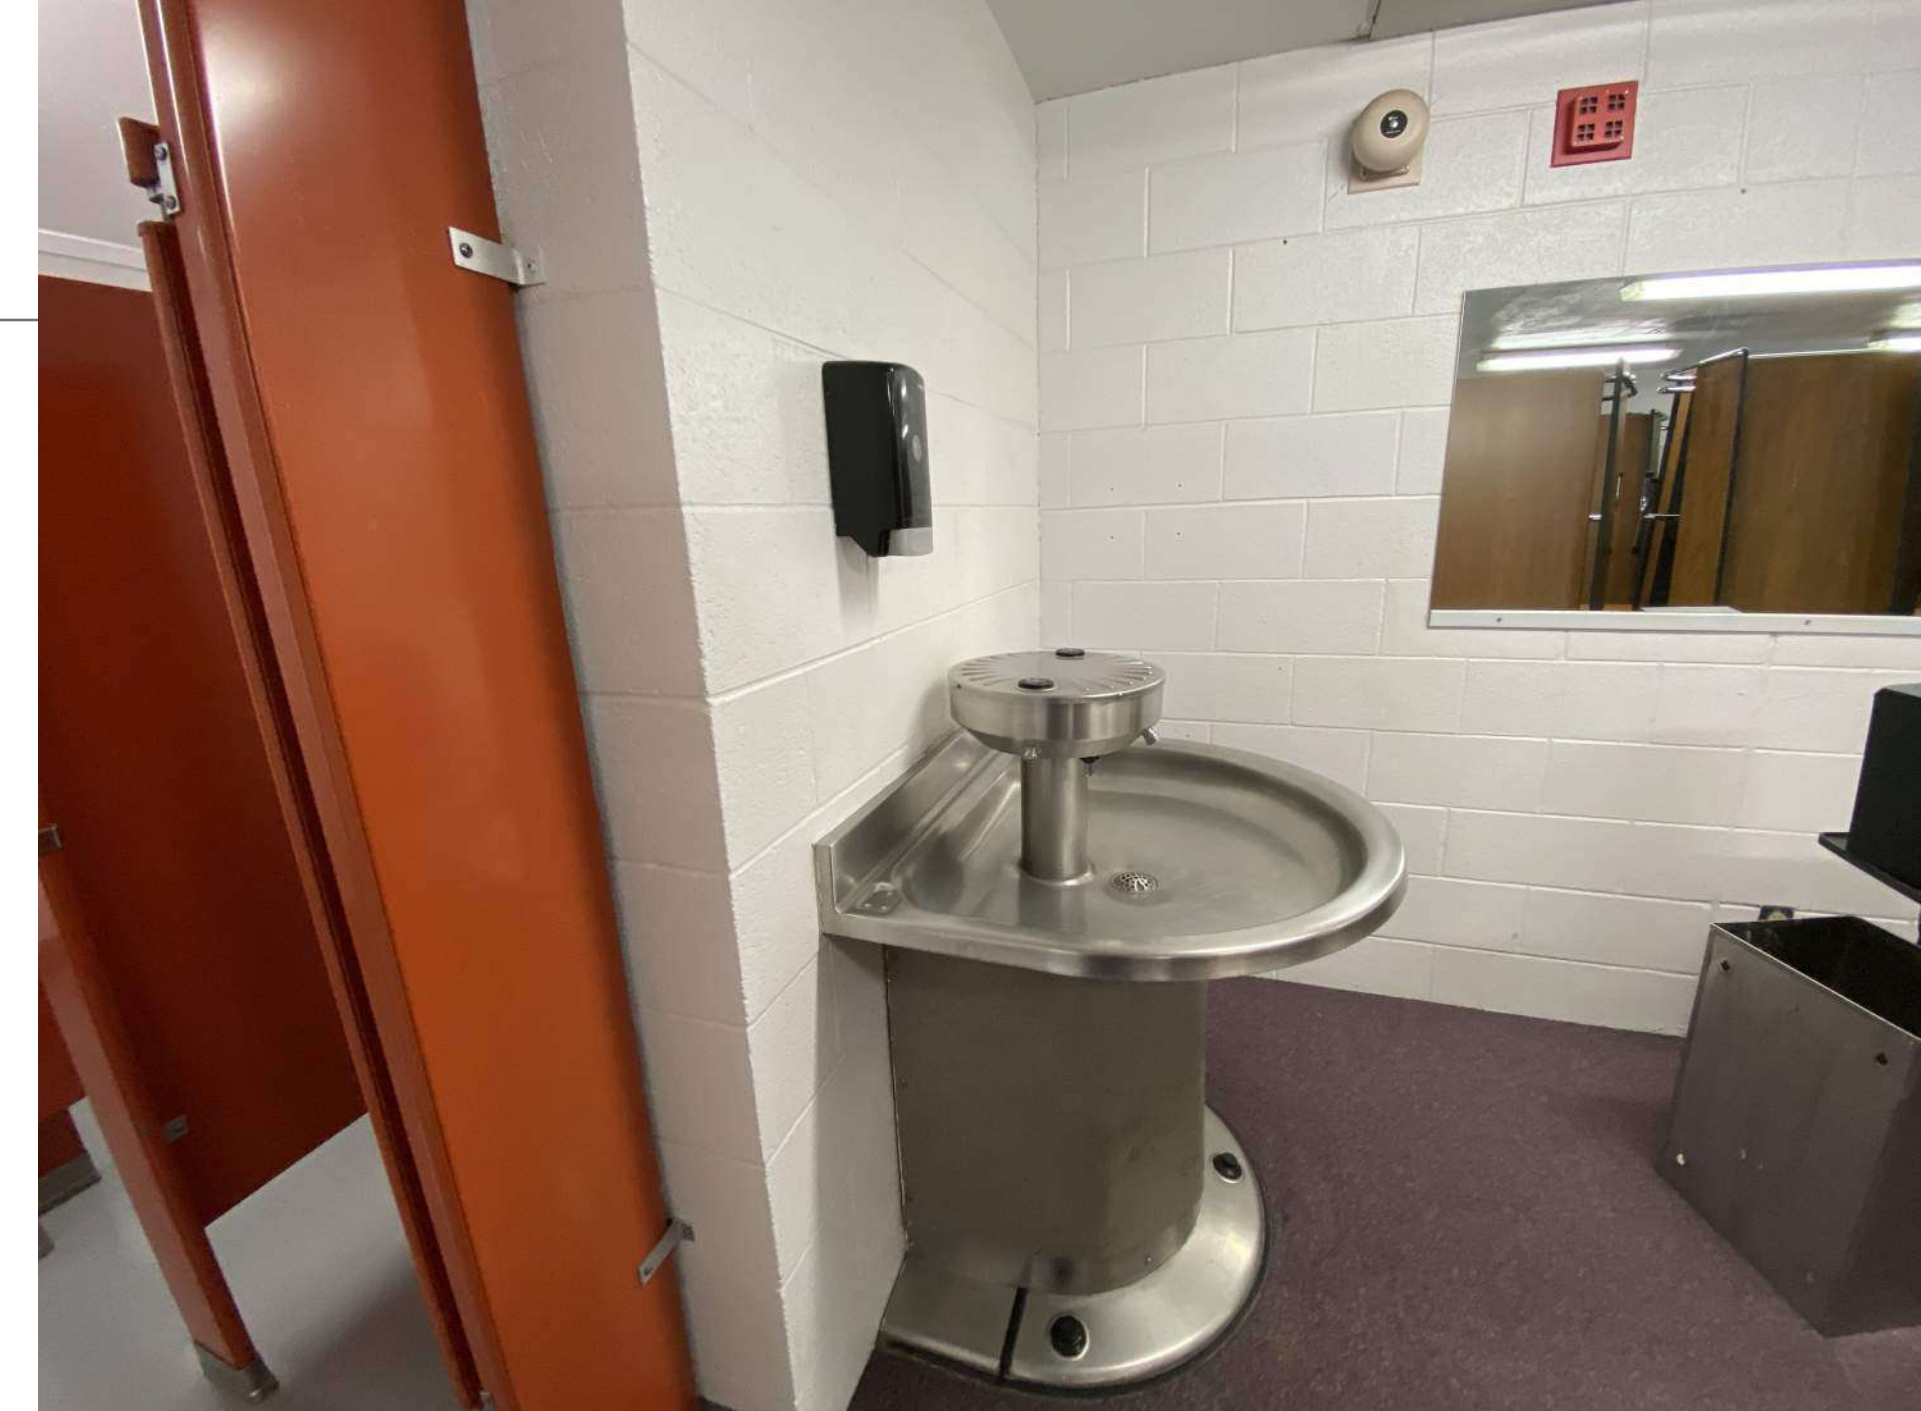
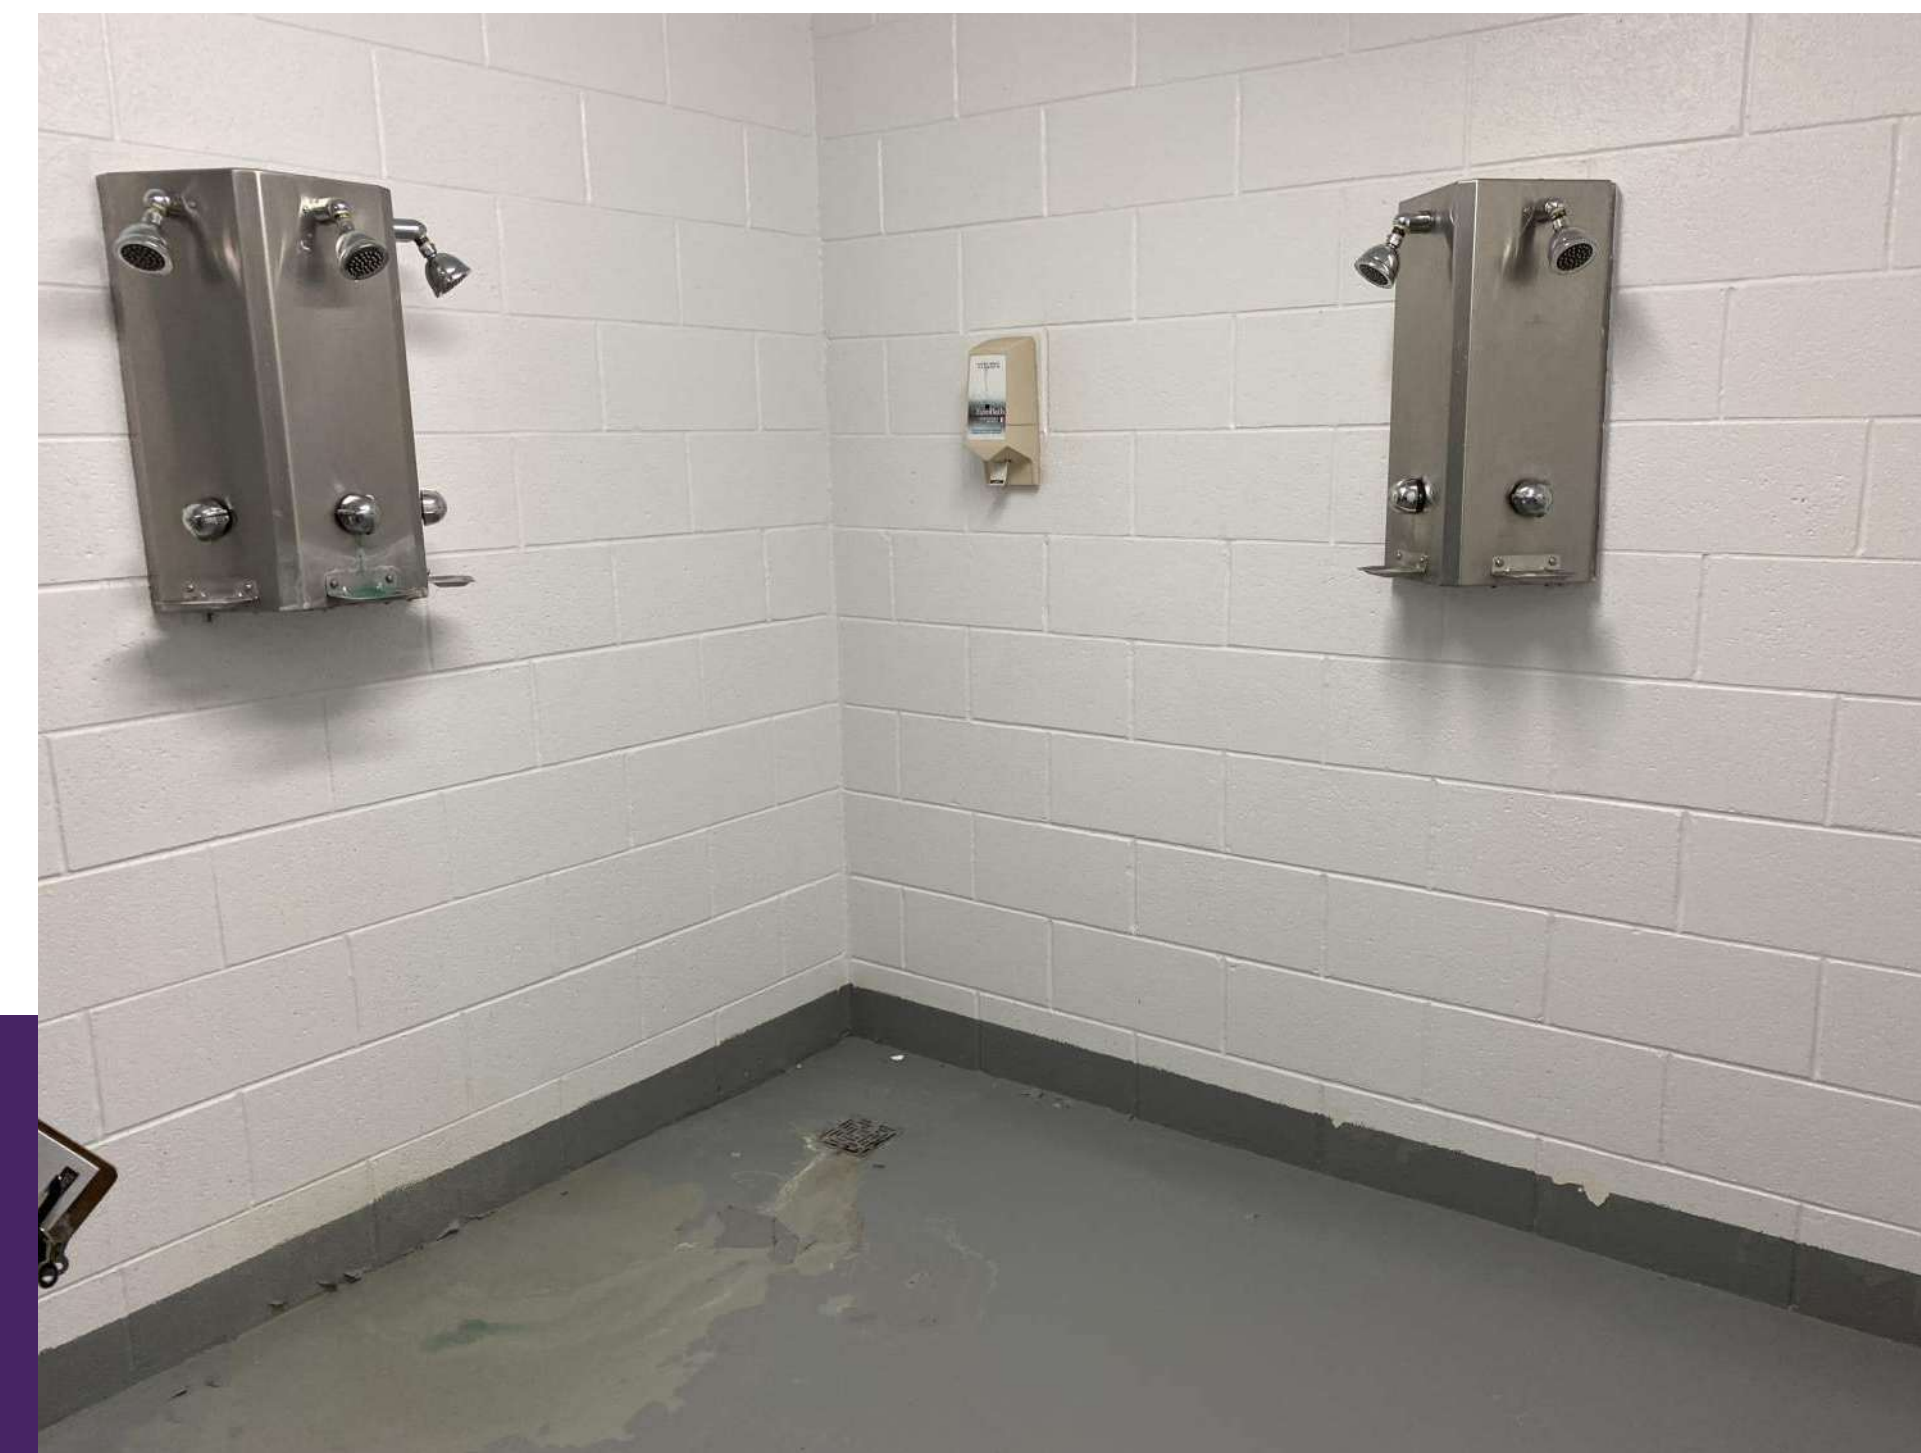
# MAIN LEVEL LOCKER ROOMS

- Used by general students for gym, weight room and wrestling
- One of few places in school with true ADA accessible toilet stalls
- Carpet flooring not ideal and can lead to mold and fungus growth
- “Gang” type showers can be a liability and are generally avoided by students to avoid body shaming and bullying
- Only a few wash basins are usable due to location

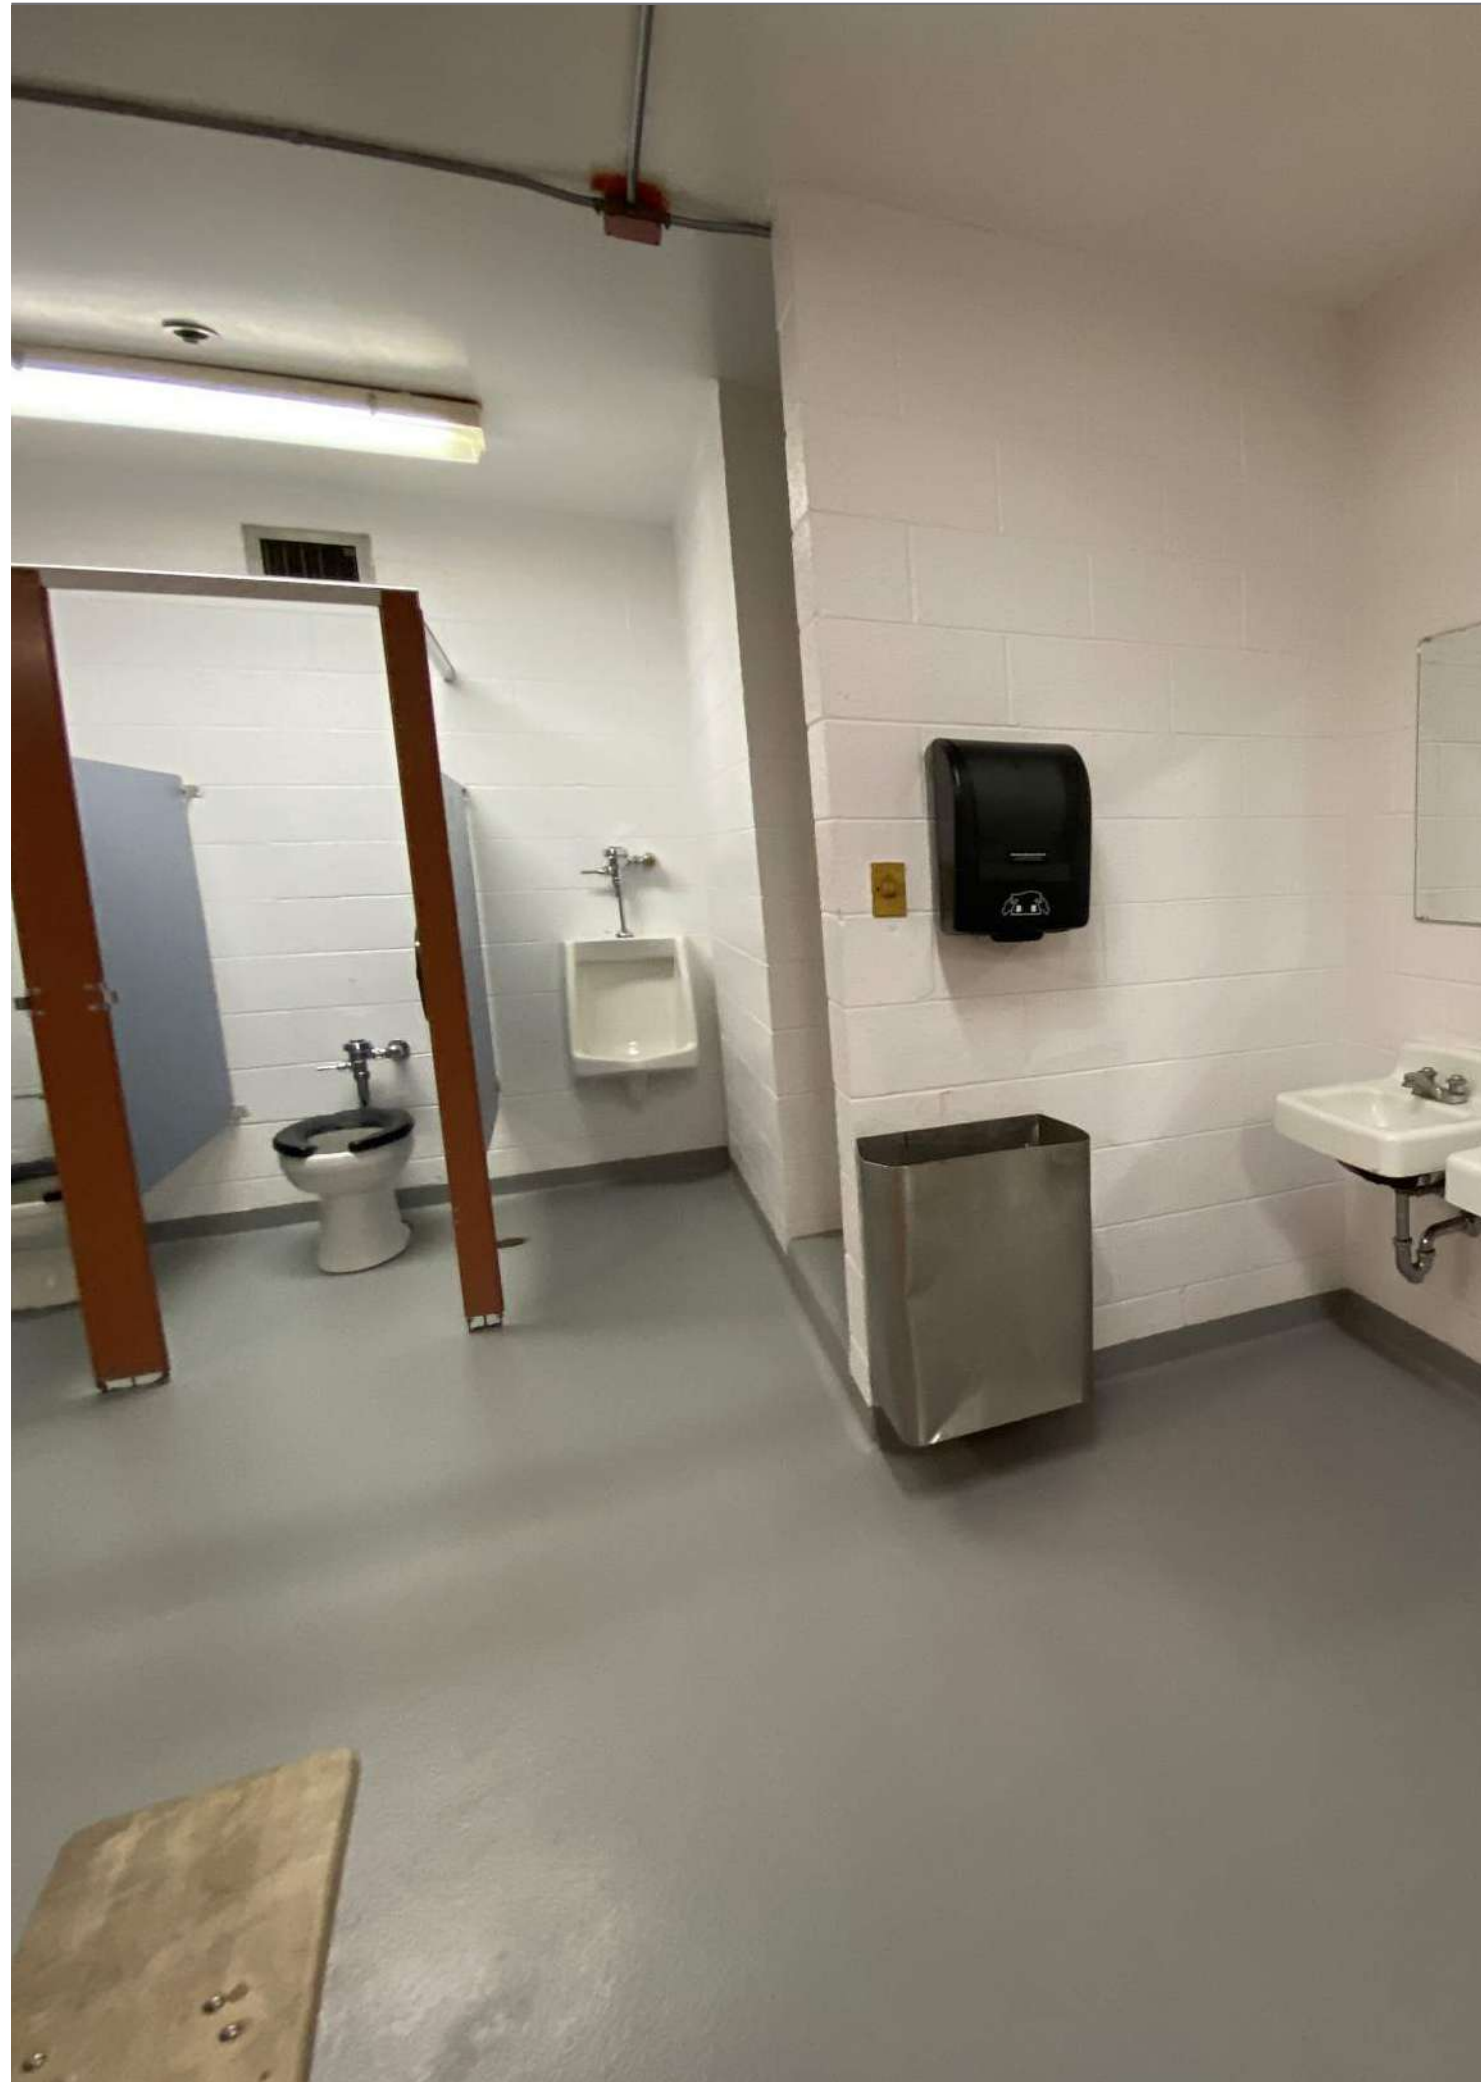
# LOWER LOCKER ROOMS

- Outdated in layout and functionality
- Adjacency problems, poor ventilation and accessibility problems
- Used by athletics such as football, tennis, track
- Finishes overall good
- Distance from rest of school creates supervision issue for staff and faculty
- “Gang” type showers- privacy concerns and bullying probable
- Toilet stalls not ADA accessible
- Men’s stall doors removed
- Other concerns included having enough storage and size of space for accommodating full teams
