# BUILDING CONDITION REPORT

**JEFFERSON HIGH  
SCHOOL DISTRICT #1**  
July 21, 2020

# BUILDING CONDITION REPORT SUMMARY

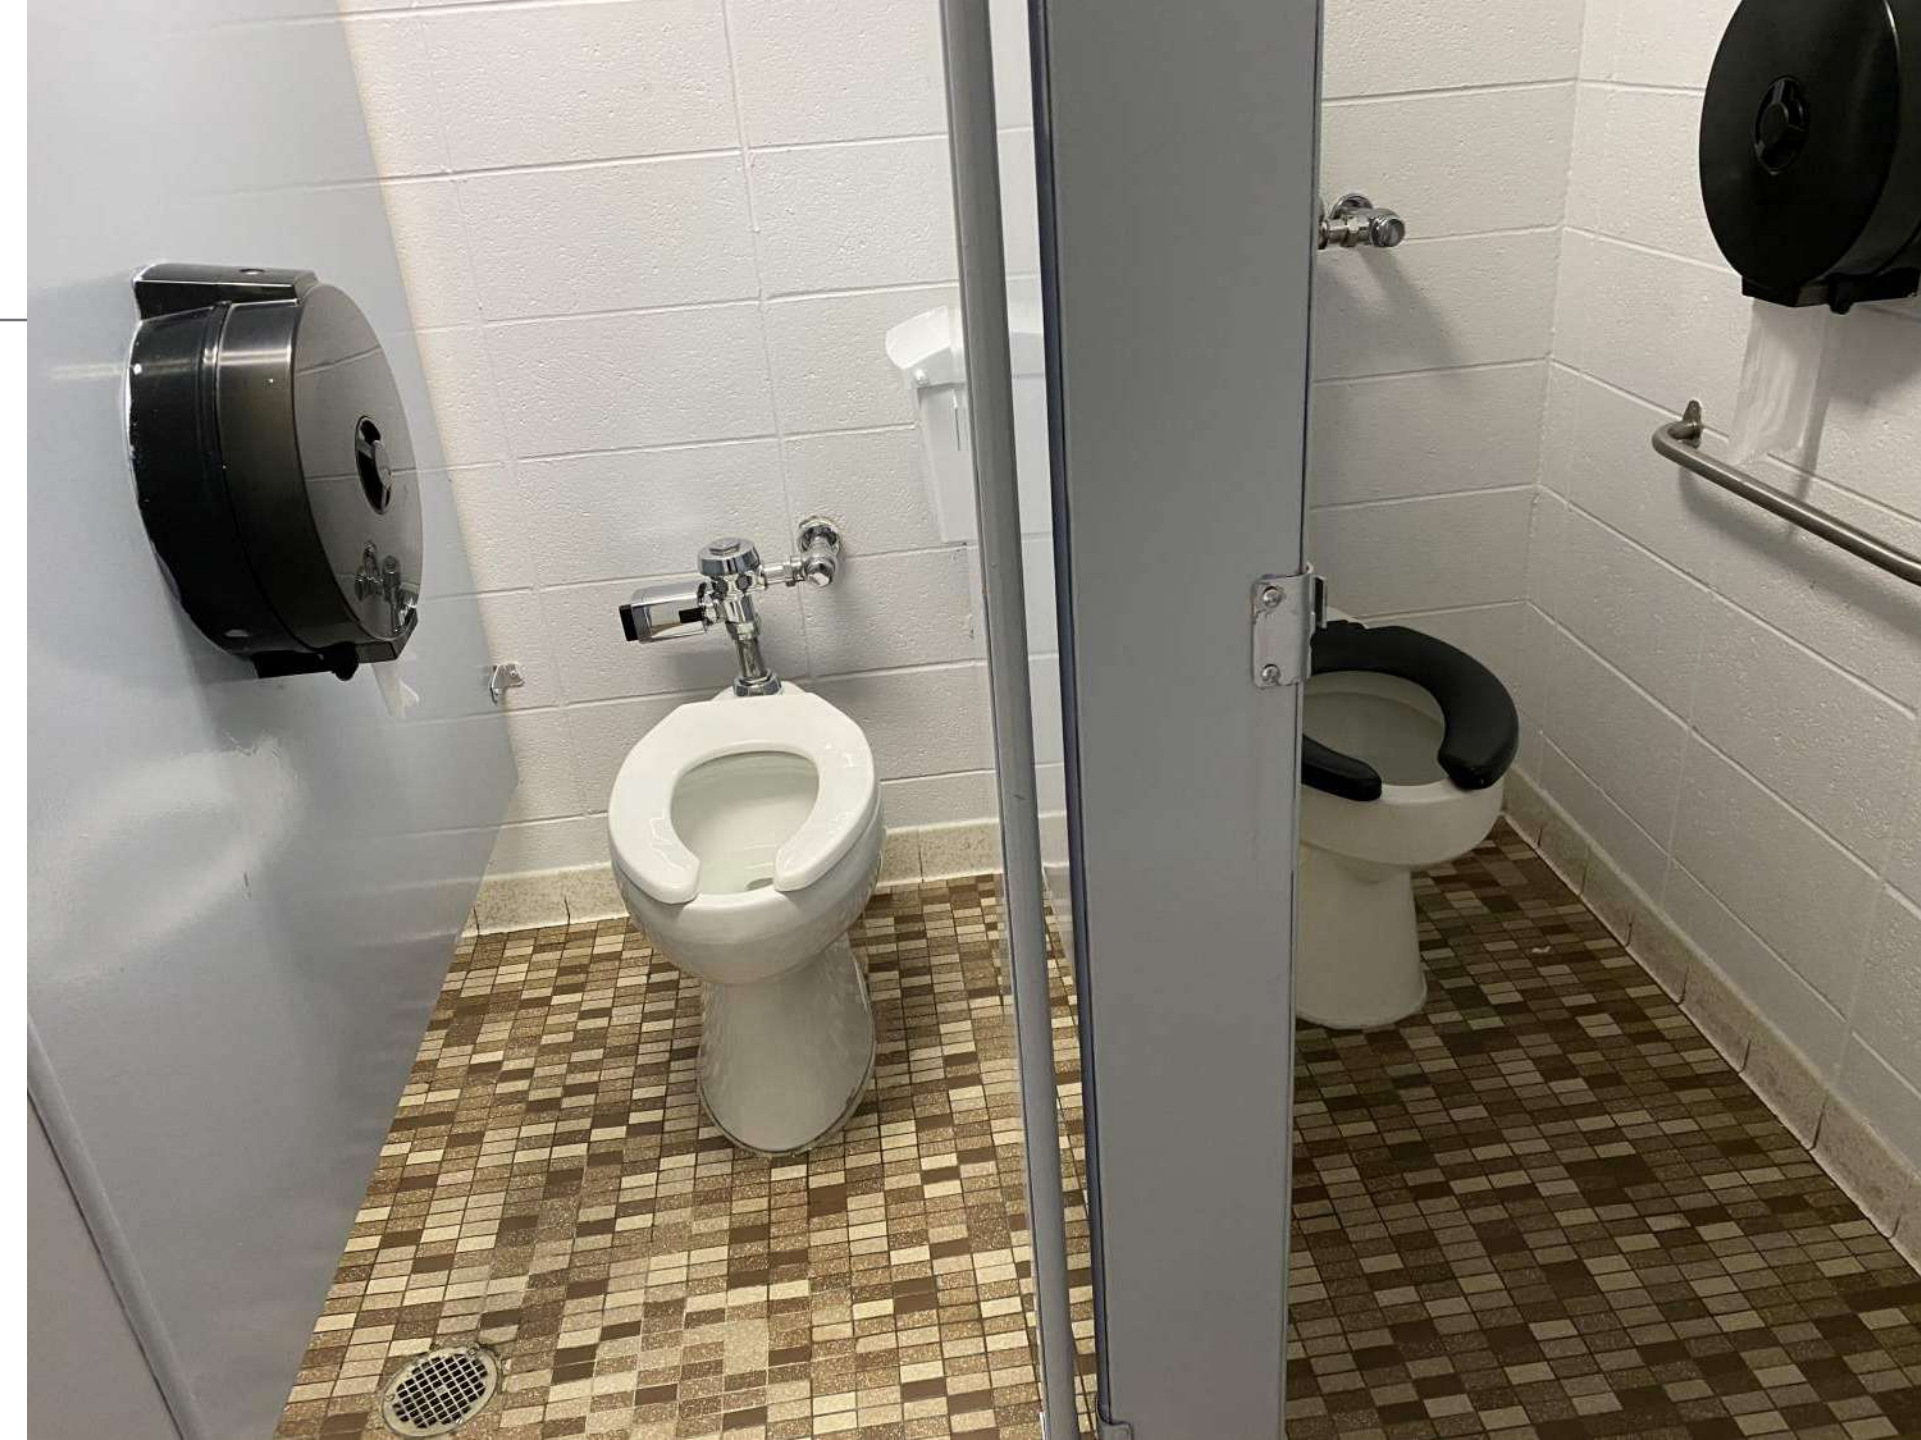
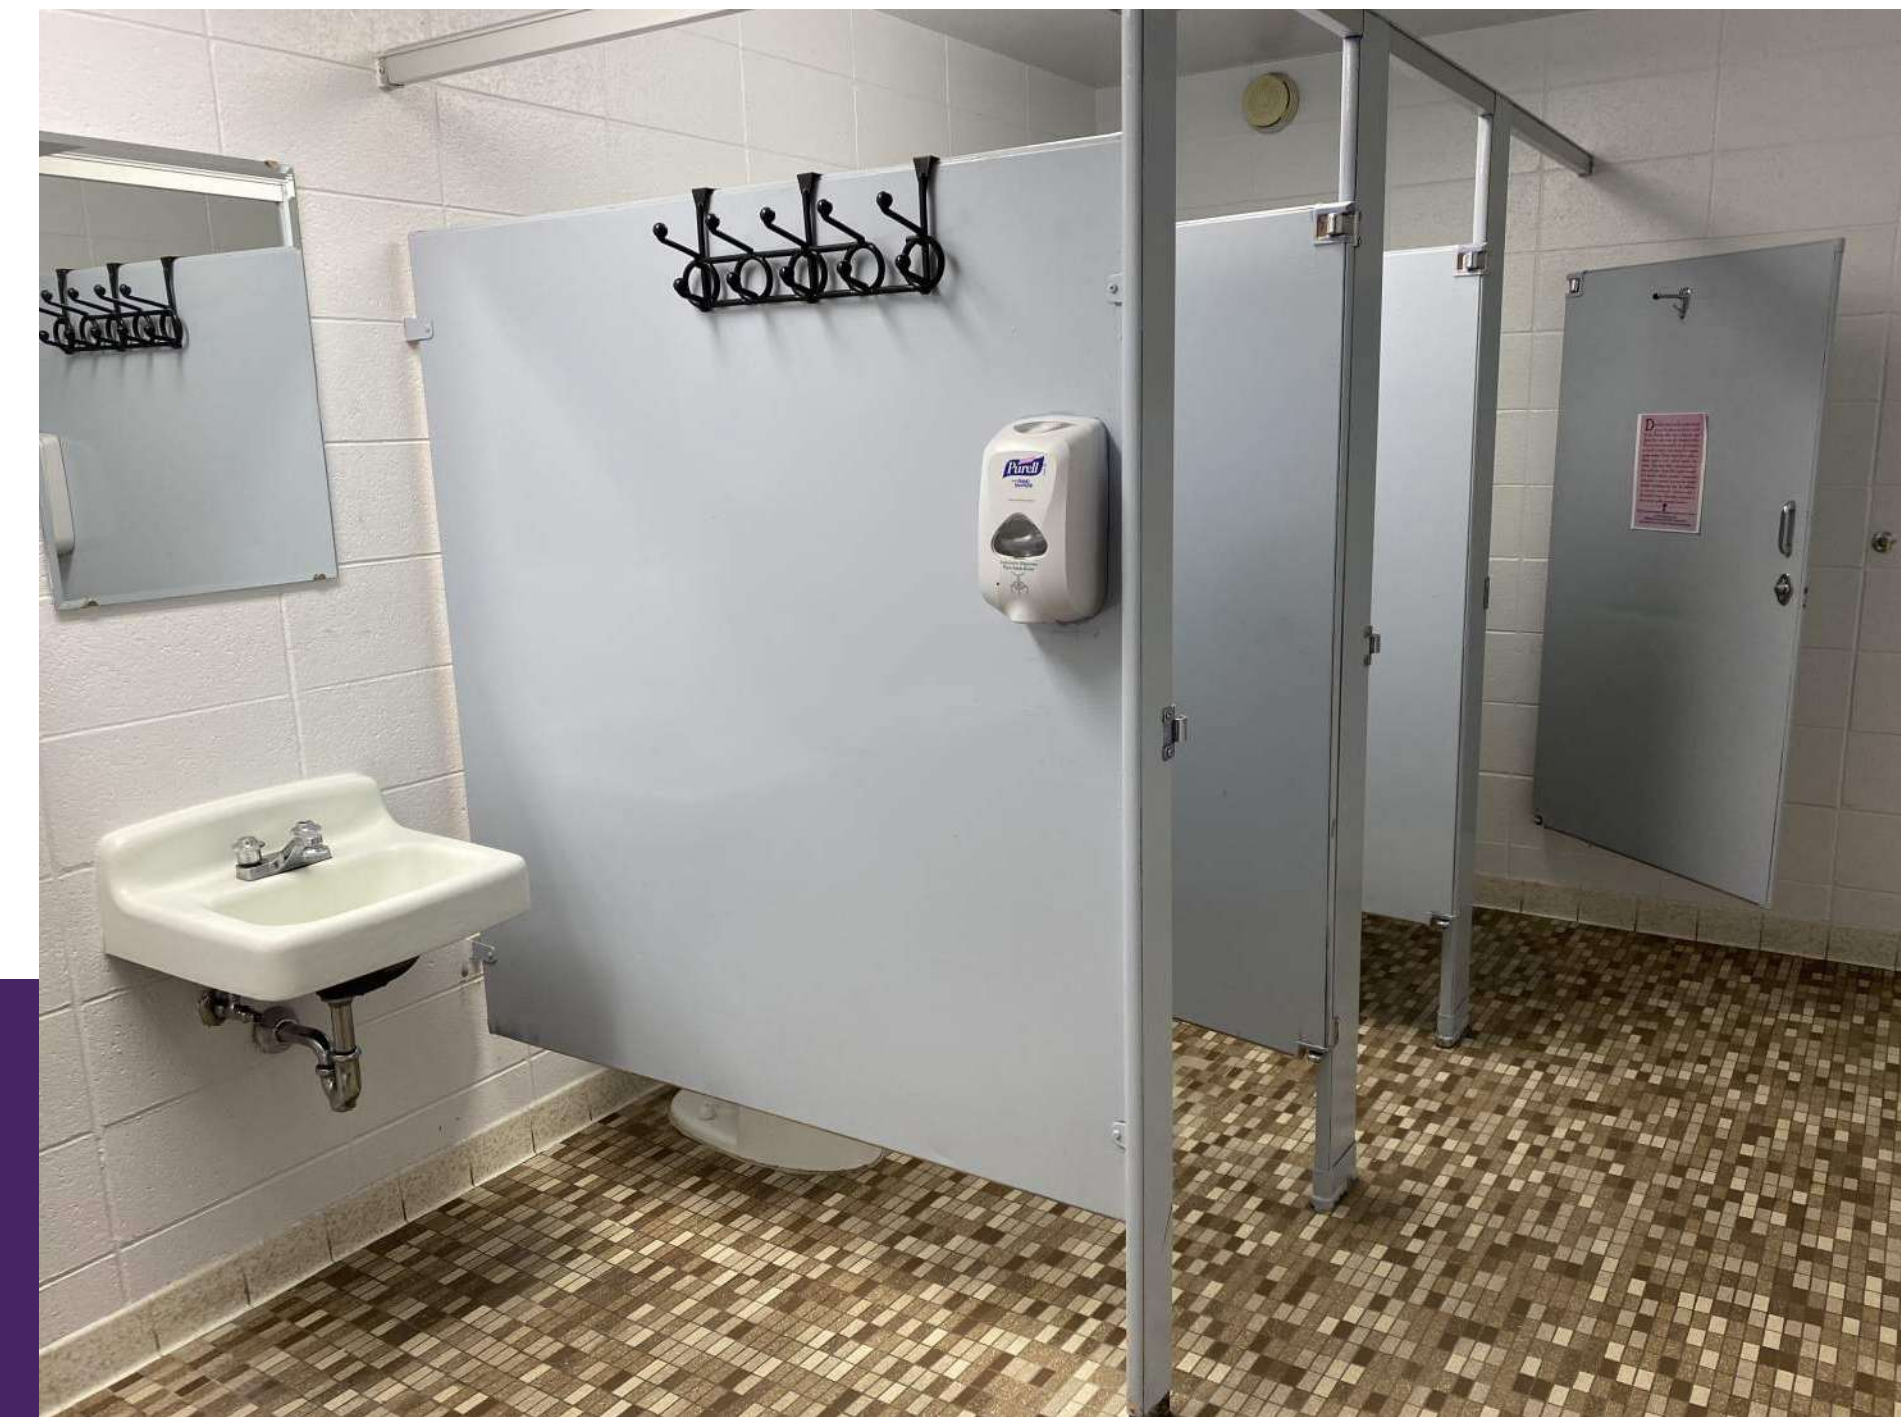
# RESTROOMS

- Most are in adequate condition
- ADA is a common problem
- Inadequate ventilation is a common complaint
- Fixture count appears adequate

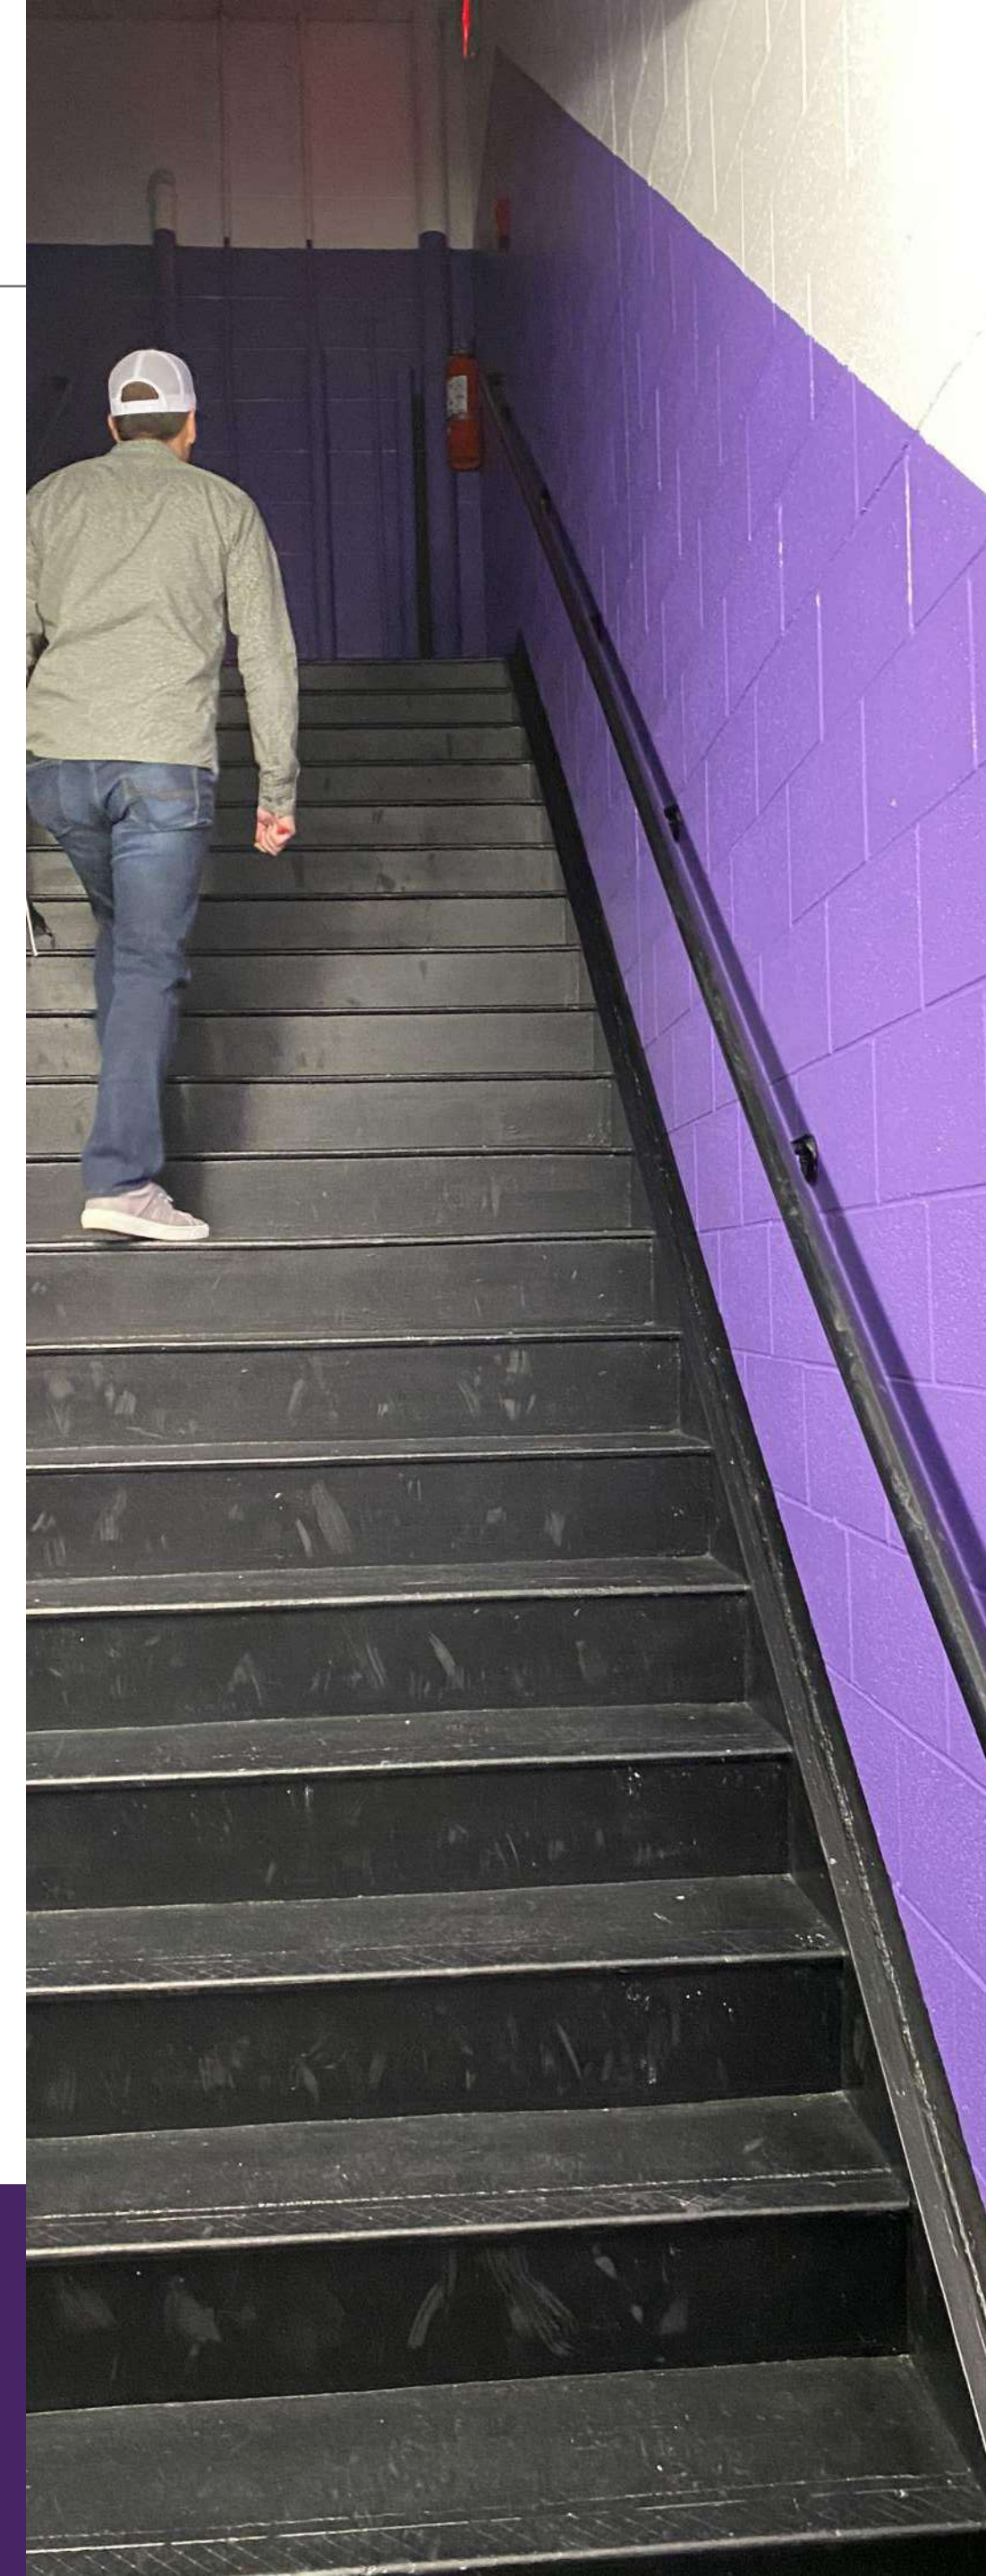
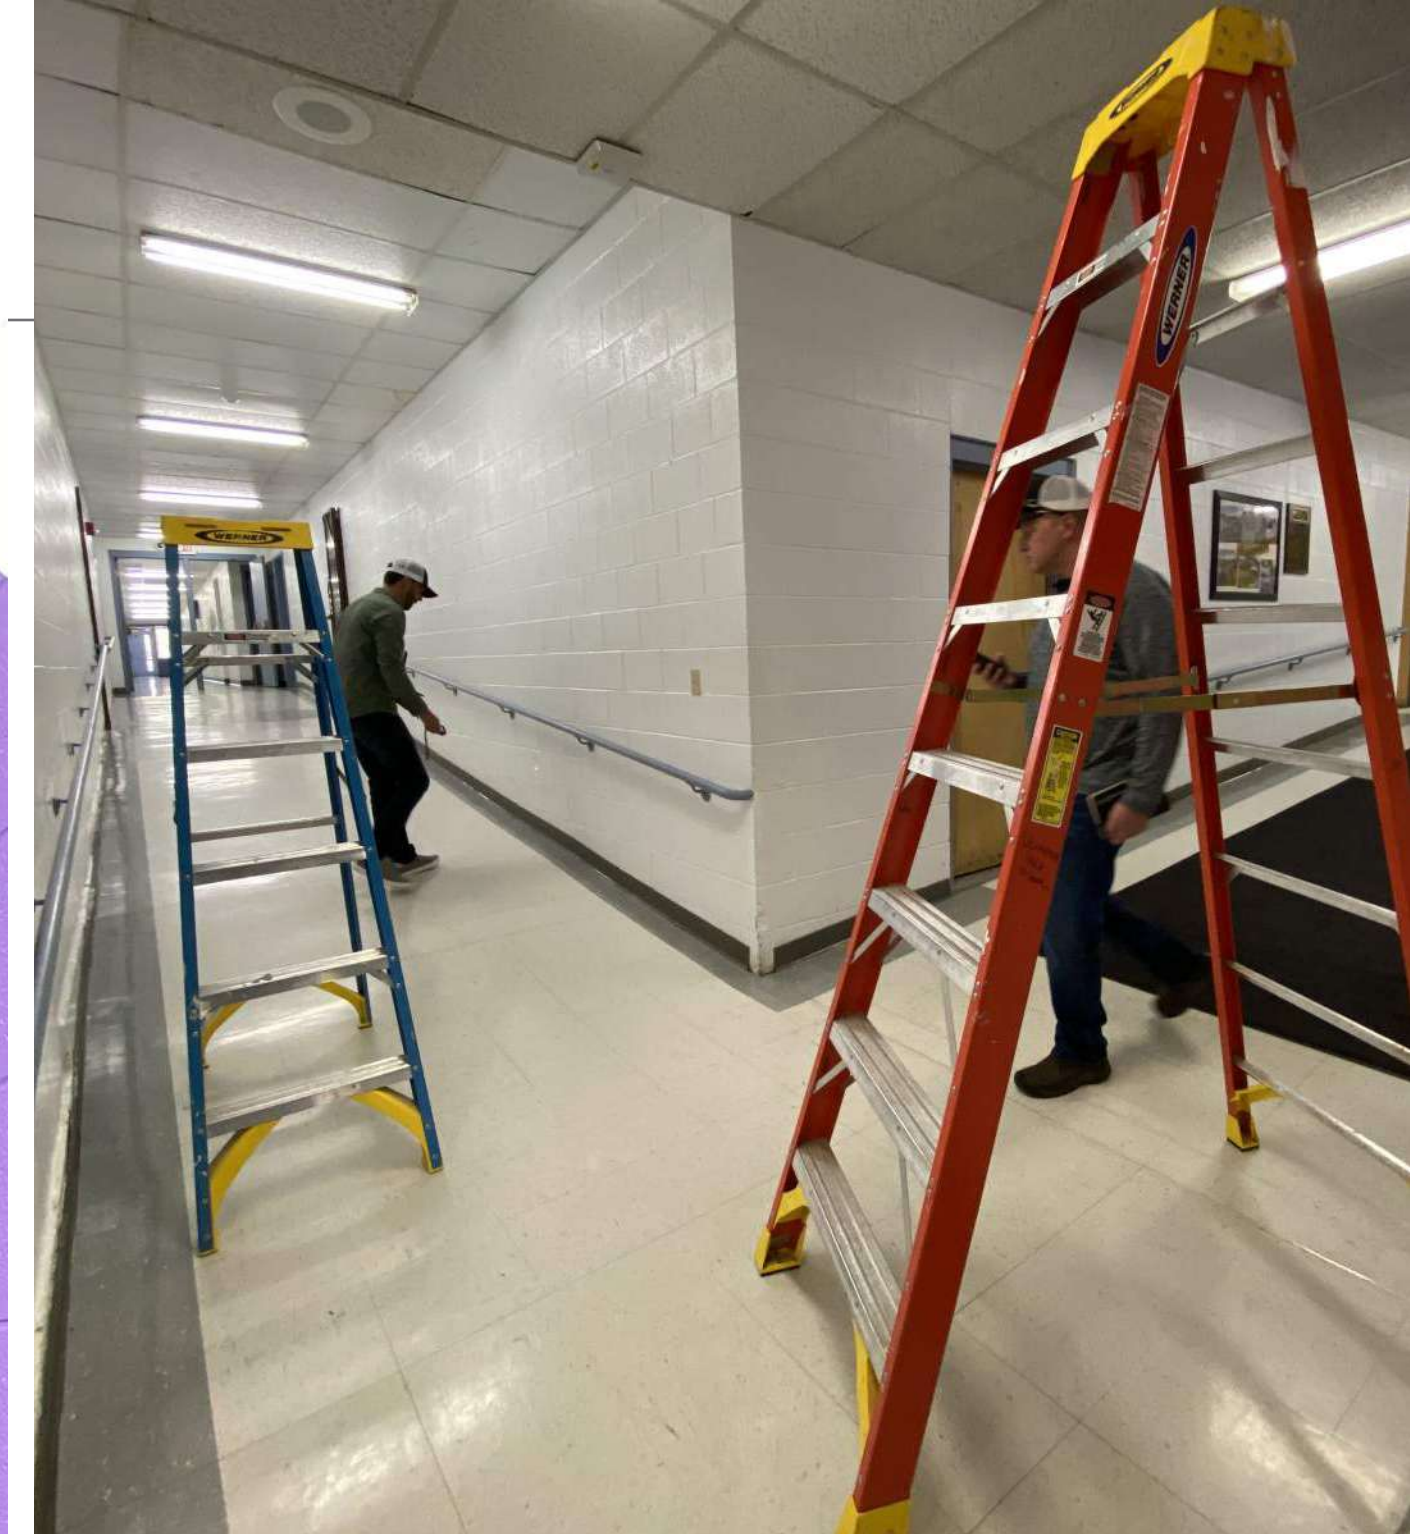
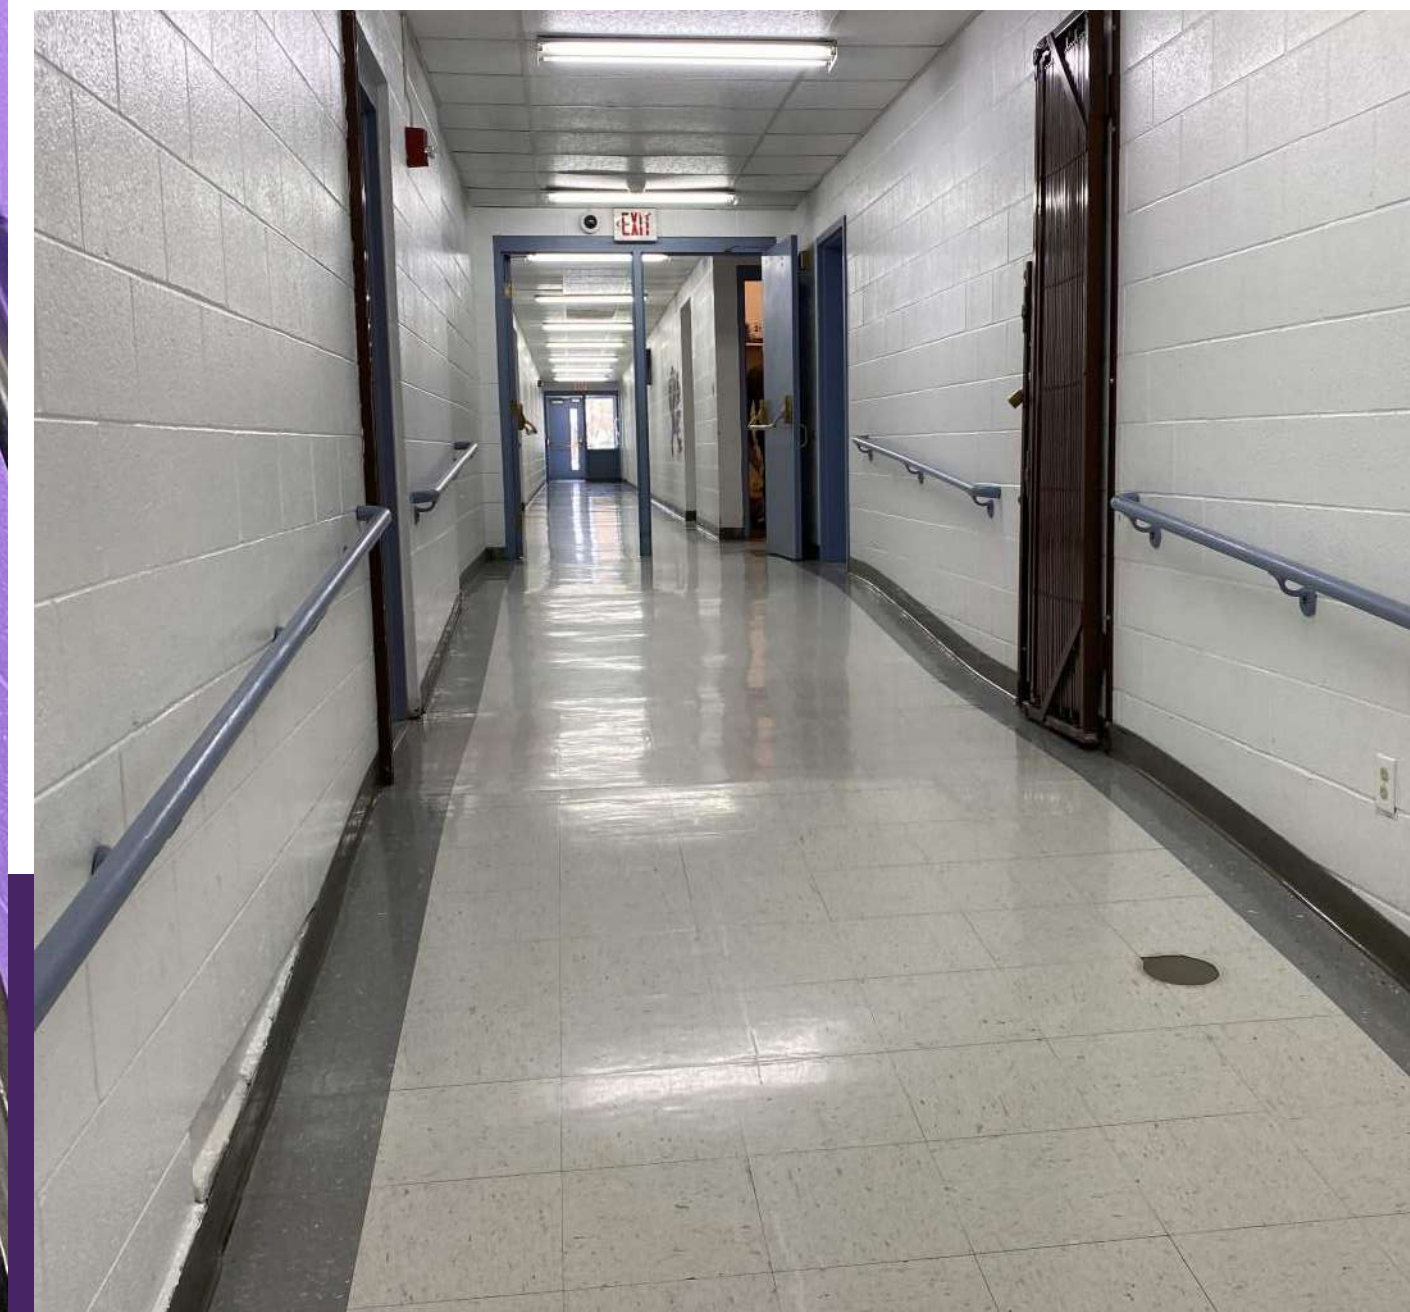
# INTERIOR STAIRWAYS & RAMPS

- Almost all ramps meet or nearly meet codes for slope, landings and railing requirements
- Stairs also meet code, excluding the weight room, and drama storage
