Jefferson High School Building Condition Report

312 S Main Street, Boulder, Montana 59632 July 30, 2020

| BUILDING CONDITION REPORT |

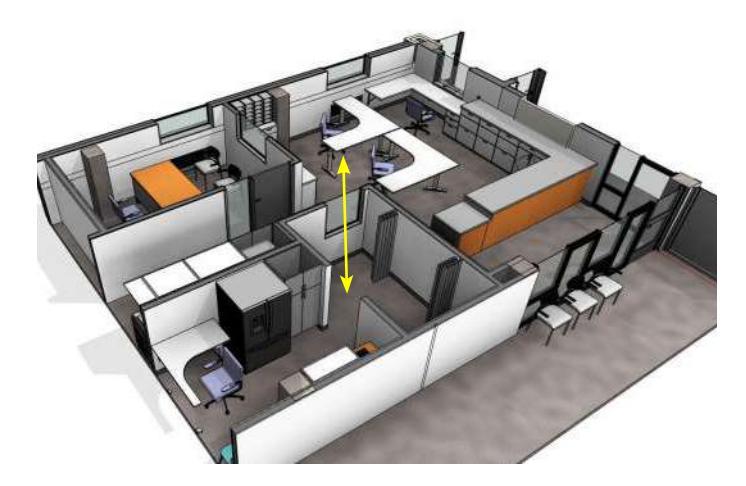
Front desk staff has views into the nurse's room and beds via a window. This gives the staff better monitoring in case of a problem.

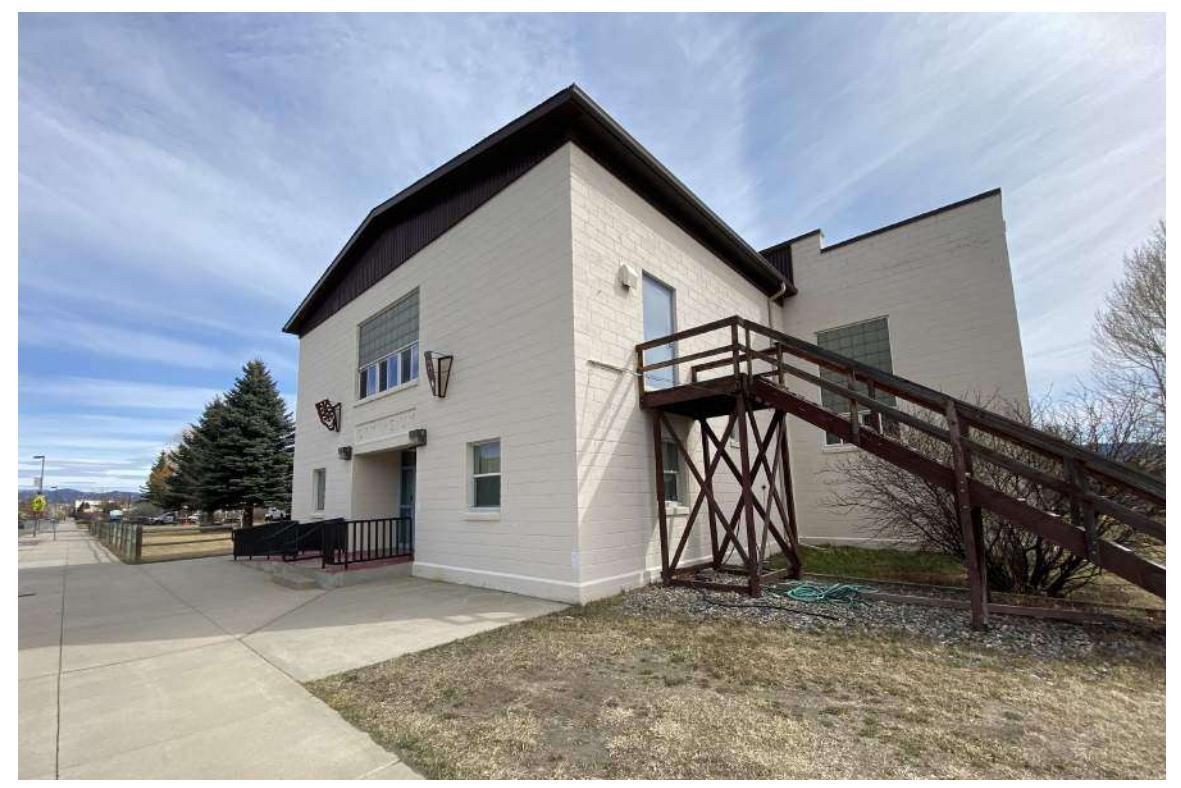
The proximity of the building to Main Street in central Boulder is not ideal for modern school security practices. The Existing Gym entrance is 25 feet from the street and is vulnerable to intrusion. From an anti-terrorism or force protection perspective, this distance provides zero protection from car explosions, and does not provide adequate time to see a hostile individual approach the building from the street. These challenges are not easily solved and are noted here only to keep an awareness of the potential security challenge. The main entry from East 4th Avenue sees the most use and is the most convenient access point for the existing parking stalls. Security upgrades within the last year have further secured the entrance; these reduce but do not eliminate the possibility of intrusion. The new security features include locked doors and a camera and speaker to identify visitors and the opportunity to restrict entry. However, the main office area does not have direct views to the exterior of the school, which limits their ability to see a potential threat approaching the school. Other entrances have seen upgrades to their security with keyless entry and cameras, which increase visibility and all-around security. The design team visited the school immediately before summer break and during the COVID-19 shutdown, and therefore was unable to observe student or staff movement through secure areas. However, based on observation of traffic patterns in all areas, the team recommends further security upgrades to technology and architecture.

West entrance at existing gym and Art Room, facing Main Street. The entrance is very close to the street edge. Art Room egress stairs are on the right.

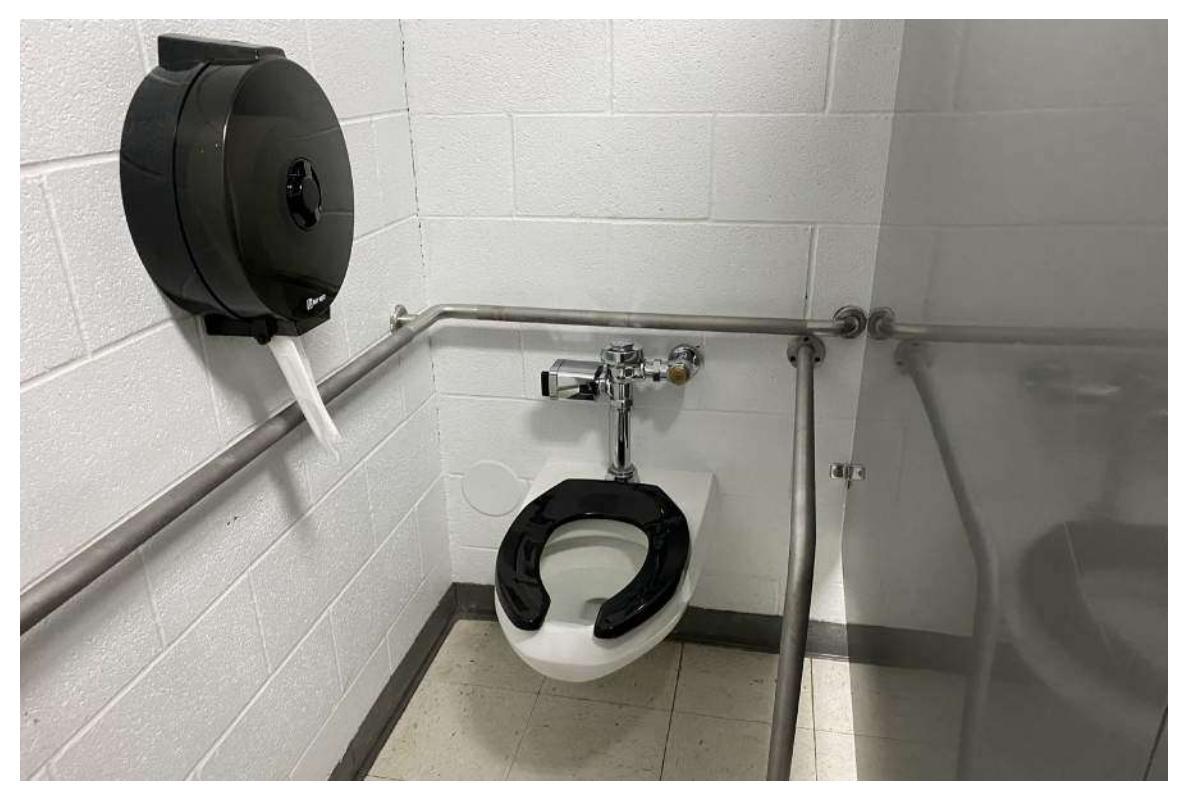
Toilet fixture and stall in restrooms adjacent to Cafeteria seating area. Even though it has several grab bars, this restroom, like most in the school, does not meet current codes for accessibility.

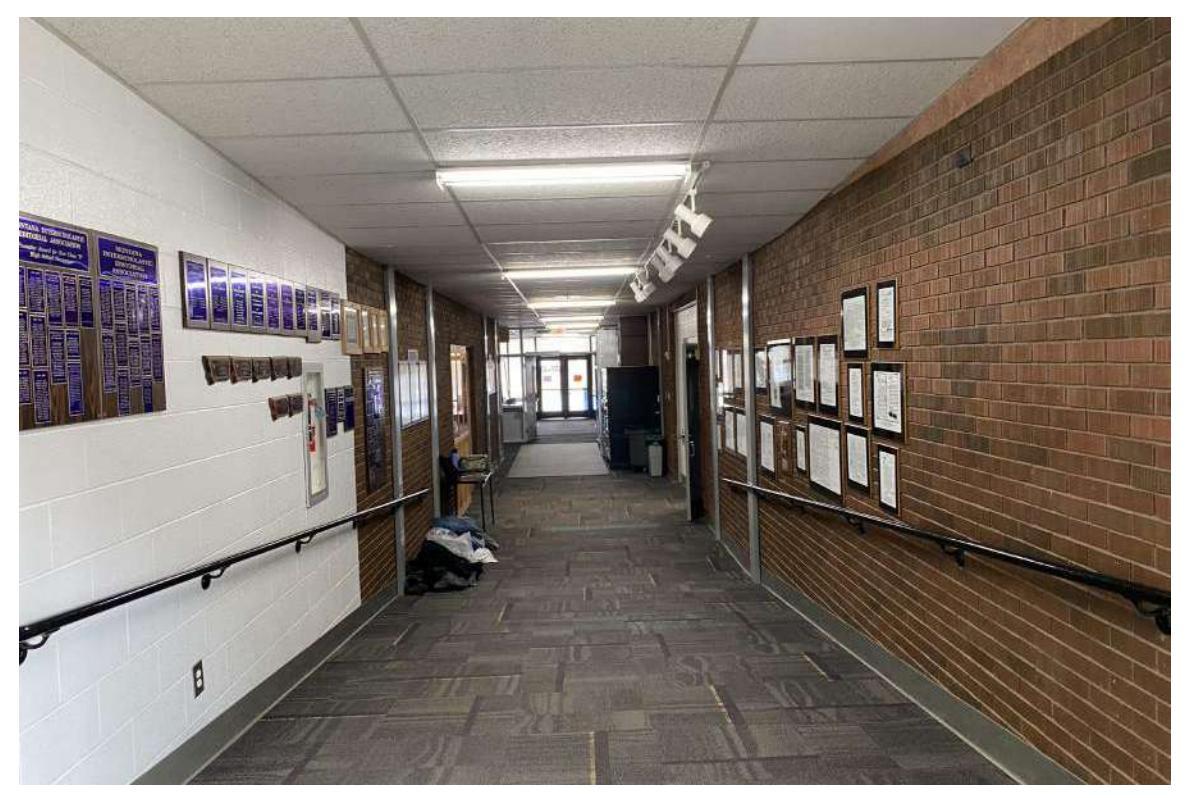
Looking north from the previous entry door location, down the ramp toward the front entry. Staff input was that this area is excessively busy between class periods and becomes a bottleneck. This intersection is the most direct way to access the gym, band room, shops, and weight room from the classroom areas.

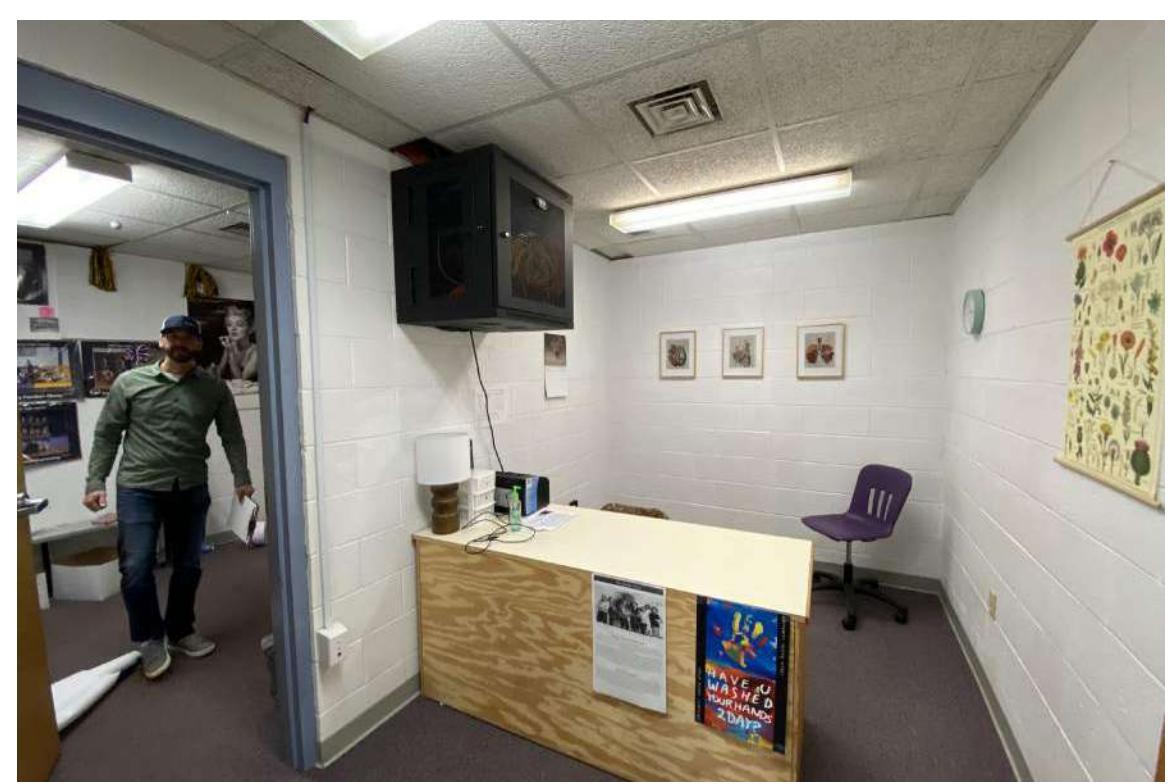
Nurse's Office. The large computer rack hangs above on the wall. Finishes in many of these offices are clean but small and outdated.

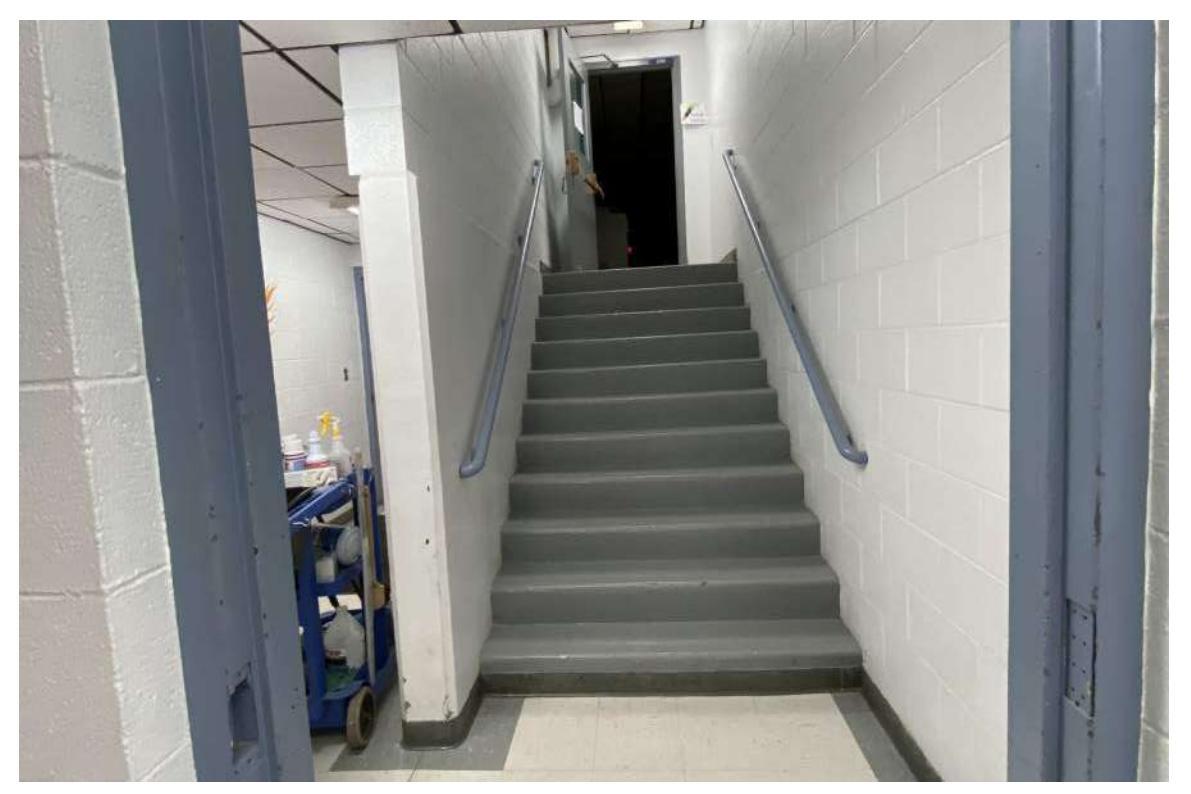
Stairs leading up to the Band Room from the Hallway. There is no accessible route to the Band Room, limiting access to those with mobility issues.

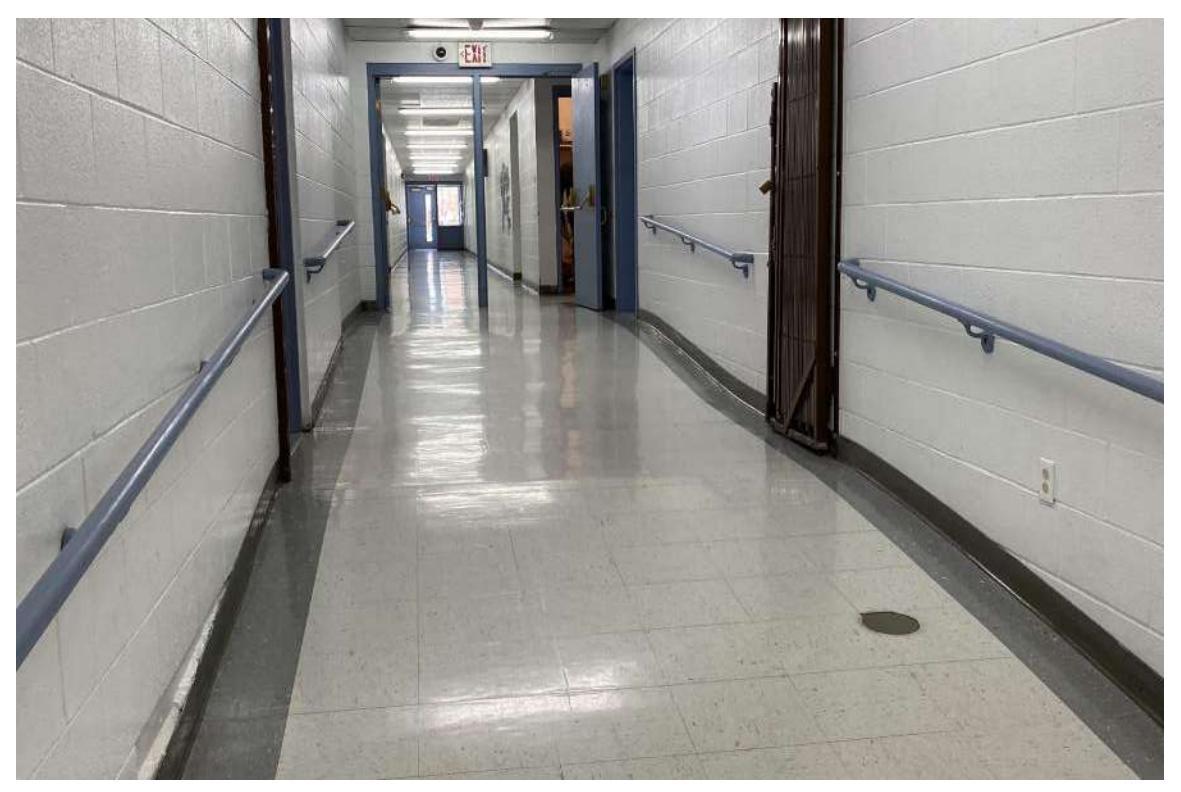
Ramps in main hallway running east-west. Landings, handrails, and slopes all appear to be within current ADA requirements.

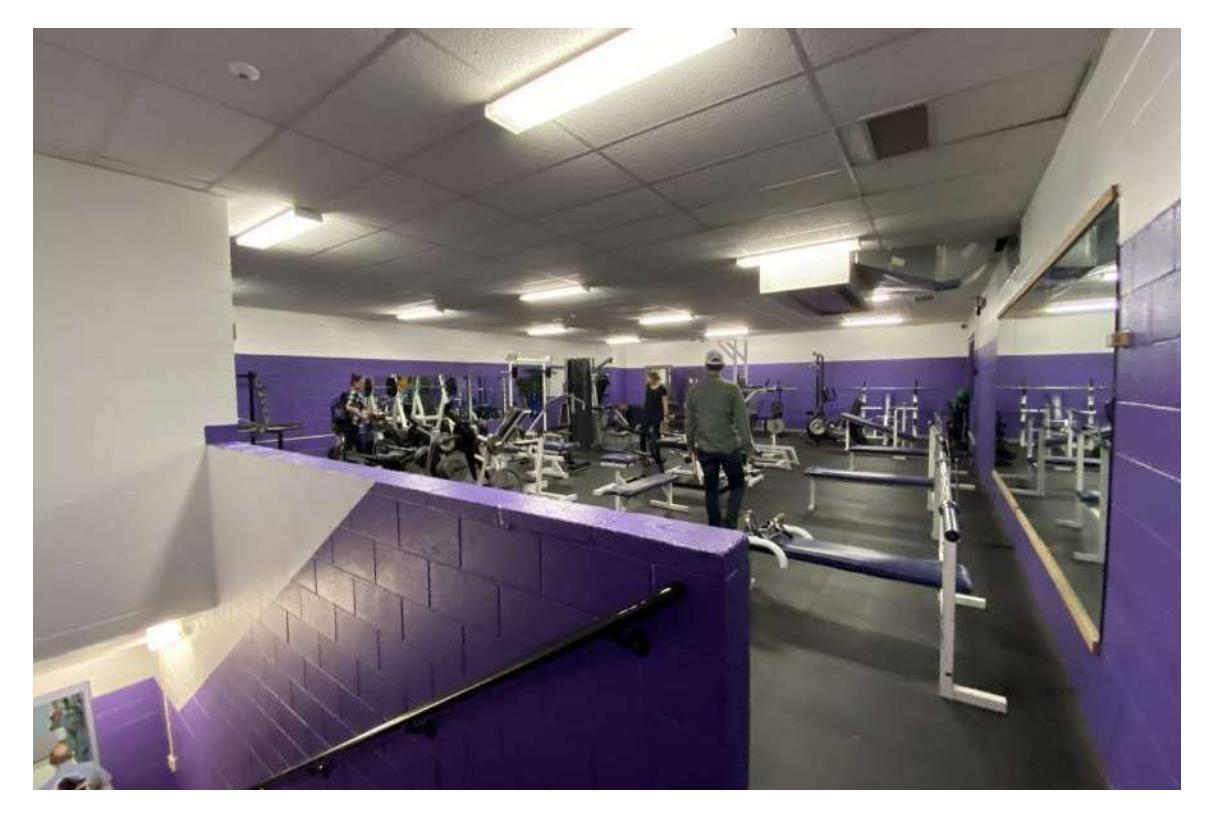
Weight room mezzanine above locker rooms and North gym. Top of stair landing area is too small for current codes.

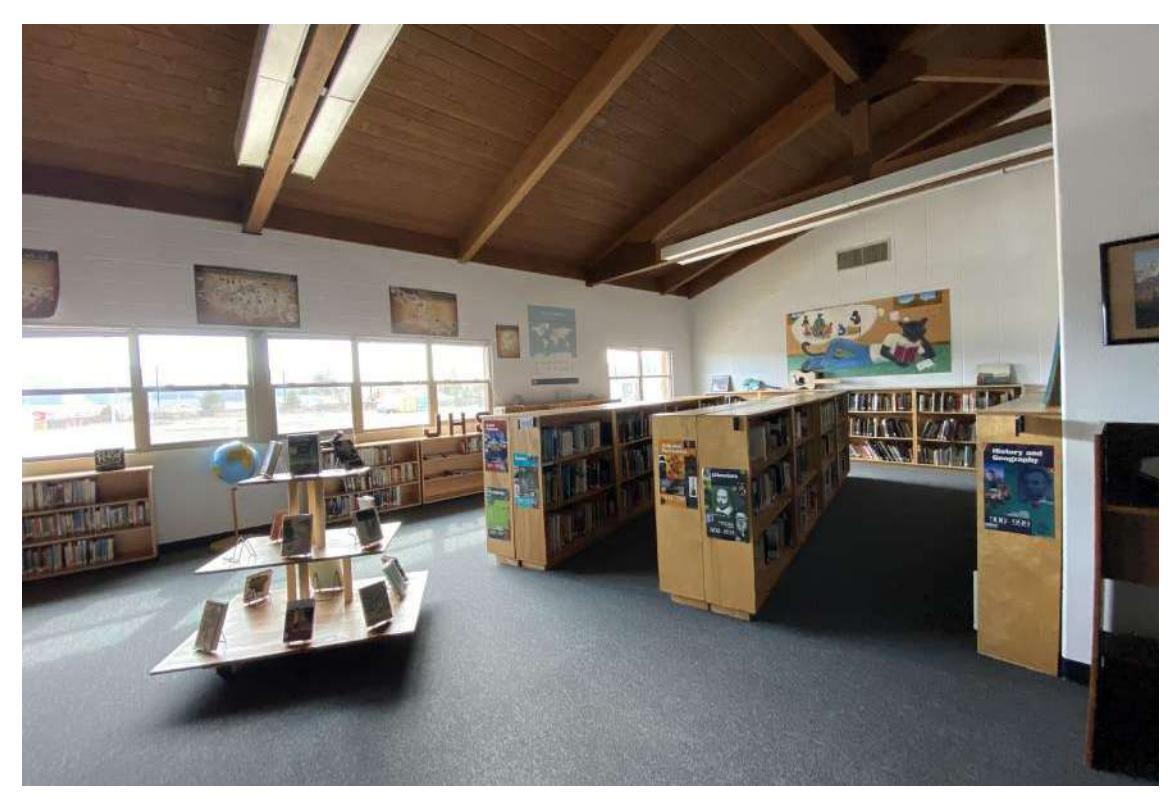
The library windows have to be opened in warm weather to cool the space. During bus loading times, this can make this area noisy.

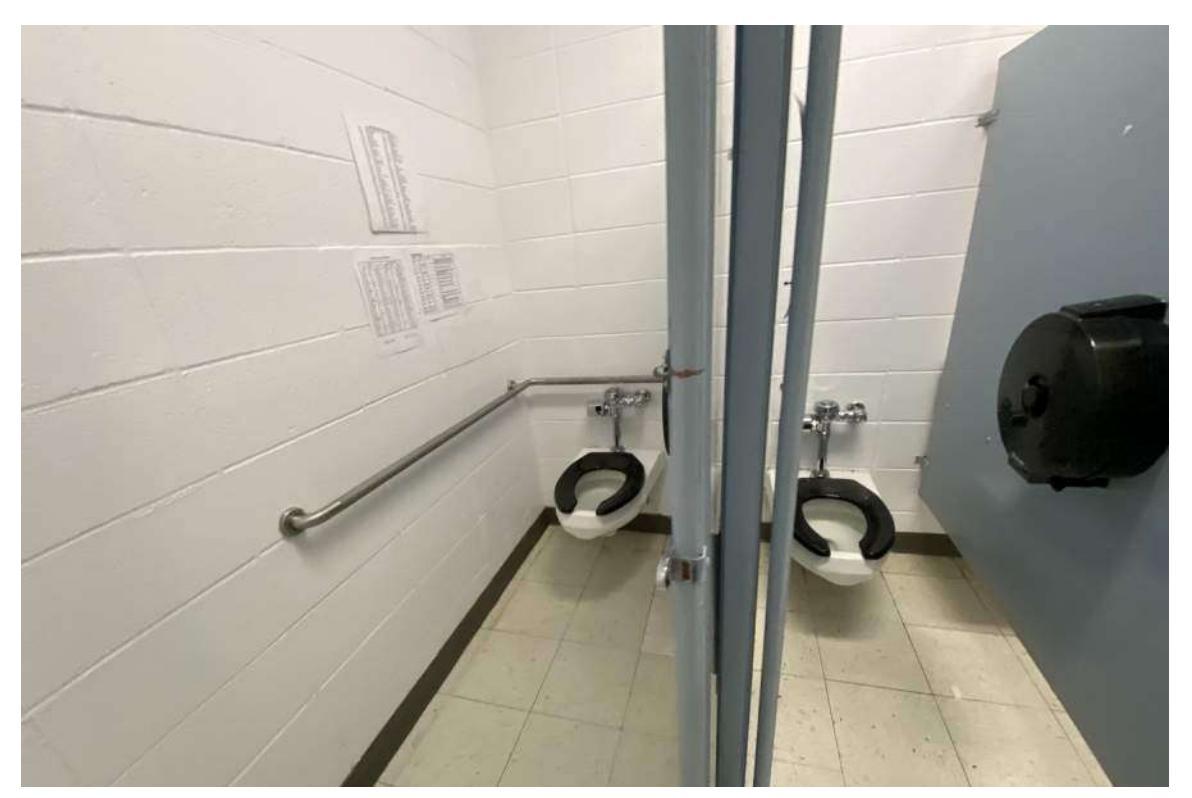
Per the building codes, a percentage of these fixtures must be accessible for each sex, however, it was observed while on site, that all existing ADA stalls do not meet today's ADA requirements. This is not uncommon, as ADA clearance requirements have evolved to be larger over the years.

A typical ADA stall in the school. While the grab bars do provide assistance in transferring to the seat, these stalls are not up to current ADA design guidelines.

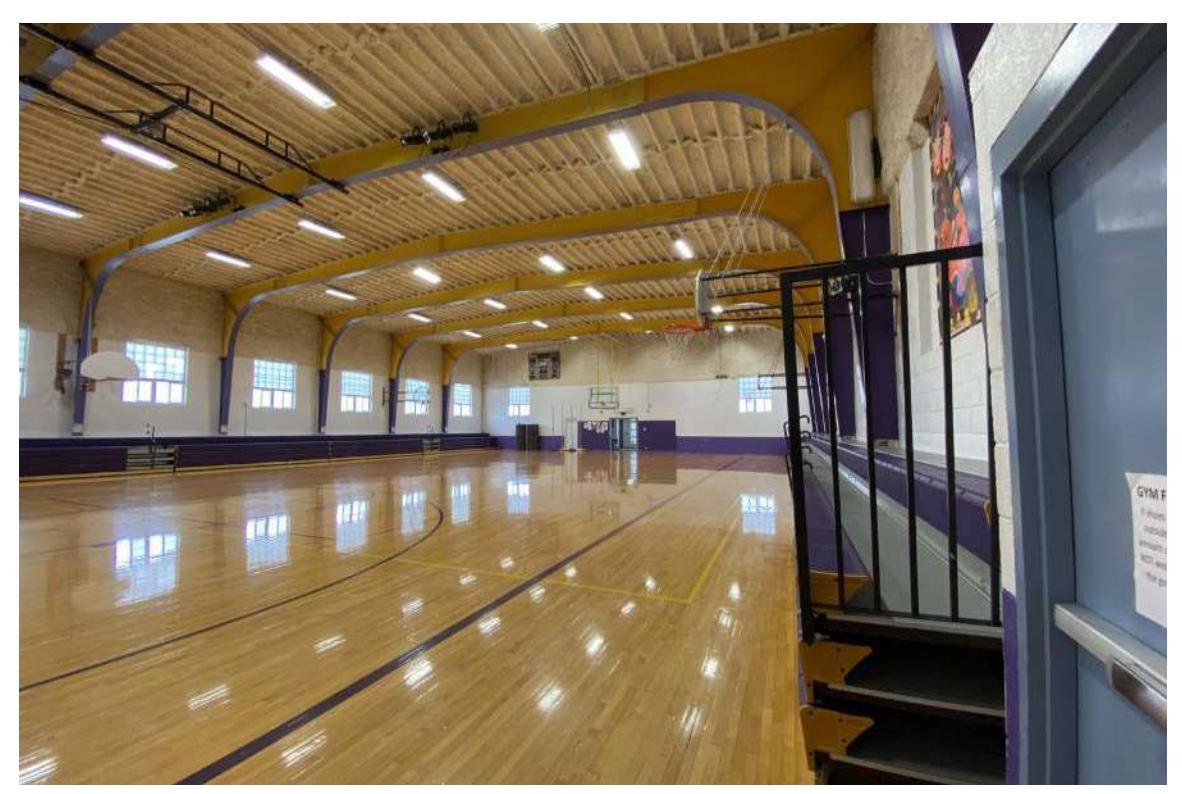
Existing (South) gym. This space is reportedly loud for drama and theater presentations, and is shared with athletics. The spray insulation on the ceiling needs to be verified for flammability and smoke spread, as the design team is not confident it should be left exposed.

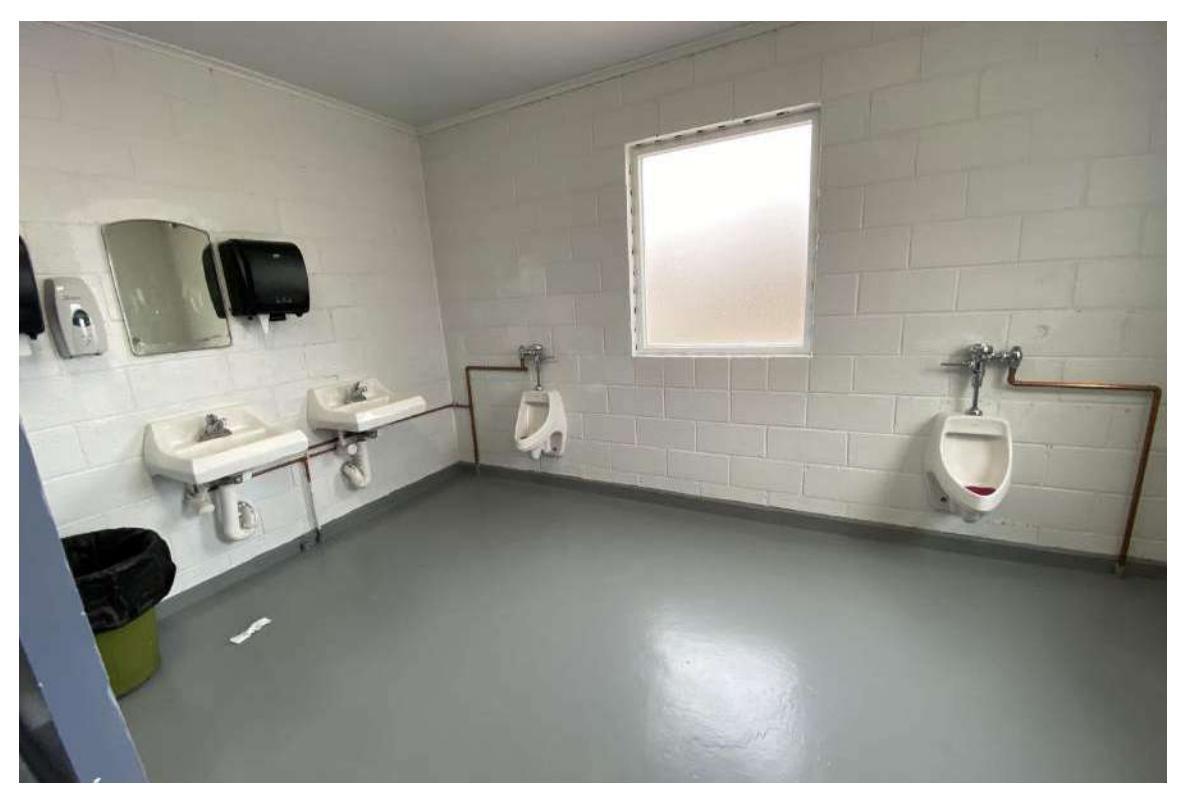
Men's restroom at the west entrance by the Existing Gym. While this room has plenty of turning and clearance space, these restrooms could be better configured to serve more students.

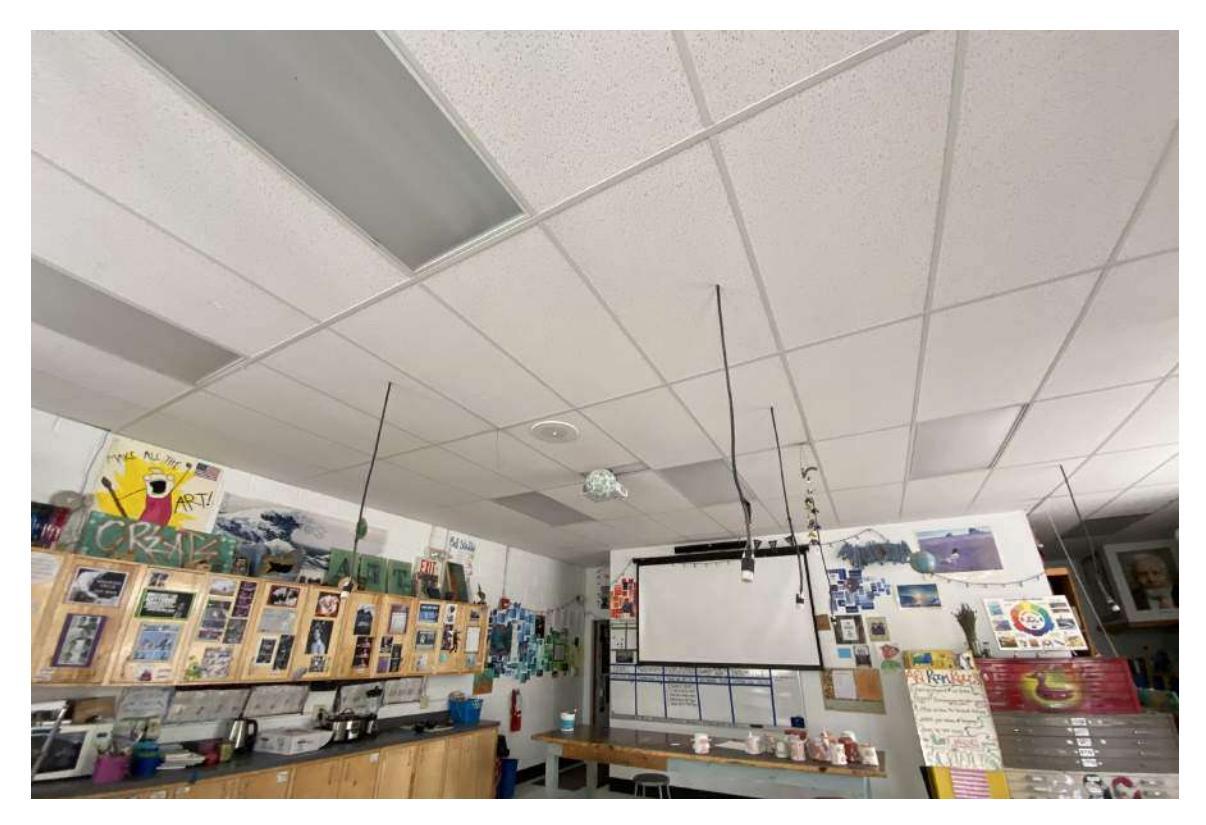
The Art Room, on the second floor. This room is only accessible by stair.

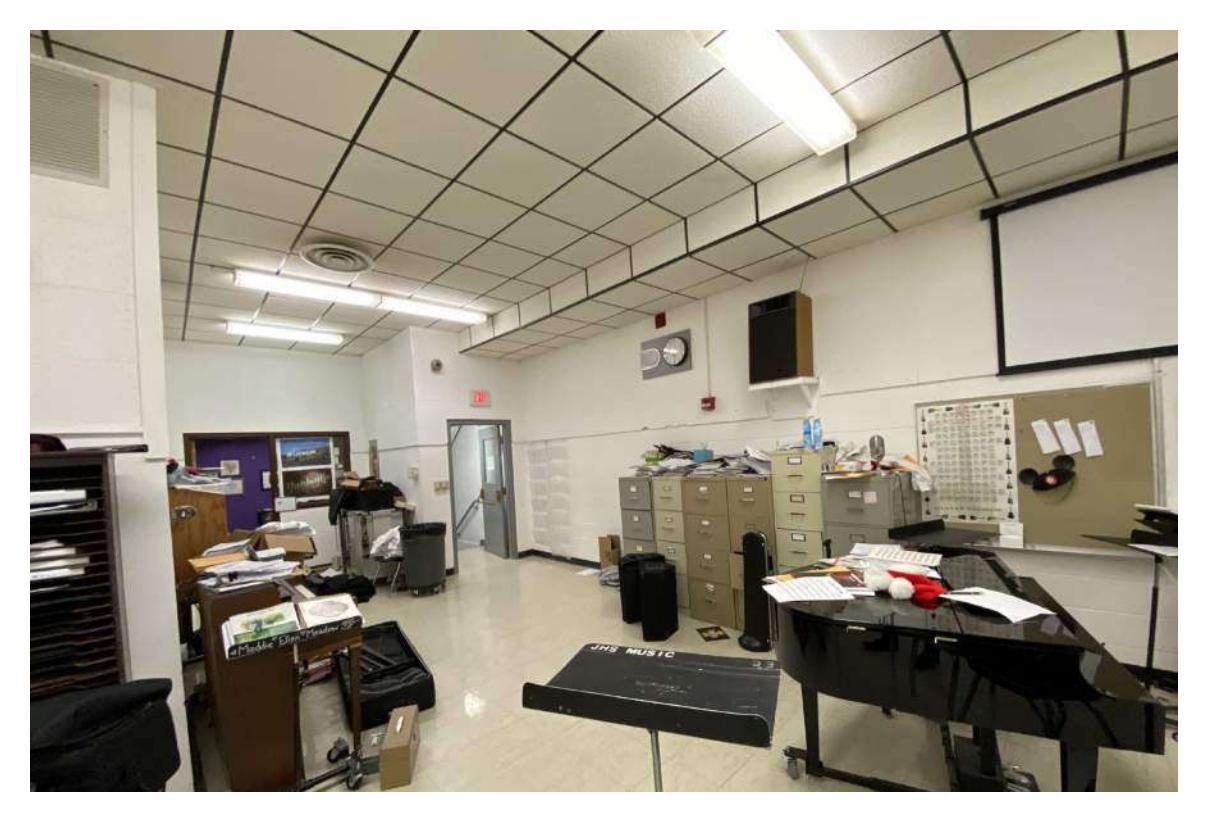
The Music/Band room, also only accessible by stair. This limits access to students and staff with mobility issues.

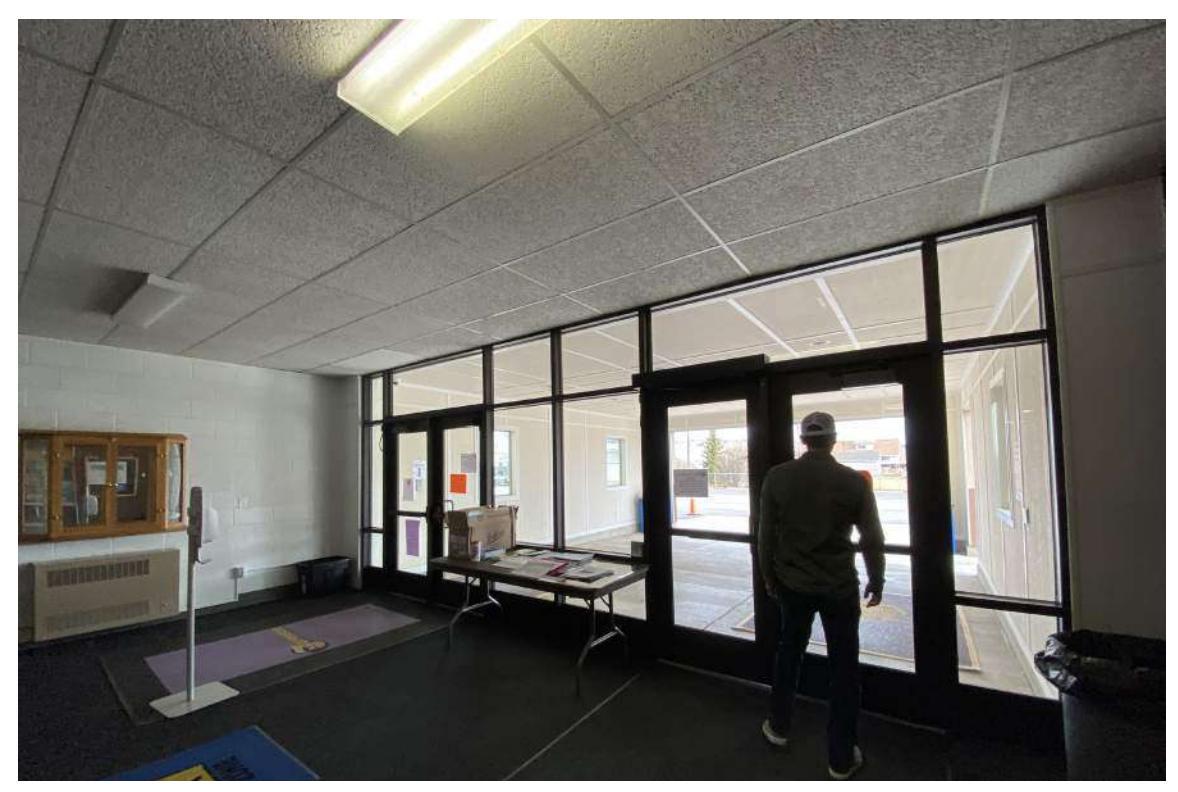
North-facing front entry doors. These have also been upgraded with enhanced security, including a camera and intercom to verify visitor access.

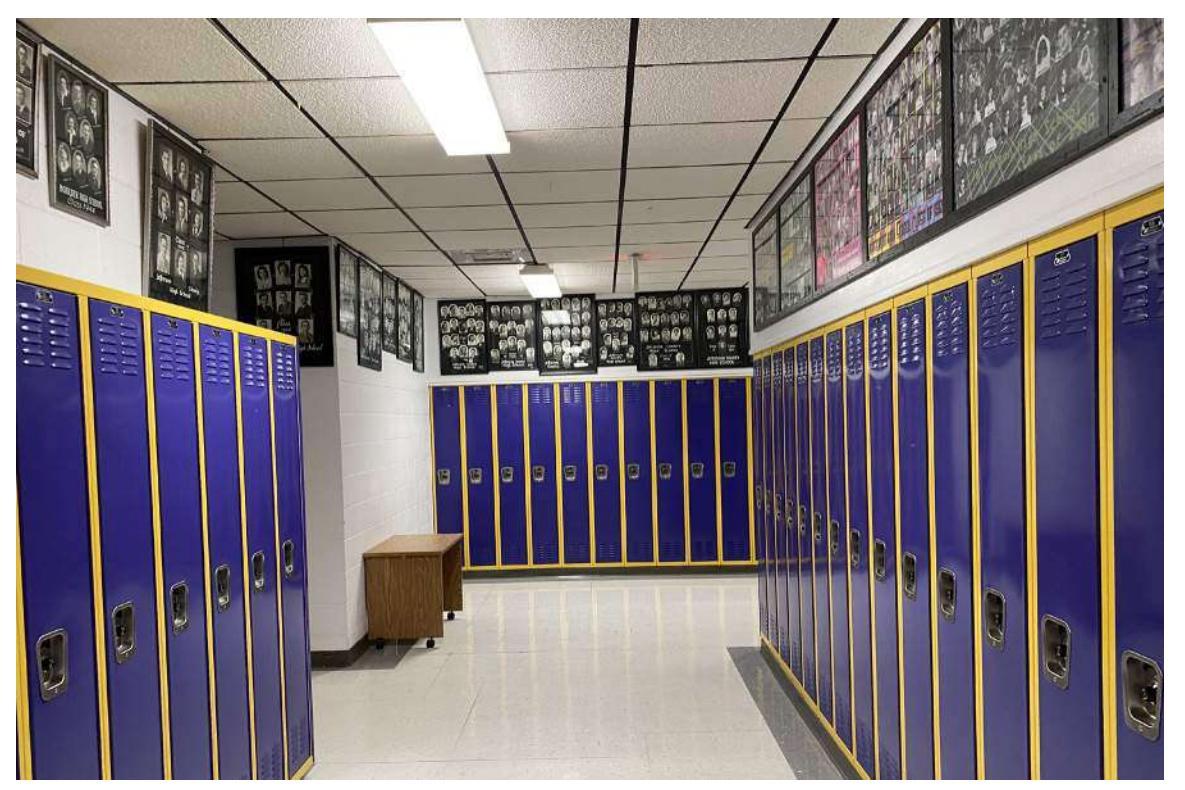
Hallway in Area C, the 1974 addition. Lockers appear clean and new, and hallway widths are acceptable for a school of this size.

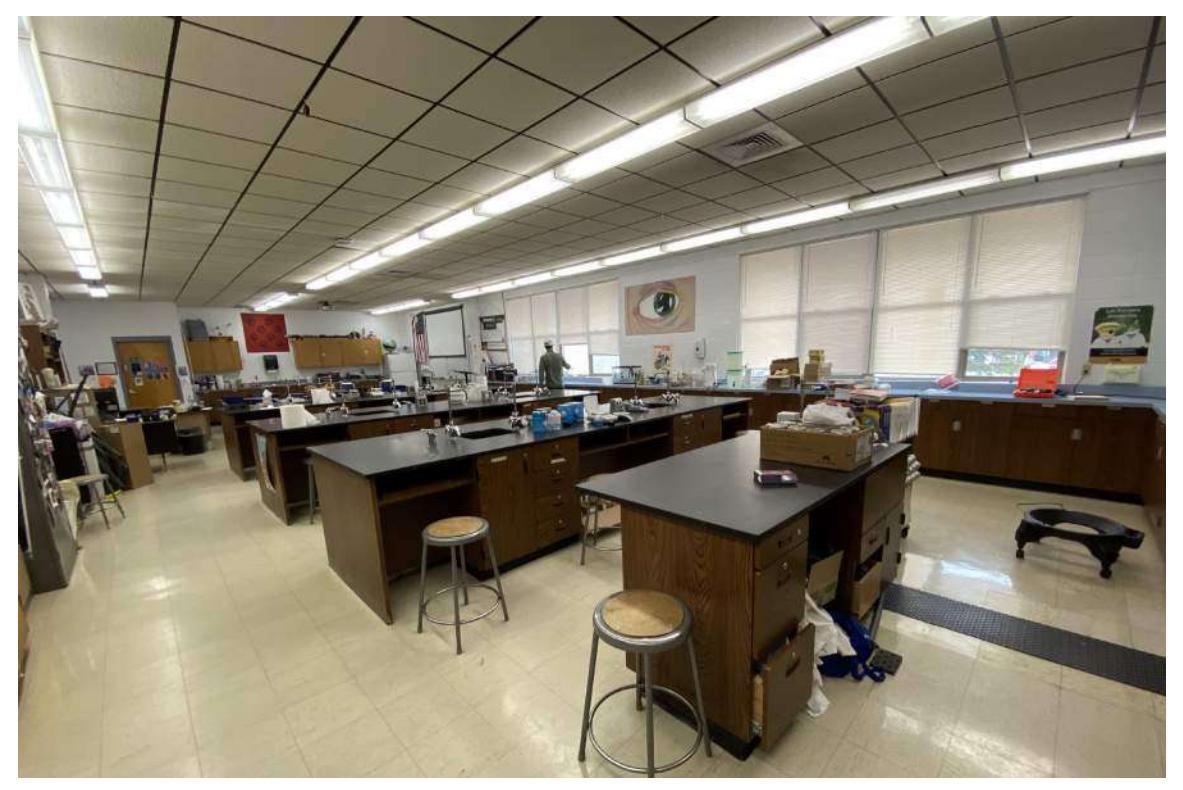
View of the Physical Sciences room. This room is a good size for a science room, based on current design guidelines.

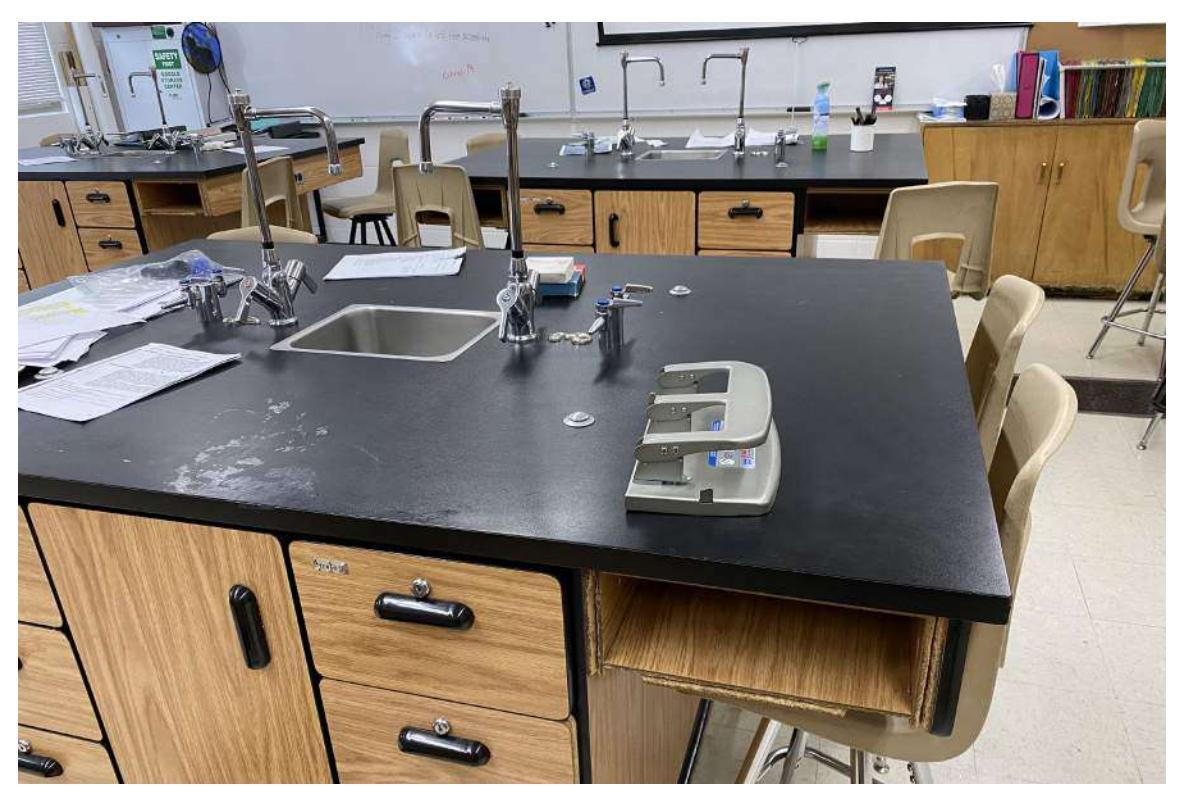
Casework and countertops in the Life Sciences room. While most of these are in good condition, there are areas of wear. This room is too small for a typical science room.

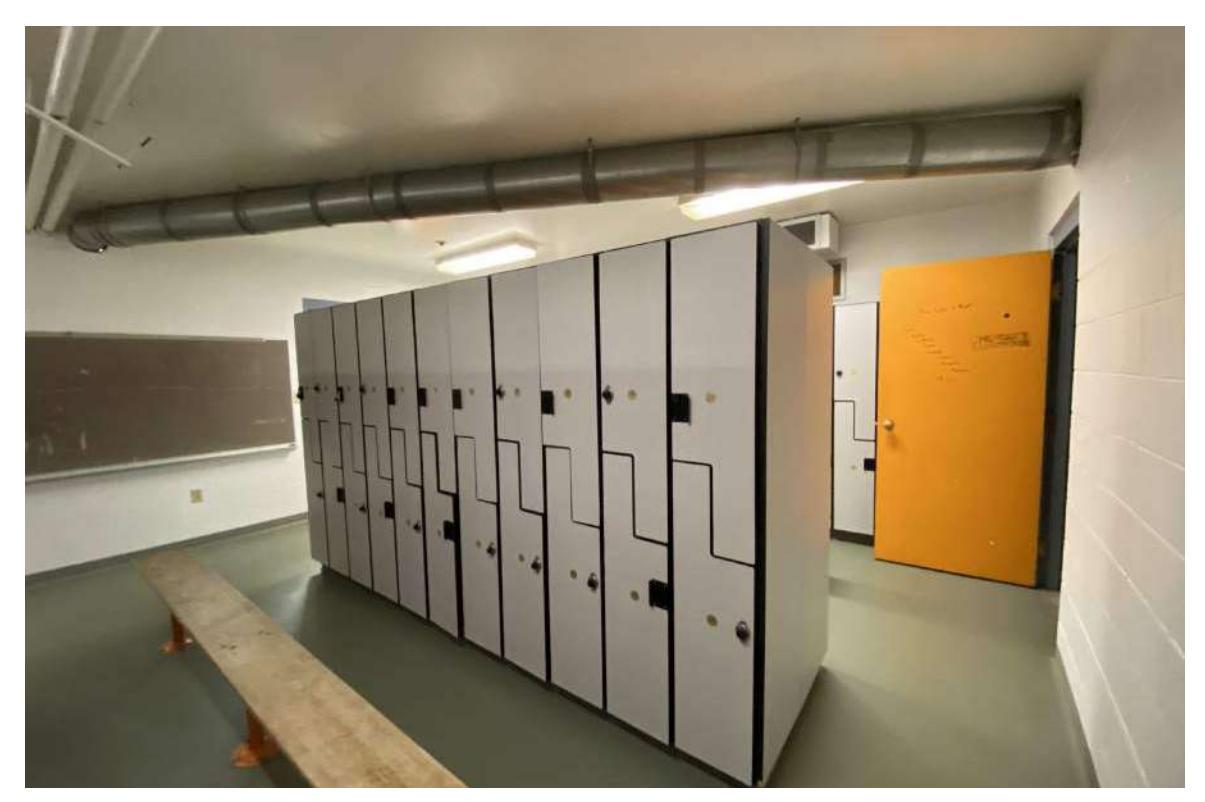
Women's lockers in the lower level of the Existing (South) Gym area. These locker rooms were reported to have issues with accessibility, ventilation, and adjacency to the Men's locker room. These are only accessible by stair.

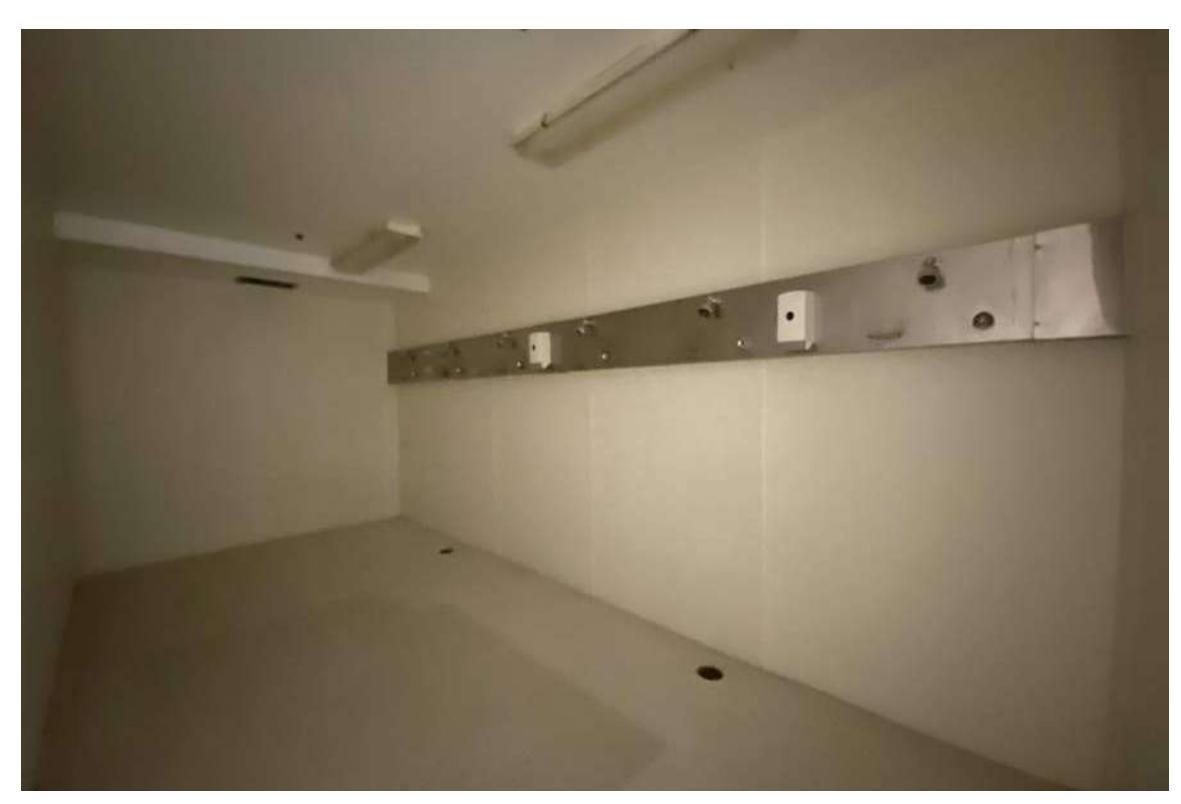
Gang showers in the lower level locker rooms are no longer designed in schools due to bullying and body shaming issues.

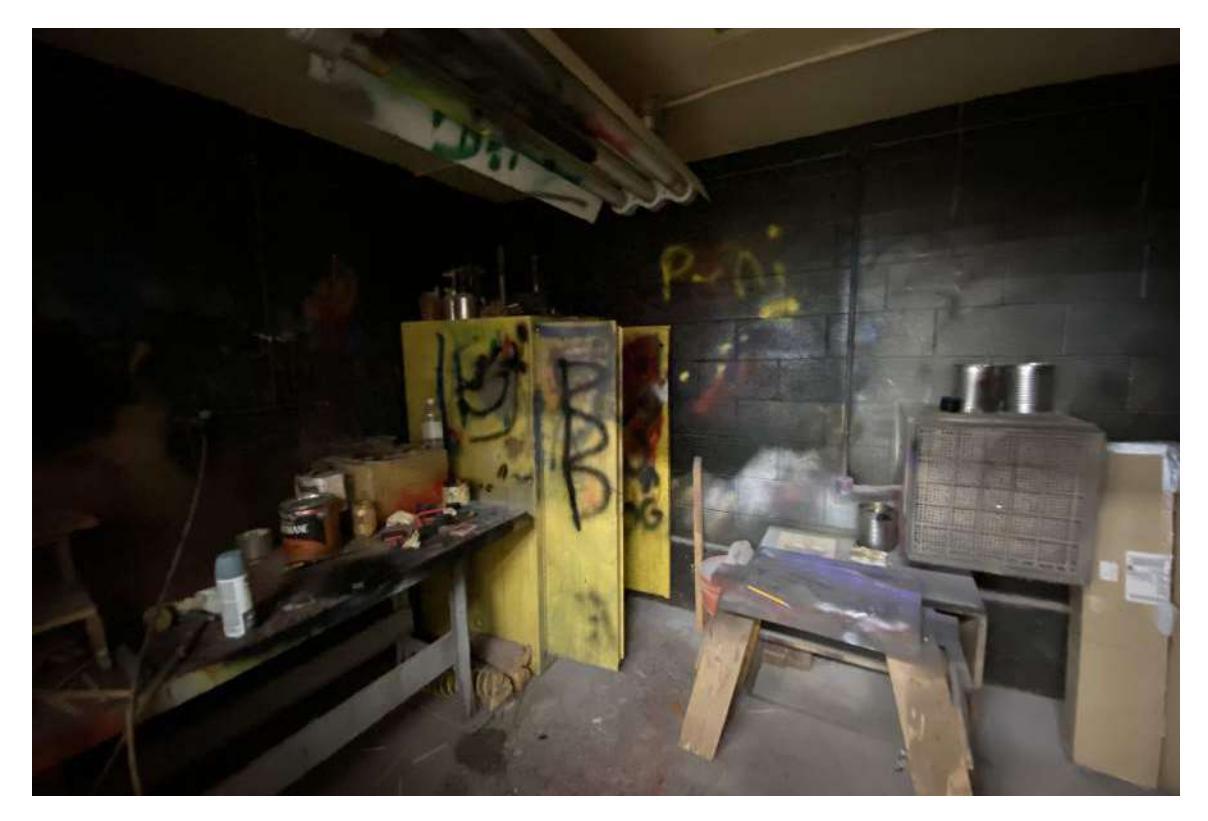
Spray booth in the CTE space. Problems of overspray are reported.

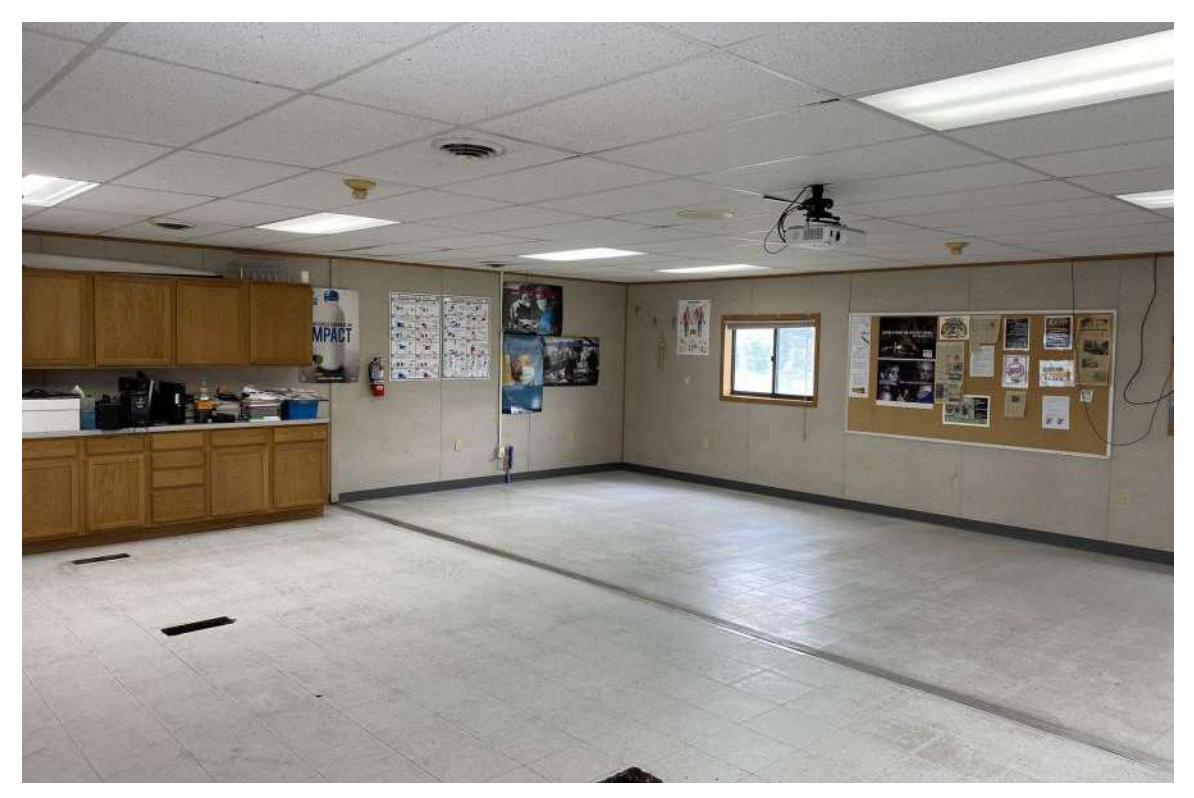
Another modular classroom. Maintenance has been kept up in these rooms and they have floors, ceilings, and casework in good condition.

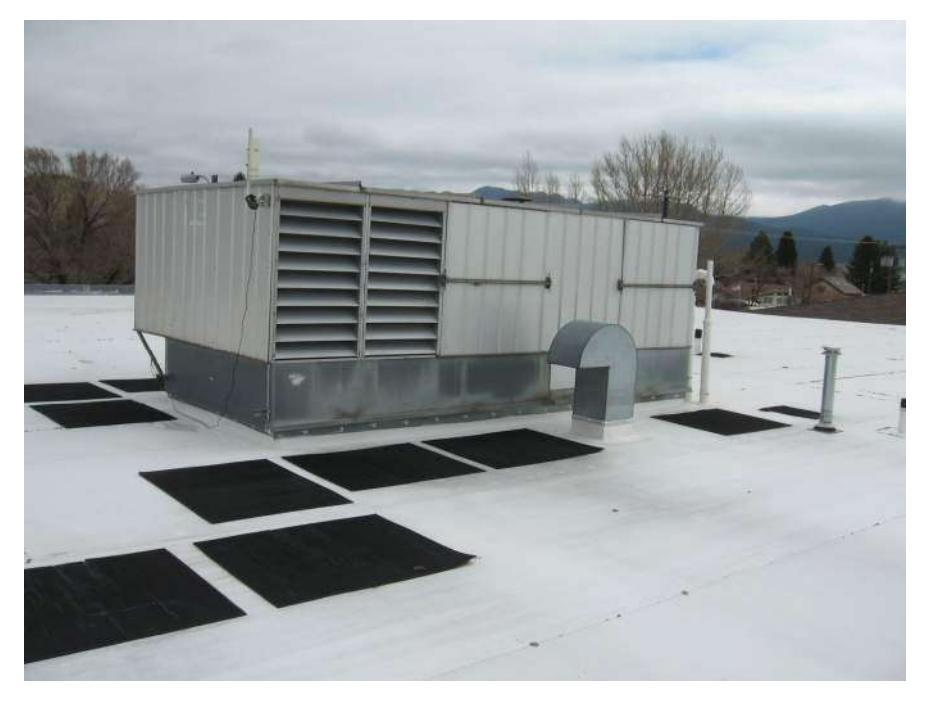
M12: Abandoned Rooftop Unit

Existing Equipment and Systems: This area was originally served with H&V ventilation air from a gas fired rooftop unit. (See M12) That unit has since been abandoned in place and replaced with numerous gas fired American Standard furnaces located in mechanical or storage rooms. Three furnaces are located in C112 with one serving the corridor, one serving C102 Commercial Lab and one serving C101 Home Ec. (See M13) These furnaces bring outdoor air in thru the roof and are separated combustion units with ducted combustion air and vent thru the roof. Room C118 houses two additional gas fired furnaces with one serving C103 and one serving C104. (See M14) These furnaces bring outdoor air in thru the roof and are separated combustion units with ducted combustion air and vent thru the roof. Room C105 is served with H&V ventilation by a gas fired furnace located in a small utility closet in the space. This unit has its vent thru the roof, but combustion air is taken from the space and it has openings thru the exterior wall for combustion air. As a result of these openings, the room is very cold and throws off the thermostat which is mounted on the wall of the utility space. The dampers for the furnace in C105 are older pneumatic style and have a tendency to leak cold air into the room thru the return duct. (Similar to M15 & M16) Room C108, Science Lab is served with H&V ventilation by a gas fired furnace located in a mechanical space D116 in area D. This furnace is a separated combustion unit with ducted combustion air and vent thru the roof.
