Jefferson High School Building Condition Report

312 S Main Street, Boulder, Montana 59632 July 30, 2020

| BUILDING CONDITION REPORT |

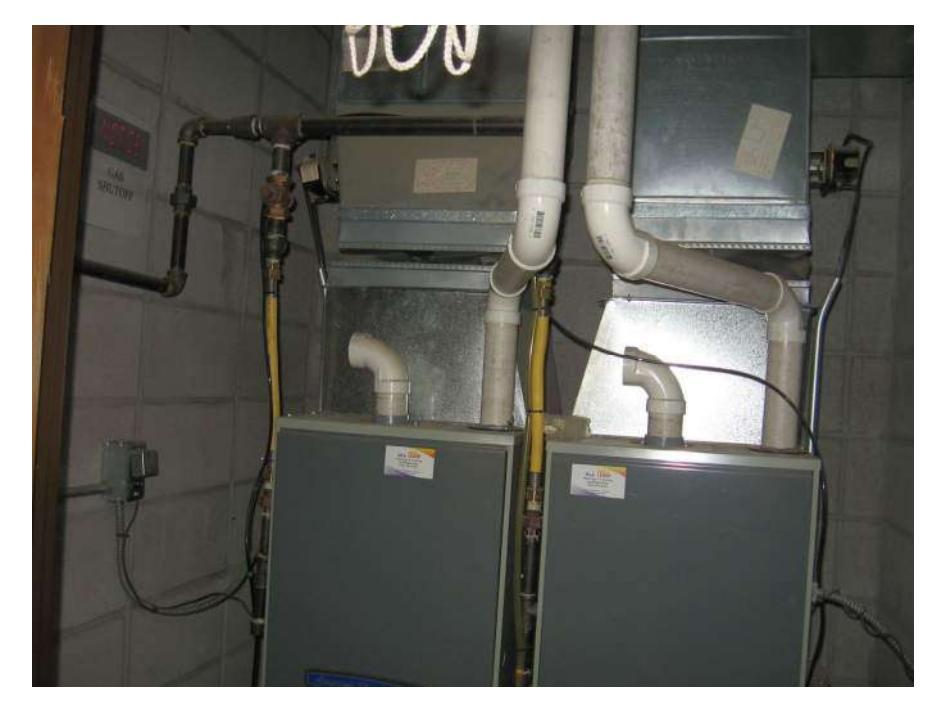
M15: Classroom Room Furnaces

Existing Equipment and Systems: These spaces are served with H&V ventilation by gas fired American Standard furnaces located in small utility closet in each space. These units have their vents thru the roof, but combustion air is taken from the space and they have openings thru the exterior wall for combustion air. As a result of these openings, the room is very cold and throws off the thermostat which is mounted on the wall of the utility space. The dampers for the furnaces are older pneumatic style and have a tendency to leak cold air into the room thru the return duct. (See M15 and M16)

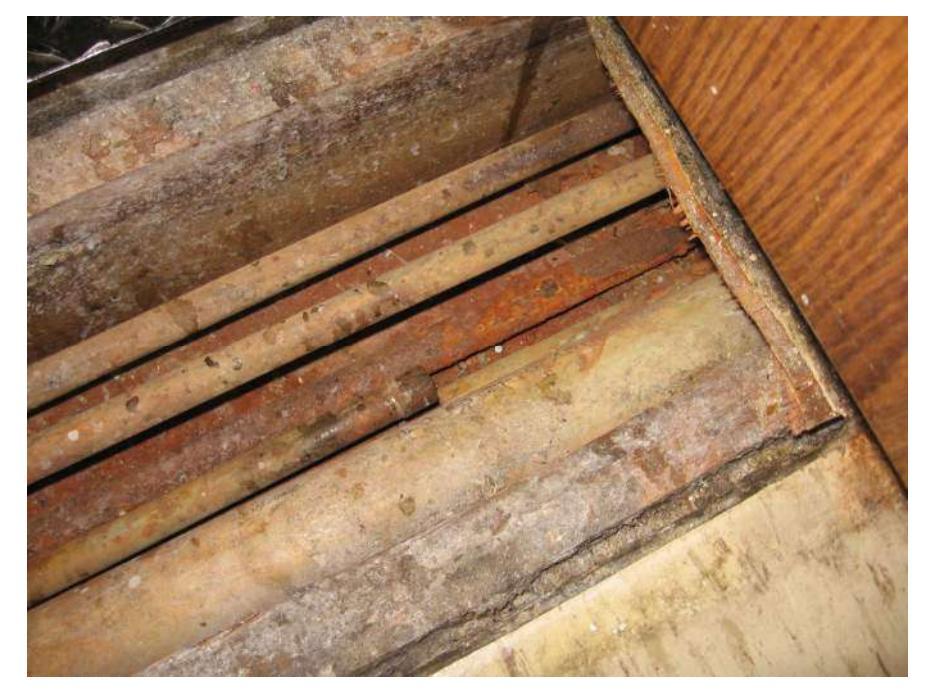
M17: Science Room Trench Piping

Existing Equipment and Systems: The restroom fixtures in this area appear in good condition. Room C108 Science Room has HW, CW, Gas and Waste lines routed a trench in the floor and out to each science table. These lines are very rusted and appear to be in poor condition. (See M17) There is an emergency gas shut off valve located in a wall cabinet at the front of the room. (See M18)

Age and Existing Conditions: These fixtures appear original and in good condition. The services routed in the Science rooms appear to be in poor condition and should be replaced.

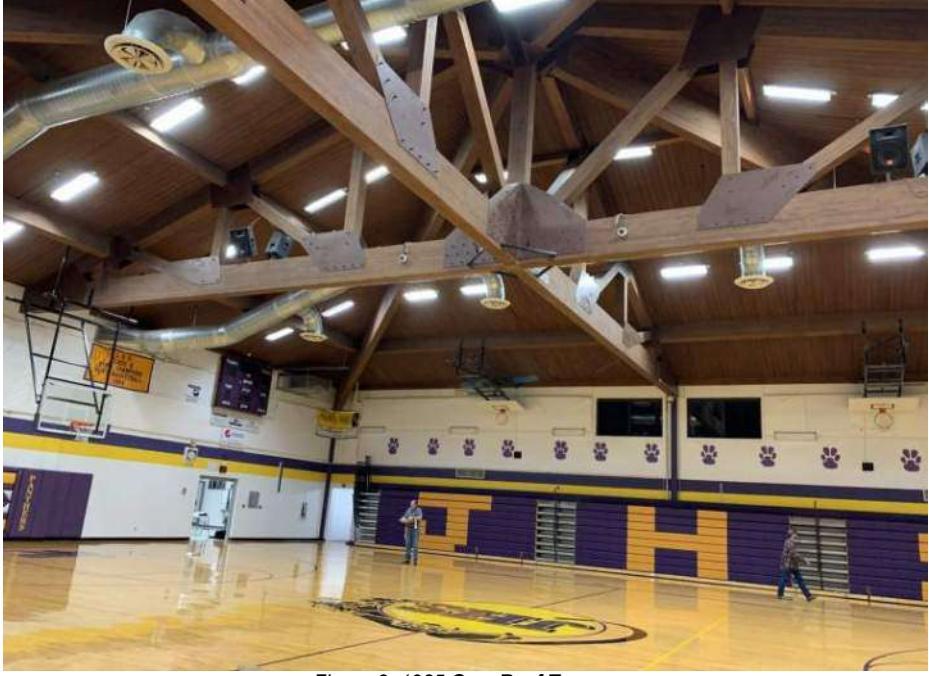
Figure 2. 1985 Gym Roof Trusses

The 1985 Gymnasium structure consists of two large intersecting roof trusses constructed of gluedlaminated timbers (glulams). These trusses intersect at the center of the gymnasium along with four glulam hip beams that span from the center to the corners of the gym area (Figure 2). Smaller glulam purlins span between the trusses and glulam hips and support the 3x6 heavy timber decking roof diaphragm.

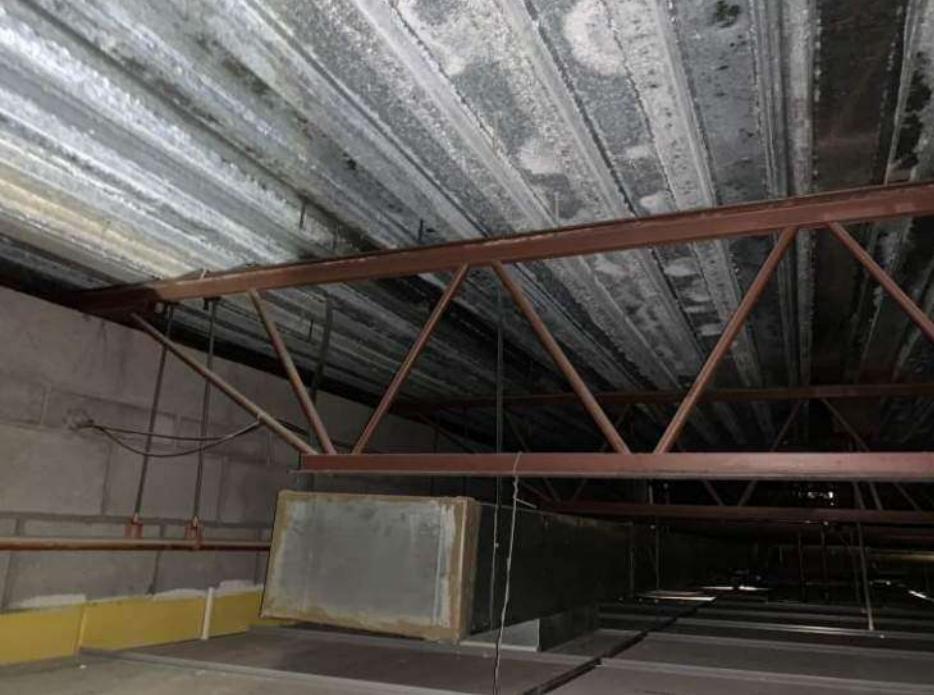
Figure 3. Roof Framing Above Wrestling Room (1985 Addition)

The south wall of the gym is shared with a two-story area consisting of locker rooms on the first floor, and a weight room and wrestling room on the second floor. The roof framing above this area consists of OWSJs spaced at 5-feet on-center supporting a metal roof deck. These joists bear on CMU walls on both ends and appear to be in good condition, as seen in Figure 3. It should be noted that signs of roof leaks could be seen at the interface between the metal decking above the weight room and the wood decking above the gym (Figure 4). At the time of the site visit, none of the structural elements showed signs of water damage.

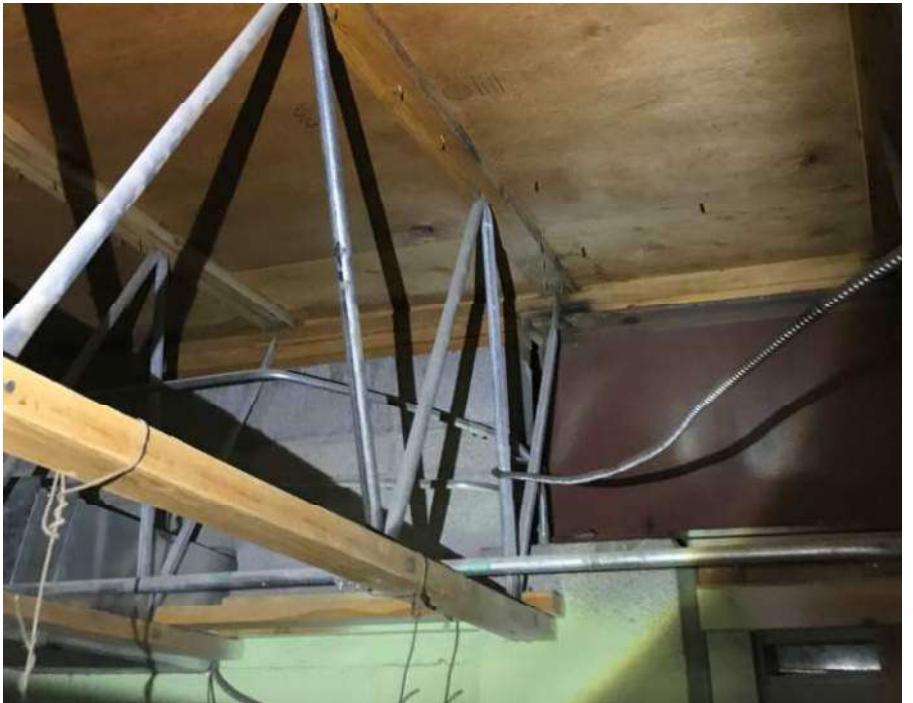
Figure 8. TJL Bearing on Interior CMU Wall (1974 Classroom Addition)

This classroom addition is a single story with CMU bearing walls at the exterior and interior, arranged in stack bond. The roof framing consists of plywood sheathing over TJL joists spaced at 36-inches on-center spanning to the CMU walls, as seen in Figure 8. At the exterior walls, the joists are bottom chord bearing and extend past the wall to form the cantilevered soffit seen from the exterior of the building. The joists and plywood appeared to be in good condition where observed.

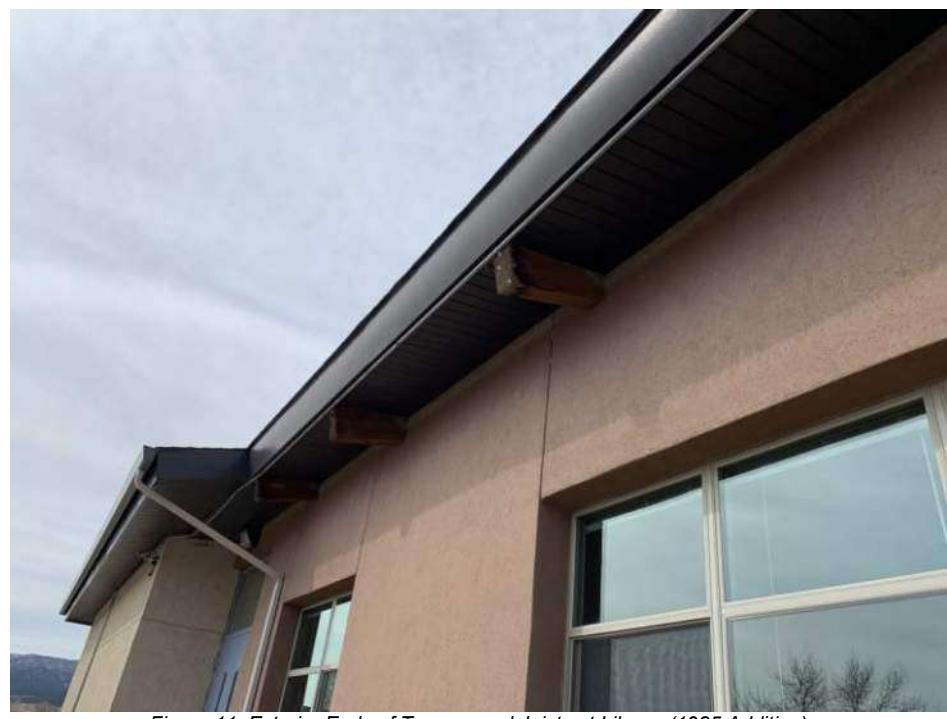
Figure 11. Exterior Ends of Trusses and Joists at Library (1985 Addition)

Over the library, the roof framing consists of 3x6 decking over glulam joists and purlins. These are supported by 3 large trusses that span between CMU bearing walls, as seen in Figure 10. At the exterior, some of the tails of the trusses and joists are showing signs of weathering (Figure 11). This weathering is not yet extreme but, if left untreated, could continue to deteriorate the structural members and eventually compromise the structural integrity.

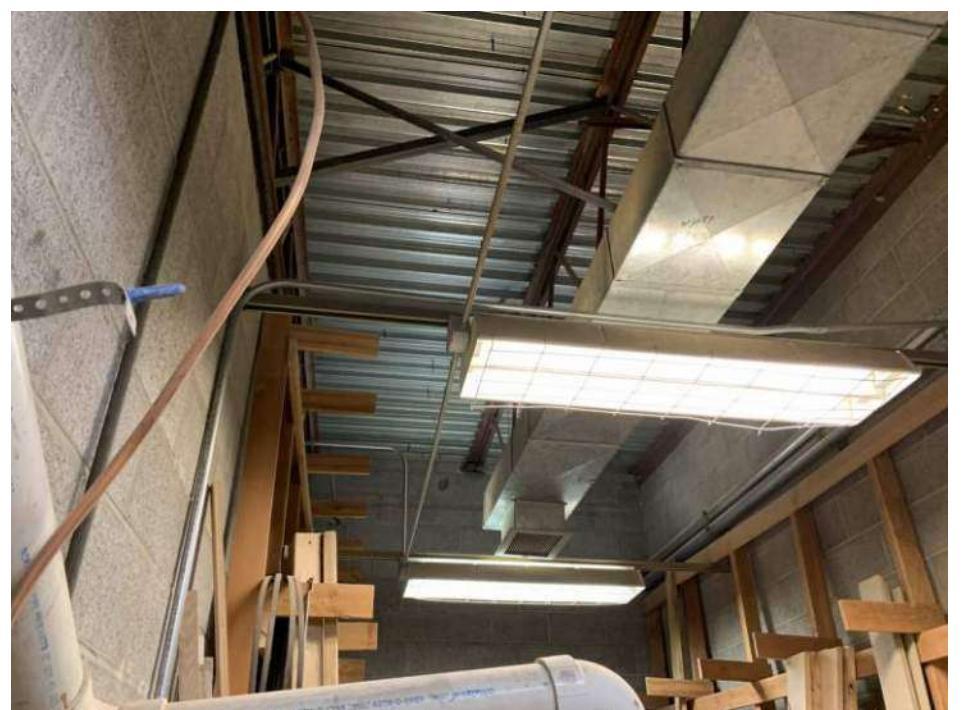
Figure 12. Roof Framing Above Wood Shop (1974 Addition)

The roof framing above the music room and the wood shop is OWSJs supporting metal deck. The joists bear of CMU walls stacked in running bond (Figure 12). The wood shop floor is a concrete slab on grade. The music room is above a basement locker room that connects to the 1956 gymnasium locker room. The walls are CMU laid in running bond and assumed to bear on spread footings. The floor of the locker room is a concrete slab on grade. In this area, the floor framing for the music room could not be observed from below.

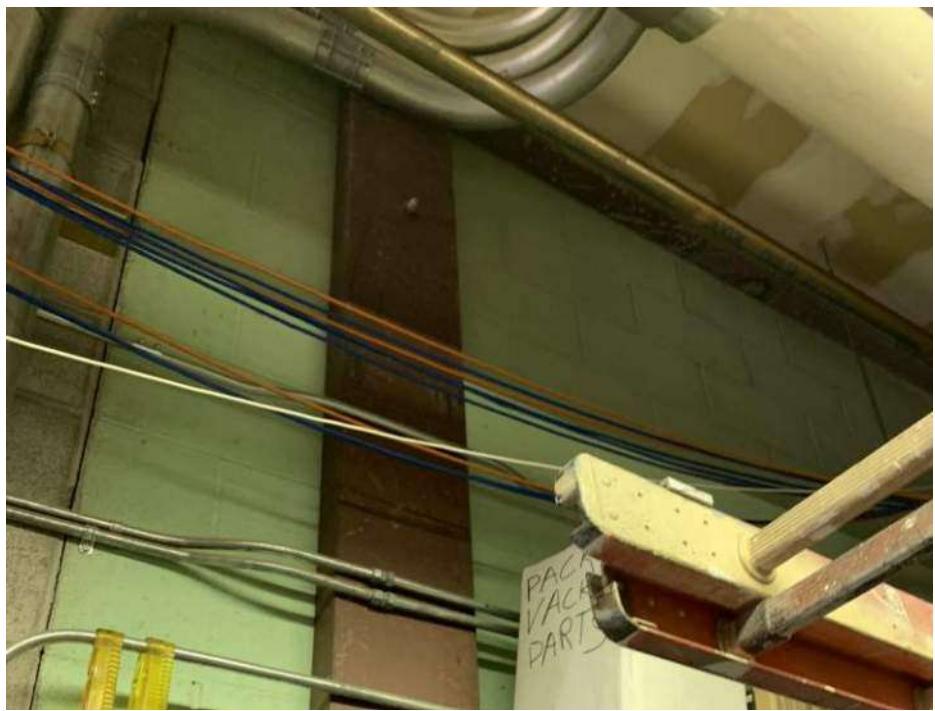
Figure 13. Channel Ledger and Column at Interface Between Mechanical Room and Wood Shop

The weld shop and mechanical room were added to this area in 1985. The construction matches the 1974 addition, with OWSJ supporting a metal roof deck. The exterior walls are reinforced CMU in running bond and bear on spread footings at frost depth with a 4-inch concrete slab on grade for the floor. At the interface between the 1974 and 1985 additions, the OWSJ from the newer addition bear on a channel ledger attached to the wall of the 1974 addition and supported by channel columns also bolted to the wall. One channel column and the bottom of the channel ledger are visible in Figure 13.

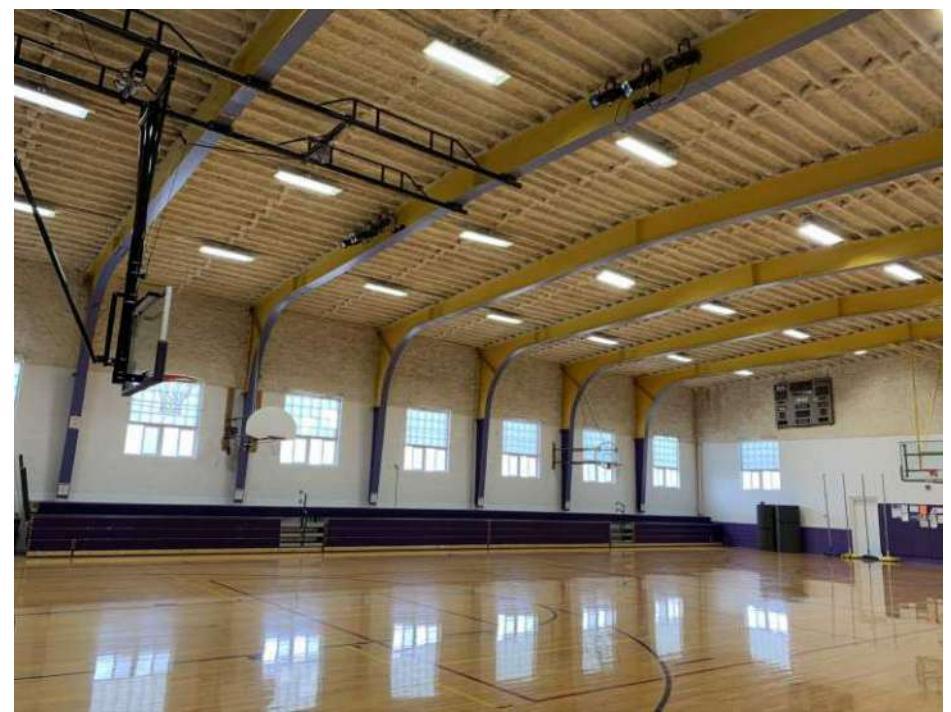
Figure 14. 1956 Gymnasium Overall Structure

The gym has large steel frames spaced at approximately 15-feet on-center that support the roof structure above, seen in Figure 14. The roof structure is covered in a coating assumed to help with acoustic damping. Based on the diagonal blocking visible between the roof joists, we assume that these are wood members spaced at approximately 24-inches on-center. While not visible, we assume that the roof diaphragm consists of diagonal 1x planking based on framing in other areas of the gym. The gym floor, as well as the entrance area, is a slab on grade.

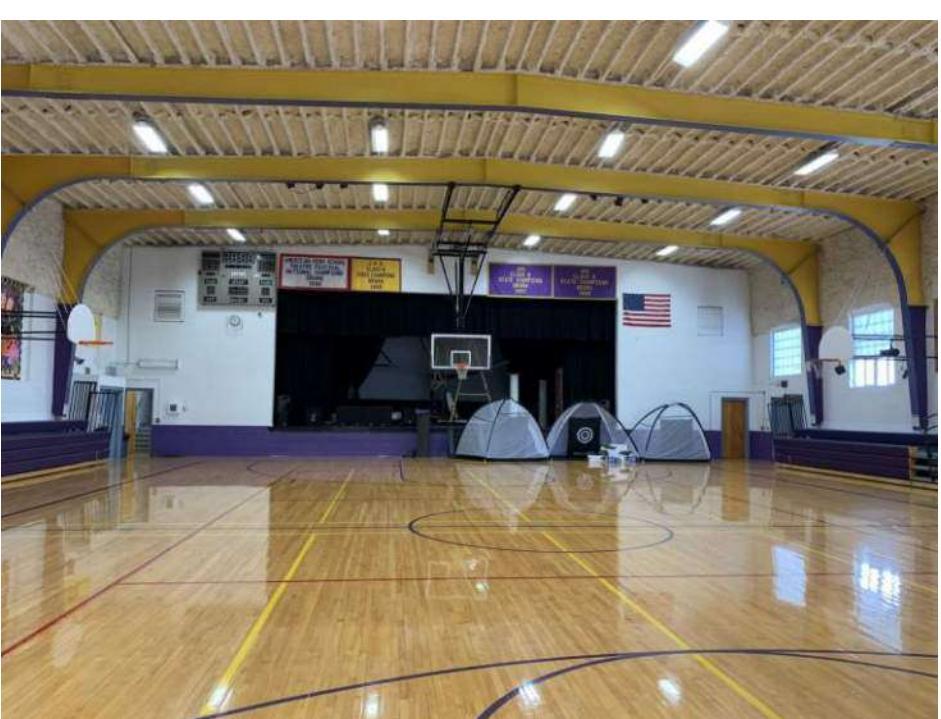
Figure 15. Raised Stage in 1956 Gym

The stage in the gym is raised about 4 feet above the gym floor (Figure 15). The floor framing of the stage is 2x12 at 24-inches on-center supporting diagonal 1x wood planking, as seen in Figure 16. The two storage areas above the stage are assumed to have similar framing.
