Brunswick Junior High School

Overview

The current Brunswick Junior High School was originally opened in 1959. Additions and/or renovations were completed in 1966, 1976 and 1983. The 1959 building included the admin wing, a classroom wing and the gym. The 1966 addition added a single story classroom wing to the west that includes the current music room. The 1976 project included renovations to the entire building plus four additions. The additions included a two story wing to the front of the building for special ed and science on the first floor and the library on the second floor; the industrial arts wing; locker rooms and an expanded cafeteria. The original two story classroom wing was fully renovated in 1983 after fire damaged the wing. Refer to the key plan below. Although there have been some upgrades and maintenance repairs over the years, no further major renovations or additions have been done to the school since 1983.

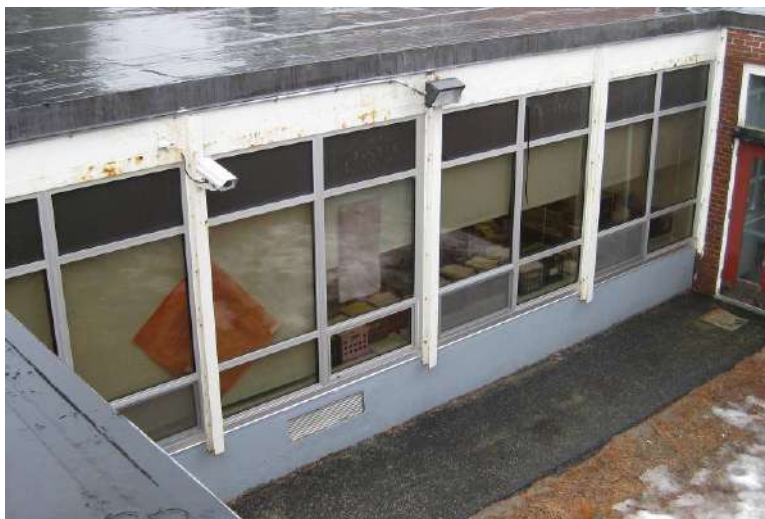
Original 1959
Windowwall

There have been a variety of window types used relative to the different additions and renovations. Aluminum windowwall was used on the original 1959 building along with the 1966 classroom addition. The 1976 additions and the 1983 renovations used non-clad wood windows. There is glazed aluminum storefront at the main and gym entrances. All glazing appears to be insulated glass. It has been reported that much of the original windowwall is leaking. In addition, some of the wood windows are rotting. This is particularly evident at the clerestory windows of the 1976 classroom addition. The windows in the gym are translucent wall panels – Kalwall - that were installed in 2000. Replacement of the original windowwall and the rotting wood windows should be a priority and are currently included in the capital improvement budget. Replacement of the remaining wood windows in the two story wing, although not a high priority, should be considered for a future project.

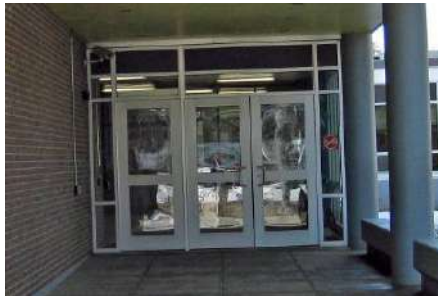
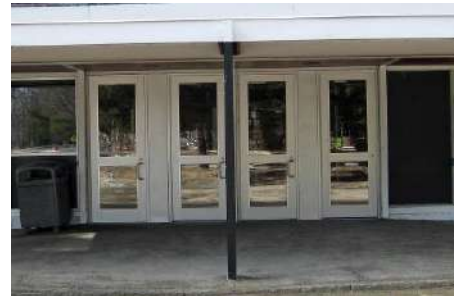
Main Entrance

The majority of the exterior doors and frames are hollow metal and are original to their respective construction. A few of the original hollow metal doors and frames have been replaced with aluminum doors and frames, such as at the gym entrance, FLS and the art room. The current main entrance is also aluminum.

Many of the exterior hollow metal doors and frames that are not in protected locations are showing signs of rust and deterioration of the finish. The hollow metal doors and frames that are in the worst condition should be considered for replacement. Those doors that are currently unprotected and most vulnerable to damage caused by moisture and rusting may want to be replaced with heavy duty aluminum doors and frames. Other doors and frames that are in more protected locations may be able to be repaired and repainted depending on the level of rust damage.

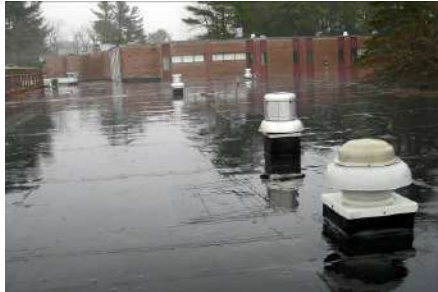
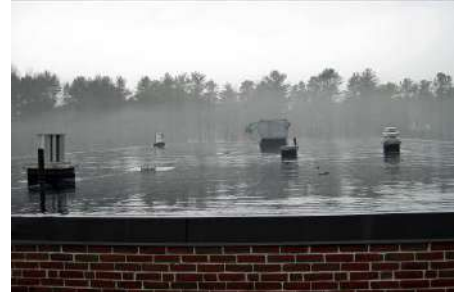
1966 wing looking east

All of the roofs are of a single-ply rubber membrane that is fully adhered typically over a base of rigid insulation. The one exception is the roof on the two-story classroom wing, which includes a layer of stone for ballast that is typically installed over top of the loose laid membrane to keep the membrane in place. The roof on the classroom wing was done in 1983 during the fire restoration.

Fully adhered rubber
membrane roof

The roofs all drain internally to roof drains that are installed in sumps. There was a reroofing project done in 1992 that originally included installation of tapered insulation to improve drainage to the drains but apparently much of the tapered insulation was deleted around the outer areas of roof that has resulted in those areas being flat with no pitch. It is not known why areas of the tapered insulation were deleted. The lack of tapered insulation over much of the roof is a contributing factor to water draining over the edge of the roof and down the face of the building impacting the windows and the brick. Consideration should be given to correcting this condition in the near future to eliminate the drainage problems by adding a raised curb or parapet or reroofing the affected areas and adding tapered insulation.

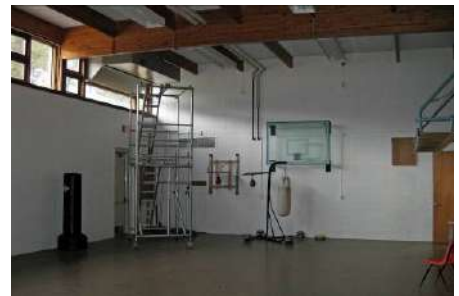
The gym floor is wood and generally in good condition but is in need of refinishing to restore it to its original condition. The adjoining small gym has a resilient floor and is in reasonable condition. The fitness room and locker rooms are painted concrete while the toilet and shower areas are ceramic tile.

Small Gym – Resilient Floor

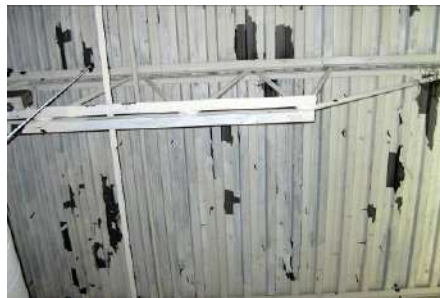
Painted Metal Deck in Art/Chorus

Most of the suspended ceilings are in reasonably good shape. Some of the ceilings in the 1966 classrooms have some tile that have been displaced and may just need some readjustment. The painted finish on the exposed metal deck in the chorus and art rooms is peeling off and needs to be stripped and refinished. The peeling is probably attributable to incompatibility between the metal deck and the paint. The metal ceiling in the lobby has loose sections and the original integrated lights are no longer used. This ceiling should be considered for replacement.

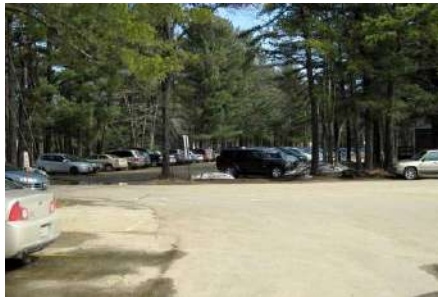
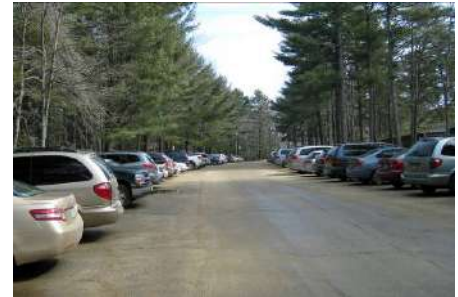
Main Drive at Parking Lot

Overall, the driveway and parking pavements are in acceptable serviceable condition, without significant deterioration. A program of patching cracks with hot-applied flexible crack sealer will help prolong the pavement life by keeping water from saturating the cracks and accelerating break-up. Currently there is no fire truck access drive around the west and south sides of the building. Historically, the maintenance crews have plowed a roadway around the building on the grass during the winter. A gravel or paved access drive approximately 10 feet wide would be recommended around the building. There are also approximately four doorways around the building that open on to lawn areas with no walkway. In the winter these doors must be accessed with a shoveled path away from the building for emergency exit. Gravel or paved walks should be constructed to each exterior door to facilitate snow removal and emergency exiting, and perhaps could be combined with a new fire lane.

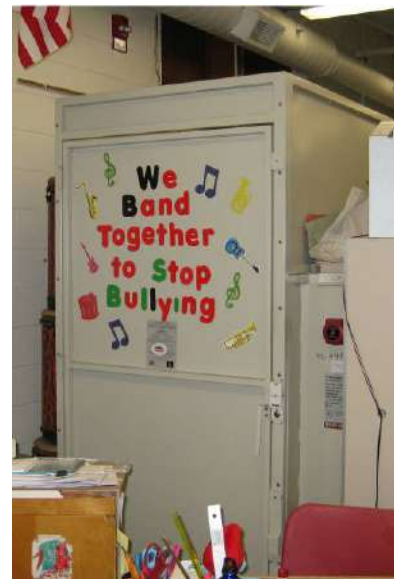
The music room and the stage are also at different levels than the first floor. Two vertical lifts have been installed – one at each location – to provide access to those two functions. It does not appear that the lifts are used frequently as both are blocked by furniture.

Vertical Lift in Music Room

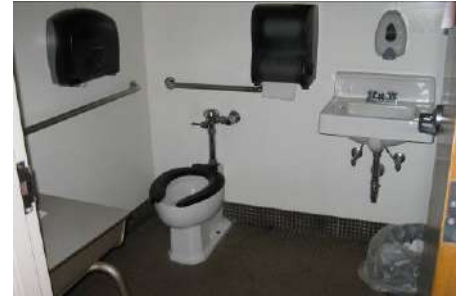
None of the student toilet rooms and most of the staff toilets rooms are not handicap accessible. A couple of single user toilets have had modifications made to them to provide limited accessibility but they are not fully compliant as they lack proper clearances, fixtures, pipe protection and grab bars. The existing toilet rooms should be fully renovated to provide compliant and accessible fixtures, paths of travel and maneuvering clearances. New fixtures would also offer water

Non-Compliant "Handicap" Toilet Room

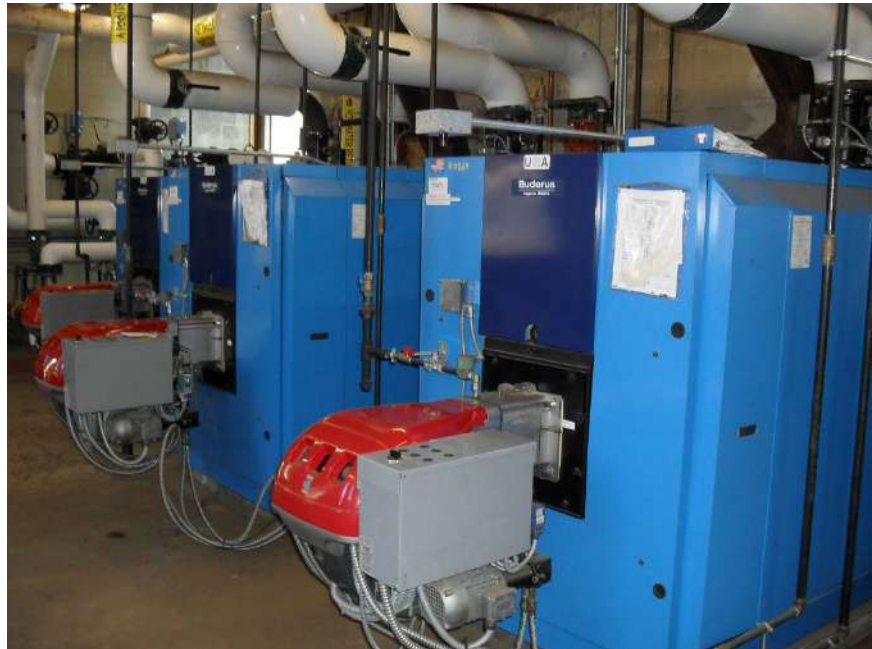
Figure 1 – Cast Iron Boilers

The three boilers that were installed in 2006 are manufactured by Buderus. Each of the boilers is equipped with dual fuel Riello burners. Boiler number one has a gross rating of 1,951 mbh and a net rating of 1,697 mbh. The remaining two boilers have a gross rating of 2,822 mbh and a net rating of 2,454 mbh. When the boilers were converted to burn natural gas a few years ago, the oil piping coming into the boiler room from an underground oil tank were cut, capped and abandoned in place.

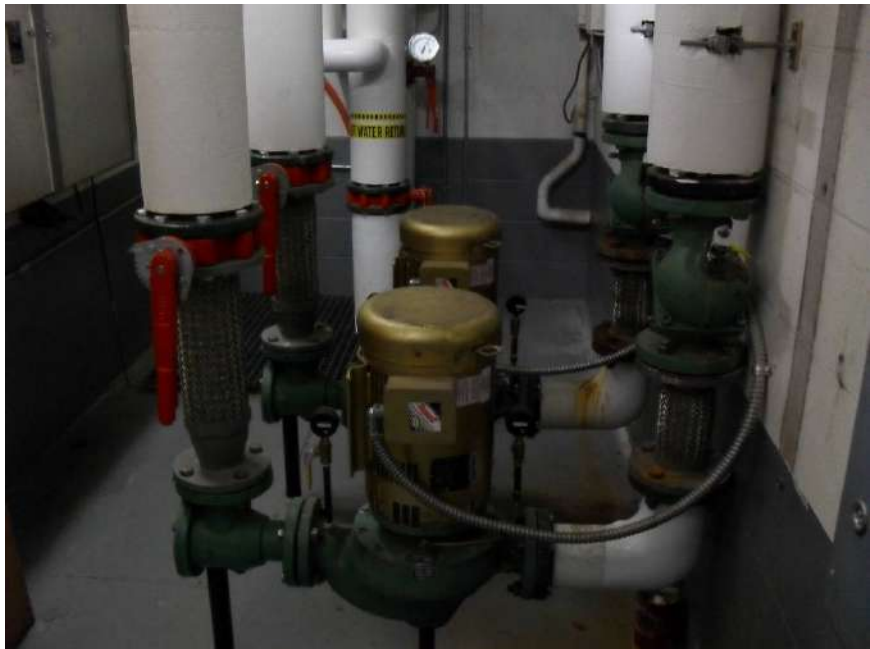
Figure 6 – Corner of building where HWS&R enters JHS

The hot water supply and return piping enters the Junior High School in the corner closet adjacent to the Special Ed classroom area. From this room the HWS & R piping is distributed throughout the entire school, feeding terminal heating devices such as unit ventilators, fin tube radiation, cabinet unit heaters, duct-mounted heating coils and hung unit heaters.

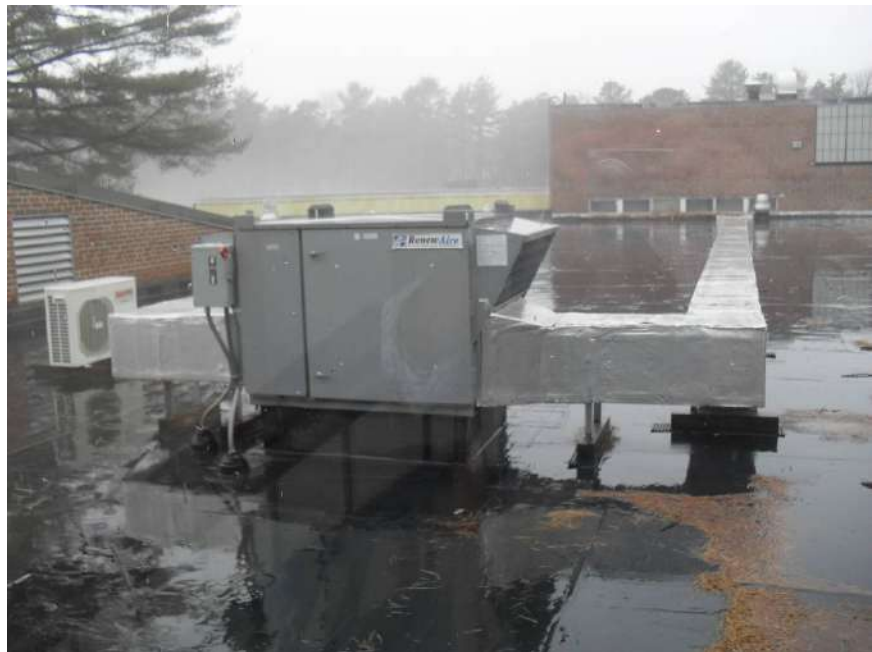
Figure 7 - Typical rooftop energy recovery unit

Over the recent several years (2006 to present), the primary ventilation system for the 200 wing classrooms, a portion of the 300 classroom wing and the cafeteria was upgraded with the installation of 9 rooftop energy recovery units and one inside energy recovery unit. These units range in airflow capacity from 1,500 cfm down to 380 cfm. These units are all manufactured by Renewaire except for the Cafeteria unit, which is manufactured by Cook. A significant amount of the ductwork serving the 200 wing is exposed to the elements and located on the roof. The ductwork serving the 300 wing area is located within the facility however it is exposed along the common corridor. During the 1983 renovation of the classroom wings (100 and 200), new ceiling hung unit ventilators were provided. Outside air was brought into the backs of the UV's via ducts that were connected to exterior wall louvers. Independent barometric pressure relief dampers and louvers were provided to account for relieving the air to the outside. Some of the ductwork associated with a couple of these units is exposed with exposed heating coils and associated piping. A five ton Trane rooftop cooling only unit was also recently provided for the Administration area of the facility. Its ductwork is primarily exposed within the space.

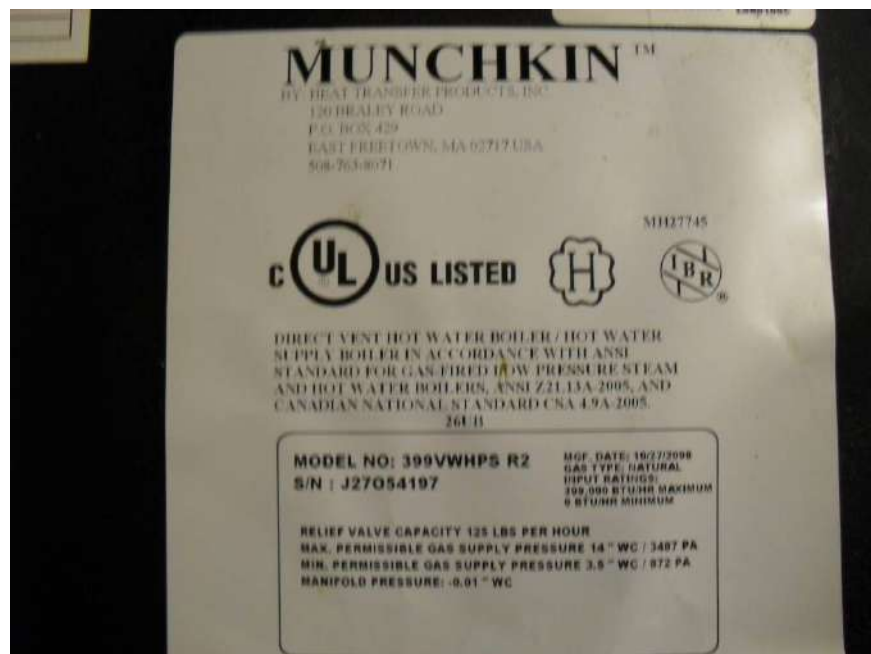
Figure 8 – Primary
Domestic Water Heater
Nameplate

The primary source for domestic hot water is provided by a natural gas fired direct vent hot water heater. The water heater is manufactured by Munchkin. The model number is 399VWHPS R2. Its input capacity is 399.9 mbh. The DHW is connected to three 115 gallon Superstor tanks. This water heater is relatively new and should last for several years to come. There is a DHW recirculation loop throughout the facility. The recirculation pump is located adjacent to the storage tanks. Reports are that the pump still takes significant time to get hot water out to the more remote parts of the school. Further investigation revealed that during the 1983 construction work in the 100 and 200 wings, the DHW recirculation loop piping was actually disconnected. We believe that if the piping in this area is reconnected to the primary recirculation loop, the time in which it takes to get DHW down to the ends of the 100, 200 and 300 wings will be dramatically reduced. There are also a couple other isolated electric water heaters located within the school. One in the health sciences wing and one in the Special Ed wing.

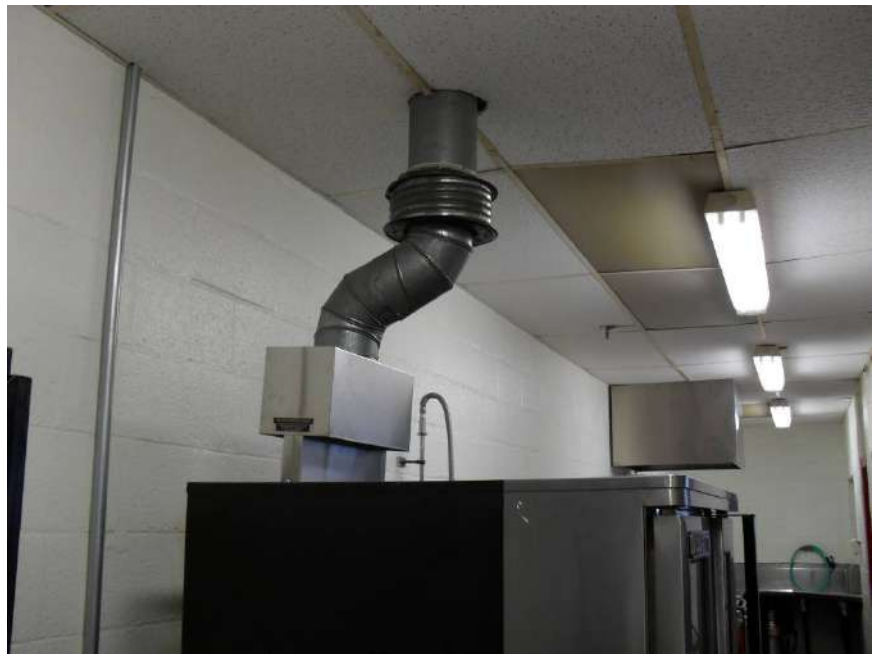
Figure 11 – Kitchen
Ovens and Dishwasher
Hood

The kitchen which is located directly off the cafeteria is only used as a warming kitchen. It is equipped with a couple of commercial ovens and a commercial dishwasher. During the end of 2011 and the first of 2012, a new roof mounted energy recovery unit was installed to provide a higher level of ventilation. A duct mounted hot water heating coil is located in the supply duct main just as it drops through the suspended ceiling outside the Ala Carte area of the cafeteria. The duct work is all exposed in the cafeteria. At the time of our site visit, the system had not been activated and automated by the control system. At the time of this writing, we have been told that it is now completely automated and operational.

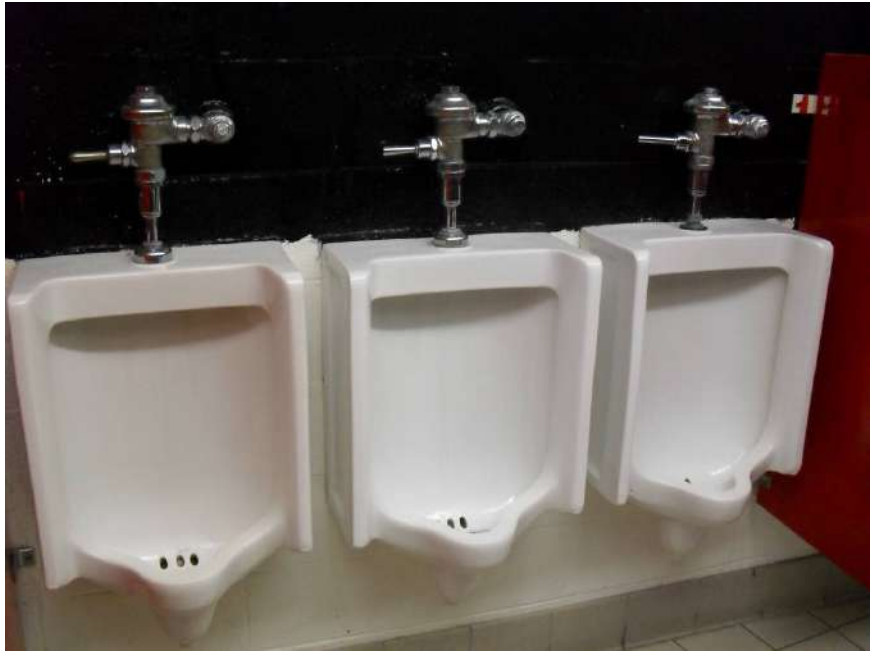
Figure 14 - Typical
Urinal Bank

The plumbing fixtures appear to all be original. The water closets are approximately flushing at 3.5 gallons per minute and the urinals are flushing at 1.25 gallons per minute. No handicap fixtures were noted throughout the school.

Plumbing	<p>Since all of the plumbing fixtures appear to be original, we would recommend replacing them with low flow fixtures. Even though there are several handicap stalls located throughout the facility the plumbing fixtures located within the stalls are not handicap accessible and will also be required to be brought up to comply with ADA requirements. Additional modifications will be required to make all lavatories and toilets accessible as well. Opinion of probable cost - \$1,000 per fixture.</p> <p>Reconnect DHW recirculation loop piping in the connecting corridor area of the 100, 200 and 300 wings. Opinion of probable cost - \$24,000.</p> <p>The existing gas fired domestic water heater located on the Mezzanine above the stage is not currently DDC automated. Recommend providing full automation. Opinion of probable cost – \$12,000.</p>

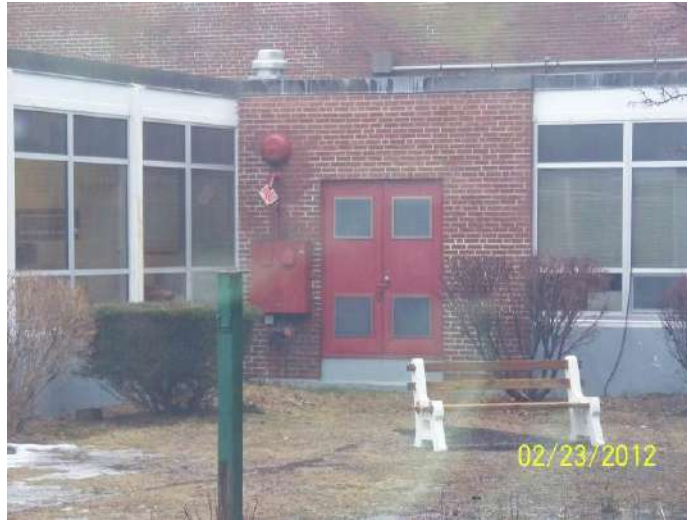
Transformer Vault &
CMP Metering Cab.

The Brunswick Junior High School is served by three 50kVA (150kVA total) transformers located in a locked vault. This 208V-3Ø-4W service is fed from an underground primary distribution system originating at the utility pole in front of the school. Information from Central Maine Power indicates that the maximum demand to date has been 136 kW.

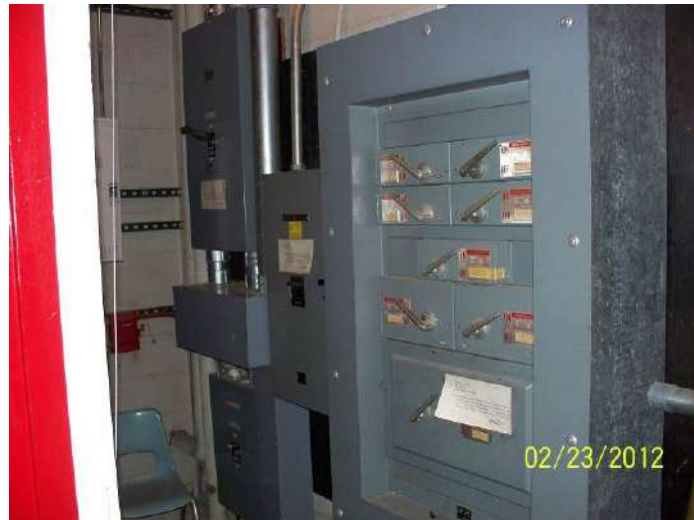
Main Disconnects:

The existing electrical service consists of multiple main disconnects that have been added over the years as the school has been expanded. The original electrical service was rated for 400A at 208/120V, and is located in an electrical room that backs up to the transformer vault. This room is very small and does not provide the clearances required by the NEC. Also located in this room are the main disconnects for the following 1976 additions; “Shop/Home Economics” (600A-208/120V), “Media-Center/Library” (400A-208/120V) and the “Gym/Cafeteria” (100A-208/120V). All main disconnects are circuit breaker type, the main distribution panel is switch and fuse. As the school has expanded distribution panels have been added and are fairly well distributed. This provides efficient electrical service to loads throughout the school. Sub-panels serving branch circuits are scattered throughout and are of many different manufactures/types, most of which are no longer manufactured.

- § The equipment that comprises the service entrance is in violation of the National Electric Code because of lack of required clearances.
- § Also, there may be a mistake in the labeling of the mains for MDP1 and MDP2, this should be verified.

The existing service entrance equipment should be upgraded, reducing the number of mains and providing required clearances and additional capacity if necessary. All of the older sub-panels should be replaced with new panels providing additional circuit capacity and maintainable equipment. Additional transformer capacity will be required if additional loads are added to the building.

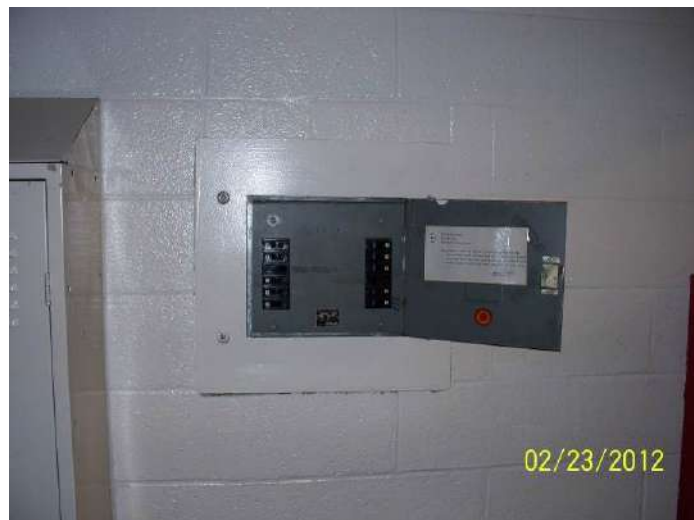
Typical panel (L6)
located in corridor near
Gymnasium.

- § Most of the existing sub-panels appear to be original (installed when the respective additions were built), between 30 and 40+ years old. Much of the equipment is from manufacturers that are no longer in business and other equipment has been discontinued and is no longer supported by replacement parts.

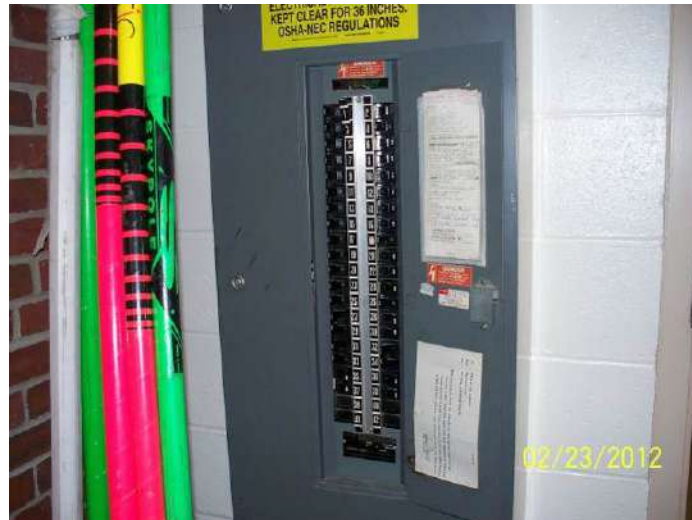
Sub-Panel (LG) located
in Gym Storage

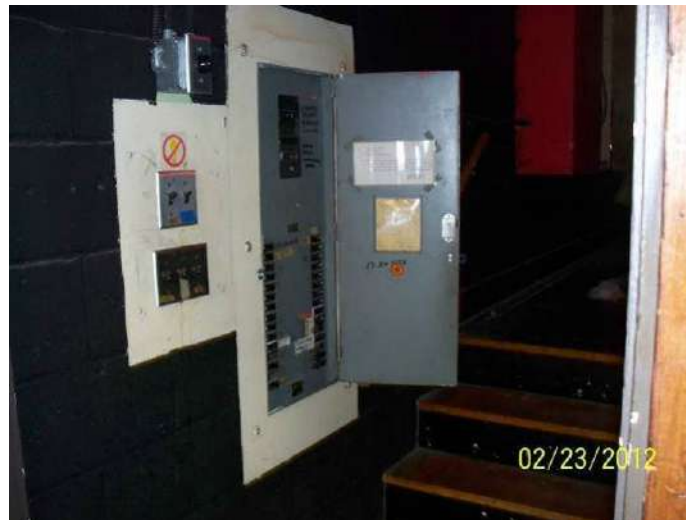
Sub-Panel (L5)
located in Stage area

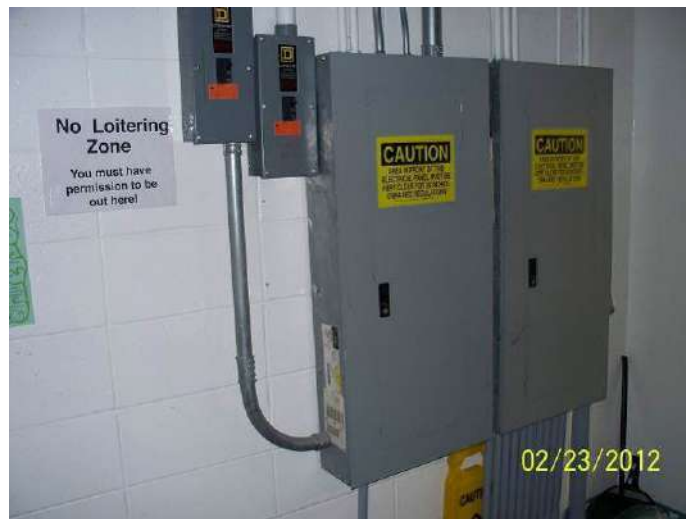
Sub-Panel (PM) in
Shop Wing

- § The panels located in the Shop/Home Economics wing are relatively new and in good condition.

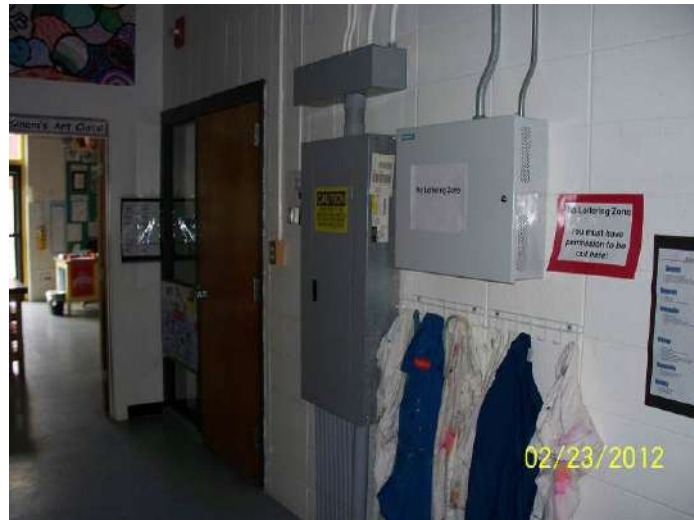
Sub-Panel (PW) in
Shop Wing

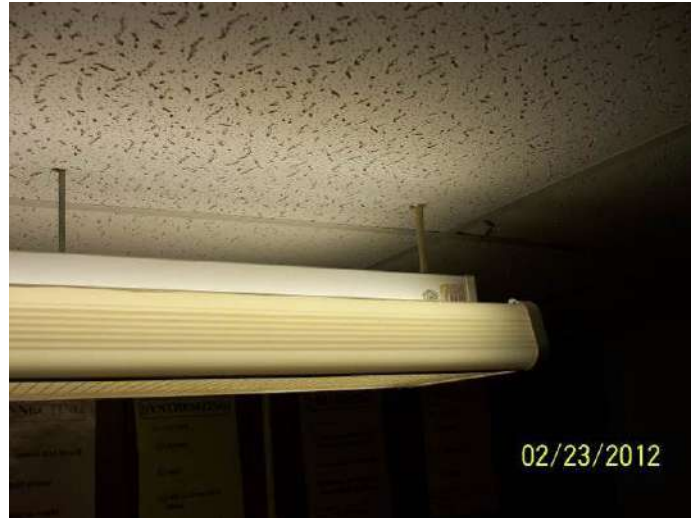
Romex - passing through
ceiling tile.

- § Romex is not approved for use other than as building wiring. All fixtures being fed with romex through ceiling tiles should be retrofitted with cords through canopies and junction boxes. It is a code violation to run wiring through building finishes.

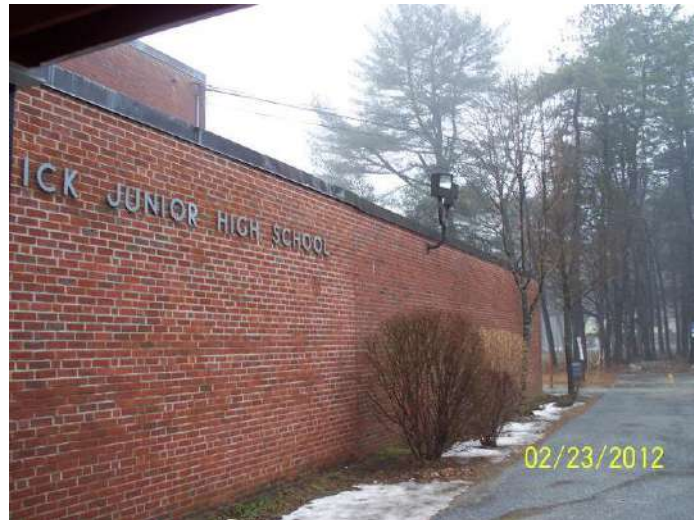
Flood Lights at front of school

The existing lighting fixtures throughout the facility have been upgraded to T8 lamps and electronic ballasts (T5 lamps in Gymnasium), are in relatively good condition and appear to provide adequate illumination. Most spaces have automatic controls to shut off lights when spaces are not occupied. Few, if any rooms/spaces appear to be candidates for day lighting controls, as there are many tall trees around the school. None of the exterior fixtures are full-cutoff, this creates a lot of glare and could lead to light trespass complaints from neighbors.

- § Cove type lighting in classrooms should be reviewed closely and most likely be eliminated to provide a more efficient installation.
- § Exterior lighting should be considered for replacement with more efficient LED full cutoff fixtures.

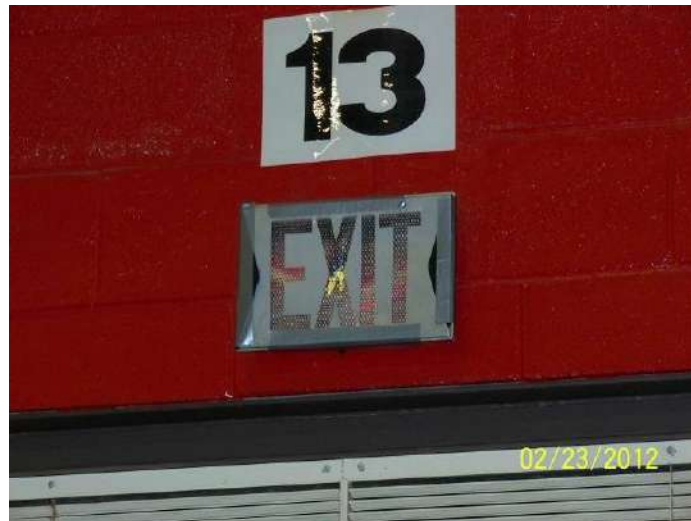
This school is primarily served with central emergency battery units and remote emergency heads and exit signs; there is no emergency generator. Some self-contained emergency battery units with integral emergency heads are being used to supplement the remote emergency lighting heads. Many of the existing exit signs were identified as being in a state of disrepair.

Exit sign in disrepair

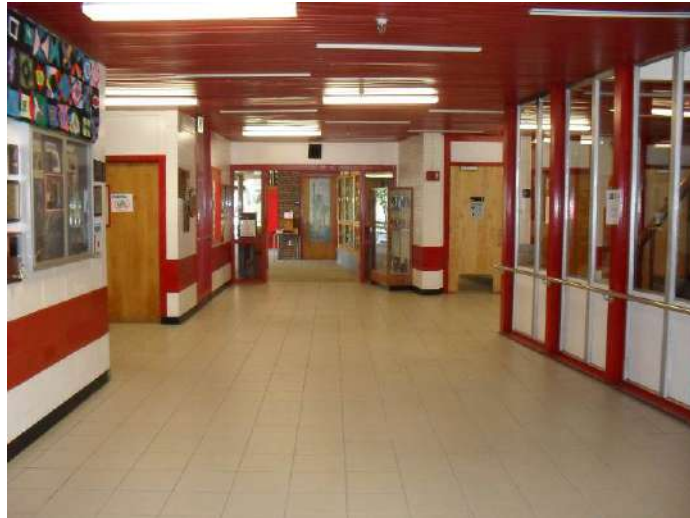
No Exit Signs are visible (approaching Main Lobby)

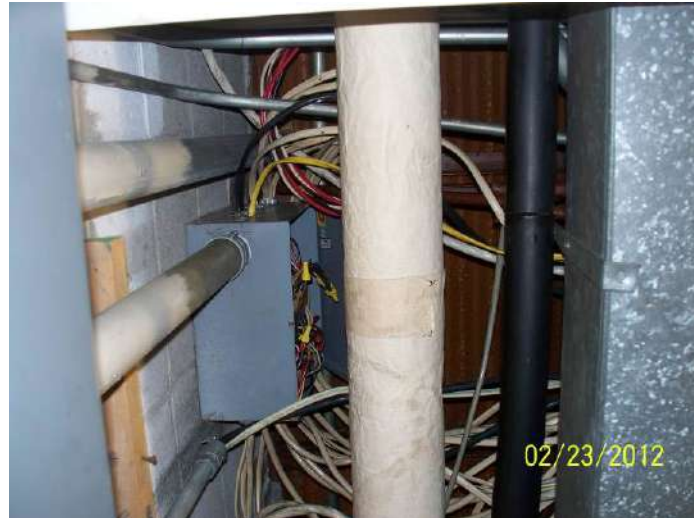
Romex wiring and open junction box.

Additional receptacles are required throughout the school to provide service where needed. In many locations this has been done, but, it appears (from the use of cords/power strips) there are many more areas that need additional receptacles. Exterior receptacle outlets should be added as needed to provide service for maintenance purposes. Also, it was noted that Romex has been used throughout this facility; current codes do not allow the use of this wiring method in this type of construction. If wiring is added to this school in the future, it should be done with an approved non-combustible material type. Also, the NEC requires the removal of all discontinued wiring. And as wiring/circuits are revised and no longer needed they should be removed completely back to the source.

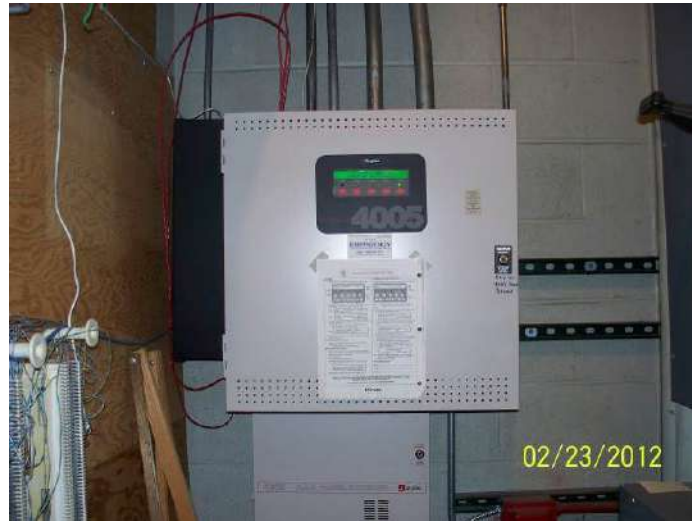
Fire alarm control panel
In Main Electric room

The fire alarm control panel appears to be in good condition and is still supported by the Manufacturer. This control panel should provide adequate service until the entire system can be upgraded. There many locations throughout the school that are not properly covered by the existing audio/visual appliances. Also, there are many egress doors that do not have a pull station within five feet.

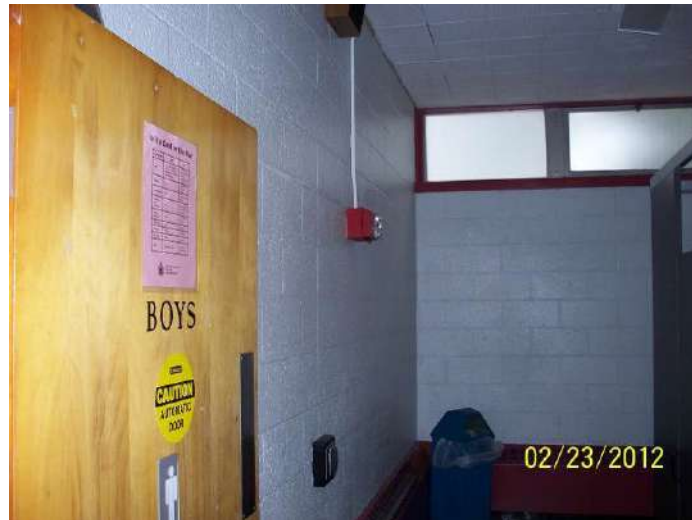
Audio/Visual appliance
in Boys Toilet

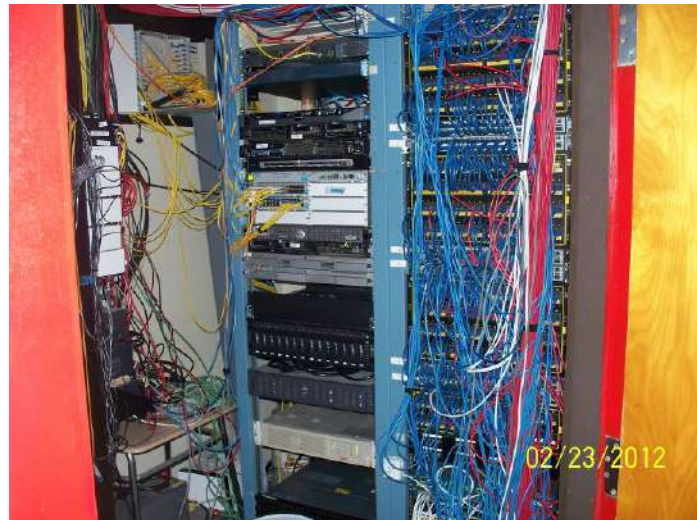
Data Networking patch panels and switches.

The existing space being used as a Data/Communications Room is very small and is completely full of equipment, not leaving any space at all for expansion. This room is so congested that proper clearances for working on equipment are not available. The existing phone system appears functional and should provide somewhat reliable service, providing the room does not over heat causing equipment failures. Voice/data infrastructure in the building is a combination of wired and wireless with most cabling being run concealed in the wall and above ceilings. There are some instances where data cables run through ceiling tiles to termination points; these cables are very susceptible to damage. Also, it appears that most spaces are lacking sufficient “drops” for telephone and data when compared to modern schools.

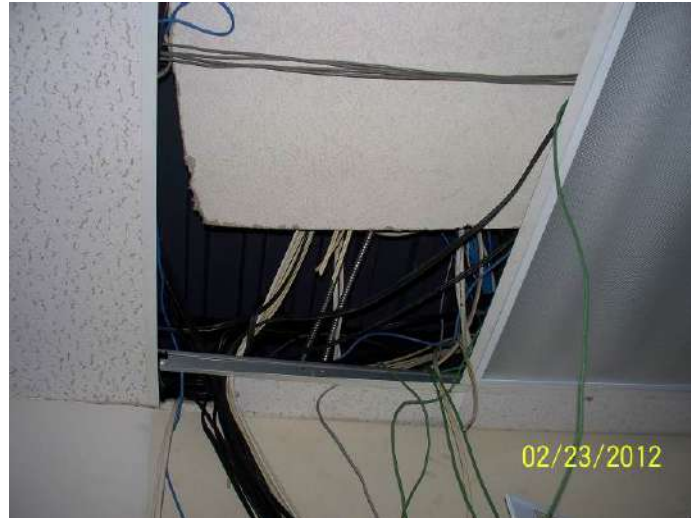
Wiring hazard and 120V wires entwined with data wiring can cause interference.

Wiring passing through ceiling. (line and low voltage running parallel)

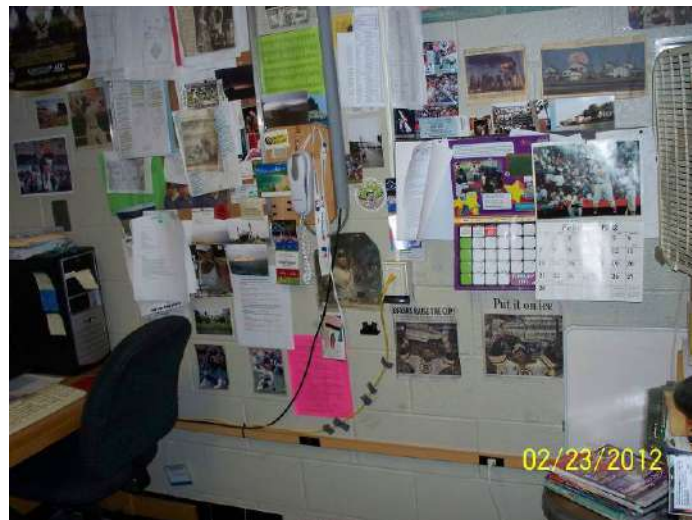
Network wiring parallel to line voltage wiring.

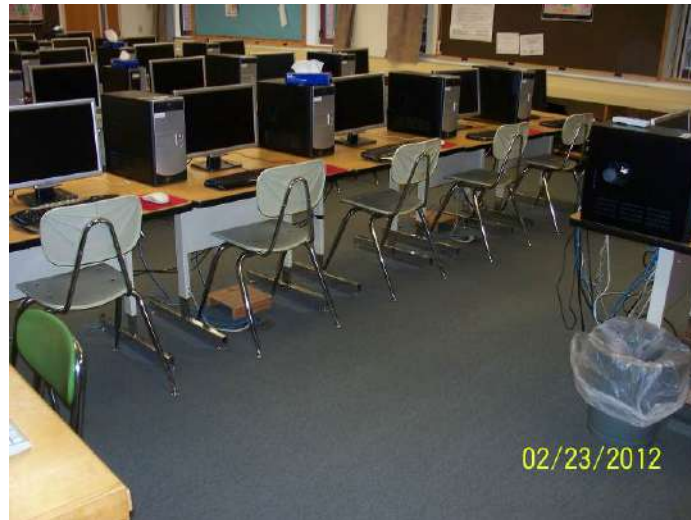
Data wiring through
floor in Computer Room.

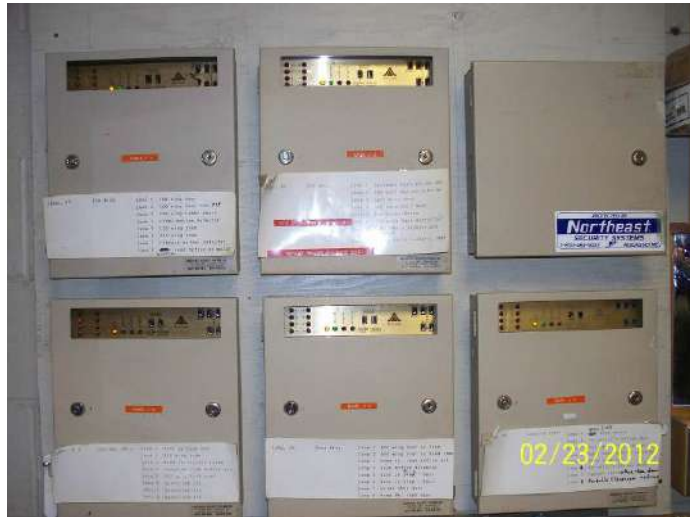
Security Panels (Custodial Office)

The existing system is outdated and should be replaced completely with a new system. An access control system with swipe card access should be included if necessary.

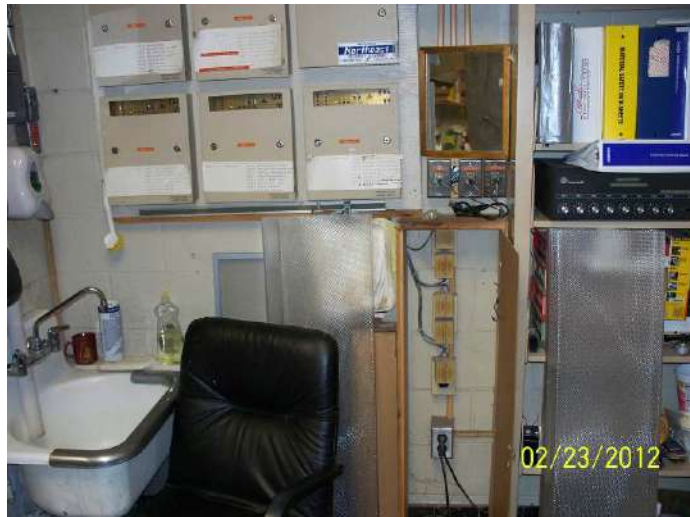
Security Panels and power supplies

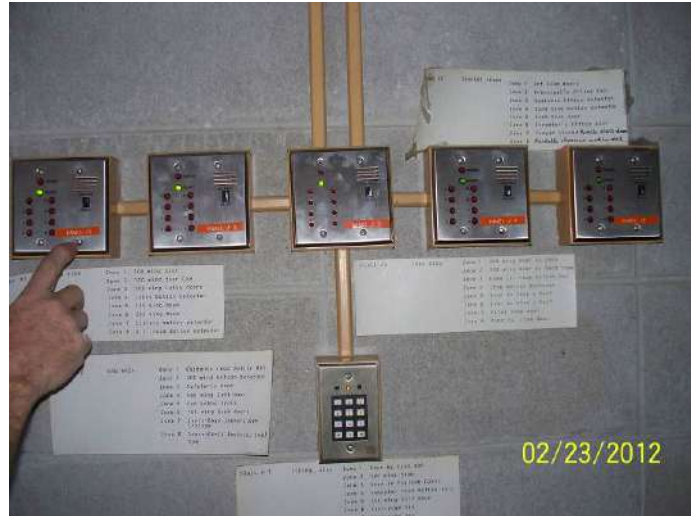
Remote Annunciators

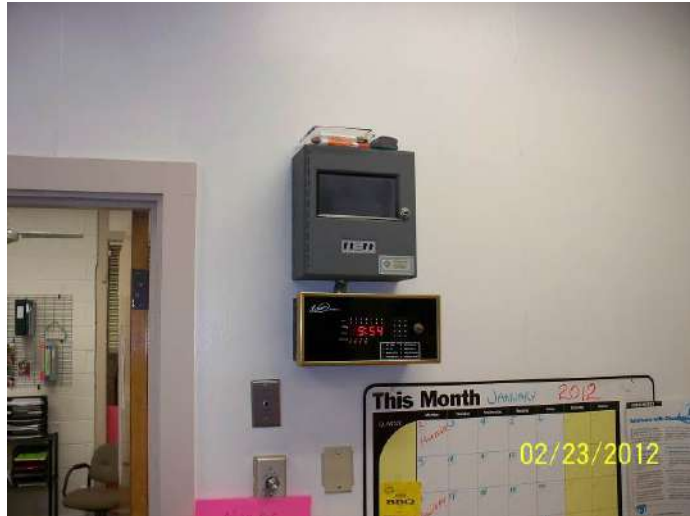
Lathem control panel in
Main Office

The existing “system” of clocks is not functional.

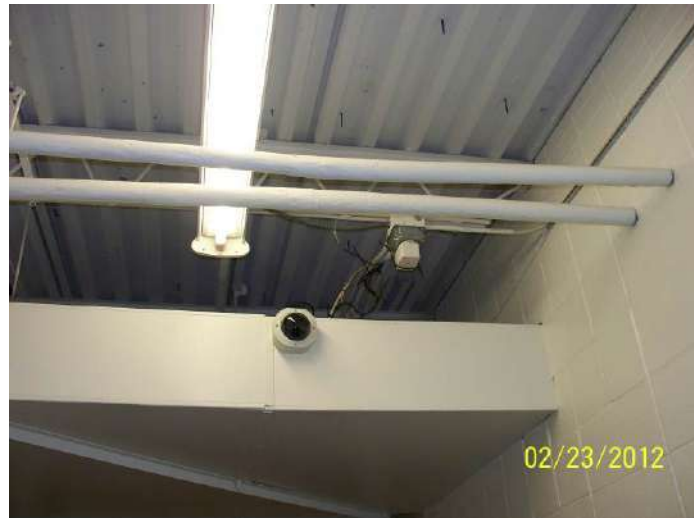
Typical CCTV camera
(Gym Storage)

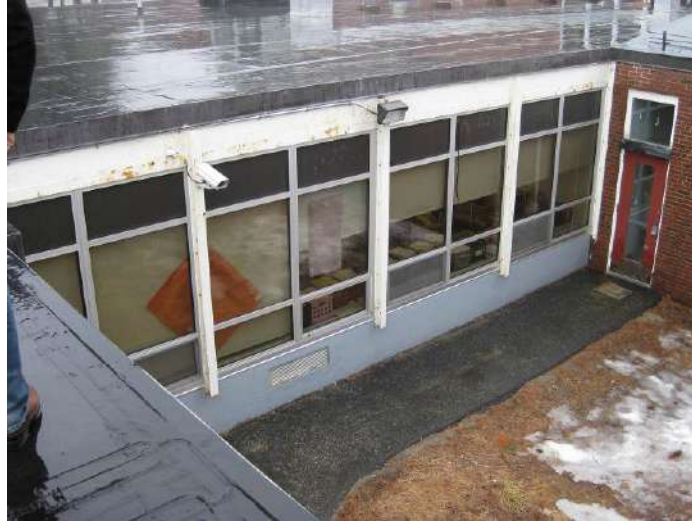
Exterior CCTV camera
in courtyard
