Coffin Elementary School

Overview

The school is a single story masonry building of approximately 57,440 sf. There are two parallel classroom wings connected at the center by a multi-purpose space. To the rear of the building is the cafeteria and kitchen. Each wing is a double loaded corridor with classrooms on one side and support spaces on the other side. The multi-purpose room has an elevated stage at one end. Below the stage is a basement work room that was originally the boiler room. There was a small storage room addition for the nutrition program added around 1990 adjacent to the kitchen at the rear of the building. Refer to Tab 7 for a plan of the existing building.

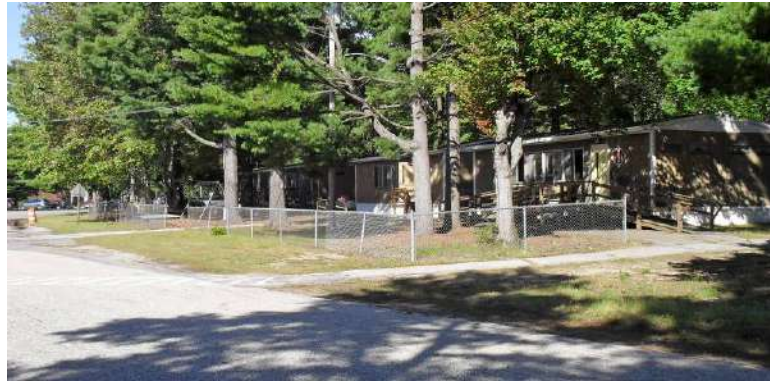
In addition to the main building, there are six temporary classroom buildings. Four of the buildings, in place since 1969, are single classroom modulares located across the main driveway at the front of the school. The other two are leased double classroom portables located in the open space between the rear classroom wing and the kitchen/cafeteria wing. Refer to site plan on previous page.

Portables across main
driveway at front
of Coffin School

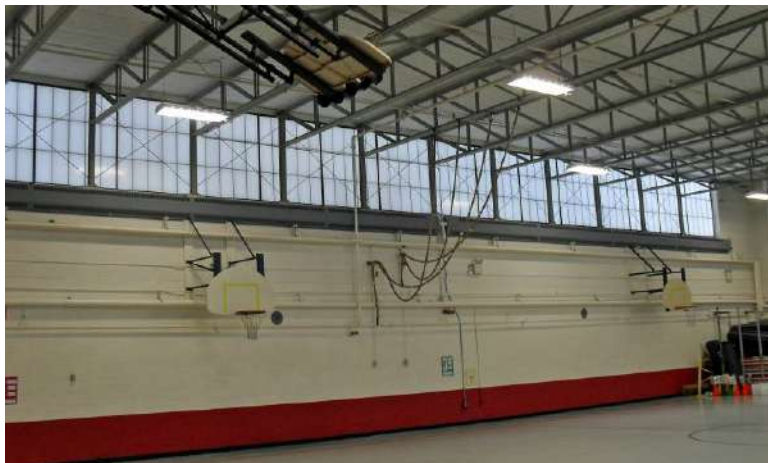
The exterior walls of the gymnasium are masonry with translucent wall panels high on the east and west facing walls. These appear to be original to the building and appear to be in good condition.

Translucent
Wall Panels at Gym

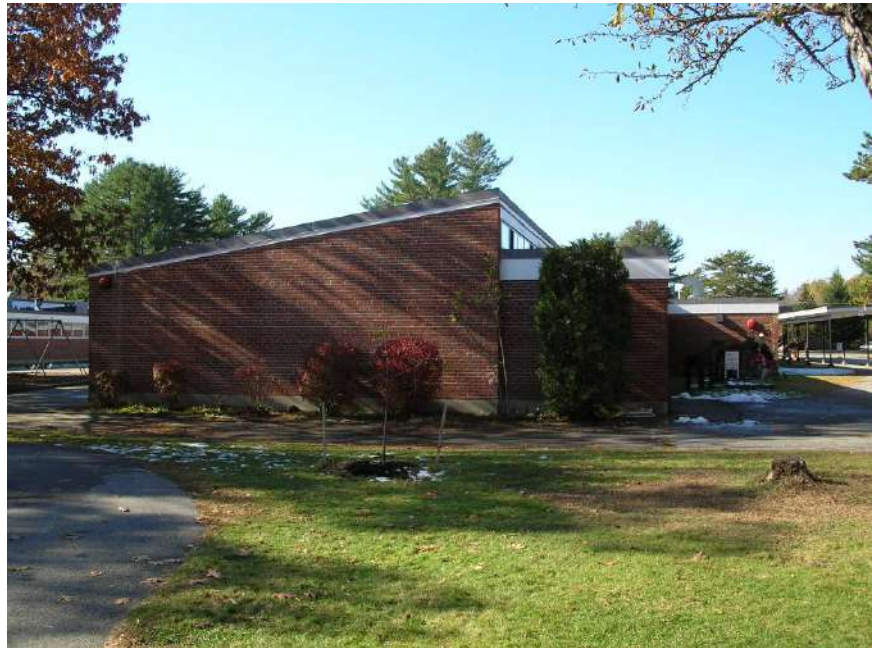
The existing roof framing consists of a combination of wood and steel members supported by interior steel columns and masonry bearing walls. The roof framing in the four classroom wings is identical. According to the original drawings, the members on the sloped surfaces consist of 4x10 wood beams spaced at approximately 6 feet on center. These beams span approximately 11 feet to 14" deep steel wide flange beams that frame to round steel pipe columns at both ends. The decking is indicated to be 2" thick tongue and groove planking spanning the 6 feet between beams. The roof framing in the flat roof areas consists of 2 x 12 joists spaced at 16" on center. These joists span 8 feet and 15 feet and are supported by masonry bearing walls.

Typical Classroom Wing

Our limited analysis indicated that the wood and steel framing at the classroom wings is capable of supporting the current code required snow loads without reinforcement. This is based on the following assumptions:

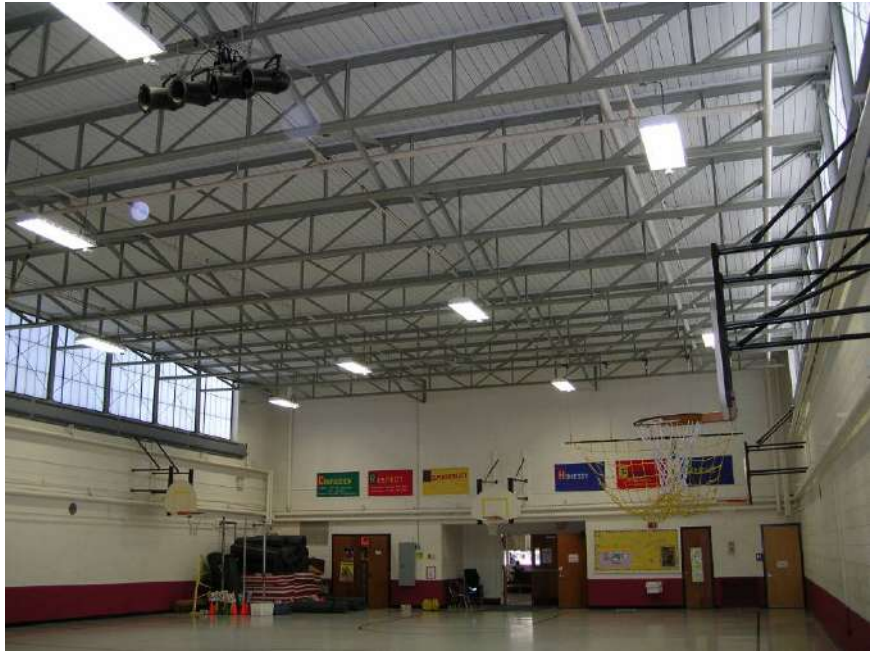
The roof framing in the gymnasium consists of the same 2" wood decking on 30" deep long-span open web steel joists. Although the spacing could not be verified, it appears that they are approximately 6 feet on center and span 54 feet. These joists are connected to steel wide flange columns which are supported by the masonry bearing walls on both sides of the gym.

Roof Framing at Gym

Again, it should be noted that no structural framing plans were available, and no physical verification of sizes was performed. Analysis of the gymnasium and cafeteria roofs was not performed due to lack of information. Further investigation of these areas should be performed to verify their adequacy.

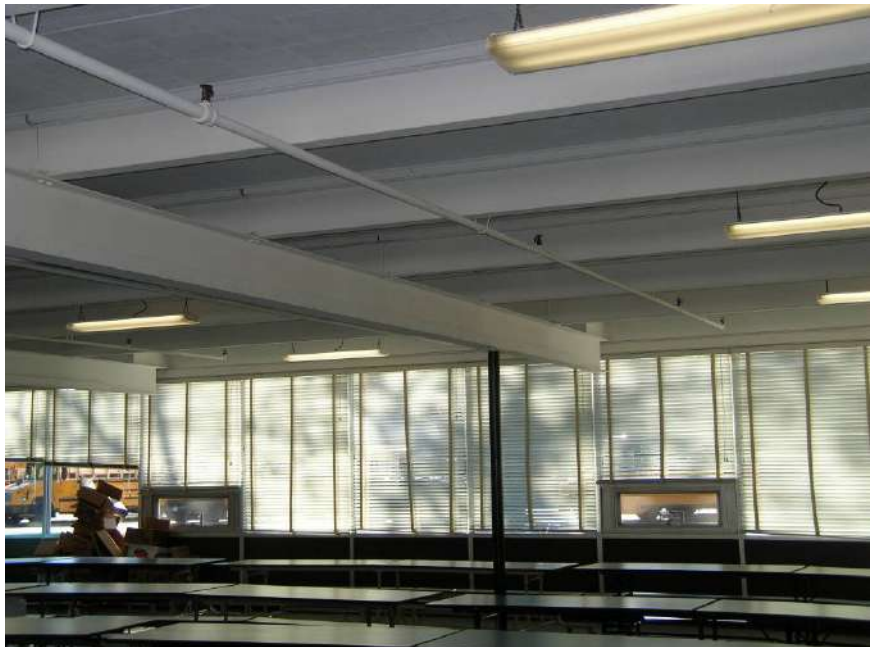
The roof framing in the cafeteria consists of 2" wood decking on 10" deep wide flange beams spaced at approximately 6 feet on center. These beams span approximately 19 feet to three 14" double cantilevered beams. The center span is 26 feet and the cantilevers are 12 feet on each side. These cantilevered beams were reinforced in 1992 during a re-roofing project. The interior columns are round steel pipe columns.

Roof Framing at Cafeteria

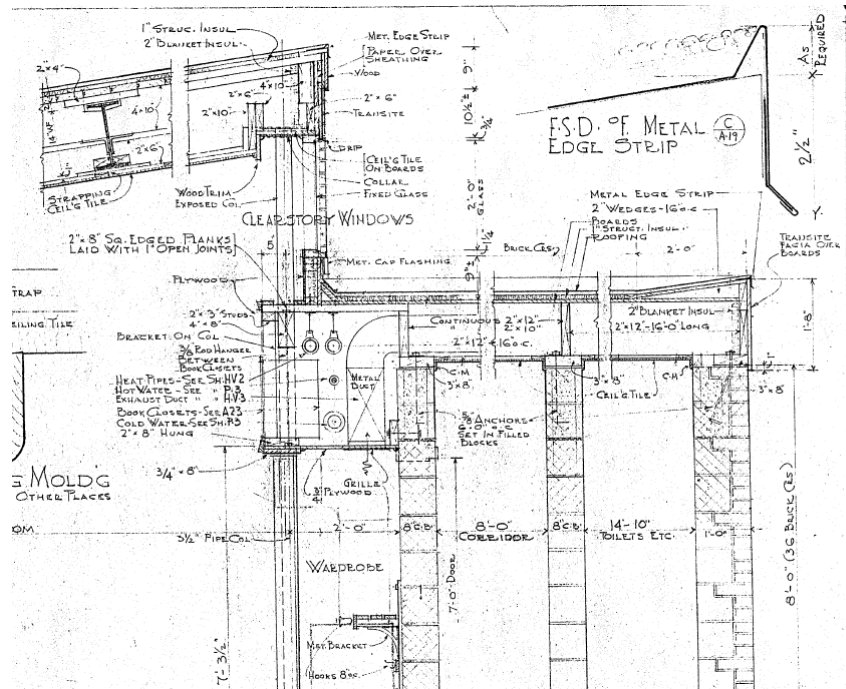
Typical Section at
Classroom Roof

- § All framing sizes are as indicated on architectural sections
- § No alterations have been done to any framing members
- § No damage due to water infiltration has occurred
- § The wood species used is equivalent to Spruce-Pine-Fir #1

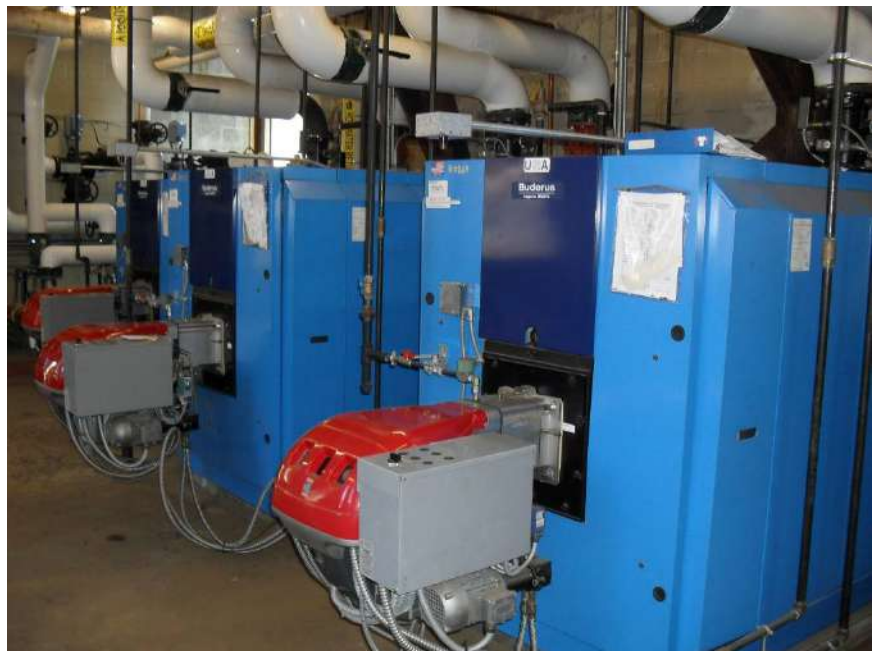
Figure 1 – Cast Iron Boilers

The three boilers that were installed in 2006 are manufactured by Buderus. Each of the boilers is equipped with dual fuel Riello burners. Boiler number one has a gross rating of 1,951 mbh and a net rating of 1,697 mbh. The remaining two boilers have a gross rating of 2,822 mbh and a net rating of 2,454 mbh. When the boilers were converted to burn natural gas a couple years ago, the oil piping coming into the boiler room from a underground oil tank were cut, capped and abandoned in place.

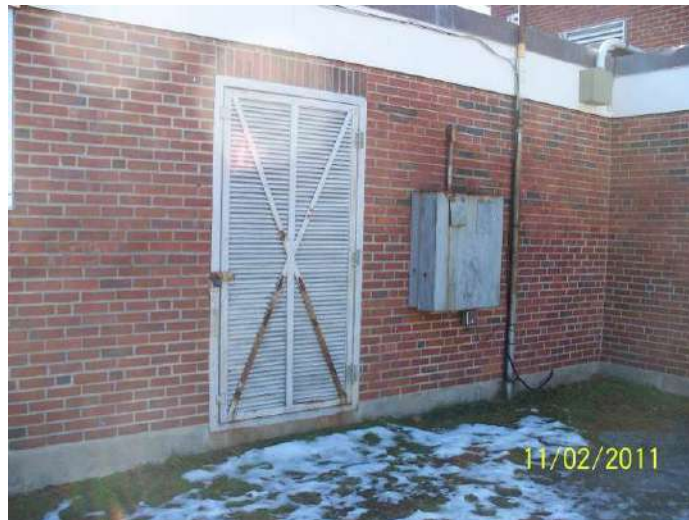
The Coffin Elementary School is served by three 50kVA (150kVA total) transformers located in a locked vault. This 208V-3Ø-4W service is fed from an underground primary distribution system. Information from Central Maine Power indicates that the maximum demand to date has been 86 kW.

Transformer Vault

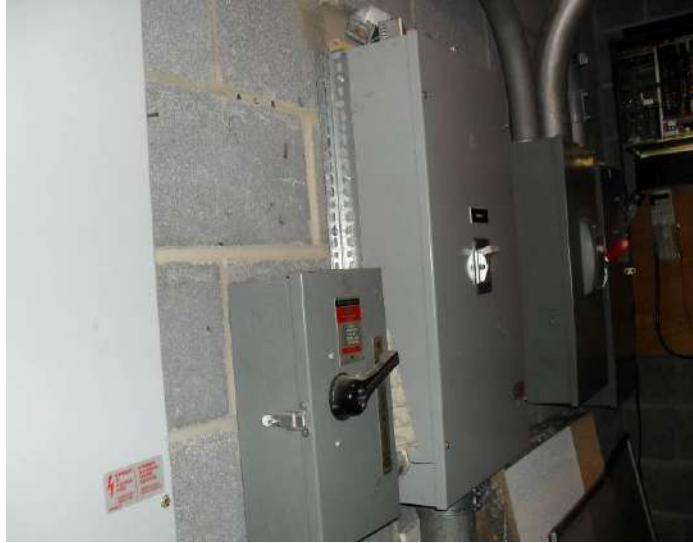
Main #2

The electrical service entrance is made up of a variety of equipment with multiple mains, Main #1, Main #2, Main #3 (mobiles), and Main #4 (mobiles). None of this equipment has the clearances required by NEC. Main #1 & #2 are circuit breakers and the rest are fused switches.

The equipment that comprises the service entrance is in violation of the National Electric Code because of lack of required clearances. Also, the configuration of multiple main breakers may be a safety concern as it is quite confusing as to which main controls which sub-panels. The capacity of the existing service is currently limited by the transformers located in the vault to 150kVA, but, the equipment when totaled (Main #1 - 400A @ 208V/3Ø), (Main #2 - 400A @ 208V/3Ø), (Main #3 - 200A @ 208V/1Ø), (Main #4 - 200A @ 208V/1Ø) is capable of approximately 297kW. This is very low for a building of this size (57k SF +/-). Most of the existing sub-panels are relatively new and in good condition, but, the panels in the Kitchen area are not in good condition and have been modified.

The existing service entrance equipment should be upgraded to combine distribution and eliminate mains, provide required clearances and additional capacity if deemed necessary. The main distribution panel is very old and unsafe and should be replaced as soon as possible. The electrical needs in the Kitchen should be evaluated and the panels upgraded accordingly. Replacing the existing service entrance equipment and getting the required clearances is going to be difficult as there is limited space available to work with.

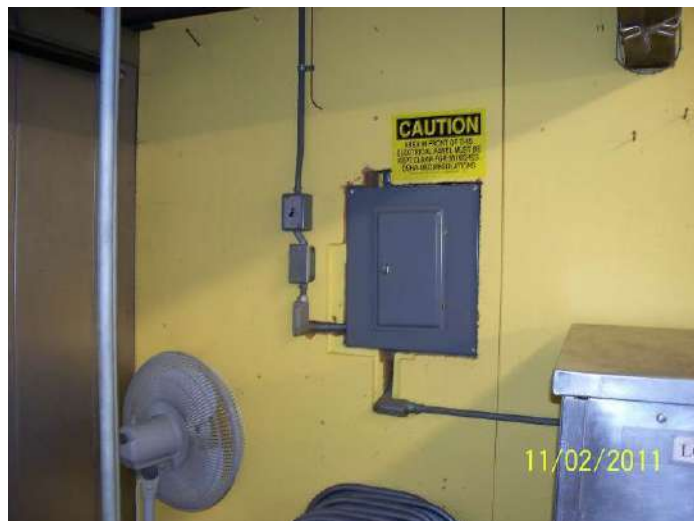
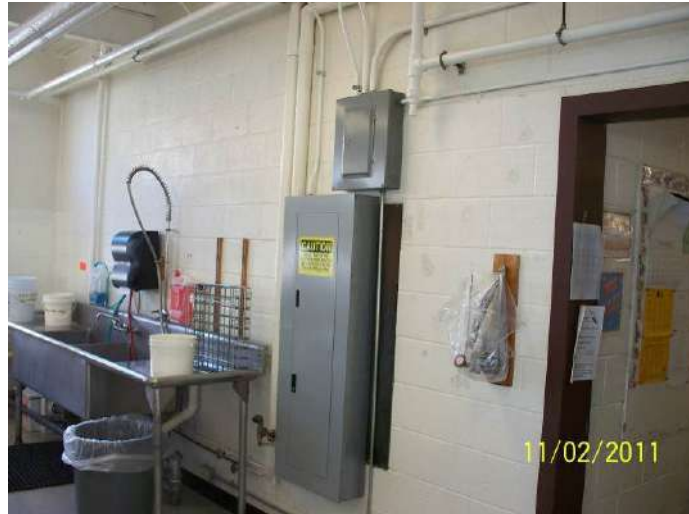
Kitchen Storage

Kitchen

The main distribution panel is a very old fuse type panel, with some dead-front panels missing that expose live parts when the door is opened. Sub-panels are located in the corridors of each wing, multi-purpose space, boiler room, and kitchen. This is a good distribution that limits the lengths of branch circuits to acceptable distances. Most sub-panels appear to be in serviceable condition. The panels in the kitchen have been modified indicating the original panels do not provide the necessary circuitry.

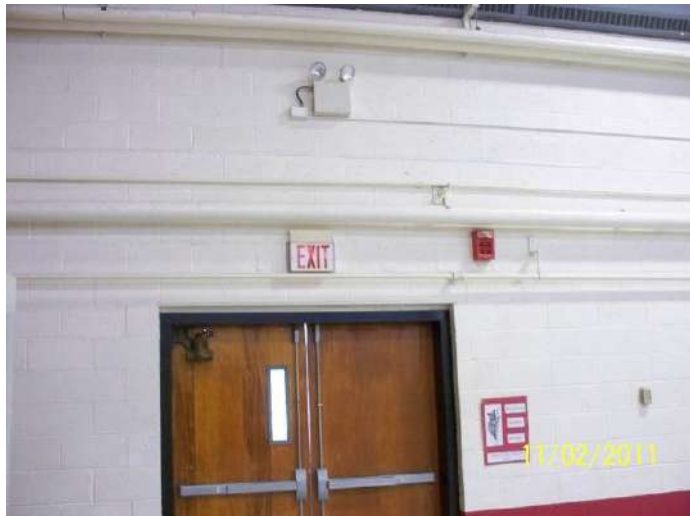
The Coffin Elementary School is served with self-contained (each unit has its own battery) exit signs and emergency life safety lighting throughout the building. Many of the exit signs do not appear to be working under normal conditions.

Self-contained exit sign (appears to be ON)

All battery units should be tested to verify proper operation. Internally illuminated exit signs should be added at all required egress doors and units that are in poor condition should be replaced. Emergency lighting units and exit signs should be added so that all paths of egress are properly marked and illuminated.

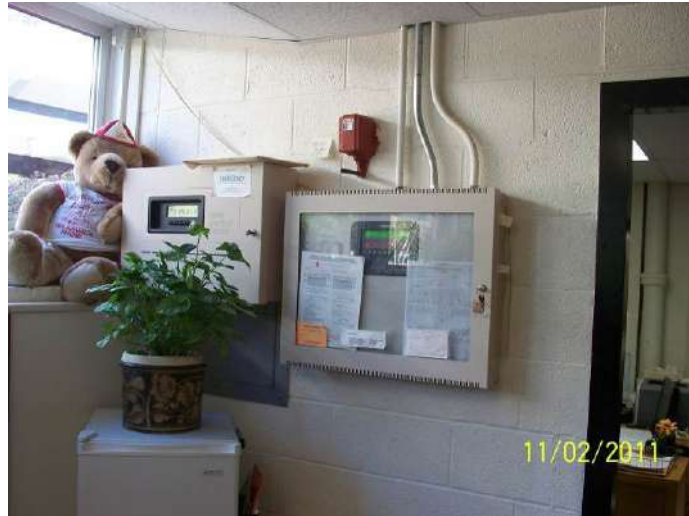
Fire alarm control panel
In Main Office

The fire alarm control panel appears to be in good condition and is still supported by the Manufacturer. This system should provide adequate service until the entire system can be upgraded. It appears that audio/visual devices have been added to cover some areas but there are still many areas that are not properly covered.

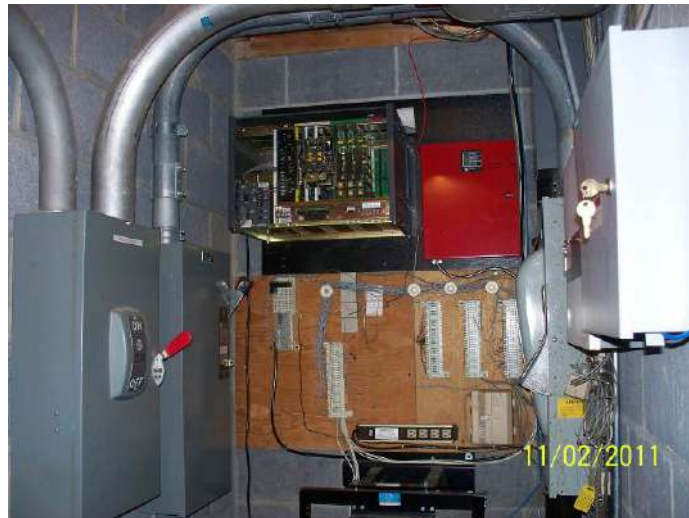
Telephone Backboard

The phone system is by Avaya and is rack mounted in the Electrical room between Main #3 and Main #4. This system is impeding on the required clear space in front of the electrical equipment. This system appears to be in service able condition. Also, the school network fiber connection to the internet was noted at this location. connection to the internet. There is also a data rack at the opposite end of the room that is floor mounted in front of the electrical main distribution panel, impeding the required clear space in front of that panel. Voice/data outlets appear to have been added throughout the school as needed, with cabling strung and run haphazardly. In locations where multiple PC's are located, wireless hubs have been installed.

The existing phone system appears functional, but, the space it occupies is needed for required clearance for electrical equipment. Voice/data cabling is in very poor condition in this building. All cables are run on building surfaces, many without raceways. These cables are very susceptible to damage. Also, it appears that most spaces are lacking sufficient “drops” for telephone and data when compared to modern schools.

A new space should be allocated for voice/data equipment to provide clear space in front of the electrical equipment. The existing cabling system should be replaced with new cables that are properly supported and protected. Connectivity should be upgraded to at least Cat 5e and to Cat 6 if budget allows.

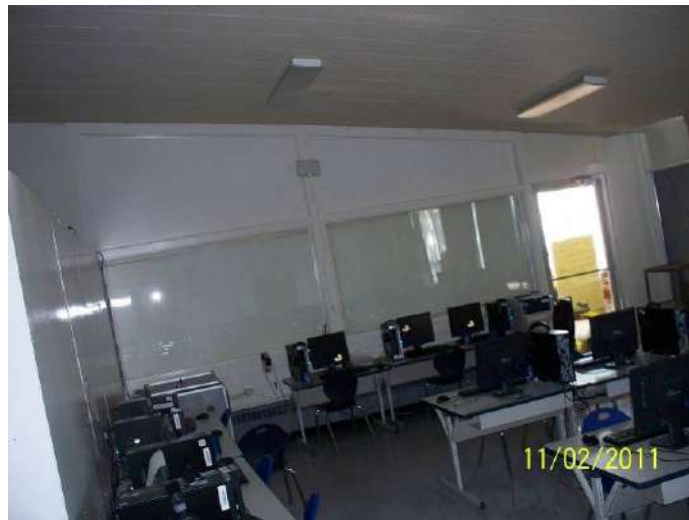
Typical surface wiring for voice/data cabling.
Note cables running through door frame

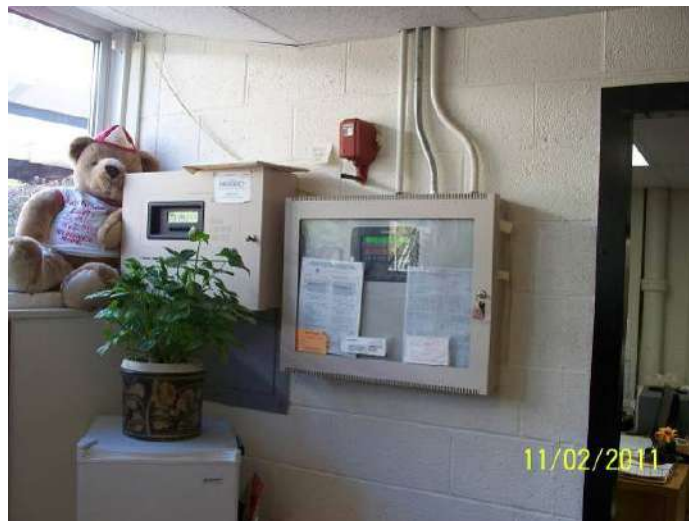
The existing system is a Simplex #6351 Master Time Control Center and is located in the main office. This system is reported by Simplex to be functional at this time. A system upgrade to automatically adjust to Daylight Savings Time is available.

Clock control panel in Main Office

The system is in serviceable condition and appears to be working properly at this time.

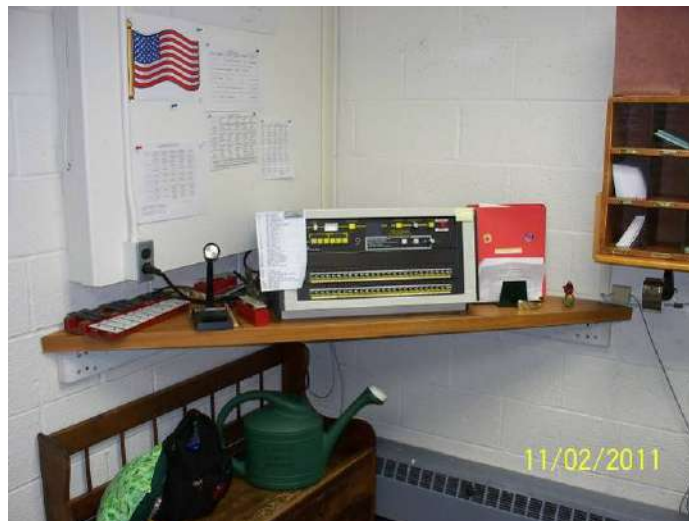
Main Console

The existing intercom system is by Dukane and is located in the Main Office. This system was installed in 1989 by Canfield Systems and is thought to be operational. All classrooms have the ability to call-in to the main office. Most classroom speakers are connected with surface wiring from the classroom stations.

The existing Intercom system is beyond its useful life. Dukane no longer manufactures parts for switch-bank type systems, therefore any repairs requiring parts could lead to lengthy down time. Spare parts come from “old stock” and salvage from old consoles.

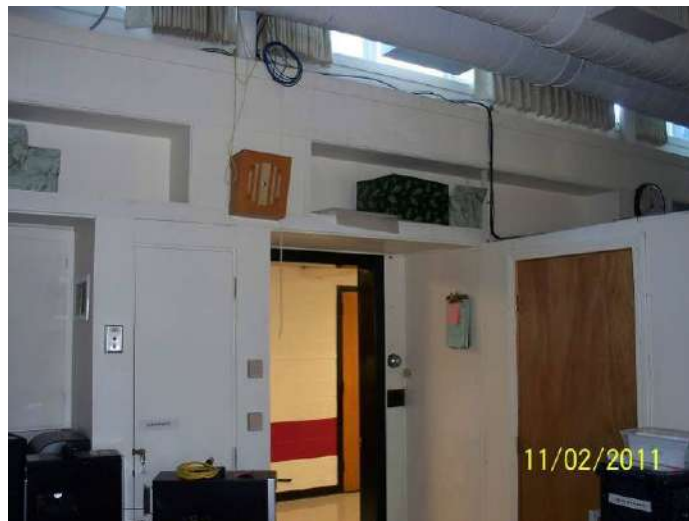
Typical classroom speaker
