Jordan Acres Elementary School

Overview

Part of the goal of this analysis is to assist the Brunswick School Department in determining whether Jordan Acres should be reopened or be closed permanently. And if the school is reopened, determine what the grade configuration and student population should be.

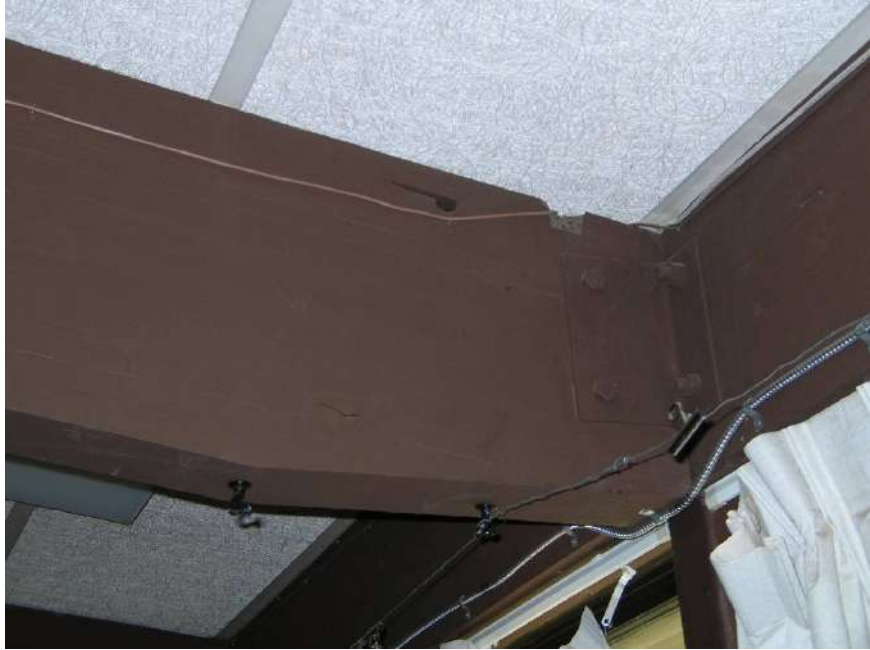
Detail at glulam beam connection

Visual observations were performed and in general the structure appears to be sound, and no obvious deterioration or damage was visible. It is our understanding that one of the glulam purlins was noticeably split at the lower end of the sloped beam. This damaged beam has since been replaced with a similar glulam wood beam.

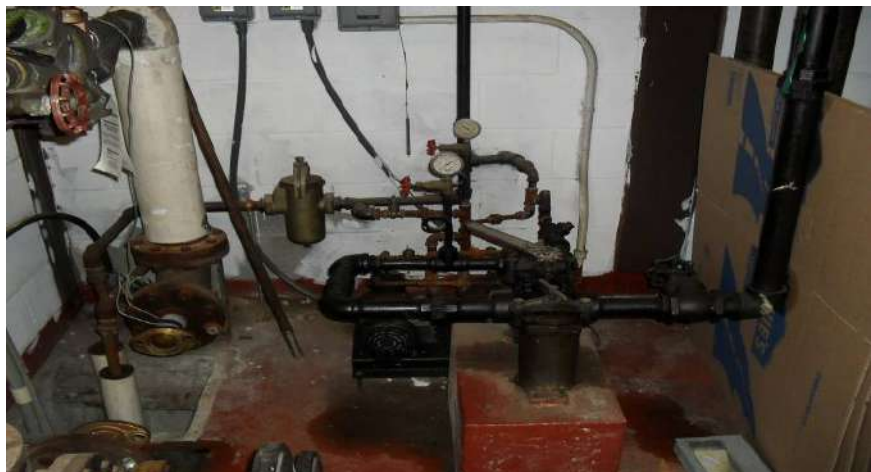
Figure 3 – Oil Transfer Pump Set

There is one existing steel underground fuel storage tank with an interstitial monitoring system in the tank and one in-ground monitoring well located just outside the boiler room. Underground suction and return piping runs from the tank into a pit in the corner of the boiler room. The oil piping connects to a duplex fuel oil transfer pump set located in the boiler room which brings the oil in from the tanks and circulates it through a pressurized distribution loop. The burner pulls oil off the distribution loop at a quantity matching the burners firing rate.

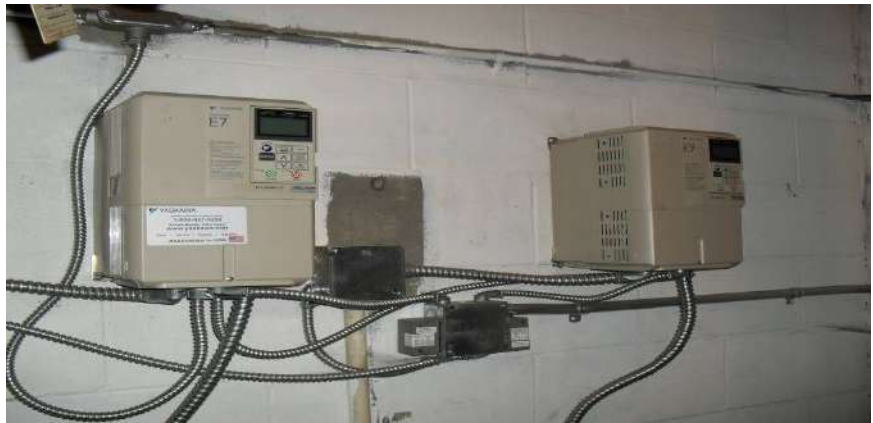
Figure 5 – Base mounted pump variable speed drives

The original hydronic heating loops consisted of a hot water supply and return loop and a hot water/glycol supply and return piping loop. Several years ago, the glycol loop and all of its accessorized components were essentially taken out of the system and abandoned in place. In 2007, a new set of Taco base mounted pumps were installed to handle the primary heating hot water supply and return for the entire facility. The pumps are rated for 226 gpm @ 65 ft of head. Each of these pumps is provided with individual variable speed drives. The VFD's are controlled by differential pressure sensors located in the piping distribution system.

Remove existing abandoned glycol heat exchanger, its pumps, associated piping and accessories. The base mounted Taco pumps along with their associated VFD’s that were installed in 2007 are still in excellent condition and should be reused.

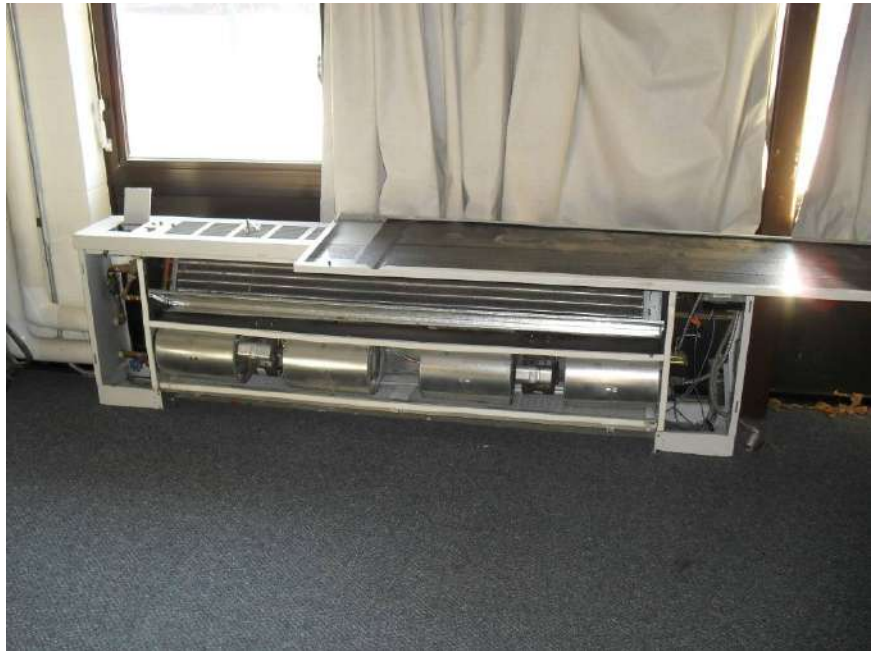
Figure 6 – New unit ventilator in classroom - typical

The primary heating and ventilating in each of the classrooms in the existing facility was originally handled by dedicated unit ventilators. The original unit ventilators were removed a couple years ago and replaced with new MagicAire unit ventilators. These replacement unit ventilators are not connected to outdoor louvers as the existing louvers were blanked off at the time of replacement. At the approximate time of the unit ventilator removal/replacement, new roof mounted energy recovery ventilators were installed. There is a significant amount of supply and return duct work located

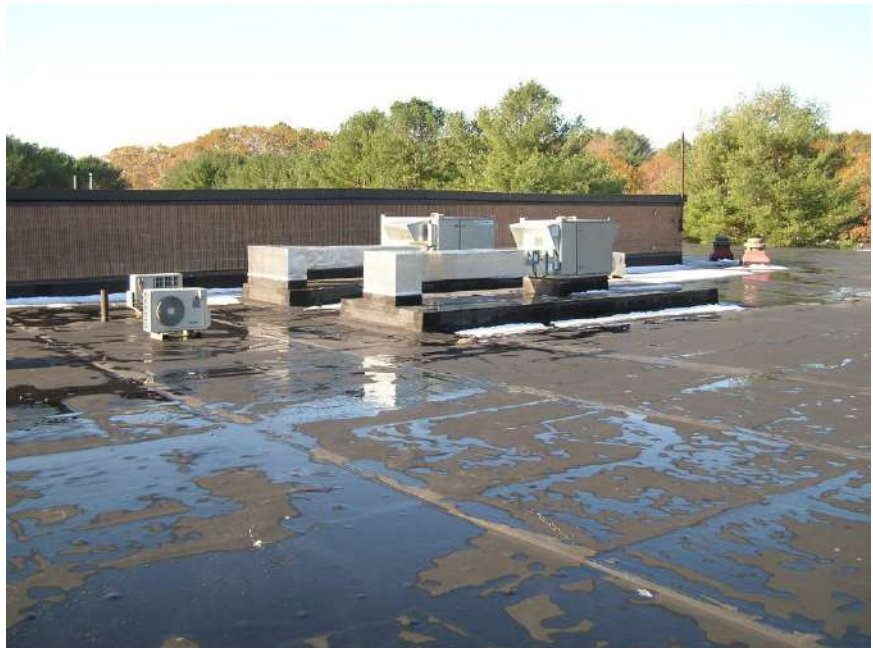
Figure 7 – Typical new Energy Recovery ventilators

on the roof. The ductwork for these several units drops through the roof and runs exposed in the open classroom spaces. Hot water heating coils are interior duct mounted for each of these units. This duct is not insulated.

Ventilation system	The existing rooftop energy recovery ventilators that were installed several years ago are still in good condition. However, because each of these units largely serve open areas with exposed, un-insulated duct work and single dedicated hot water heating coils, the duct distribution system would need to be removed and re-distributed according to new space layouts. Quite a few new duct mounted hot water heating coils would also need to be provided. The coil placement and number of coils would be determined by any new layout of the spaces.
Heating terminal units	We would recommend removing the replacement unit ventilators that were installed a few years ago and replacing them with hot water baseboard radiation in active lengths that are appropriate for any new classroom layout.
Sprinkler	If the building is to be renovated and reused, we would recommend providing sprinklers throughout the entire facility.

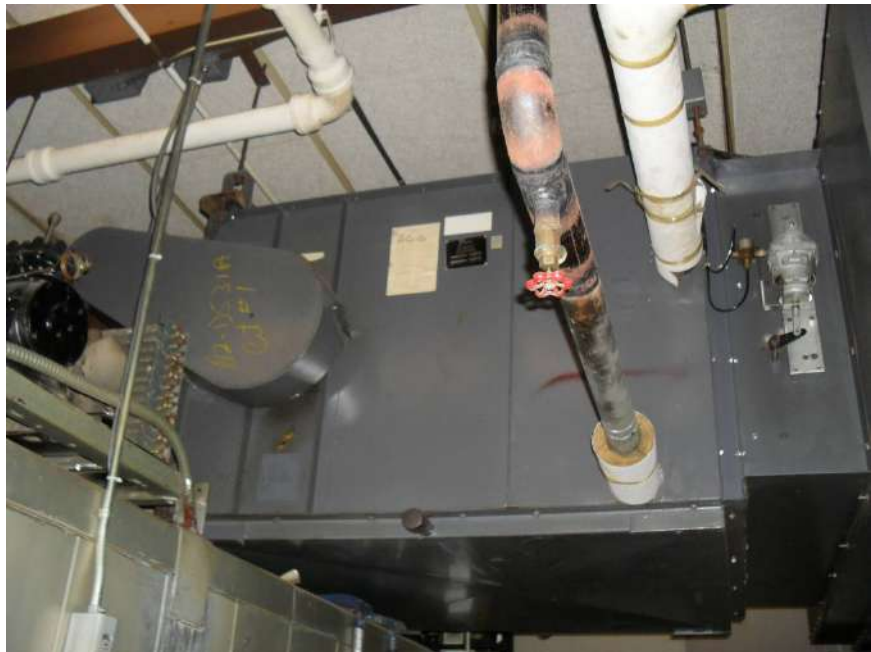
Figure 8 –
Gym/Multipurpose
AHU

The Gym/Multipurpose area is served by a single Trane climate changer air handling unit that is ducted to several wall-mounted supply air grilles. This AHU has a hot water heating coil integral to the unit and is pneumatically controlled. Only one of the hot water lines feeding the unit is fully insulated. The other line is partially insulated.

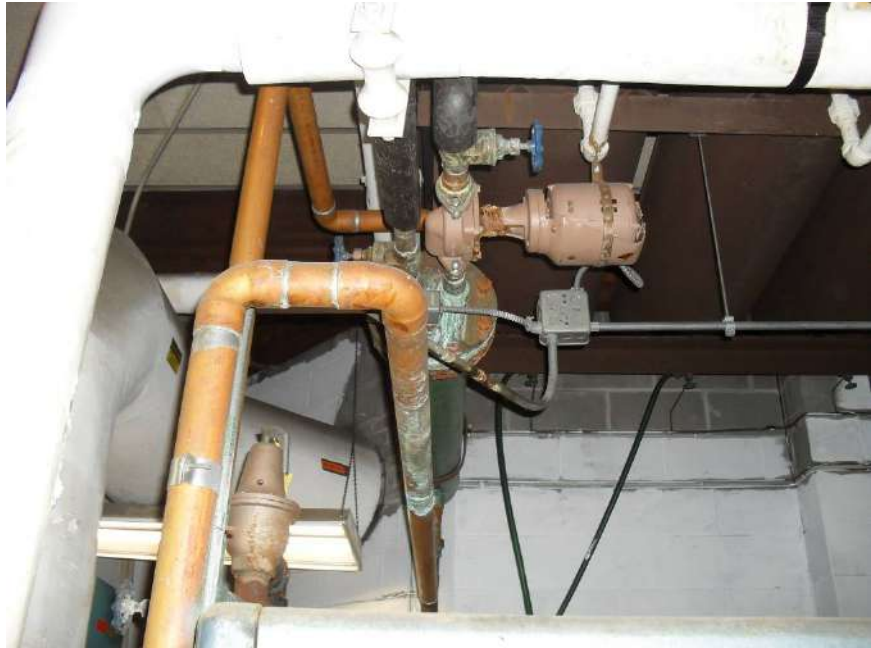
Figure 9 - DHW shell & tube heat exchanger

The domestic hot water is provided by the main heating boiler. A shell and tube heat exchanger located on top of the boiler is sized to handle only a portion of the DHW load within the school. A Patterson-Kelley 72 kW electric water heater located adjacent to the Kitchen storage area handles the remaining DHW load. Although the name plate data on the heater shows it as being installed when the school was first constructed, it appears to be newer than approximately 40 years old.

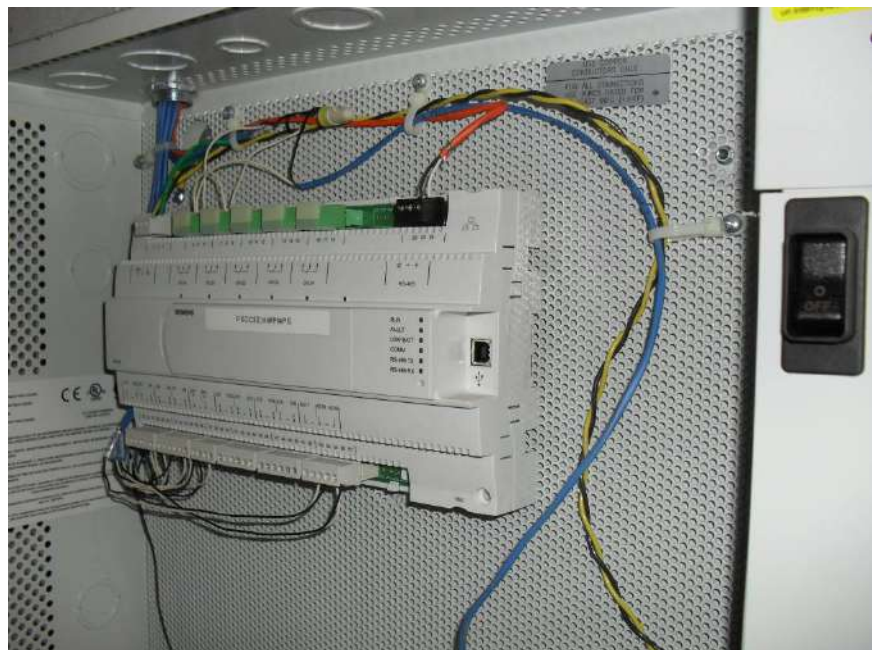
Figure 12 - DDC Controller

The temperature controls in the facility are primarily pneumatic with a bit of updated DDC control as well. It has been reported that this system has not provided consistent temperature control throughout the facility. Some areas are quite warm while others can be quite cool.

The existing pneumatic control system in the facility is also clearly showing its age. Although a pneumatic control system was virtually the only viable control option available when the school was originally designed and constructed, these systems have proven over time to be quite inefficient and difficult to control and maintain. We recommend removing the complete pneumatic control system which includes all controllers, air compressor, dryers, tubing, actuators, sensors and all other associated accessories. A new direct digital control (DDC) will be provided for the entire facility. This control system would be provided by Siemens and would be tied back into the main head end in the Facility Directors office.

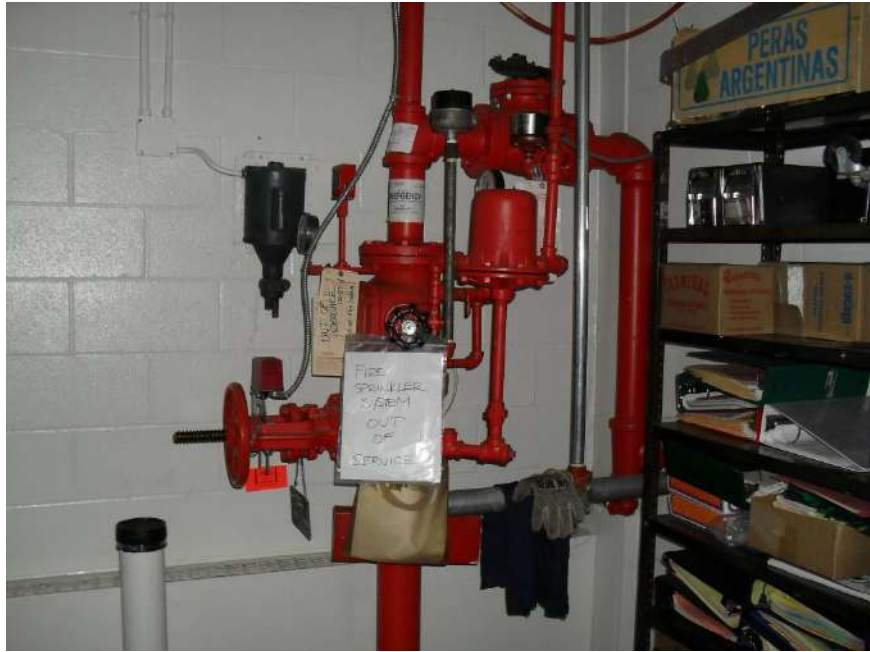
Figure 13

The sprinkler system enters the building in the storage area adjacent to the kitchen. The line size coming in is 4". Based on conversations with staff, the only area that is served by this sprinkler system is the kitchen area. No other sprinkler heads were observed throughout the building.

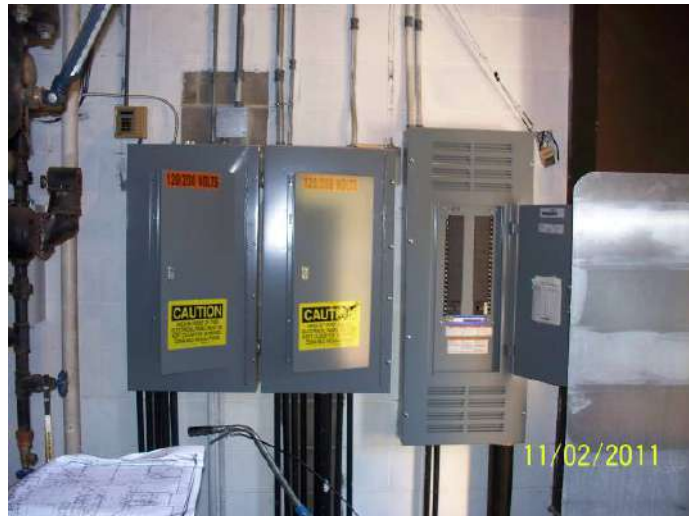
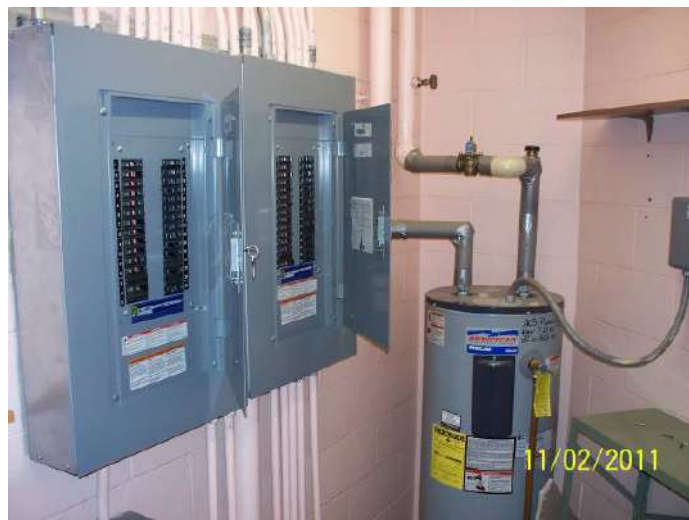
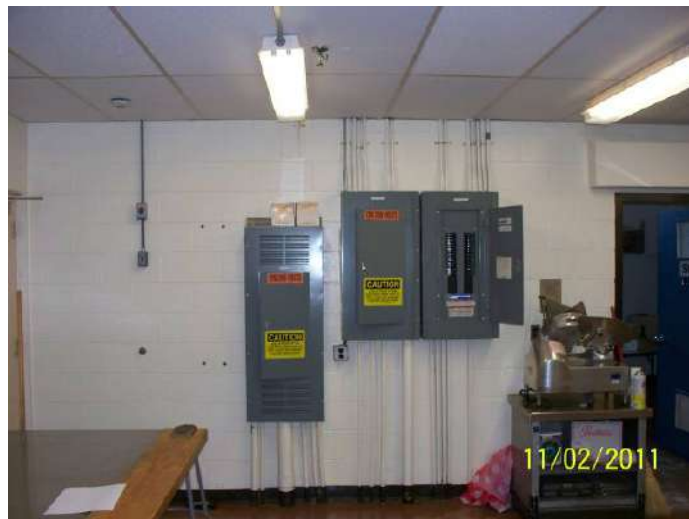
Typical Sub-Panels:
Boiler Room

Sub-panels are evenly distributed throughout the school in a manner that limits the lengths of branch circuits to acceptable distances. All sub-panels appear relatively new and in very good condition.

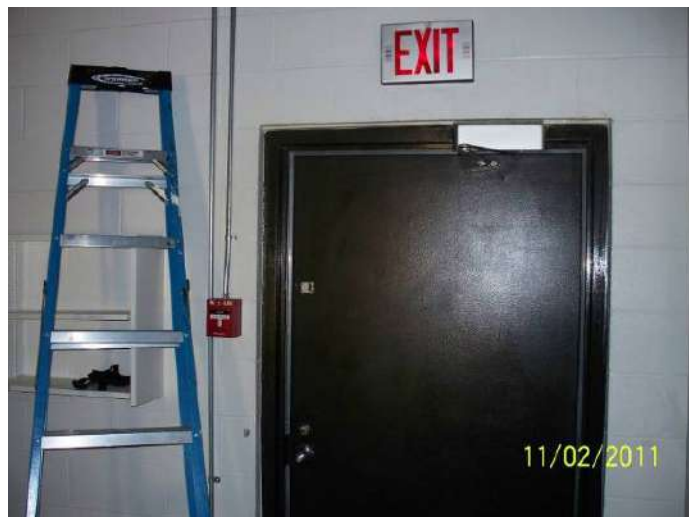
Typical internally illuminated exit sign

Exit signs appear to have been upgraded with LED retro-fit kits but are not very evenly illuminated and some are in poor condition. This may be of concern to the local code officials. Also, some signs are not internally illuminated and do not have an emergency lighting fixture nearby to illuminate in case of a power outage. It is a code requirement that all non-internally illuminated signs be illuminated with emergency lighting during a power outage. No record of testing of the emergency units was observed. It is very possible that the emergency battery units will not function properly if a strict testing and maintenance policy is not being followed. Also, emergency lighting fixtures are spaced such that they will not provide an average of 1 fc throughout all paths of egress.

All battery units should be tested to verify proper operation. Internally illuminated exit signs should be added at all required egress doors and units that are in poor condition should be replaced. Emergency lighting units should be added so that all paths of egress are properly illuminated.

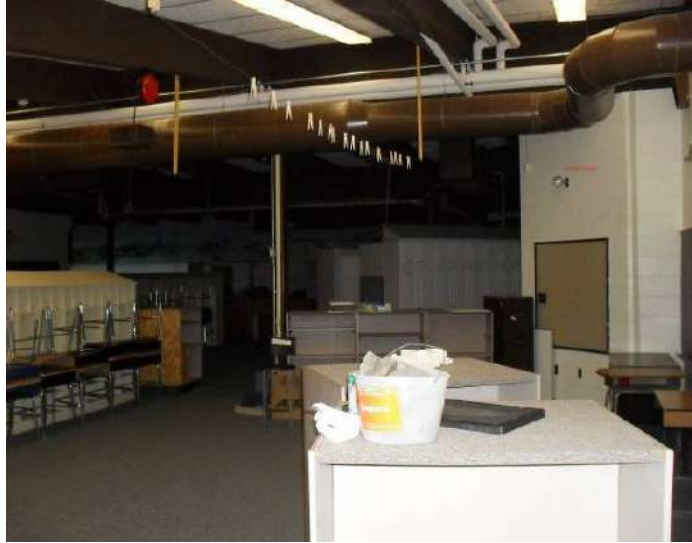
Typical Emergency Light

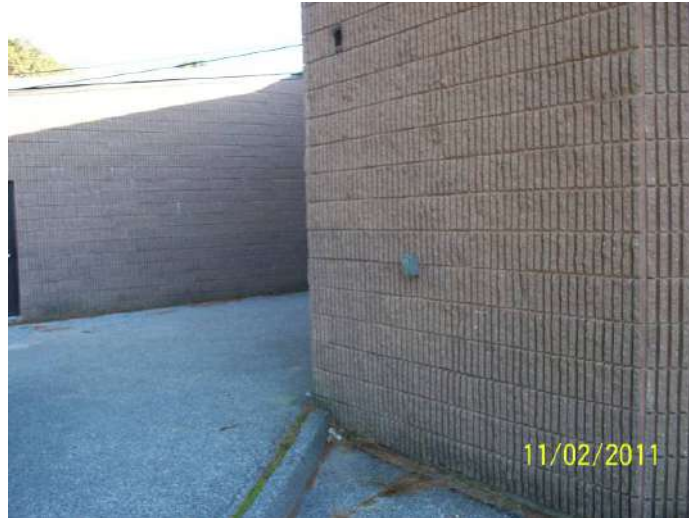
There are wall mounted grounded receptacles located throughout the school. In the “Open Concept” areas there are outlets on retractable cord reels mounted at the ceiling. These create an unsafe condition in an educational setting. Only one exterior outlet was observed in the site survey.

Exterior Outlet

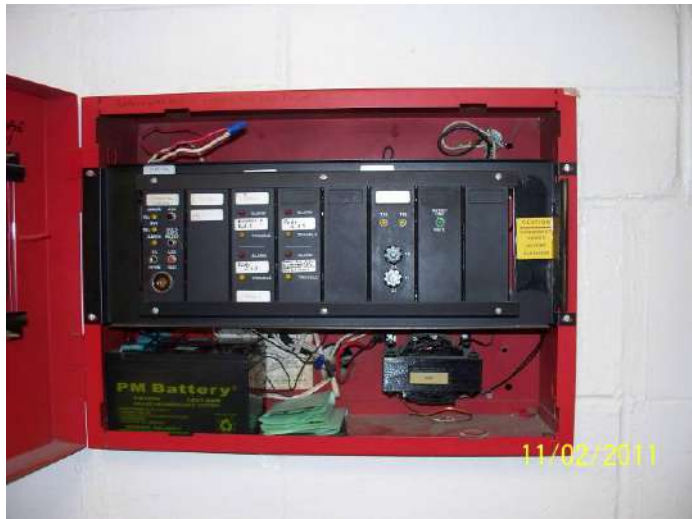
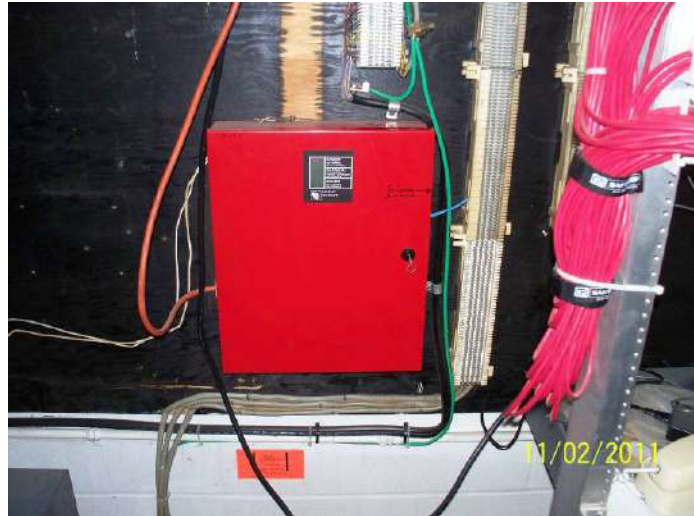
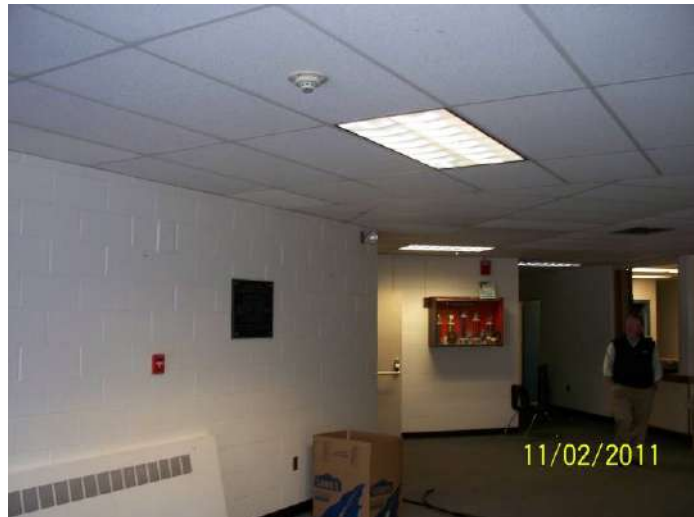
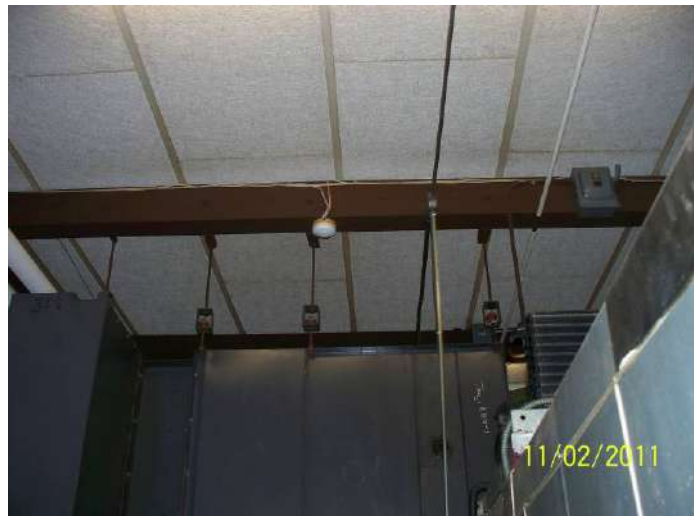
The fire alarm control panel is now obsolete and is no longer supported by the manufacturer. Although, additional audio/visual devices have been added since the school was built there are some locations that are not properly covered. This system is beyond its life expectancy and should be replaced.

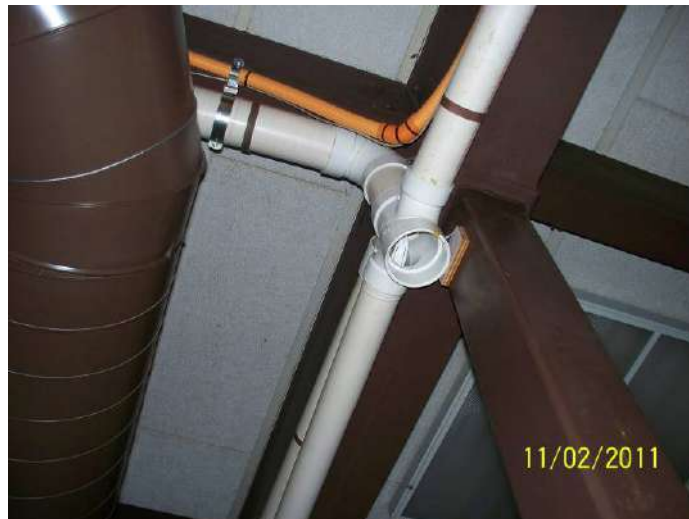
Typical Data Cabling
routed in DWV pipe

The existing phone system appears relatively new and functional, however the phone wiring is in worse condition. Most if not all cables are run in surface raceways, with many not extended completely to the point of use. Data cabling has been run through the “Open Concept” space in drain waste and vent pipe. This is not a proper use for this “piping system”. Conduit rated for electrical cables should be used. Also, it appears that most spaces are lacking sufficient “drops” for telephone and data when compared to modern schools.

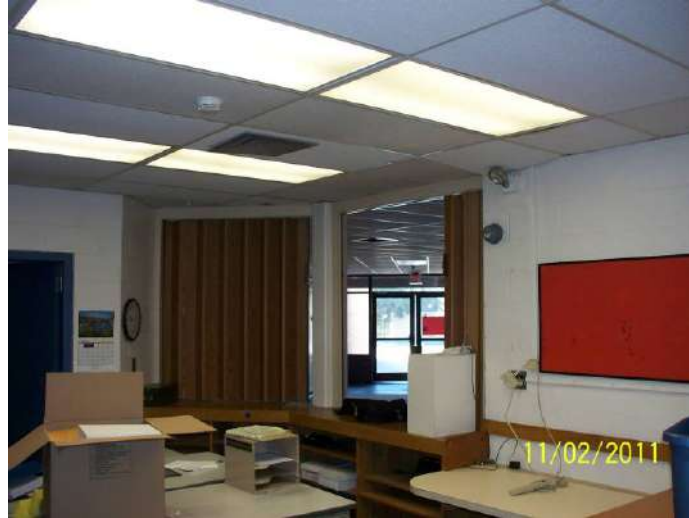
Typical Tel/Data
cabling run surface to
point of use

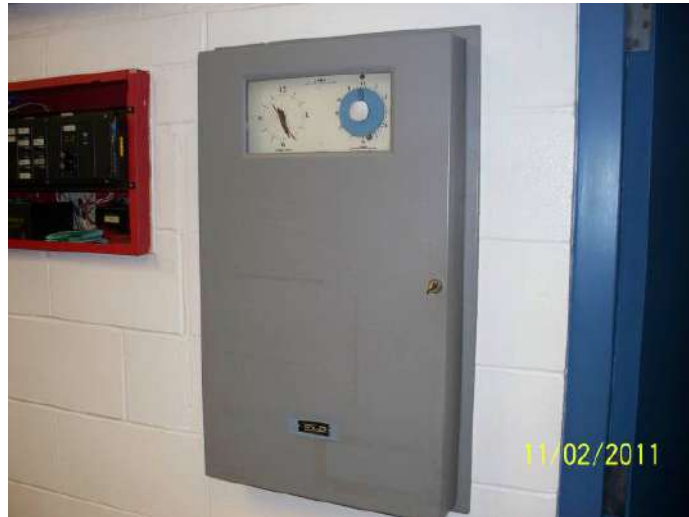
Clock control panel in
Main Office

An Electric Time Co. model #F2004 clock system is located in the main office. All of the following pictures were taken within one hour of each other. Some of these clocks are not keeping time.

The existing system should be removed and replaced with a new system if it is deemed necessary to have a central clock system in the building.

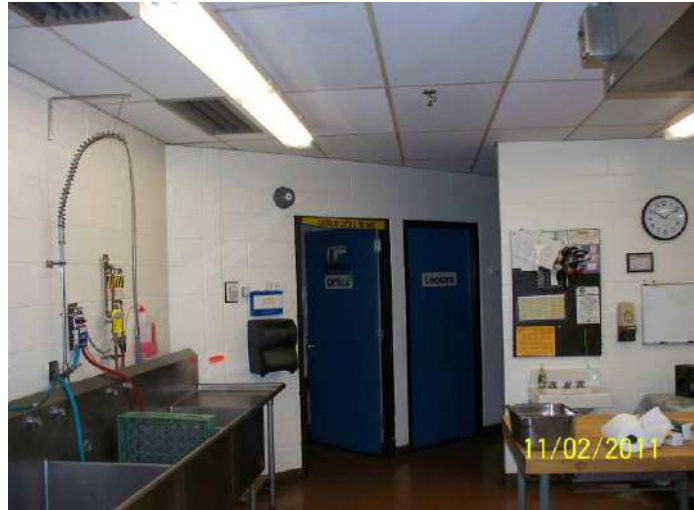
10:10 – May be correct

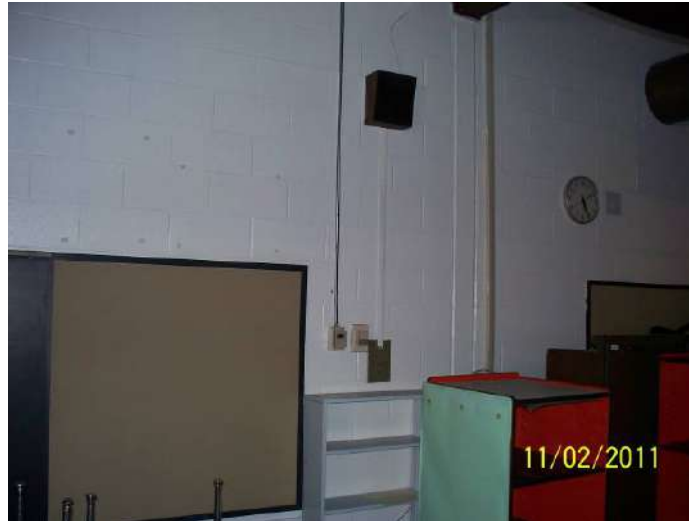
Typical classroom
speaker

The existing Dukane Intercom system is beyond its useful life and much of the surface wiring to the speakers is susceptible to damage. Dukane no longer manufactures parts for switch-bank type systems, therefore, any repairs requiring parts could lead to lengthy down time. Spare parts come from “old stock” and salvaged parts from old consoles.
