# *Smyrna School District Central Plant*

## *Certificate of Necessity*

Gipe Associates, Inc.  
Project: 18047  
August 09, 2019

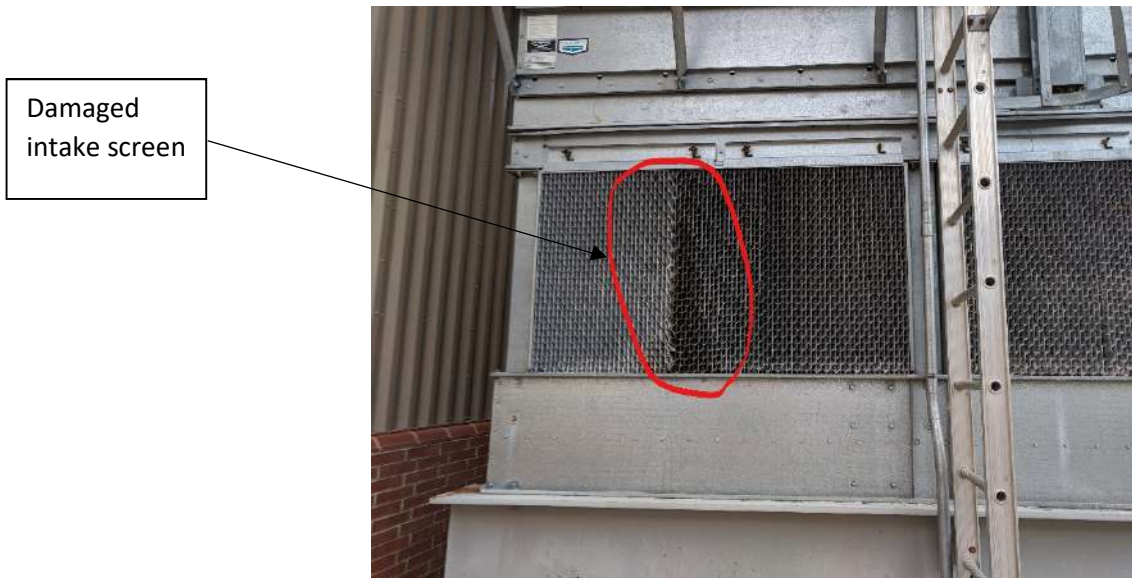
*Photograph 1: Cooling Tower Damage*

- Cooling Tower Repair – CT-1 intake screen is damaged and leaking tower water.

| COST ESTIMATE | | |
|---|---|---|
| 1 | Cooling Tower (CT-1) Repair Allowance | \$ 16,500.00 |

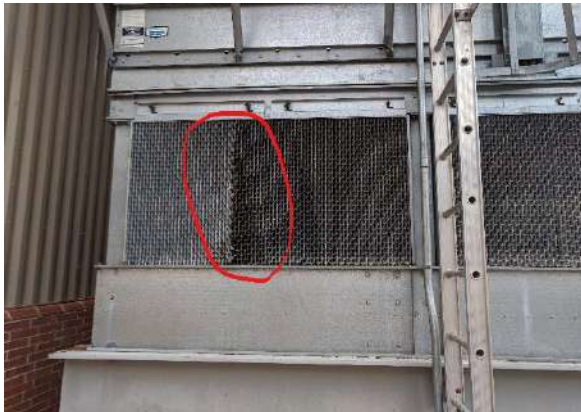
Photo #1 Cooling Tower (CT-1) intake Damage and Leak

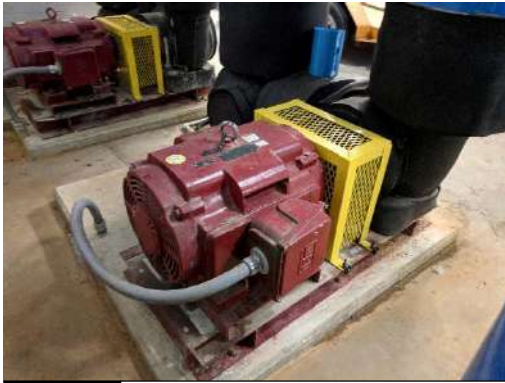
- Primary Chilled Water Pumping – Maintenance staff has identified chilled water capacity limitation issues at the Middle School. It is believed the primary pumps are undersized at the central plant. A study is required to look at the chilled water system holistically to confirm the issue and determine the best solution but it will likely require upgrading pumps (or pump components) and integrating a new control scheme. This will require a chilled water survey be performed by a Test and Balance Engineer.
- The (3) water cooled chillers are due for a manufacturer recommended overhaul rebuild. To complete this task, supplemental modifications to the chiller plant will be required.

Photo #6 Primary Chilled Water Pumps

| COST ESTIMATE | | |
|---|---|---|
| 2 | Primary Chilled Water Pump System Survey and Evaluation | \$ 38,500.00 |

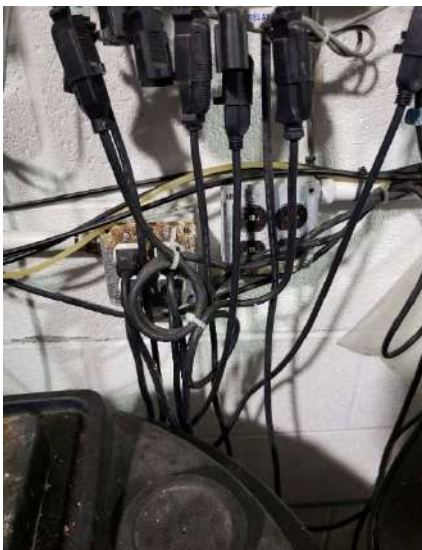
There are no immediate or significant repairs that need to be made to the building receptacles or building specialty systems. While the majority of the building receptacles are in good condition, there are two outlets in the shop space that are showing signs of rust and will probably need to be replaced within the next couple of years.

Photo #5 Receptacles in mechanical shop with evidence of rusting.

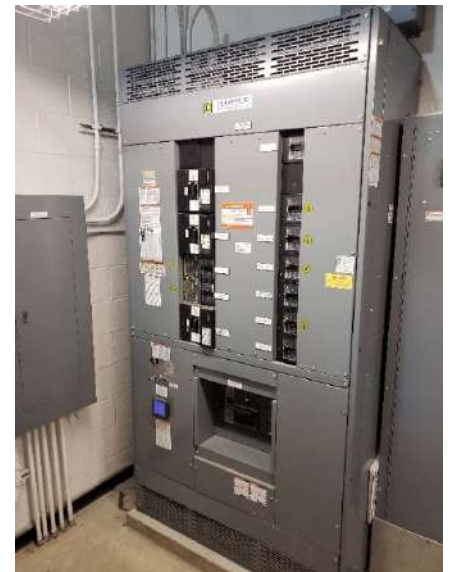
There are no immediate or significant repairs that need to be made to the electrical service or panelboard(s) in the building. The building has a 1,600A, 277/480V, three phase switchboard located in the main electrical room and panelboards throughout the building including in the main electrical room, mechanical space, shop area and vehicle bay spaces. The switchboard and panelboards throughout the building are manufactured by Square D and were installed in 2010.

Photo #6 Main Switchboard CPMPP
