Addendum 1

Project: **RFP NUMBER 2425-02 – TROY SCHOOL DISTRICT 2025 ROOF PROGRAM**

BID NO. 2425-02
Troy School District
2025 Roof Program

ADDENDUM NO.:	1	DATE:	10/30/24
PROJECT IDENTIFICATION			
PROJECT NAME:	BID NO. 2425-02 Troy School District 2025 Roof Program		
SITE ADDRESS:	4400 Livernois Rd., Troy, MI 48098		
ADDENDUM DESCRIPTION			
The following is a summary of changes to the Drawings and Specifications that shall be considered as a part of your Bid. Receipt of this Addendum shall be acknowledged in the Bid submission. This Addendum consists of 2 pages.			
SUMMARY OF ADDENDUM:

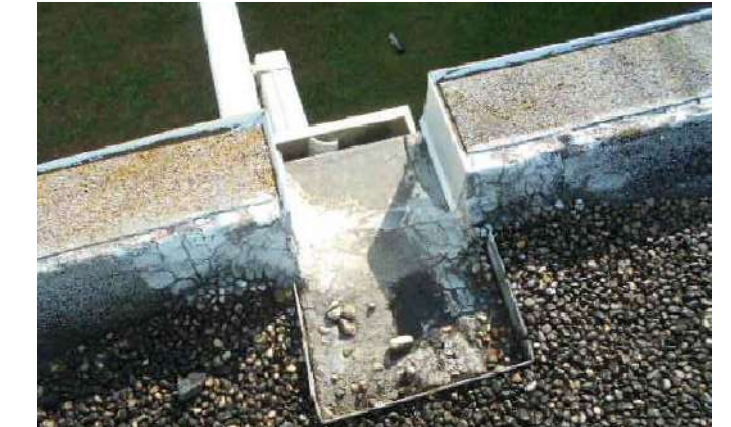
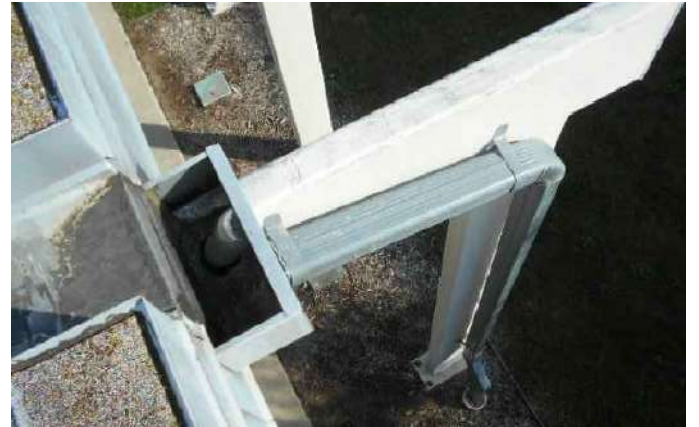
- Scupper Drain, Leader Box and Downspout:** Remove existing scupper drain, leader box and downspout; Replace with new to match with existing metal profile. **Ref. Photos 1746 and 1748.**
- Perimeter Wood Nailers:** Furnish and install new wood nailers on perimeter edges to level wall cap and provide base flashing required heights. **Ref. Detail 1.05.**
- Edge Metal:** Install new continuous cleat 24-gauge clear anodized aluminum edge metal. **Ref. Detail 1.14; Photo 1753.**
- Deck Flutes:** All debris to be removed from deck flutes.

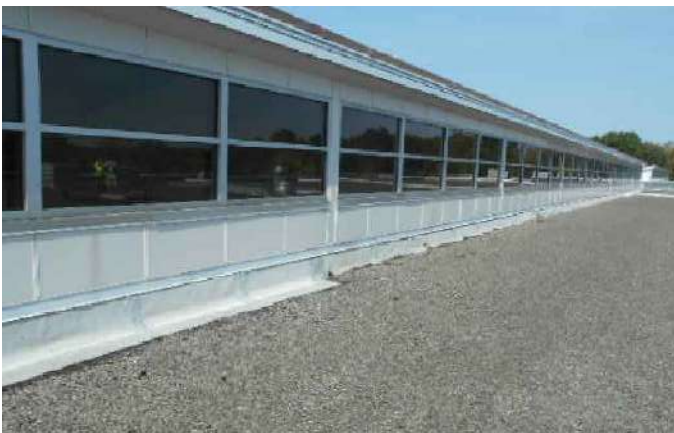
1791

7. Metal Counter Flashing: Install new termination bar and new 24-gauge clear anodized aluminum counter flashings. Ref. Detail 1.14; Ref. Photo 1791.
8. Walkways Pads: Add walkway pads at west side shingle roof perimeter edge run off and at all RTU access doors, wall ladder and roof hatch. Ref. Photo 1855.

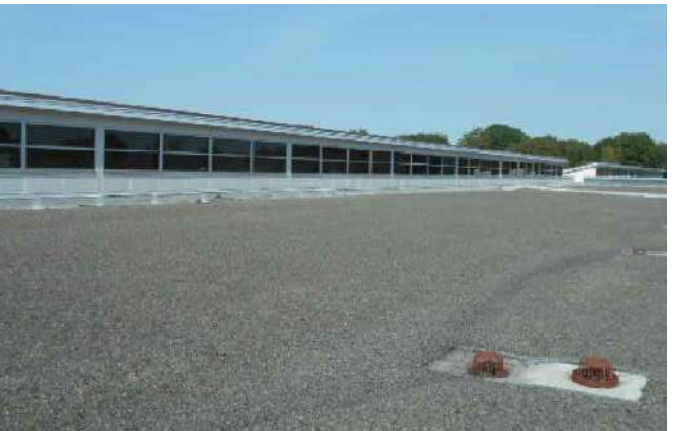
1797

1. Saddle & Crickets: Contractor to provide saddle and crickets where indicated on roof plan and other areas as required by the roofing membrane system manufacturer. Ref. Photo 1797.

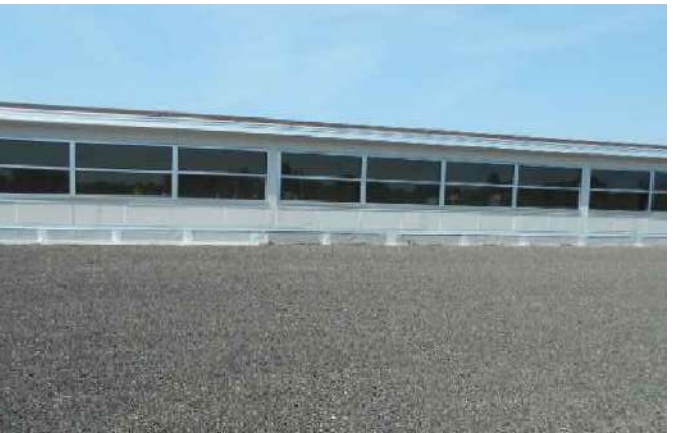
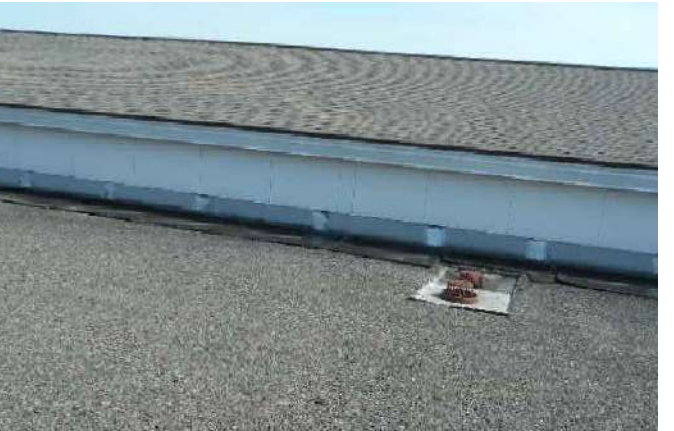
11. North Side Extension Wall: Furnish and install new wood nailer, base flashing and anodized aluminum coping cap on extension wall. Ref. Photo 1890.
12. Penthouse Walls: Add new plywood at wall flashing locations on penthouse. Ref. Photos 1798 and 1835.

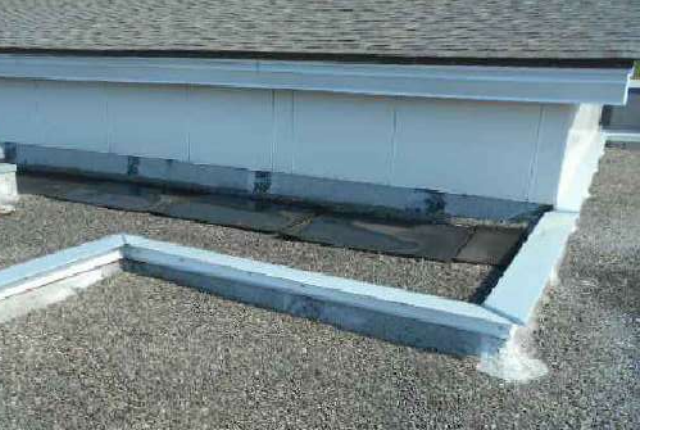
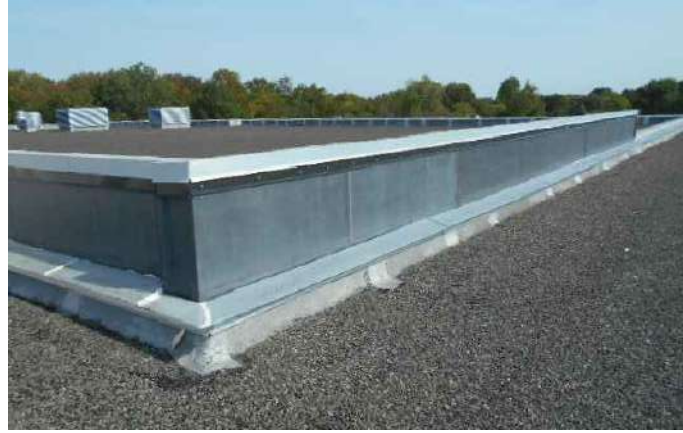
9. Wall Ladder: Furnish and install new roof access ladder required at east side drop down roof. Ref. Photo 1905.
10. Expansion Joint: Furnish and install new aluminum expansion joints, where required. Ref. Photos 1883 and 1885.

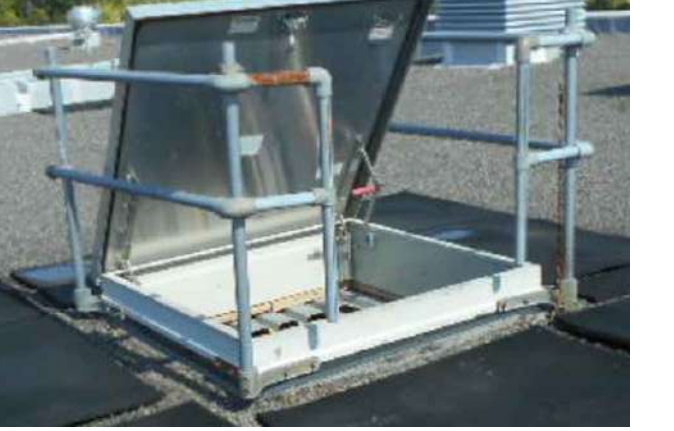
1902

5. Perimeter Wood Nailers: Furnish and install new wood nailers on parapet walls, as needed where needed.
6. Roof Hatch: Furnish and install new roof hatch, safety rails, ladder up pole and ladder rung grips. Ref. Photo 1902.

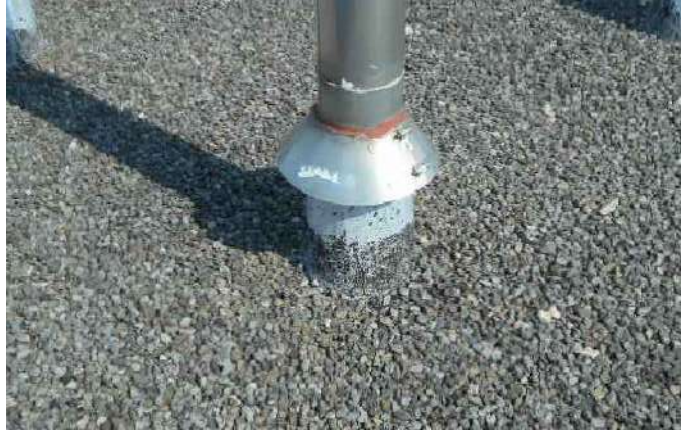
1898

13. Hot Stacks: Remove and replace existing pipe sleeves. Reuse the existing stainless-steel umbrellas on hot stacks and seal with heat resistant ceramic sealant. Ref. Photo 1898.

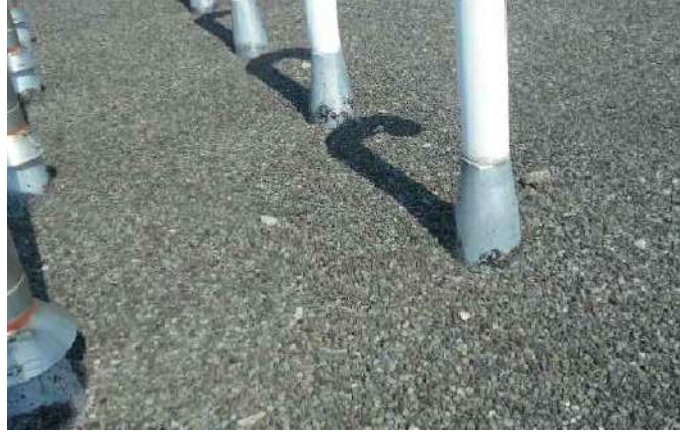
1899

14. Exhaust Pipes: Remove and replace existing pipe sleeves. Flash as required. Install new metal pipe umbrellas. Ref. Photo 1899.

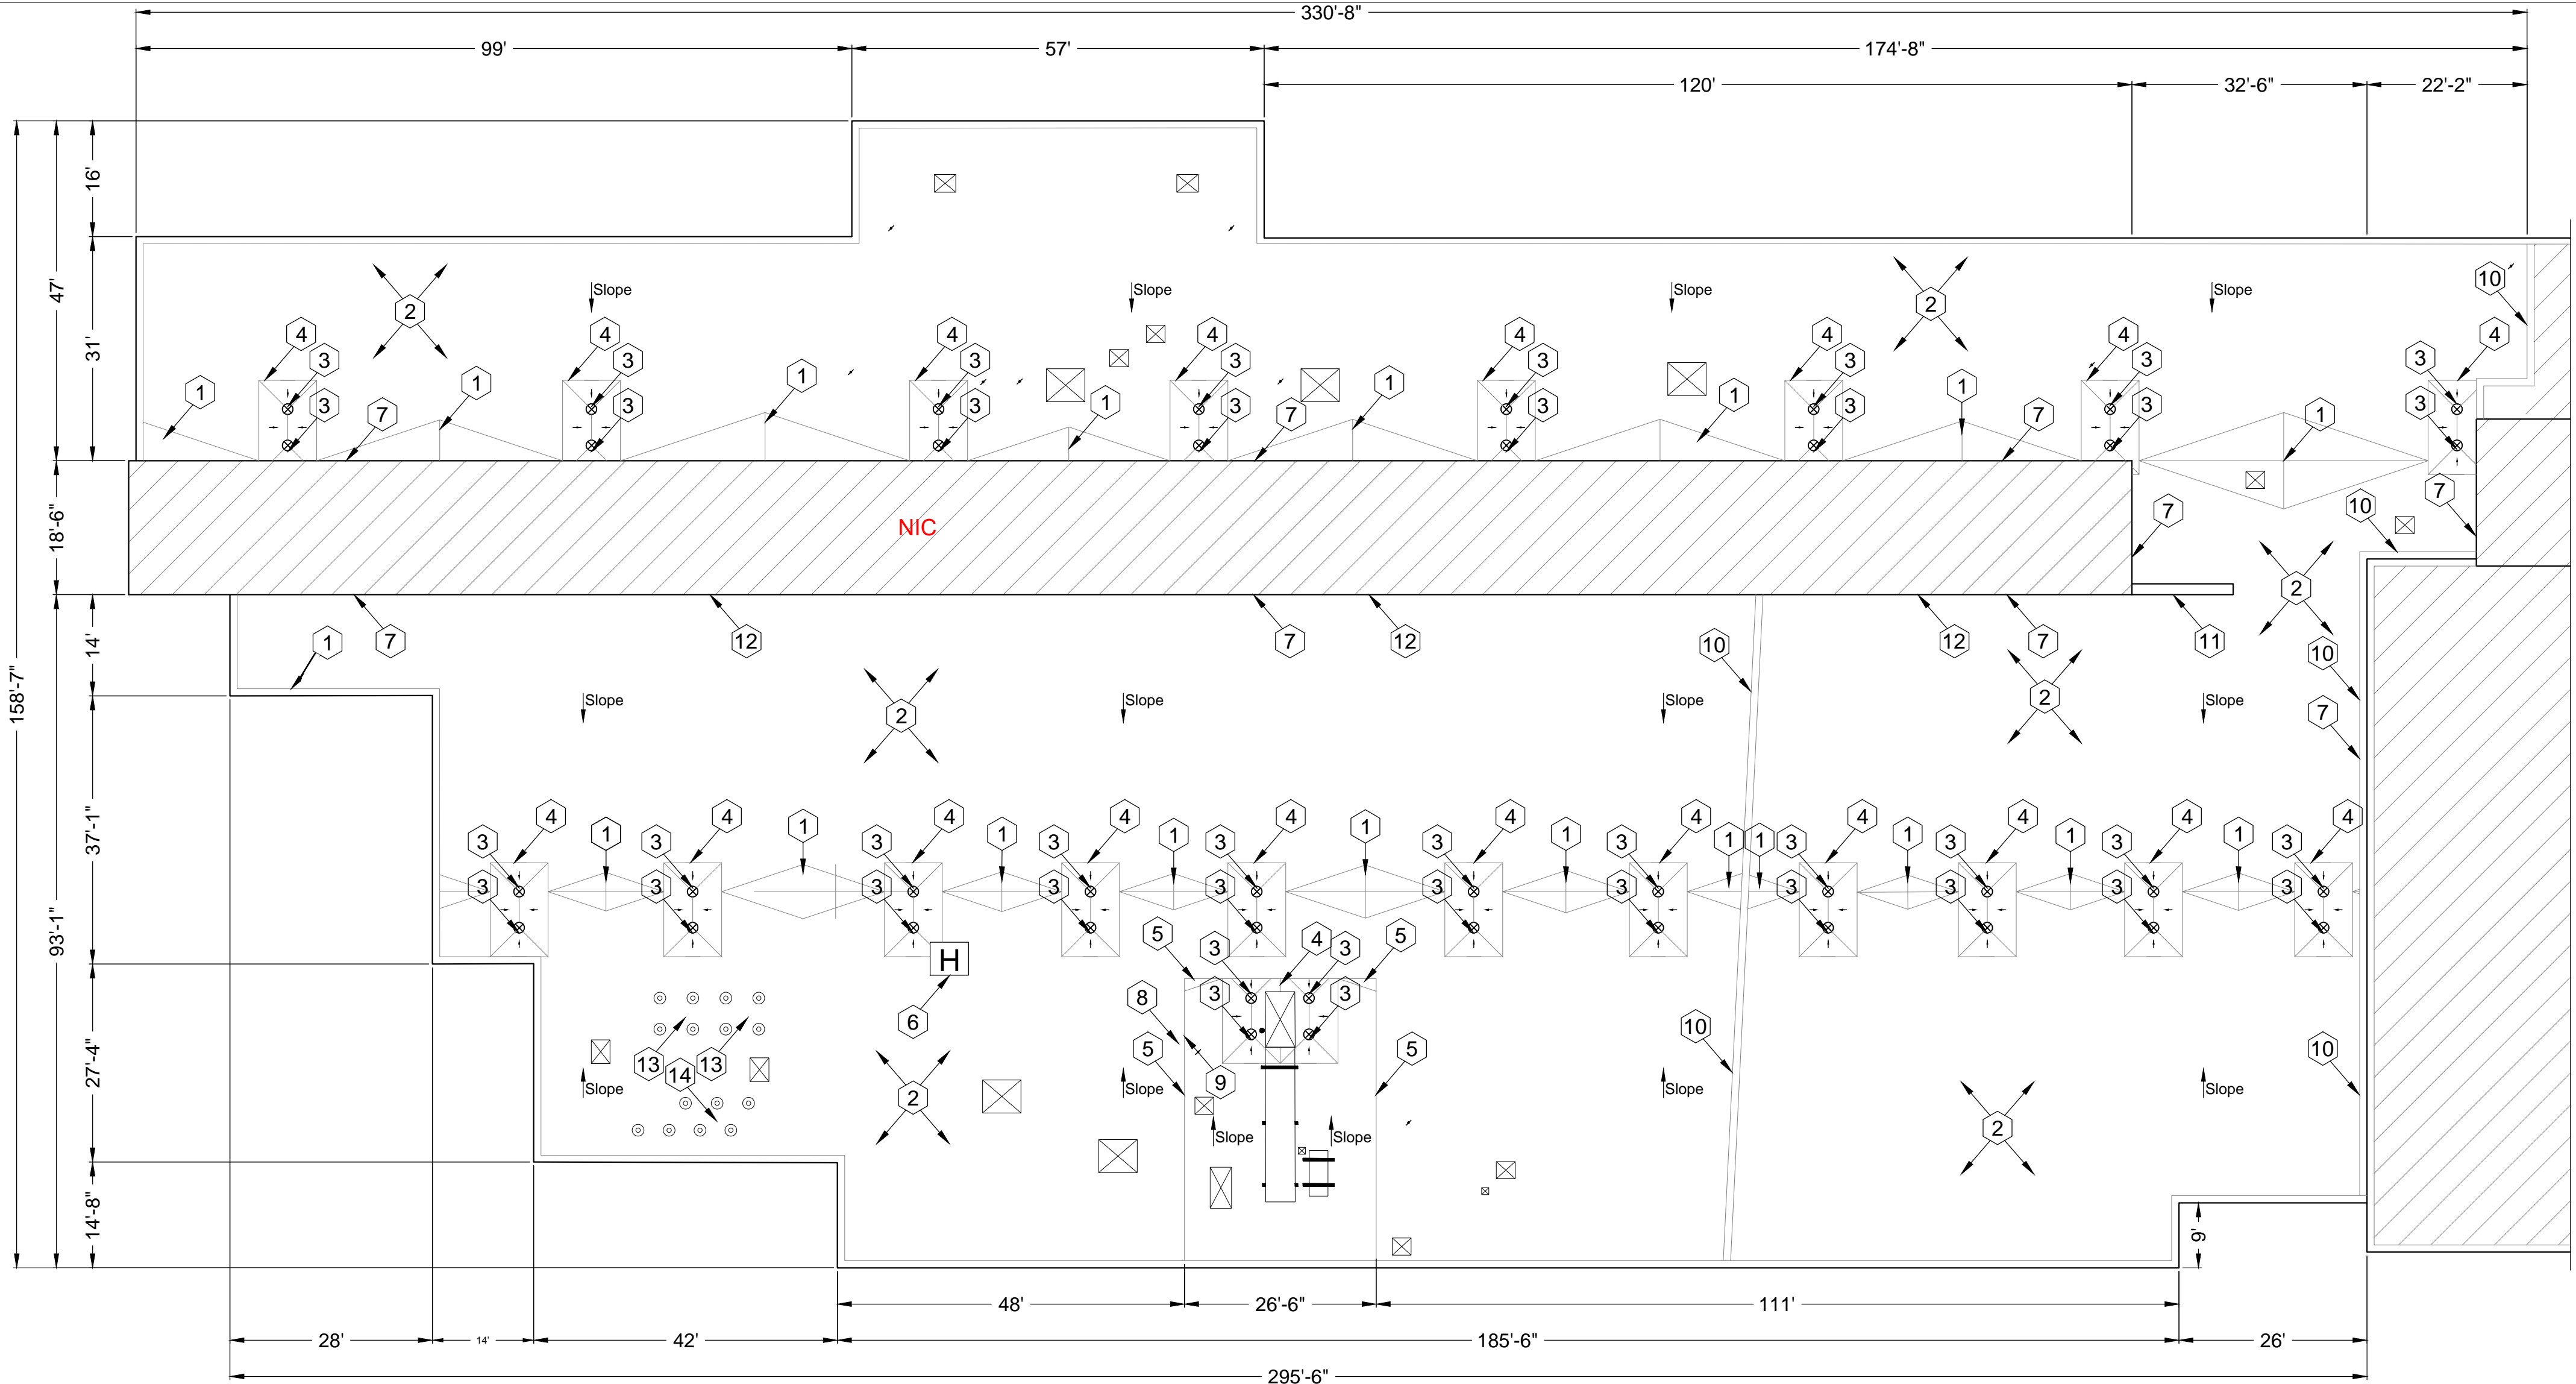
Baker Middle School
Roof Area B

- A. Roof Membrane: Gravel BUR with cap and plies with asphalt
B. Insulation:
1) Top Layer: Insulation 1/2" Fiberboard Insulation
2) Base Layer: Approx. 3-inch polyisocyanurate insulation.
C. Deck: Metal B: Slope in deck

Work includes removal and disposal of existing roofing, insulation, flashing systems and all sheet metal flashings down to the surface of the deck, repair deteriorated decking, install new roof insulation, fully adhered EPDM single ply roof membrane including all flashing, new roof related sheet metal, and accessories as detailed in the specifications and drawings. **Approx. Roof Area B 35,350 sq. ft.**

- a. Roof Membrane: EPDM, 60 mil, adhered to insulation.
b. Insulation: R30:
1) Top layer set-in low-rise foam adhesive.
2) Bottom layer mechanically attached to metal deck.
c. Deck: Metal B: Repair as necessary to comply w/ building codes.
d. Interior Ceiling: As needed, drop ceiling
e. Building Height: Ground to building edge: 60 ft.

Item	Description		
1.	Drawing A2.1 Roof Plan – Baker Middle School, Roof Area B (<i>Ref. A2.1 revised drawing</i>) CHANGE: Shingle roof is not included.

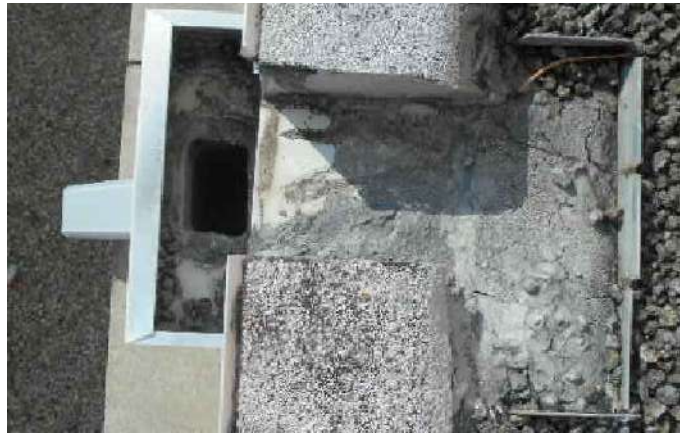
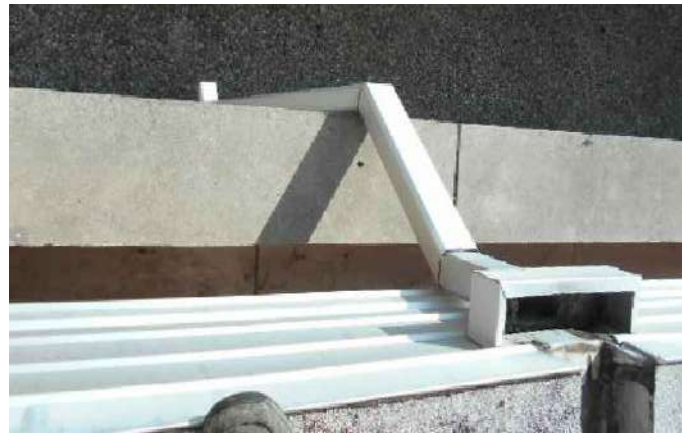
3. Scupper Drain, Leader Box and Downspout: Remove existing scupper drain, leader box and downspout; Replace with new to match with existing metal profile. Photos 1769 and 1770.

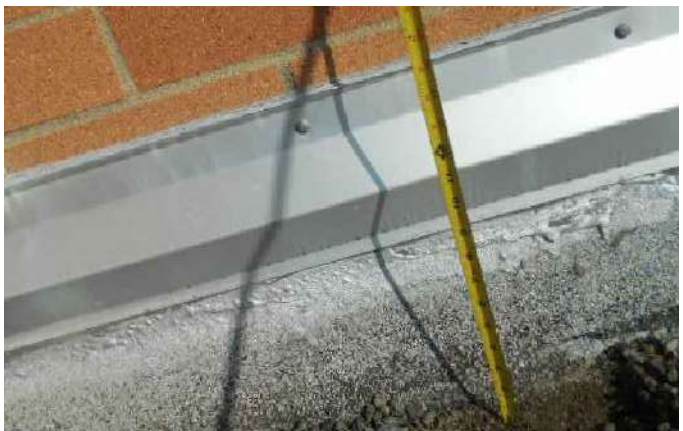
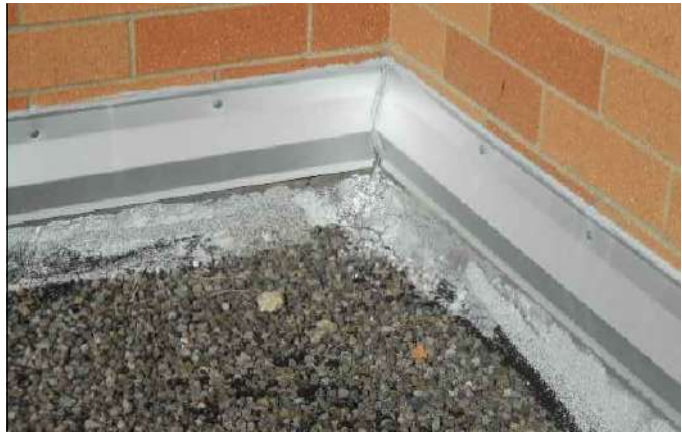
2. Metal Counter Flashing: Install new termination bar and new 24-gauge clear anodized aluminum counter flashings. Ref. Detail 1.14; Ref. Photos 1772 and 1774.

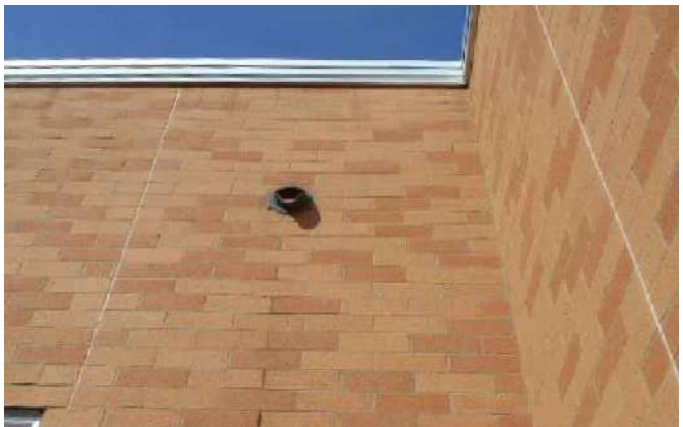
1775

5. Walkway Pad and Splash Block: Add new walkway pad and splash block below upper roof drainage. Ref. Photo 1775.

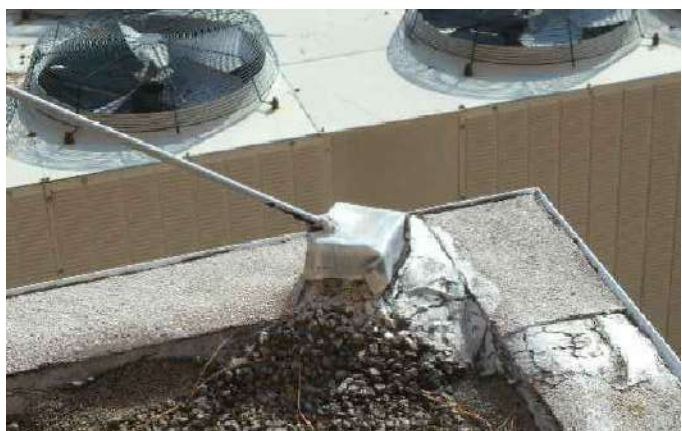
1778

6. Support Rods: Furnish and install new pitch pans and metal covers, as needed, for the canopy support rods. Ref. Photo 1778.

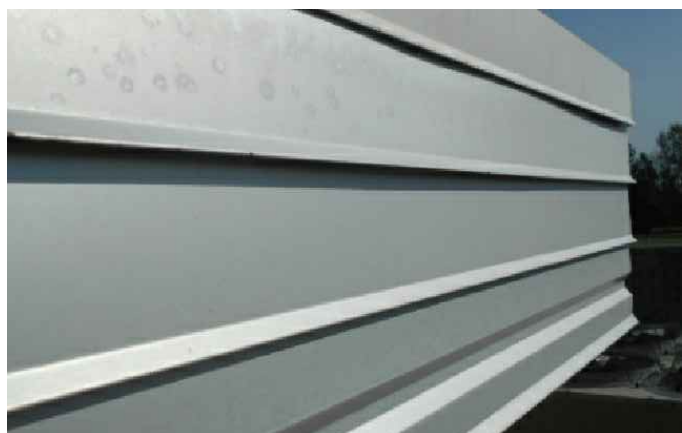
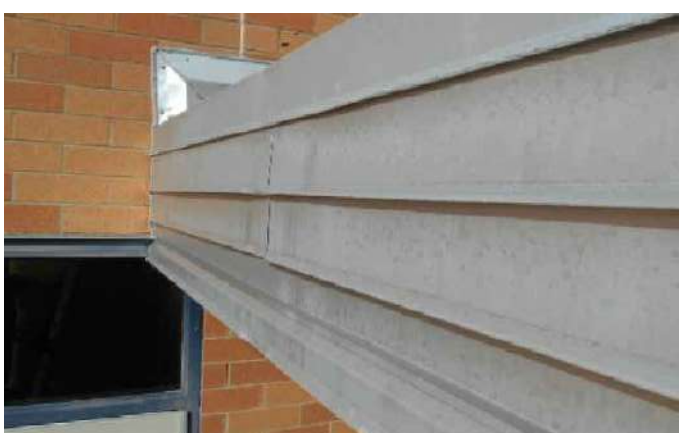
4. Fascia: Remove and replace damaged fascia metal and edge metal to match existing anodized aluminum metal and profile. Ref. Photos 1780 and 1783.

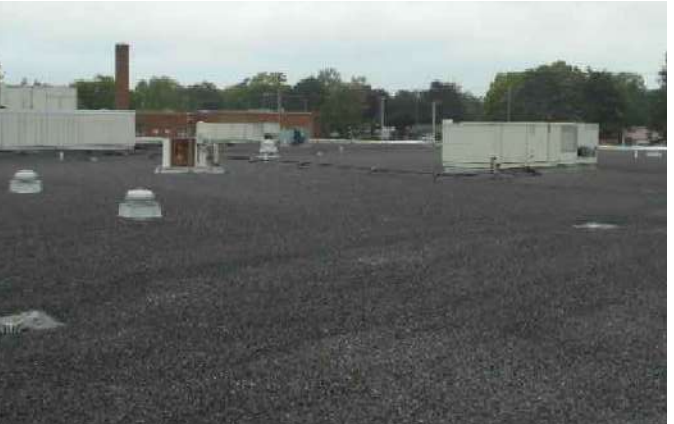
1619

4. Saddle & Crickets: Contractor to provide saddle and crickets where indicated on roof plan and other areas as required by the roofing membrane system manufacturer. Ref. Photo 1619.

3.	Drawing A4.0 Roof Plan – Troy Union Elementary School, Roof Area F (<i>Ref. A4.0 revised drawing</i>) ADDITION: Refer to revised A4.0 drawing for additional tapered saddles as noted in Key Note 4 Saddle & Crickets.

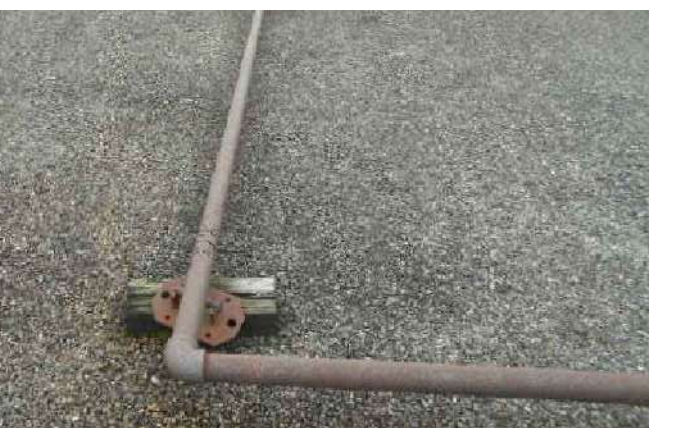
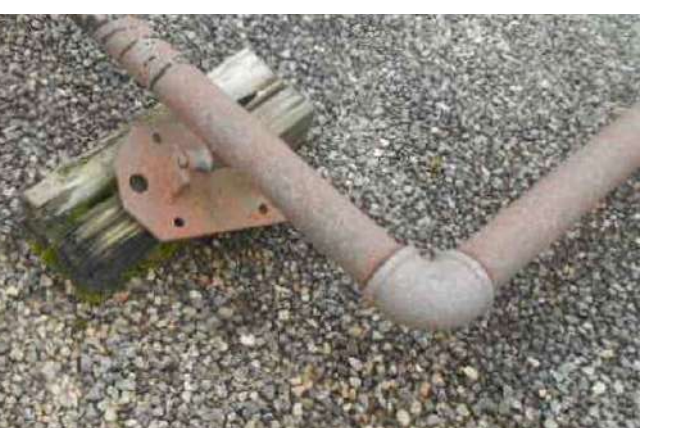
2. New Pipe Supports: New gas blocking, minimum 6"X6" and wrapped, over walk pad. No more than 10ft apart, per code. Ref. Photos 1671 and 1672.

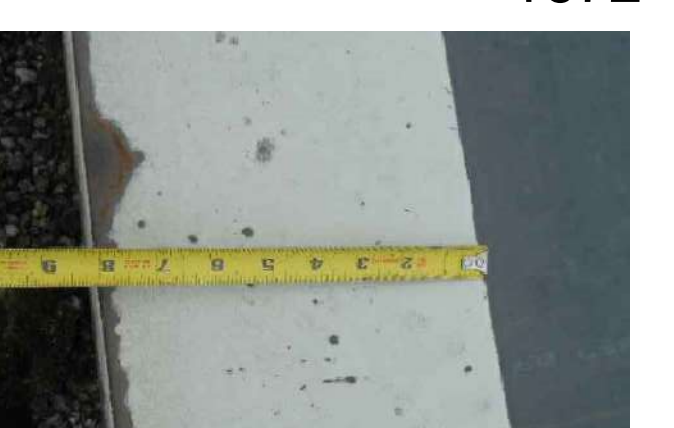
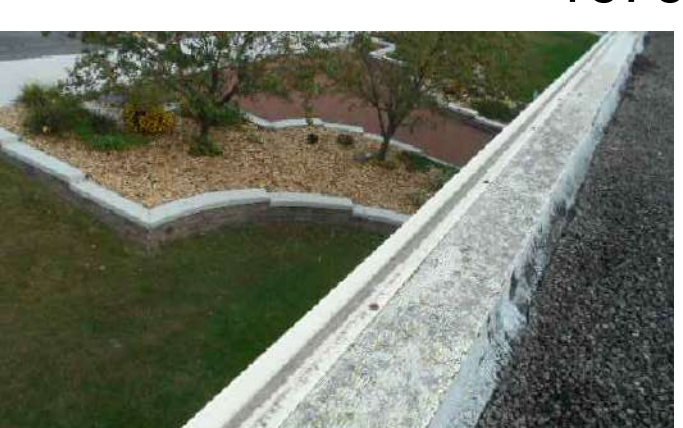
3. Metal Coping: Remove existing metal coping and install new 24 gauge prefinished galvanized metal with continuous face cleat and standing seam joints; color as selected by Owner. Ref. Details 1.04 and 1.08; Photos 1679 and 1684.

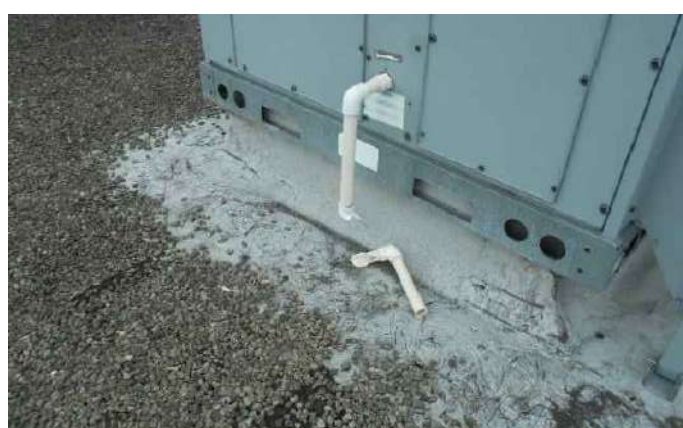
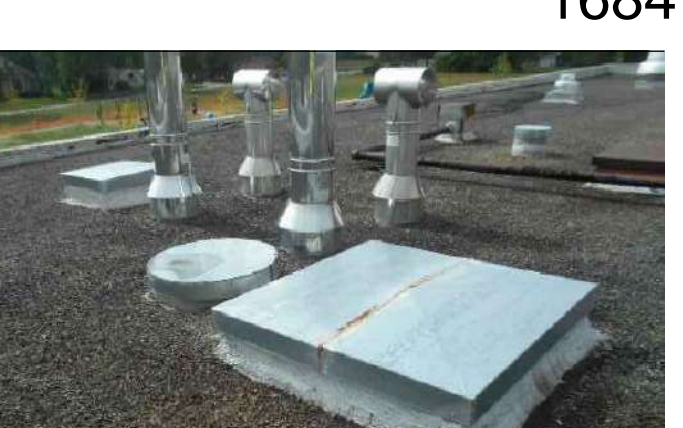
5. Deleted Curbs: Remove deleted items, as marked by TSD, fill-in deck and roof over. Ref. Photos 1676 and 1694.
