CENTRAL HIGH SCHOOL

4th Avenue S. and E. 34th and 35th Streets

1931

### DETAILED REPORT

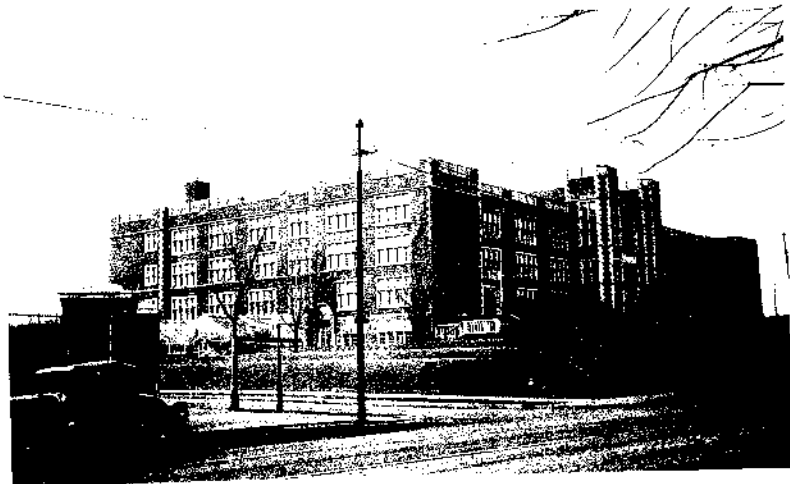
# CENTRAL HIGH SCHOOL

SCALE: 1 IN.=50 FT.

ERECTED	1913.
CONDITION	Good.
HEIGHT	One, three and four stories.
AREA	Bsm't., 8,820 sq. ft.; 1st floor, 75,700 sq. ft.; 2nd floor, 50,000 sq. ft.; 3rd and 4th floors, 41,600 sq. ft on each floor.
WALLS	20 in. and 16 in. brick.
FLOORS	Concrete.
ROOF	Ordinary wood over concrete; concrete on unprotected metal in gymnasium.
FLOOR OPENINGS	One stairway basement to 1st floors; two open stairways 1st and 2nd floors; four open stairways 1st to 4th floors, and one enclosed elevator 1st to 4th floors.
