CLARINDA COMMUNITY SCHOOL DISTRICT

FACILITY CONDITION ASSESSMENT
February 19th, 2018

EXECUTIVE SUMMARY

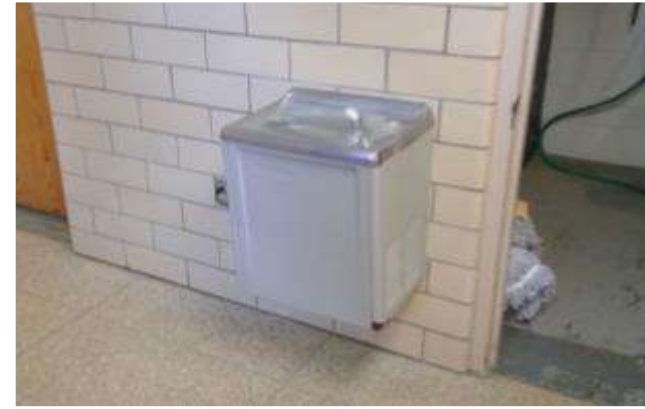
Existing water cooler

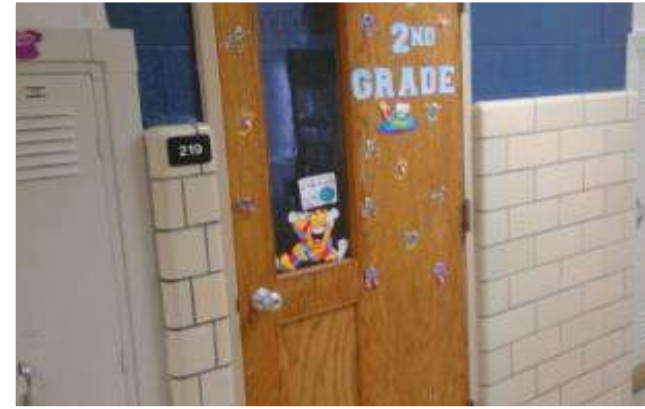
Existing non-compliant door and hardware

Replace existing doors and hardware.

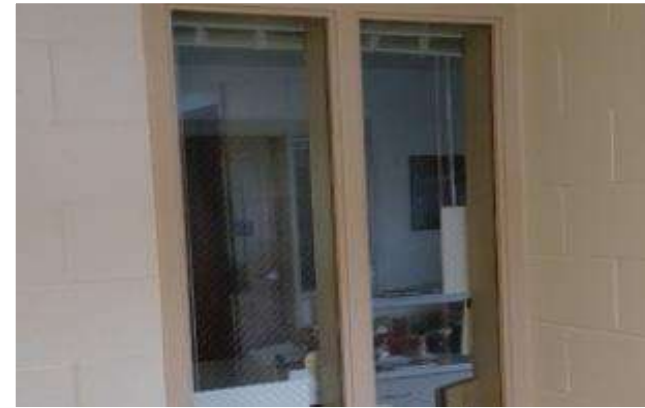
Existing wired glazing

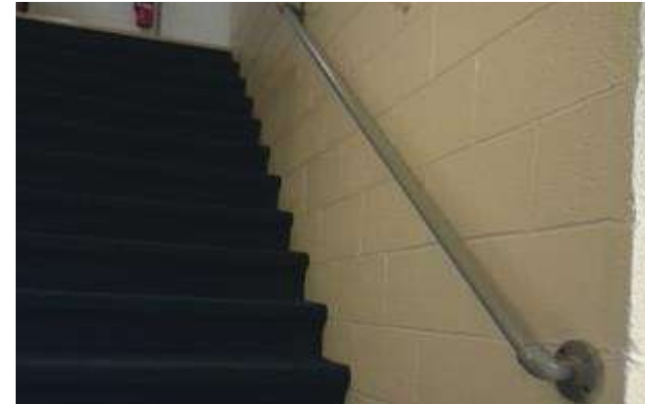
Existing non-compliant stair railings

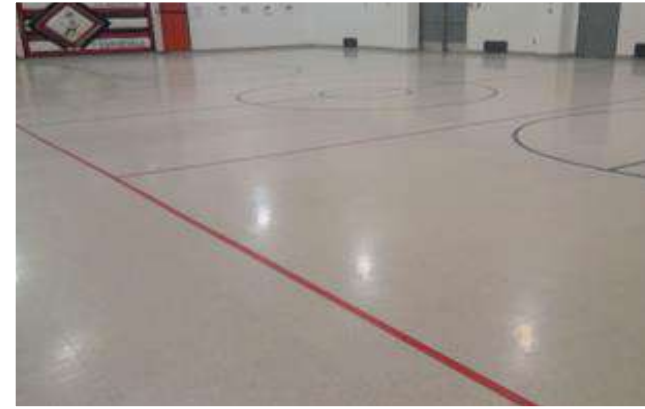
Existing VCT gymnasium flooring

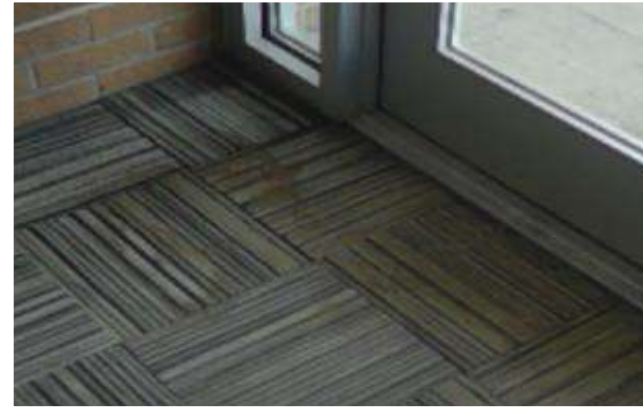
Existing walk off carpet

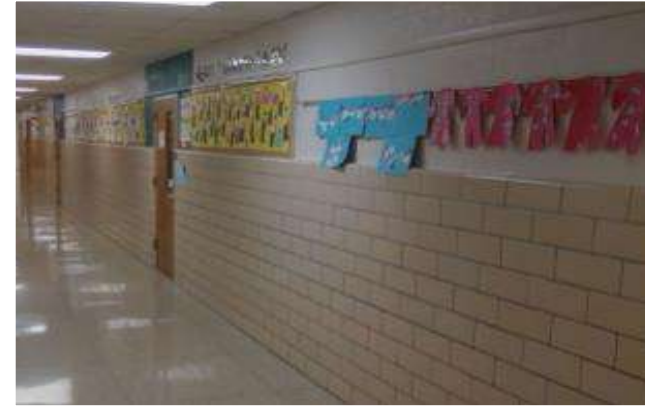
Existing tile wainscoting

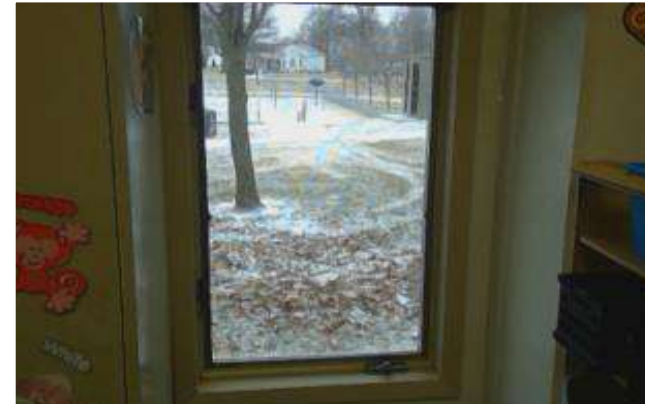
Existing exterior window

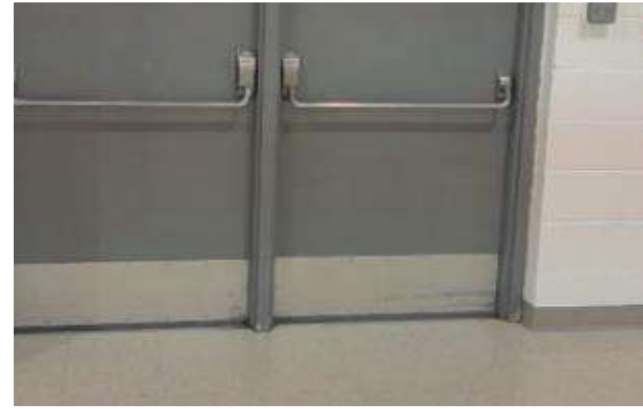
Existing exterior door

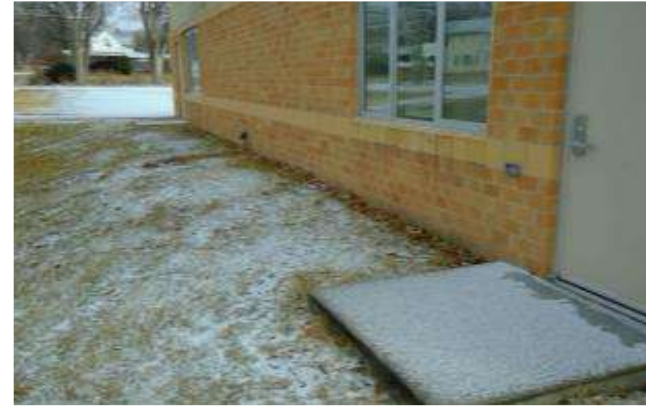
Existing exit doors without path of egress

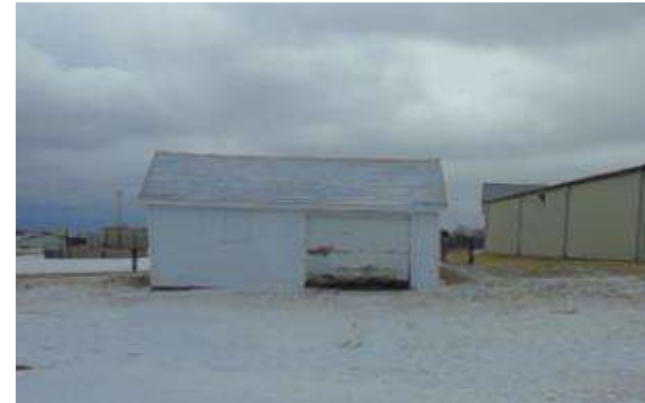
Existing overhead door at storage shed

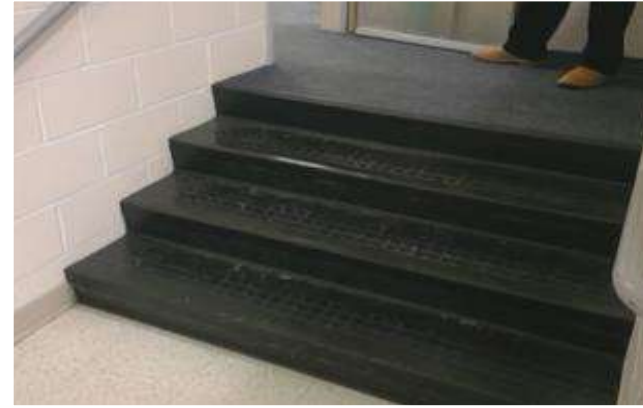
Existing stairs to stage

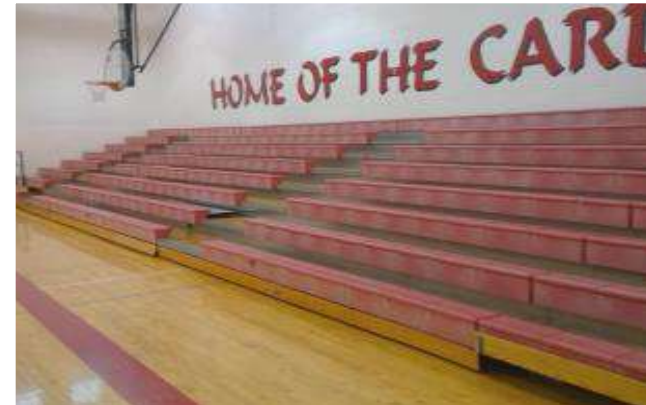
Existing bleachers

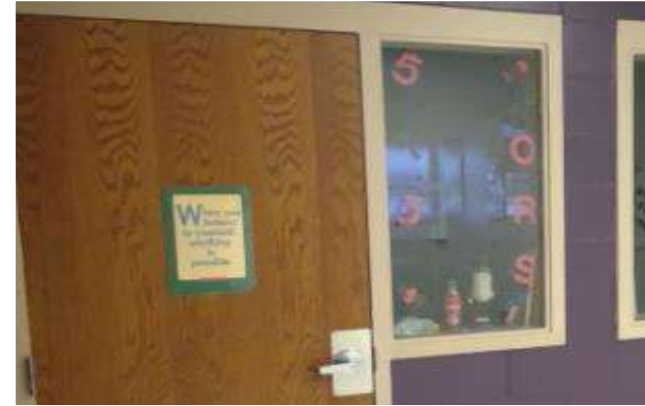
Existing non-compliant glazing

Replace the existing non-compliant glazing with new safety rated or tempered glazing.

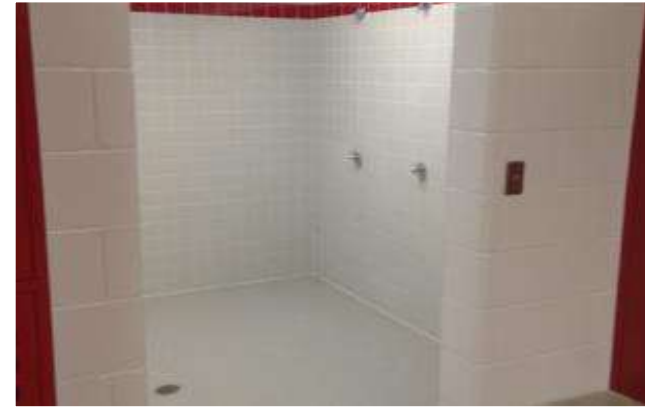
Existing communal drain in shower

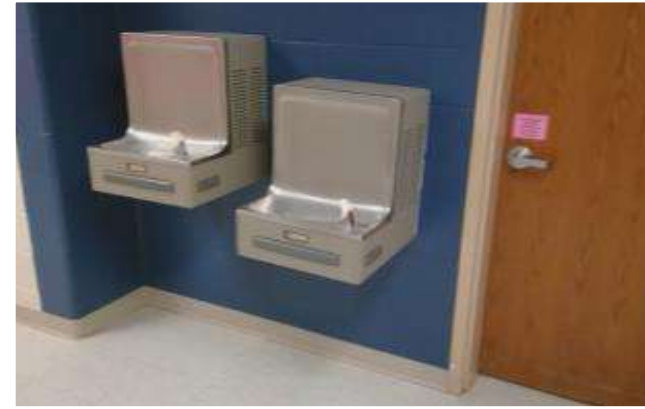
Existing water cooler

Replace existing water coolers with bottle fill style water coolers.

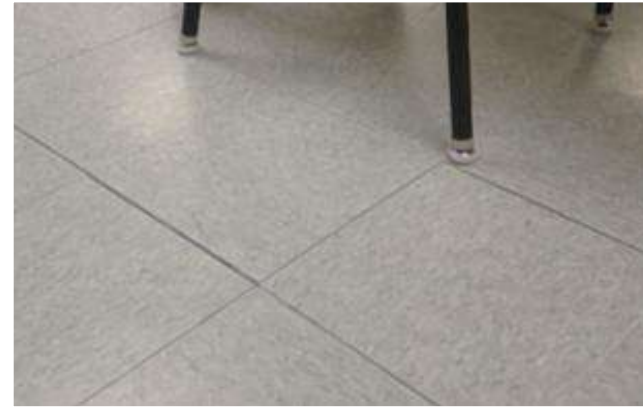
Existing flooring

Remove and replace existing VCT flooring.

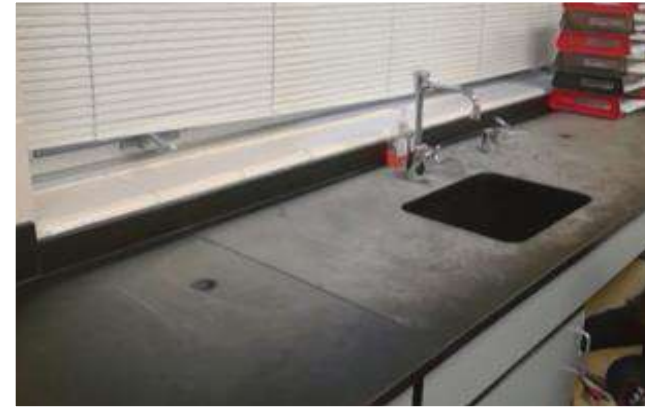
Existing countertop

Remove and replace existing countertops with new acid-proof countertops.

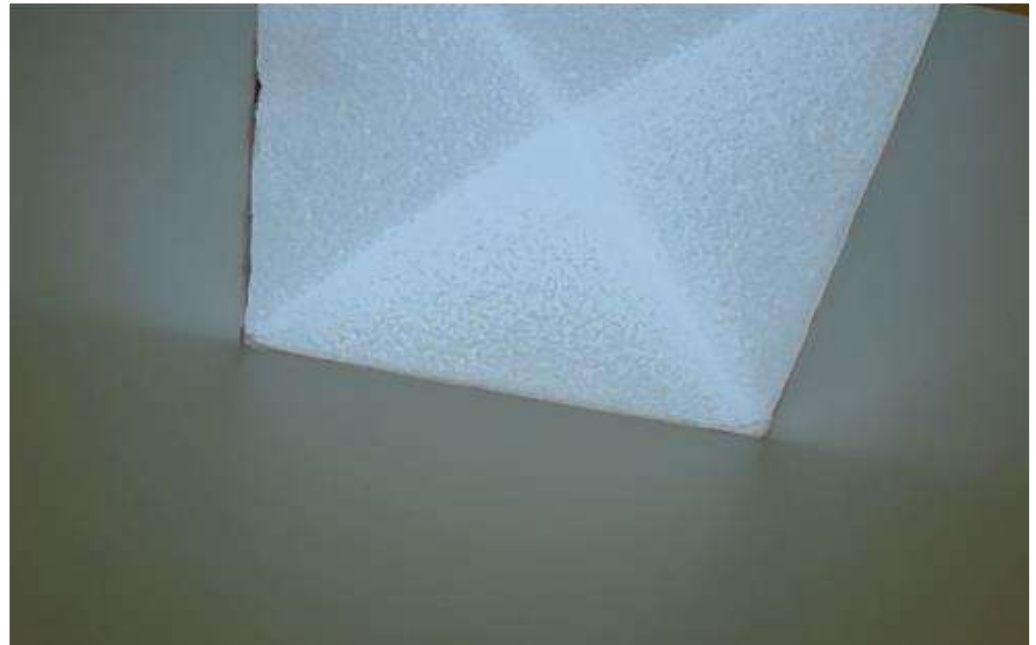
Existing wall finishes located at skylights in corridors are showing signs of water damage.

Existing wall finish at skylights

Repair damaged finishes, re-caulk around skylights.

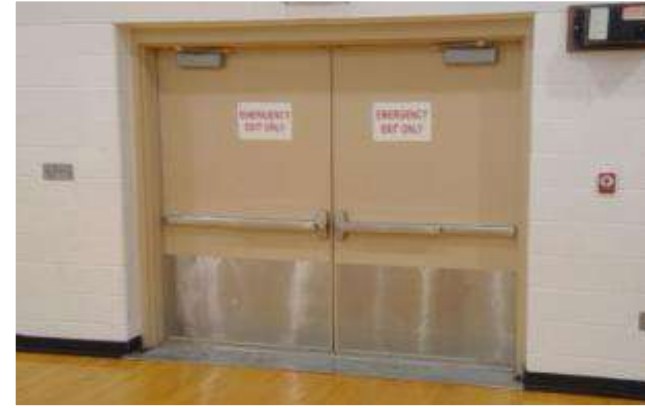
Existing exterior door

Replace existing exterior doors with new.

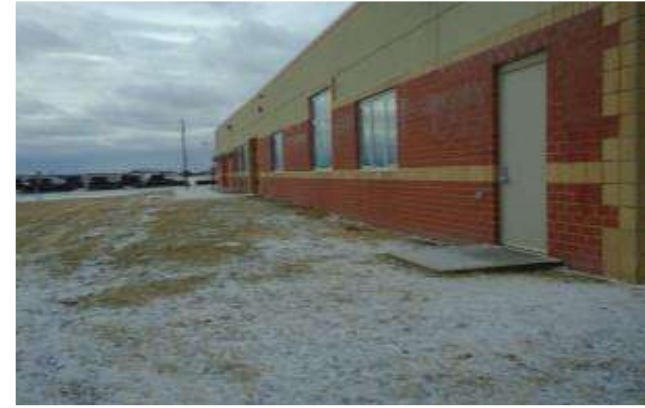
Existing exit doors without path of egress

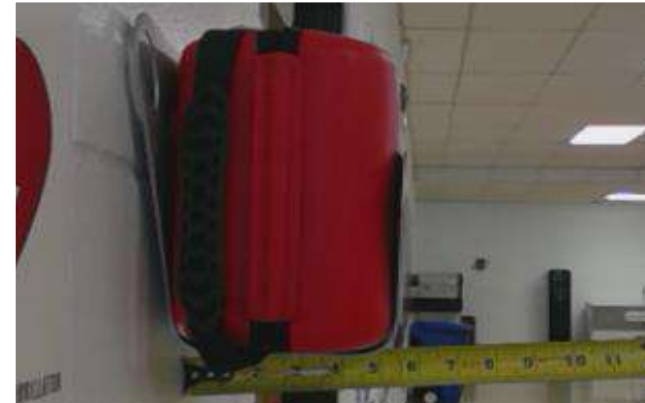
Existing defibrillator

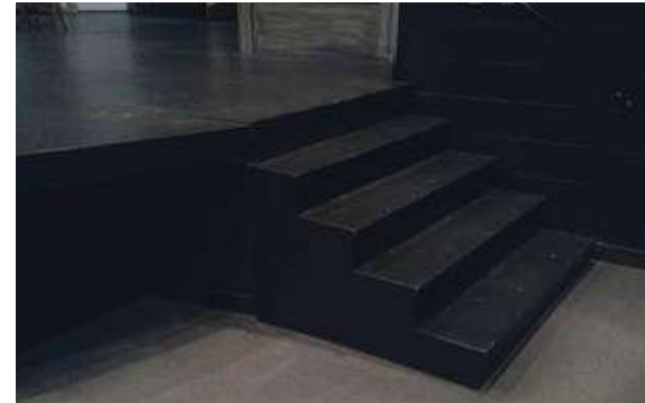
Existing stage access

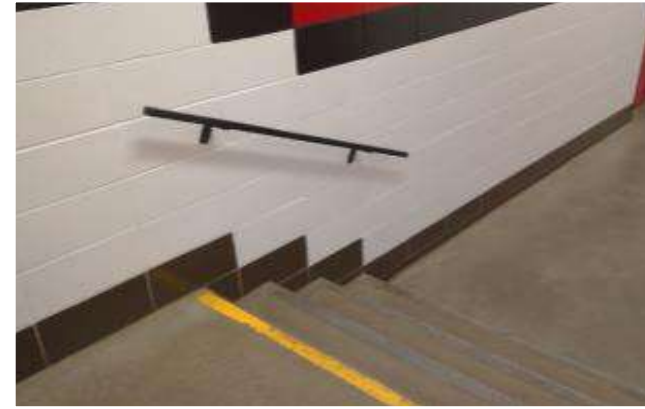
Existing non-accessible floor

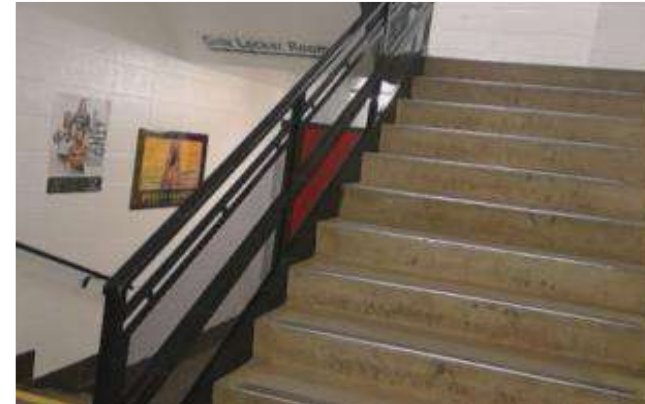
Existing non-compliant stair railings

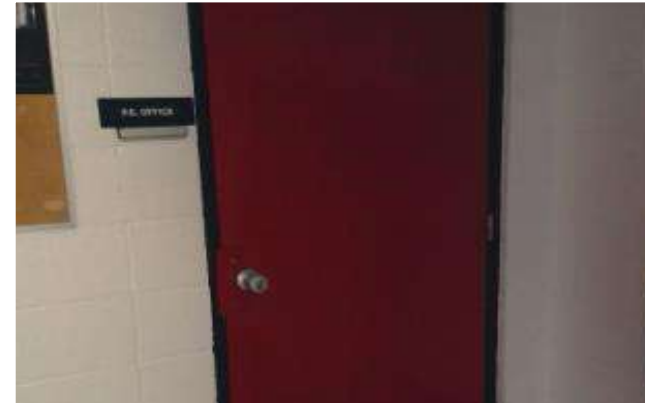
Existing non-compliant door hardware

Replace existing hardware with new code compliant hardware.

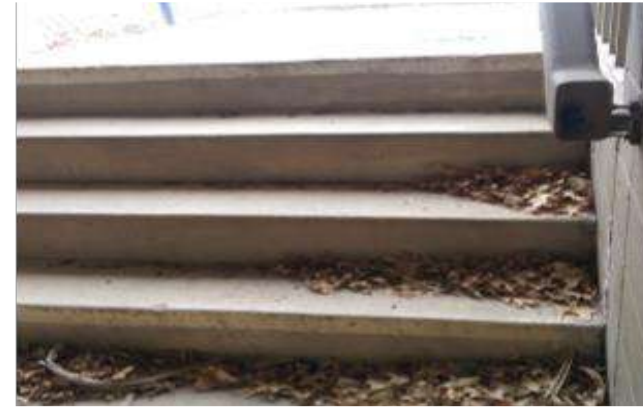
Existing non-accessible entryway

Replace exterior egress stairs with new ADA compliant ramp.

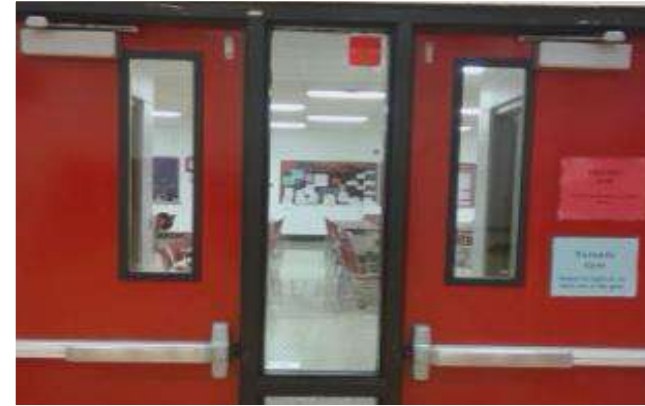
Existing non-rated corridor door

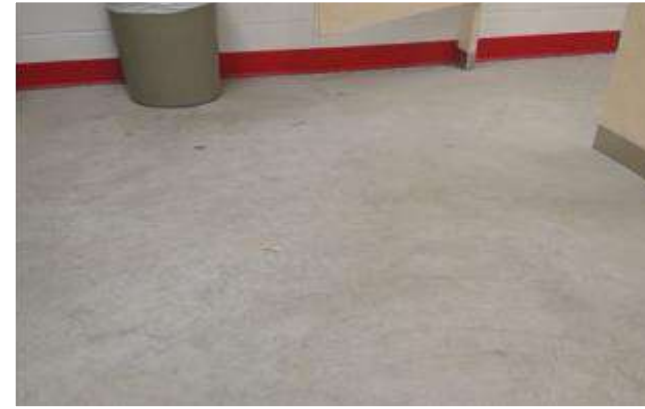
Existing sealed concrete floor

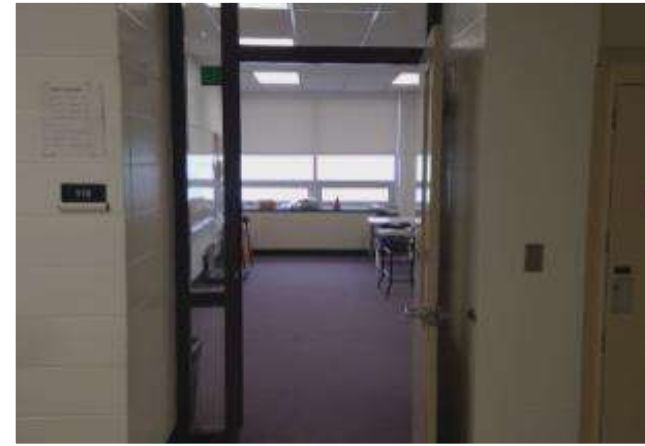
Example of existing door/frame

Remove existing door and frame and replace with new.

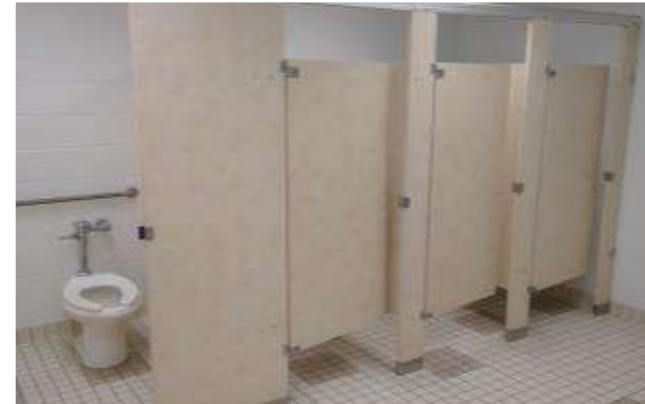
Existing restroom finishes are worn, dated, and have reached end of useful life.

Existing restroom finishes

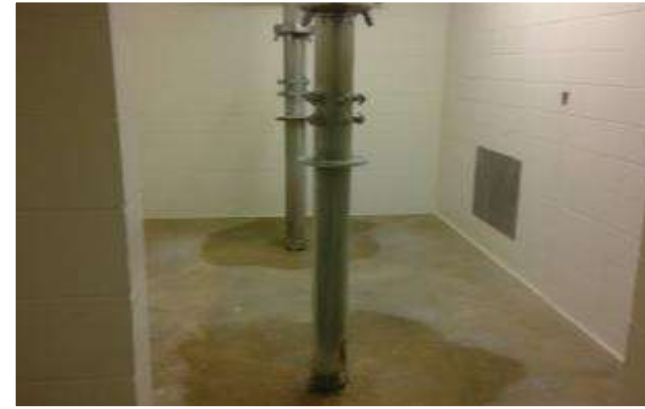
Existing shower finishes are worn, dated, and have reached end of useful life.

Existing shower finishes

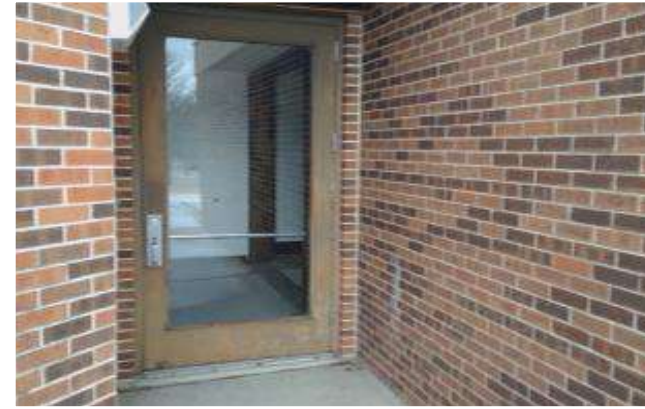
Existing exterior door

Replace the existing with new energy-efficient exterior doors.

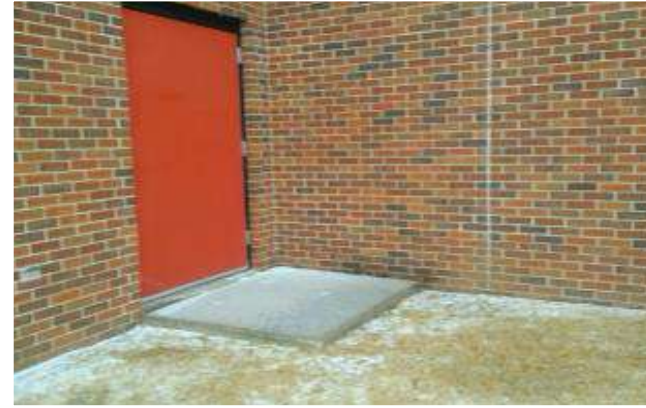
Existing exit doors without path of egress

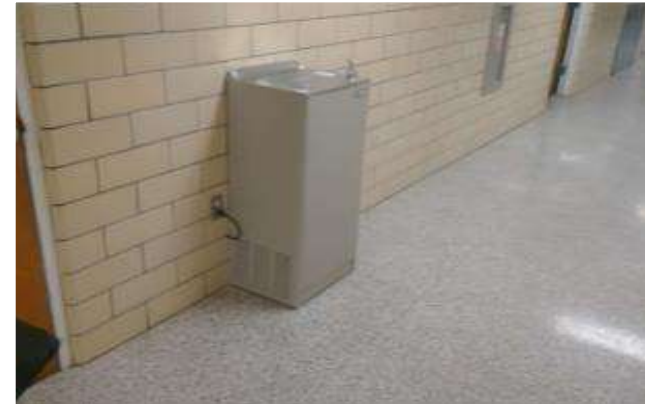
Existing water cooler

Replace existing with new water coolers that are compliant with the Americans with Disabilities Act (ADA).

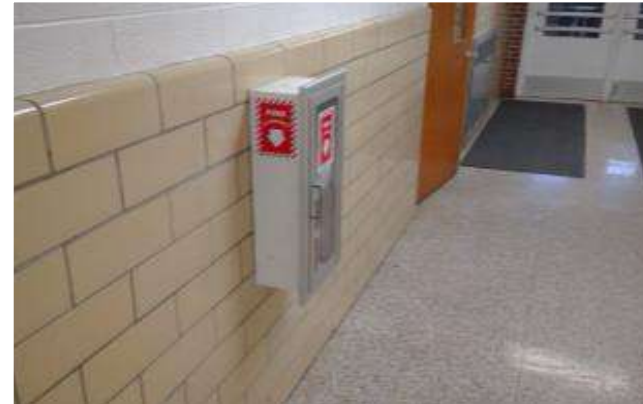
Existing fire extinguisher cabinet

Remove existing fire extinguisher cabinets and replace with a recessed or semi-recessed ADA compliant fire extinguisher cabinet.

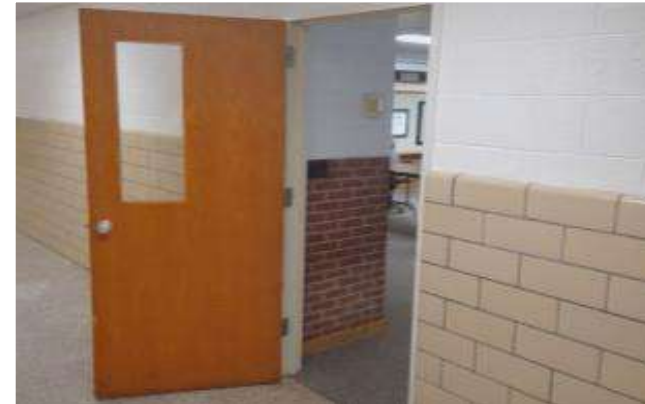
Existing non-compliant door

Replace existing doors and hardware with new.

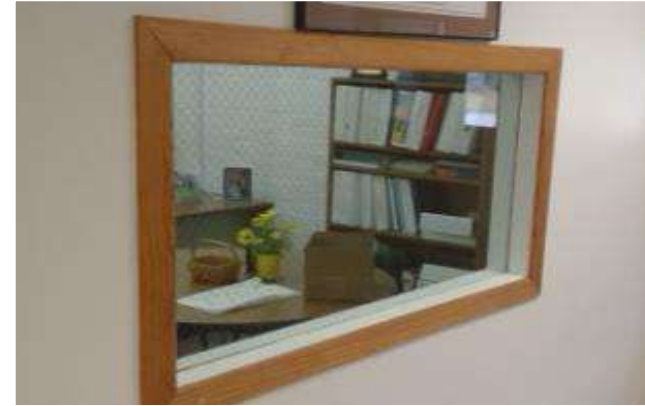
Existing non-compliant glazing

Replace the existing non-compliant glazing with new safety rated or tempered glazing.

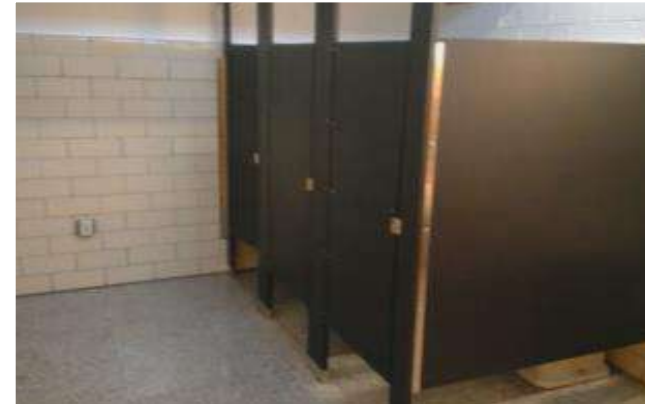
Existing conditions

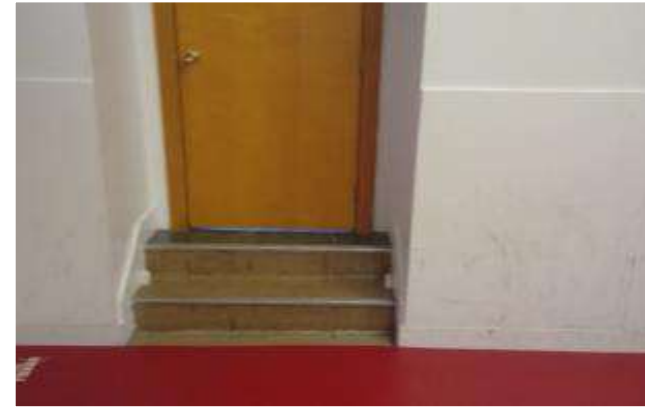
Existing non-accessible floor

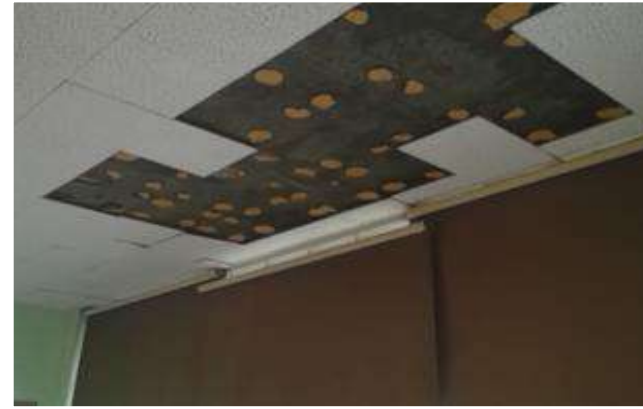
Existing ceiling

Remove and replace with a new acoustical ceiling system. Acoustical ceilings cost are determined by tile size, thickness and finish desired.

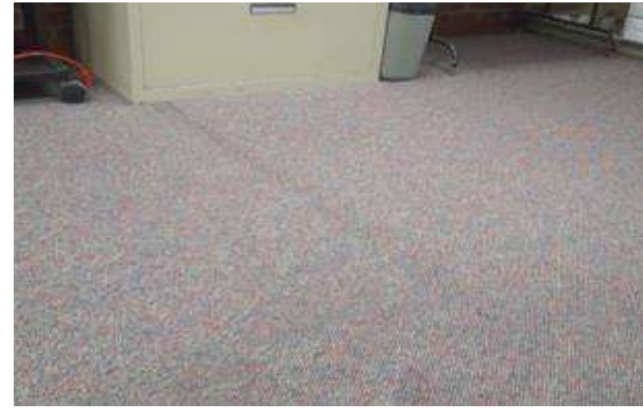
Existing flooring

Removed and replace existing flooring. Flooring costs vary based on product type, thickness, and finish desired.

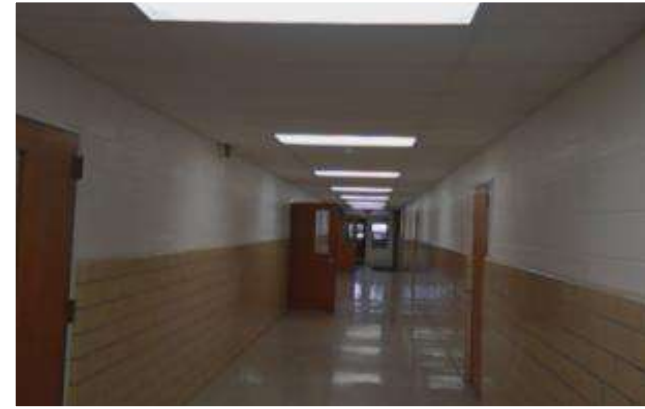
Existing wall finish

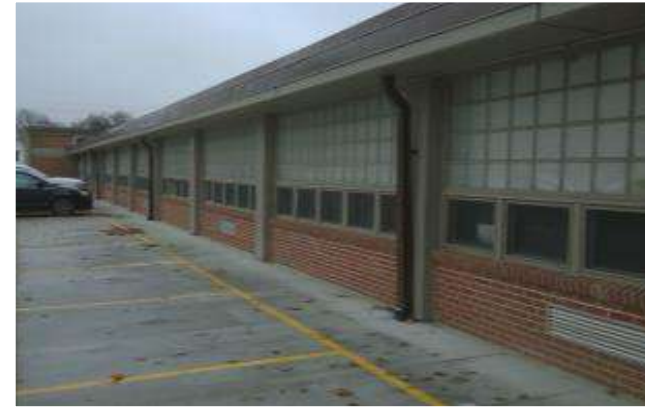
Existing exterior windows

Replace the existing with new energy-efficient exterior doors and windows.

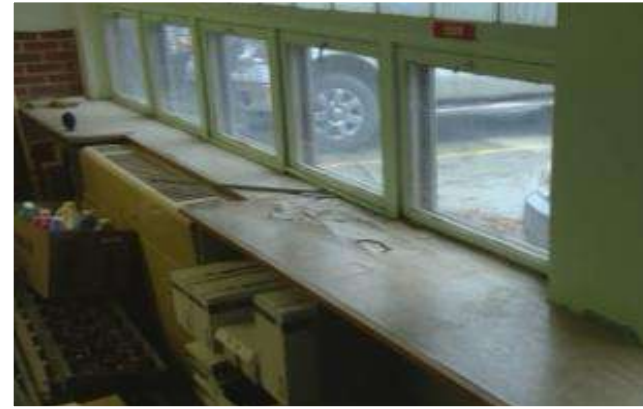
Existing casework

Remove and replace existing casework with new.

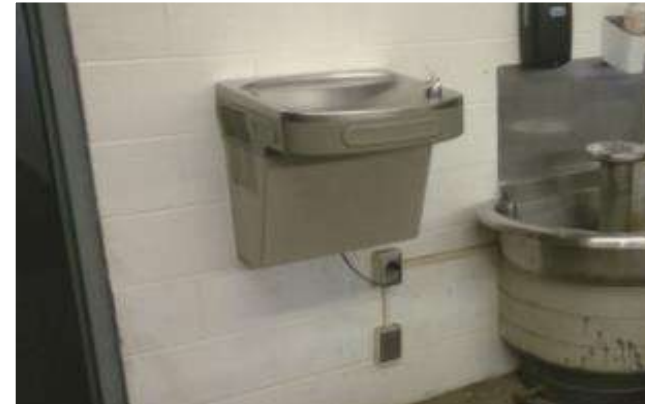
Existing water cooler

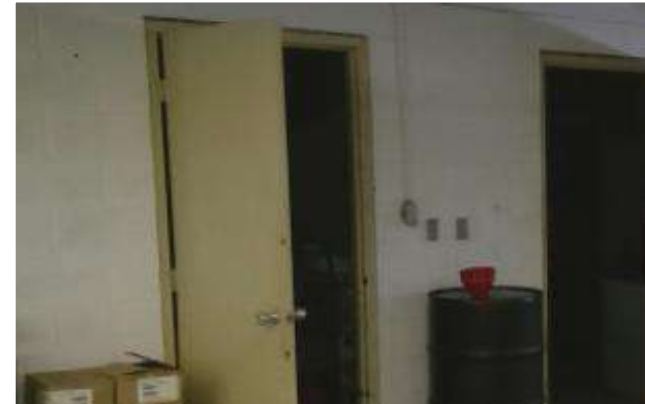
Existing door and hardware

Replace existing doors and hardware with new.

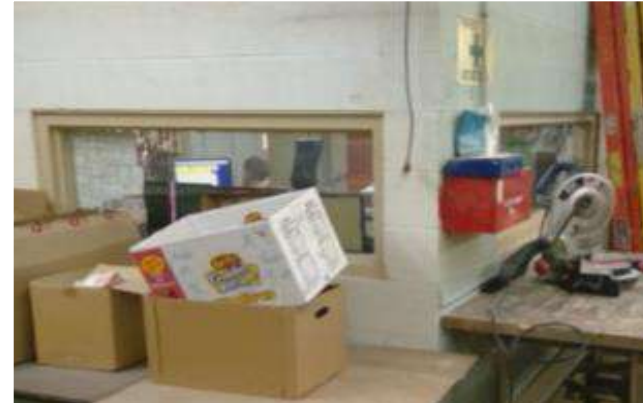
Existing glazing contains wired glazing and is no longer compliant with current building codes.

Existing non-compliant glazing

Replace the existing non-compliant glazing with new safety rated or tempered glazing.

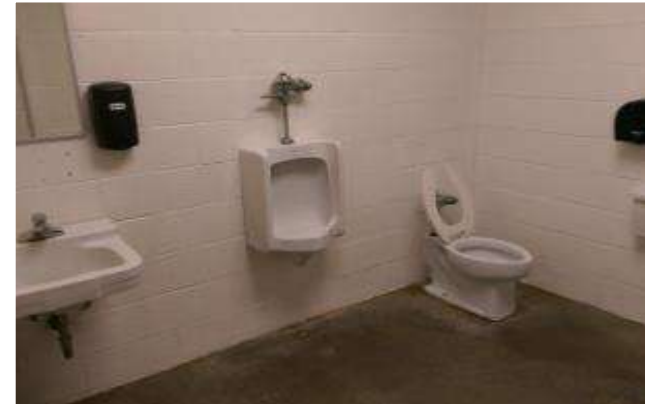
Existing conditions

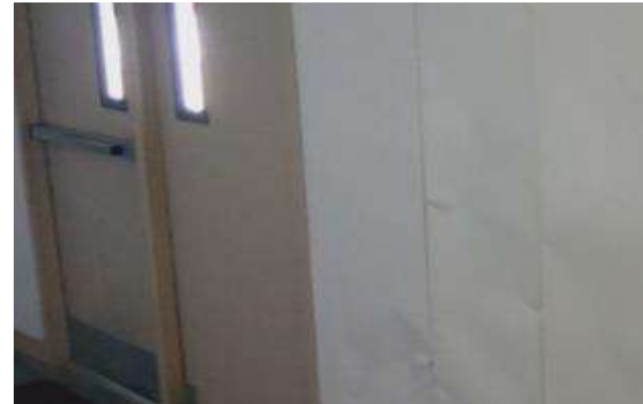
Existing exterior door

Replace existing exterior doors with new.

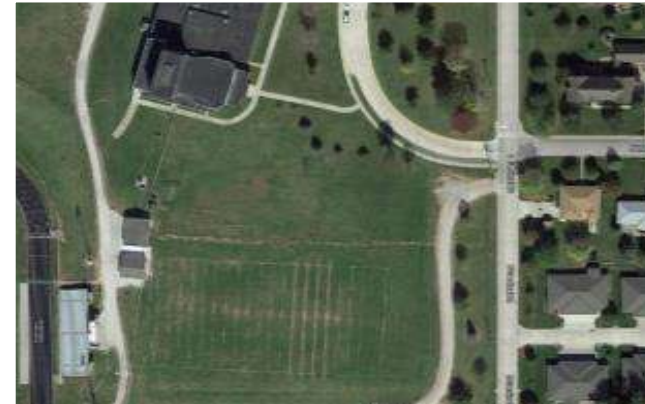
Area in need of additional parking

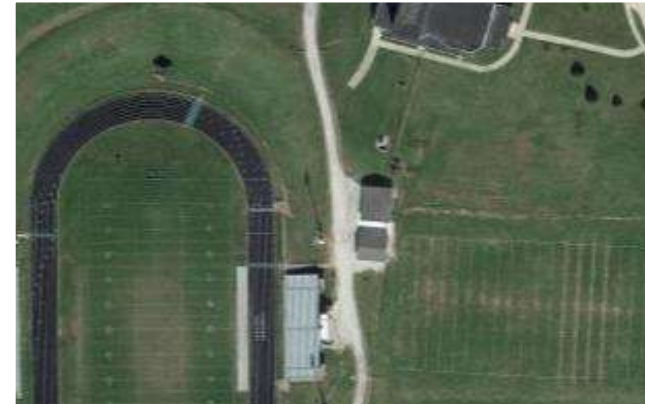
Existing athletic field

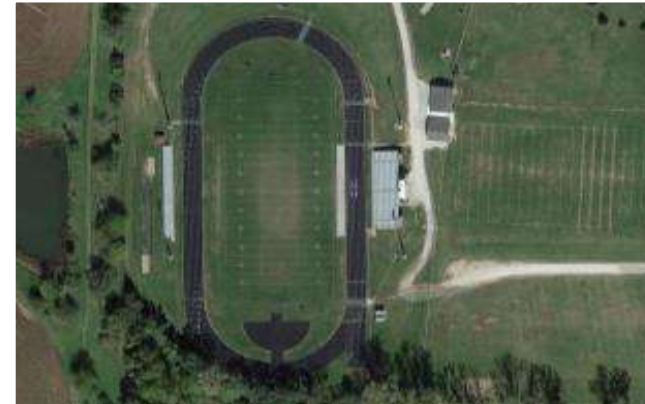
Existing athletic field

Replace the existing track and asphalt substrate with new, install new asphalt and athletic surface to "D" areas at each of the end zones.

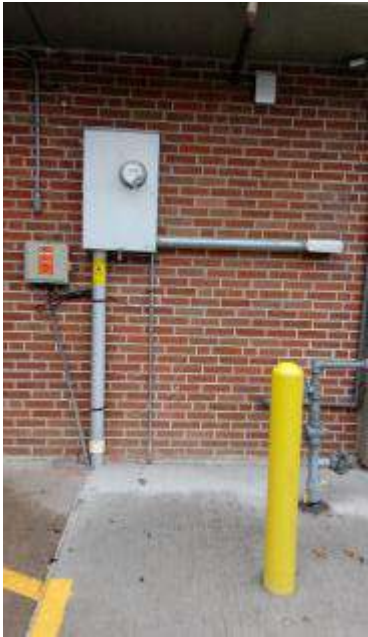
Picture E1

The electrical service to the Administration building is fed underground from utility poles that are located on the north side of the property [Picture E1]. The service comes into the building and feeds a wireway that feeds three panelboards and two disconnect switches in the electrical room [Picture E3]. The service is 240/120V, single phase. The majority of the service appears original to the building with two of the panels appearing to have been replaced more recently. There is an additional utility feed to existing outdoor lighting that is feed from an overhead utility line [Picture E2]. The controls conductors for the fixture appear to enter the building near the existing electrical room. There is a branch panel located in one of the office closets that appears to have been original as well. This branch panel does not have the code required working space due to closet shelving [Picture E4]. There is a second branch panel located in one of the administration offices that is located high on the wall [Picture E5] that used to feed an air conditioning unit in the window but now feeds the water cooler and several office loads. This panel does not have code required accessibility due to the mounting height of the panel. The receptacle feeding the drinking fountain in the hallway is not a GFCI receptacle [Picture E6]. There are no receptacles located in the restrooms near the sinks.

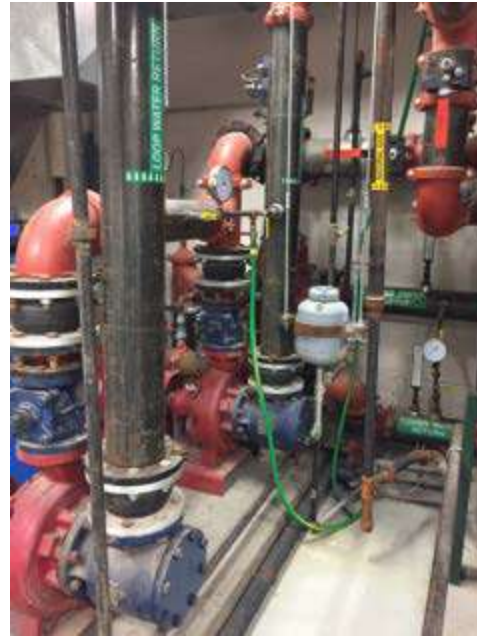
Picture M3

The secondary base-mounted loop water pumps which were replaced in 2008 operate on a lead-lag basis with one in operation and the other a 100% standby. [Picture M3] The pumps are 10 years old. The estimated median service life of this equipment is 20 years. Switchover between the two (2) pumps is manually performed. The pumps do not have variable frequency drives. The pumps circulate water to the various heat pumps.

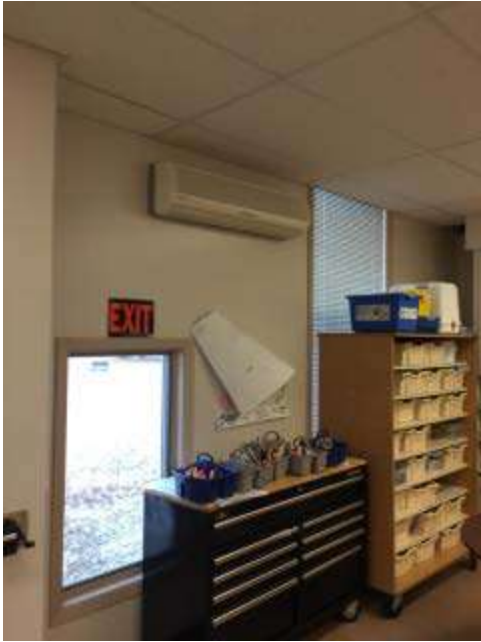
Picture M5

Each classroom is served by a split system (13 total). They were installed at varying times between 1997 and 2018. Each is replaced as they fail. [Picture M5]

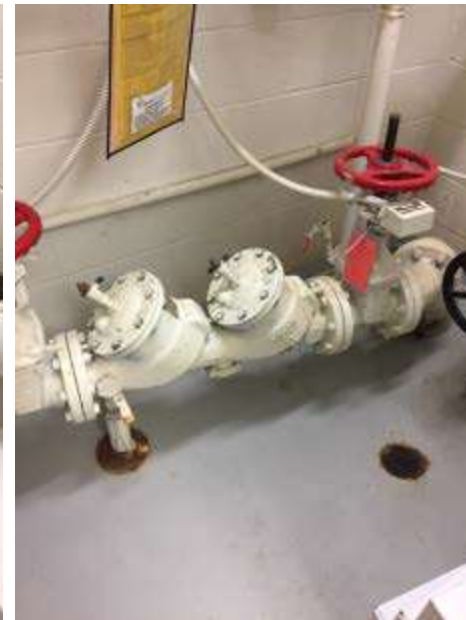
Picture M19

The west end of the Elementary School building is equipped with a fire protection sprinkler system. Incoming service in the Sprinkler Room is provided with a backflow preventer. [Picture M19]

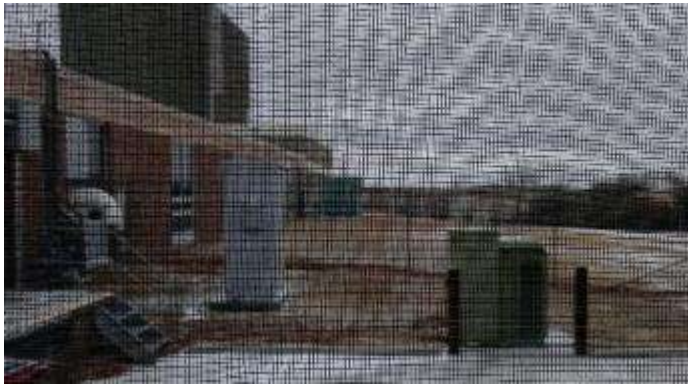
Picture E1

The High School electrical service is a 208/120V, 3 phase, 4 wire, 2,000A NEMA 3R panel that is located outside near the main electrical room. It is feed by a pad-mounted utility transformer [Picture E1]. It appears to have been installed with the most recent addition to the building. The newer service feeds an older 1200A, 3 phase, 4 wire, 208/120V fused switch that appears original to the 1968 portion of the building [Picture E2]. The branch panels are a mixture of newer and older panels, some of the panels in the older areas appear to have been replaced while others appear original [Pictures E4 through E6]. The main panel for the 1968 portion of the building is 1200A 208/120V freestanding panel [Picture E3]. In many cases items were stored in front of the electrical panels infringing on the code required 3'-6" clear space [Pictures E4 through E6]. The receptacles for the drinking fountains in a few areas in the building may need to be replaced with GFCI receptacles [Picture E7]. There were also power strips and heavily loaded floor boxes in the computer lab [Pictures E25 and E26] additional receptacles or power to the room may need to be considered. It was noticed on of the branch panels had a modified latch for the cover [Picture E27].

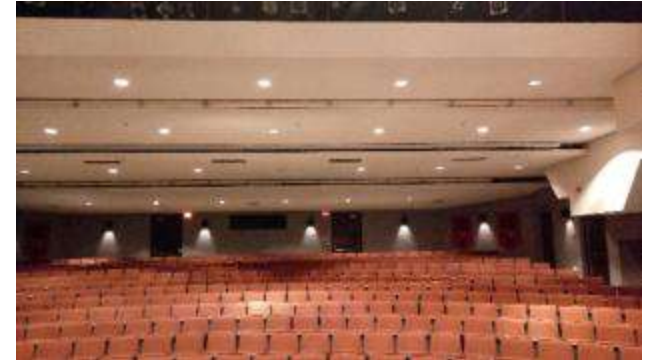
Picture E14

purpose lighting and accent T-12 fixtures [Pictures E14 through E15]. The school mentioned that they would like to update the theatre in the near future and update the lighting in this area. The T-12 fixtures had many bulbs that were in need of replacement, and the middle row had been removed during a previous project. The egress lighting was accomplished by battery powered wall pack fixtures in some of the commons areas, wrestling and various other locations. General lighting fixtures with battery backup are also used in some locations [Pictures E10 and E11]. Exit signs were located by the doors and throughout and appeared to be adequate [Picture E10]. Art room is missing an exit sign above the egress door. Back door located in the kitchen is also missing the code required exit signage.

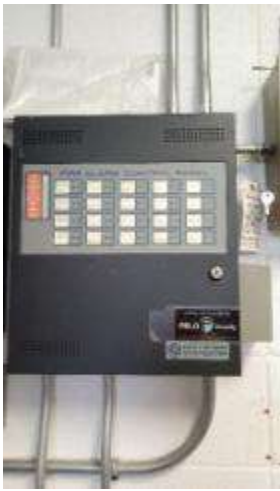
Picture E18

The existing fire alarm system is a Honeywell System with a Notifier main Fire Alarm Panel and Firelite and Notifier annunciators [Pictures E18, E20 and E21]. The addition for the theatre which was added in 1977 is the only portion of the building with a sprinkler system. Horn strobes, smoke detectors, and pull stations are also located in hallways and throughout the building [Picture E19 and E21]. Men's public restroom is missing a code required strobe device. Both restrooms near the theater are missing a code required strobe device.

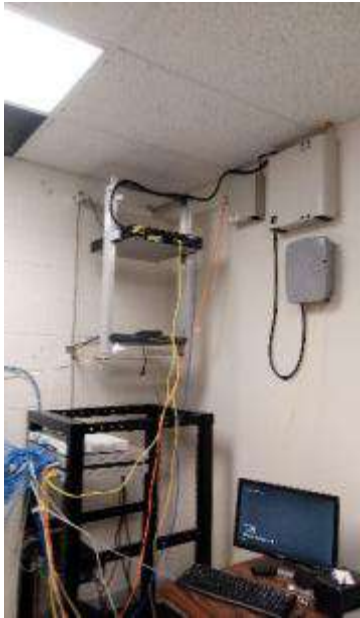
Picture 24

The data appears to be recently renovated throughout the building [Picture E24]. WIFI and data access points were noted as adequate by staff.

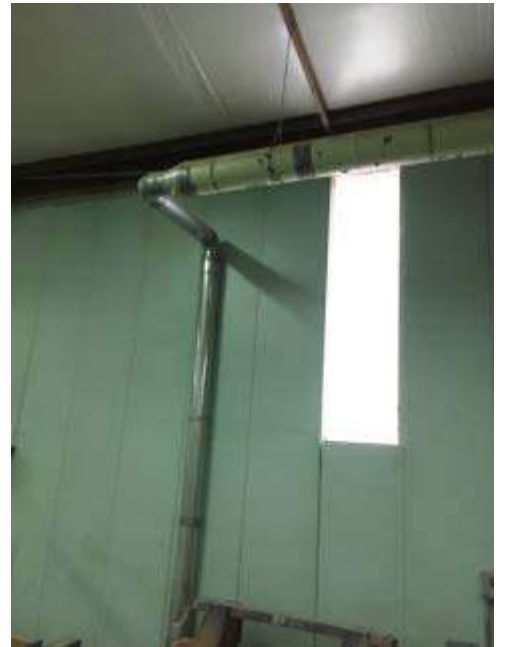
Picture M10

Various gases are located inside the building [Picture M10] along with blowdown of dust from the dust collection system, flammables, and dust accumulation everywhere creates an environment in the woodworking area that is susceptible to fire and explosion.

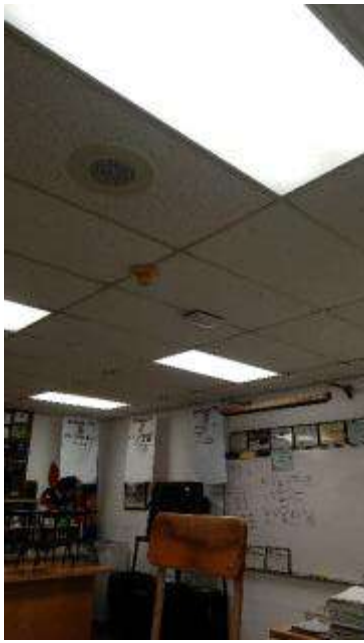
Picture E5

The classroom had WIFI access and it was noted by staff as adequate for the building [Picture E5].

The PA system consists of speakers that are fed from the system that feeds the main building of the high school [Picture E5]. The school expressed wanting to upgrade to a web based system. If the high school system is upgraded the Vocational Building would need to be re-fed by the new system as opposed to the existing switched PA system currently in use at the high school.
