JESUP COMMUNITY SCHOOLS

Facility Assessment Report

July 2020

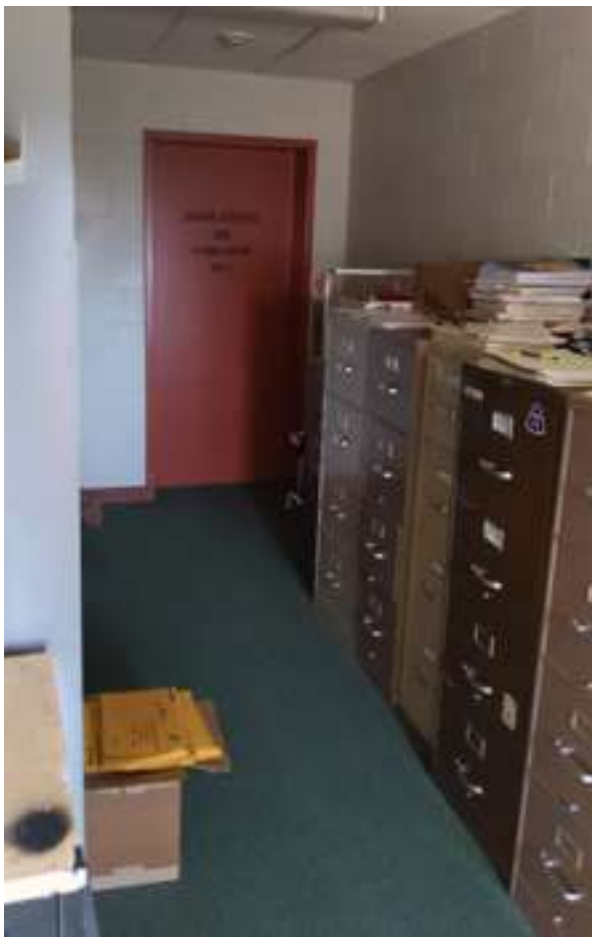
FIGURE 06 - Elevator connecting multiple levels - not all doorways to elevator are accessible. Storage blocking accessible route

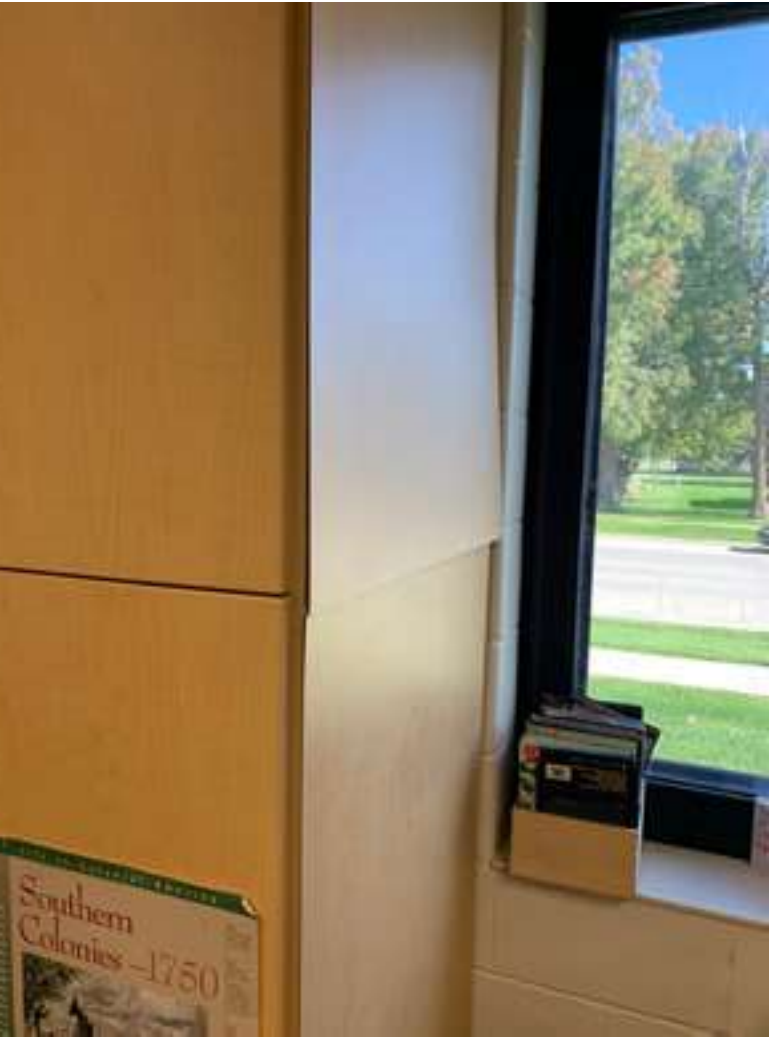
FIGURE 07 - Storage cabinet delaminating

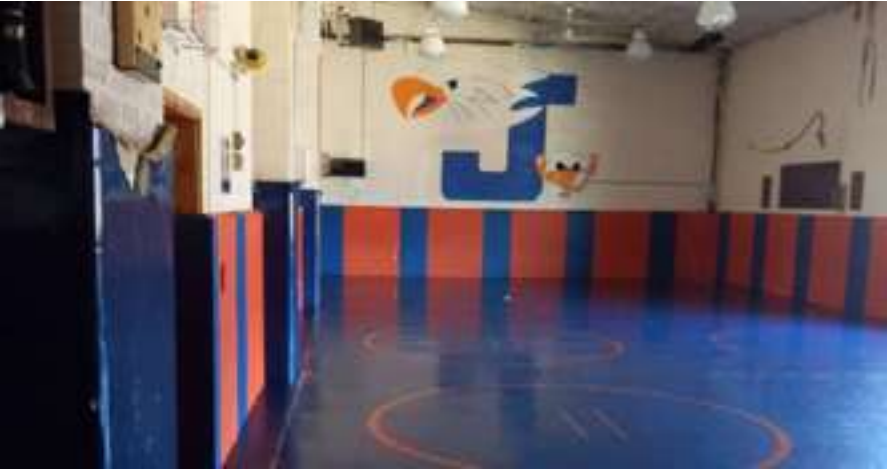
FIGURE 08 - Wrestling room mats peeling at wall

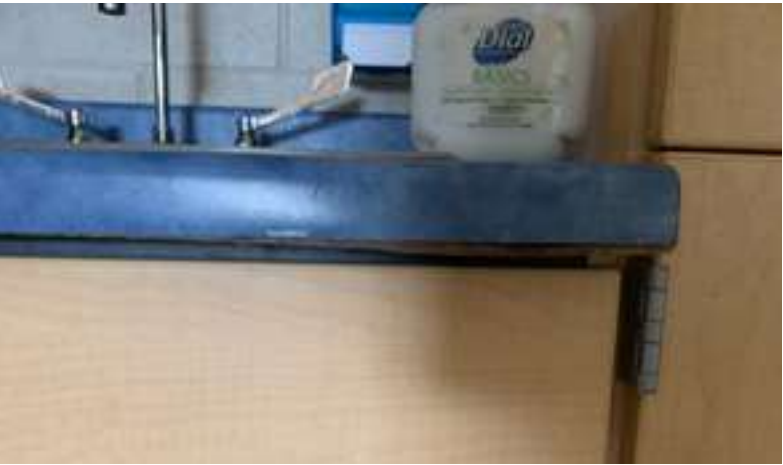
FIGURE 11 - Delaminating counter top

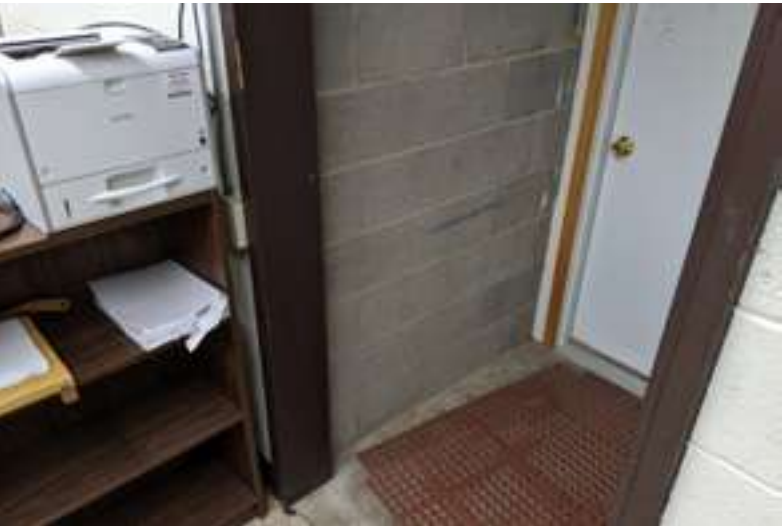
FIGURE 13 - Non-accessible entrance to classroom

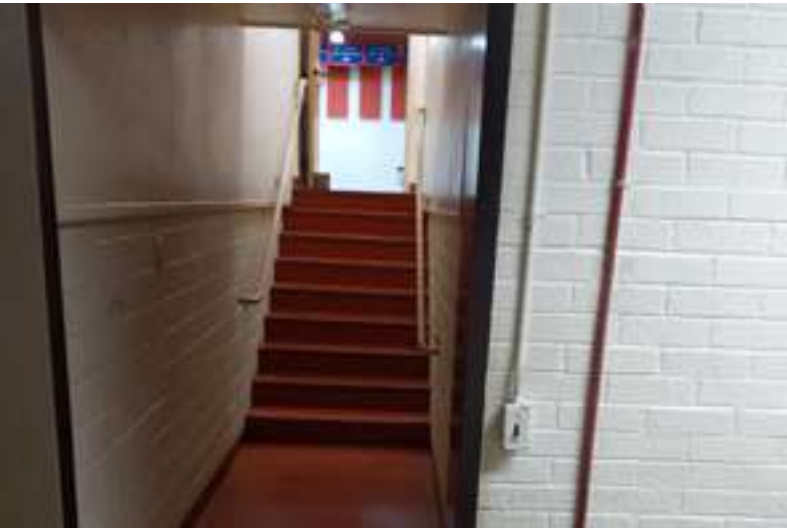
FIGURE 33 - Non-accessible route from locker room to gym

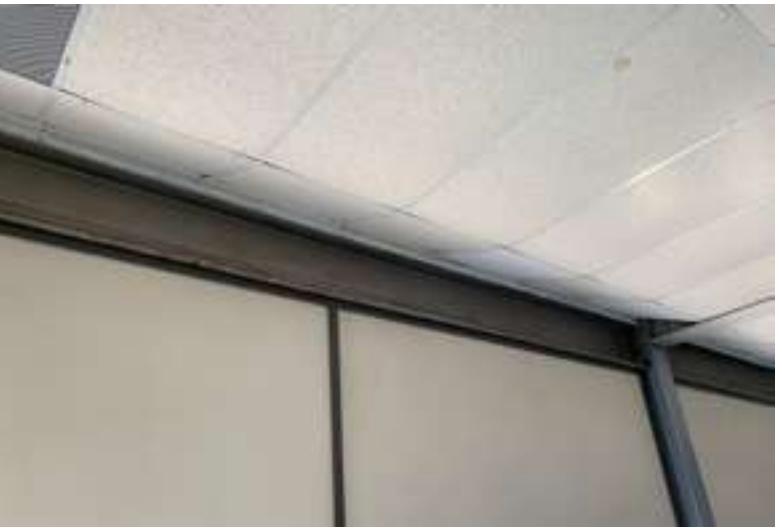
FIGURE 34 - Exposed metal structure at classroom - possibly uninsulated and may need fireproofing/sprinklered

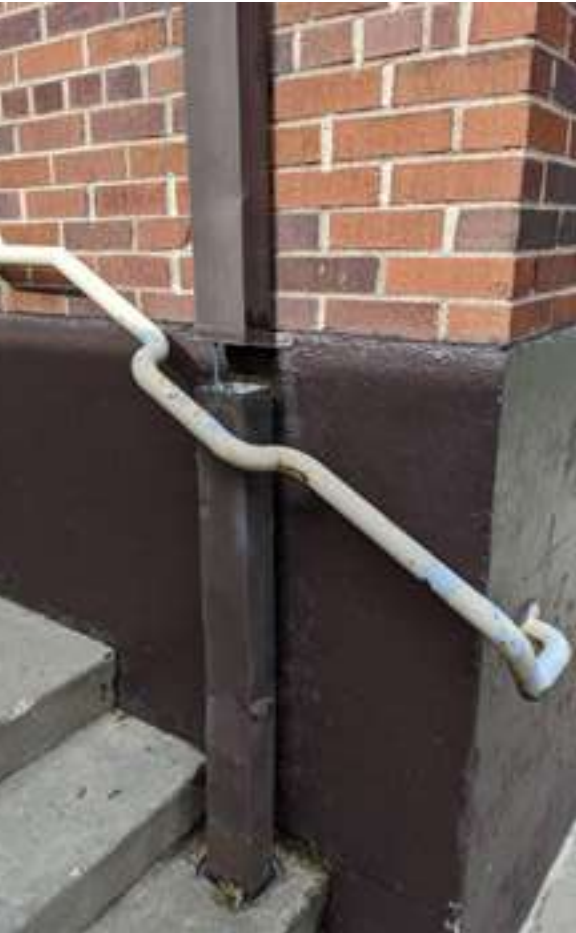
FIGURE 49 - Disconnected downspout

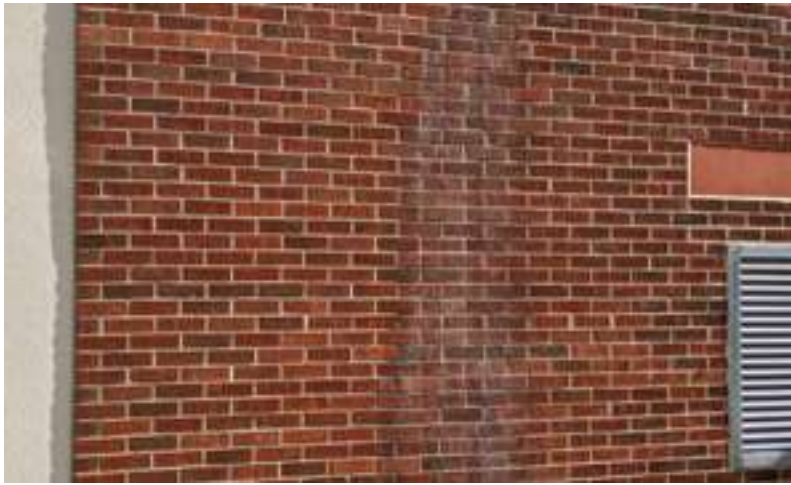
FIGURE 54 - Water damage at mechanical unit louver and piping

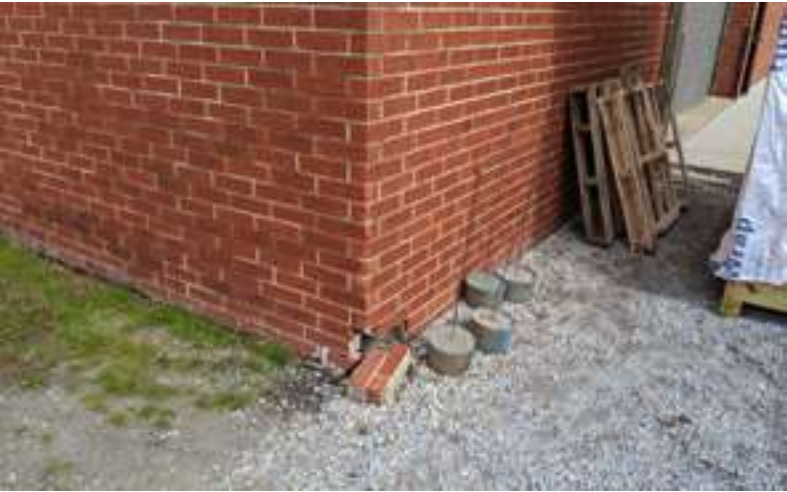
FIGURE 61 - Brick deteriorating at Ag building bas
